Geomorphic Analysis of the Main Channel of the Golf Club of Kansas Site in Lenexa, Kansas

By: Dr. Robert T. Pavlowsky
May 22, 2007

This report describes the geomorphic condition and stability of the main stream channel draining the Golf Club of Kansas Site in Lenexa, Kansas. It is prepared for Olsson Associates by Dr. Robert T. Pavlowsky of the Ozarks Environmental and Water Resources Institute at Missouri State University. The information provided in this report was provided by on-line sources, Olsson Associates, and fieldwork at the site by Pavlowsky and three staff on April 11-12, 2007. This report provides data and professional opinion to support the restoration planning and channel design for the site.

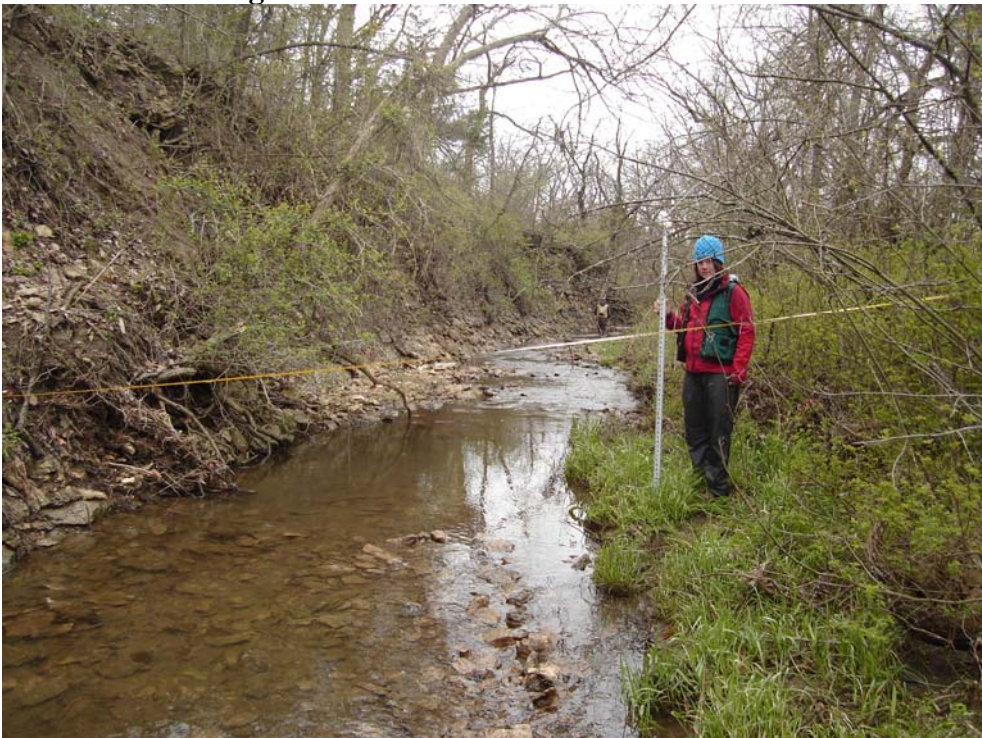
>30+00 ft: Adjacent property that is relatively undisturbed (Pictures 1 to 4)

Picture 1. Looking upstream at distance 3146 ft.

Picture 2. Cutbank at distance 3120 (Ladoga Soil Series)

Picture 3. Cutbank at distance 3106 (Kennebec Soil Series)

Picture 4. Looking downstream at distance 3030

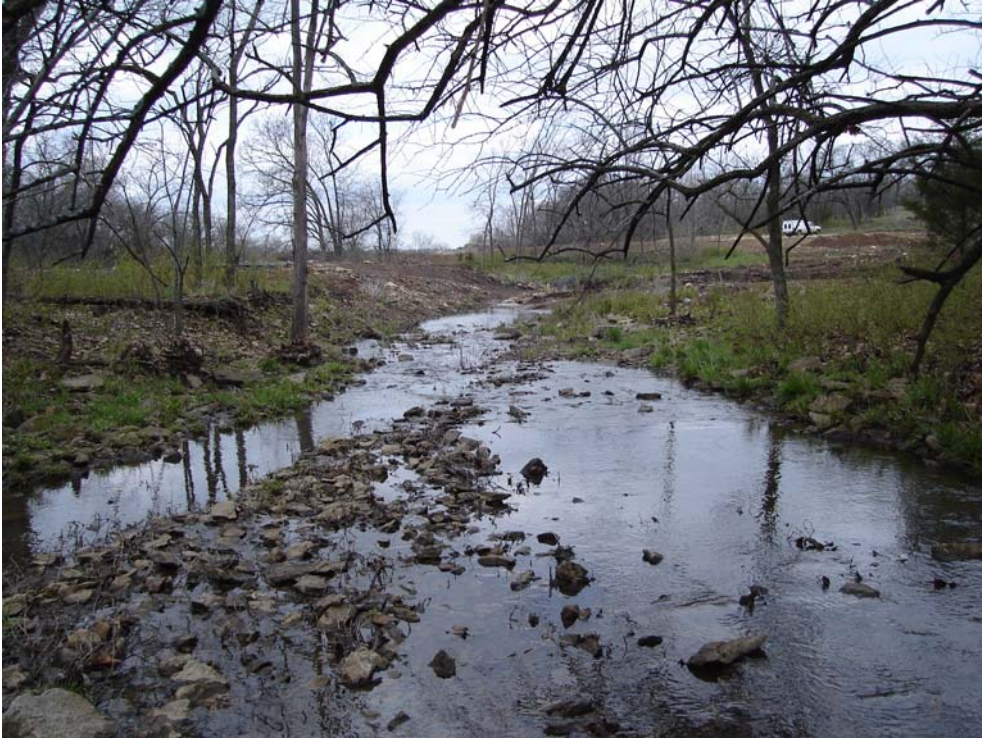
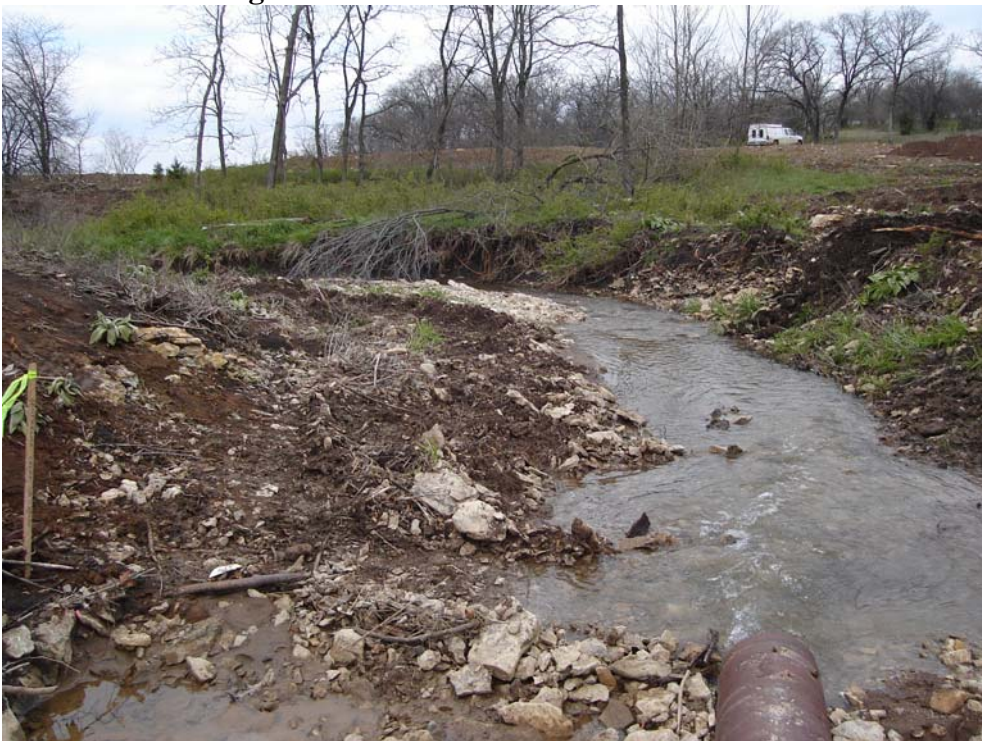
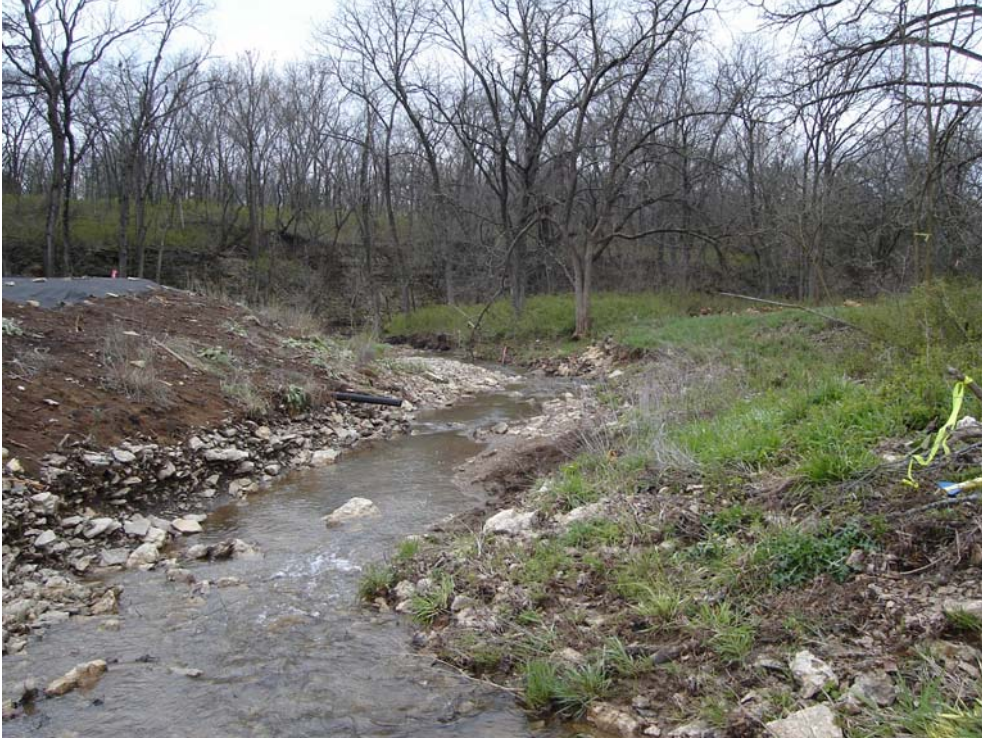
30+00 to 26+00 ft: Somewhat disturbed area around the 13th green (Pictures 5 to 7)

Picture 5. Looking downstream at distance 2944

Picture 6. Looking downstream at distance 2800

Picture 7. Looking downstream at distance 2696

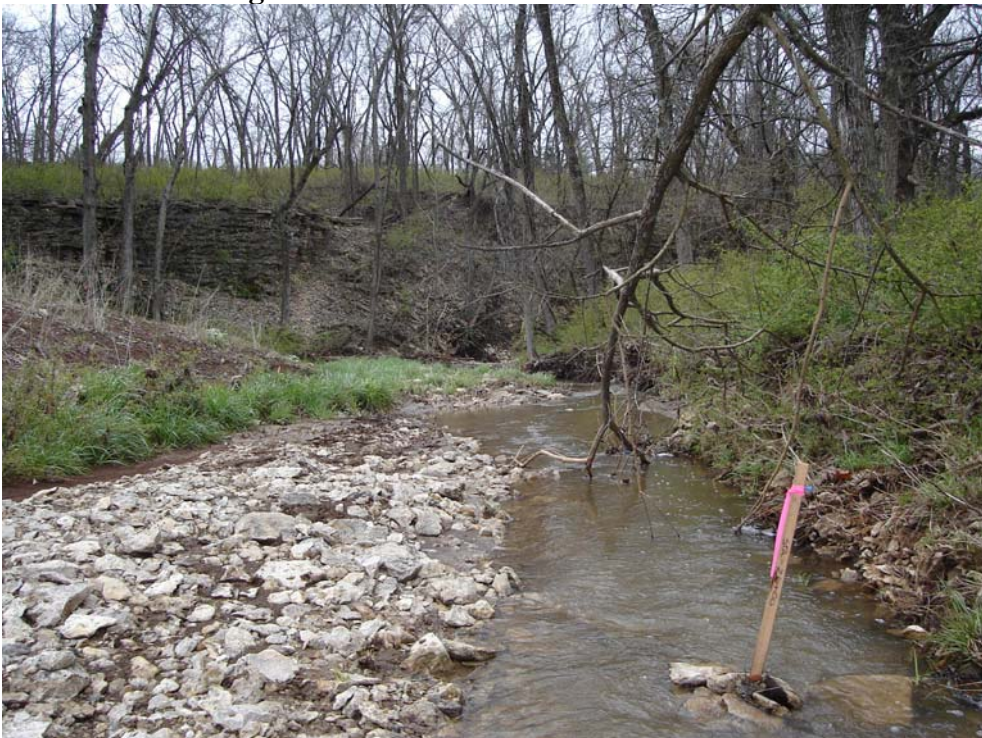
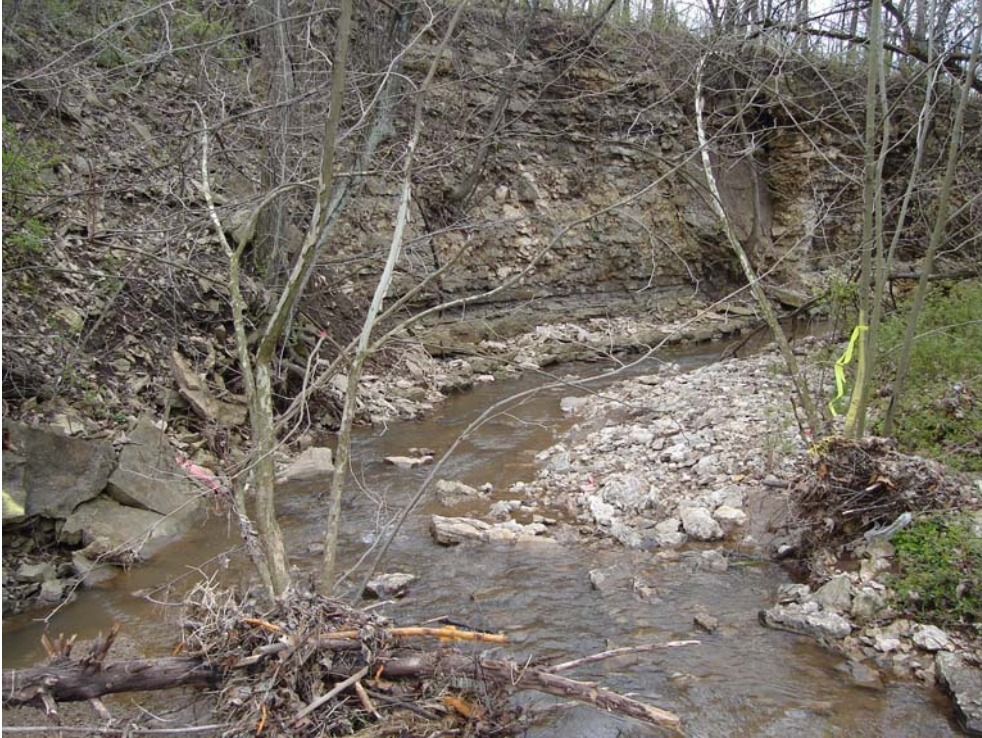
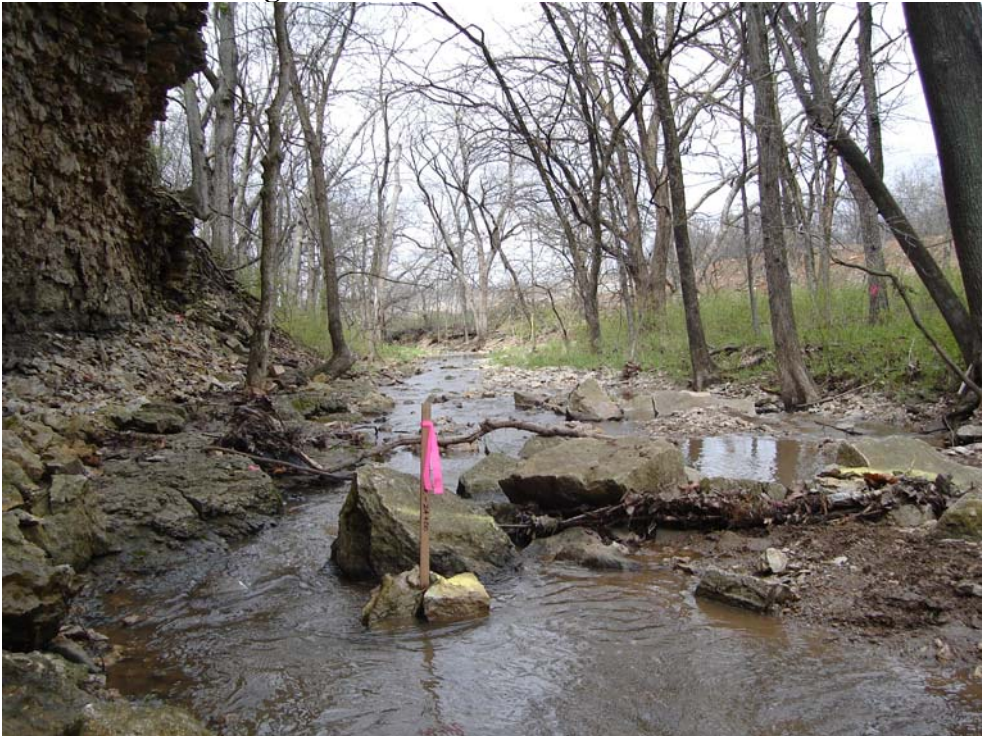
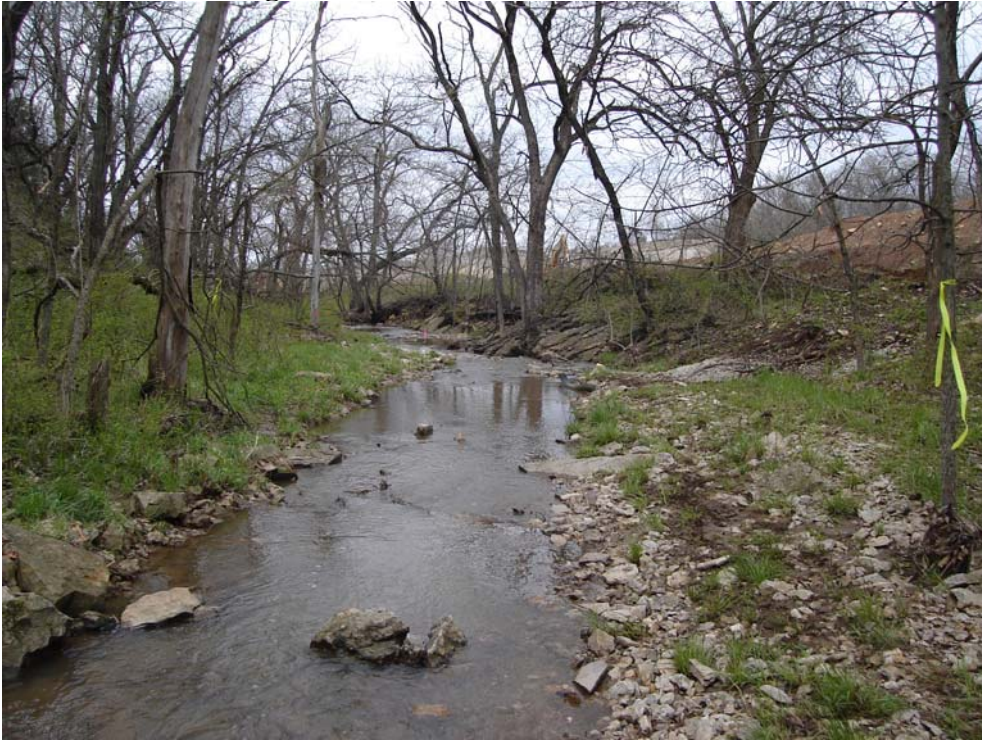
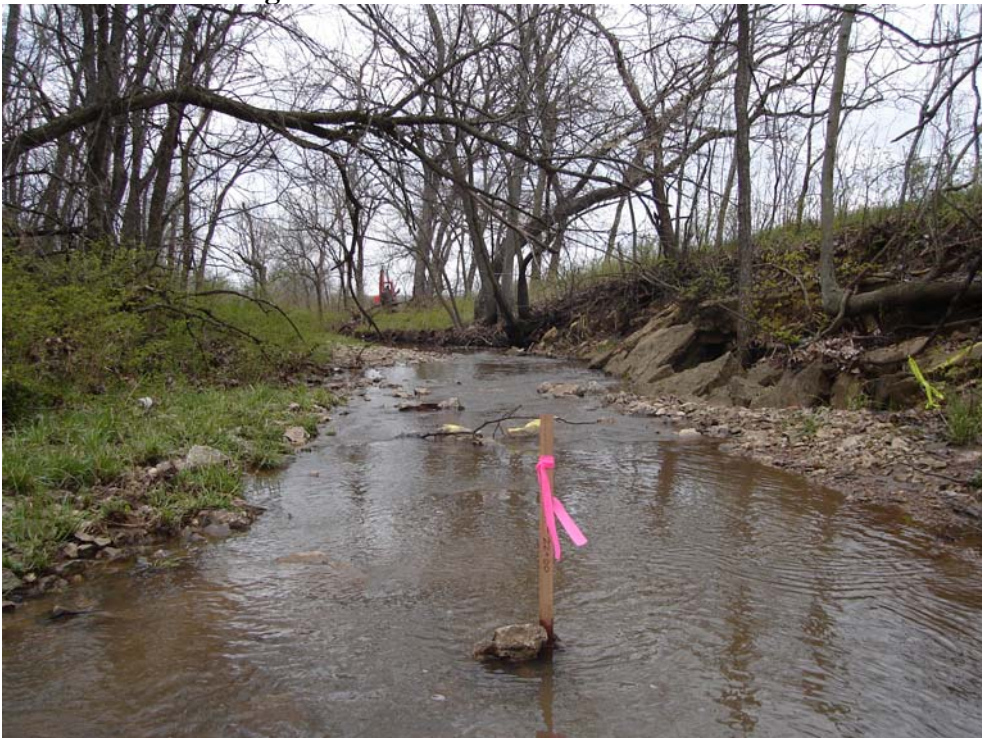
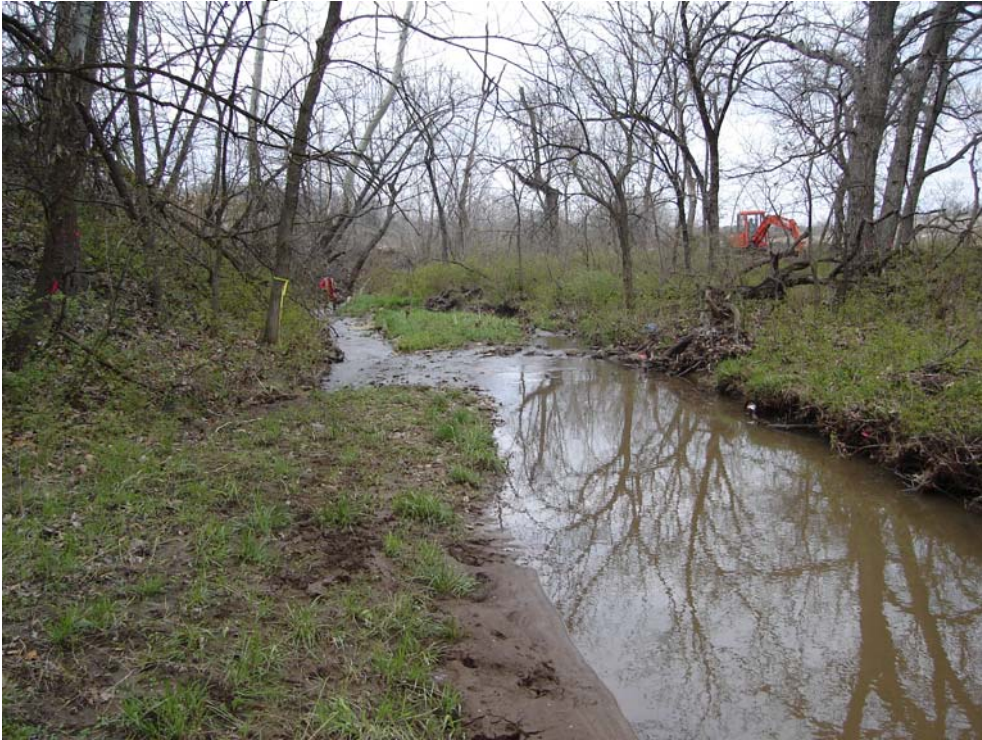
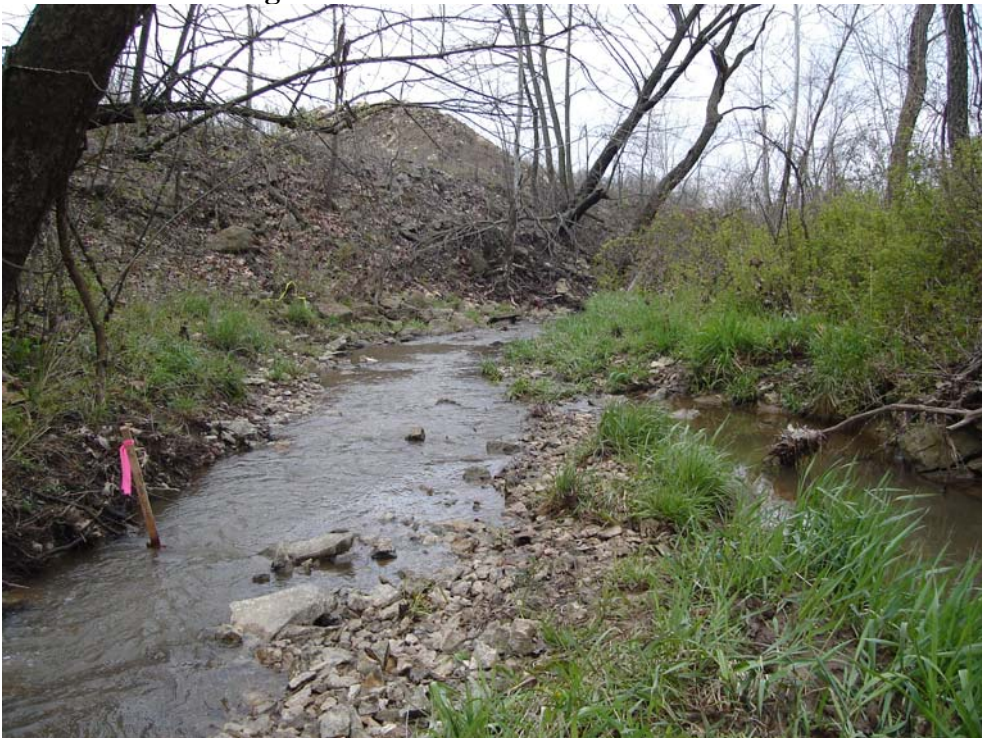
26+00 to 20+50 ft: Reference reach with relatively intact riparian corridor (Pictures 8 to 14)

Picture 8. Looking downstream at distance 2600

Picture 9. Looking downstream at distance 2500

Picture 10. Looking downstream at distance 2400

Picture 11. Looking downstream at distance 2300

Picture 12. Looking downstream at distance 2200

Picture 13. Looking downstream at distance 2100

Picture 14. Looking downstream at distance 2000

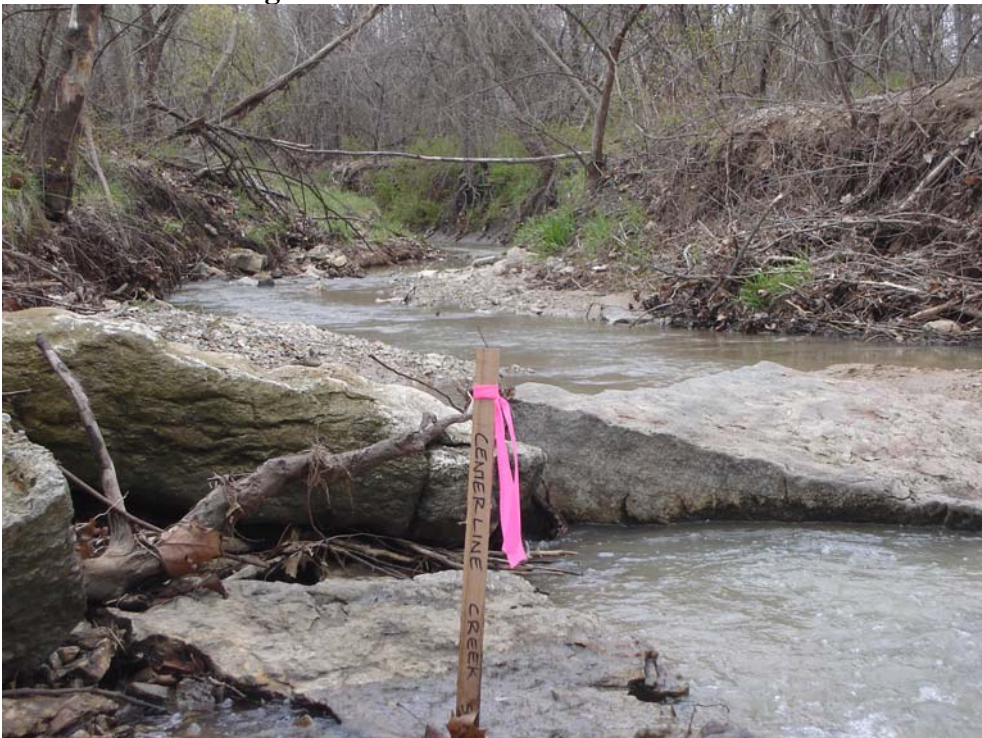
Picture 26. Looking downstream at distance 0

0+00 ft: End of stationing downstream of main road (Picture 26)
