The Ozarks Environmental and Water Resources Institute (OEWRi)

PRE-CONSTRUCTION REPORT FOR THE WARD BRANCH STREAM RESTORATION PROJECT

November 14, 2007

OEWRi EDR-07-004

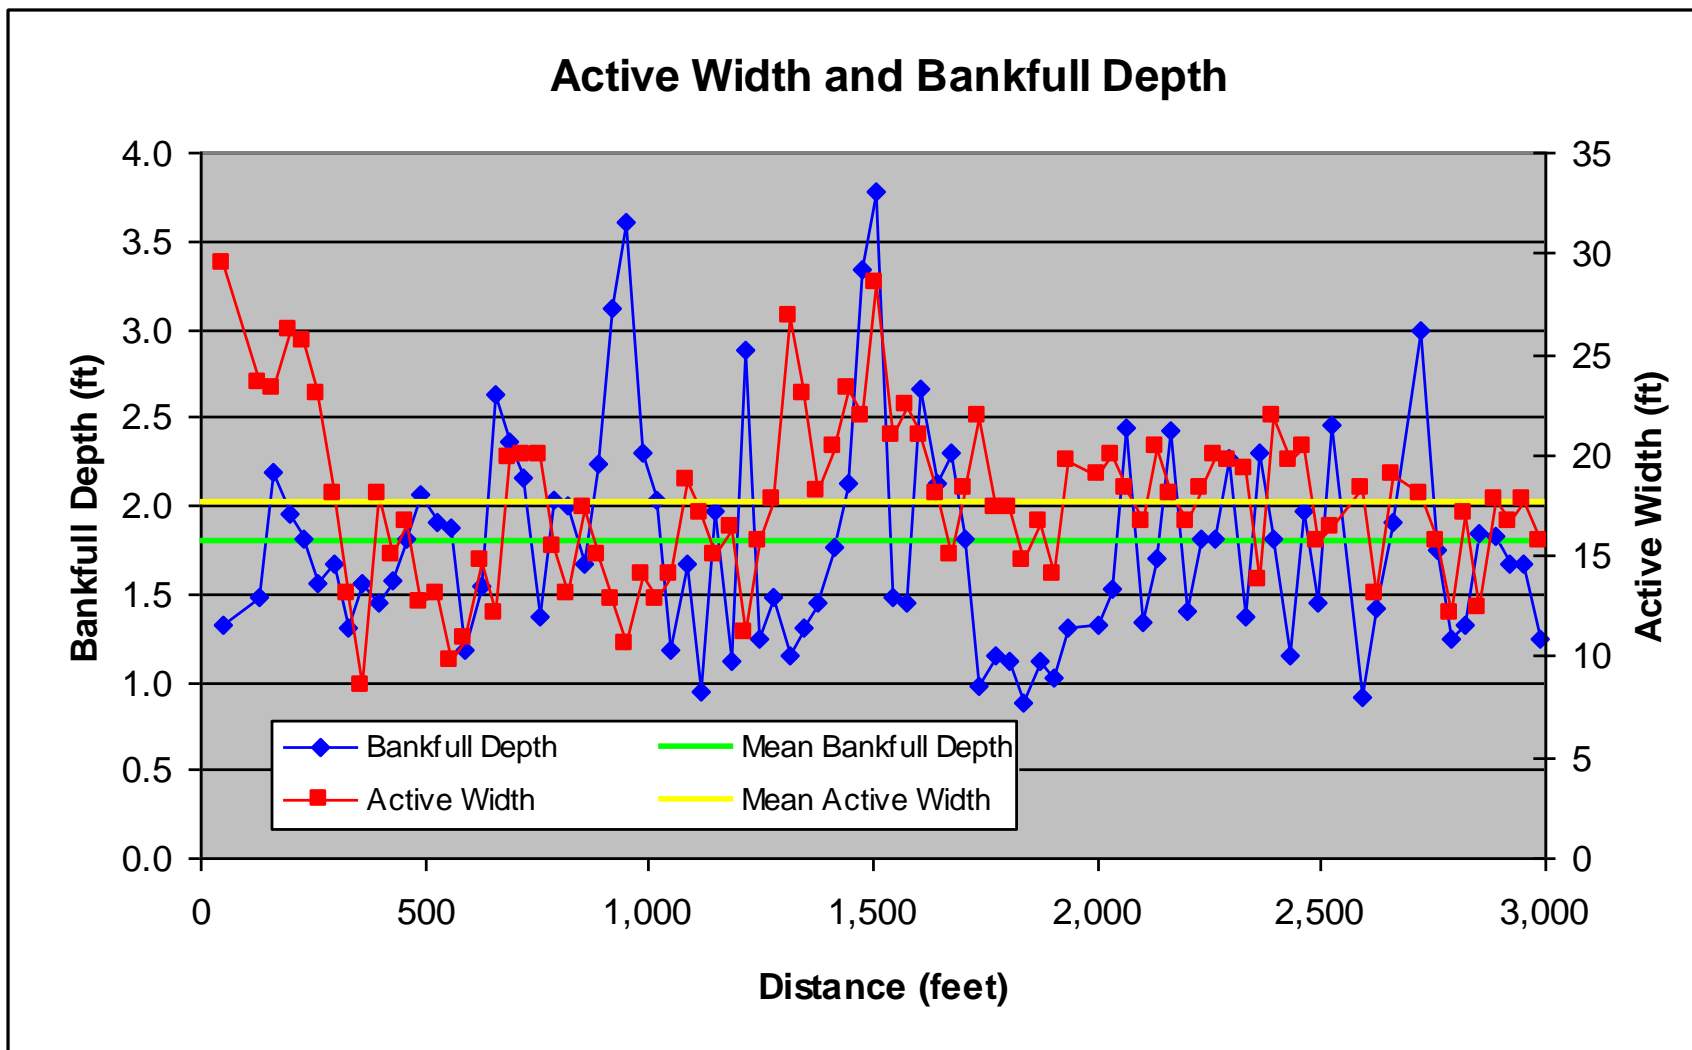
Figure 4. Bankfull Depth and Active Width

The mean bankfull active width for the entire study reach is 17.7 feet (Figure 4). Higher active bankfull widths are found below the Republic Road culvert from 0-200 feet and in the meander sections of the disturbance reach at stations 1,300-1,500 feet. High widths found below the culvert are probably due to construction of the culvert, but the high widths in the disturbance reach are probably due to a geomorphic response. In this section, sediment transport potential should be low and sediment accumulation would be expected causing flow to spread against the banks and widening the channel. Channel bend increases shear against the steep high banks.

The average bankfull depth of this reach is 1.8 feet (Figure 4). High bankfull depths are found in the reach at stations 1,000 and 1,500 feet. High bankfull depths indicate areas

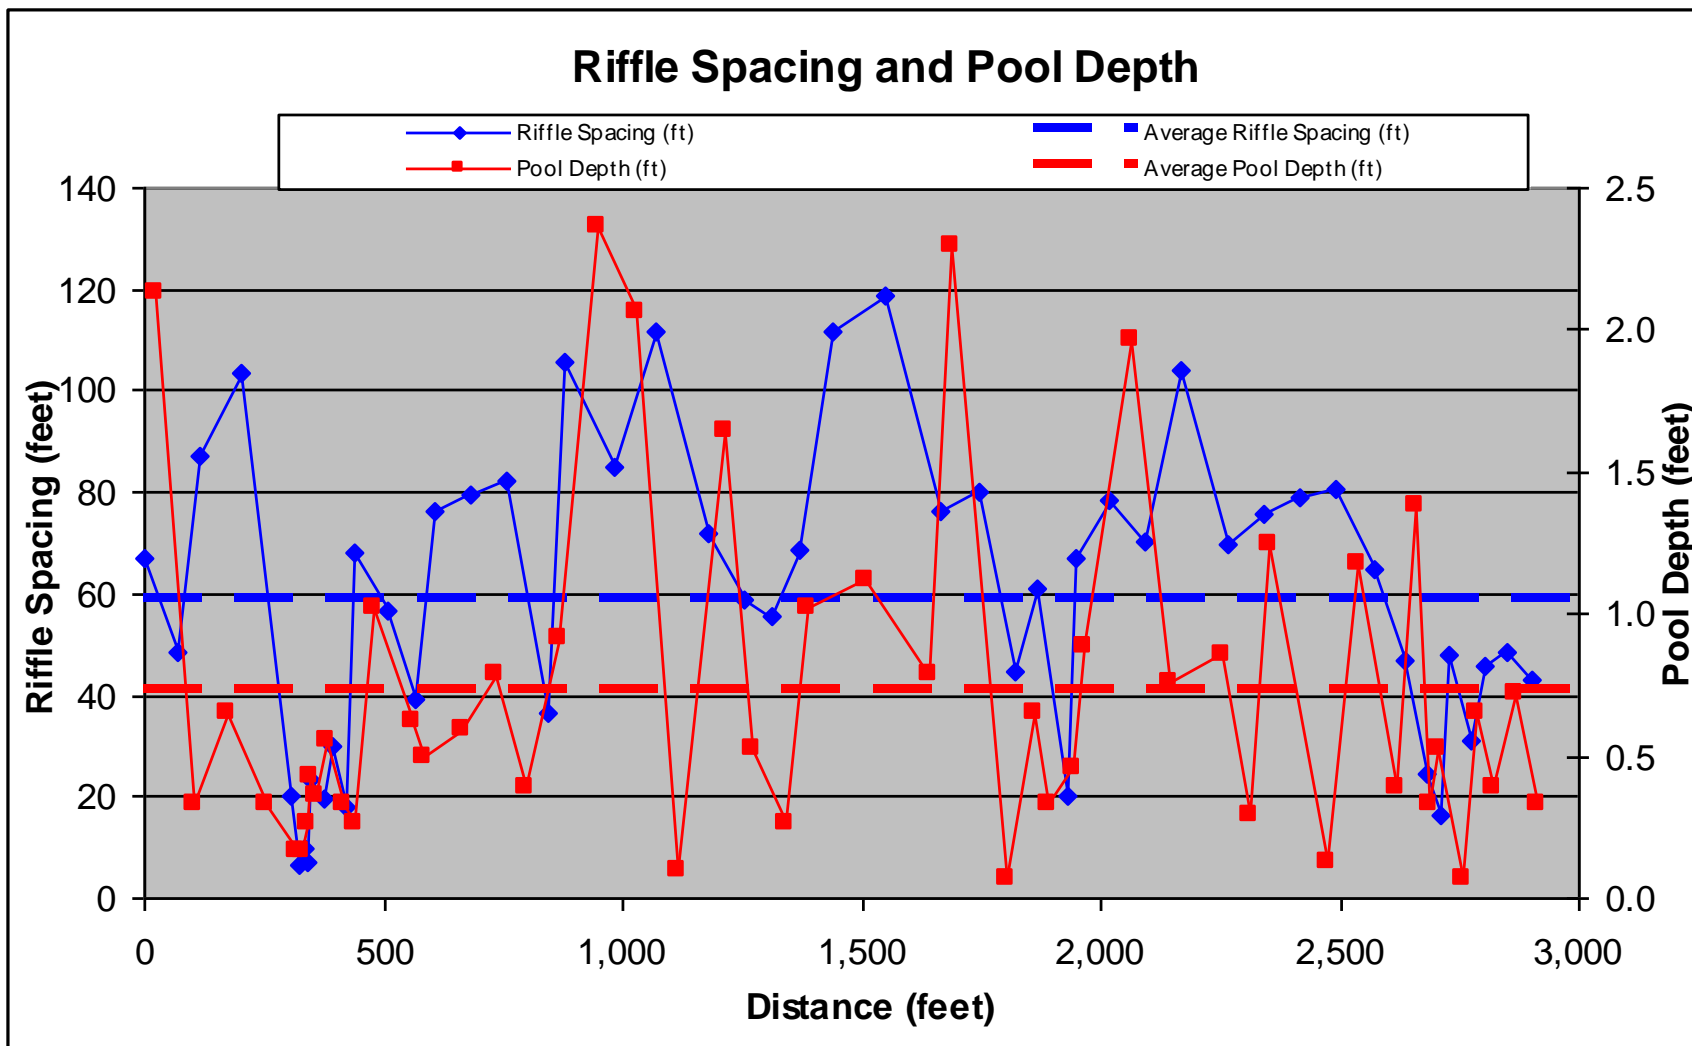
Figure 5. Riffle Spacing and Pool Depth

Fifty riffles and fifty pools were noted through the reach with an average riffle spacing of around 59 feet and an average maximum residual pool depth of 0.73 feet (Figure 5). Relatively short riffle spacing and low maximum residual pool depths are found together through the steep reach between 300 and 500 feet, upstream of the first bridge at Holland Ave, and below the Camino Bridge in the bedrock controlled reaches. High riffle spacing and high pool depths are found below the steep reach between 800 and 1,100 feet on the longitudinal profile. Since the distribution of these bedforms does not appear to follow a discernable pattern, the elevation of bedrock in the stream seems to be the chief factor influencing the variability of riffle spacing and pool depths. Therefore, these data are not recommended to be used in the design. Appendix C is an inventory of pools and riffles along the reach.

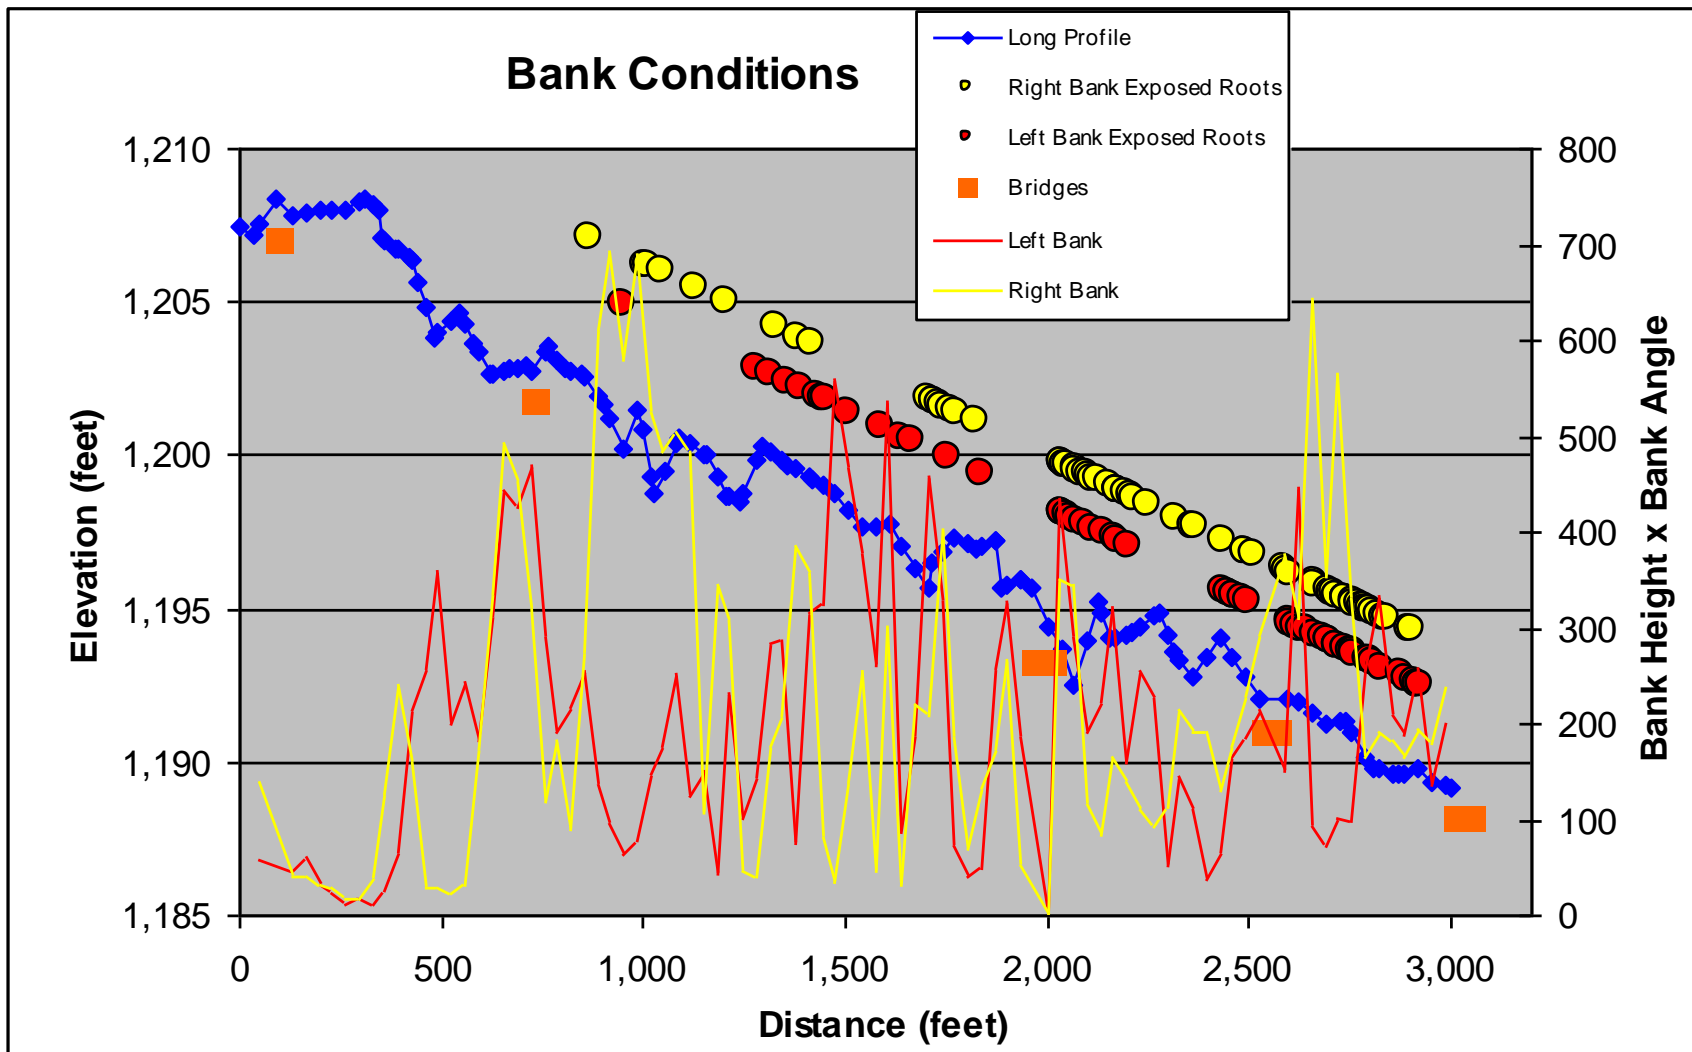
Figure 6. Bank Conditions

Relatively high BCI numbers for right banks are found at stations 800-1,200 and 2,600-2,800 feet on the longitudinal profile (Figure 6 and Photo 6). These two areas were also identified above in the channel survey section, but the BCI highlights these areas as significantly higher potential for erosion compared to the rest of the reach. Moderately high banks are found between 600-800 and 1,400-1,700 feet on the profile. Moderately high banks are also found directly below the first bridge at 2,100 feet along the profile, but seem to be a localized problem due to the bridge. Alternating high and low BCI scores indicate the lower floodplain and point bar formation on the inside of a bend with

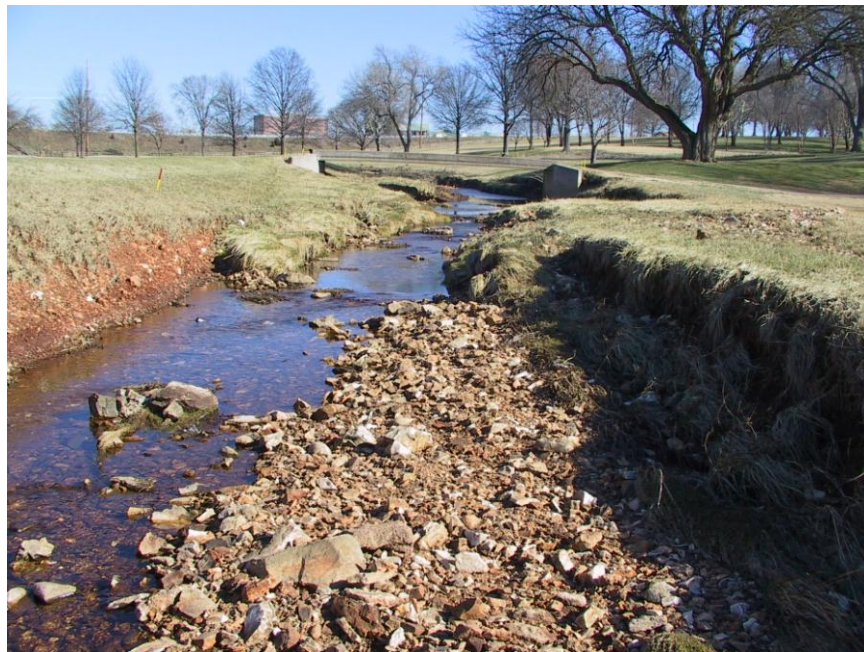
Photo 2. Bottom of steep reach at station 800 feet

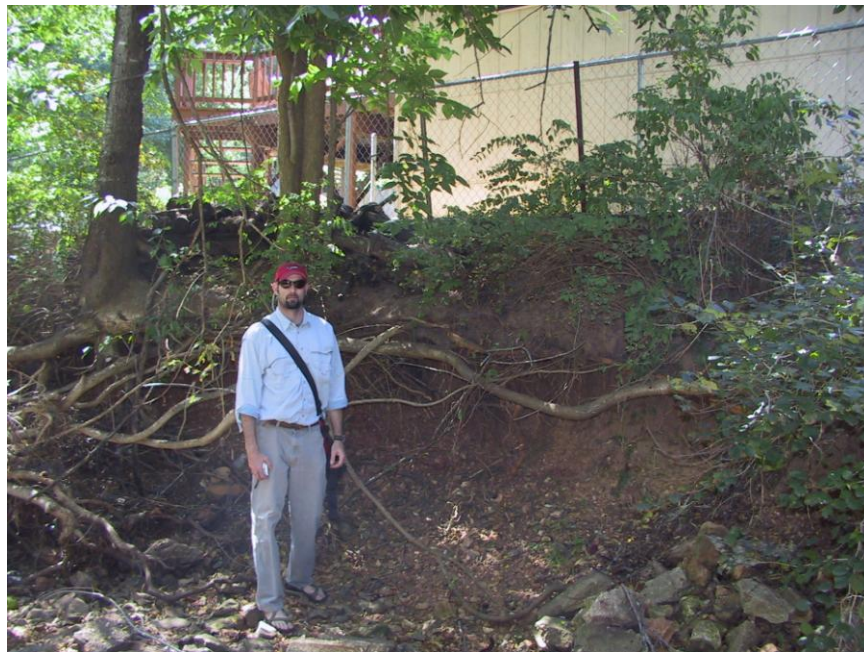
Photo 6. High right bank at station 2,700 feet

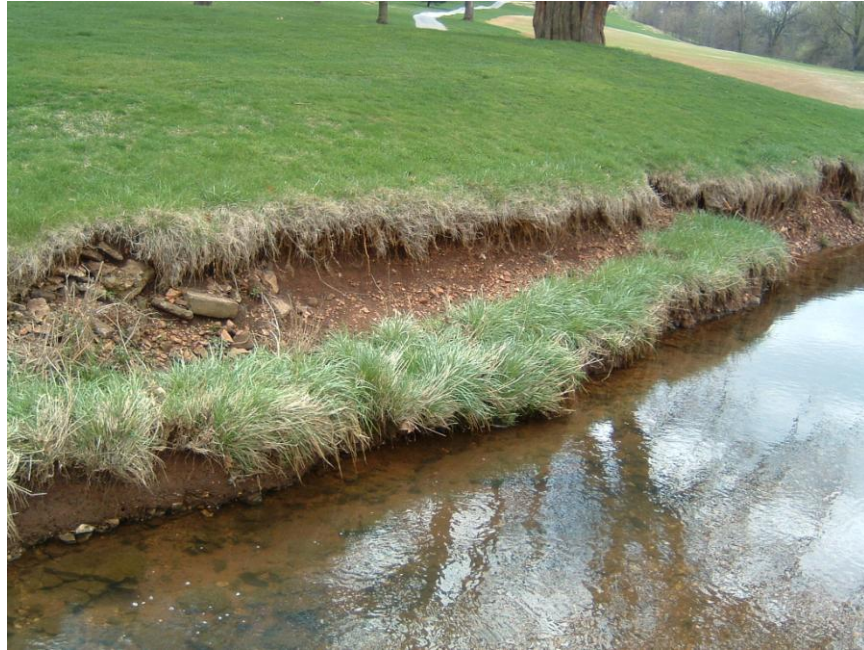
Both sides of the stream above 800 feet have no exposed roots in the bank indicating poor riparian conditions (Photo 7). This section goes through the golf course where trees have been removed and replaced by turf grasses, with poor rooting depths. Sporadic, low density exposed roots are found between 800-1,300 feet through the golf course. Below 1,300 feet exposed root density increases with a few holes along both banks as seen in Figure 6. Data collected for the bank condition analysis can be found in Appendices E and F.

Photo 7. Bank failure due to poor riparian conditions in golf course reach

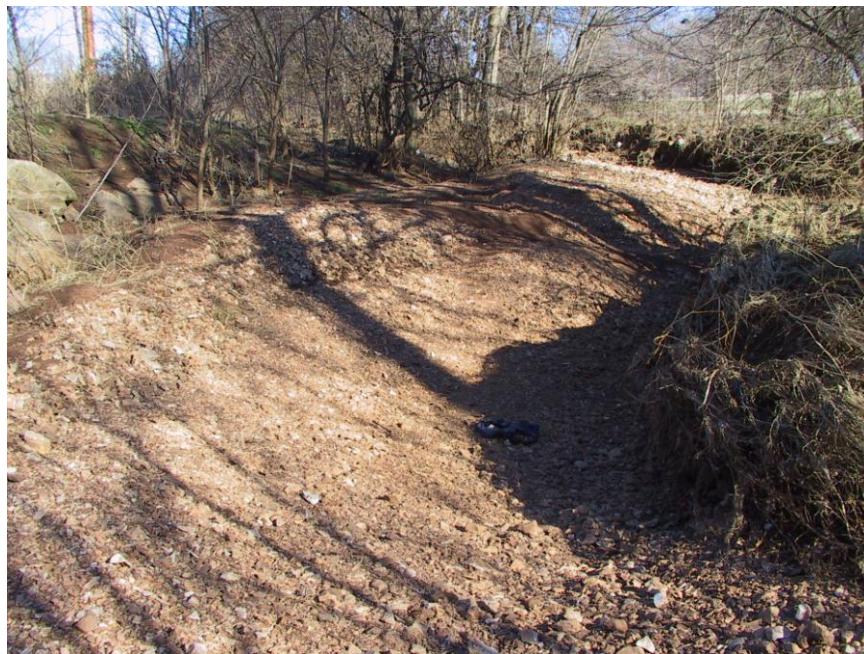
Over 1,000 pieces of sediment at 103 transects were measured along the study reach (Photo 8). Overall, the largest Dmax sediment sizes tend to be found in the upper 2,000 feet of the stream, which is above the first bridge in the subdivision (Figure 7). From station 2,000-3,500 the overall Dmax seems to be lower. This suggests sediment transport potential is higher in the upstream sections. The D50 however is relatively consistent through both the upper and lower section with the exception of the portion of the stream immediately upstream of the first bridge where slopes increase due to the scour hole formed at around station 2,000. The mean D50 was 40 mm (very coarse gravel) and the reach mean Dmax was 176 mm (large cobble). Data collected for bed material evaluation can be found in Appendix G.

Photo 8. Gravel accumulation in disturbance reach

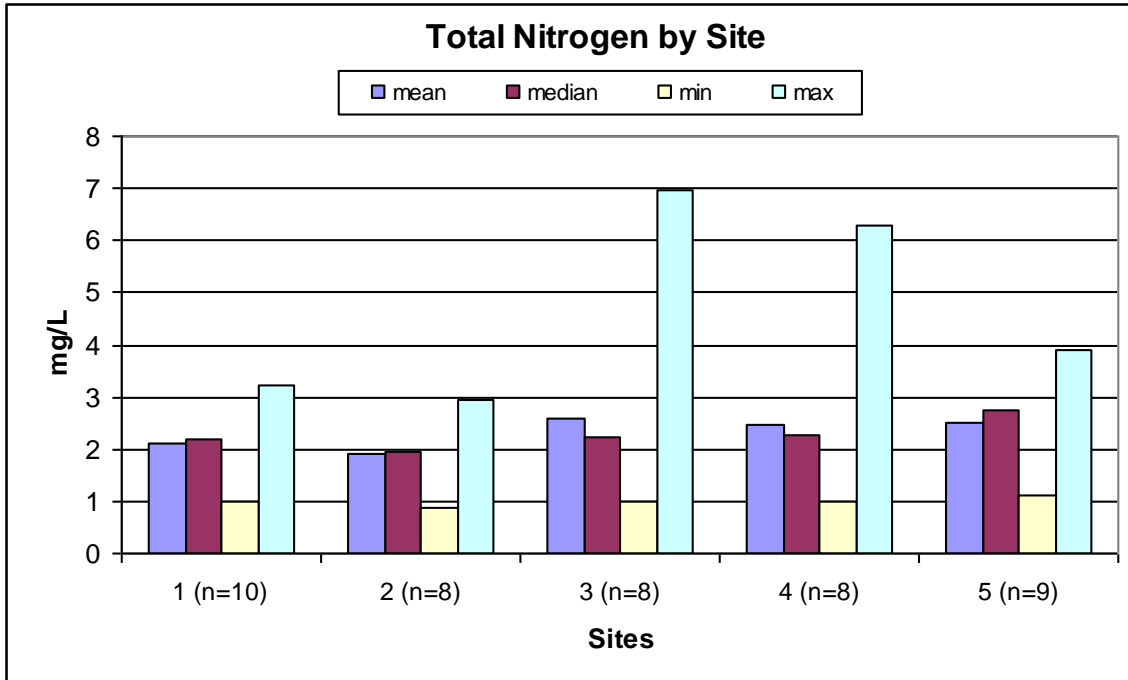
Figure 34. Total Nitrogen Data by Site

Mean TN concentrations for all 5 sites range from 2 to 3 mg/L (Figure 34). These concentrations are higher than the recommended concentration from the TMDL for the James River of 1.5 mg/L (MDNR, 2001). Median concentrations are similar suggesting extremes are not influencing the average concentrations. Maximum TN concentrations were as high as 7 mg/L and minimum concentrations came in near 1 mg/L TN. No downstream pattern exists when looking at mean concentration, but single high concentrations more than twice the mean were found at sites 3 and 4. Sites 3 and 4 are draining the subdivision property and both spikes occurred on October 31st of 2005.

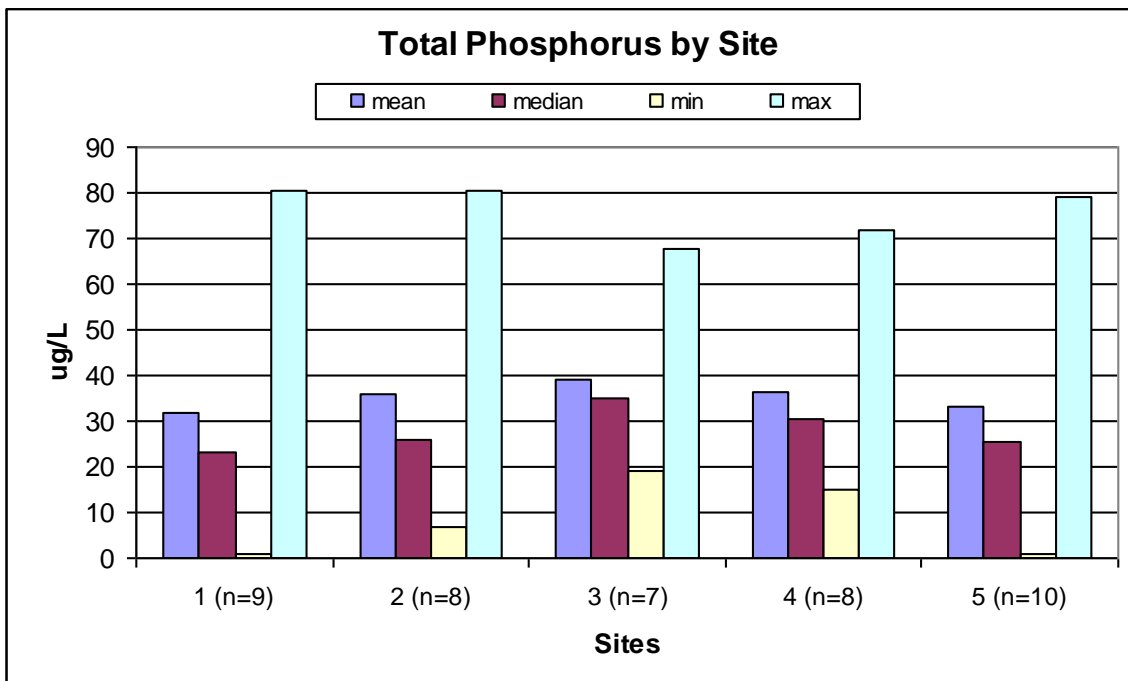
Figure 35. Total Phosphorus Data by Site

Mean TP concentrations for all 5 sites are between 30 and 40 ug/L (Figure 35). These concentrations are below the recommended concentration of 75 ug/L in the James River TMDL (MDNR, 2001). Median concentrations come in consistently lower suggesting extremes are influencing the average concentrations. Maximum TP concentrations were as high as 80 ug/L and minimum concentrations came in less than detection limit. Gradual increase in mean concentration downstream exists from site 1 to 3. This gradually decreases downstream from site 3 to 5. These spikes do not occur in the same event

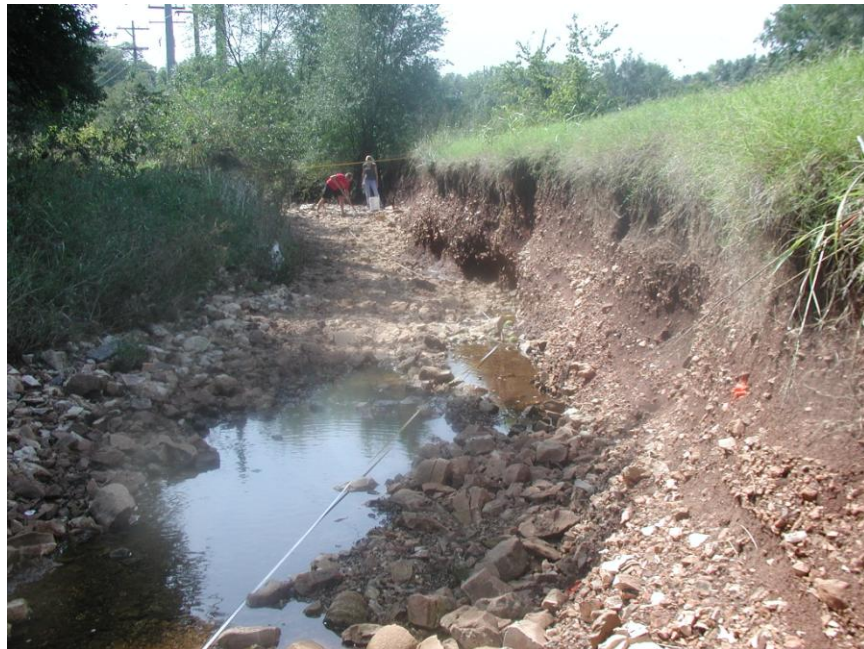
Photo 2. Bank erosion monitoring through golf course reach
