**Geomorphic Assessment of City Center Athletic Club
Development Impacts on Existing Stream Channel
Stability, Lenexa, KS.**

**Final report to Olsson Associates for
the City of Lenexa, Kansas**

OEWRI TR-09-001

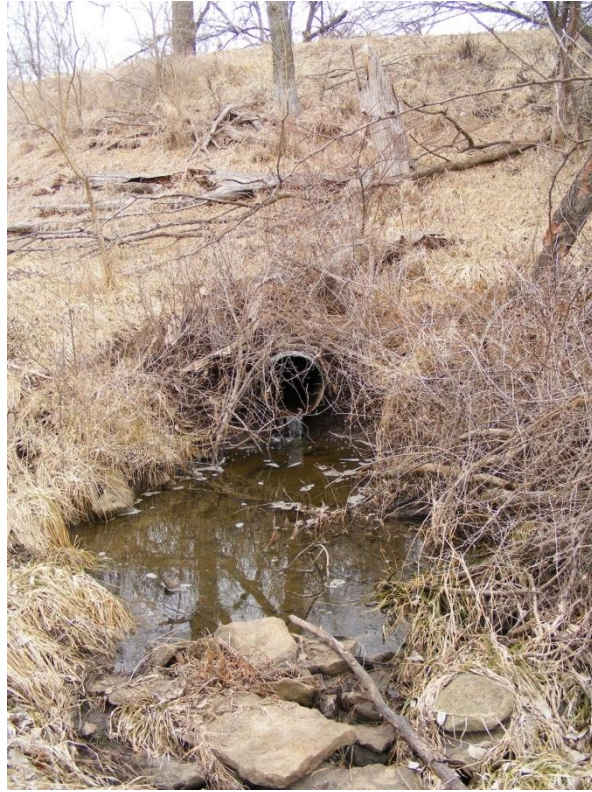
The farm pond above this sub-reach has limited flood storage capacity with outlet controlled through a 24" pipe. A small scour pool has formed at the outlet to dissipate energy. The channel below the outlet is straight with exposed bedrock or boulders common. In some areas a step-pool bedform is obvious. The bankfull channel averages about 5.3 ft wide, ranging from 3.7 ft to 7.8 ft. A young treed buffer is present. The steep stream and low sediment supply due to deposition in the upstream pond results in incision to bedrock. Without the pond, this reach would probably look more like a grassed-waterway or colluvial channel like described for sub-reach 2 below (Photos 1 and 2).

Photo 1. Pond dam outlet begins SR-1 (Feb. 2008)

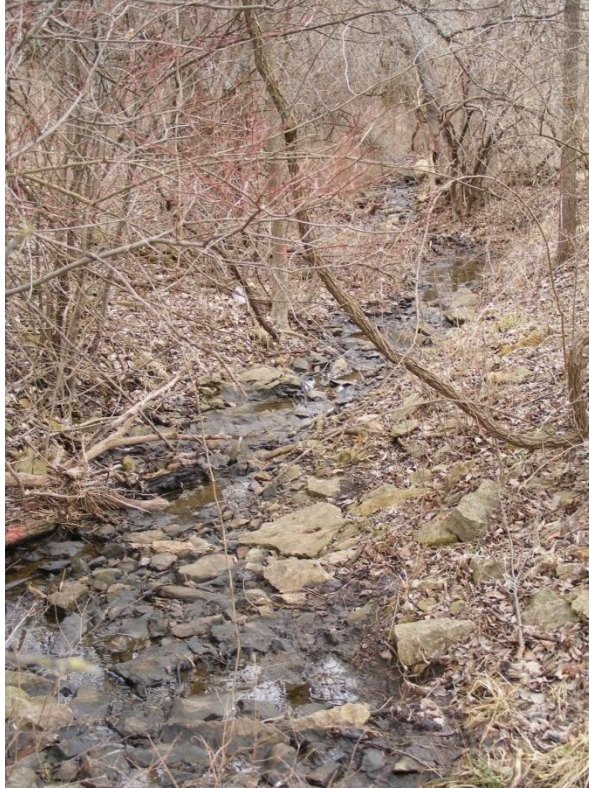
This sub-reach is similar to 3a but with some meandering. Pin array 1 (PA-1) is located in this sub-reach consisting of 4 pins, 3 on the outside of the meander, and 1 pin on the inside. The three outside pins are positioned evenly in a vertical orientation (Photo 5). While no slope measurements were collected in this reach, there appears to be a slight break in slope between SR-3a and SR-3b.

Photo 5. SR-3b looking downstream (Feb. 2008)

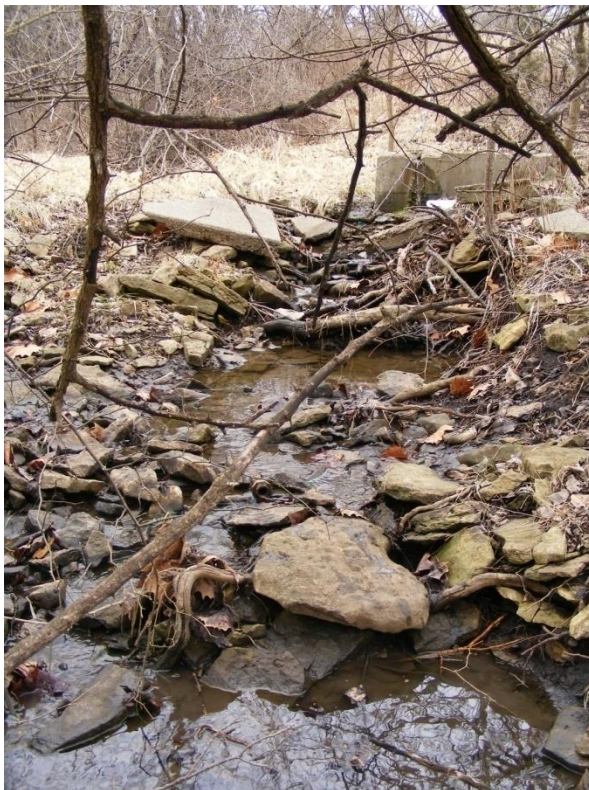
The channel is straight and with a riffle-pool form that is about 6.8 ft wide and 0.75 ft deep. The bed is composed of large flat cobbles and coarse gravel and sometimes takes on a step-pool form where boulders or bedrock influence the channel bed. Sub-reaches 4a, 4b, and 4c contain historical alluvial deposits with higher bank development than upstream areas. In effect this is the transition between steeper, upland areas and gentler, valley areas where alluvial floodplain deposition begins to occur (in contrast to occurrence of colluvial valley floors above this point). A small ephemeral spring marked by an old cattle watering tub is located at the top of this sub-reach. A minor head cut appears to be stalled at the upstream end of sub-reach 4a where bedrock comes to the surface and increases channel resistance to erosion (Photo 6).

Photo 6. SR-4a looking downstream at headcut near concrete stock tank (Feb. 2008)

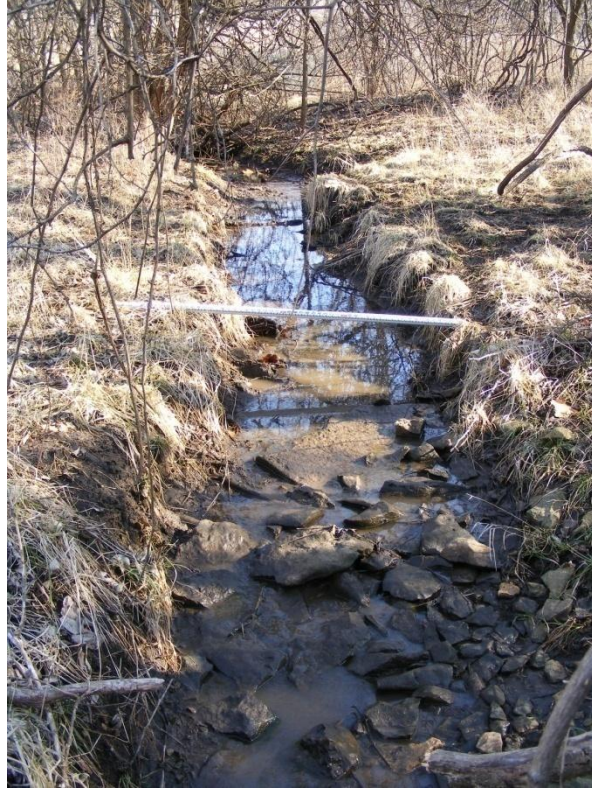
The channel is straight and slightly steeper with a riffle-pool form that is about 8.3 ft wide and 0.75 ft deep. The bed is composed of large flat cobble and sometimes takes on a step-pool form where boulders or bedrock influence the channel bed. PA-2 is located in this sub-reach where 3 sets of evenly spaced vertical pin arrays are located on a cutbank. The upstream set consists of three pins and the two downstream sets have two pins each (Photo 7).

The channel is meandering (sinuosity of about 1.3) with a riffle-pool form that is about 4 ft wide and 0.75 ft deep. Bed slope is decreasing due to the downstream control of flow by the damming of the channel by rubble dam and a 30" diameter concrete pipe. Bed material becomes finer with silt and mud covering the bed in most places. PA-3 is located in this sub-reach with three sets of vertical pin arrays with two pins in each array (Photo 7).

Photo 7. SR-4b looking downstream to SR-4c (Feb. 2008)

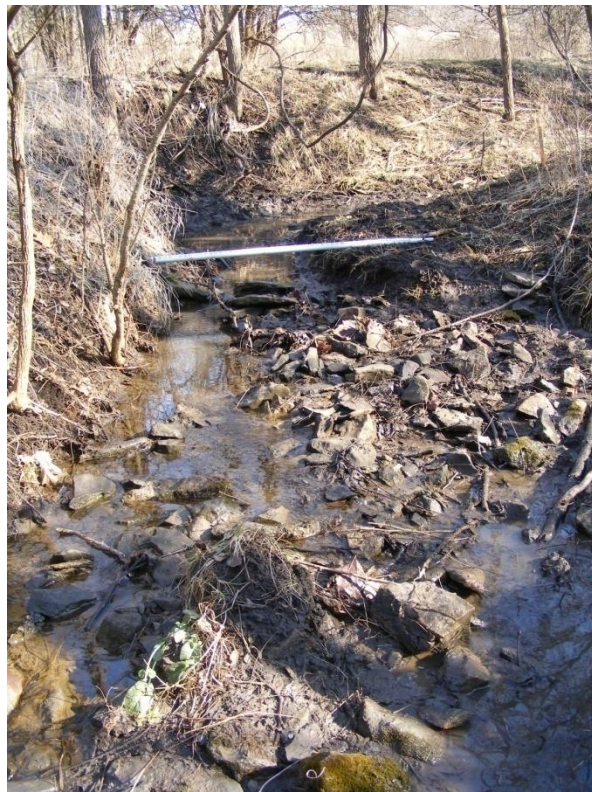
The channel is meandering (sinuosity of about 1.2) with a riffle-pool form that is about 4.5 ft wide and 0.75 ft deep. Locally, bed slope increases a bit and the bed substrate becomes more gravelly with some cobbles. This is probably due to locally shallow bedrock conditions as observed in the bed and along the valley margin. PA-4 is located in this sub-reach with one set of four pins. Three pins are vertically spaced on the cutbank and 1 in the eroding active floodplain on the inside of the meander (Photo 8).

Photo 8. SR-5 looking downstream (Feb. 2008)

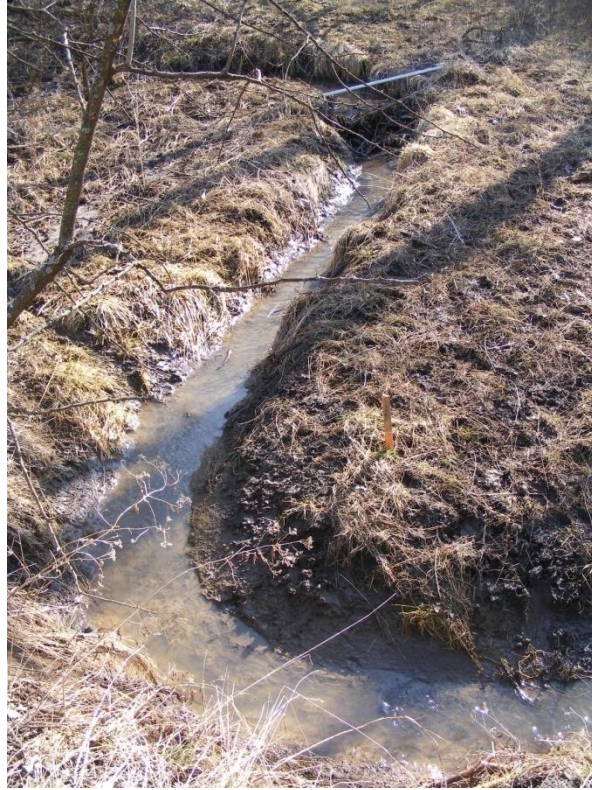
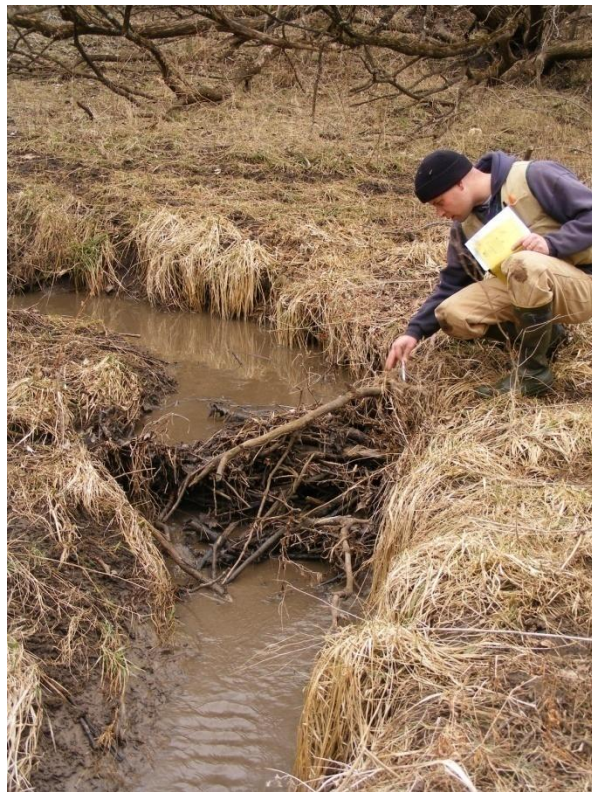
lower due to channel aggradation at this location. In addition, 2 pins were driven horizontally into the top of the active floodplain to measure overbank sedimentation. PA-6 consists of 1 set of 3 vertically spaced pins on a cutbank location 30 feet upstream of the property line (Photos 13, 14 and 15).

Photo 13. SR-6 looking downstream (Feb. 2008)

Photo 14. SR-6 forced riffle (Feb. 2008)

Photo 15. End of SR-6 at property line looking downstream (Feb. 2008)

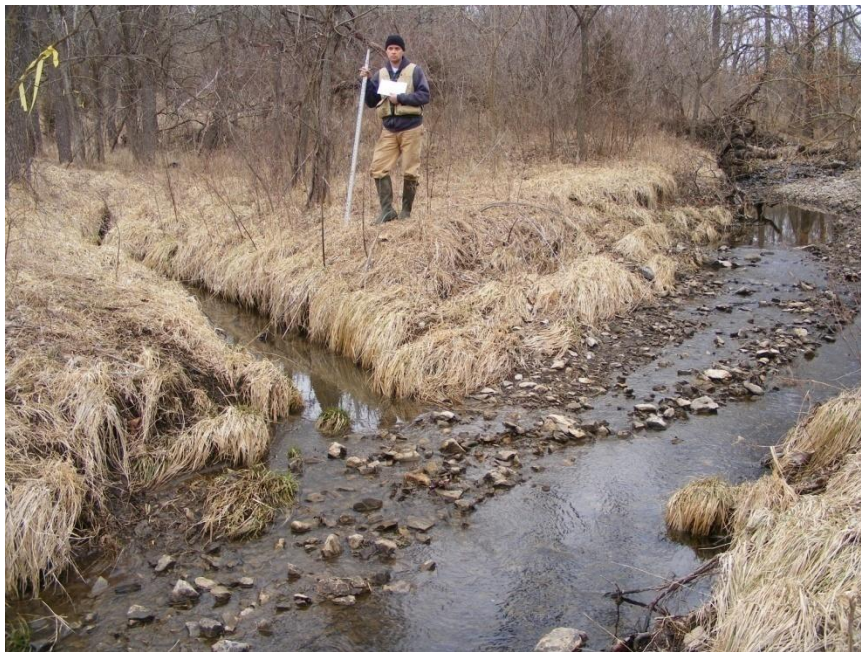
The channel meanders as it is affected by the floodplain control of the larger stream valley. The channel is 2.4 ft wide and 1.1 ft deep with coarse gravel and large cobble on the bed. PA-8 is located in this sub-reach consisting of 2 sets of pins; two vertically spaced pins in the upstream set and three in the downstream set. One pin was positioned in the eroding active floodplain on the inside of the meander at both locations (Photos 21 and 22).

Photo 21. SR-12 looking downstream to confluence (Feb. 2008)

Photo 22. End of SR-12 at confluence with main tributary (Feb. 2008)

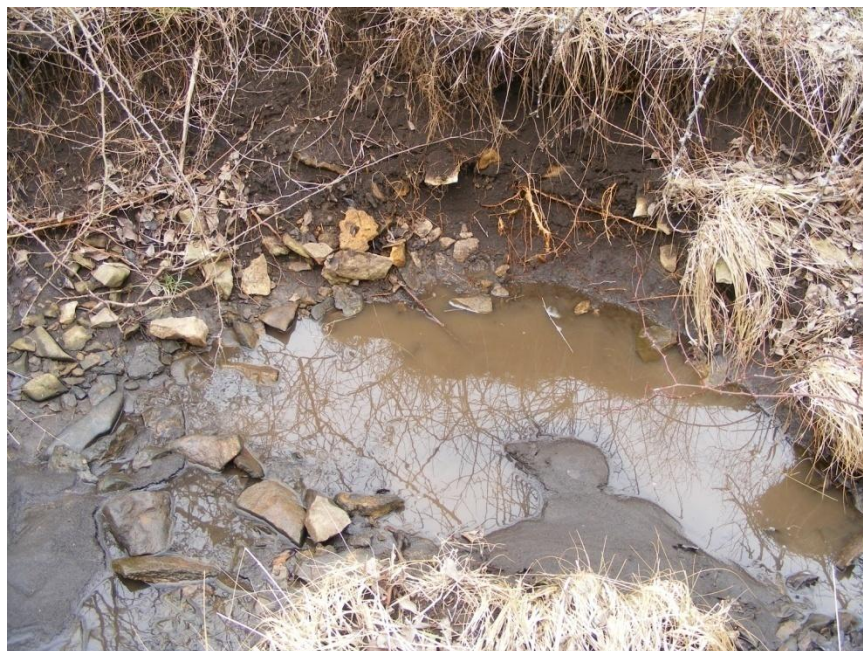
PA-1 is located in SR-3b where the channel starts to meander. Pins here showed no change over the monitoring period, but the channel did have some fresh fine gravel deposition on the bed (Photos 23 and 24).

Photo 23. PA-1 installation September 12, 2008

Photo 24. PA-1 in Feb. 2008.

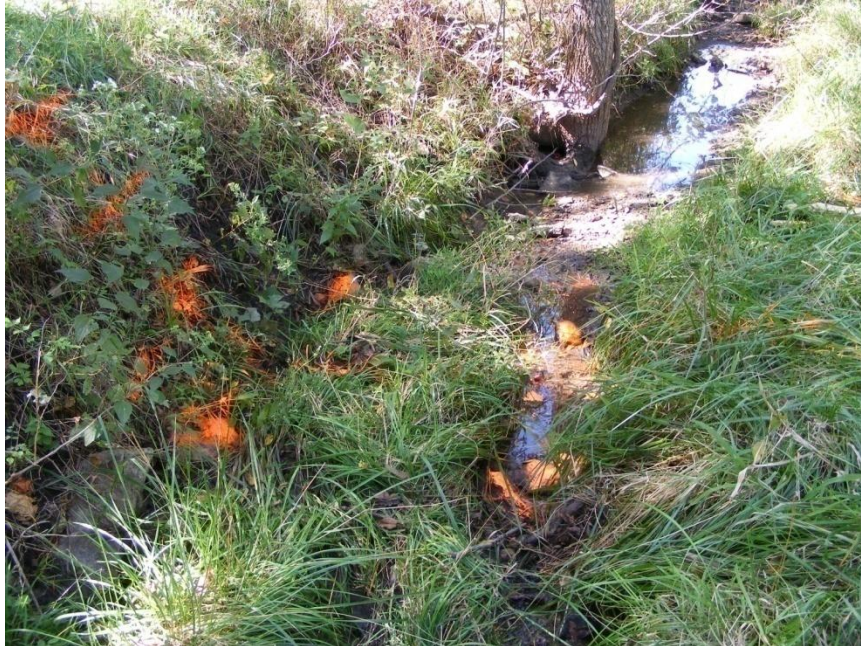
PA-7 is located in SR-10 which is a sinuous stable reach below the valley fill. Pins here had <1 ft of upper bank slump deposition at the toe of the bank (Photos 35 and 36).

Photo 35. PA-7 installation Sept. 2007

Photo 36. PA-7 Feb. 2008
