Ozarks Environmental and Water Resources Institute (OEWRI)

Geomorphic Assessment of Galloway Branch in Sequiota Park, Springfield, Missouri

April 24, 2009

OEWRI TR-09-002

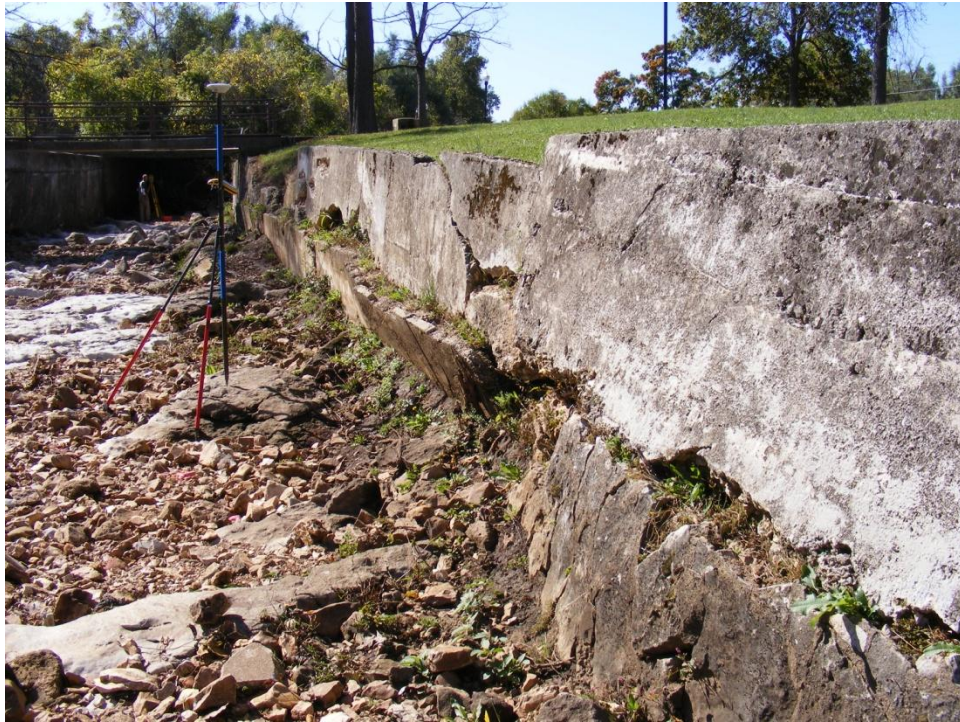
Subreach #3- This reach receives water and sediment directly from reference reach B and runs from stations 1,025 to 1,400 ft on the MSU longitudinal profile. It has a slope of about 0.2% and active width of 15 ft. Bedrock in this reach is relatively smooth and covered by a thin veneer or patches of gravel and cobble material (Photo 1, 2, 3, 25). The D50 for this reach ranges from 20 to 50 mm, D84 from 60 to 90 mm, and maximum mobile clast size from 118 to 222 mm (Photo 23). Older channel walls are being undercut and failing in most places (Photo 4, 24, 26).

Photo 4. Looking downstream at SR-3 near station 1,050 feet (10/16/2008)

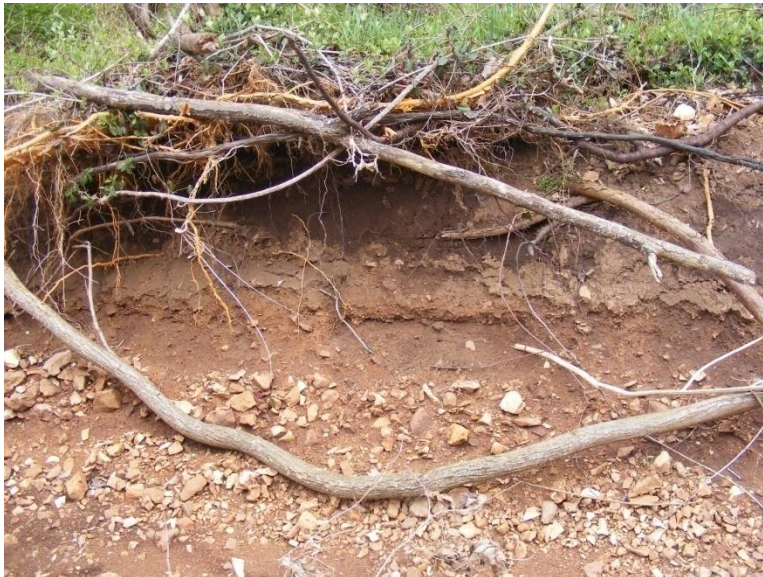
Photo 20. Bank erosion downstream of Lacuna bridge in reference reach B (4/6/09)

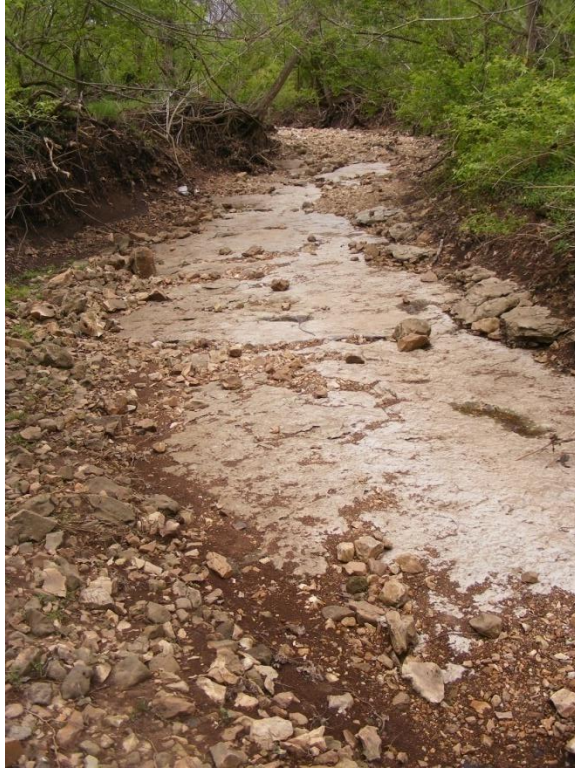
Photo 21. Bedrock bed in reference reach B looking upstream (4/6/09)

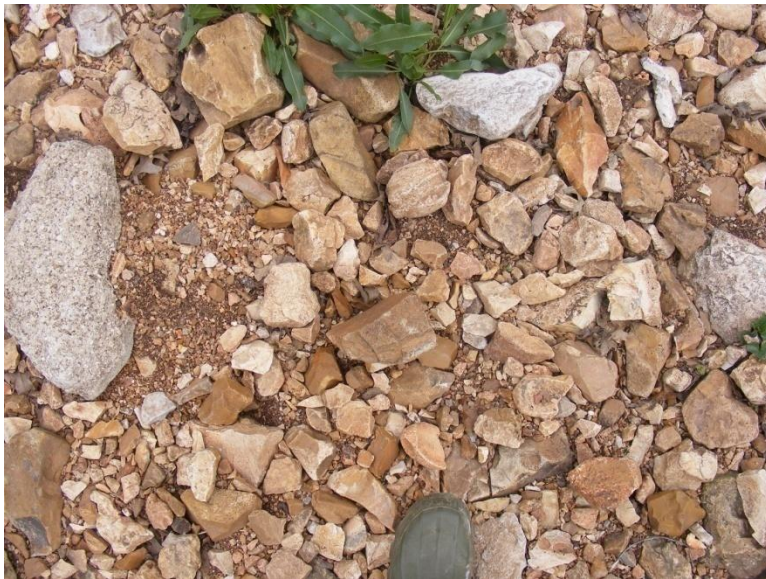
Photo 23. Bed material near station 1,200 feet SR-3 (4/6/09)

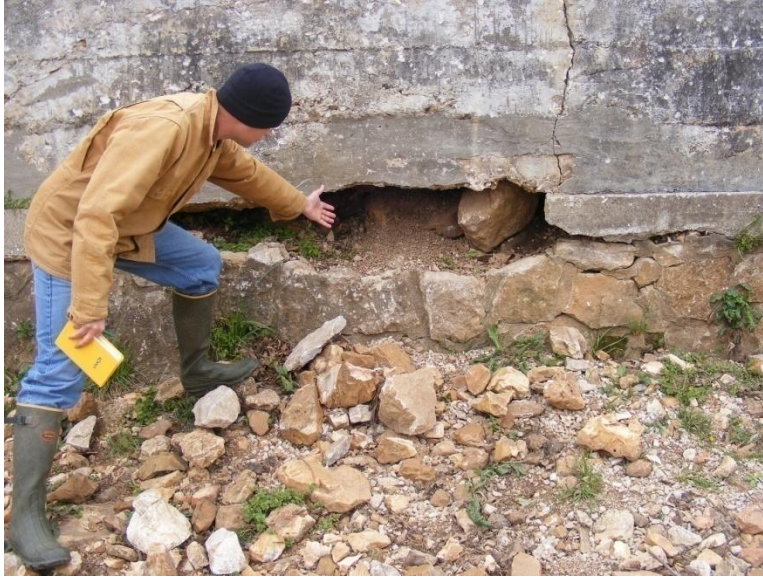
Photo 24. Cobble and coarse gravel source from backfill of failing wall along left bank near SR-3 station 1,200 feet (4/6/09)

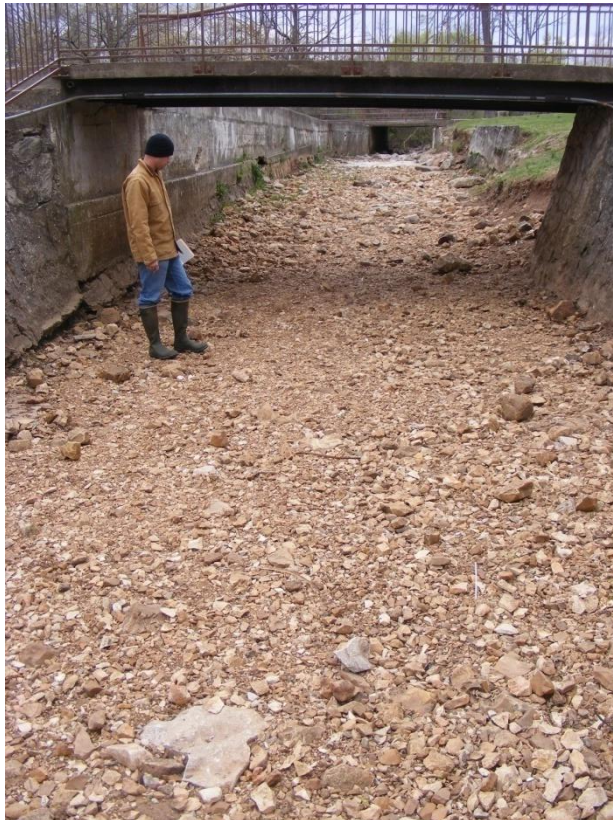
Photo 25. Plane bed reach near station 1,140 feet looking downstream at SR-3 (4/6/09)

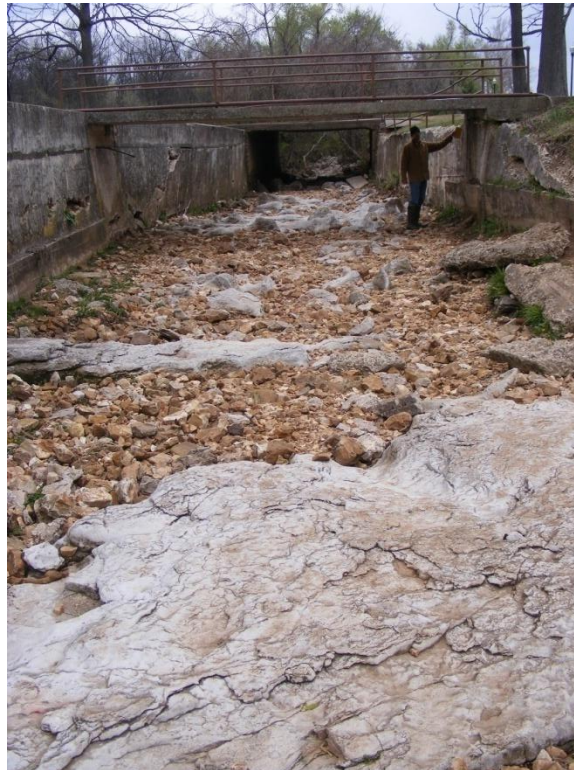
Photo 27. Bedrock bed near station 1,000 feet looking downstream SR-2 (4/6/09)

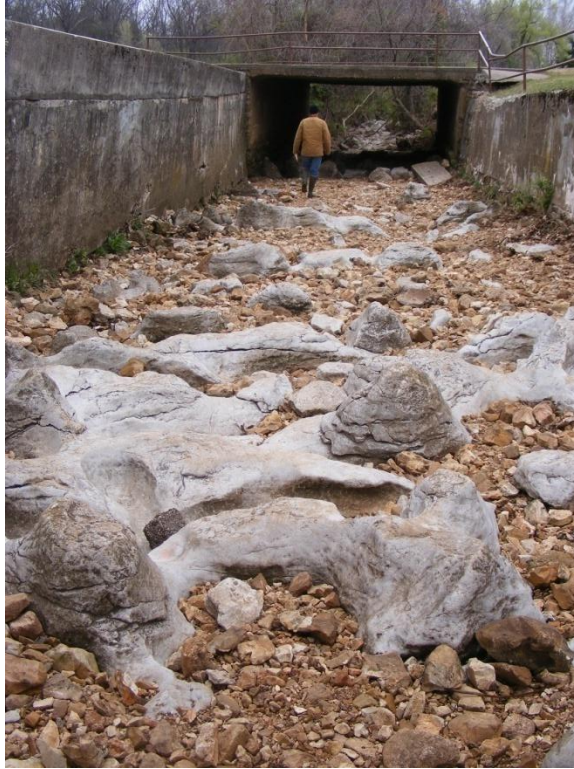
Photo 28. Bedrock pinnacles near station 900 feet looking downstream SR-2 (4/6/09)

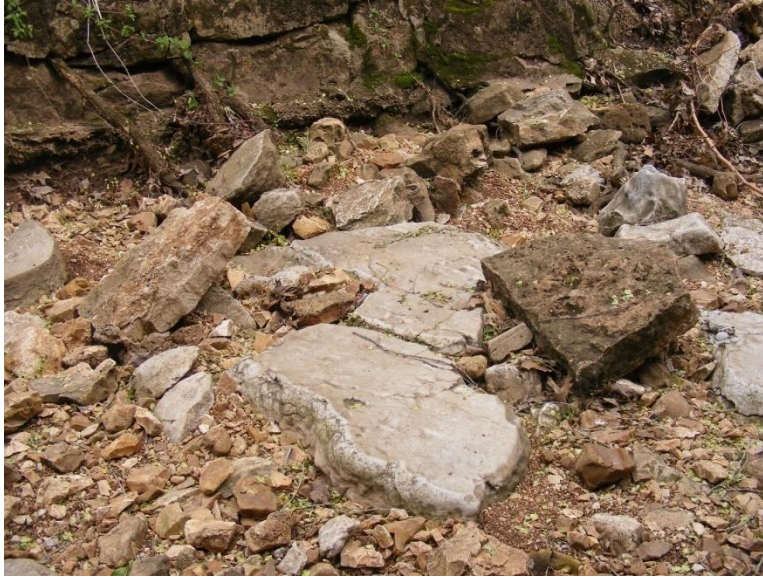
and maximum mobile clast diameter of 326 mm (Photo 31). Older channel walls are being undercut and failing in some places and anthropogenic debris is entering the channel from fill bank erosion (Photo 30). During dry periods, water is observed to enter the channel in this section from under the east wall by pond seepage through the earth berm.

Photo 30. Large blocks from failing walls and construction rubble at station 500 feet SR-1 (4/6/09)

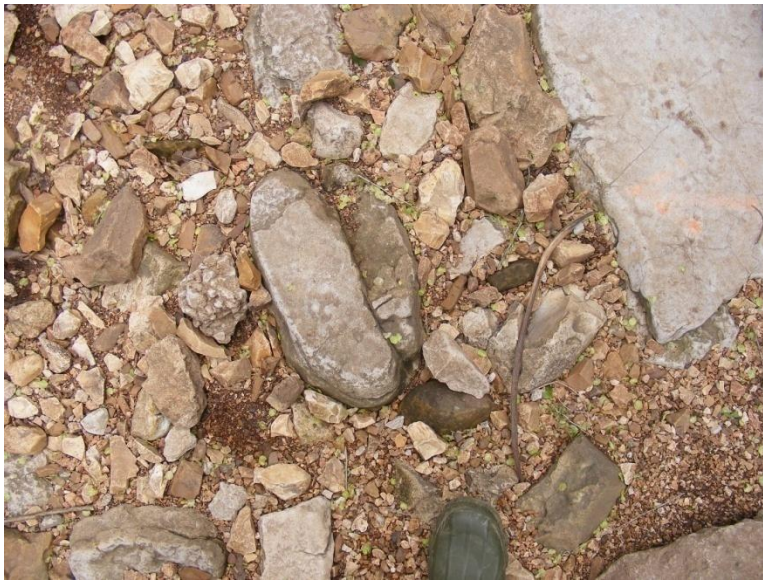
Subreach #1- The reach runs from stations 100 to 600 ft on the MSU longitudinal profile. It has a slope of about 0.3% and active width of 15 ft. Bedrock in this reach is relatively smooth with some rough spots and covered by a thin veneer or patches of gravel and cobble material (Photo 10, 11, 12, 13, 14, 15, 16, 17). The D50 for this reach is about 20 mm, D84 about 60 mm,

Photo 31. Fine to medium gravel fill between cobble and boulder size material near station 500 feet SR-1 (4/6/09)
