Geomorphic Analysis of Lackman Tributary, Lenexa, KS.

Final report to Olsson Associates for the City of Lenexa, Kansas

December 17, 2009

OEWRI TR-09-004

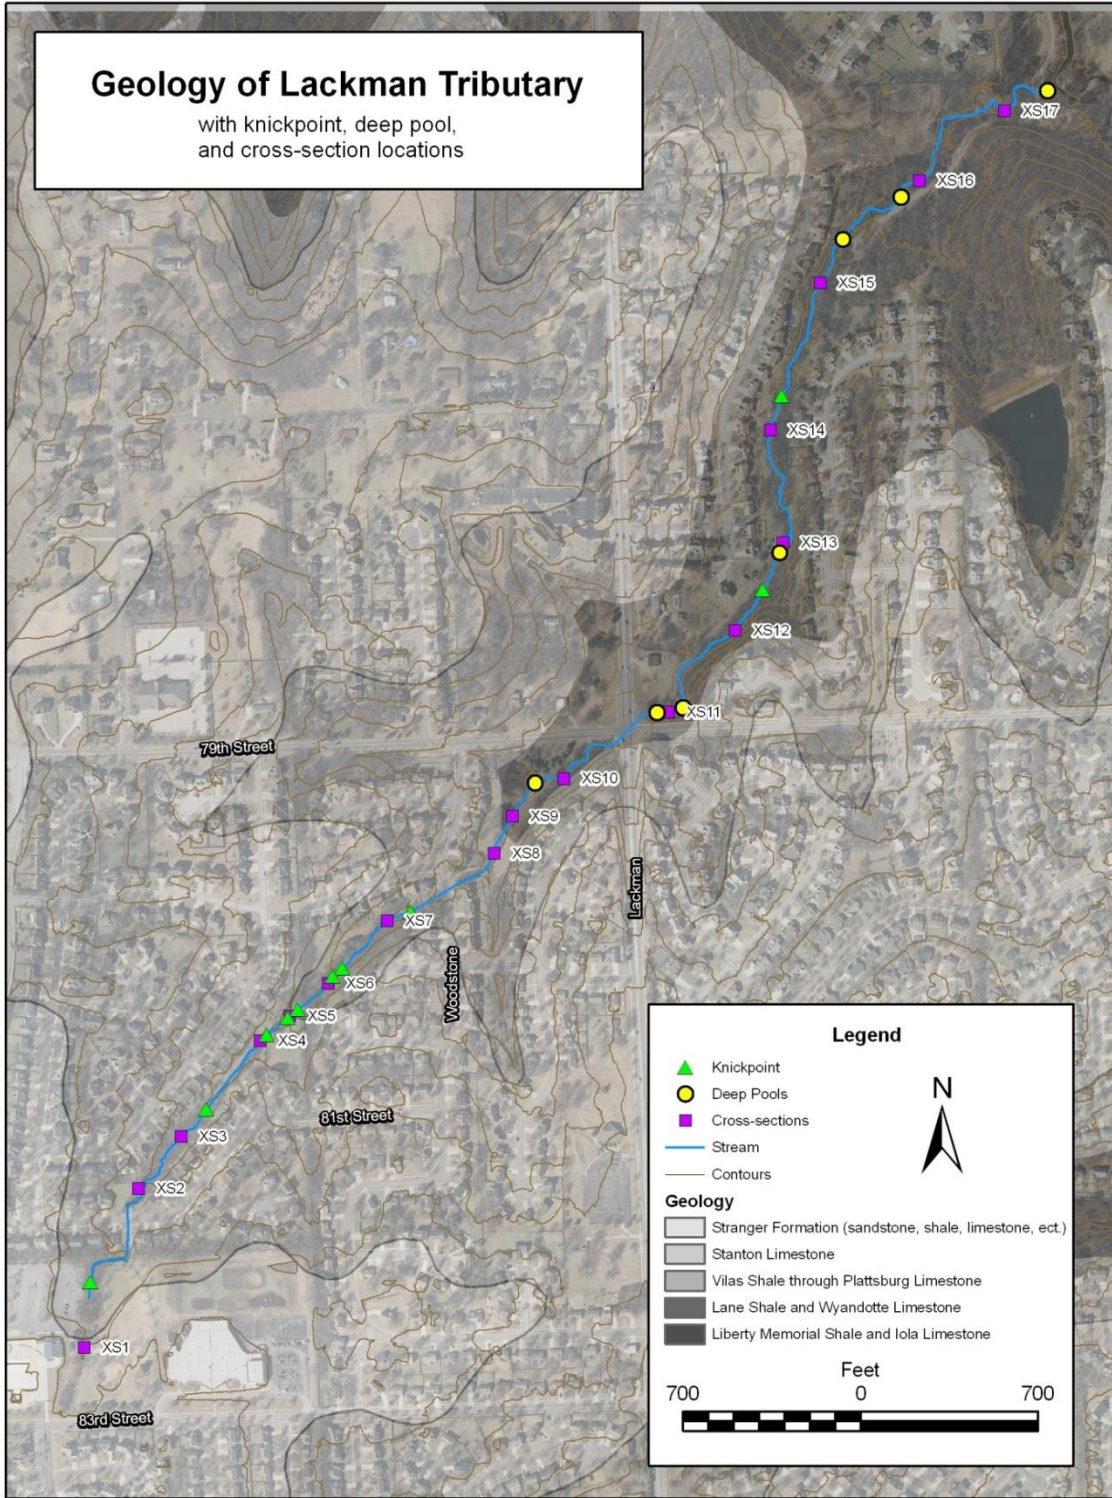
Figure 3. Geology of the Lackman Tributary with knickpoints and deep pool locations

There is a strong influence from bedrock and bedrock residuum on channel form and substrate in Lackman Tributary (Table 2; Figure 3). The locations of relatively stable knick-points and head-cuts are probably controlled by horizontal layers of more resistant limestone beds. Knick-points in more resistant limestone develops as steps, small cascades, or falls across the bed of the stream. In longitudinal profile, bedrock knickpoints indicate locations where channel erosion is slowly lowering bed elevation by retreat of the step through block plucking, scour of weathered material, and joint failure. Since bedrock erosion rates are orders of magnitude less than for soil materials and alluvial deposits, knick-point response can lag behind other geomorphic adjustments and so they can function as natural slope controls for the stream. On the other hand, unstable head-cuts tend to have a similar form in longitudinal profile, but usually occur in less resistant materials such as weaker shale units or soil materials. Since unstable head-cuts are in more erodible materials, they generally migrate or cut headward at a faster rate compared to bedrock knick-point counterparts. It is possible that head-cuts form first, initially erode rapidly in weaker shale or weathered limestone, and then stall out as shale units pinch out. Field observation suggest that larger knick-points and head-cuts (up to 7 ft of local drop) are associated with thicker underlying shale units such as found in the Vilas and Lane Shale units (Table 2).

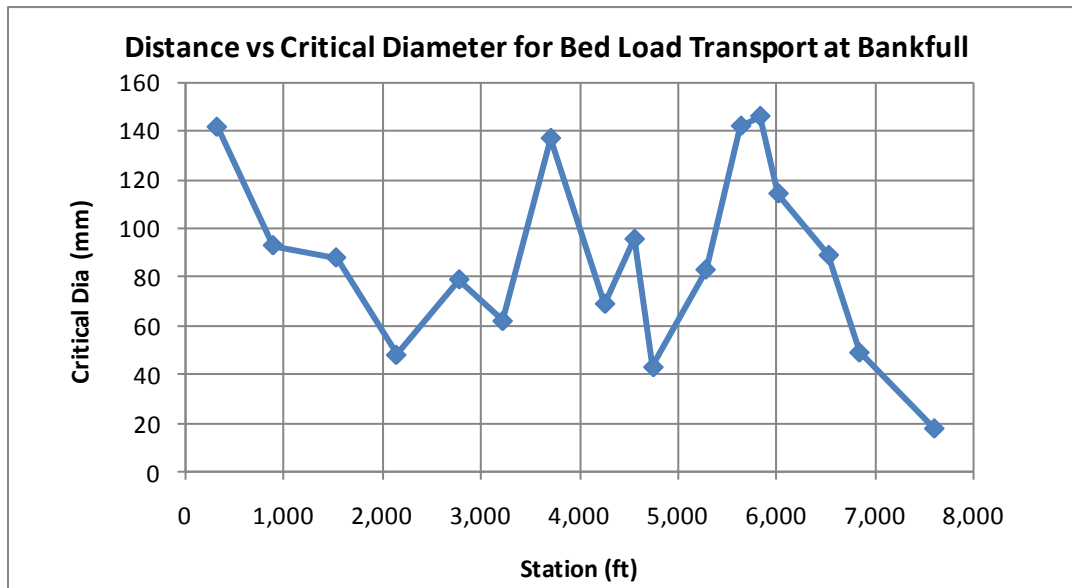
Figure 11. Downstream changes in critical diameter for bed load transport

The critical diameter calculated for Lackman Tributary ranges from 40 mm to 140 mm (Figure 11). The downstream patterns are controlled by shear stress values calculated for each site (Table 6). Relative bed stability values indicate that all but four of the sites are within normal ranges of a balanced condition between imposed hydraulic force and sediment size on the bed (Figure 12). Typically, LRBS* values between -0.5 and 0.5 are in the stable range and values <-2 are considered unstable and values >2 are considered extremely stable. Three relatively unstable sites are have LRBS* values below -0.5:

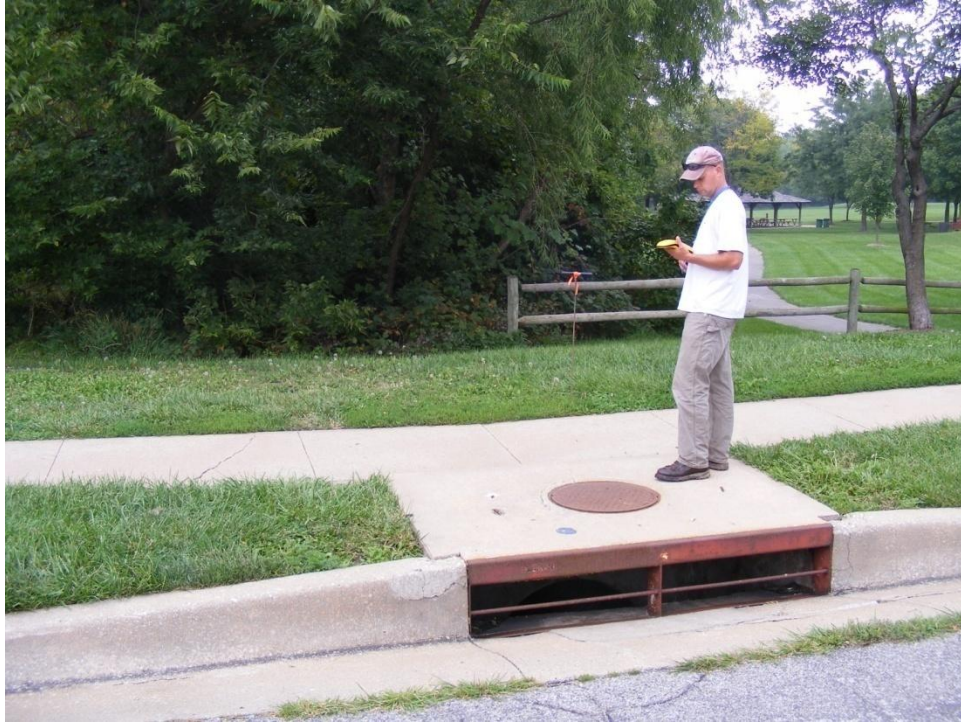
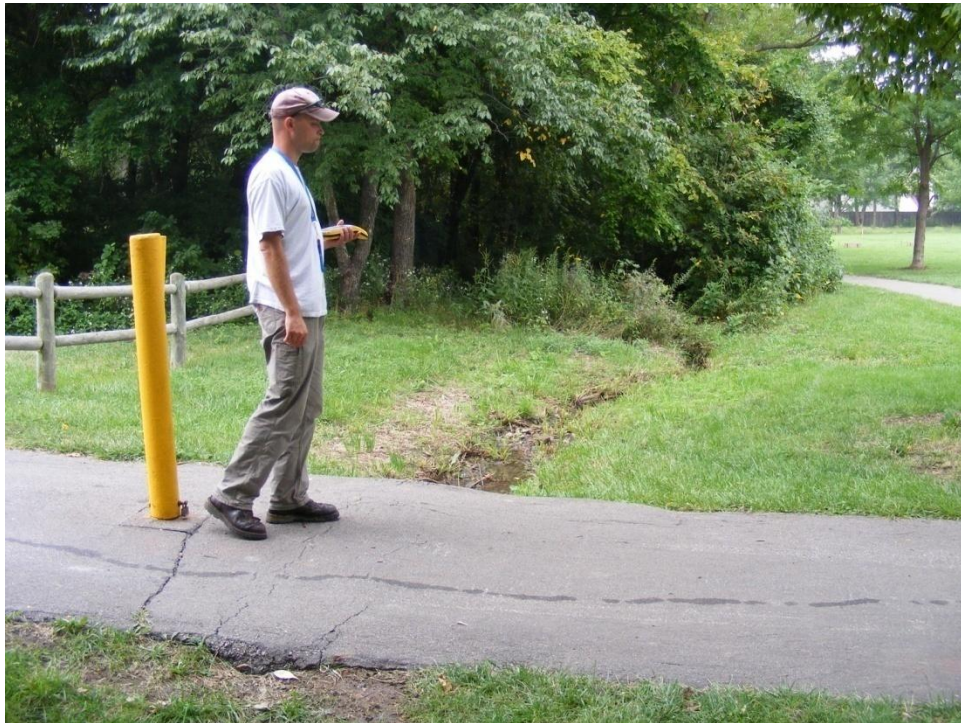
SR-1-A: Typical colluvial channel (Station 7,870-7,350 ft)- The stream bed and banks consist of silty material with occasional construction debris, such as asphalt and crushed limestone, being deposited on the bed. Forced riffles caused by roots, utility crossings, and walking path culverts cause small scour-hole formation locally, but there is no evidence of systemic instability. Cross-section site 1 is in this sub-reach (Photos 1-2)

Photo 1. R1-A Start of Project St. 7,870 ft looking downstream (Sept. 2009)

Photo 2. R1-A Path at St. 7,550 looking downstream (Sept. 2009)

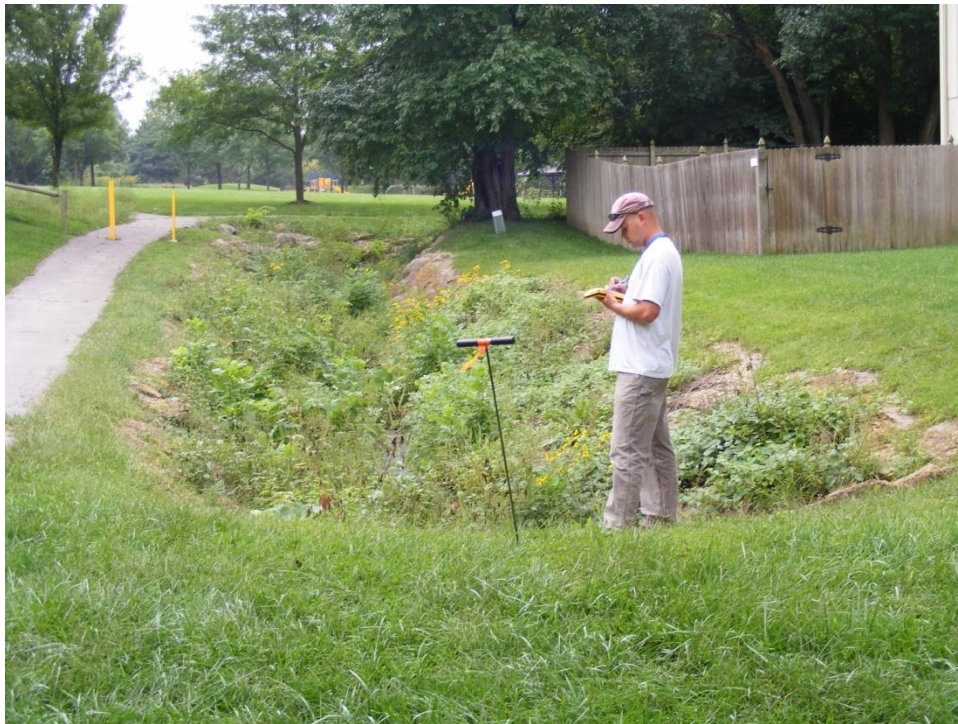
Photo 4. R3 - Rip-rap and culvert inlet St. 7,030 looking upstream (Sept. 2009)

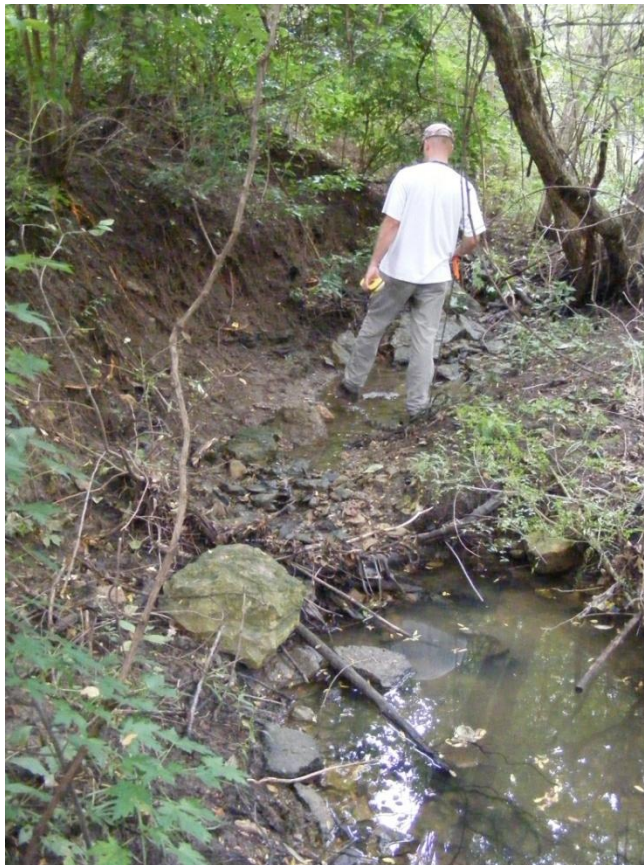
The stream flows across the Vilas Shale and Plattsburg Limestone in this section. Five well expressed knick-points are formed in this unit with bed elevation drops from 3 to 5 ft. The Vilas shale beds are relatively thick and erodible. Thus, knick-points tend to form when overlying limestone beds fail after underlying shale support is removed by erosion. Only the upstream knick-point at station 5,890 ft seems to be head-cutting upstream at timescales of potential concern, albeit slowly. A smaller extension of this head-cut is moving up a small tributary. The limestone unit here is relatively thin over a thick shale unit. The others are formed in relatively thickly-bedded limestone where shale layers are thinner maybe have pinched out. (Photos 8-10)

Photo 8. R6-A knick St. 6,375 ft looking upstream (Sept. 2009)

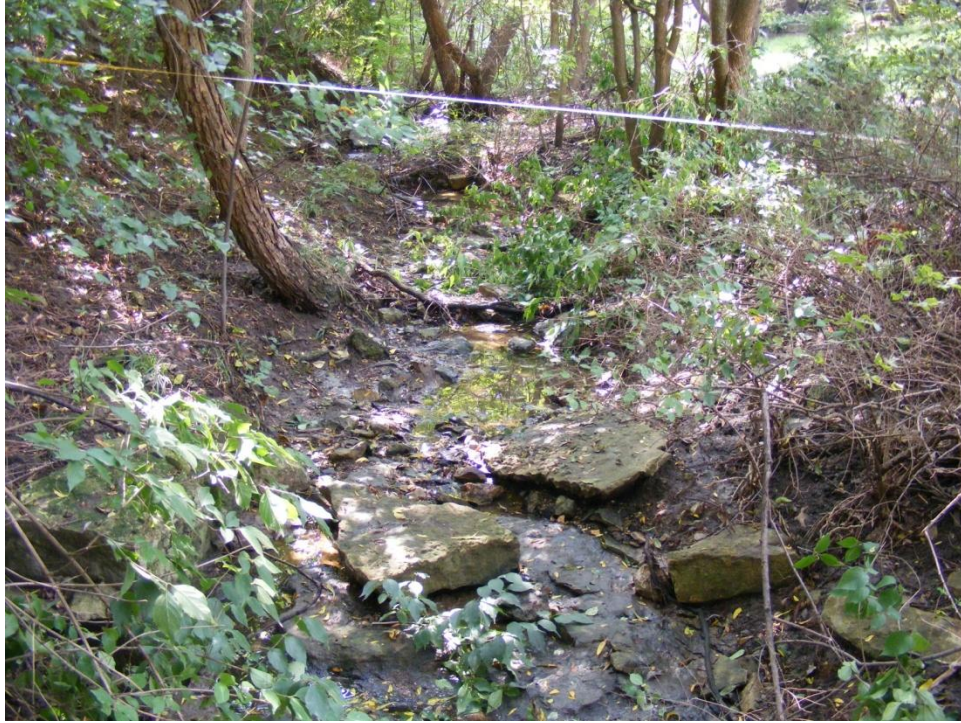
Photo 9. R6-B xs 4 St. 6,020 ft looking upstream (Sept. 2009)

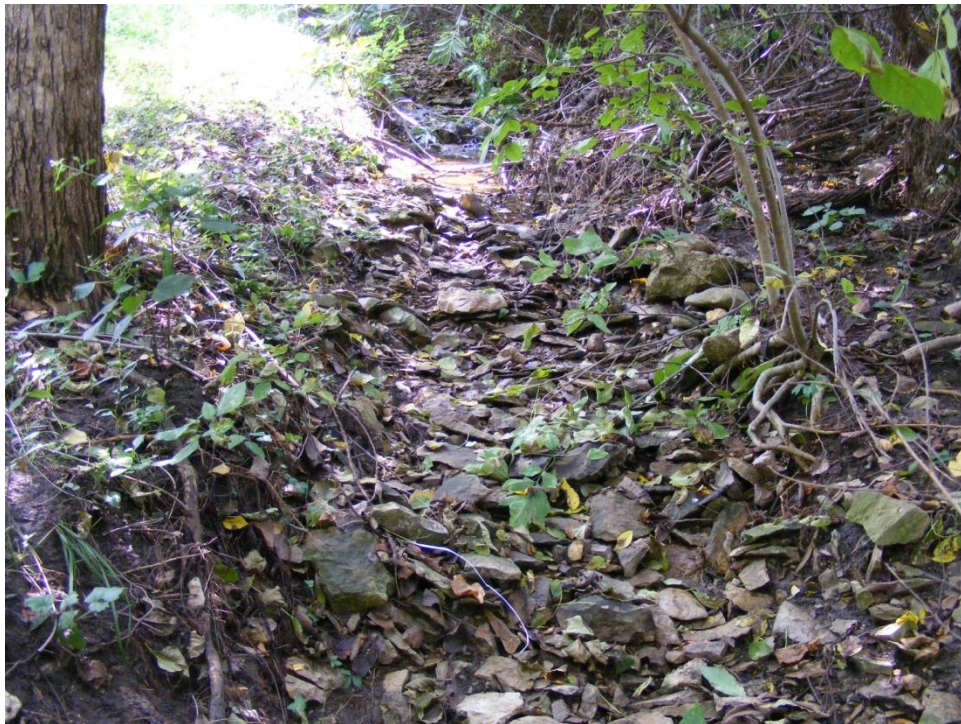
Photo 10, R6-C xs 5 St. 5,835 looking upstream (Sept. 2009)

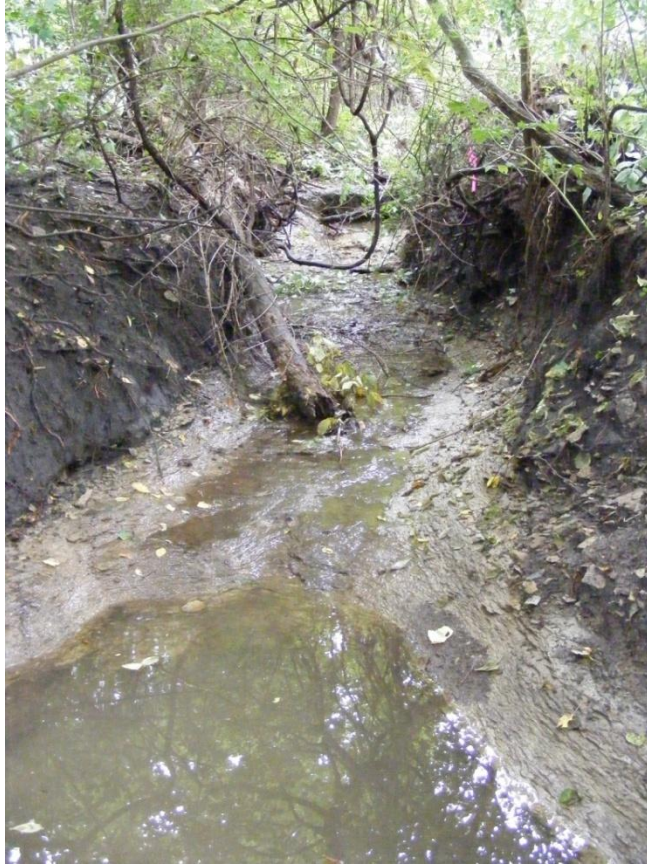
(2) **Bedrock Knick-points:** Bedrock is intermittently exposed on the channel bed and along lower banks below station 6,500 ft to the mouth on Mill Creek. Seven well formed bedrock knick points, some with drops to 7 feet, are found between stations 2,000 to 6,400 ft between elevations of 900-1000 feet. Less resistant shale erodes out from under limestone beds until the slab fails and forms a step. The ages of these knick-points are not known, but most do not appear to be actively migrating upstream at timescales of interest here. However, there are several head-cuts that may be actively migrating upstream at rates of concern between stations 5,800 to 5,900 ft.

Photo 11. R6-C Knick St. 5,800 looking upstream (Sept. 2009)
