**The Ozarks Environmental and Water Resources Institute (OEWRI)
Missouri State University (MSU)**

FINAL REPORT

**Nonpoint Source Bank Erosion and Water Quality
Assessment, James River at River Bluff Farm, Stone
County, Missouri**

August 16, 2013

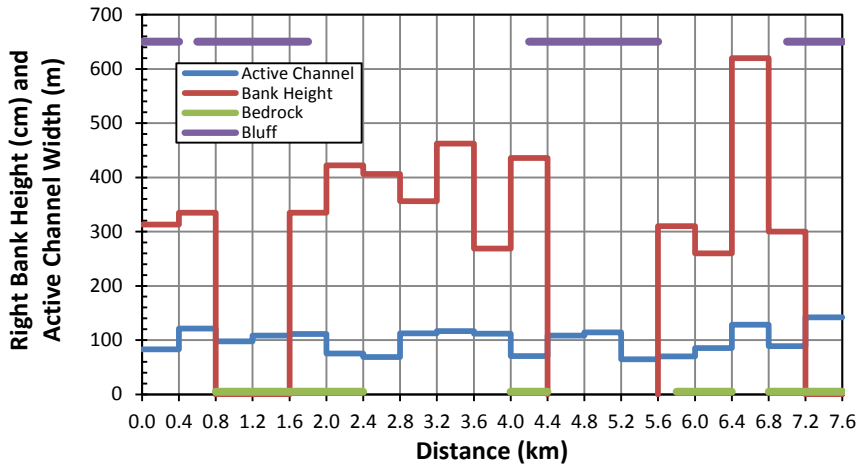
Figure 4. Bank and channel conditions in study reach.

Bedrock has a major influence on the channel along the 7.6 km long study reach. Bluffs form the right bank of the river along the easement for nearly half the reach length and bedrock can be found along the bed of the river frequently (Figure 4). Bedrock in the bed and along bluffs limits the ability of the river to meander and scour the bed and is typical of streams in the Ozarks (Pavlowsky, 2004). Field measurements taken in May 2012 the active channel width varies from about 60 m to 120 m (197-394 ft) in some places. The active channel refers to both the wetted part of the channel at low flow, but also the gravel bars located adjacent to the water, but set below the bank. The high active channel widths indicate areas where large bars are present in the channel. Bank heights vary from around 2.5-6.2 m (8.2-20 ft) through the study reach. Bank heights vary due to the age of the deposit from terraces that could be >10,000 years old to recently formed benches only formed over the last 100 years (Brakenridge 1981; Hajic et al. 2007; Owen et al. 2011). There was no bank present in areas with bluffs along the right bank, but in a few cases, such as between 0-0.8 km, banks did exist right at the base of the bluff. Bank heights measured in the field were used to calculate total sediment volume lost to erosion from the historical aerial photography analysis.

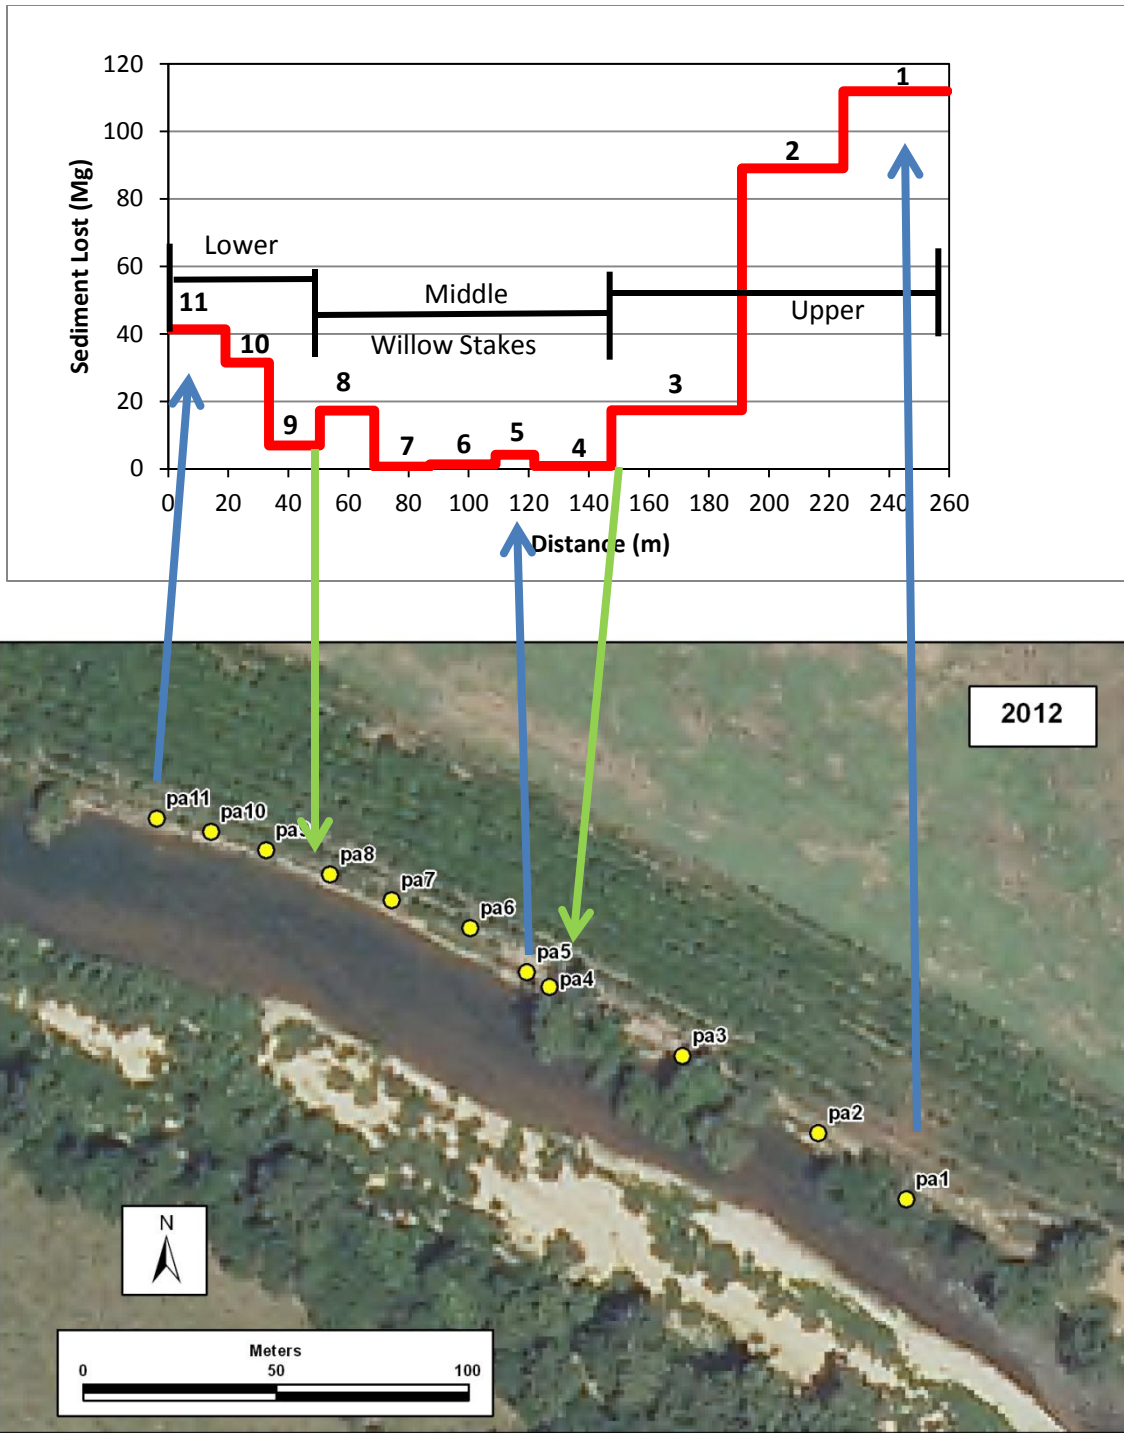
Figure 10. Total sediment loss from short-term bank erosion pin monitoring.

Monitoring results show the majority of the bank erosion occurred in the upper 100 meters of the reach the area upstream of the willow stake section (Figure 10). The second highest amount of erosion occurred in the lower section of the reach and the lowest erosion in the middle section of the reach where the willow stakes were located. The upper section makes up 43% of the reach and consists of erosion pin transects 1-3 (Table 4). The upper section lost 218 Mg of sediment and 87 kg of P over the monitoring period, which is about 68% of the total lost for the reach. The middle section is 97 m long ($\approx 37\%$ of total) and includes pin transects 4-8. The middle section lost 24.3 Mg of sediment and 9.7 kg of P over the monitoring period, which is $<8\%$ of the total lost for the reach. The lower section includes pin transects 9-11 and is only 51 m long, which is about 20% of the reach. Here a total of 79.8 Mg of sediment and 31.9 kg of P was eroded, which is around 25% of the total lost for the reach. Rates of sediment loss per unit of bank ranged from 0.25 Mg/m in the middle section to 2 Mg/m in the upper section, with a total of 1.2 Mg/m for the reach. The P loss per unit of bank ranged from 0.1 kg/m in the middle section to 0.8 kg/m in the upper section, with a total of 0.5 kg/m for the entire reach.

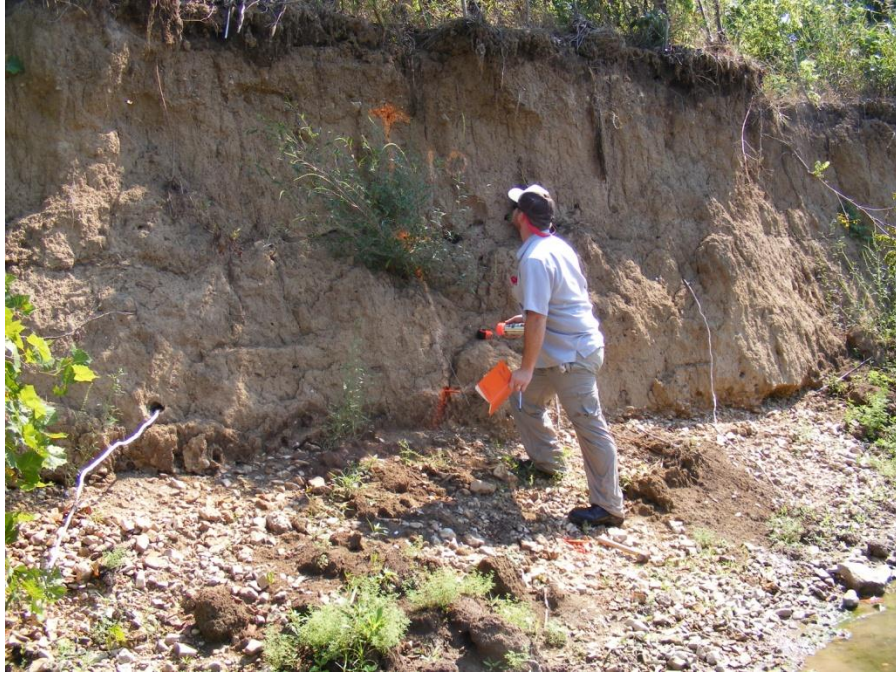
Photo 5. Erosion pin transect 10 at low flow, July 2012.

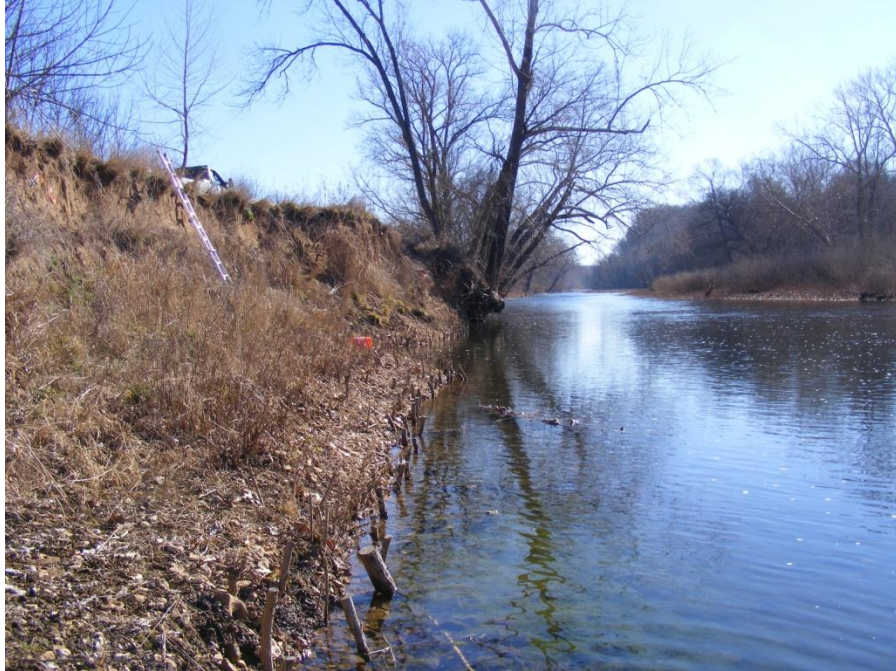
Photo 7. View upstream of transect 5, with dormant willows, January, 2013.

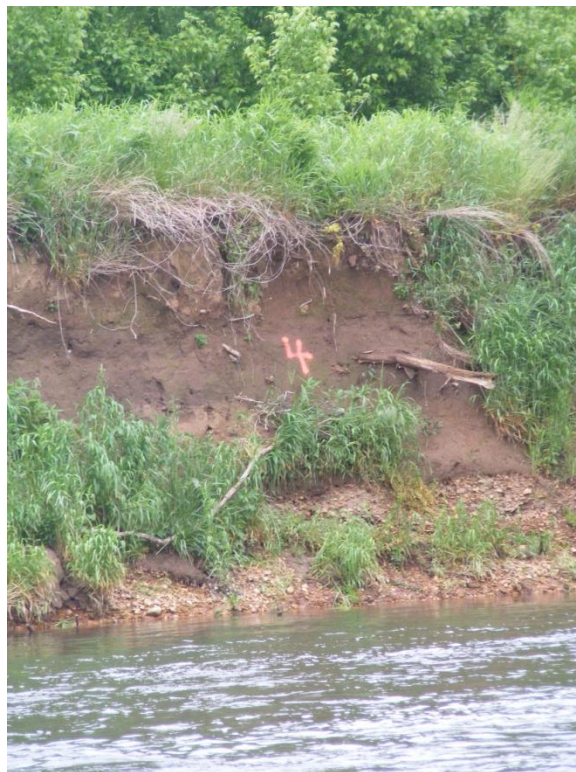
Photo 8. Erosion pin transect 4 at high flow, willows under water, May 2013.

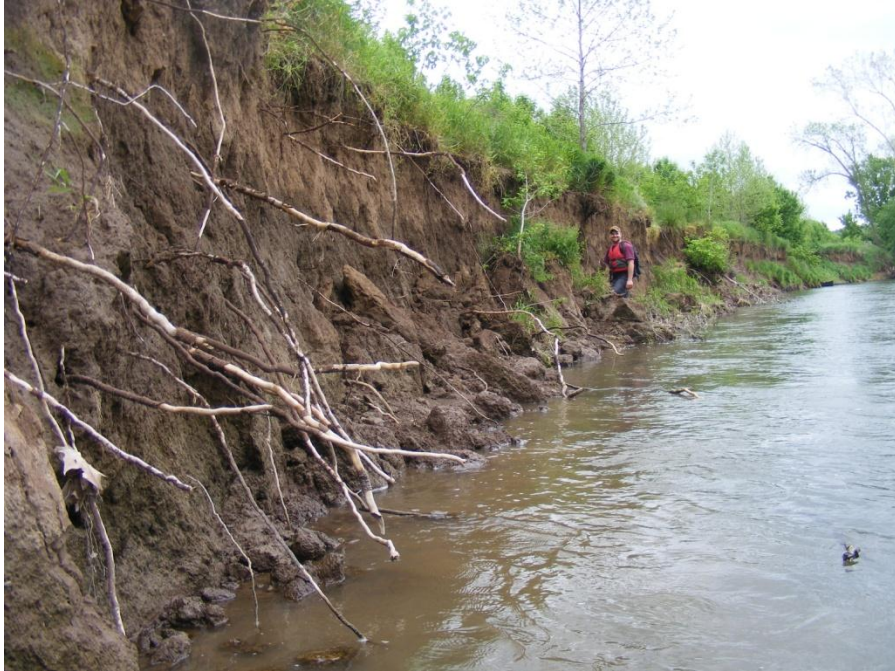
Photo 9. Roots exposed immediately following bank erosion from recent floods, May 2013.

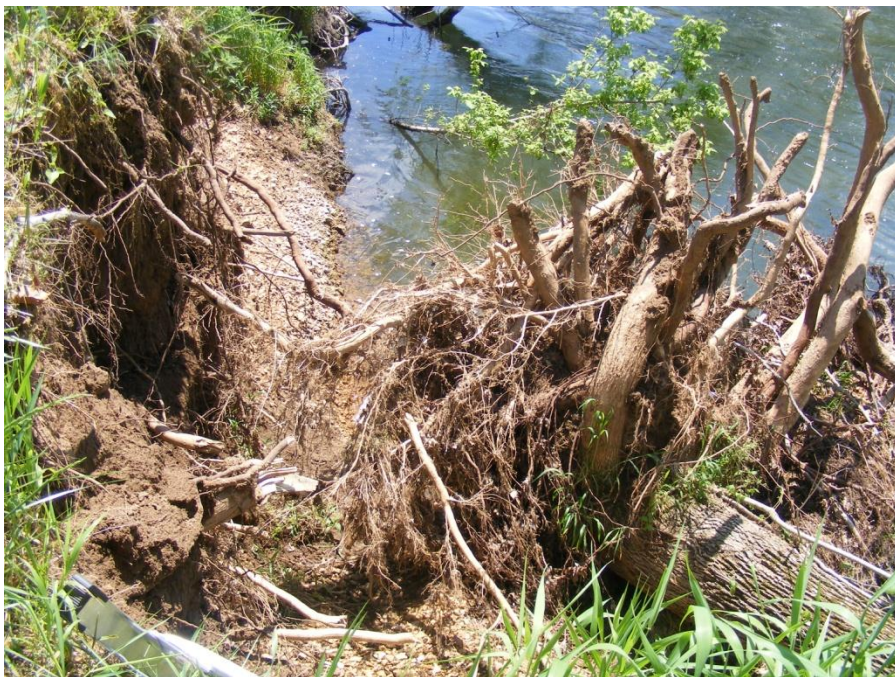
Photo 10. Recently downed tree after bank failure, May 2013.
