**Ozarks Environmental and Water Resources Institute
(OEWRI) Missouri State University (MSU)**

**Stream Crossing Inventory and Evaluation,
Upper Big Barren Creek Watershed, Southeast
Missouri**

FINAL REPORT

January 26, 2018

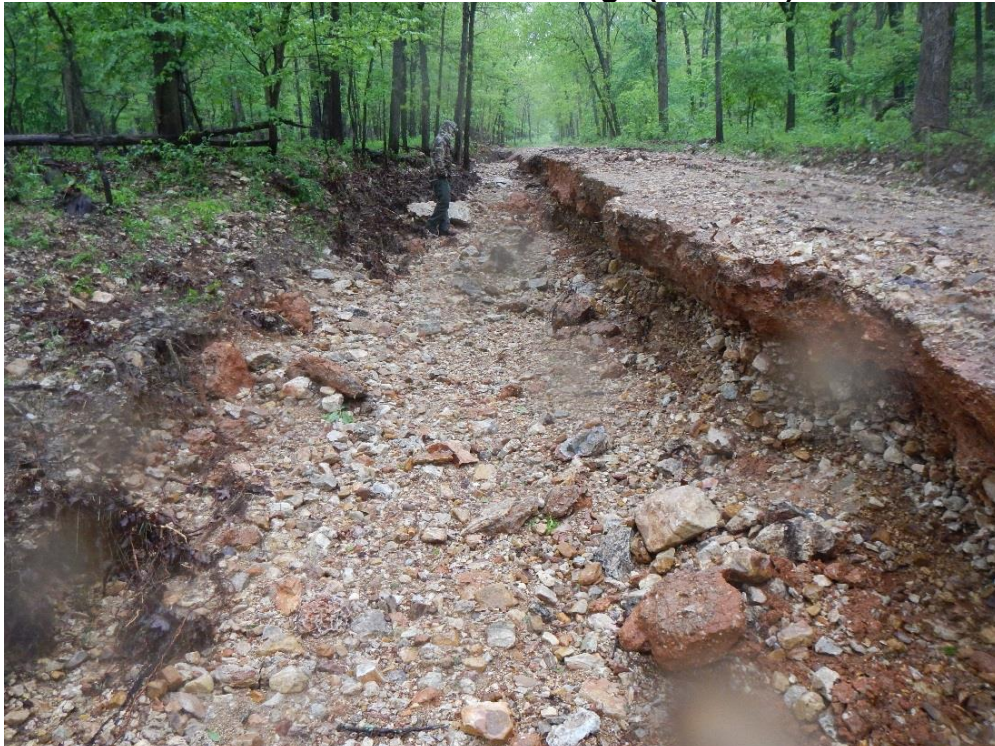
After Flood: Left Road Edge (5-4-2017)

5. Head cuts moving up tributaries from the lowering of base level at the modified main channel causes repeated episodes of crossing failure (Sites 10, 11, and 16). If traffic volume is a concern here, these crossings may be good candidates for box culverts that can pass flow generally as large as the present channel capacity. This could lower maintenance costs over time.

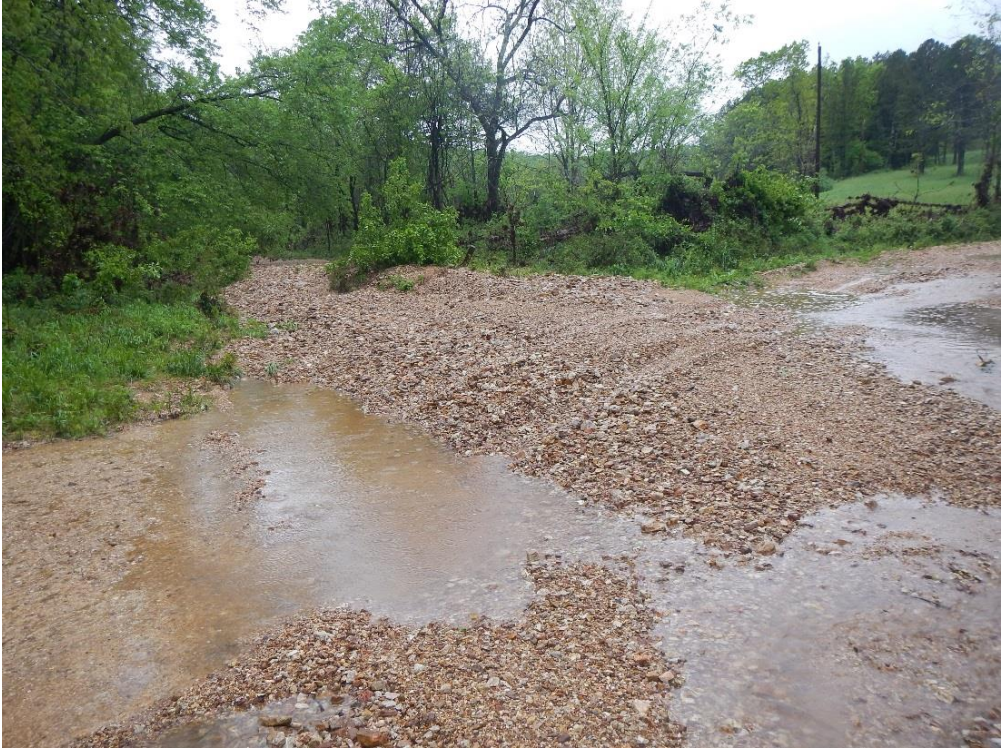
After Flood: Upstream View (5-4-2017)

3. Crossings at or below grade create sediment deposition zones where the increased channel width at a crossing decreases velocity (Sites 7, 13, 14, and 15). Again, this situation offers an opportunity to access road aggregate for construction and maintenance without further destabilization of the bed and bank.
