**WARD BRANCH STREAM RESTORATION
PROJECT**

POST-CONSTRUCTION ASSESSMENT

FINAL REPORT

August 27, 2008

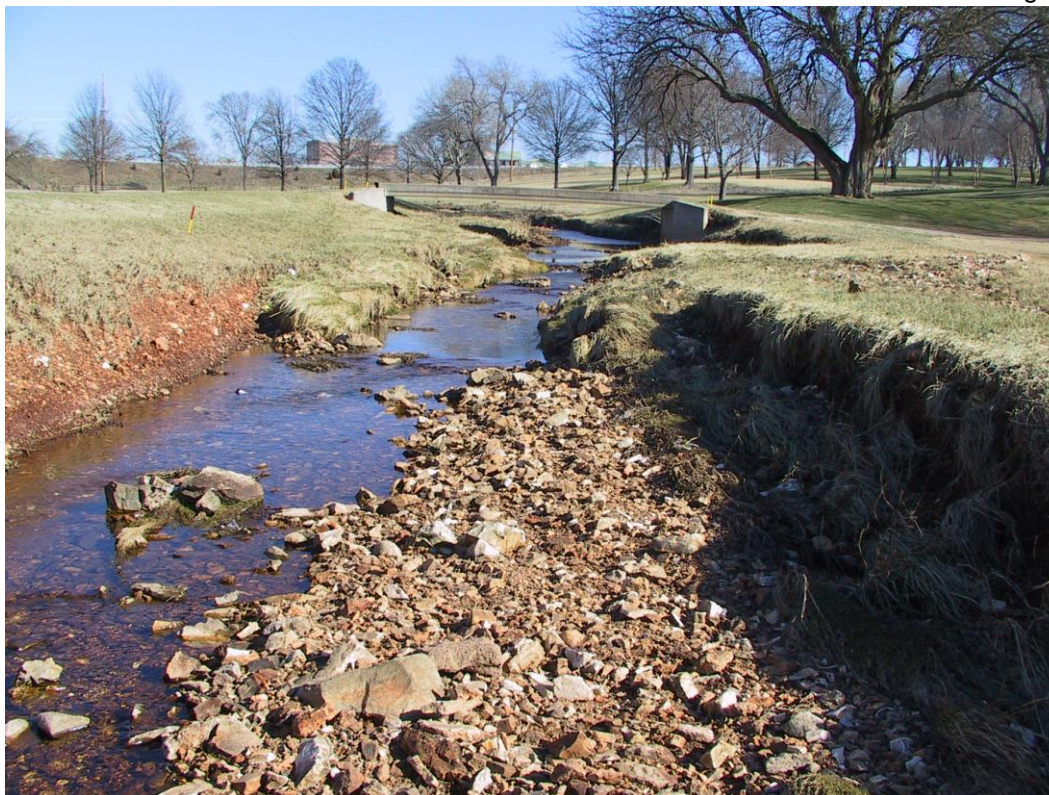
Picture 13. BEFORE - Riffle crest, bank failure, poor riparian conditions below second cart bridge looking upstream December 2004 (St. 850 feet)

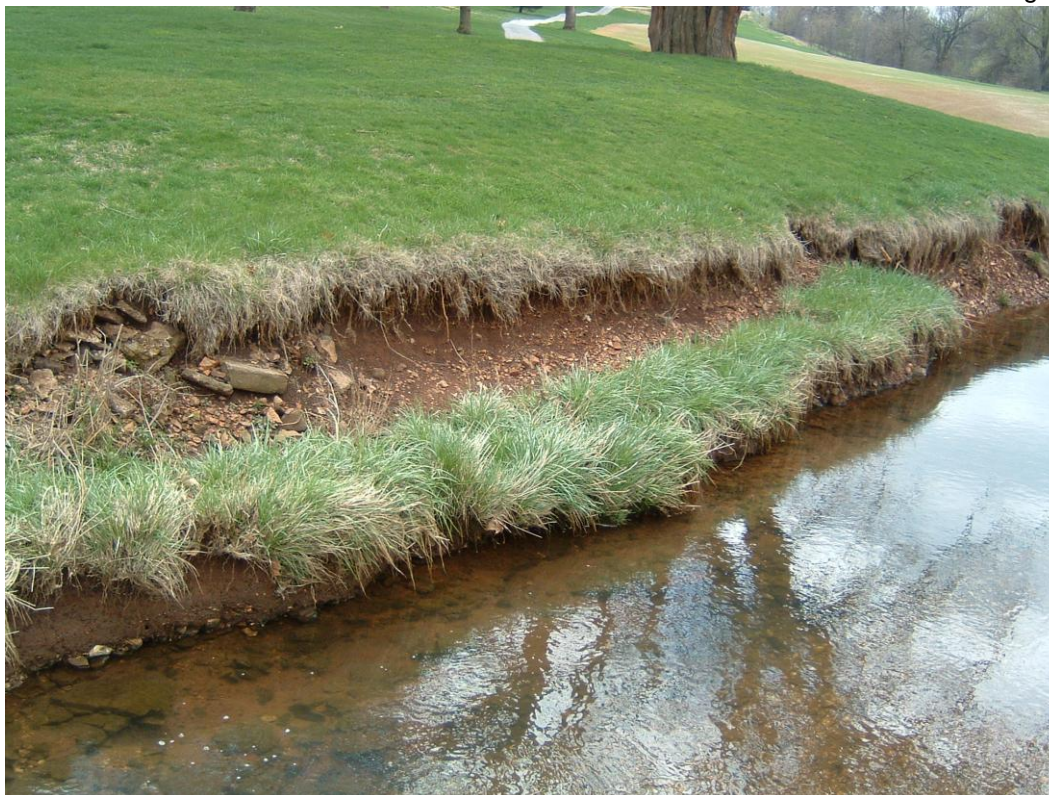
Picture 15. BEFORE - High bank angle collapse above second cart bridge looking downstream August 2005 (St. 700 feet)

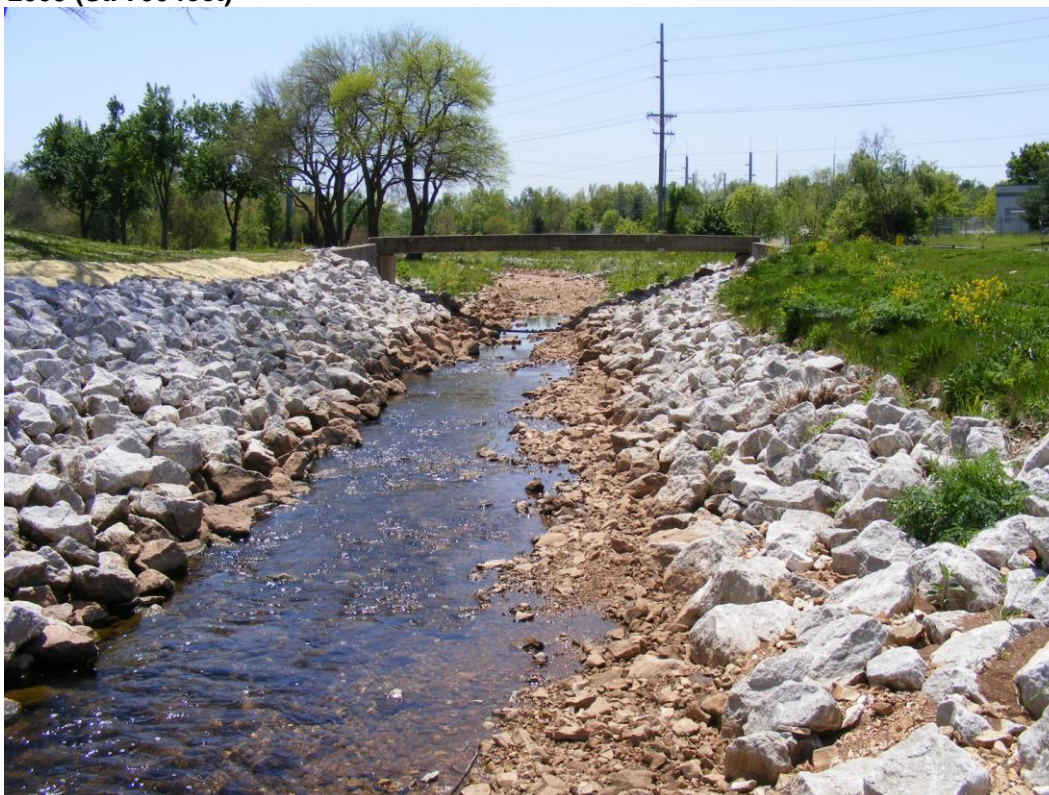
Picture 16. AFTER - Bank angle lower and toe rock above second cart bridge looking downstream May 2008 (St. 800 feet)

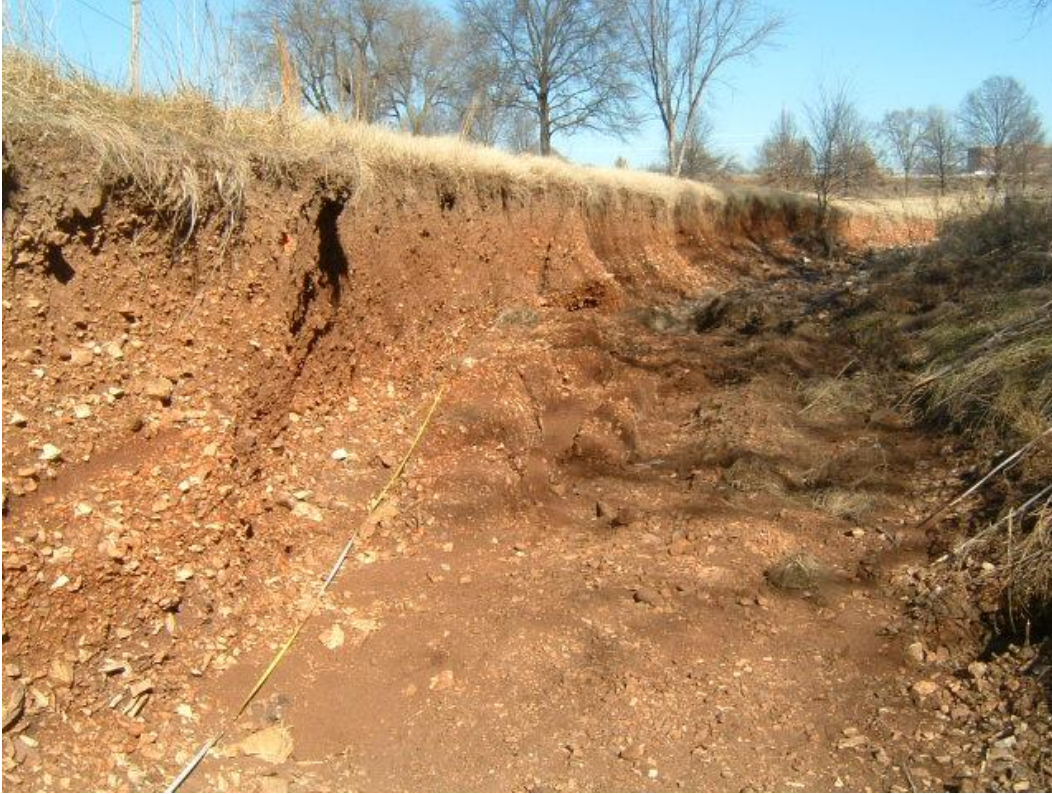
Picture 17. BEFORE - High west bank failure looking upstream January 2006 (St. 1,050 feet)

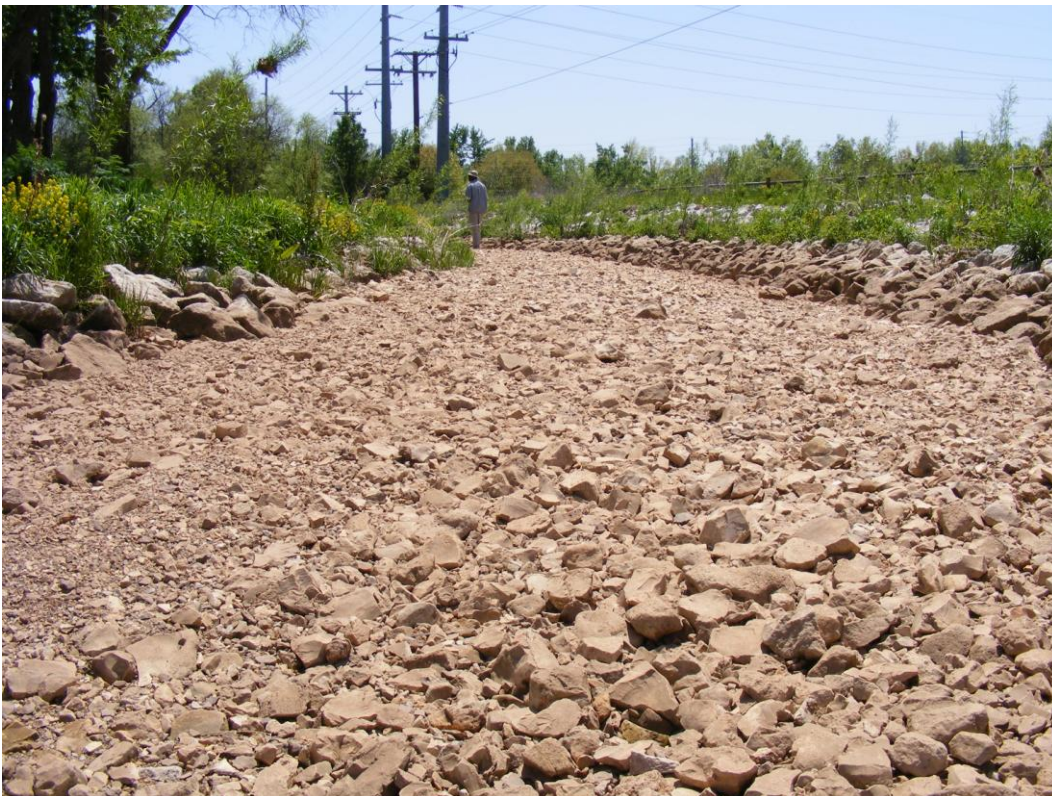
Picture 18. AFTER - Composite revetment installed on high west bank looking downstream May 2008 (St. 1,000 feet)

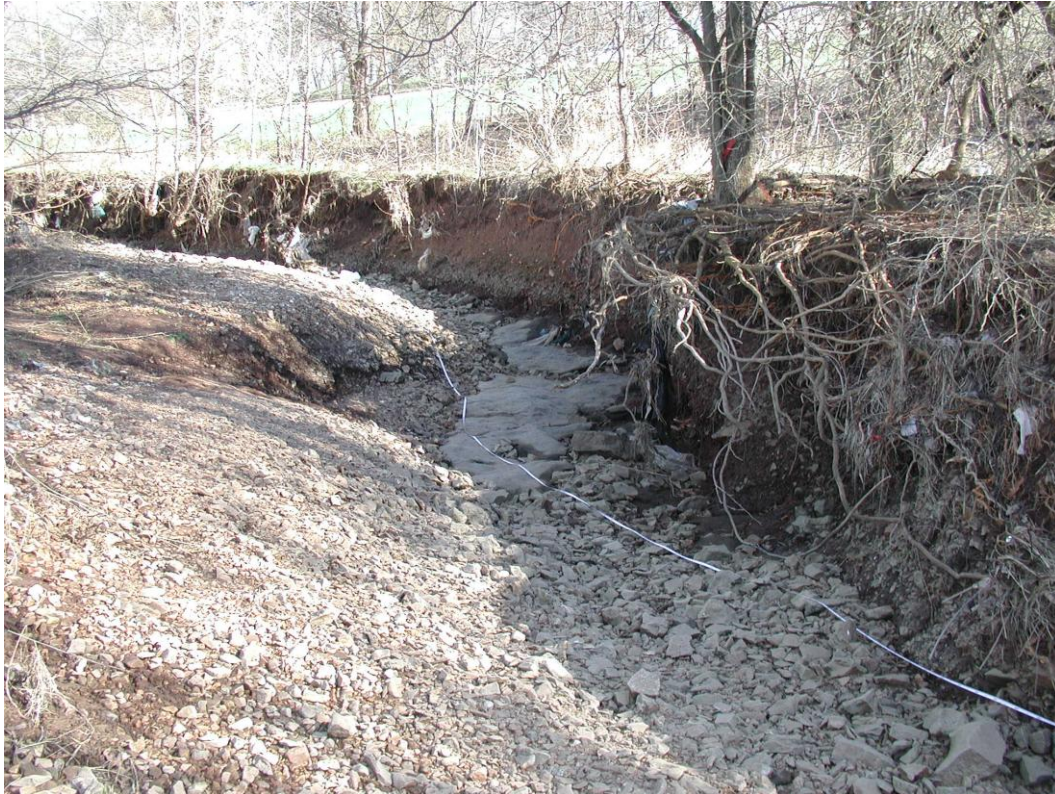
Picture 19. BEFORE - Eroding bank of meandering reach looking upstream December 2004 (St. 1,550 feet)

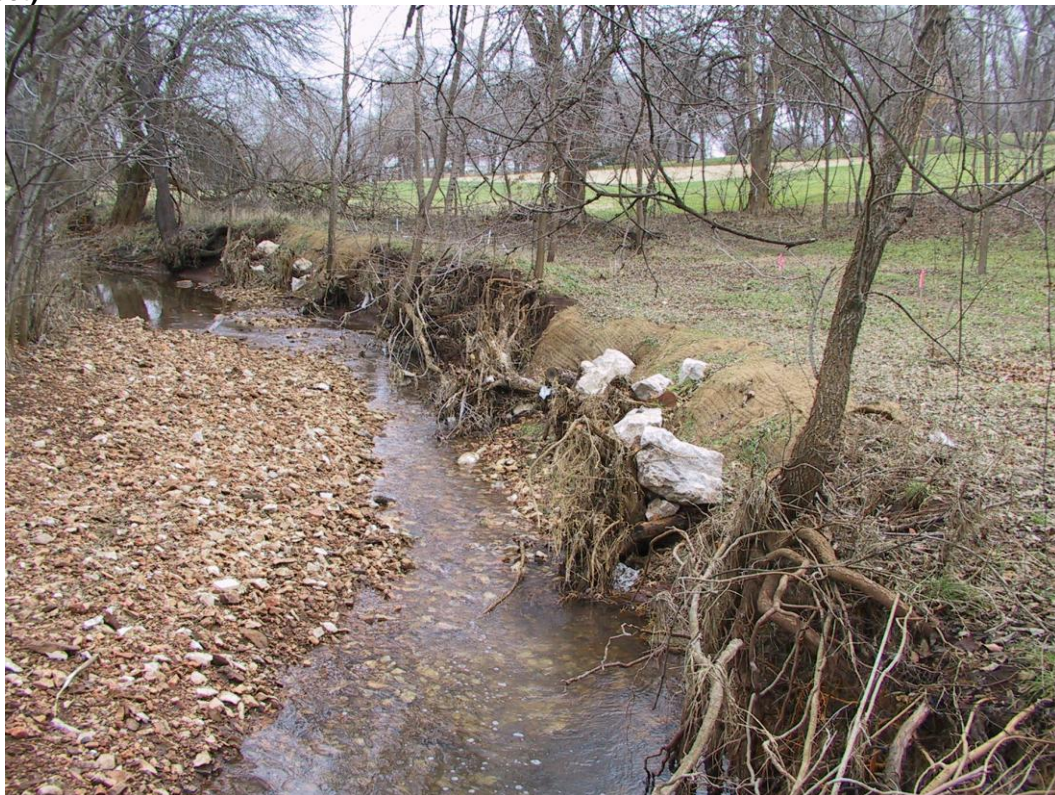
Picture 20. AFTER - Root wads installed along meandering reach looking upstream March 2007 (St. 1,500 feet)

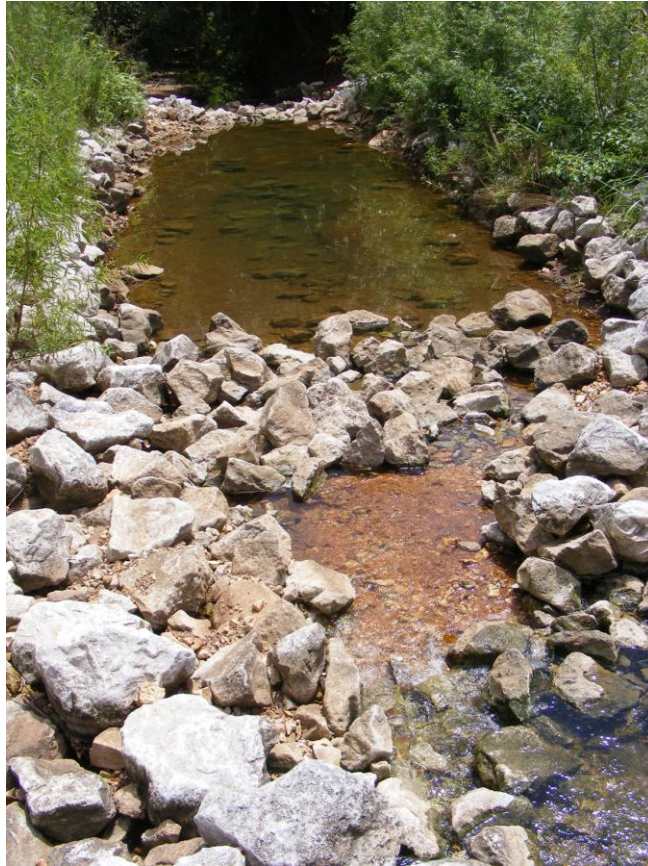
Picture 25. Undermined grade control structure exposing residuum, July 2008 (St. 1,120 ft)

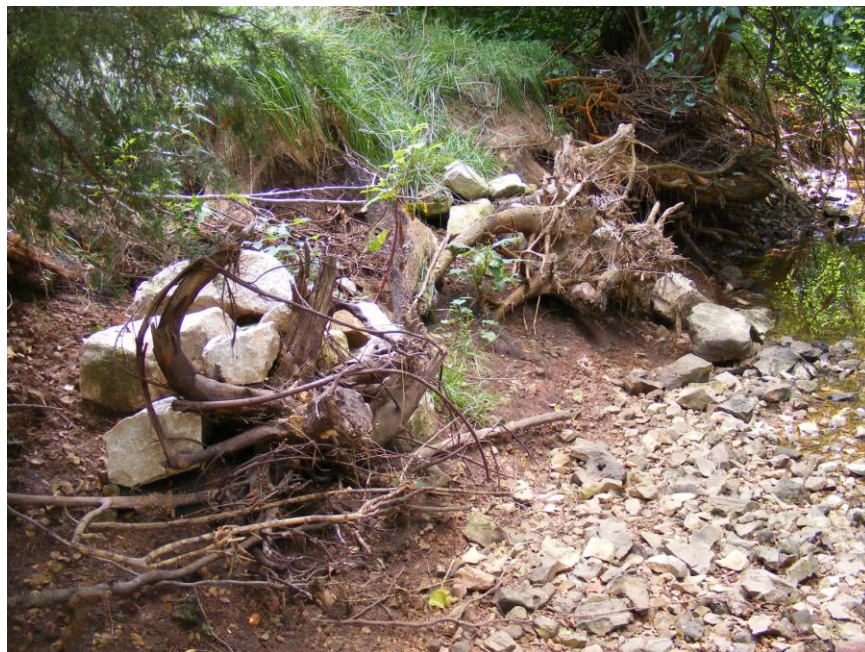
Picture 26. Possible bed elevation lowering at root wad structures, July 2008 (St. 1,320 ft)

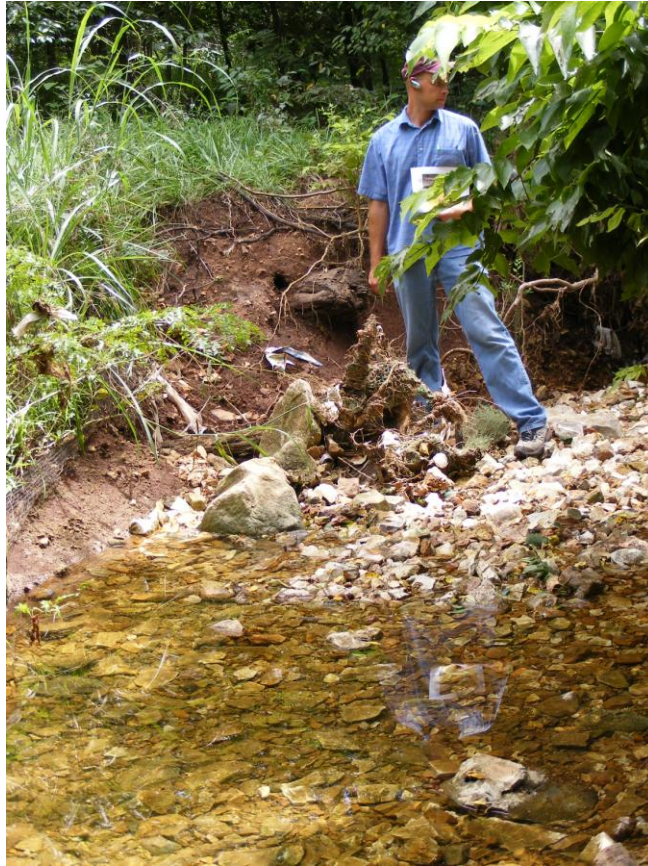
Picture 27. Aggrading bed at root wad structures, July 2008 (St. 1,500 ft)

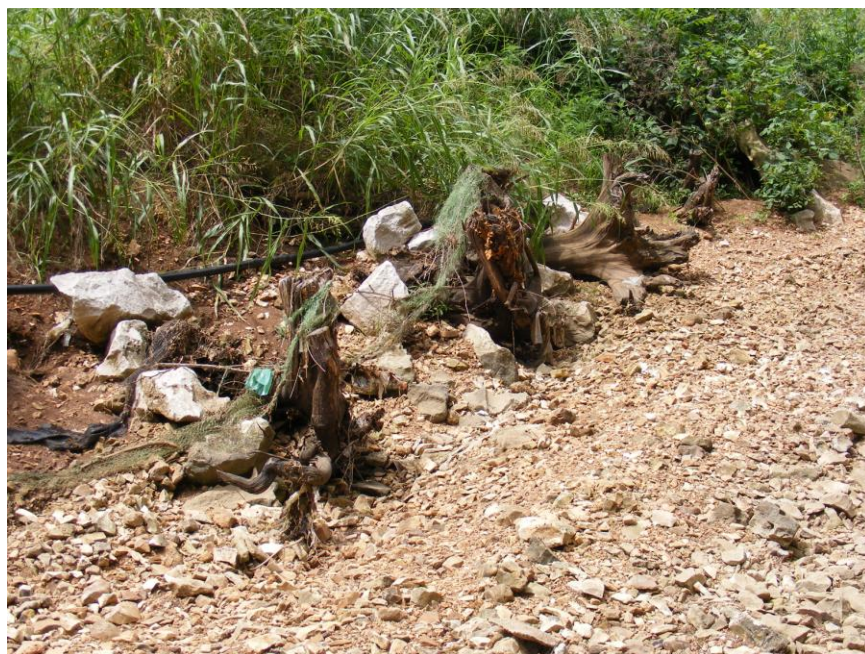
4. Some root wad structures are failing with missing header logs and banks are failing along the backhoe trenches. The buried phone cable is being uncovered

Picture 28. Phone cable exposed behind root wads, July 2008 (St. 1,580 ft)

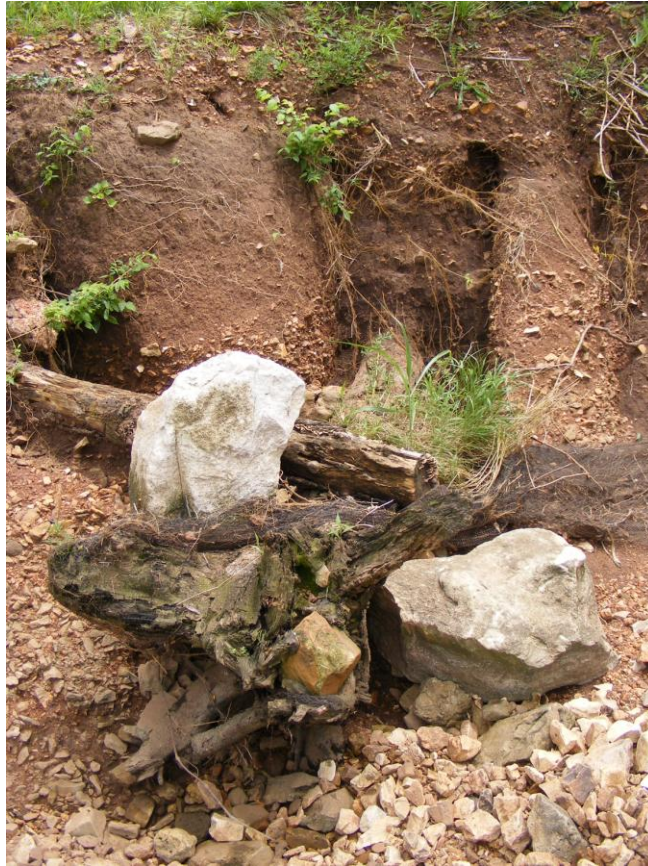
Picture 29. Bank failing at backfilled trench behind root wads, July 2008 (St. 1,660 ft)

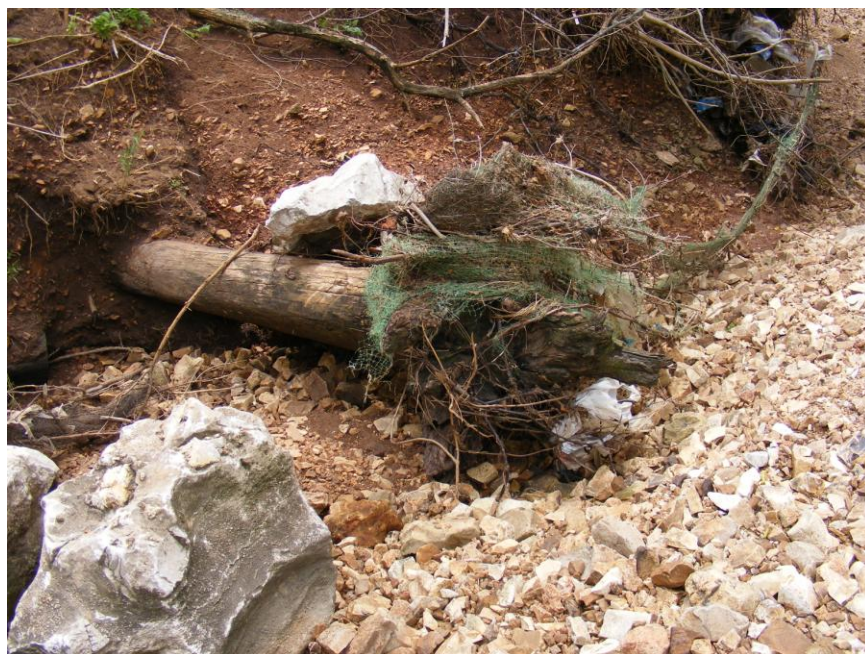
Picture 30. Missing header log at root wad structure, July 2008 (St. 1,660 ft)
