**The Ozarks Environmental and Water Resources Institute (OEWRI)
Missouri State University (MSU)**

FINAL REPORT

**Nonpoint Source Bank Erosion and Water Quality
Impairment Assessment, James River at Rivercut Golf
Course, Greene County, Missouri**

September 17, 2013

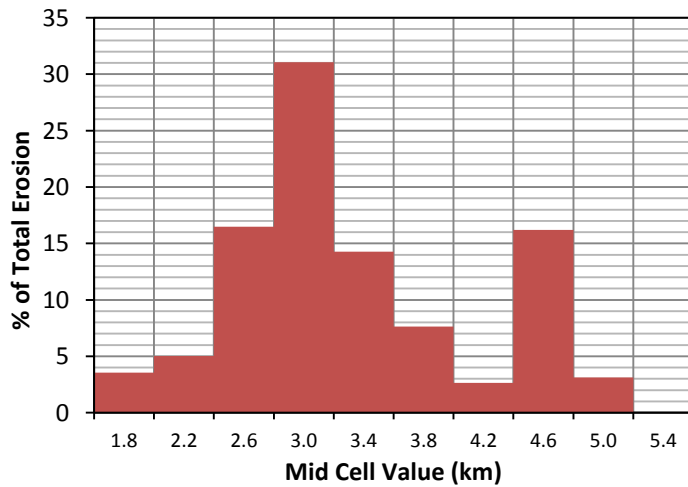
Figure 6. Percent of total erosion by cell.

thought to be experiencing widening over the 12 years between photos (Figure 6). Annual sediment eroded per unit length of stream varies from 0-2.11 Mg/m/year by 400 m cell. The annual average over this period has been 680 Mg/km/yr.

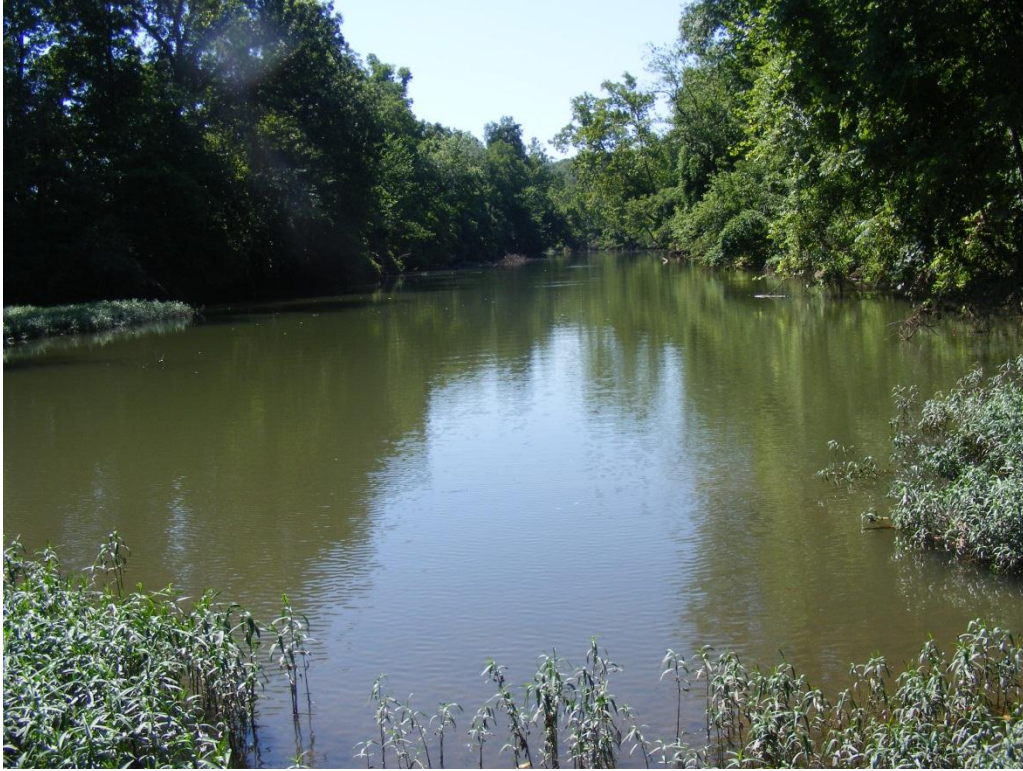
This is a relatively straight reach with a bluff present along the left bank. The right bank appears stable with a thin riparian buffer.

Photo 1. Straight reach looking downstream station 1.6 km

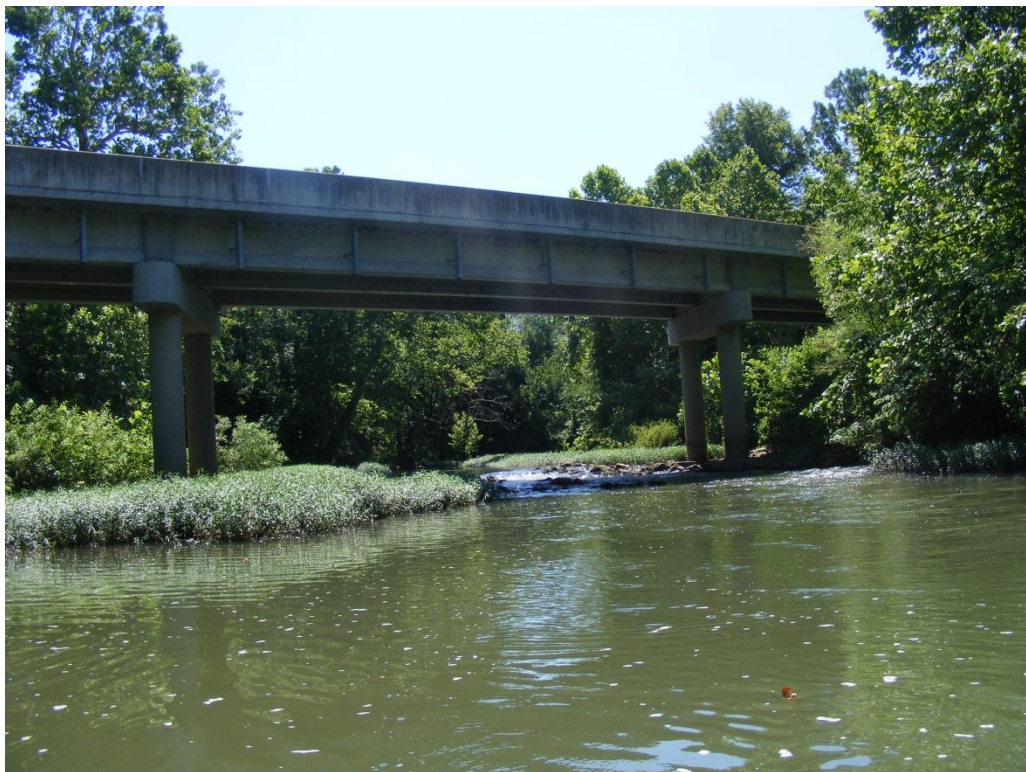
Photo 4. Cox Road Bridge at station 2.7 km

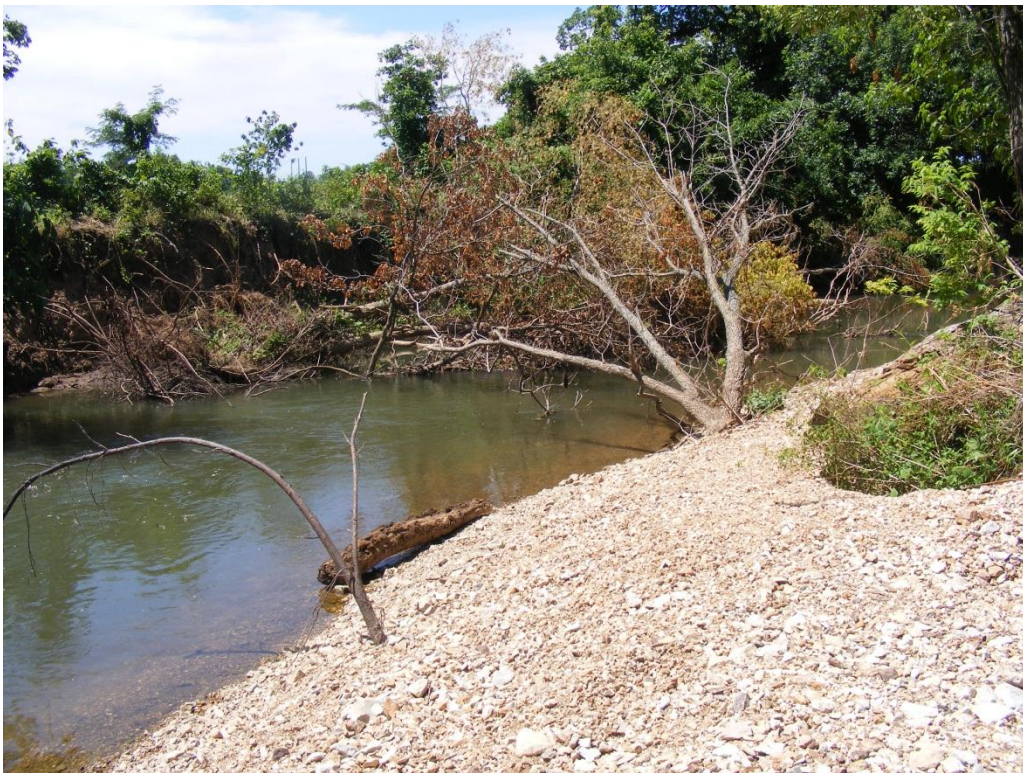
Photo 6. Bank erosion across the channel from delta bar at station 3.4 km

Disturbance Reach #2 is located from 3.2-3.8 km at the confluence with Ward Branch. There appears to be a high bedload entering the river from Ward Branch forming a delta bar at the mouth. Excess bedload is likely originating from bed and bank scour in the highly urbanized areas of Ward Branch upstream. The bar that has formed at the mouth is causing localized bank erosion, but it does not appear to be impacting the road or other infrastructure. This area should be monitored after large floods to watch out for any expansion of the disturbance.

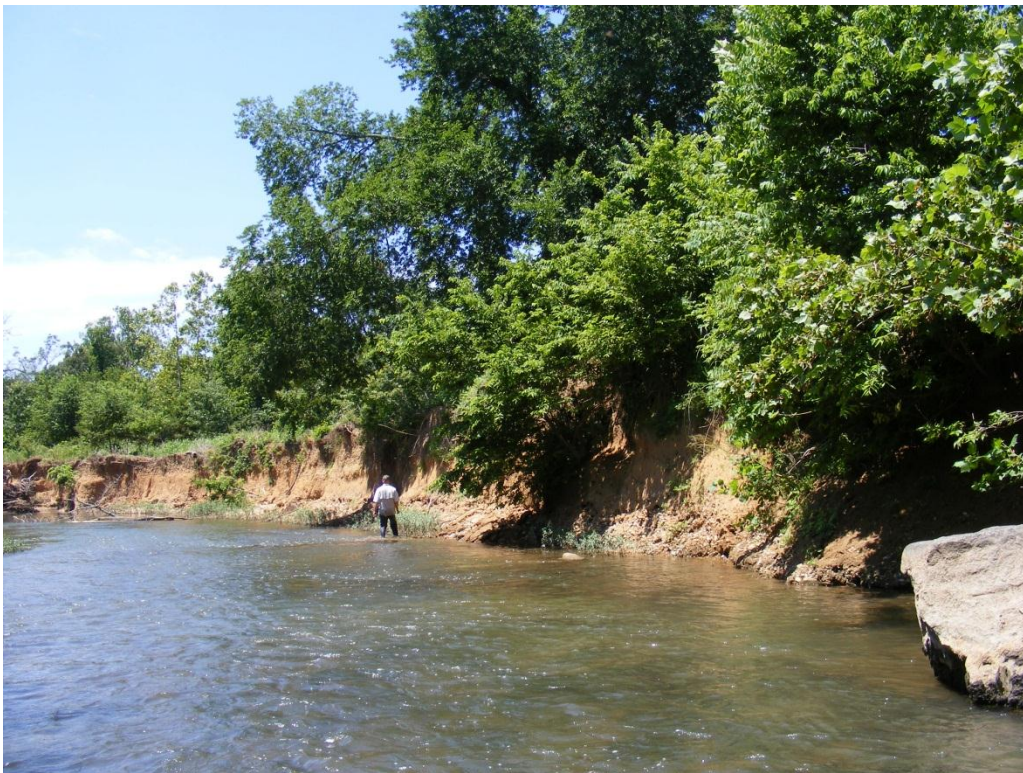
Just downstream of the strath terrace an active cutbank is eroding along the right bank. A gravel bar is building along the left bank of the river. This area is downstream of the easement, but is adjacent to the golf course property.

Photo 15. Cutbank erosion below last disturbance reach at station 5.6 km

Disturbance Reach #4 from 5.6-5.9 km is located just downstream of the easement along the golf course property. Moderately-high bank erosion has formed a cutbank below the bedrock knickpoint along the right bank adjacent to the golf course property near station 5.6 km.
