# **Geomorphic Assessment of the South Dry Sac River below Valley Water Mill**

By: Robert T. Pavlowsky, Ph.D.  
Ozarks Environmental and Water Resources Institute  
Missouri State University

Submitted to the Watershed Committee of the Ozarks on March 15, 2006

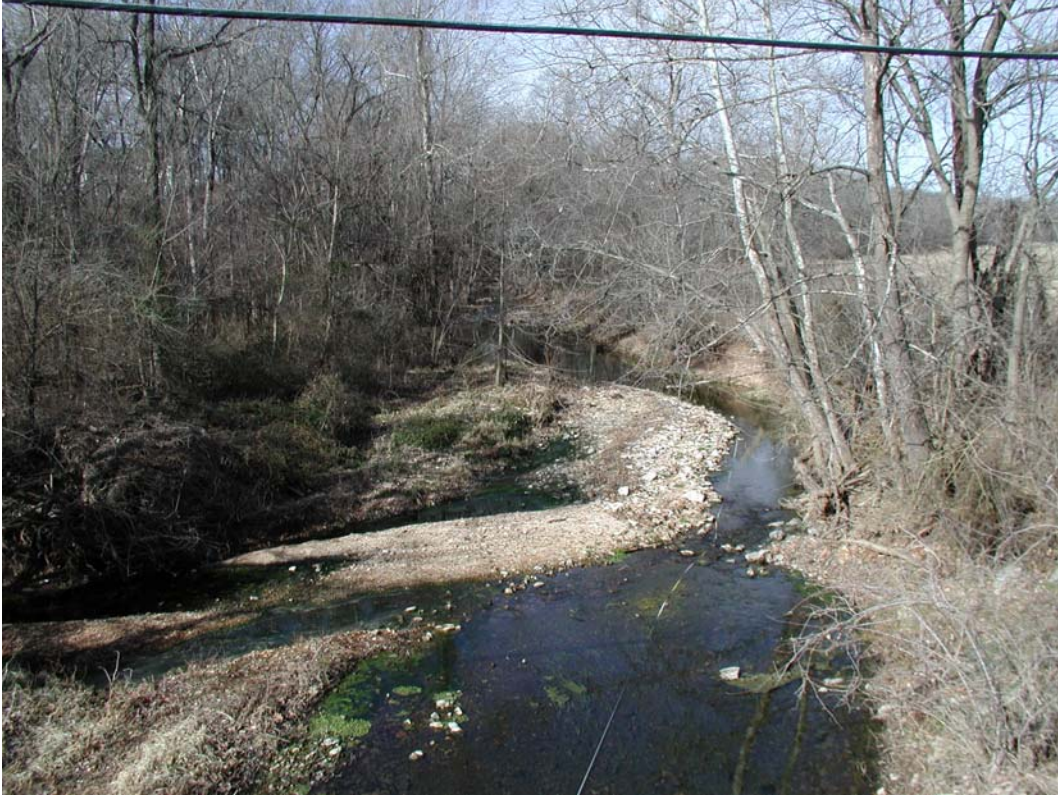
Picture 1. Gravel Bar at Grandview Tributary DS of Farm Road 171 bridge (0 m)

4. **Monitor, and maybe stabilize, the Grandview Tributary Confluence sub-reach from TD 12 m to 60 m.** This area is receiving stormwater and sediment from Grandview Tributary that is affected by urbanization. Restoration activities and stormwater BMP implementation should continue in the watershed to decrease the influence on the South Dry Sac River. Controlling sediment clogging of the channel and stabilizing the right bank may also help reduce the instability of this reach. The instability of this reach could possibly lead to downstream instability that may reactivate or remobilize mega-bar #1. Monitoring activities should extend down to TD 100 m to watch for these downstream progressing effects.

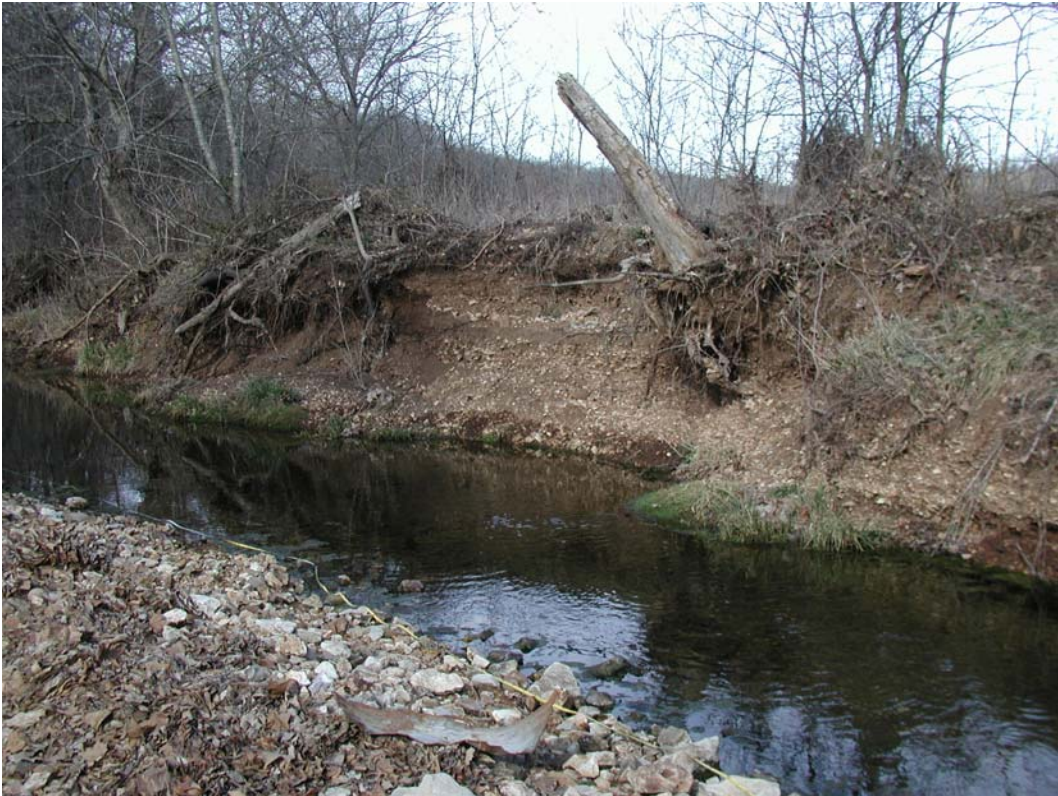
Bank stability was assessed visually by observing upper bank angle, bank height, vegetation cover, and evidence of erosion such as exposed tree roots or recent bank collapse. As mentioned before, channel location has been relatively stable over time so few severely eroding banks were found in the study area. The banks showing the most consistent extent of erosion are located on the floodplain/terrace features on the right side of the stream in locations where flood flows are forced to converge and increase in erosive force as they enter a bluff-lined reach (Map 4). Additional locations for bank erosion occur at relatively tight bends or any bend along a steep reach. Finally, bank erosion is also noticeable at a slight bend being affected by the Grandview tributary and the depositional bar below it (TD 45 m) (Picture 2).

Picture 2. Cutbank at 50 m

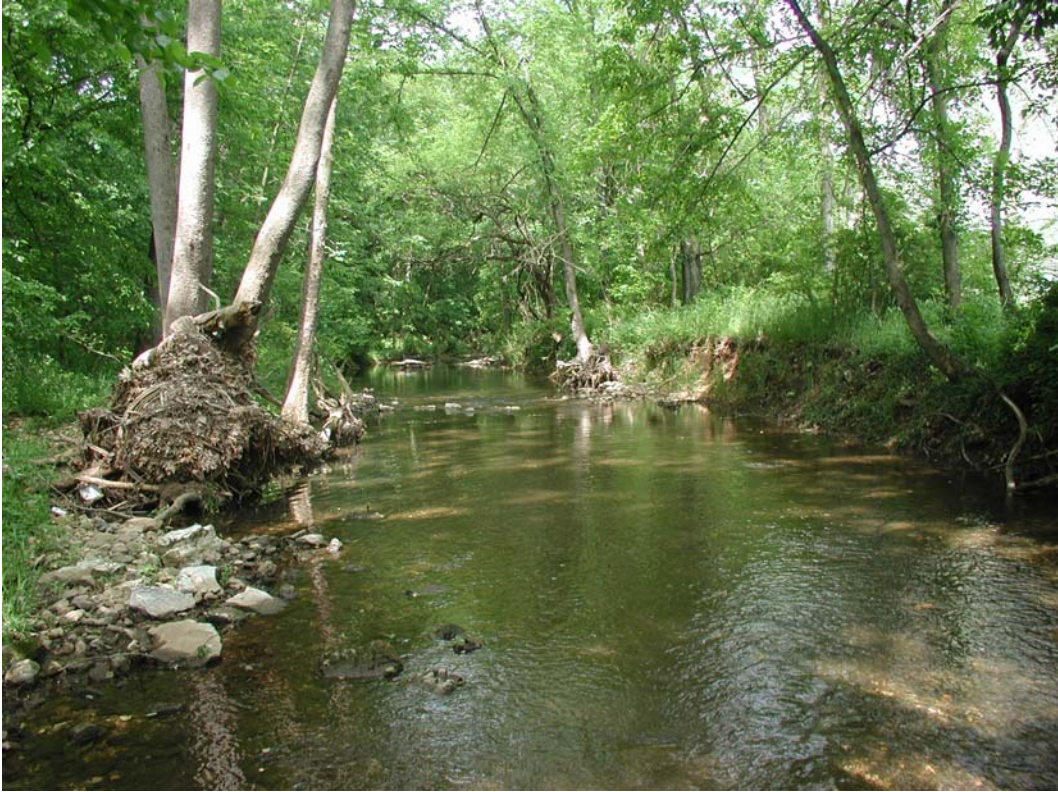
Picture 3. Flood debris jam at high bank level (100 m)

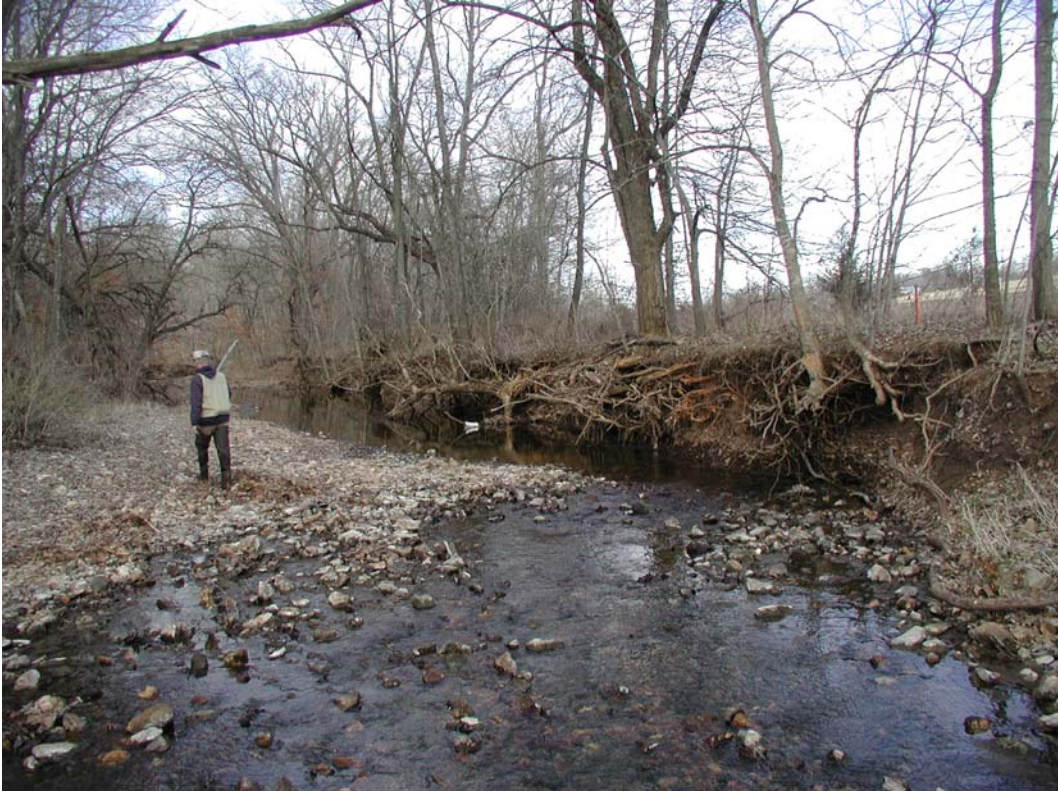
Picture 11. Exposed roots along eroding bank looking downstream (400 m)

- b. The bend at TD 400 m seems to be undergoing a recent episode of erosion where exposed roots have a fresh appearance and mid channel gravel bars are slowly advancing downstream toward it. This reach should be examined for stabilization and restoration action—at the least it needs to be monitored.

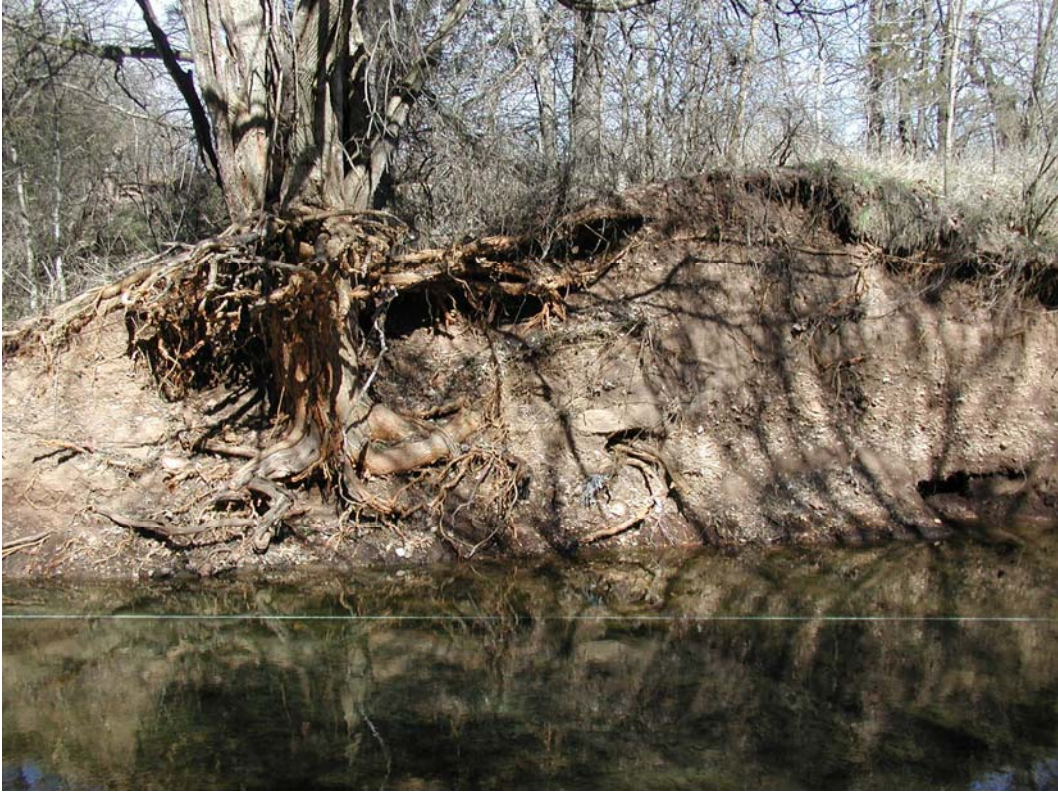
Picture 25. Disturbance reach cutbank (800 m)

- c. The bend below mega-bar #2 and TD 800 is very unstable. Bank regrading, stabilization, and toe-protection is needed to stabilize this area. Some of the excess energy could be directed around this bend by expanding the chute channel on the low floodplain on the left side of the channel to direct floodwater around it.
