**Geomorphic Assessment of Ravenwood Creek
Lake Springfield Park, Springfield, Missouri**

**Final report to Olsson Associates for
the City of Springfield, Missouri**

May 2, 2008

OEWRI TR-08-001

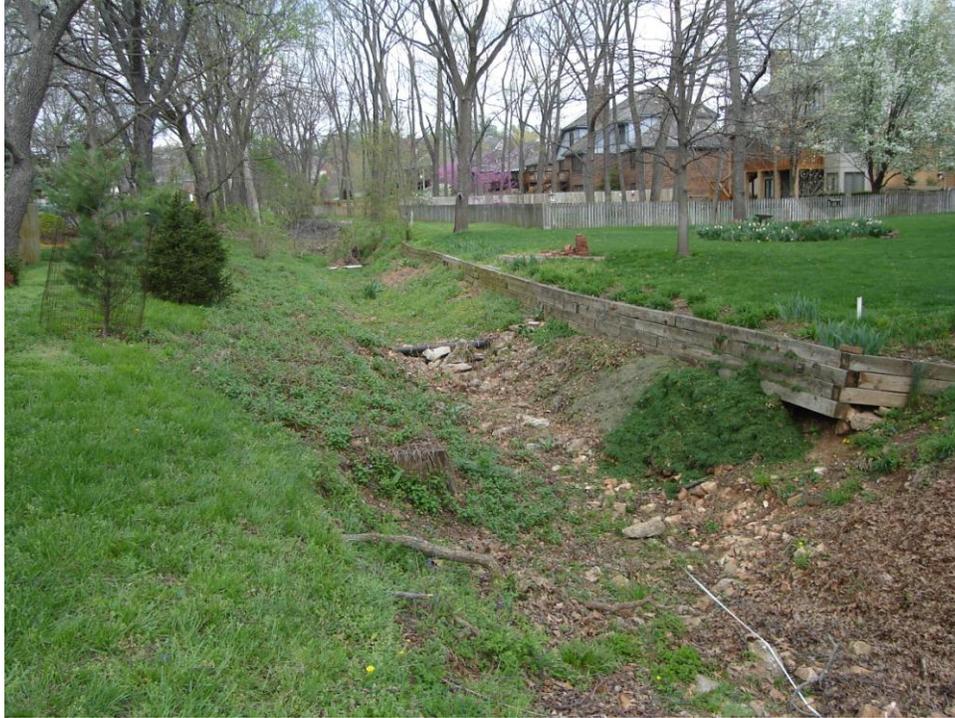
Sub-reach #1 occurs between stations 878 ft to 667 ft and directly drains the residential community in a grass-lined channel (Figure 4a and Picture 1). The upper bank angle along this reach is relatively low ranging from 30 to 40 degrees and top bank width averages about 18 ft. The top bank surface is 3 to 5 ft above the channel bed or about 3x the bankfull stage. Channel slope ranges from 0.0068 along the channel bed to 0.0106 between the crests of the two concrete utility covers. The bed is stable and has been scoured or graded to bedrock in several places. Typical bankfull channel dimensions are 10 ft in width, 0.6 feet in mean depth, and 6ft² in area (Table 2). This reach is analogous to the zone of the “oversteepened reach” below the “precursor knickpoint” (Figure 5). However, erosional affects are attenuated by the protection of the two concrete utility covers in this reach. In Spring 2008 after several >20 year storms had hit the

Picture 1 – Looking upstream at 800ft (sub-reach #1)

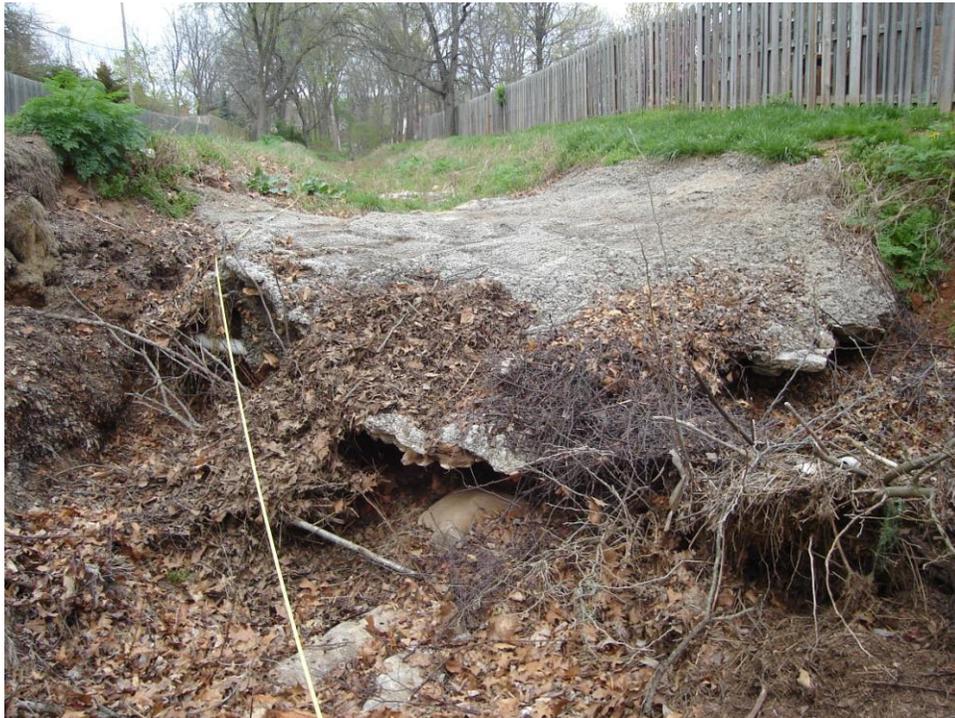
Sub-reach #2 extends downstream from stations 667 ft to 530 ft and represents a recently active portion of a headward incising channel or “headcut.” However, upstream migration of the head cut has presently stalled due to inadvertent bed protection by the concrete cover (Figure 5 and Picture 2; note exposed PVC pipe under apron to the left side of the picture). This is a zone of local channel disequilibrium where the bed form is flat or uneven and bed slope approaches zero. There are three zones in sub-reach #2. Sub-reach #2A designates the zone of maximum incision depth immediately below the concrete cover forming a large “plunge pool” between stations 667 ft and 640 ft. Channel bed elevation drops by almost 6 feet over a horizontal distance of a few feet to expose bedrock between 660 ft to 655 ft. Upper bank angles range from 60 to 90 degrees and top bank width is 27 ft across the plunge pool. Top bank height is 9 ft above the bed. Bankfull stage indicators were not identified in this sub-reach. The underground pipe and phone line was almost completed undermined in April 2008 and should be checked by authorities as soon as possible.

Picture 2 – Concrete bed obstruction/headcut at 670ft (looking upstream)

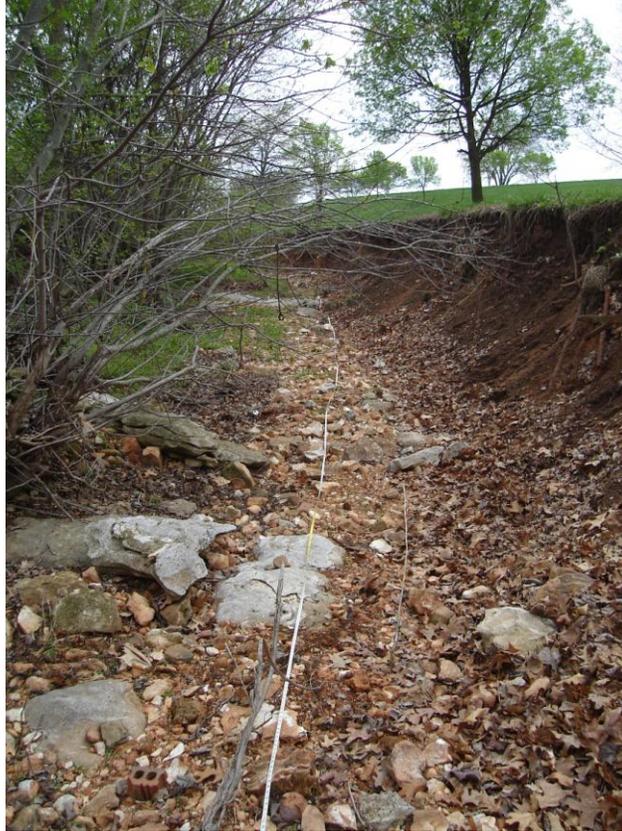
Sub-reach #2B is a zone of scour and sediment transport extending below the core zone of the plunge pool from 640 ft to 575 (Pictures 3 and 4). Bedrock is exposed in some places between patches of gravel sheet deposits. Upper bank angle averages about 60 to 80 degrees and top bank channel width is 25 ft. Top bank heights rise from 5 to 7 ft above the bed, about 5x bankfull stage. Sub-reach #2C is a zone of deposition between stations 575 ft and 530 ft where the erosional energy of the plunge pool has dissipated (Picture #5). The rate of bed load delivery into the project reach from upstream sources is probably relatively low compared to the amount of gravel and cobble released by bed and bank erosion in the plunge pool zone or from channel widening in sub-reaches 2A and 2B. Channel width and depth trends are similar to sub-reach #2B. There are two locations where historical farm artifacts are buried by about 3 ft of alluvial and presently exposed in eroding banks on the right side of the channel. A wagon bed and frame (not really sure, but my best guess) is located at 615 ft and the iron band from around an old wagon wheel is found at 565 ft. These artifacts are presently (April 2008) being unearthed by lateral bank erosion with several pieces already on the channel bed available for transport.

Picture 3 – Bedrock exposure and bank artifacts on the right side at 600ft (sub-reach #1)

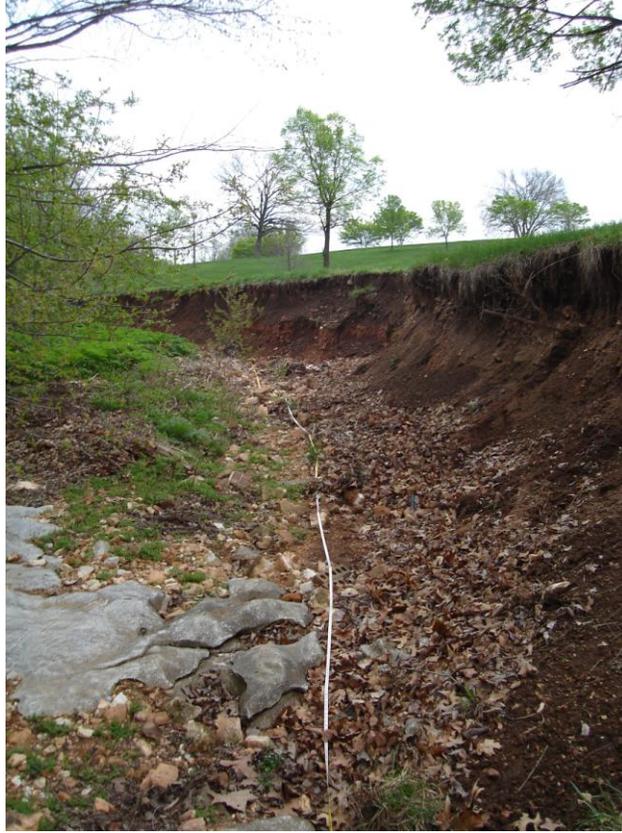
Picture 5 – Bedrock exposure at 550ft (sub-reach 2b-c)

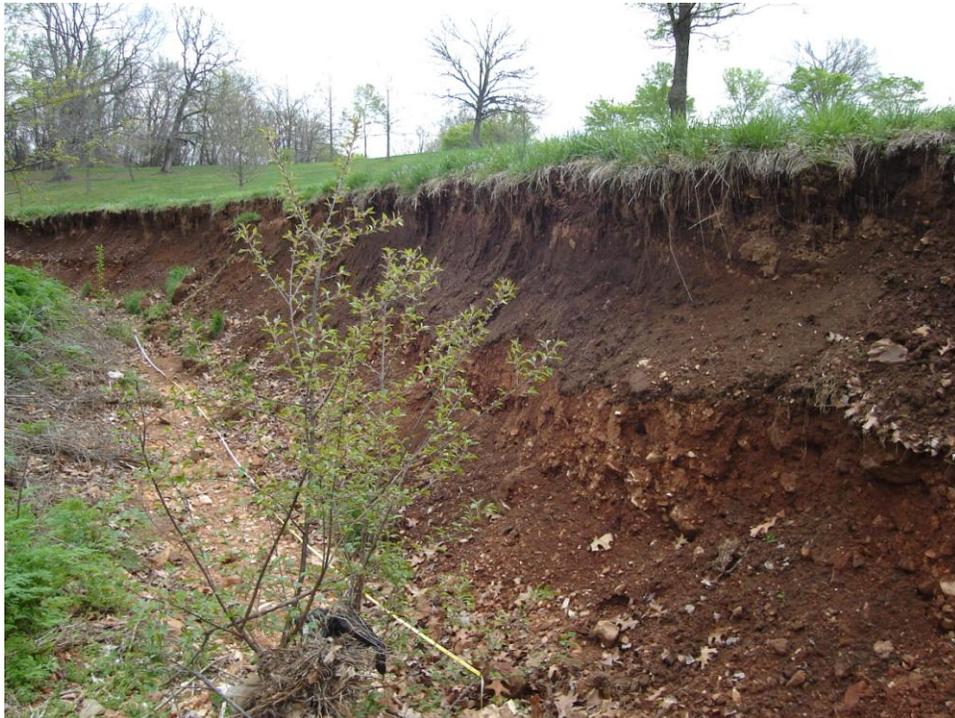
Sub-reach #3 extends from 530 ft to 369 feet (Pictures 6 to 8). Channel slope in this reach averages about 0.0063. This is a reach where there is a relatively long bend to the left or north by the channel and a long lateral pool trough has formed along the cut bank as expected between stations 520 ft to 410 ft. There are also several smaller-scale erosional steps at stations 500 ft to 470 ft within the longer pool form (Figure 3). Thus, this reach may reflect the composite influence of both meander pool and secondary knickpoint formation (Figure 5). The top bank width of the channel reaches 30+ ft and bankfull width ranges from 13 ft to 18 ft (Figure 4b). Top bank height ranges from 4 to 7 ft, about 3 to 5 times the bankfull stage. Five riffles, including smaller steps, occur in this sub-reach with an average riffle crest spacing of 40 ft. A poorly developed point bar and incipient floodplain has formed on the inside of the bend with exposed and almost vertical upper banks occurring on the outside bend.

Picture 6 – Eroding bank along long bend at 500ft (sub-reach #3)

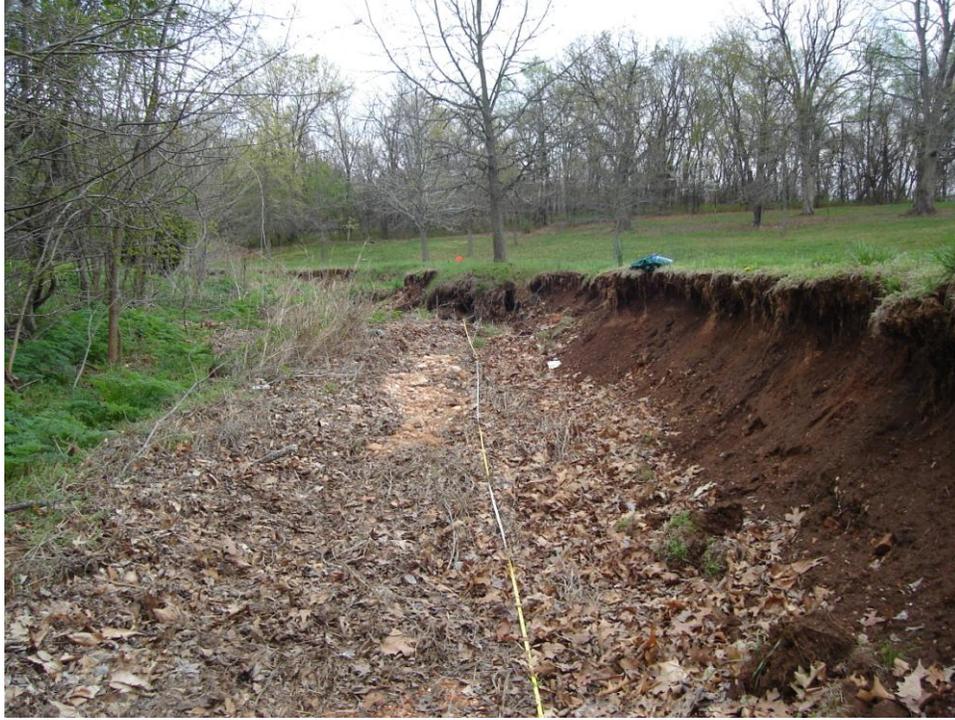
Picture 7 – Point bar on left (under leaves) at 450ft (lower end of sub-reach #3)

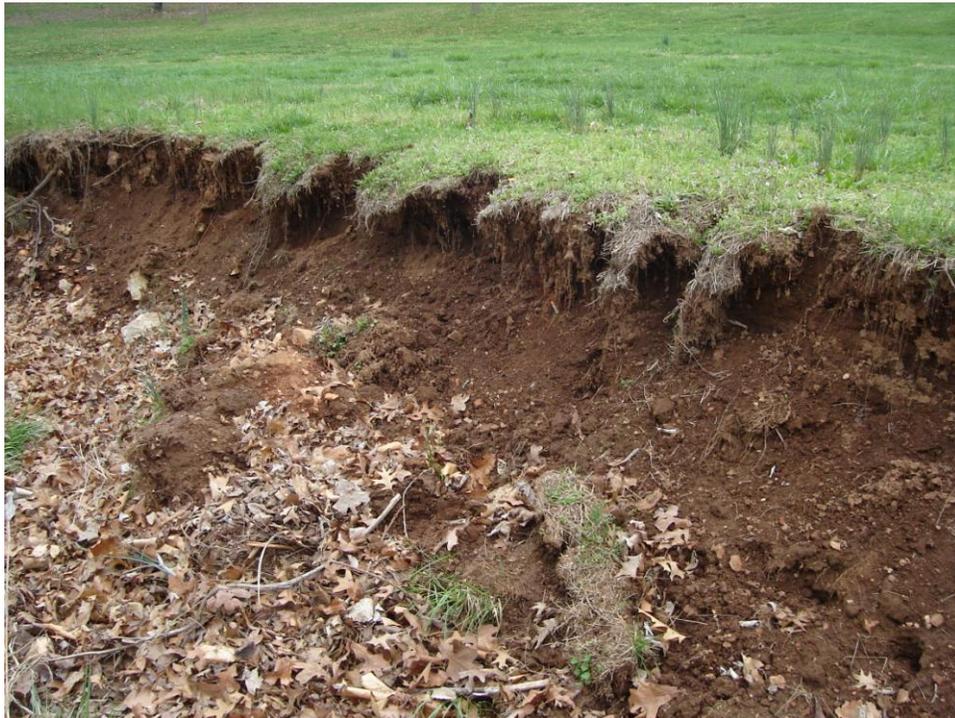
Picture 8 – Eroding bank at 400ft (sub-reach #3)

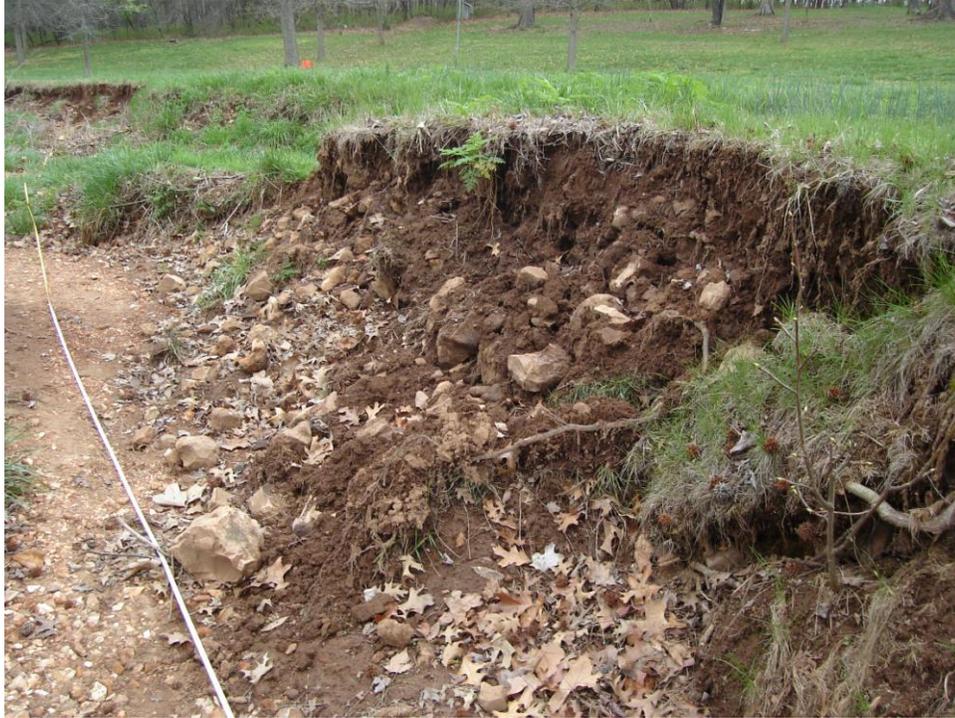
Sub-reach #4 occurs between stations 369 ft and 19 ft and generally represents the “aggradational zone” at the tail end of both the head cut and long eroding cut bank (Figure 5; Pictures 9 to 13). This sub-reach presently shows signs of incision in several places into the aggraded gravel on the channel bed and scour to underlying cohesive material. The recent trend of incision in the sub-reach is possibly related to the decrease in sediment supply from upstream sources and relative increase in sediment export (i.e. negative sediment budget). As the sediment load released from eroding bed and banks decreases, the excess fluvial energy is applied to the bed causing erosion. As also observed in April 2008, woody debris from yard waste dumping, ice storm tree damage, and bank erosion litters the secondary channel area and channel “flood plains” along most of the reach, possibly obstructing flow and also increasing bed erosion.

Picture 9 – Slumping, failing bank just above stream crossing at ~320ft (Sub-reach #4)
Notice: Maybe old channel bed deposits collapsing into the present channel.

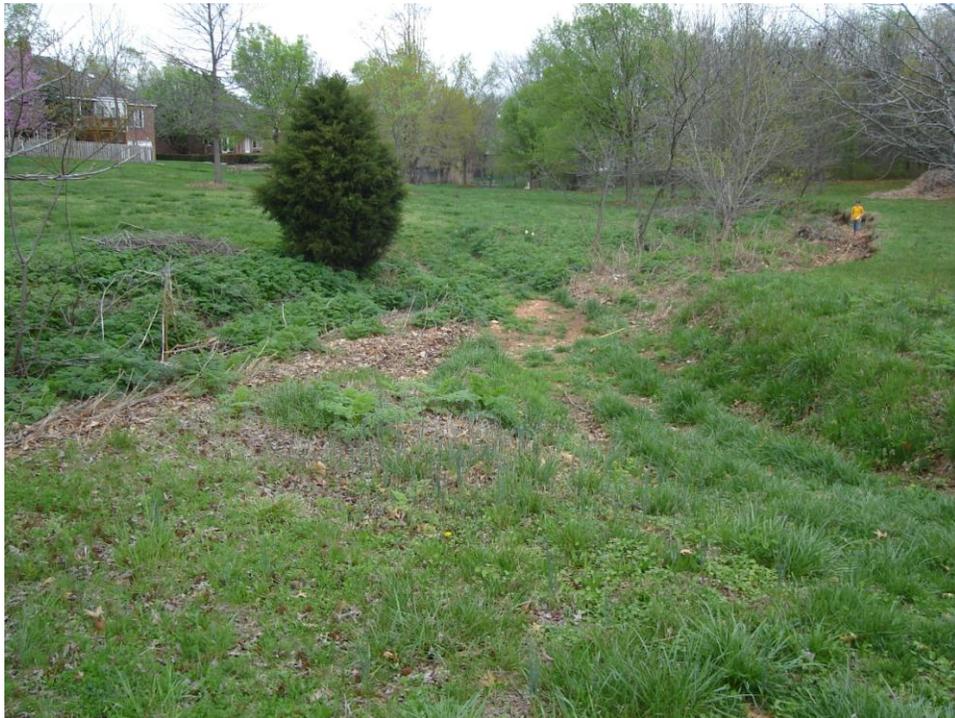
Picture 10 – Stream crossing at ~310ft (sub-reach #4a)

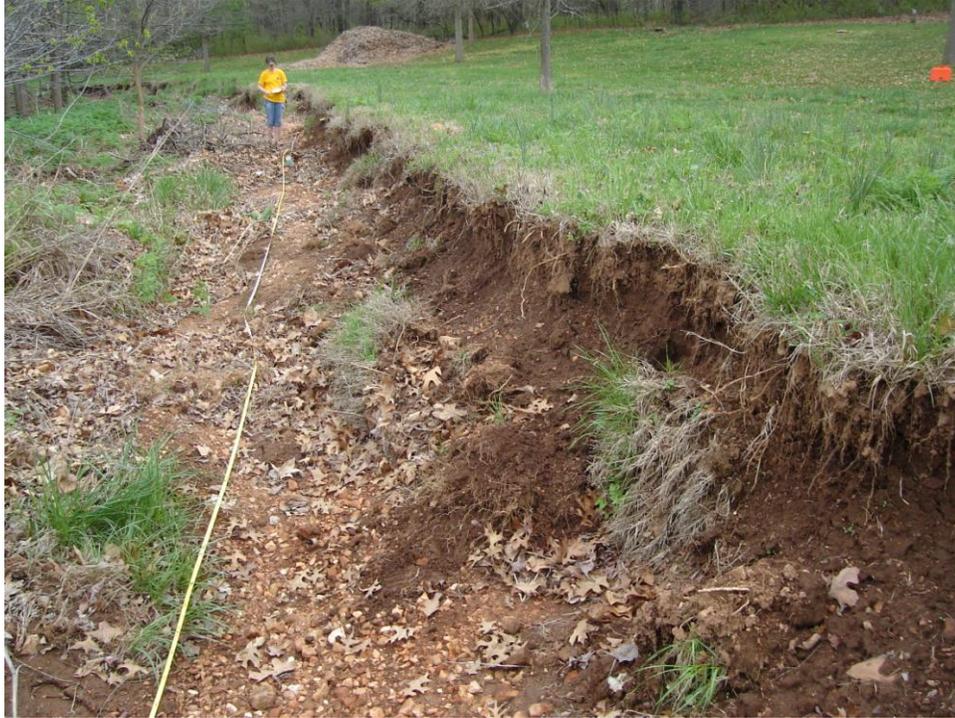
Picture 11 – Lower channel banks at 300ft (sub-reach #4)

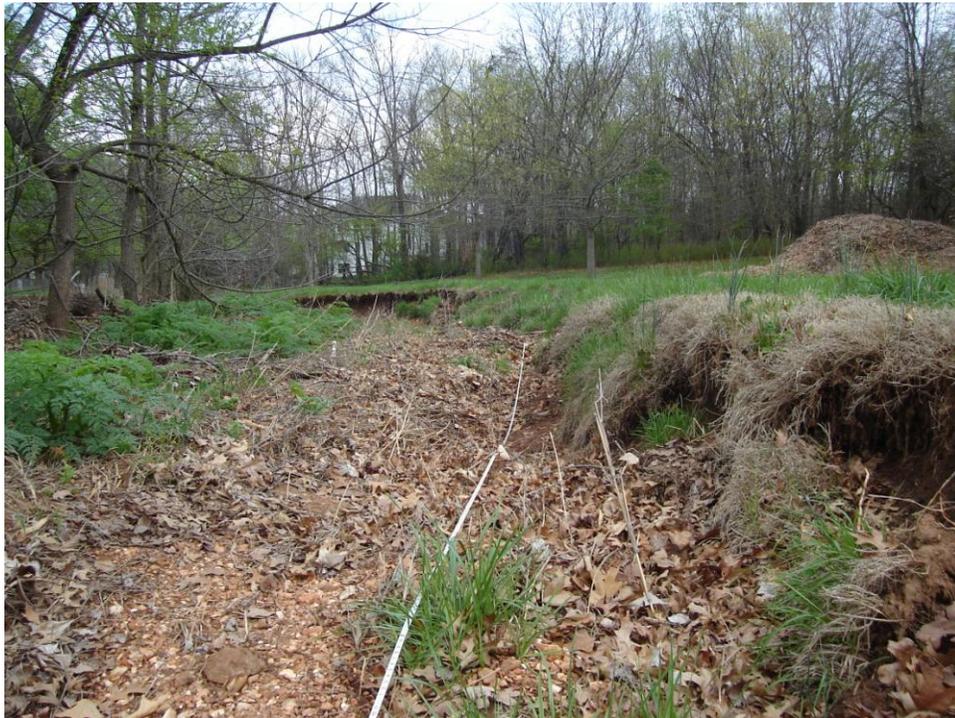
Sub-reach #4A extends from 369 ft to 92 ft. Here the channel is relatively wide with low banks (Figure 4c). Top bank width is 25 ft and bankfull width is 8 ft. The top bank height is only 2 to 3 ft or 2+ times the bankfull height. The planform of the channel changes to a split or double thalweg habit in this reach. One channel thread tends to be the primary thalweg (on the right side) while the other appears to be a secondary chute channel (left side). Deposition of sediment into a mid-channel bar form or bench occurs between these channels. **Sub-reach #4B** occurs from 92 ft to 19 ft. The channel is still double-threaded but the primary channel thread switches from the right to left side of the channel. The channel narrows in this sub-reach to a top channel width of 21 ft and a bankfull width of 4 ft (Figure 4b). Top bank height is about 3 to 4 ft from the bed of channel or about 3x the bankfull stage. The bed elevation and slope of sub-reach #4B may reflect that of the pre-incision channel and bed slope increases to 0.0125 slightly below station 144 ft. Eight riffles were identified between stations 369 ft and 40ft for an average riffle crest spacing of 41 ft.

Picture 12 – Wide and shallow channel with “double thalweg” at 200ft (sub-reach #4)

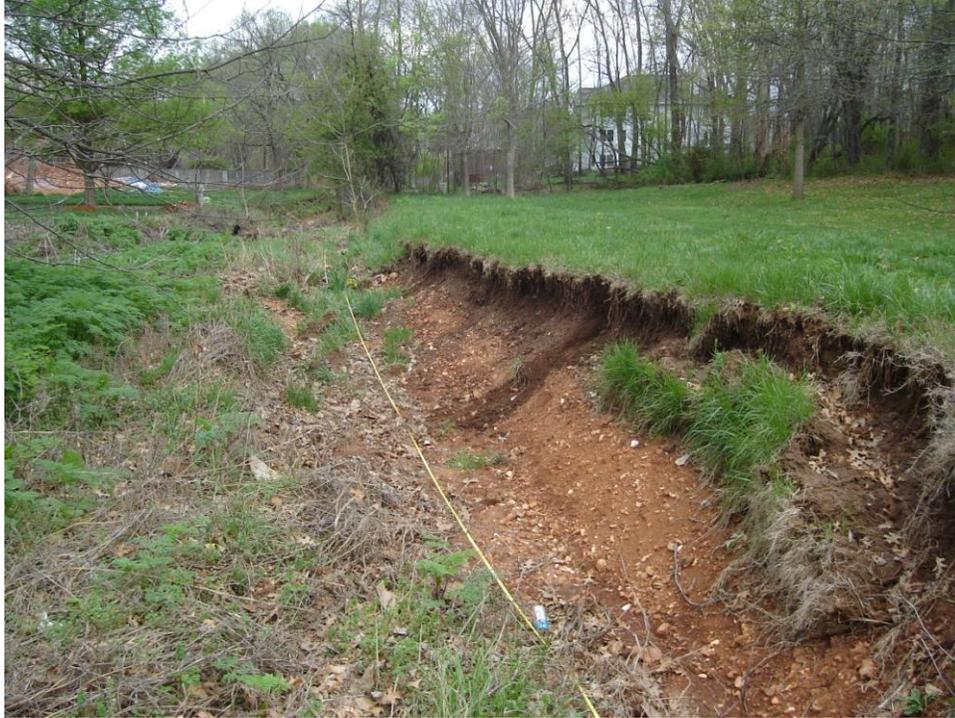
Picture 13 – Lower on of “double thalweg” at 100ft (sub-reach #4b)

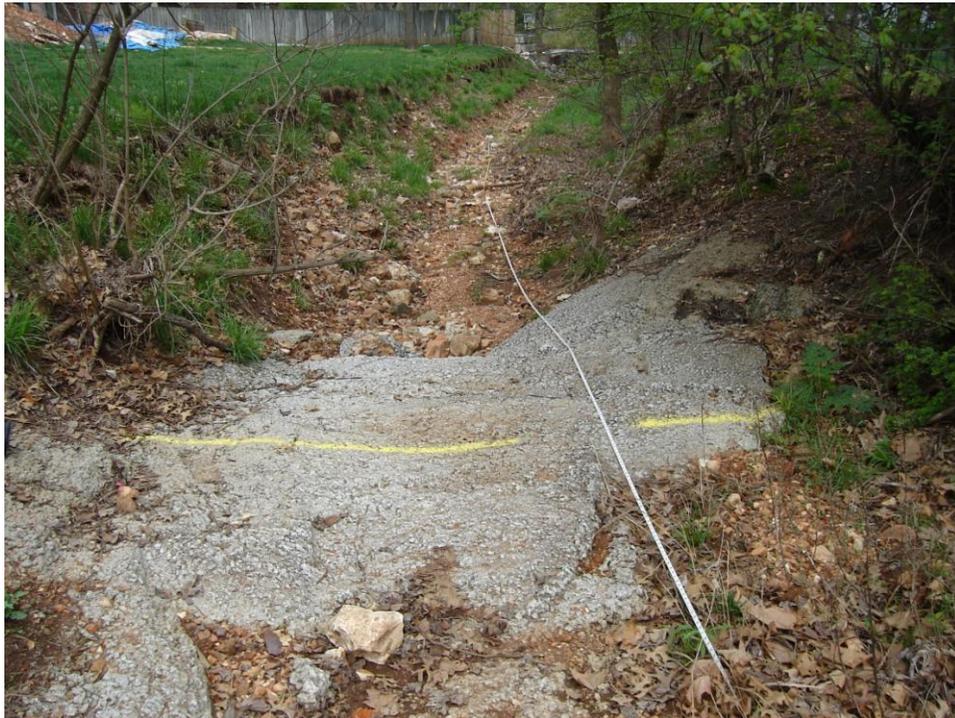
Sub-reach #5 occurs between stations 19 ft and zero ft. The form of this reach is largely controlled by the large concrete apron at station zero where the stream flows off park property (Picture 14).

Picture 14 – Concrete bed obstruction marking end of study reach at 0ft

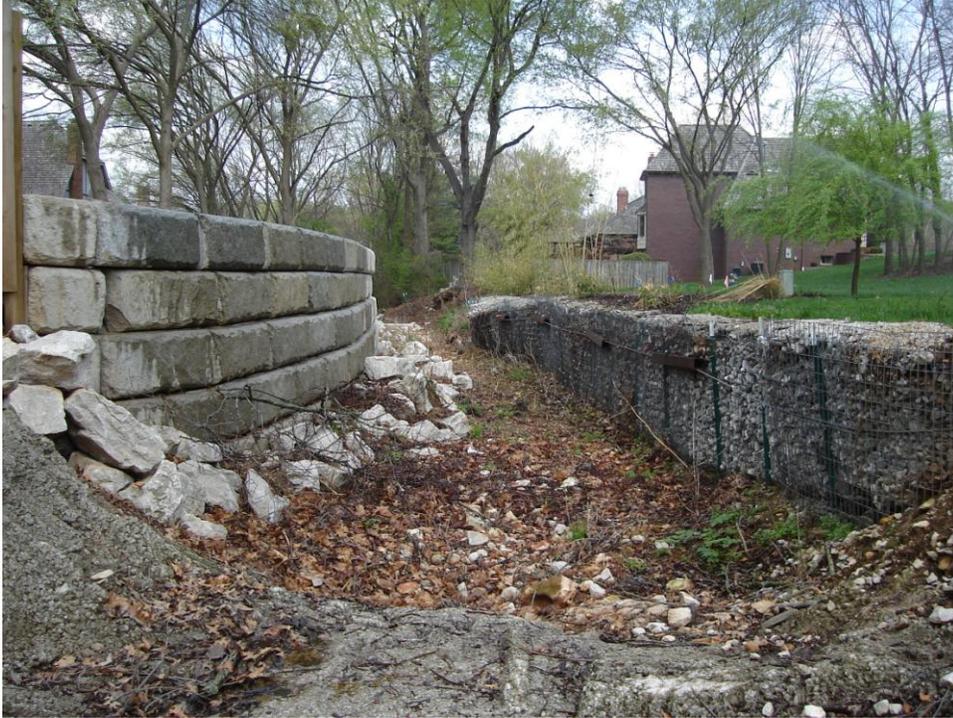
Sub-reach #6 occurs from zero to -140 ft (notice negative sign indicating that this sub-reach is downstream of station zero) (Picture 15). This reach is not on park property but was visually evaluated for geomorphic stability. Upper banks are steep and top bank heights are about 4 to 5 ft off the bed, or about 2 to 3x bankfull stage height. Top bank width is 17 ft and active bank width is about 4 ft. Fill from residences infringe on the channel area on both sides in some places. A 12” white PVC line is exposed on the channel bed at station -108 ft. On April 29, 2008, construction of a new channel with stone bed and banks was in progress at the end of sub-reach #6.

Picture 15 – Engineered channel -140ft downstream of 0ft on survey (end of sub-reach #6)

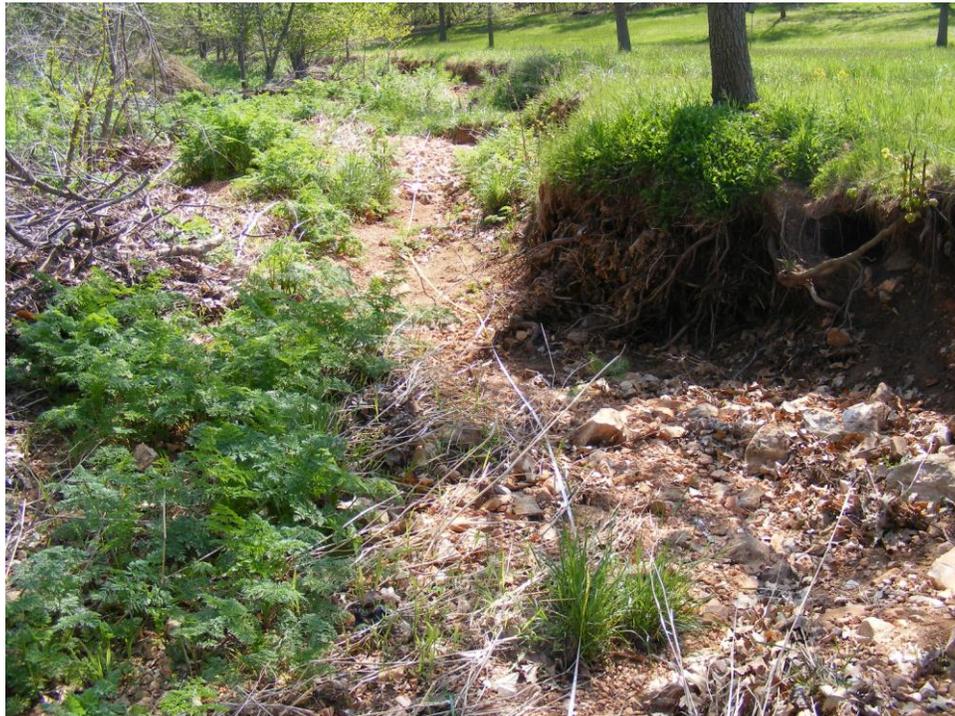
Picture 24 - Scour pool around a tree root at 310 to 340 ft (4-29-08)

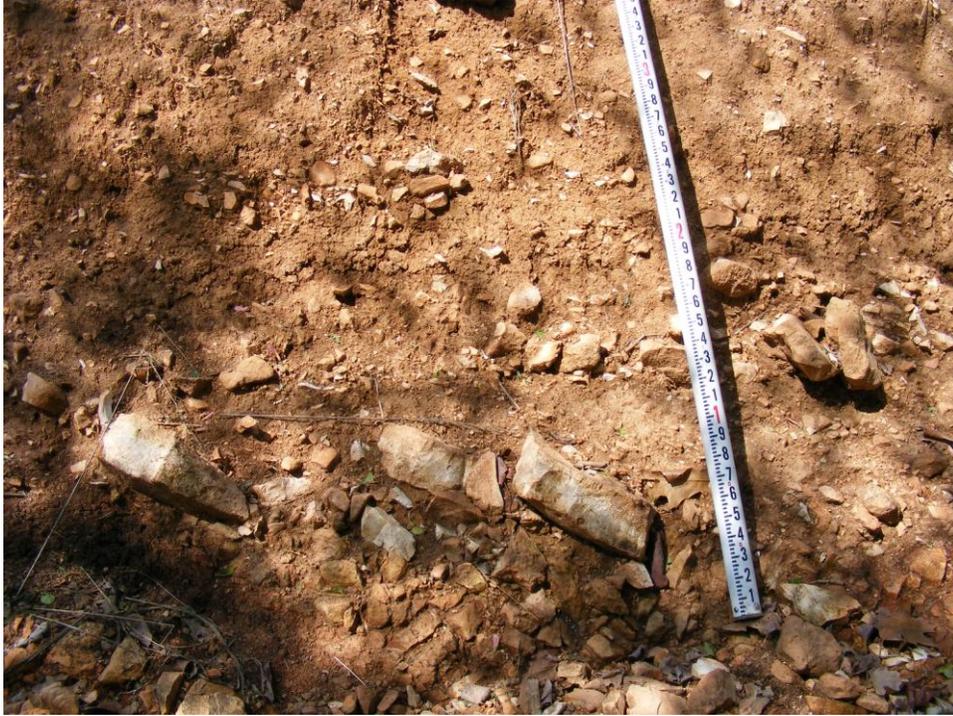
the base of the right bank at around the 600 ft point at the same elevation of the present degraded bed. These paleo-channel bed lag deposits suggest that significant channel incision occurred at this location prior to 1800 due to climate change or natural sediment supply variations. This is more evidence of the fact that this location is prone to periodic incision and cut-and-fill cycles.

Picture 25 - Imbricated cobbles indicating the elevation of the bed of a pre-settlement paleo-channel (4-29-08)

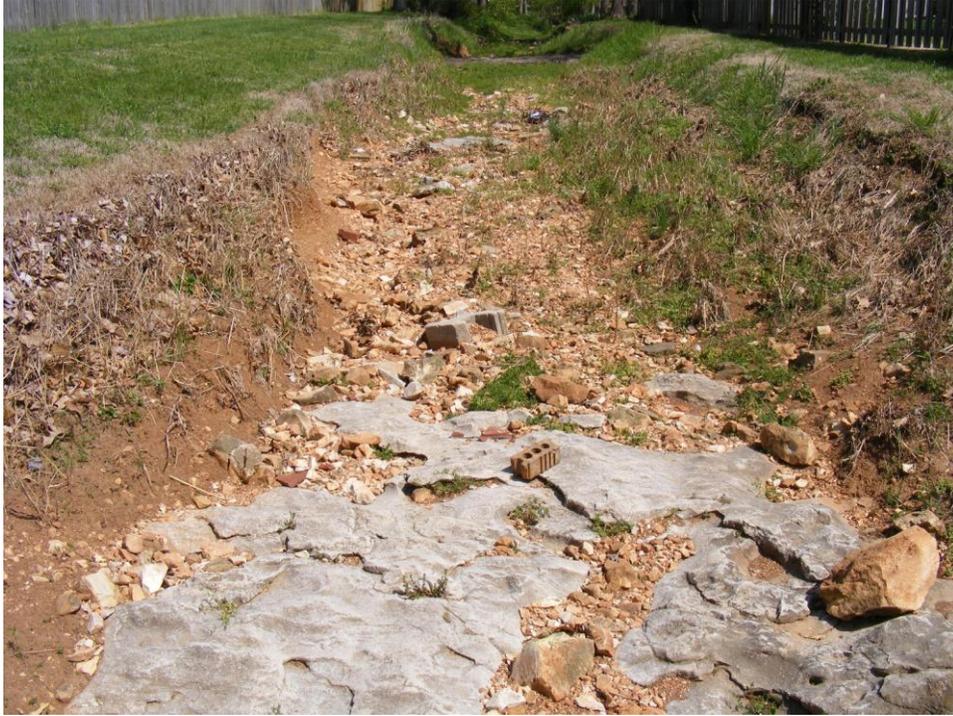
Finally, there is excess energy for sediment transport in the stream and “hungry water” increases bed and bank erosion in order to maintain the “equilibrium” balance between sediment transport and channel form. Observations of the channel bed along the upstream grass-lined channel (sub-reach #1) indicated that active bed load transport did occur during the period of several large floods in winter and spring 2008. However, it is highly probably that sediment delivery to the project channel from the upstream basin area is now reduced relative to historical conditions associated with peak land disturbance due to agriculture and more recent urbanization. After the construction phase was completed, most bare soil areas were healed-over with grass or landscaping and therefore decreased the loads of gravelly and fine-grained sediments to the project reach. The grassed reach is relatively stable and has only exhibited minor bed instability after several severe floods in 2008. It is expected that the recent bed scour areas formed in the grass channel will recover in the future.

Picture 27 - Grass channel bed-upstream (4-29-08)

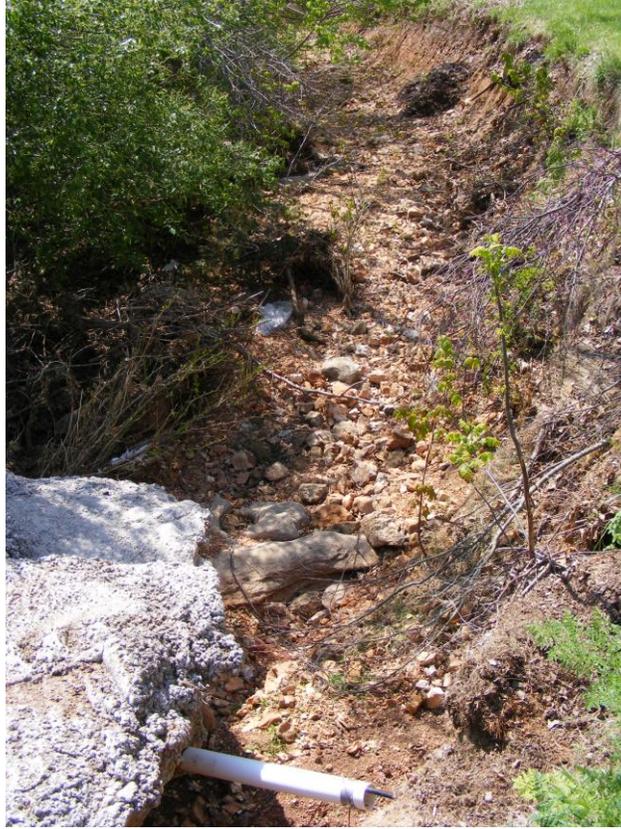
Picture 29 - Plunge pool (SR #2a+b) (4-29-08)

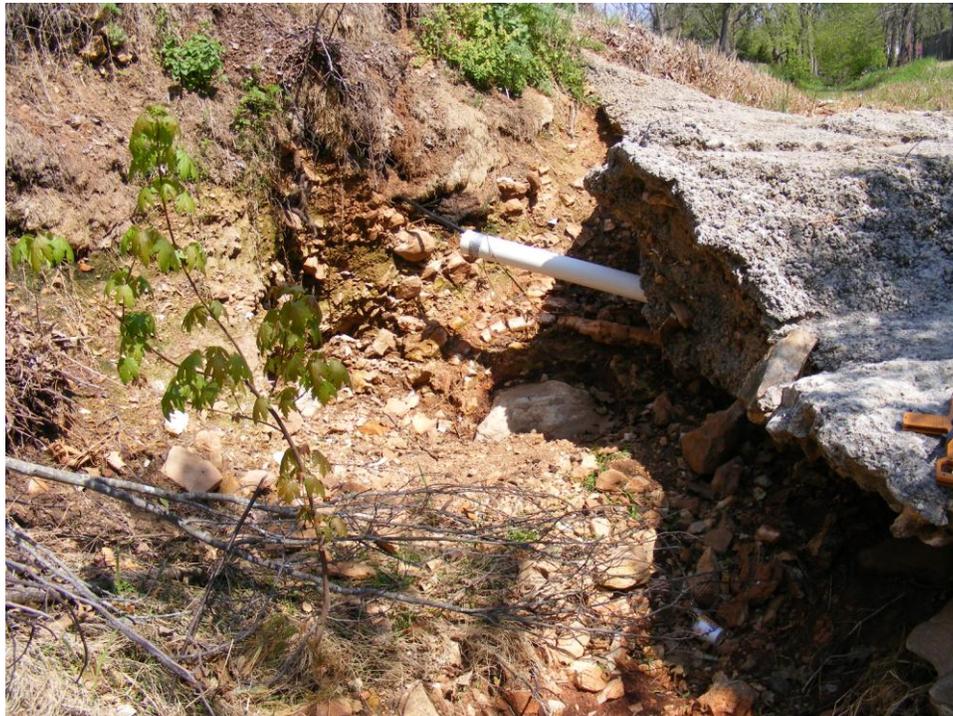
a negative sediment budget. The head cut has stalled at location of the concrete phone line cover and the amount of sediment being introduced to the stream from plunge pool erosion and channel widening may have decreased significantly.

Picture 30 - Exposed phone line (4-29-08)

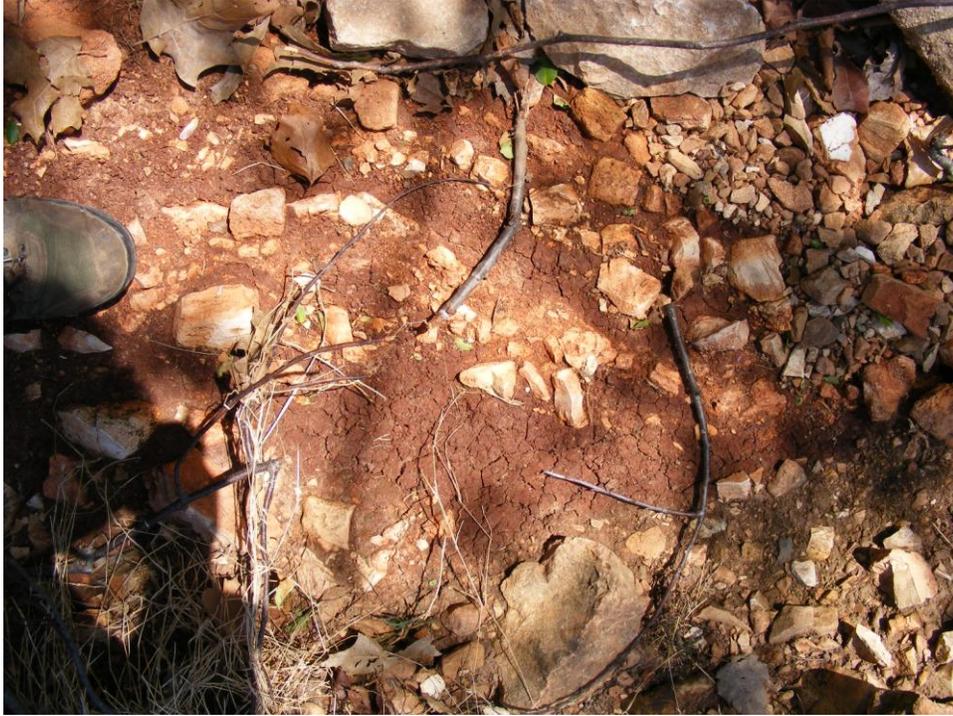
Picture 31 - Scoured residuum in plunge pool (4-29-08)
