# **Channel Stability and Riparian Corridor Assessment to Identify Nonpoint Source Pollution, Wilson Creek, Springfield, Missouri**

*Field work completed July 20, 2012*

August 3, 2012

OEWRI EDR-12-003

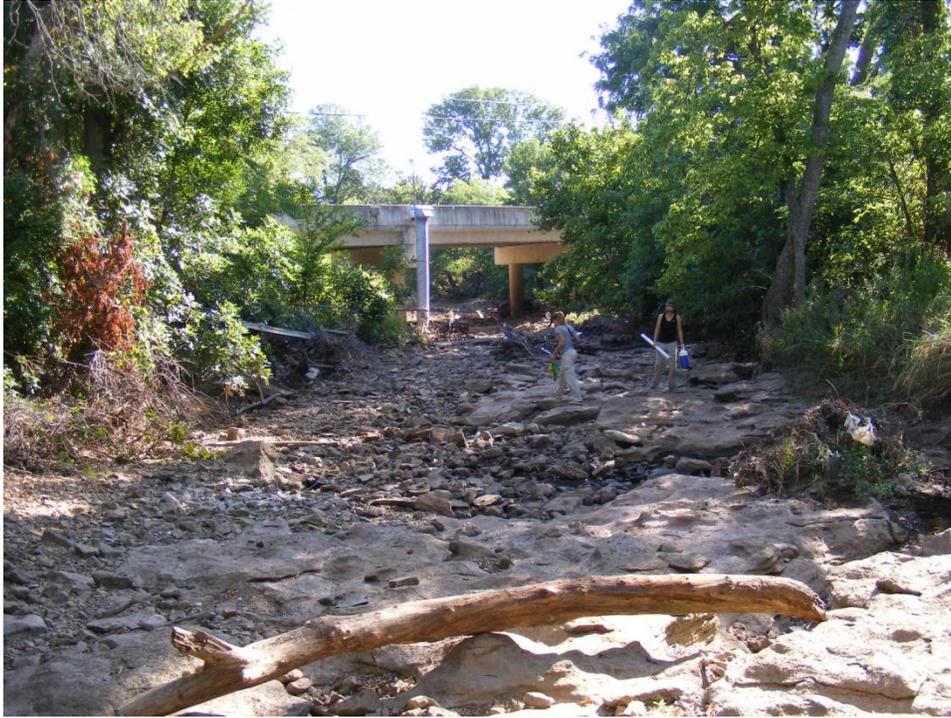
1. *Bridge Reach (3,950-3,850 ft)* – This reach is immediately downstream of the FR 156 Bridge (Photo 1). The wire cable with cattle panels stretched across the channel at the right-of-way collects trash and debris just below of the bridge. The bed is about 50% bedrock with the remainder large gravel and cobble. Banks show slight to moderate erosion with an adequate riparian corridor. Local erosion is typical downstream of bridges where the alignment can deflect flow toward the bank.
2. *Bedrock Bed Reach (3,850-3,650 ft)* – The entire bed along this reach is a bedrock slab or large boulders where pieces of the bed have broken off (Photo 2). The banks along this reach

Photo 1. Bridge Reach (3,850 ft) looking upstream at USGS gage at FR 156.

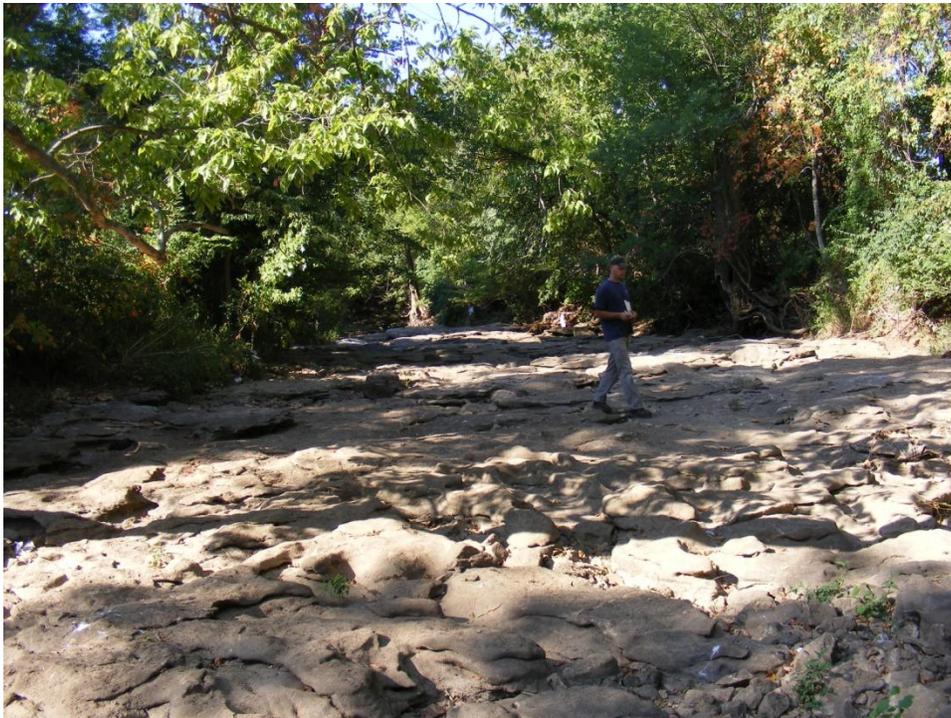
show moderate erosion with a fairly healthy riparian corridor. This suggests this area is trying to widen due to the bedrock control of the bed.

Photo 2. Bedrock Bed Reach (3,800 ft) looking downstream.

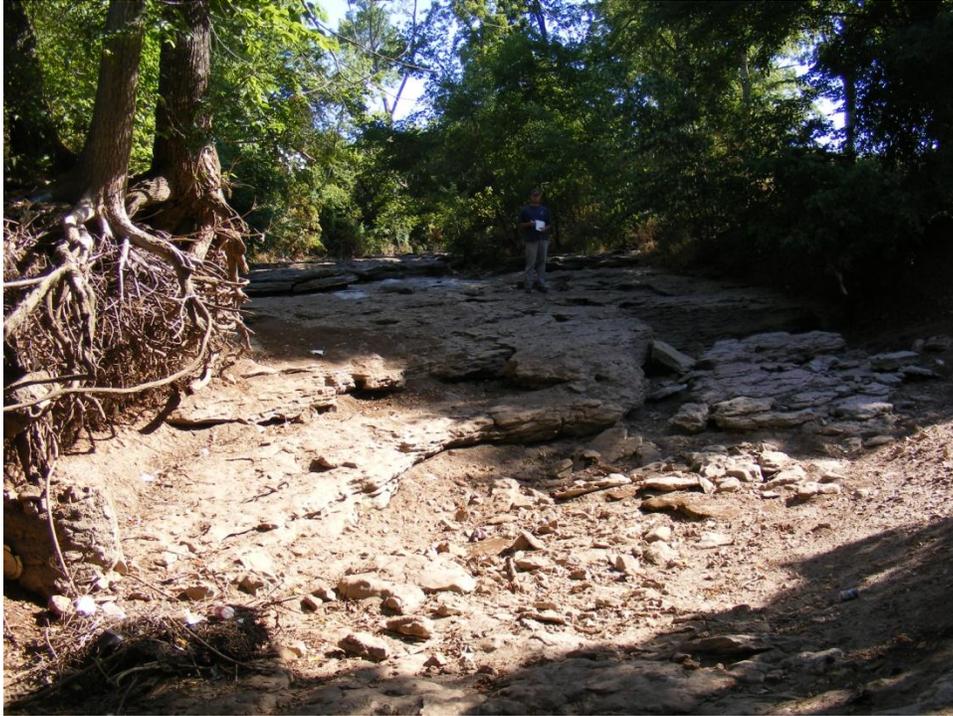
3. *Knickpoint Reach #1 (3,650-3,600 ft)* – A knickpoint is a drop off, or step, cut into the bedrock along the bed of the stream over geologic time. Locations of the knickpoints described in this report are probable locations that would have to be determined by a more thorough survey of the stream. The knickpoint in this reach appears to be caused by a fracture/swallowhole within the bedrock creating a 7-8 foot drop in the bed at this location (Photo 3). Additionally, flow deflection during large floods is causing left bank erosion locally (Photo 4).

Photo 3. Knickpoint Reach (3,600 ft) looking upstream from the bottom of the knick/reverse sinkhole?

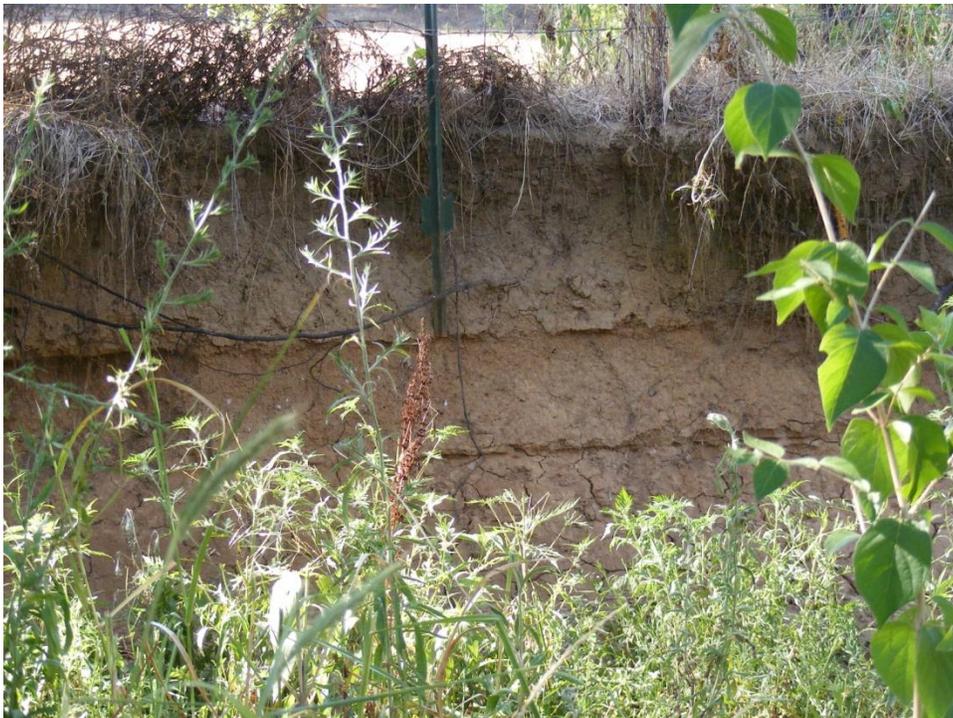
Photo 4. Knickpoint Reach (3,600 ft) left bank erosion.

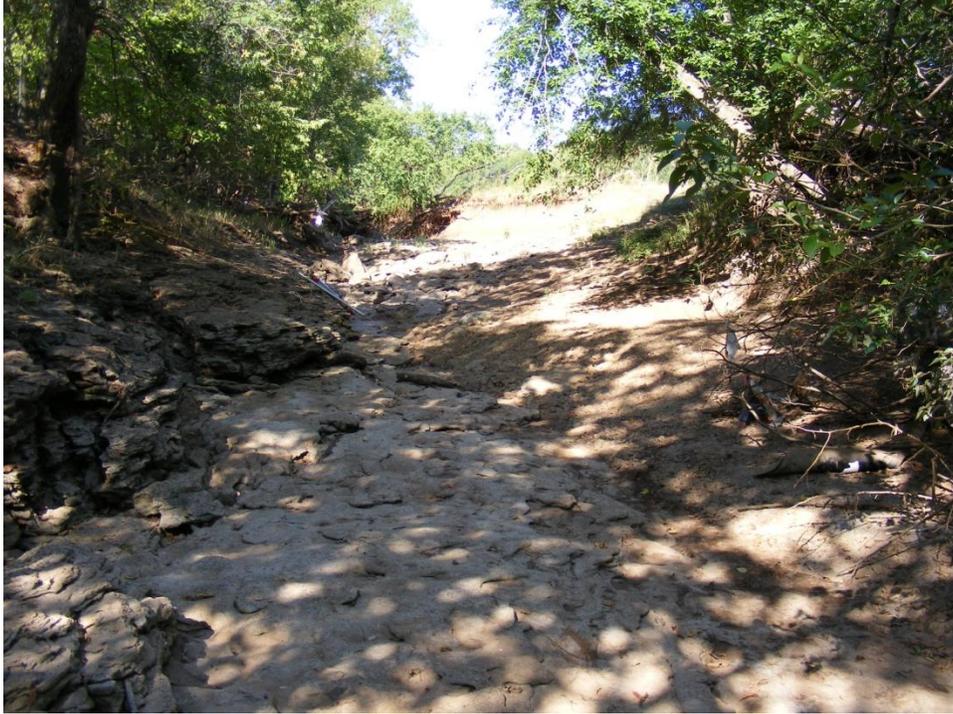
4. *Bedrock Bluff Reach (3,600-3,400 ft)* – The channel through this reach is adjacent to a bedrock bluff along the left bank (Photo 5). Approximately 50% of the bed is bedrock or large boulders with gravel deposits along the right margin of the channel. The right bank has moderate erosion with a thin line of mature trees protecting the bank.

Photo 5. Bedrock Bluff Reach (3,500 ft) looking downstream.

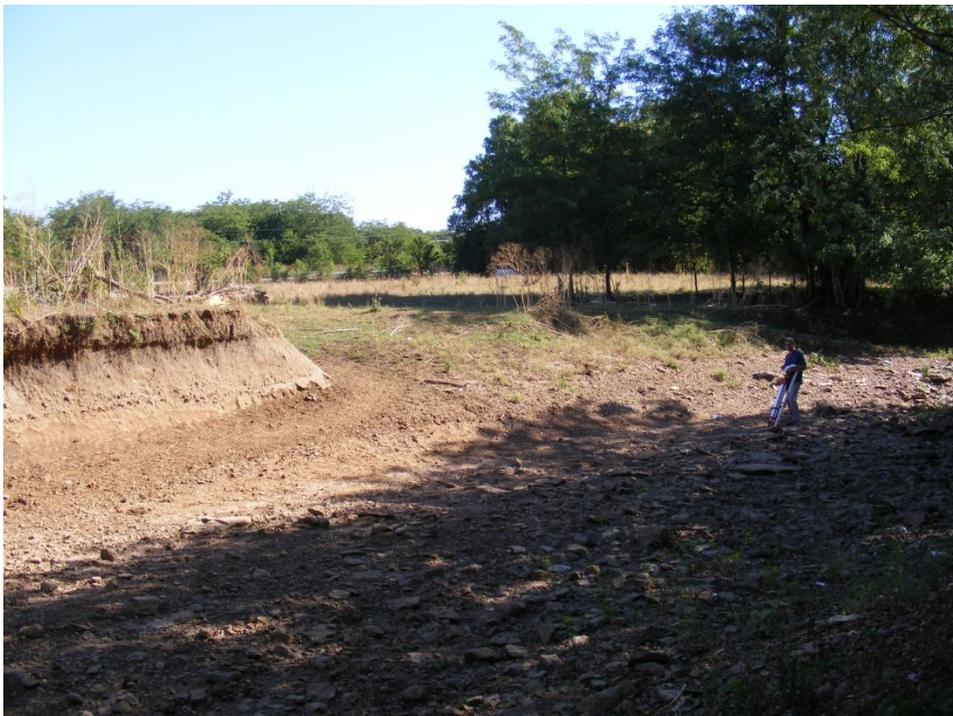
5. *Cattle Entrance and Cutbank Reach (3,400-3,200 ft)* – The right bank along this reach has little to no riparian cover creating a cutbank that is approximately 7-8 ft high (Photo 6). Additionally, cattle have been entering the stream at this location causing further bank instability. A new floodplain is forming along the left bank of the stream adjacent to the bedrock bluff suggesting the channel has been moving at this location. The bed is mostly bedrock here as well.

Photo 6. Cattle Entrance and Cutbank Reach (3,300 ft) looking at the right bank.

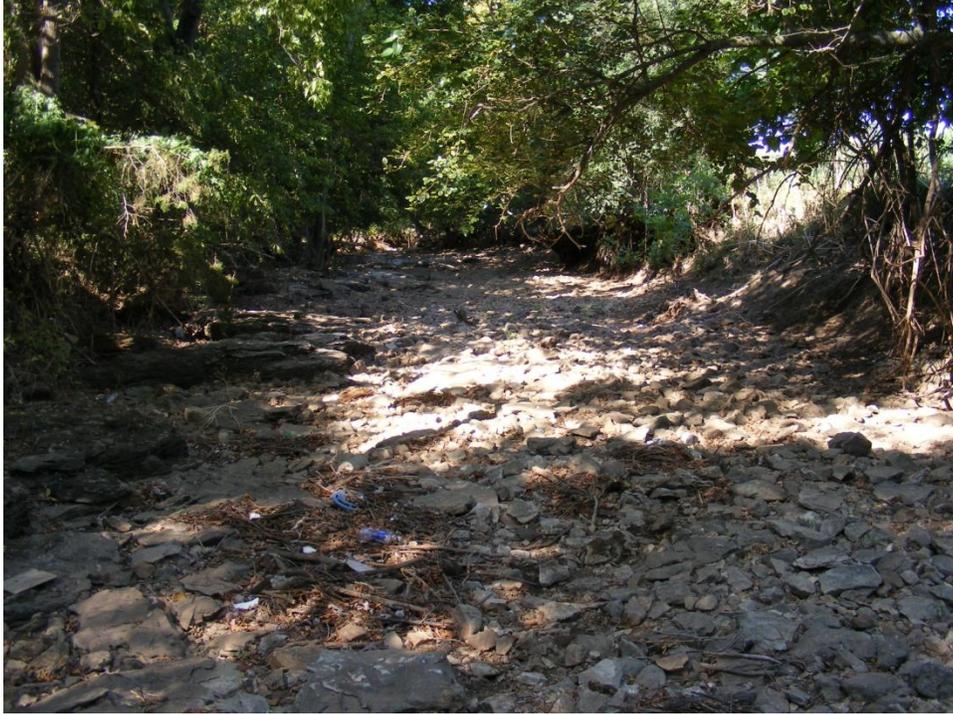
6. *Bedrock/Cattle Entrance Reach (3,200-2,900 ft)* – The bedrock bed continues through this reach with bedrock also along the toe of the left bank (Photo 7). The right bank shows signs of erosion but is weakly protected by a thin line of mature trees. However, cattle have been entering the stream at two locations in this reach creating localized erosion.

Photo 7. Bedrock/Cattle Entrance Reach (3,200 ft) looking downstream.

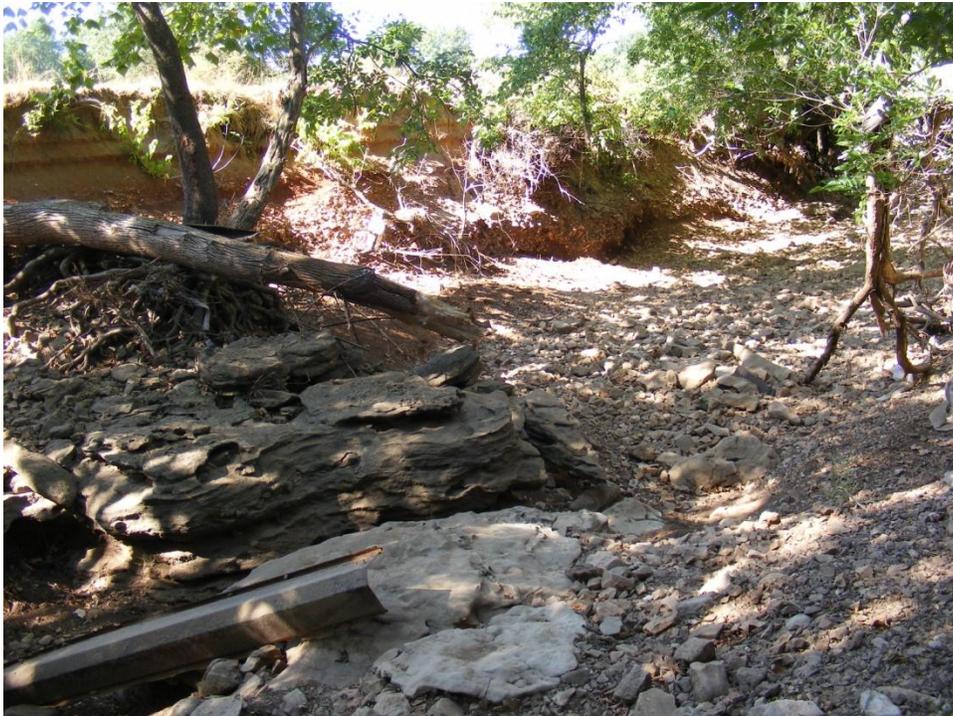
7. *Knickpoint Reach #2 (2,900-2,850 ft)* – Similar to the knickpoint at station 3,600, but at a smaller scale, a fracture/swallowhole has created a knickpoint in the bedrock at this location that is approximately 5 feet deep (Photo 8). Also, flow deflection has caused erosion along the left bank where cattle are entering the stream.

Photo 8. Bedrock Knickpoint #2 (2,900 ft) looking at the left bank erosion near the second knickpoint on the north property.

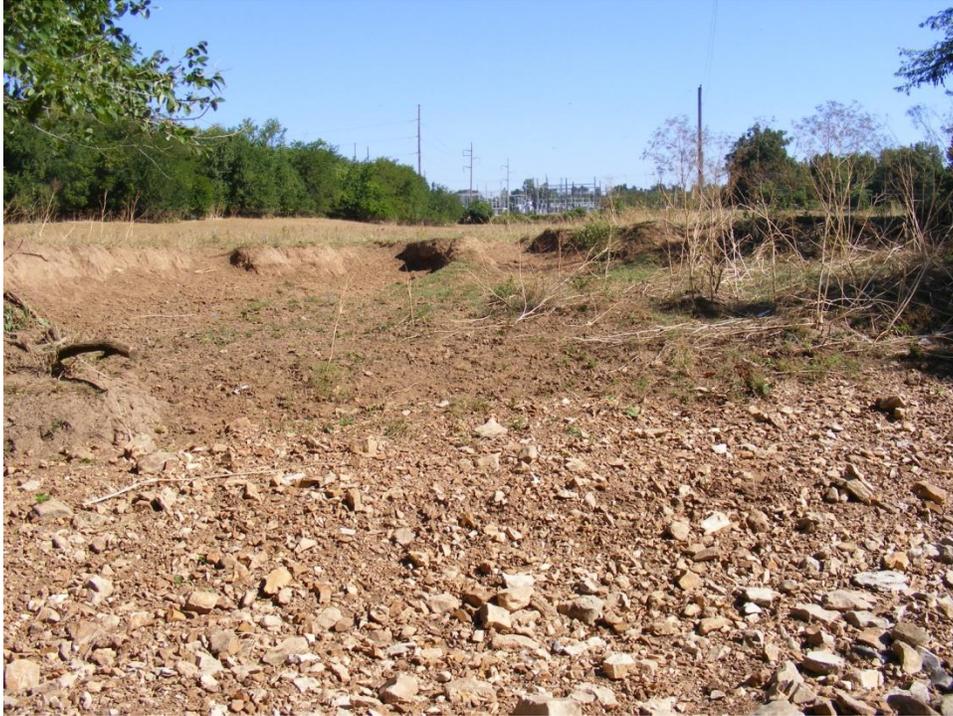
8. *Gravel Bed Reach #1 (2,850-2,200 ft)* – The bed of this reach is gravel, however bedrock is likely close to the surface and a small pool of water is located at 2,500 ft. There is a cattle crossing between stations 2,600-2,700 ft with no riparian vegetation on the right bank (Photo 9). The riparian corridor that is present is a thin line of mature trees, but cattle appear to be using it as a loafing area, damaging the banks (Photo 10). A channel cross-section was collected at station 2,300 ft.

Photo 9. Gravel Bed Reach #1 (2,700 ft) cattle entrance on right bank.

2. *Fence Cattle Out of Stream* - Unlimited access for cattle to the stream at the north segment is a significant nonpoint source for pollution to the stream. Hoof action has caused floodplain scour gullies and erosion near several cattle entrance points along the channel. Additionally, cattle allowed to loaf in the riparian corridor further destabilizes banks, damages vegetation, and concentrates manure near the channel with no buffer to filter sediment and pollutants during storm events. Fencing 100 ft on either side of the stream will allow the banks and vegetation to recover over time and reduce nonpoint sediment and nutrients from entering the stream during storms. This will also allow for the removal of the cables on each end of the property that are currently trash and large woody debris traps. Debris collected here can cause flows to deflect, creating local erosion problems. This property can still be used to pasture cattle and provides an opportunity to demonstrate best management practices for cattle operations near stream corridors. The Missouri Department of Conservation and the Natural Resources Conservation Service private land specialists can provide technical assistance for installing alternative water sources, limiting access to stabilized cattle crossings, and providing shaded areas away from the stream.

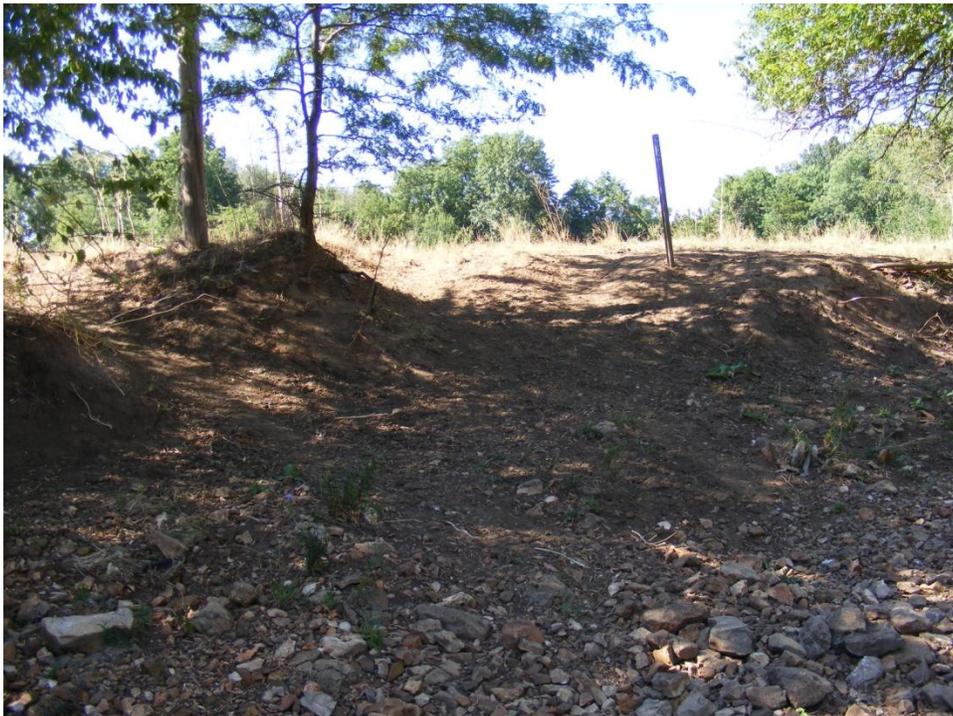
Photo 10. Cattle damaged banks (2,600 ft).

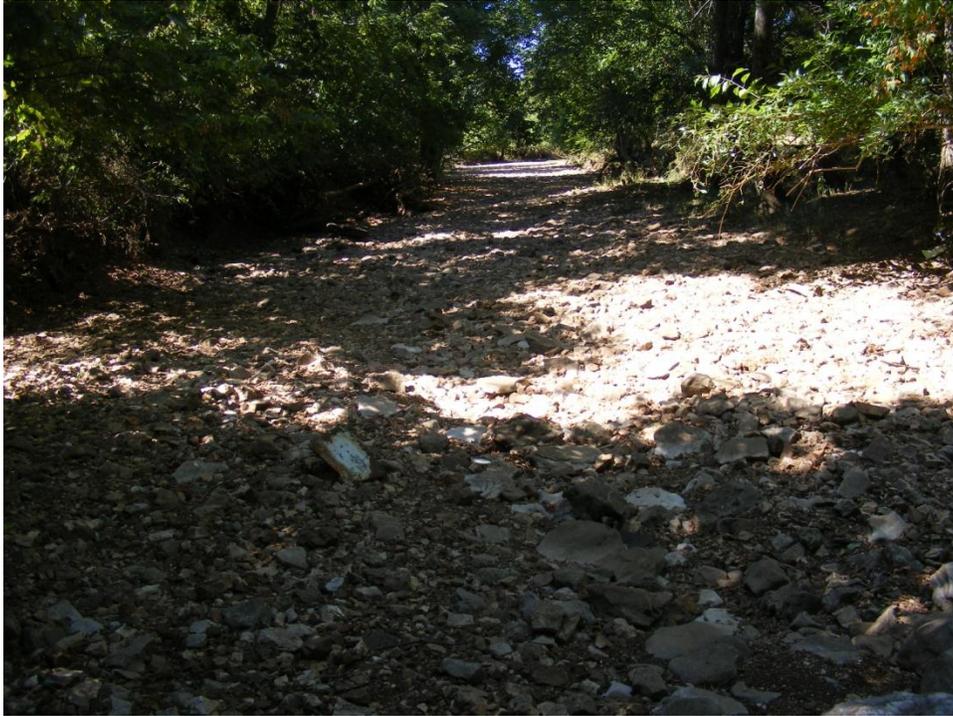
9. *Bedrock Pinnacles (2,200-2,100 ft)* – Localized bed obstruction
10. *Gravel Bed Reach #2 (2,100-1,700 ft)* – The stream bed in this reach is a gravel and cobble bed (Photo 11). The thin riparian corridor is interrupted by several cattle entrance points and loafing areas that cause localized erosion. However, a 6-7 ft diameter “legacy” tree at 1,800 ft on the left bank suggests the channel has not moved much at this location, but may have been widening (Photo 12). A road/cattle crossing is located at station 1,700 ft.

Photo 11. Gravel Bed Reach #2 (2,100 ft) looking downstream.

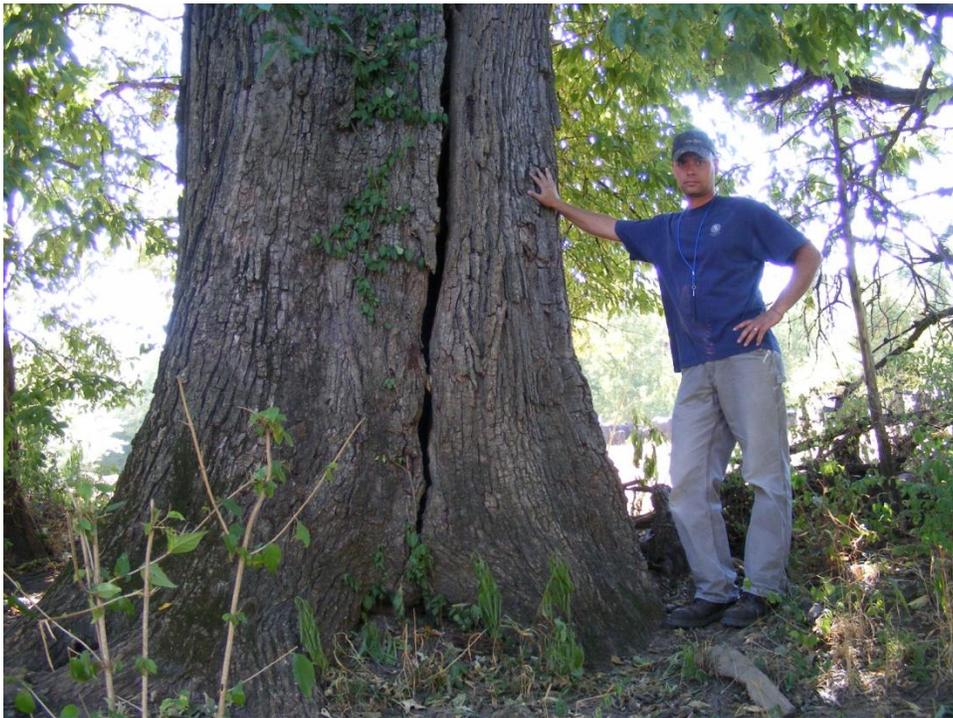
Photo 12. Legacy tree at station 1,800 ft.

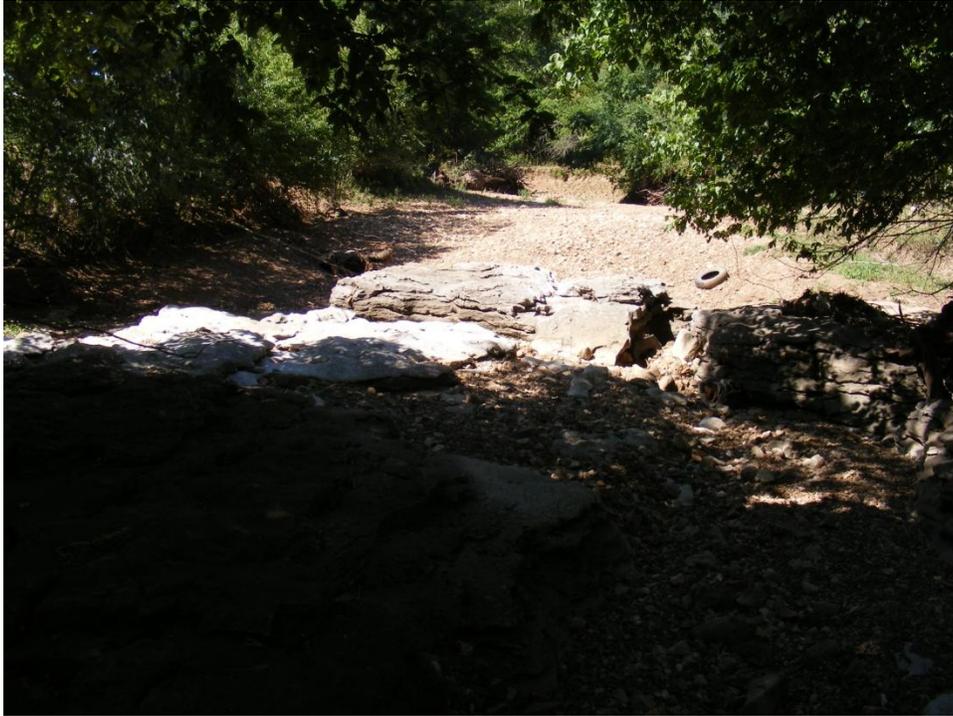
11. *Bedrock/Knickpoint Reach #3 (1,700-1,400 ft)* – Bedrock appears at the surface along the bed in this reach and ends with a 5 ft knickpoint at station 1,450 ft (Photo 13).

Photo 13. Bedrock Knickpoint Reach #3 (1,450 ft) looking downstream.

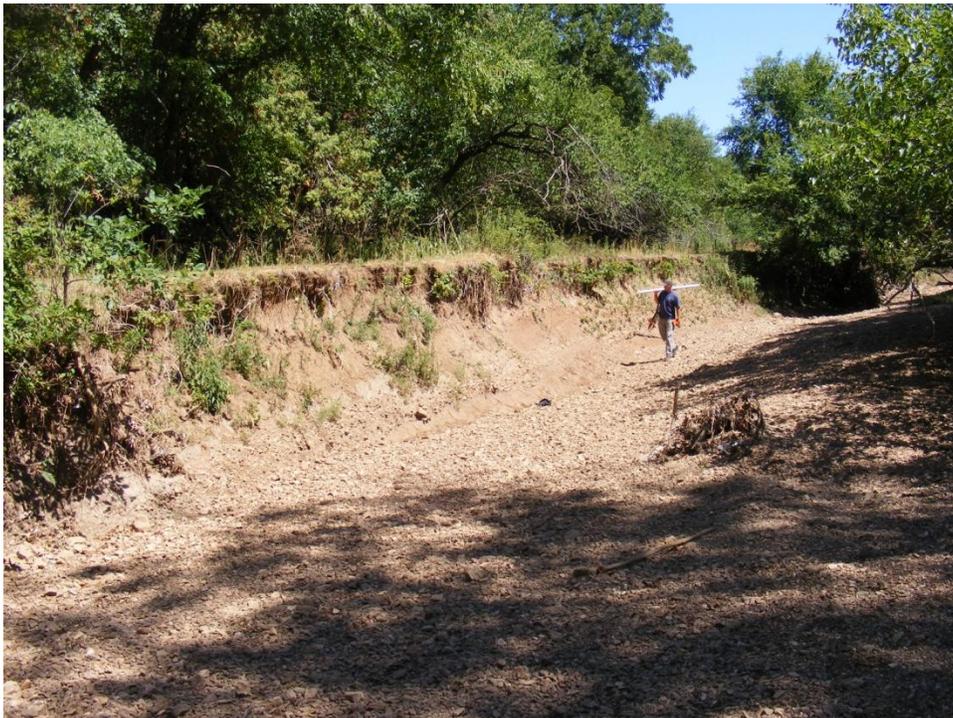
12. *Bank Erosion Reach (1,400-1,000 ft)* – This gravel bed reach is located just upstream of where the channel meets a bluff. Erosion is occurring along the 6-8 ft high, 200 ft long, right bank where there is no riparian vegetation (Photo 14). Additionally, localized erosion is occurring at a cattle crossing at 1,350 ft and cattle loafing areas near 1,050 ft.

Photo 14. Bank Erosion Reach (1,300 ft) looking at the right bank.

4. *Monitor High Erosion Areas* - In-channel work is probably not necessary at either site at this time, but should be monitored. Most severe bank erosion at both sites is limited to local areas associated with cattle entrances and thin riparian buffers. The floodplain and riparian corridor areas are connected by flashy urban hydrology, so systematic channel recovery should be closely monitored. The south segment is unique because it has base flow augmentation and water quality improvements by the treatment plant will directly affect aquatic habitat and water quality of Wilson Creek. Specific areas to be monitored are:

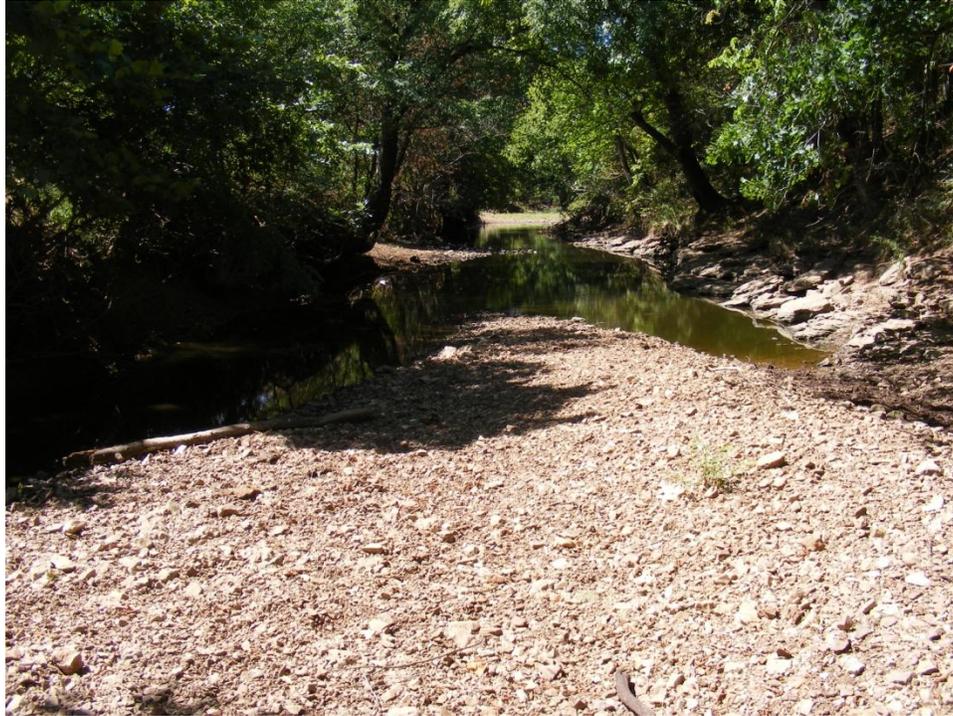
13. *Bedrock/Bluff Pool Reach (1,000-700 ft)* – The right side of the channel in this reach is adjacent to a bedrock bluff and is currently holding water (Photo 15). This is the largest of three pools of water on this site and cattle have been entering the stream here at several locations causing local erosion (Photo 16).

Photo 15. Bedrock/Bluff Pool Reach (700 ft) looking upstream.

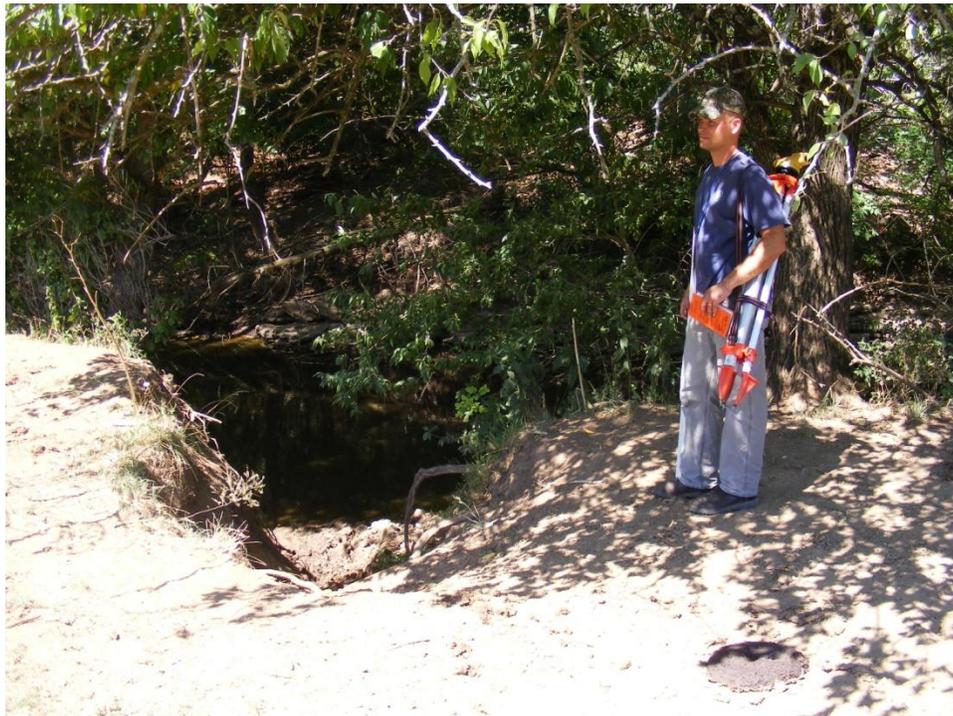
Photo 16. Erosion caused by a cattle entrance to water along the bluff pool.

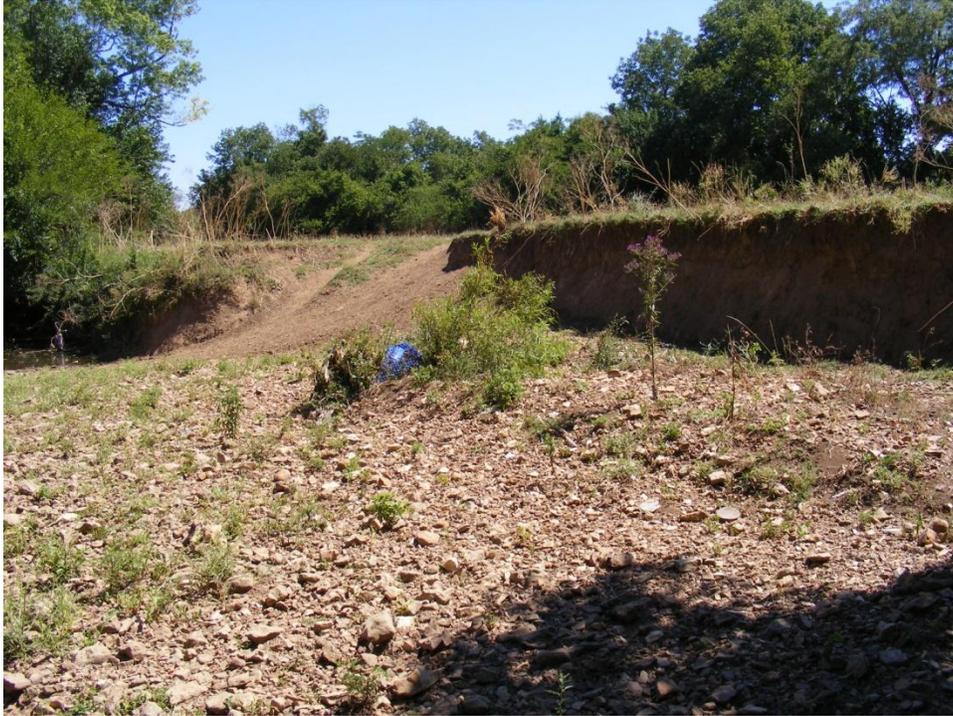
14. *Utility Easement and Cattle Entrance Reach (700-600 ft)* – In this reach a utility easement crosses the channel with overhead powerlines coming down from the bluff on the right. Here the bluff has been cleared of mature vegetation. The left bank is eroding due to a cattle entrance ramp and no riparian vegetation present on the bank (Photo 17).

Photo 17. Utility Easement and Cattle Entrance Reach (600 ft) looking at the cattle entrance and left bank erosion.

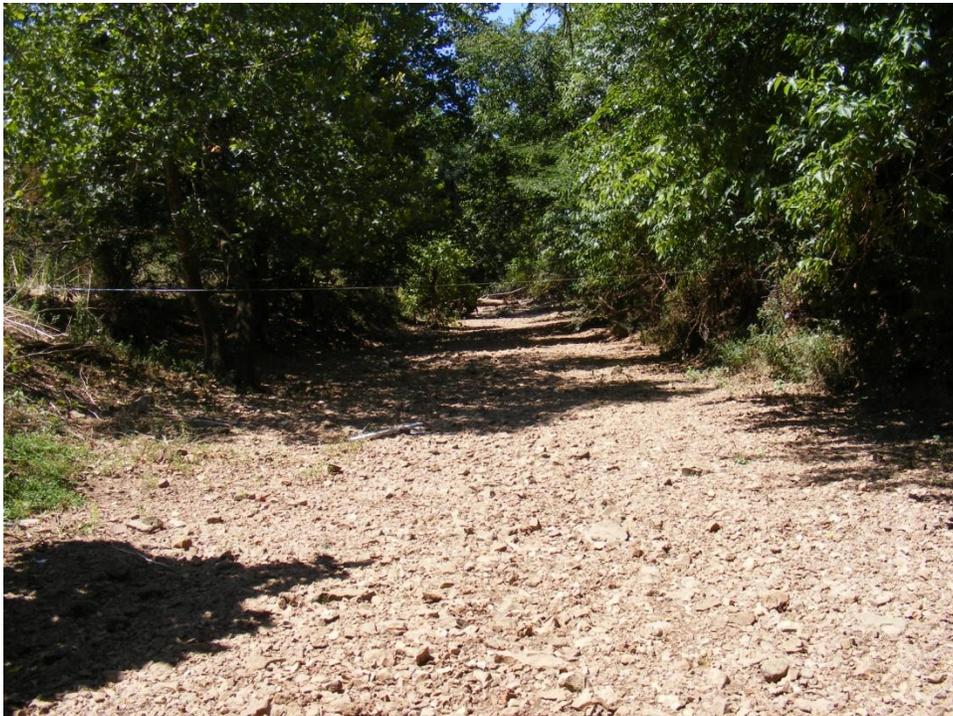
15. *Gravel Bed Reach #4 (600-200 ft)* – This reach has a gravel bed with slight-moderate erosion on both banks (Photo 18). Here, the right bank has a relatively narrow floodplain where the channel has left the valley wall and has mature vegetation. The left bank has a thin line of mature trees with cattle entrances at 400 and 500 ft.

Photo 18. Gravel Bed Reach #3 (300 ft) looking downstream.

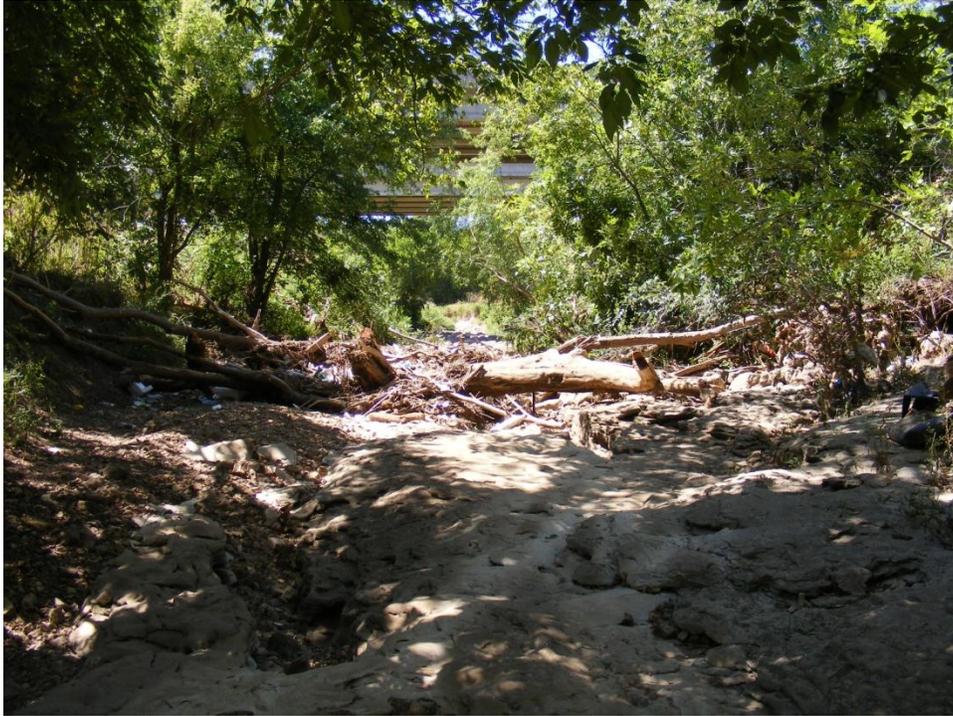
16. *Bedrock/Bridge Reach (200-0 ft)* – This reach has a bedrock bed with banks that have slight-moderate erosion with a thin riparian corridor (Photo 19). A cable across the channel at station 100 ft collects large woody debris and trash at the property line.

Photo 19. Bedrock/Bridge Reach (200 ft) looking downstream.

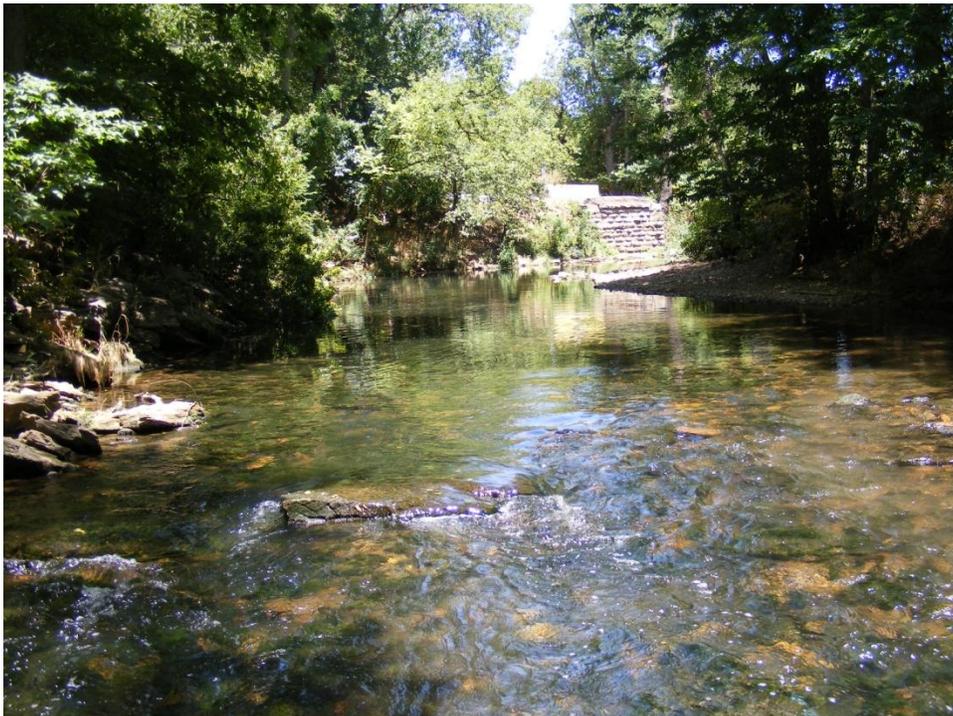
1. *Bedrock Controlled/Bluff Reach (3,200-2,100 ft)* – The channel is adjacent to a bluff along the right bank and there is moderate erosion along the left bank in this reach (Photo 20). Bedrock is exposed in the bed along with deposits of gravel and cobble. A spring seep appears along the right bank at 2,600 ft and a currently dry tributary enters on the left at 2,500 ft.

Photo 20. Bedrock Controlled/Bluff Reach (3,100 ft) looking upstream toward old FR 168 bridge.

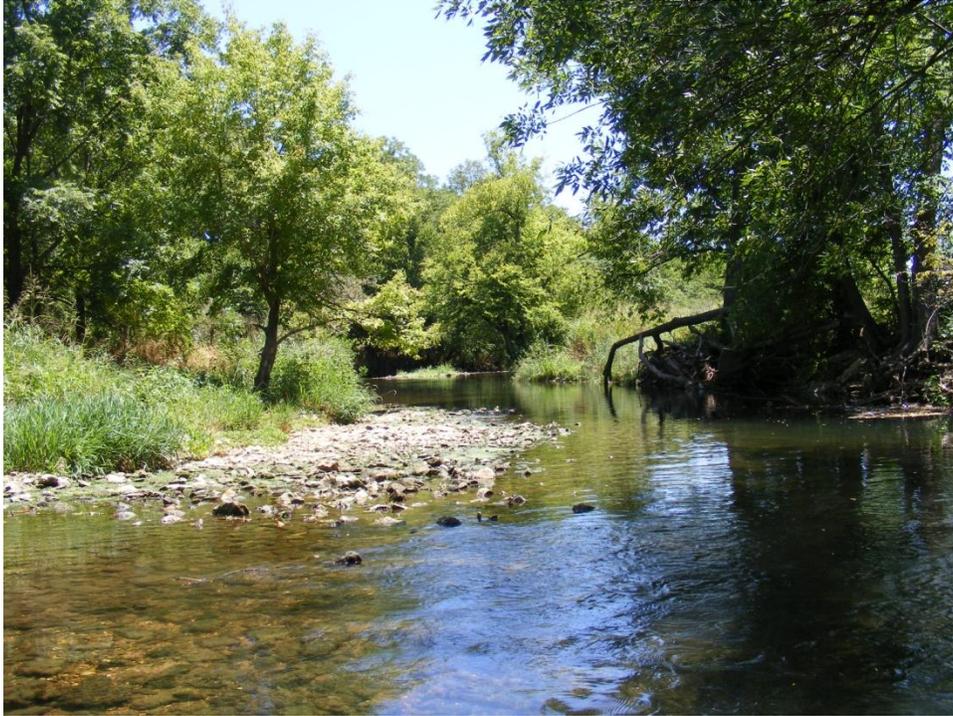
2. *Transition Reach (2,100-1,800 ft)* – Through this reach the channel moves away from the bluff and forms a floodplain on the right bank with a thin riparian buffer consisting of tall grass and small trees (Photo 21). The banks on the both sides have slight-moderate erosion, but the right bank appears to be more susceptible due to less deep-rooted vegetation along the bank. A tributary enters this reach at 1,900 ft.

Photo 21. Transition Reach (2,100 ft) looking downstream.

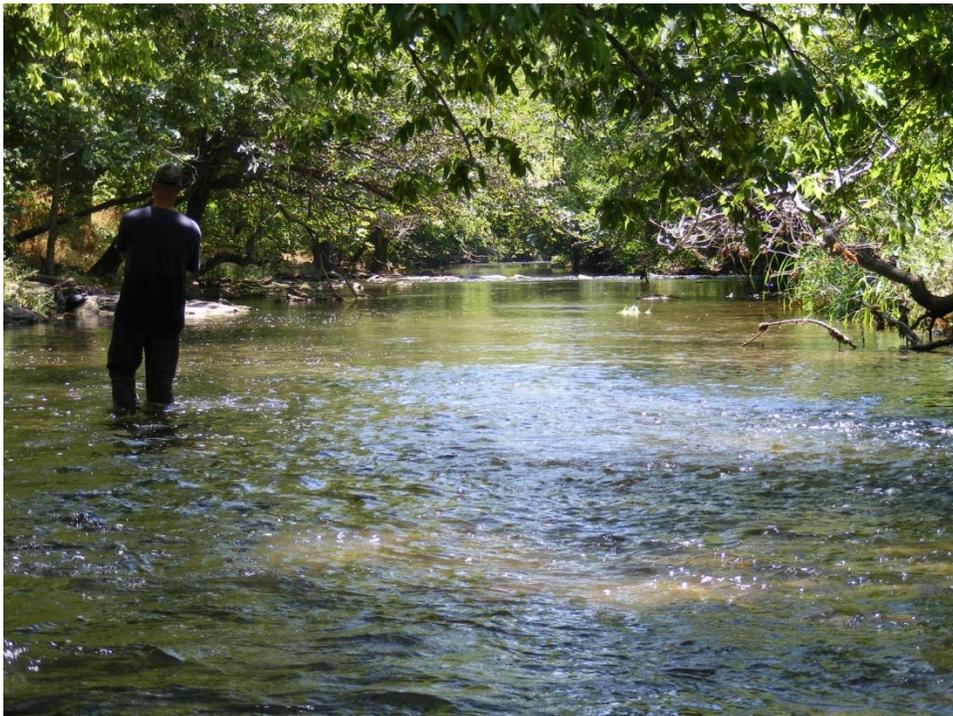
3. *Straight/Bedrock Toe Reach (1,800-1,300 ft)* – Bedrock is prominent along the bed and the toe of the left bank through this reach (Photo 22 and 23). The 500 ft reach is very straight with a bedrock knick/riffle from 1,500-1,400 ft. The right bank has slight-moderate erosion and a thin riparian buffer of mature trees.

Photo 22. Straight/Bedrock Toe Reach (1,800 ft) looking downstream.

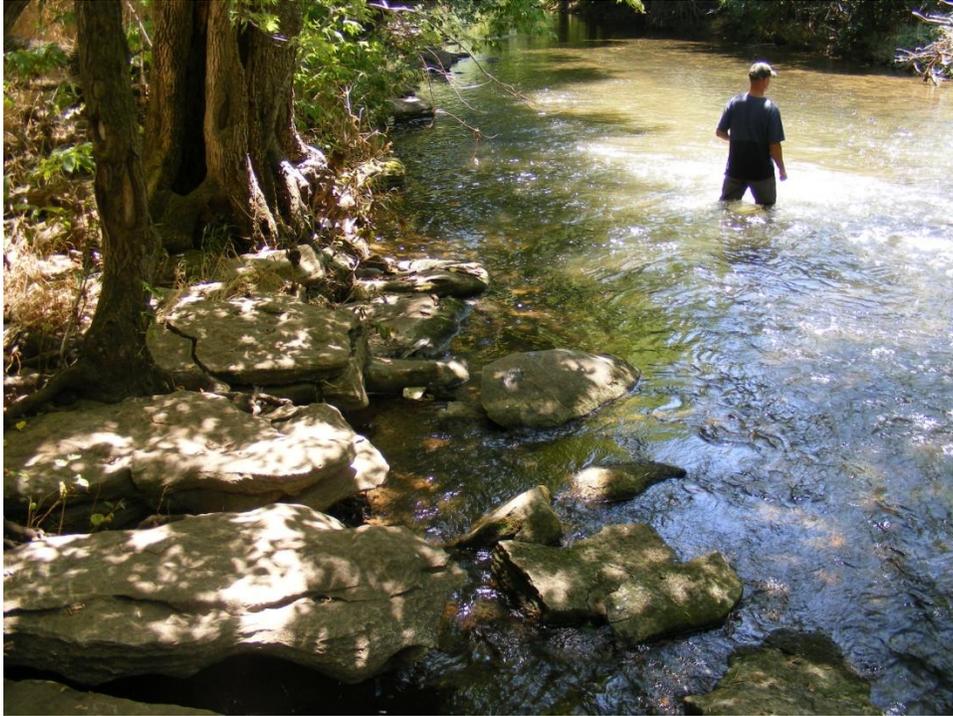
Photo 23. Bedrock exposed along the toe of the left bank at station 1,400 ft.

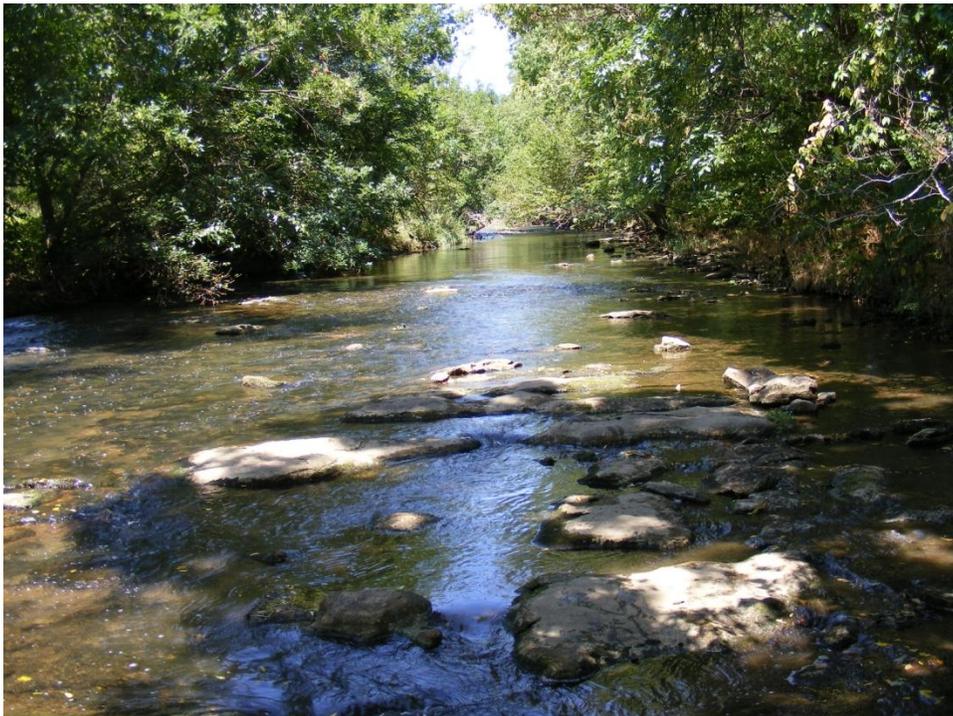
4. *Bedrock Reach (1,300-650 ft)* – This reach is similar to the upstream reach, but there is no bedrock exposed along the bank, only in the bed (Photo 24). Both banks show slight erosion. The right bank has a thin riparian corridor of small trees and is susceptible to more severe erosion than the vegetated left bank (Photo 25). There is a floodplain scour hole at 700 ft (Photo 26).

Photo 24. Slick Bedrock Reach (1,300 ft) looking downstream.

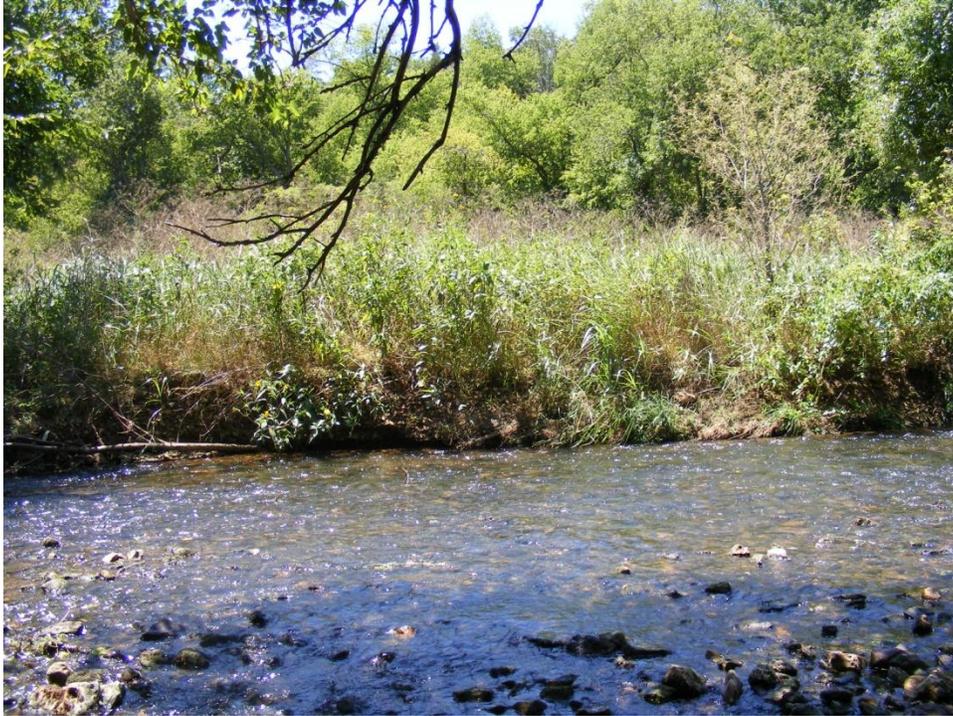
Photo 25. Thin riparian buffer on right bank at station 900 ft.

3. *Establish a Healthy Riparian Buffer* - Currently, the riparian corridor along most of the north segment and the west side of the south segment is too thin. There is 8.7 acres of riparian buffer currently in pasture available for planting in the north segment and 2.3 acres of pasture available along the south segment. Since the stream on the north segment is intermittent, drought tolerant native trees and shrubs appropriate for planting around streams should be used. Trees and shrubs should be planted at a higher density than is currently present that will provide resistance to erosion during flood events, help filter pollutants and sediment washing into the stream, and provide habitat to birds and other non-aquatic species using the stream corridor. The main channel should remain disconnected from urban drainage system now and in future. Runoff from pasture areas and from upstream areas during floods should be forced to go over buffer for filtering and infiltration, not through channels or pipes.

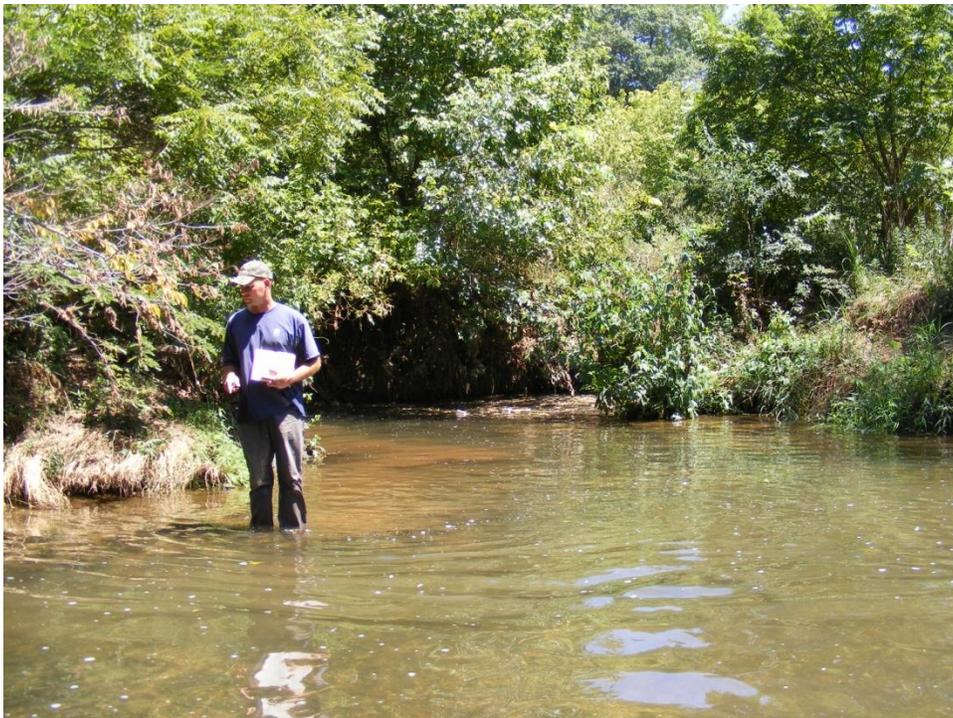
Photo 26. Floodplain scour hole on left bank at station 700 ft.

- b. South segment areas to be monitored:
    - 1) Channel widening at 1,900 ft
    - 2) Floodplain scour hole at 700 ft
    - 3) Bank erosion at 600-400 ft

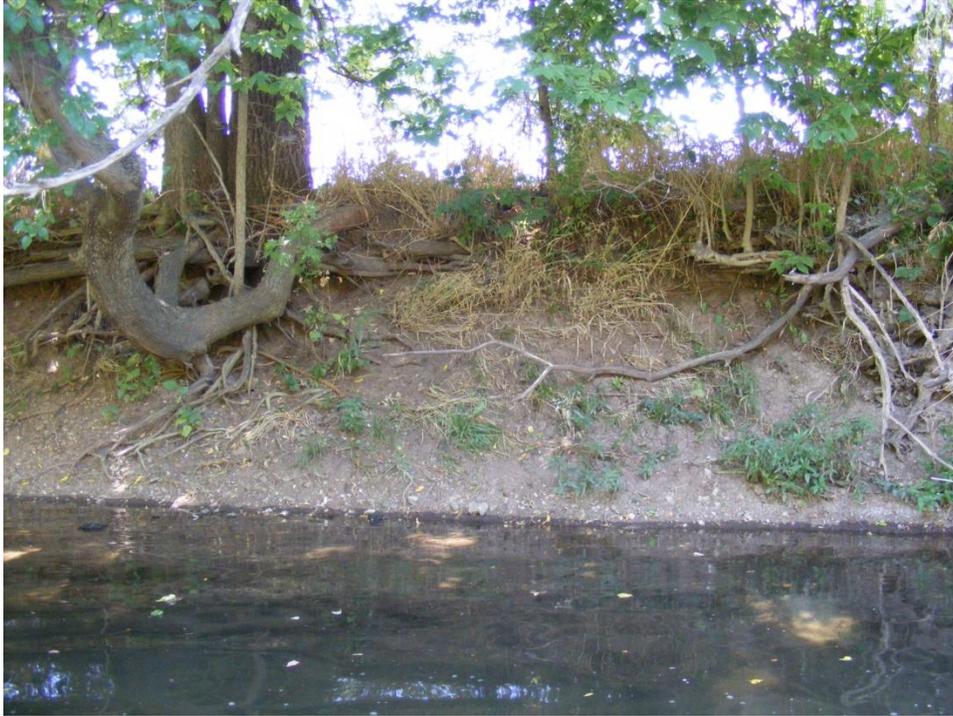
5. *Gravel Bed Reach (650-250 ft)* – The bed through this reach consists of gravel with bedrock exposed only in the bottom of deep pools. There is 200 ft of right bank erosion near the confluence with a tributary coming into the channel from the west at 500 ft (Photo 27). Additional erosion occurs downstream at 400 ft on the left bank.

Photo 27. Gravel Bed Reach (500 ft) looking at the right bank.

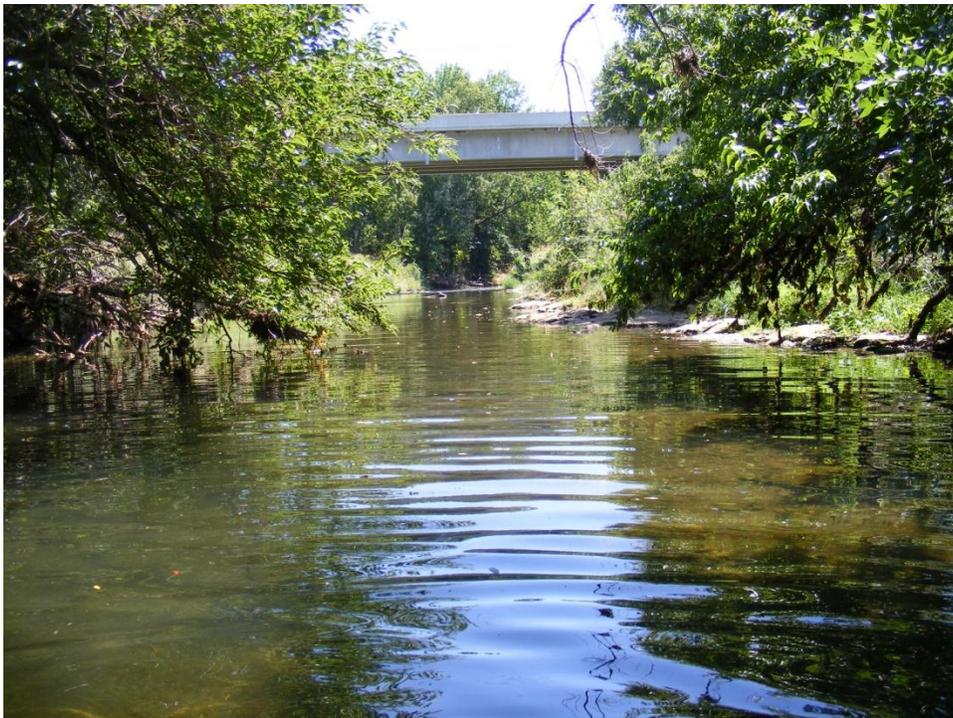
6. *Bedrock Bed/Bridge Reach (250-0 ft)* – Around 250 ft upstream of the Republic Road Bridge, bedrock is exposed along the bed of the stream (Photo 28). Bedrock is also exposed at the toe of the right bank. The riparian buffer stops at the road right-of-way line at station 100 ft.

Photo 28. Bedrock Bed/Bridge Reach (250 ft) looking downstream toward Republic Road Bridge.
