**Ozarks Environmental and Water Resources Institute (OEWRI)
Missouri State University (MSU)**

**INDIAN CREEK FLUVIAL GEOMORPHOLOGY STUDY,
OLATHE, KANSAS**

**Final report to Olsson Associates for
the City of Olathe, Kansas**

OEWRI EDR-13-004

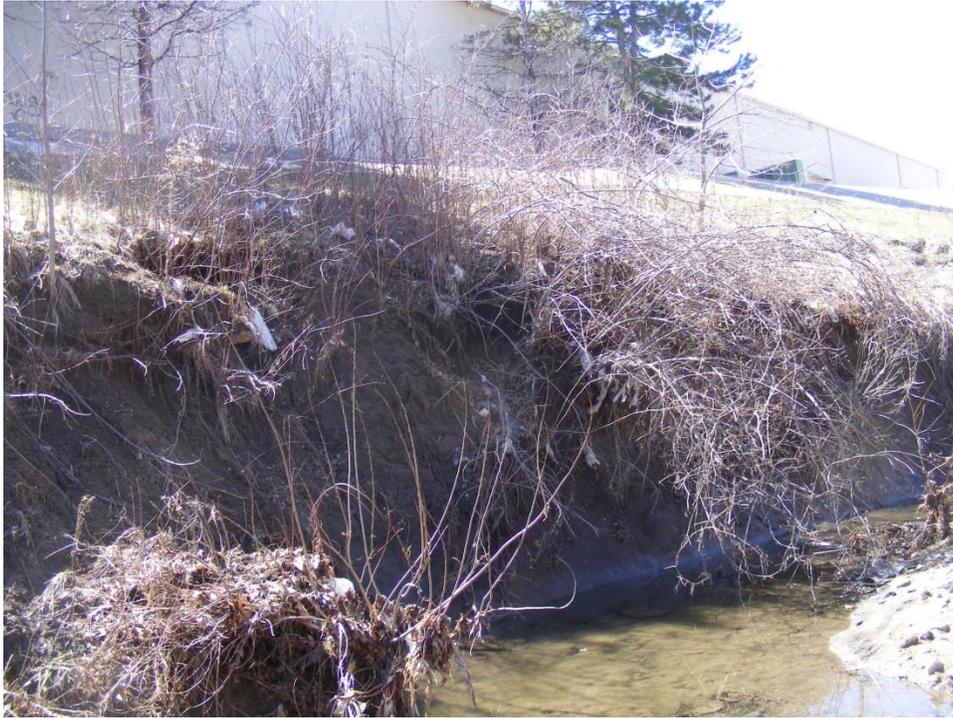
1. Bank erosion and failure risk-commercial property – Channel migration or channel widening poses a threat to commercial property that may include a building or parking lots (Photo 1). Level of concern is based on proximity to the property and the bank showing indicators of erosion such as bank angle, erosion scars, and newly uncovered tree roots.

Photo 1. Example of problem type 1. Bank erosion and failure risk-commercial property

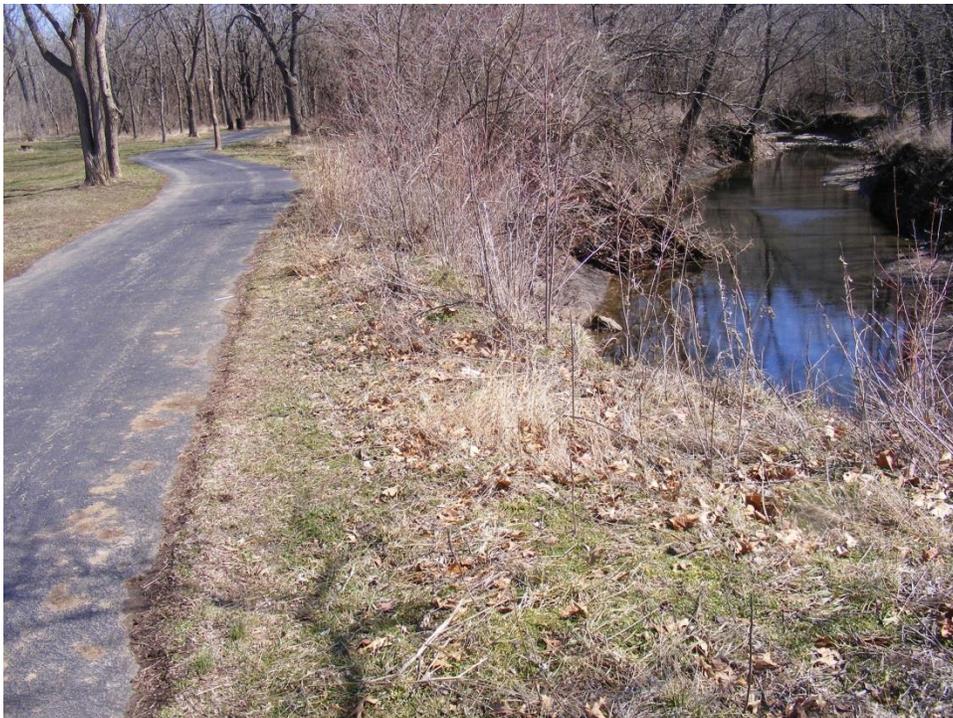
2. Bank erosion and failure risk-greenway trail - Channel migration or channel widening poses a threat to a greenway trail (Photo 2). Much of the main channel has a greenway trail constructed adjacent to the stream. Level of concern is based on proximity to the trail and the bank showing indicators of erosion such as steepness of the bank angle, presence of recent erosion scars, and newly uncovered tree roots.

Photo 2. Example of problem type 2. Bank erosion and failure risk-greenway trail

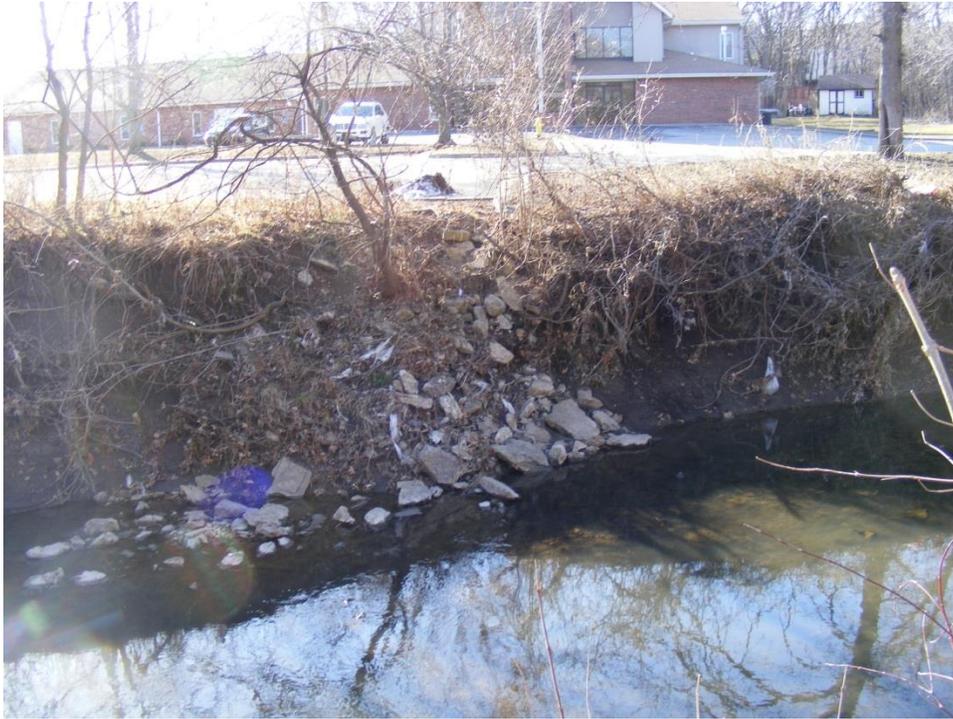
3. Bank erosion and failure risk-public building - Channel migration or channel widening poses a threat to a public owned building that may also include the parking lot (Photo 3). Level of concern is based on proximity to the property and the bank showing indicators of erosion such as steep bank angle, erosion scars, and newly uncovered tree roots.

Photo 3. Example of problem type 3. Bank erosion and failure risk-public building

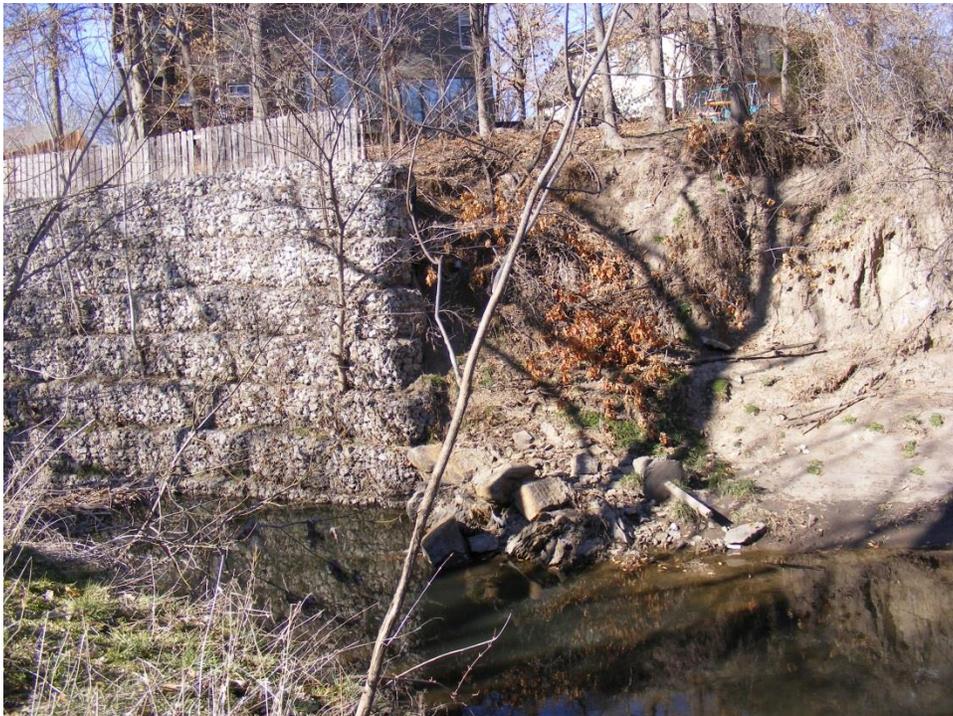
4. Bank erosion and failure risk-residential private - Channel migration or channel widening poses a threat to residential private property (Photo 4). This may include channel encroachment on the property line that may threaten fences or outbuildings. Level of

concern is based on proximity to the property and bank erosion indicators such as bank angle, fresh erosion scars, and newly uncovered tree roots.

Photo 4. Example of problem type 4. Bank erosion and failure risk-residential private

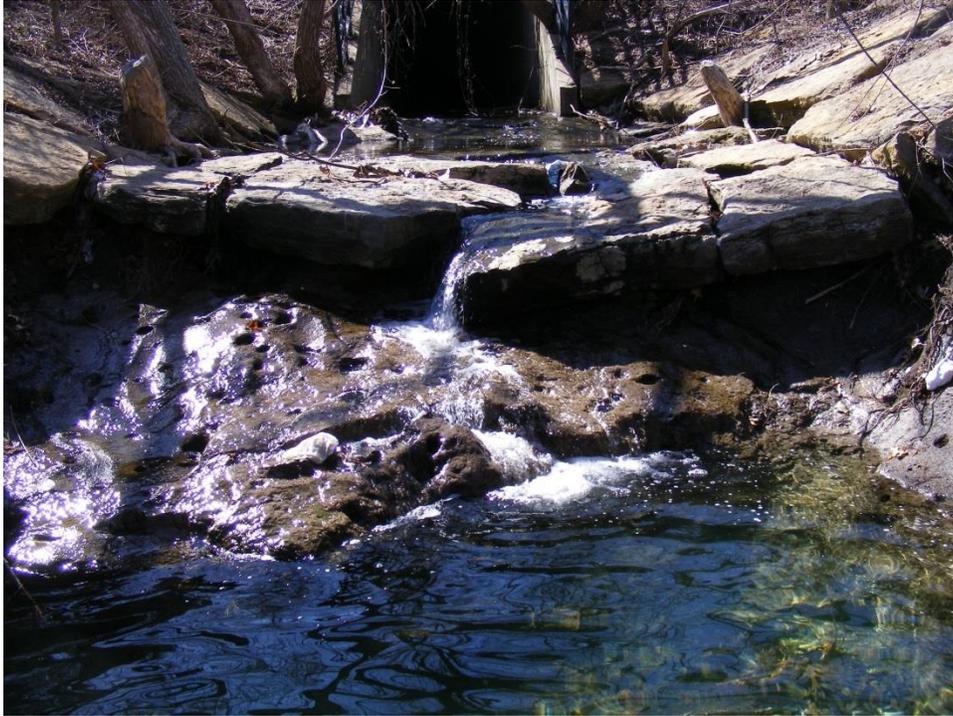
5. Bed erosion/undermining at bridge - Channel incision, or down-cutting has compromised the integrity of a bridge (Photo 5). Typically this will occur on the downstream footing when a headcut moves upstream lowering the stream bed or when a deep scour pool is formed downstream that undermines the bridge footing or wingwalls. Level of concern is based on the depth of the stream bed below the footing and any signs of failure to the bridge structure.

Photo 5. Example of problem type 5. Bed erosion/undermining at bridge

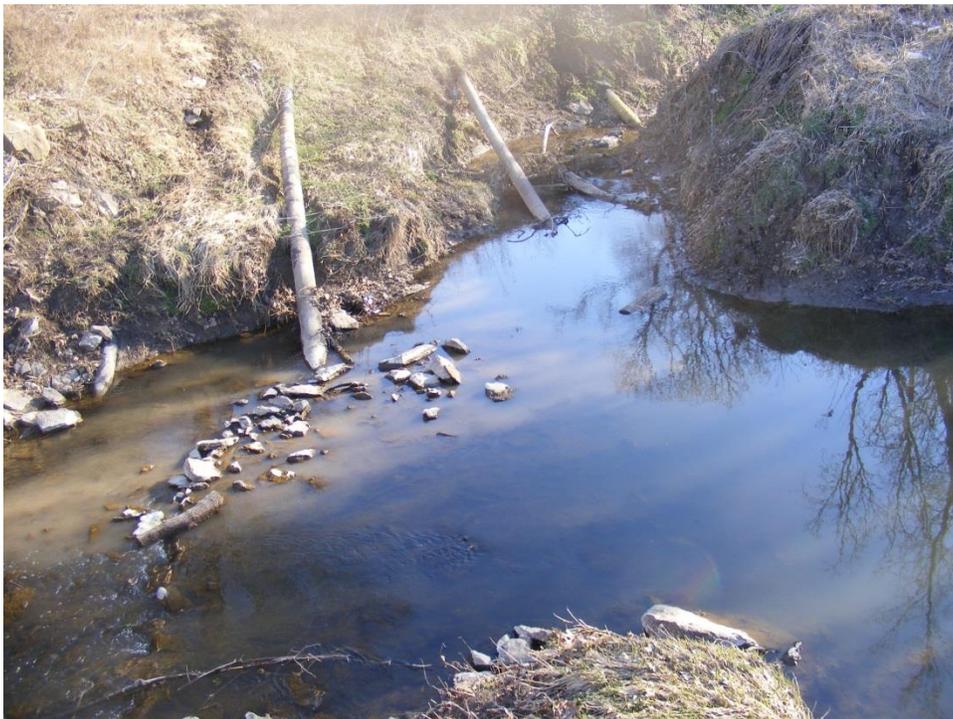
6. Exposed pipes or cables due to erosion - Occurs when channel migration or channel widening expose utility lines in the channel bank, or when channel incision exposes utilities in the bed of the stream (Photo 6). Level of concern is based on the type and degree of exposure, as well as presence of bank erosion indicators such as bank angle, fresh erosion scars, and newly uncovered tree roots

Photo 6. Example of problem type 6. Exposed pipes or cables due to erosion

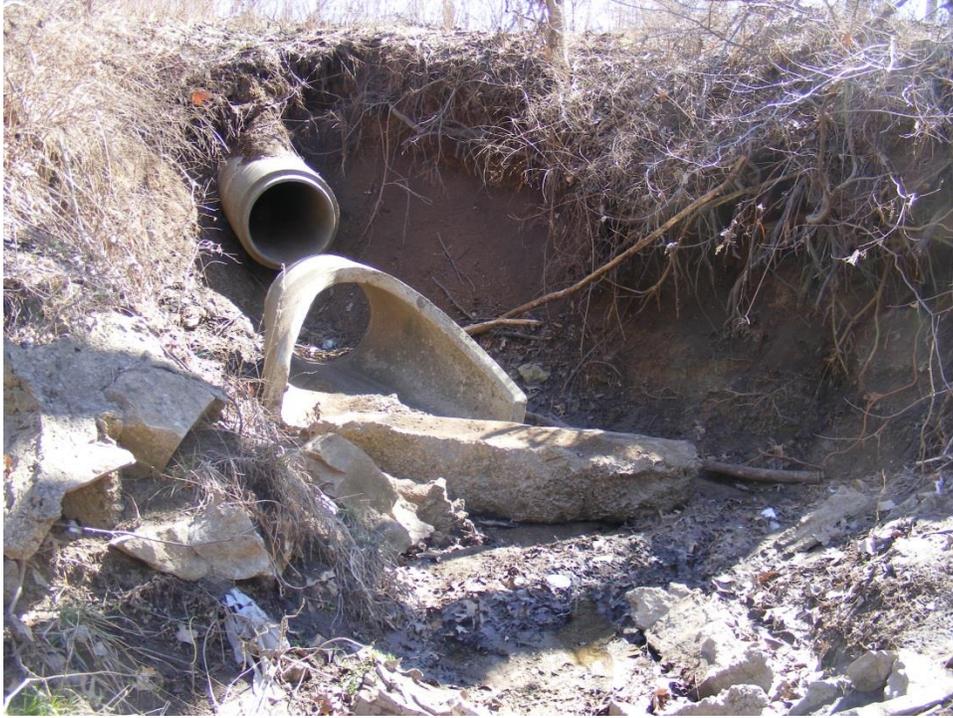
7. Failed culvert/inlet due to undermining - This occurs when flow carried through a pipe to the stream outlet undermines, or scours, below the apron causing bank erosion to occur (Photo 7). In some cases an attempt to stop the bank scour has occurred with rip-rap or large flat bedrock slabs. Level of concern is based on the severity of erosion around the pipe and any structural failure of the pipe or apron.

Photo 7. Example of problem type 7. Failed culvert/inlet due to undermining

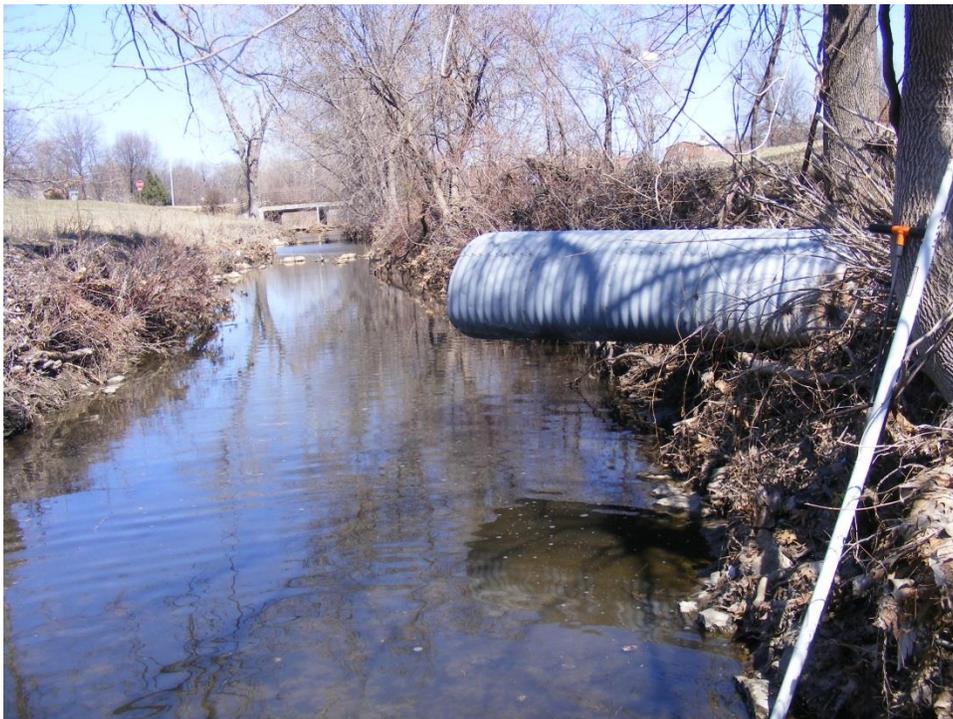
8. Hanging culvert or inlet due to incision - Bed incision has left a culvert outlet above, or “hanging” out over the bed of the stream (Photo 8). In many cases the apron and last section of pipe may have fallen into the stream creating a flow obstacle inducing local bank erosion and bed scour. Level of concern is based on the severity of erosion, the distance from the pipe to the bed, and presence of structural failure of the pipe or apron.

Photo 8. Example of problem type 8. Hanging culvert or inlet due to incision.

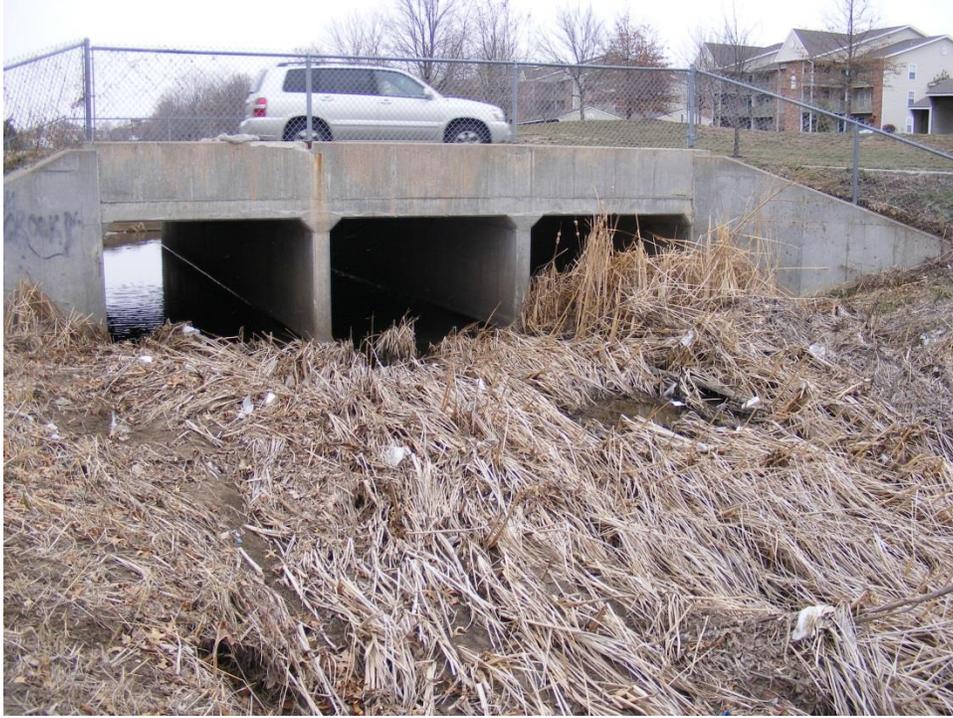
9. Sedimentation inside culvert decreasing flow capacity – Over-widened culvert cells or bridges can accumulate sediment that will decrease the ability of the structure to pass flood flows. Clogged culverts can cause upstream flooding and sedimentation problems. Level of concern is based on the degree of which the cell is blocked.

Photo 9. Example of problem type 9. Sedimentation inside culvert decreasing flow capacity.

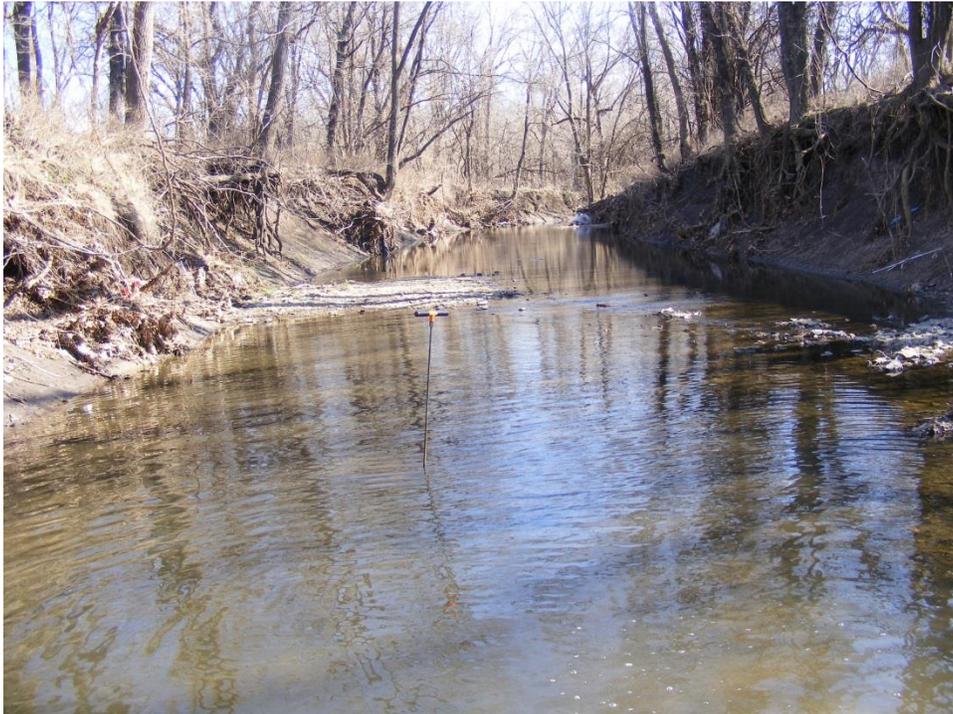
Results of the main channel assessment suggest bank erosion is the major process creating infrastructure problems along the main channel of Indian Creek as it appears bedrock is limiting incision along much of the channel. Increased impervious surface in the watershed due to urban development has caused the main channel to enlarge from increased storm water loads. Channel width increases rapidly downstream going from about five feet in the upper main channel to about 40 ft about five miles downstream at station 10,000 ft (Table 3, Figure 4). At the same time channel depth increases at a much lower rate from about 5-10 ft at station 15,000 ft. This suggests bedrock that was observed along the bed has limited the ability of the channel to incise, as a result the channel is increasing its capacity through bank erosion (Photo 10). However, below station 8,000 ft, where there is a large bedrock knick point in the stream, evidence suggests the channel bed has lowered through incision as the banks are getting higher as the channel width is getting lower (Photo 11). This pattern on incision and bedrock control is likely to continue downstream beyond the limits of this study. Also, in the lower 8,000 feet of stream the channel appears to be migrating into high loess bluffs with houses built near the edge. The stability of the slope and the level of stability due to bedrock needs to be determined.

Photo 10. Example of main channel widening - high vertical banks, exposed tree roots, and slumping are indicators of erosion.

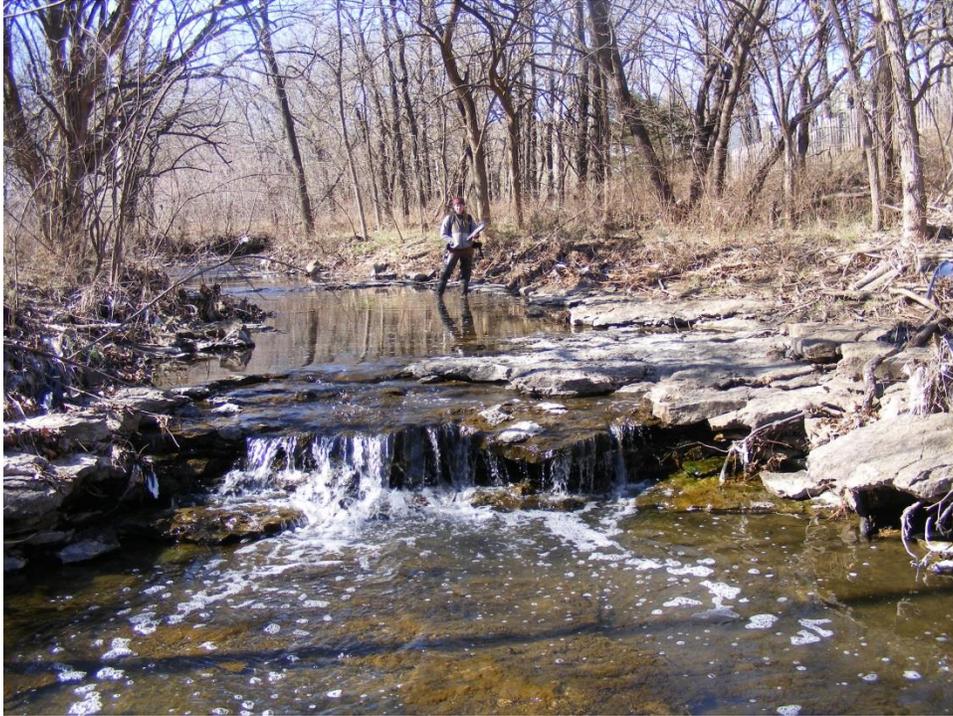
Photo 11. Bedrock knickpoints serve as natural grade controls in the main channel and in the lower reaches of many tributaries.

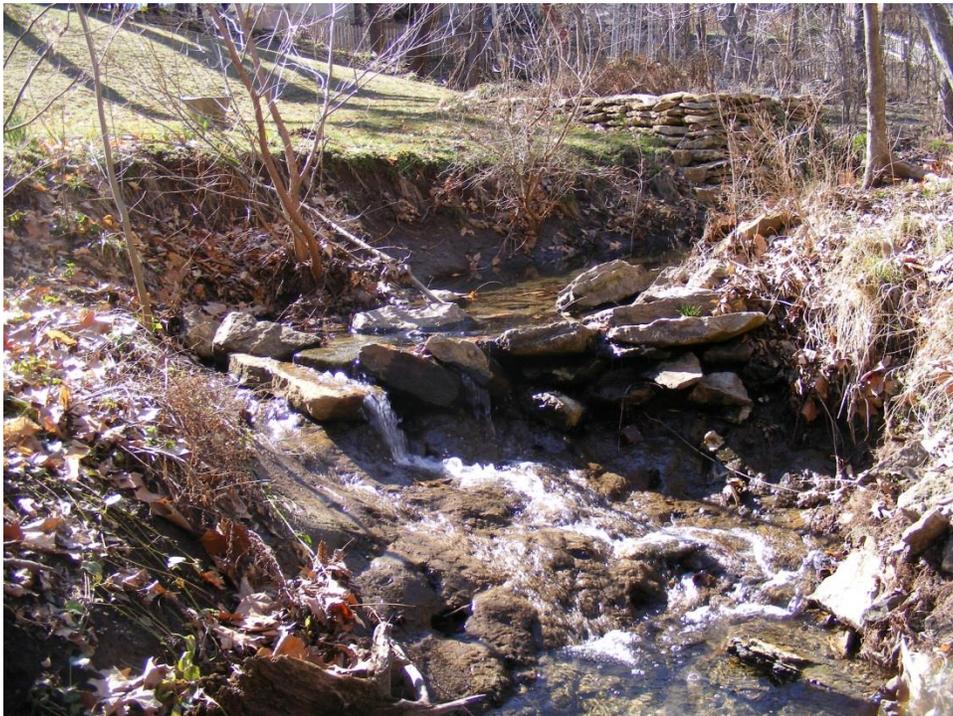
Channel incision is the major process impacting public infrastructure and private property along the tributaries within the Indian Creek watershed. Primary, secondary, and in some cases tertiary head cuts were observed in all tributaries investigated for this project (Photo 12). The lowering of the bed exposes utility crossings and undermines culverts as the head cuts progress upstream. Subsequent bank erosion has created a situation where liberated sediment is deposited downstream in areas of lower slope causing the lateral channel migration. Lateral migration creates problem areas in the tributaries when the channel meanders into private property and utilities (typically phone and cable lines) that are often placed adjacent to the back property lines (Photo 13). Furthermore, obstacles and other debris (homemade rip-rap, trees, trash etc.) along the tributaries add to local stream instability (Photo 14).

Photo 12. Headcuts are progressing upstream in most of the tributaries.

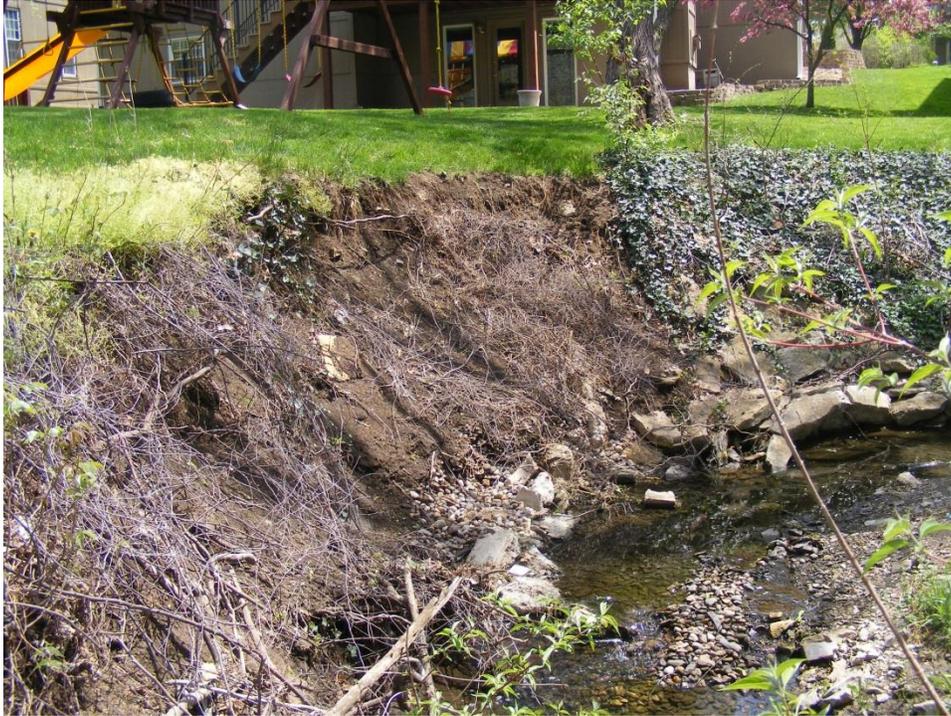
Photo 13. Lateral channel migration encroaches on to private property in areas downstream of headcuts.

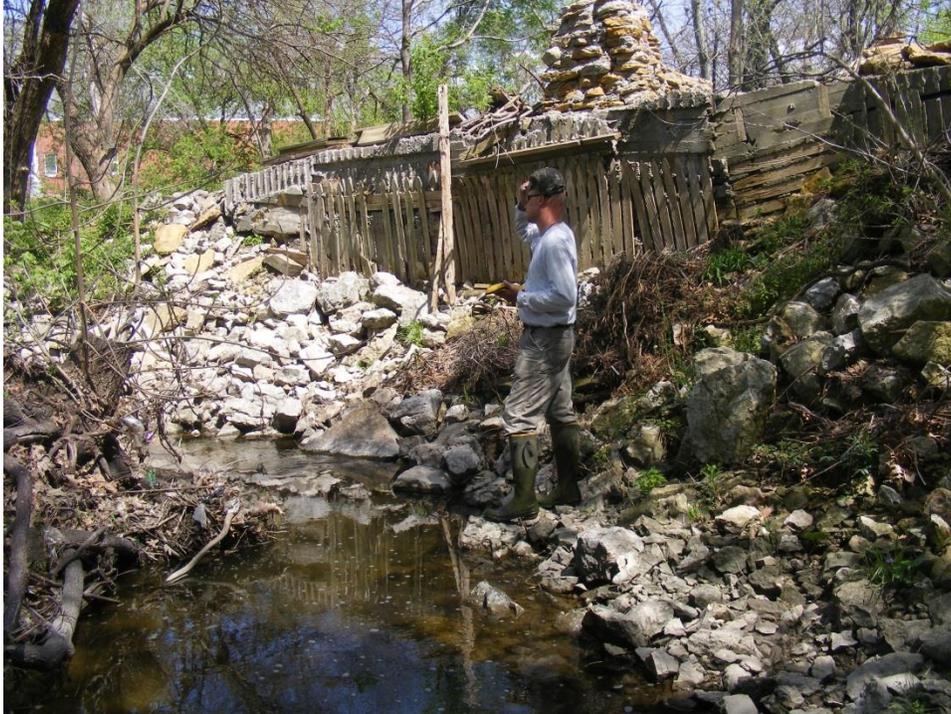
Photo 14. Local residents are trying to protect their land in areas where bank erosion threatens their property.
