**The Ozarks Environmental and Water Resources Institute (OEWRI)
Missouri State University (MSU)**

**Mississippi River Basin Healthy Watersheds Initiative (MRBI)
Watershed Assessment for:**

**Coon Creek Watershed (HUC-071100080104)
Sandy Fork-West Fork Cuivre River Watershed (HUC-071100080105)
Headwaters Indian Creek Watershed (HUC-071100080201)**

FINAL REPORT

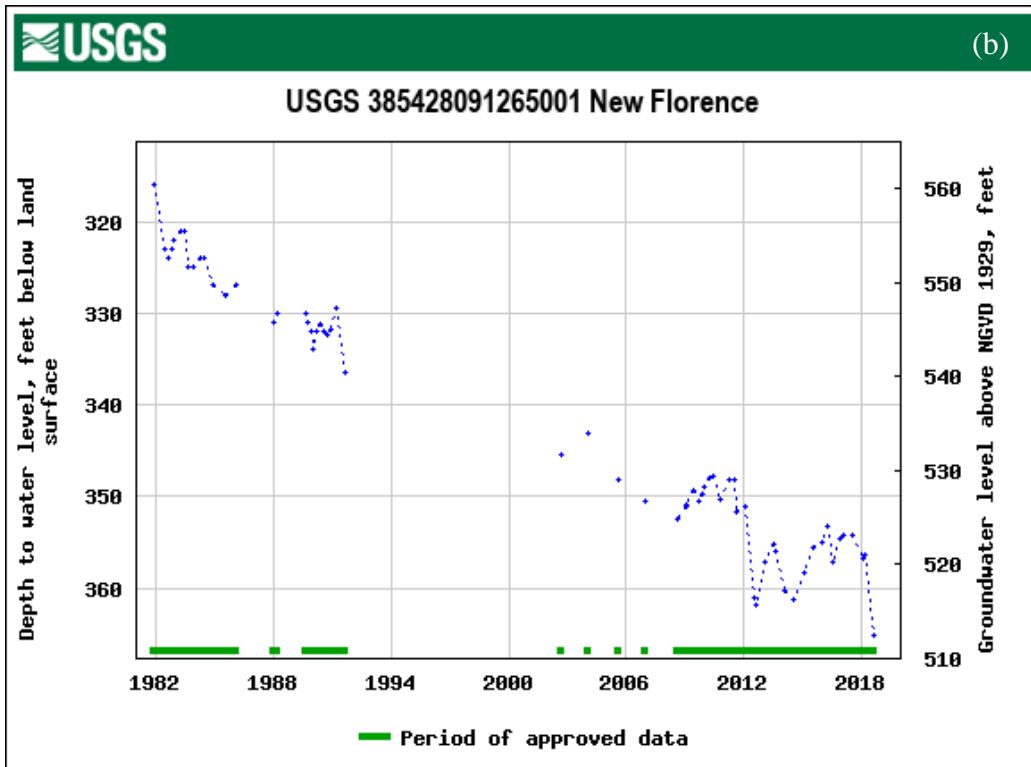
Figure 14. Ground water level change for (a) Vandalia (2007-2019) and (b) New Florence (1981-2019).

There is a ground water monitoring station in Vandalia, 1.2 miles north of the headwaters of Shady Creek (Site Number: 391825091285101). This station has been operating since 2007 and data shows a relatively consistent level from 2007-2015. Since 2015, water levels have consistently increased by nearly 6 feet as of 2019 (Figure 14a). There is also a ground water monitoring station in New Florence that has been operating for about 30 years located approximately 13 miles south of the Coon Creek watershed (Site Number: 393544093075601). This station, in contrast, shows a steady ground water level decline of nearly 40 feet over that time (Figure 14b). Data from these stations suggest high local variability in ground water levels in the area.

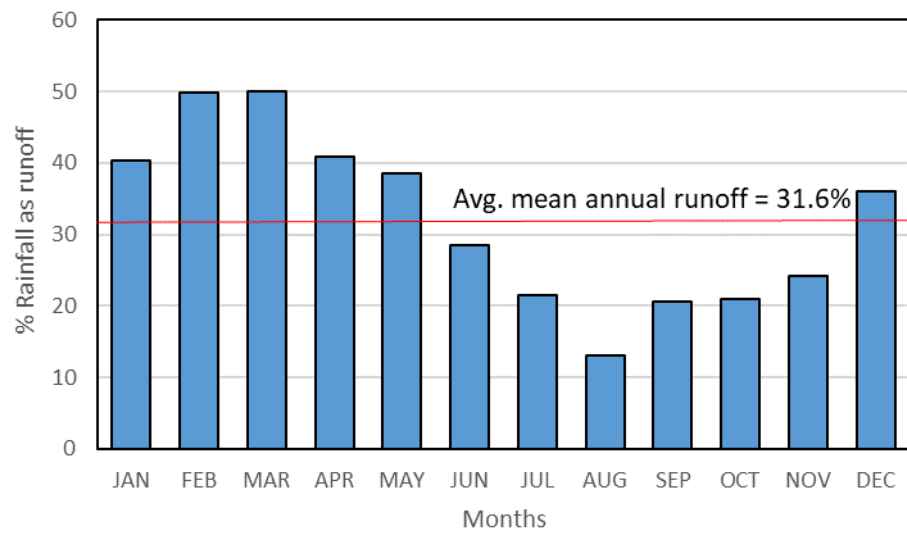
Figure 21. Mean monthly discharge and runoff percentage for the three study watersheds.

Annual and monthly runoff rates for the selected Cuivre River watersheds were estimated using equations developed from 27 USGS gaging stations in the region. Monthly runoff rates are important for understanding seasonal variability and how rainfall-runoff relationships correspond to land management. Estimated annual runoff rates from these gages will also be used to help validate the STEPL model hydrology results. A list of the equations used for this analysis of monthly mean discharge values can be found in Appendix E. Mean annual discharge for the Coon Creek watershed is 44.7 ft³/s, 48.2 ft³/s for Sandy Fork-West Fork Cuivre River, and 52.6 ft³/s for Headwaters Indian Creek. Total runoff volume for the Coon Creek watershed was 32,387 ac-ft, 34,915 ac-ft for Sandy Fork-West Fork Cuivre River, and 38,104 ac-ft for the Headwaters Indian Creek watershed. Average runoff as a percentage of rainfall for the Coon Creek watershed was 31.8%, Sandy Fork-West Fork Cuivre River was 31.6% and 31.4% for Headwaters Indian Creek. These estimates are comparable with existing literature that state evapotranspiration rates for Missouri range from 60–70% (Sanford and Selnick 2013). Monthly mean runoff as a percentage of rainfall is highest in the late winter and early spring and lowest in the late summer and early fall ranging from around 13% in August to near 50% in February and March (Figure 21). The remainder of the rainfall is either lost to evapotranspiration or moved through the soil into groundwater storage through infiltration (USDA, 2009b).

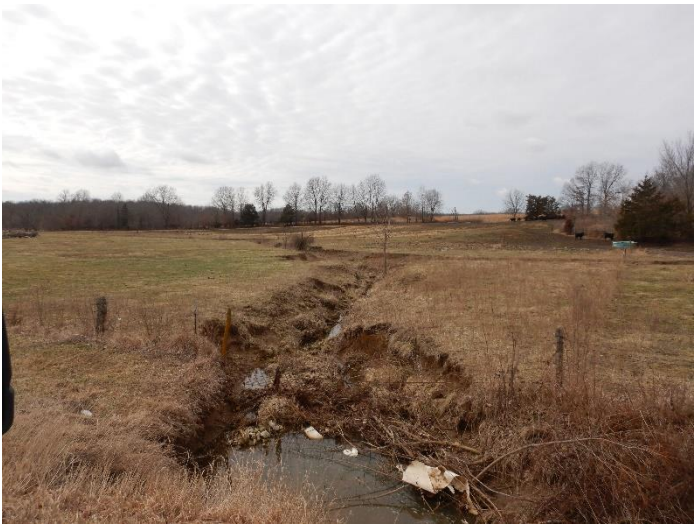
Channel condition	<input type="text" value="10"/>	<div style="border: 1px solid black; padding: 5px; text-align: center;"> Overall Score 4.0 </div>

Hydrologic alteration	<input type="text" value="6"/>		
Riparian zone	<input type="text" value="1"/>		
Bank stability	<input type="text" value="3"/>		
Canopy cover	<input type="text" value="1"/>		
Manure presence	<input type="text" value="3"/>		
Channel condition	<input type="text" value="10"/>	<div style="border: 1px solid black; padding: 5px; text-align: center;"> Overall Score 6.7 </div>

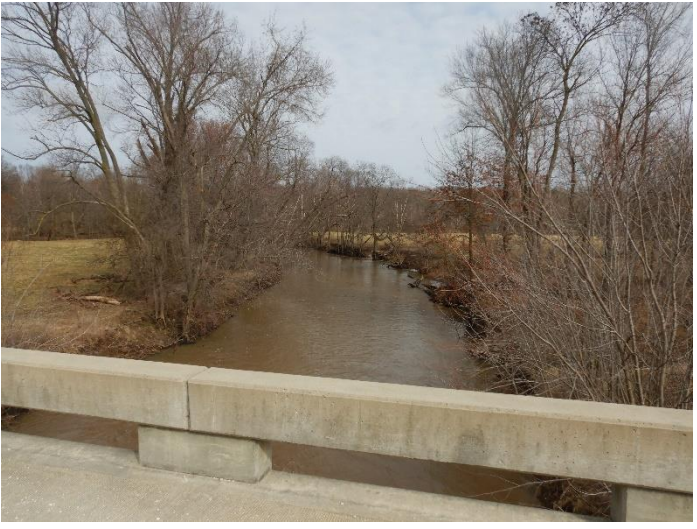
Hydrologic alteration	<input type="text" value="9"/>		
Riparian zone	<input type="text" value="2"/>		
Bank stability	<input type="text" value="8"/>		
Canopy cover	<input type="text" value="6"/>		
Manure presence	<input type="text"/>		
Channel condition	<input type="text" value="10"/>	<div style="border: 1px solid black; padding: 5px; text-align: center;"> Overall Score 8.4 </div>

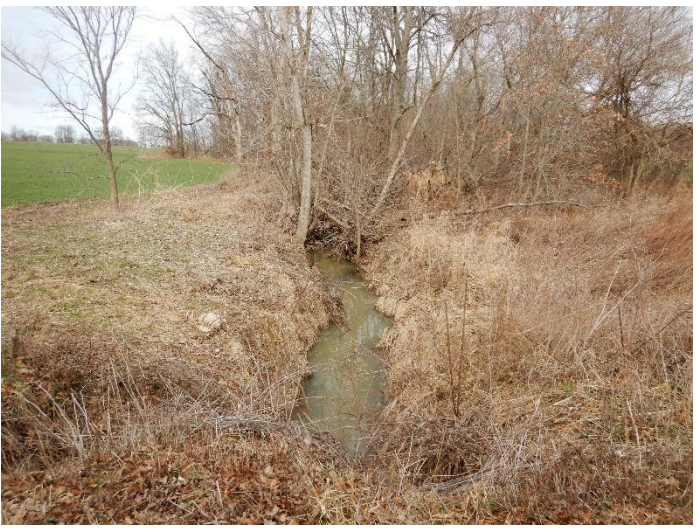
Hydrologic alteration	<input type="text" value="7"/>		
Riparian zone	<input type="text" value="8"/>		
Bank stability	<input type="text" value="8"/>		
Canopy cover	<input type="text" value="9"/>		
Manure presence	<input type="text"/>

Channel condition	<input type="text" value="3"/>	Overall Score 4.0	 
Hydrologic alteration	<input type="text" value="3"/>		
Riparian zone	<input type="text" value="5"/>		
Bank stability	<input type="text" value="4"/>		
Canopy cover	<input type="text" value="4"/>		
Manure presence	<input type="text"/>

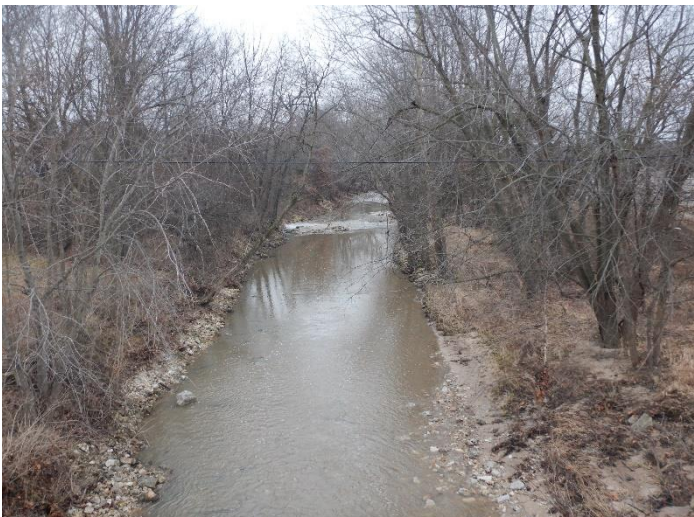
Channel condition	<input type="text" value="10"/>	Overall Score 8.0

Hydrologic alteration	<input type="text" value="8"/>		
Riparian zone	<input type="text" value="7"/>		
Bank stability	<input type="text" value="8"/>		
Canopy cover	<input type="text" value="7"/>		
Manure presence	<input type="text"/>

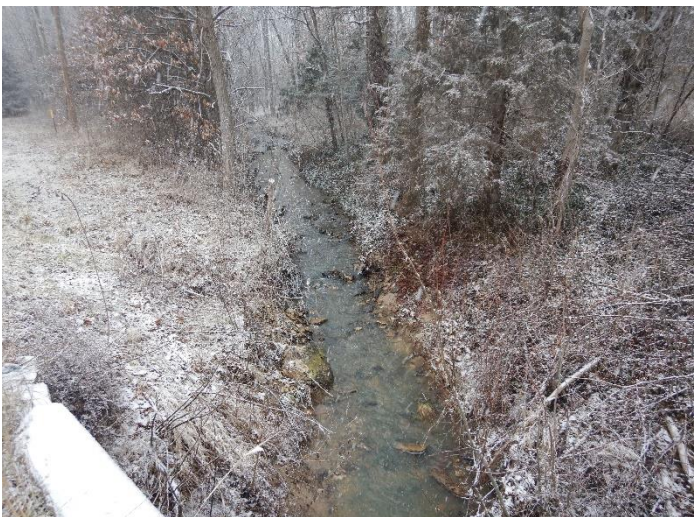
Channel condition	<input type="text" value="10"/>	Overall Score 8.4

Hydrologic alteration	<input type="text" value="7"/>		
Riparian zone	<input type="text" value="10"/>		
Bank stability	<input type="text" value="7"/>		
Canopy cover	<input type="text" value="8"/>		
Manure presence	<input type="text"/>
