**GEOMORPHOLOGY AND METAL CONTAMINATION OF AN URBAN
FLOODPLAIN ALONG WILSON CREEK, SPRINGFIELD, MISSOURI**

A Masters Thesis

Department of Geography, Geology, and Planning

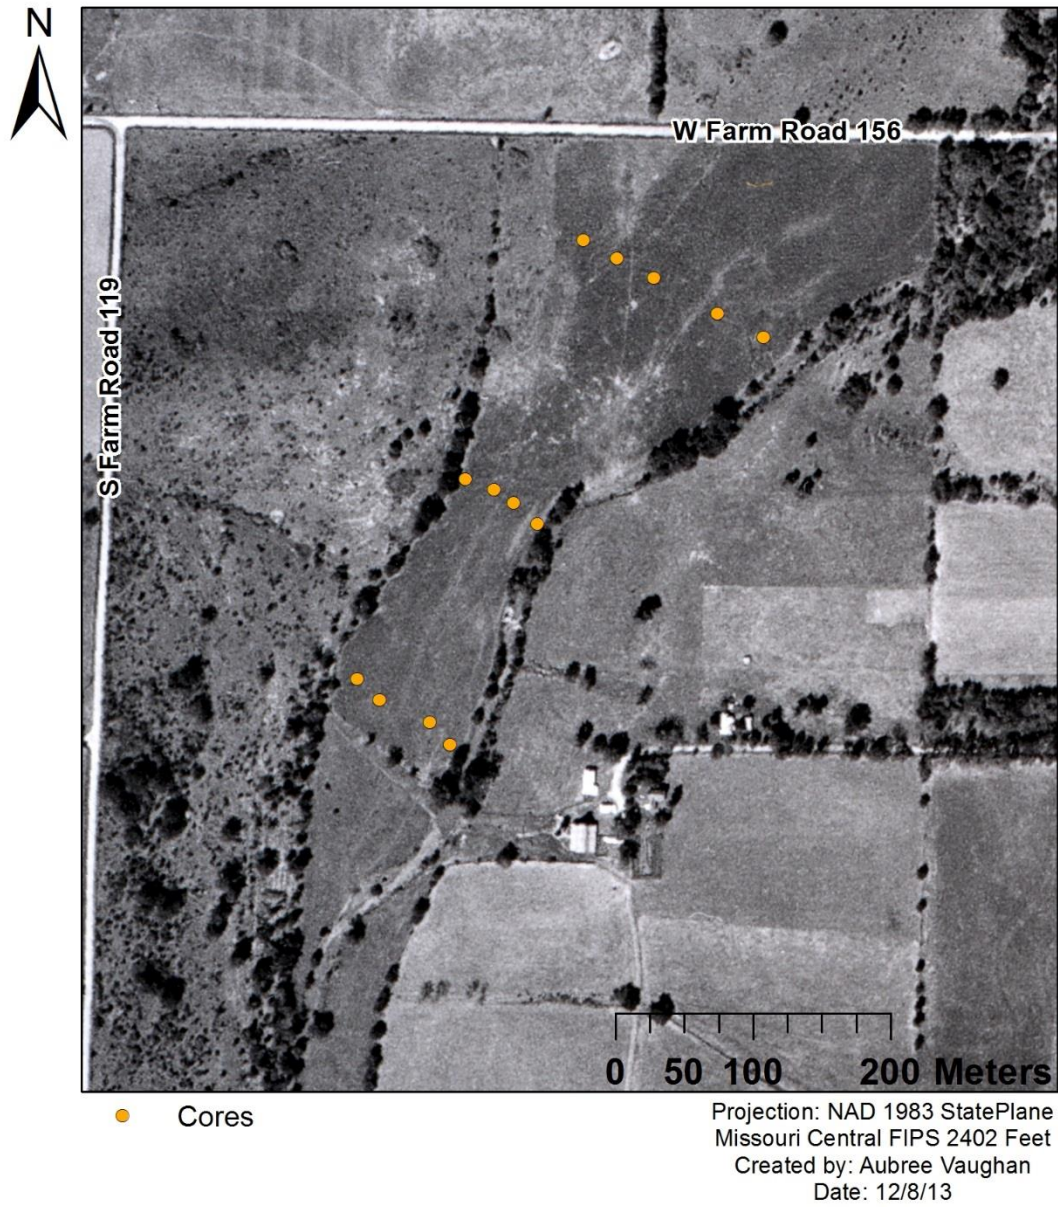
Figure 8. 1970 aerial photograph of study area and core sampling locations.

Aerial photographs from 1953, 1970, and 2010 display land cover changes around the study area (Figure 7 through 9). Between 1953 and 1970, a few more structures were built along the terrace on the east side of the channel. Tree removal is also evident between the years 1953 and 1970, which can be seen north of FR 156 and along the east terrace. The most recent aerial from 2010 displays an increase in vegetation on the terrace along the west side of the valley floor as well as the area north of FR156 where tree removal previously occurred. To the far west of the 2010 aerial, some rooftops can be seen from a nearby neighborhood that was developed between 1970 and 2010. From 1950 to 1980, the population of Greene County increased nearly 20% every 10 years (Forstall, 1995). The construction of this neighborhood and others to meet the demands of the growing population of Greene County may have influenced the hydrology and sedimentation of the study area (Dunne and Leopold, 1978; Paul and Meyer, 2001).

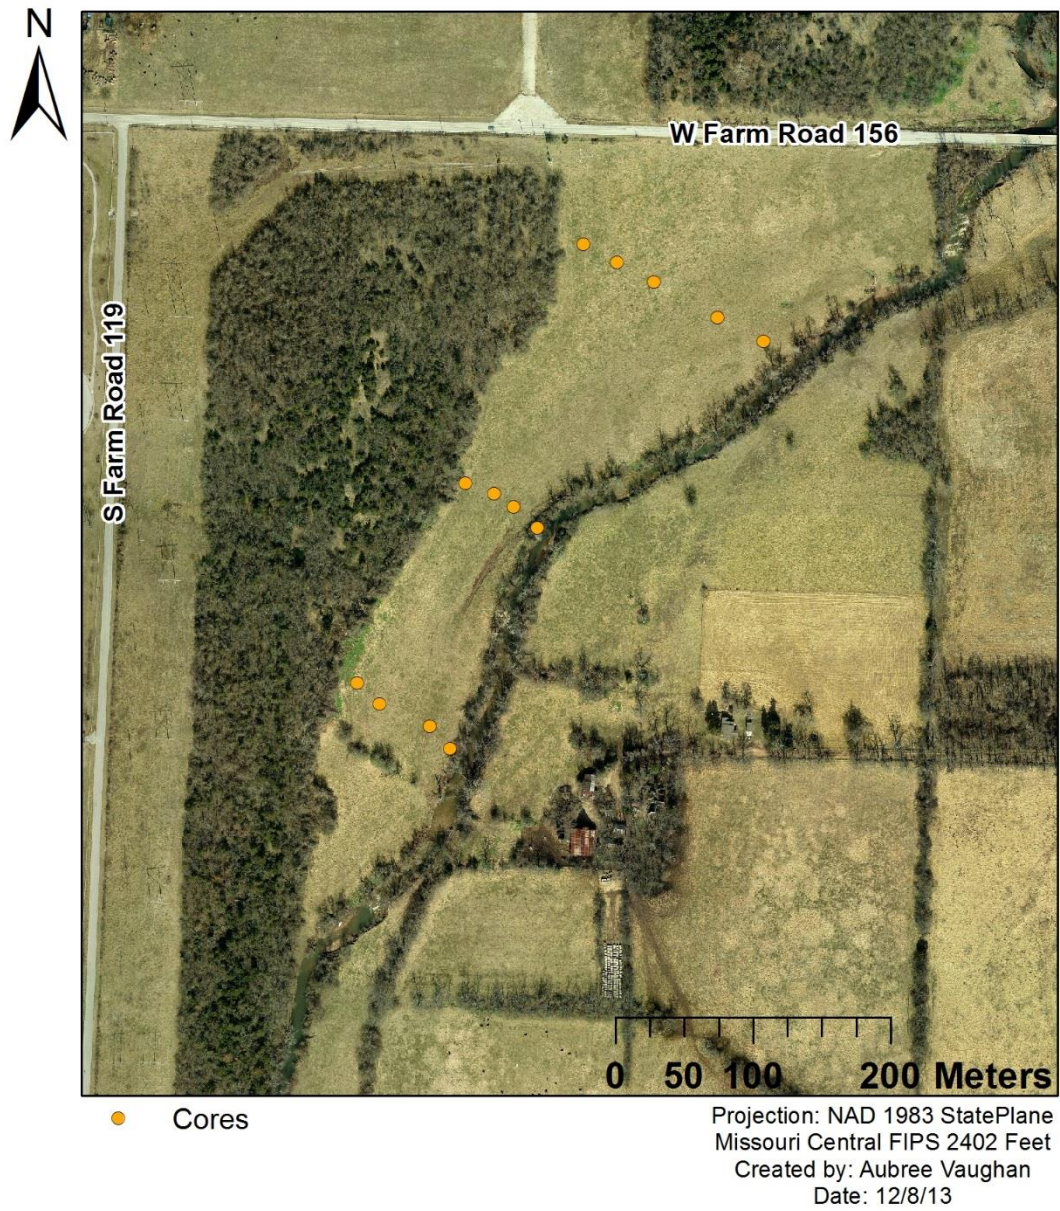
Figure 9. 2010 aerial photograph of study area and core sampling locations.

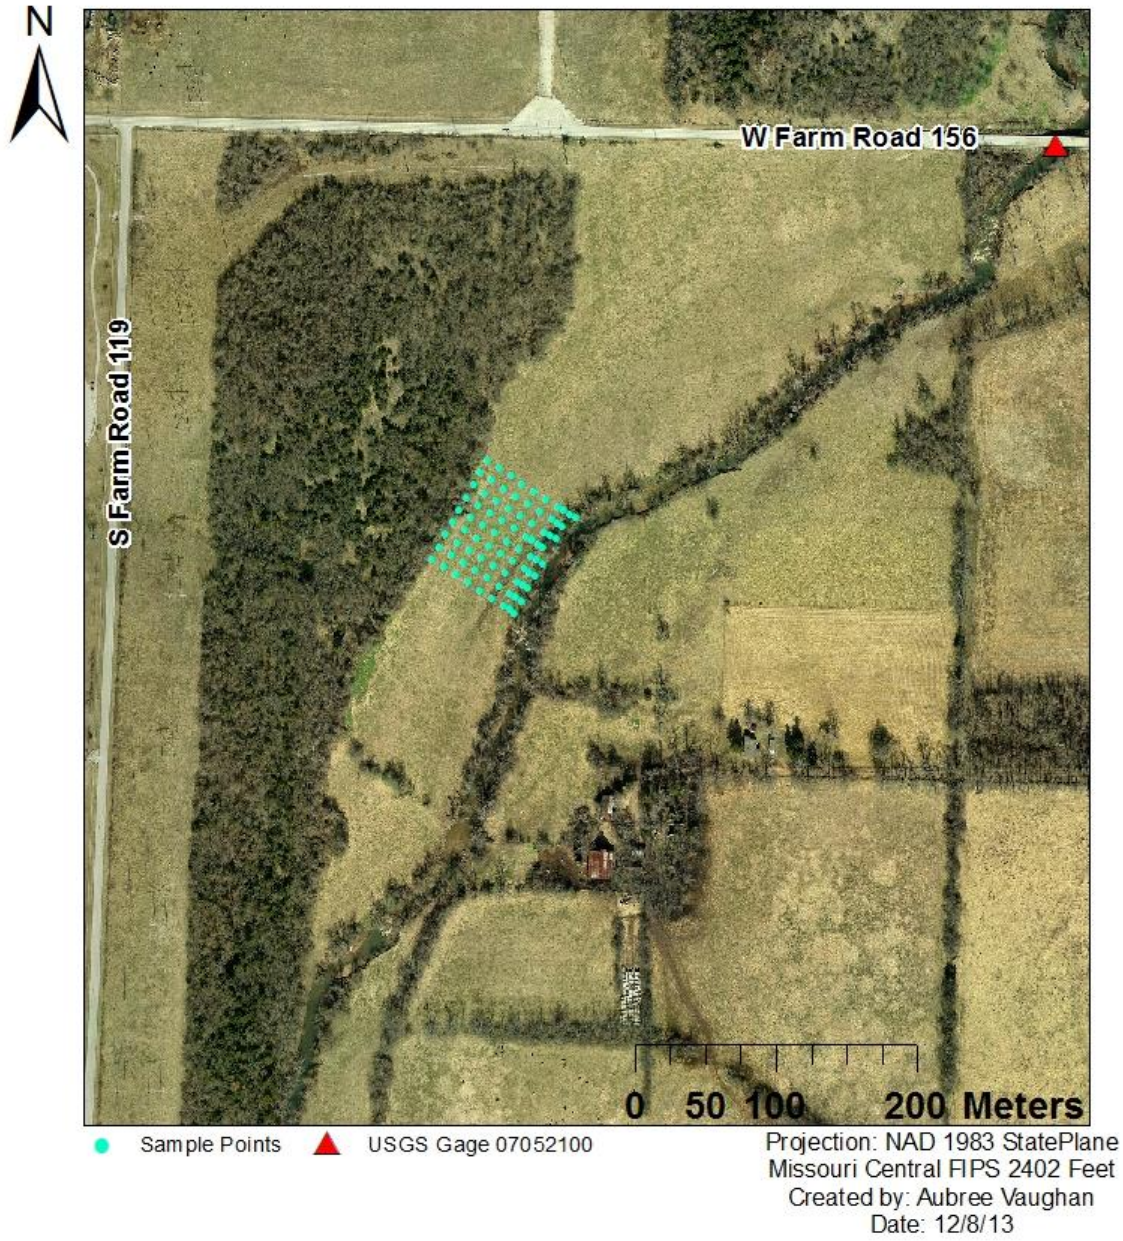
Figure 13. Floodplain surface sampling grid.

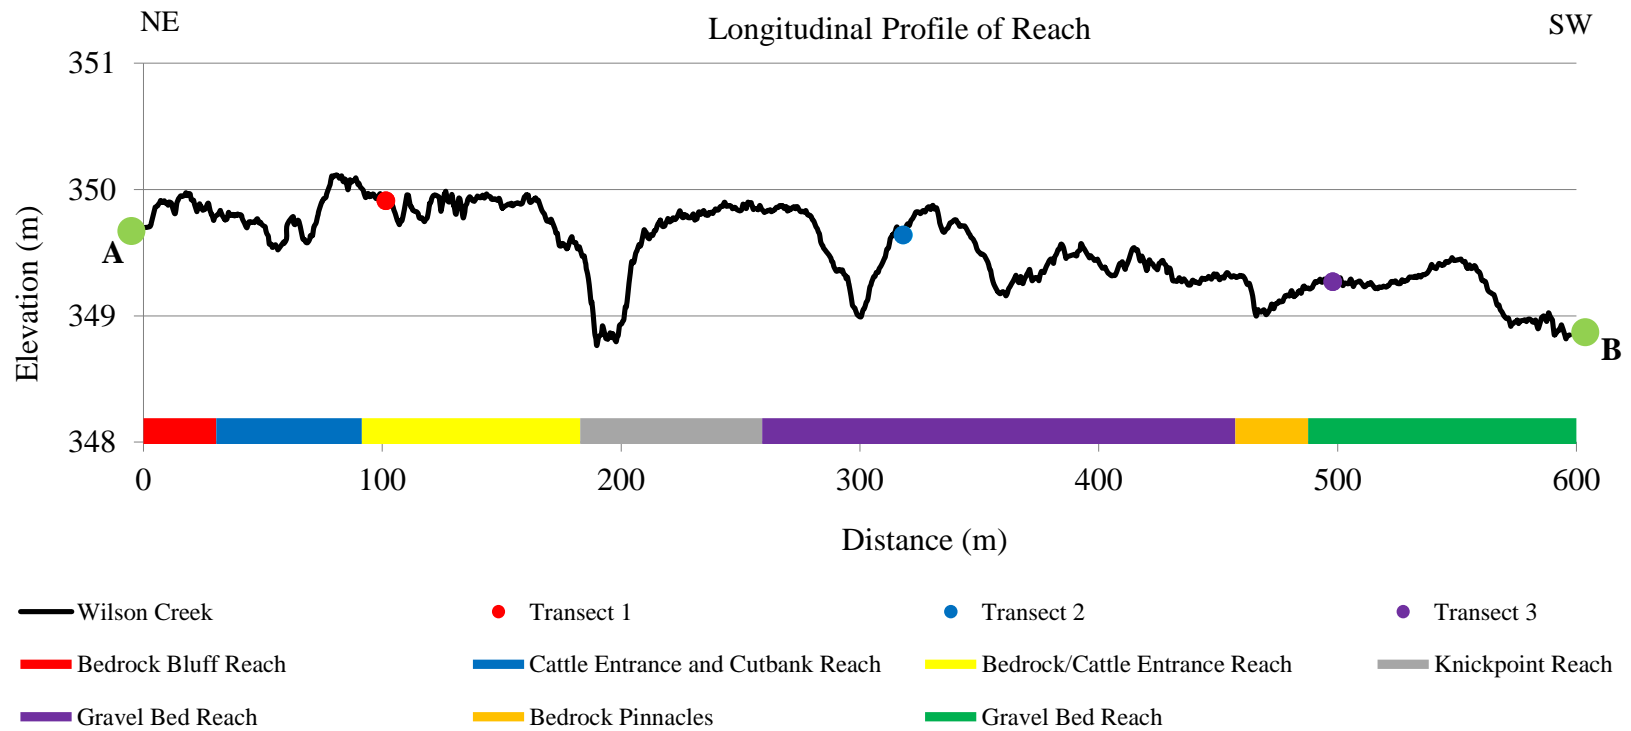
Figure 14. Longitudinal Profile of study area reach, reading Northeast (NE) to Southwest (SW). Points “A” and “B” correspond to the letters and points in Figure 9, marking the beginning and end of the reach.

The bed of the study reach is approximately 30 % bedrock with most of the bedrock exposed along the upstream portion of the study reach near the bluff and

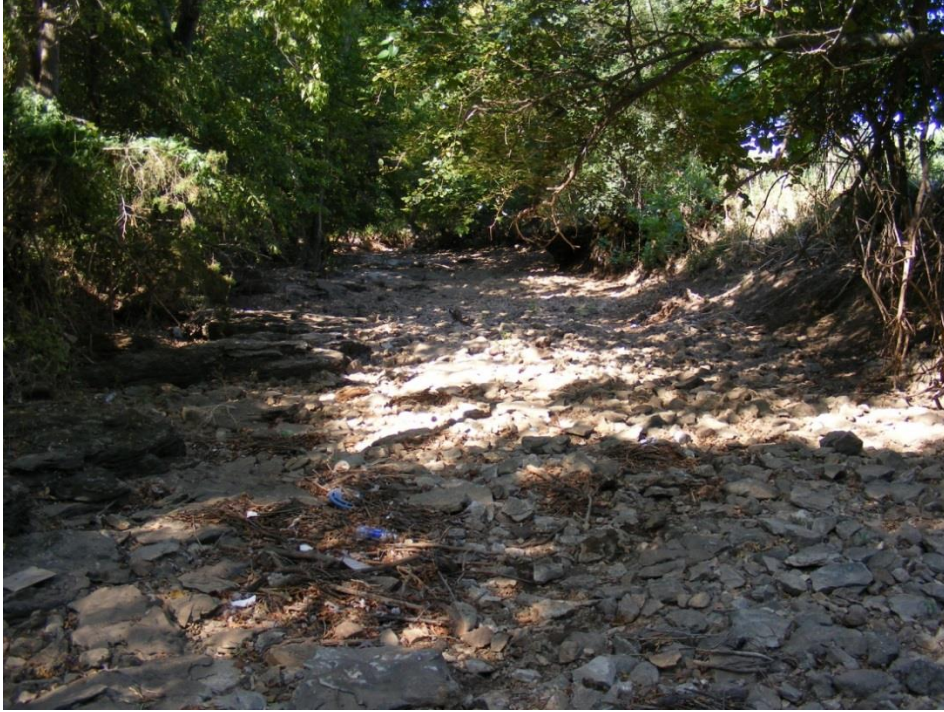
Figure 16. Bedrock/Cattle Entrance Reach (90 m) looking downstream (Owen et al., 2012).

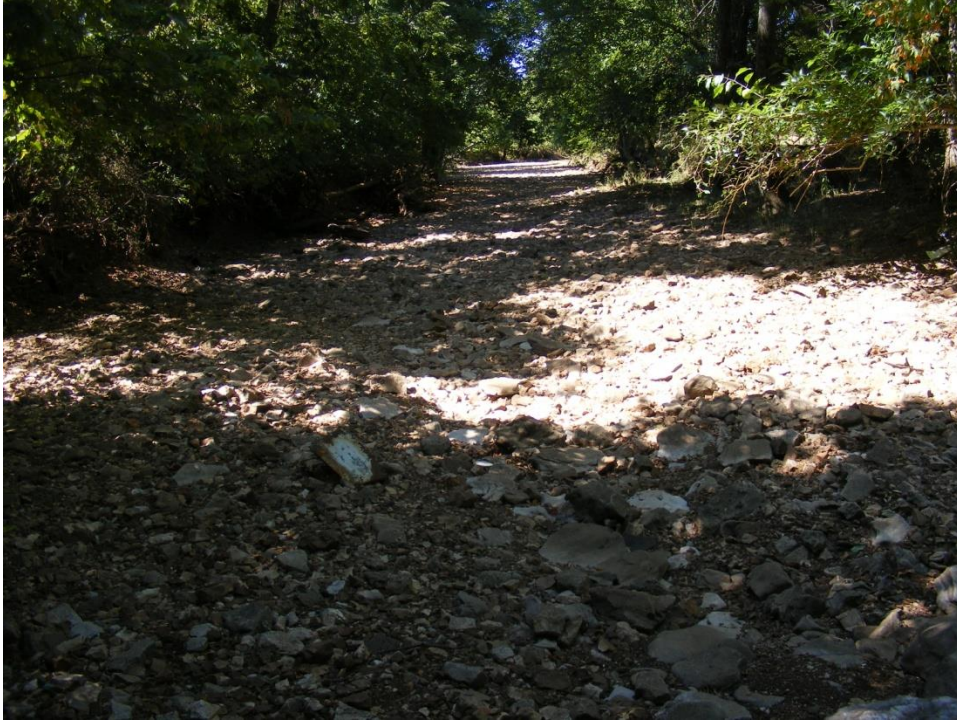
Figure 17. Gravel Bed Reach (457 m) looking downstream (Owen et al., 2012).

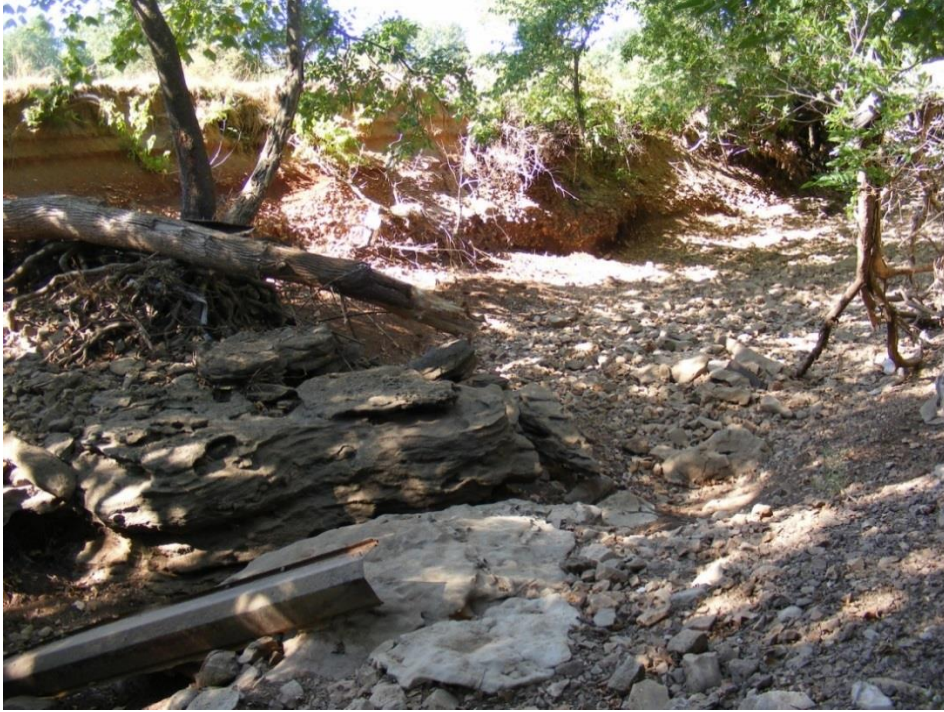
Figure 18. Bedrock Knickpoint (200m), looking at the left bank erosion (Owen et al., 2012).

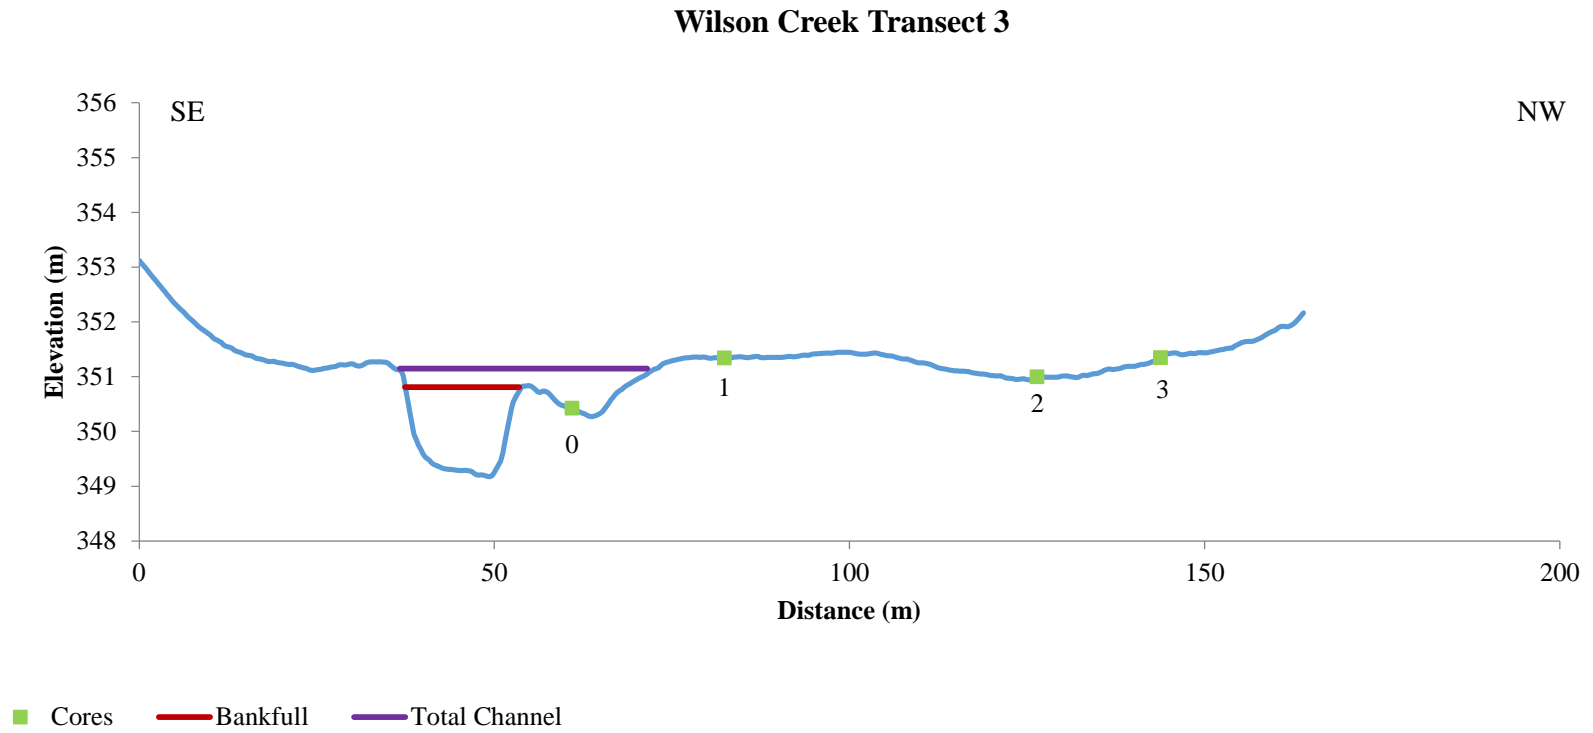
Figure 22. Transect 3 downstream cross-section profile, reading SE to NW, with core locations, bankfull level, and total channel level.

Channel cross-sections were surveyed to capture elevation changes and locate core sites. Based on cross-section profiles, Transect 1 appears to have a natural levee forming along the west bank, and Transects 2 and 3 both have a chute forming along the west of the bank (Figures 20 through 22). Bankfull is represented by the width of the water surface at the point where water would spill out into the adjacent floodplain if the natural levee was not in existence. A previous study at this segment of Wilson Creek also found bank height to decrease, and bankfull channel width to increase as distance downstream from the observed knickpoint increased (Figures 23 and 24) (Owen et al., 2012). These findings indicate a typical knickpoint model, and downstream channel widening, in response to flood energy and gravel and cobble deposition in the channel.

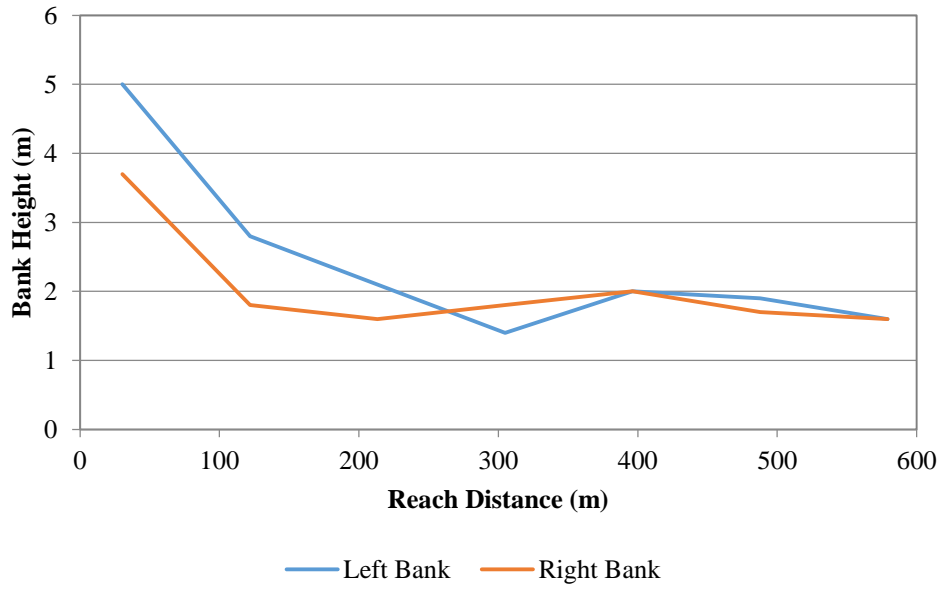
Figure 23. Bank Heights throughout study reach (Owen et al., 2012).

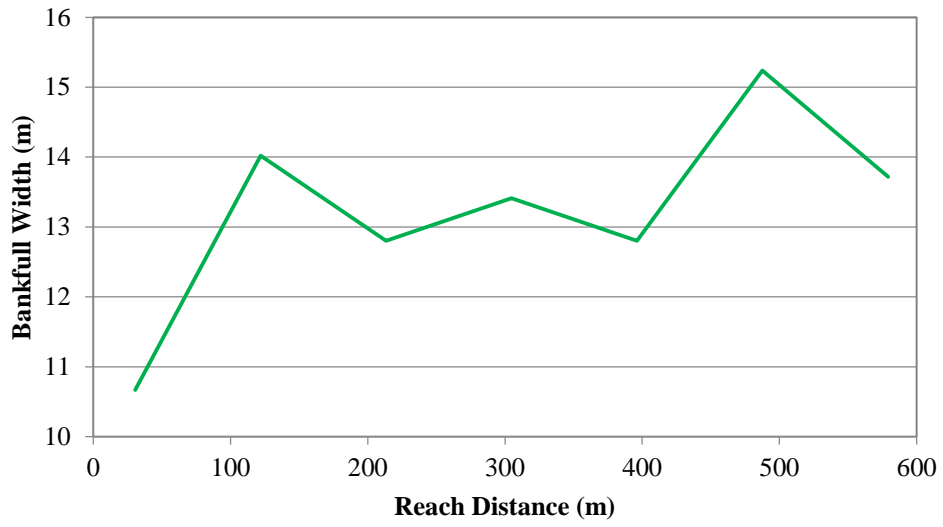
Figure 24. Bankfull widths throughout study reach (Owen et al., 2012).

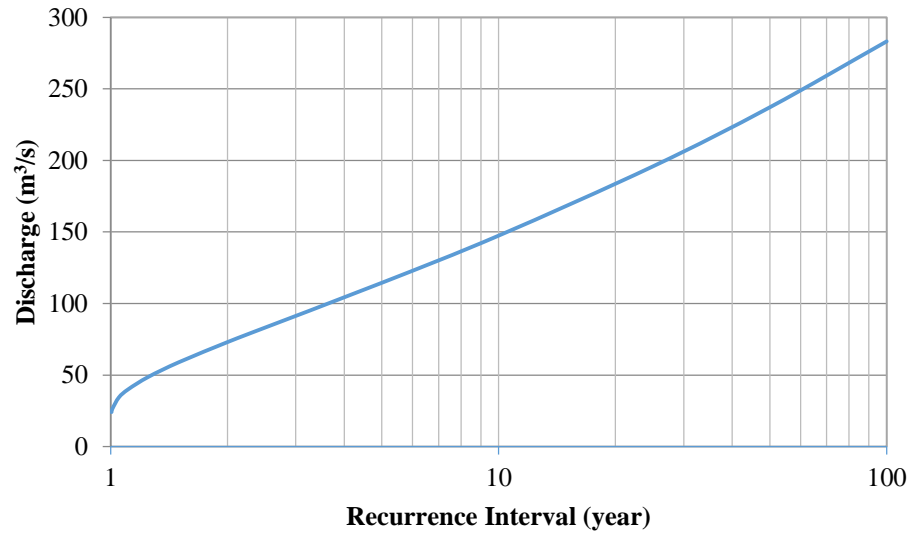
Figure 25. Flood frequency curve for USGS gaging station 07052100 at FR 156.

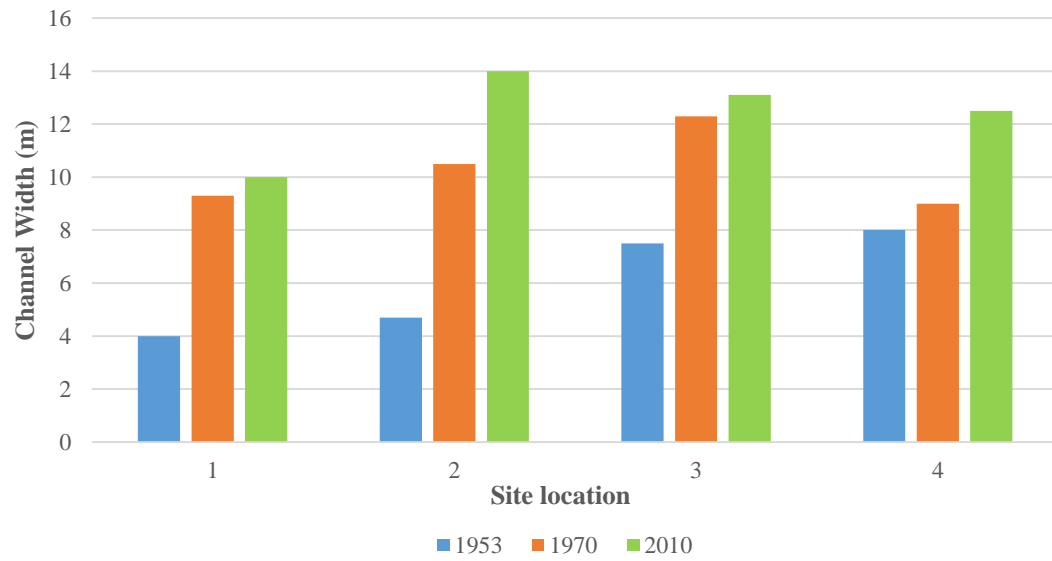
Figure 27. Changes in channel widths between 1953 and 2010, moving downstream.

Analysis of the aerial photographs indicate that historical floodplain changes have occurred in the form of bank erosion and channel widening. Between Transects 2 and 3, the floodplain has likely been eroding due to channel widening. This trend should continue as an effort to accommodate the 1.5 year flood, or until dynamic equilibrium is achieved. Also, greater gravel and cobble deposition in the channel below the bedrock knickpoint reach will fill the channel, decreasing channel area, and cause the channel to respond by widening to accommodate floods and transport bed load.

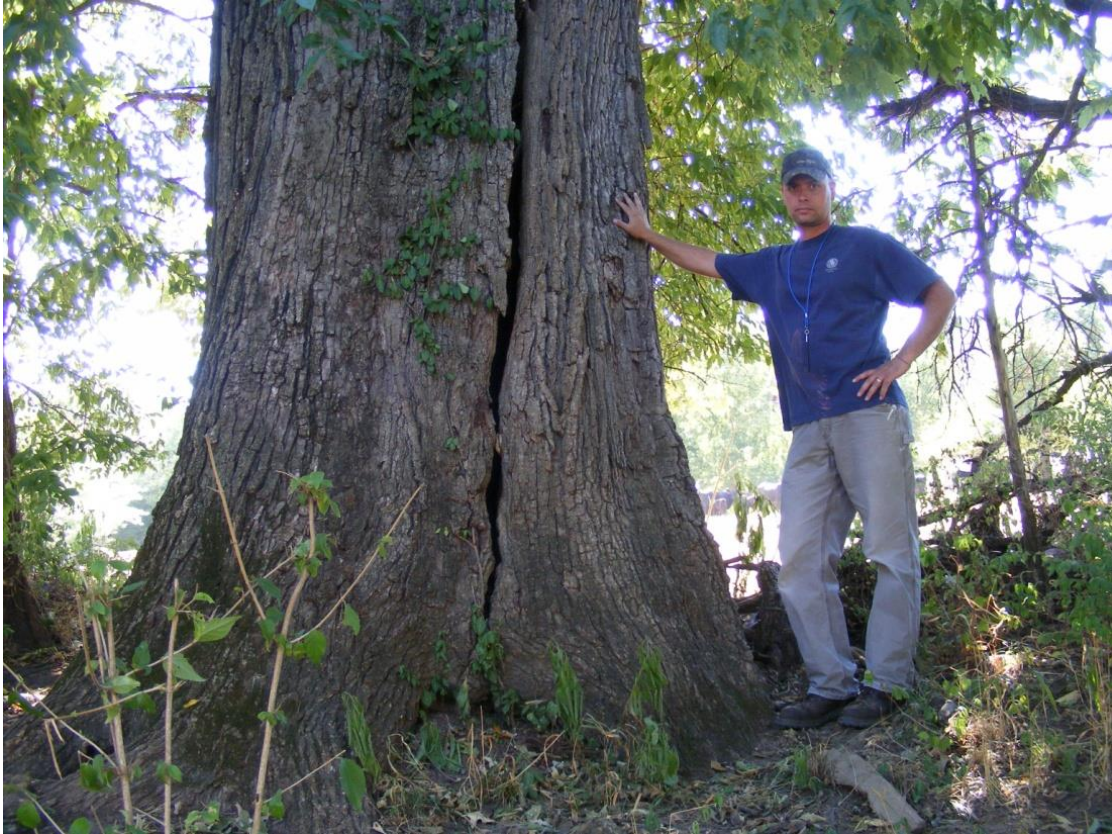
Figure 28. Legacy tree (550 m) on left bank (Owen et al., 2012).

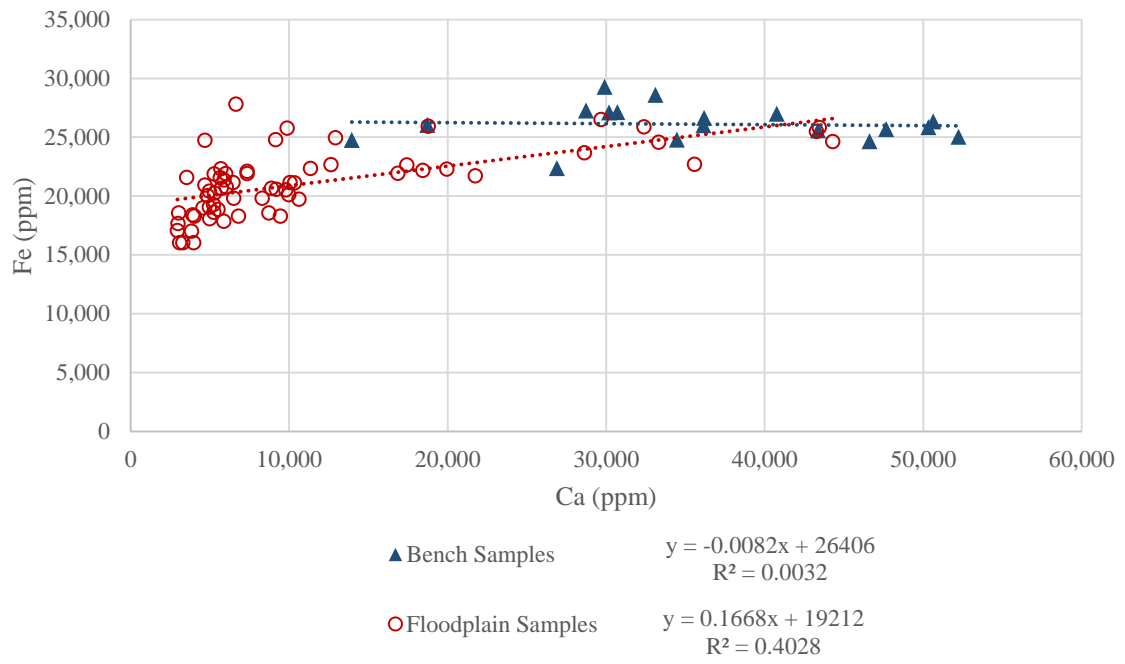
Figure 31. Fe x Ca correlations of floodplain and bench samples.

Regression analysis was performed for three different metal associations based on the identified landform the surface samples were collected from. Figures 31 through 33 display results for regression analysis of samples collected from a bench, floodplain, and all samples combined. Little to no correlation is found between either Fe and Ca or Fe and Cu. No correlation exists between Zn and Pb across the bench landform, but a high correlation of nearly 0.9 is exhibited by the Zn and Pb relationship in floodplain samples. The lack of correlation among Fe, Ca, and Cu suggest that each metal is unique in its upstream sources. The positive correlation between Zn and Pb indicate that parent sources within the floodplain landform are similar, or possibly the same.

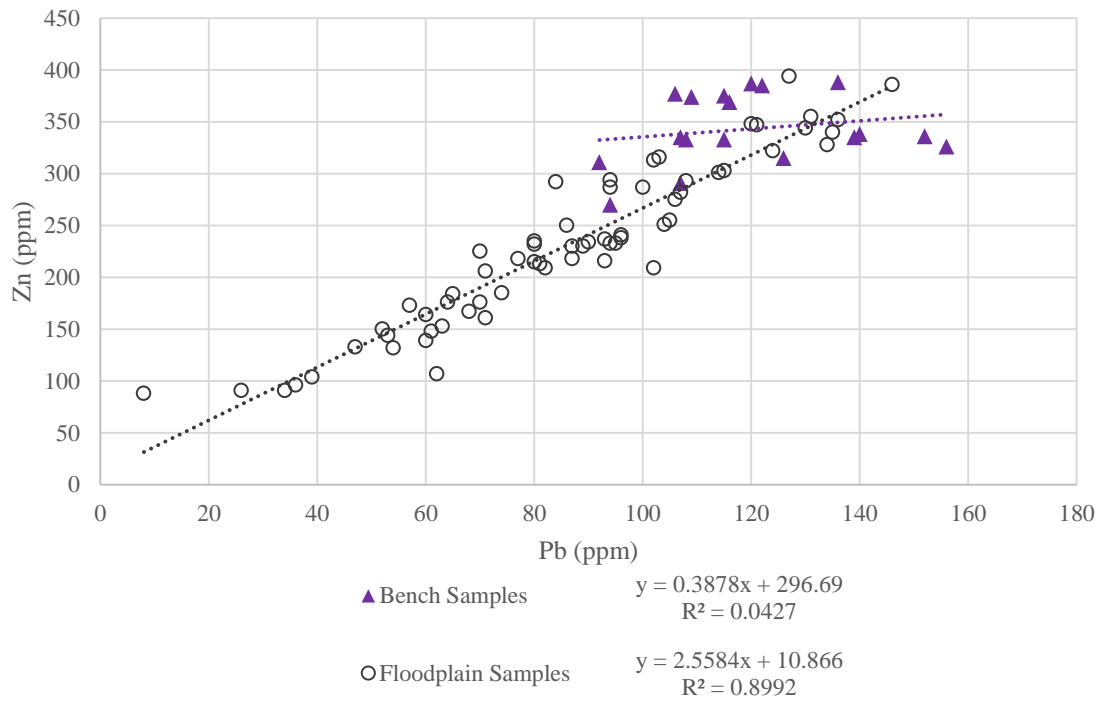
Figure 32. Zn x Pb correlations of floodplain and bench samples.

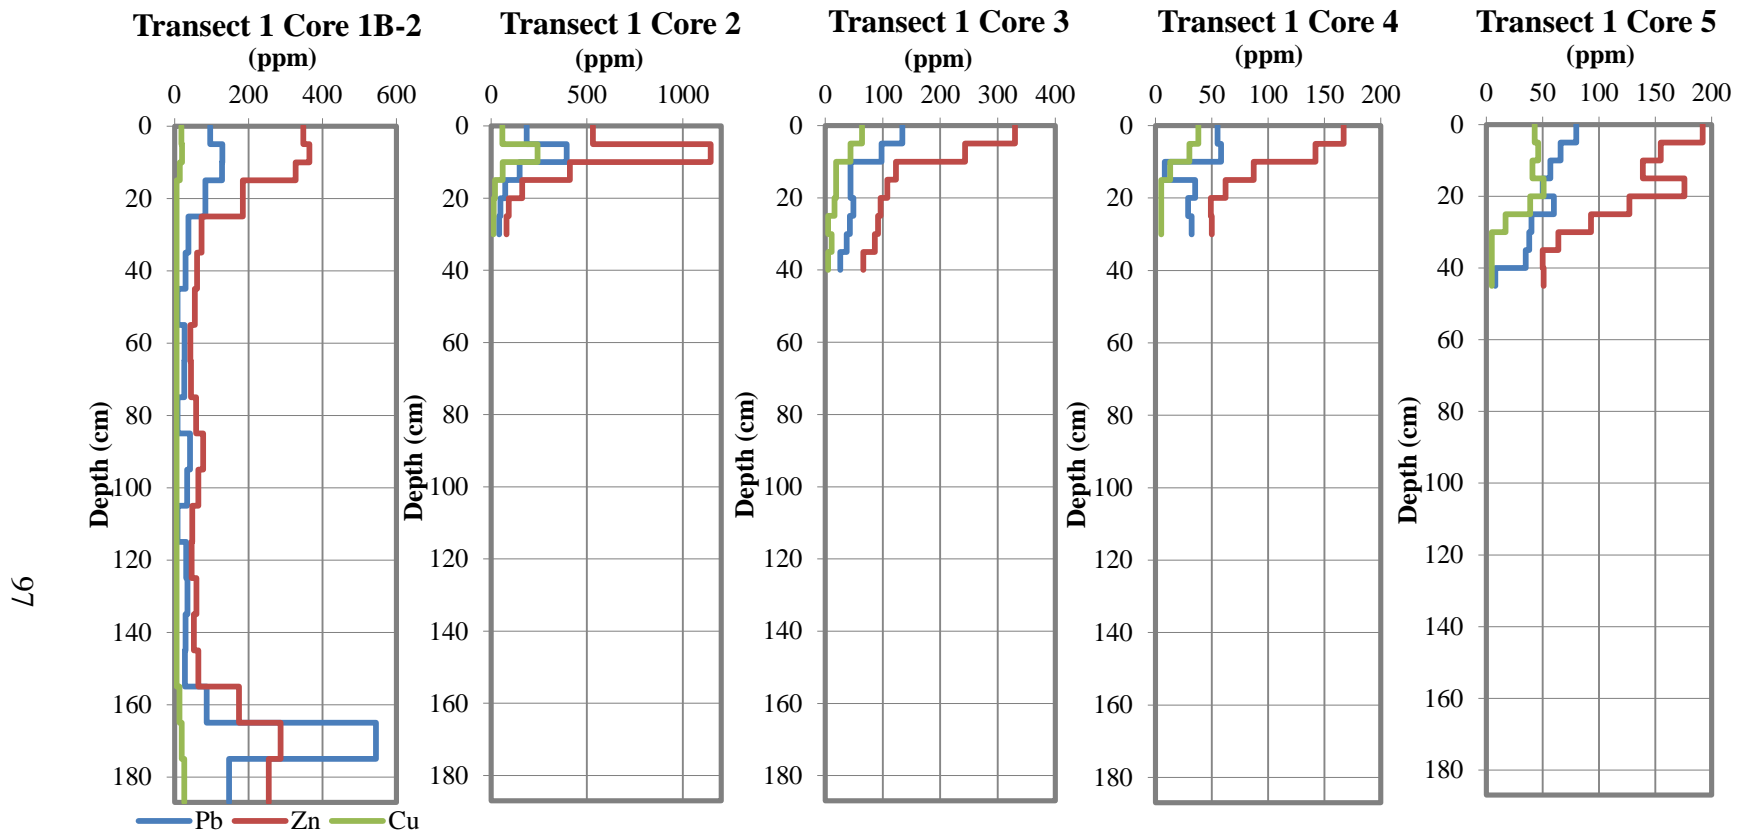
Figure 39. Pb, Zn, and Cu concentrations for cores in Transect 1.

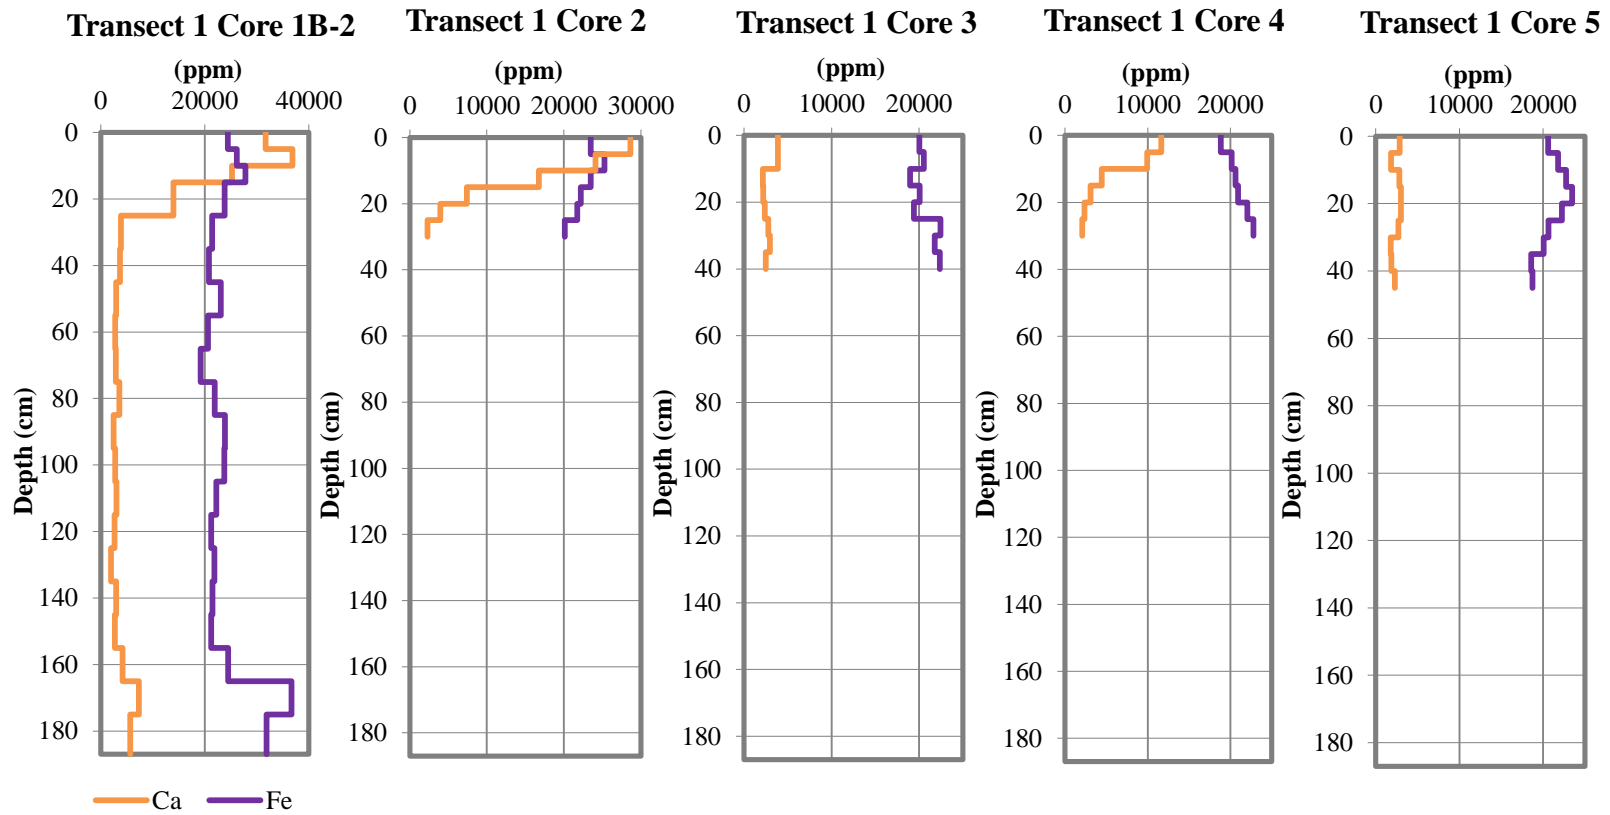
Figure 40. Ca and Fe concentrations for cores in Transect 1.

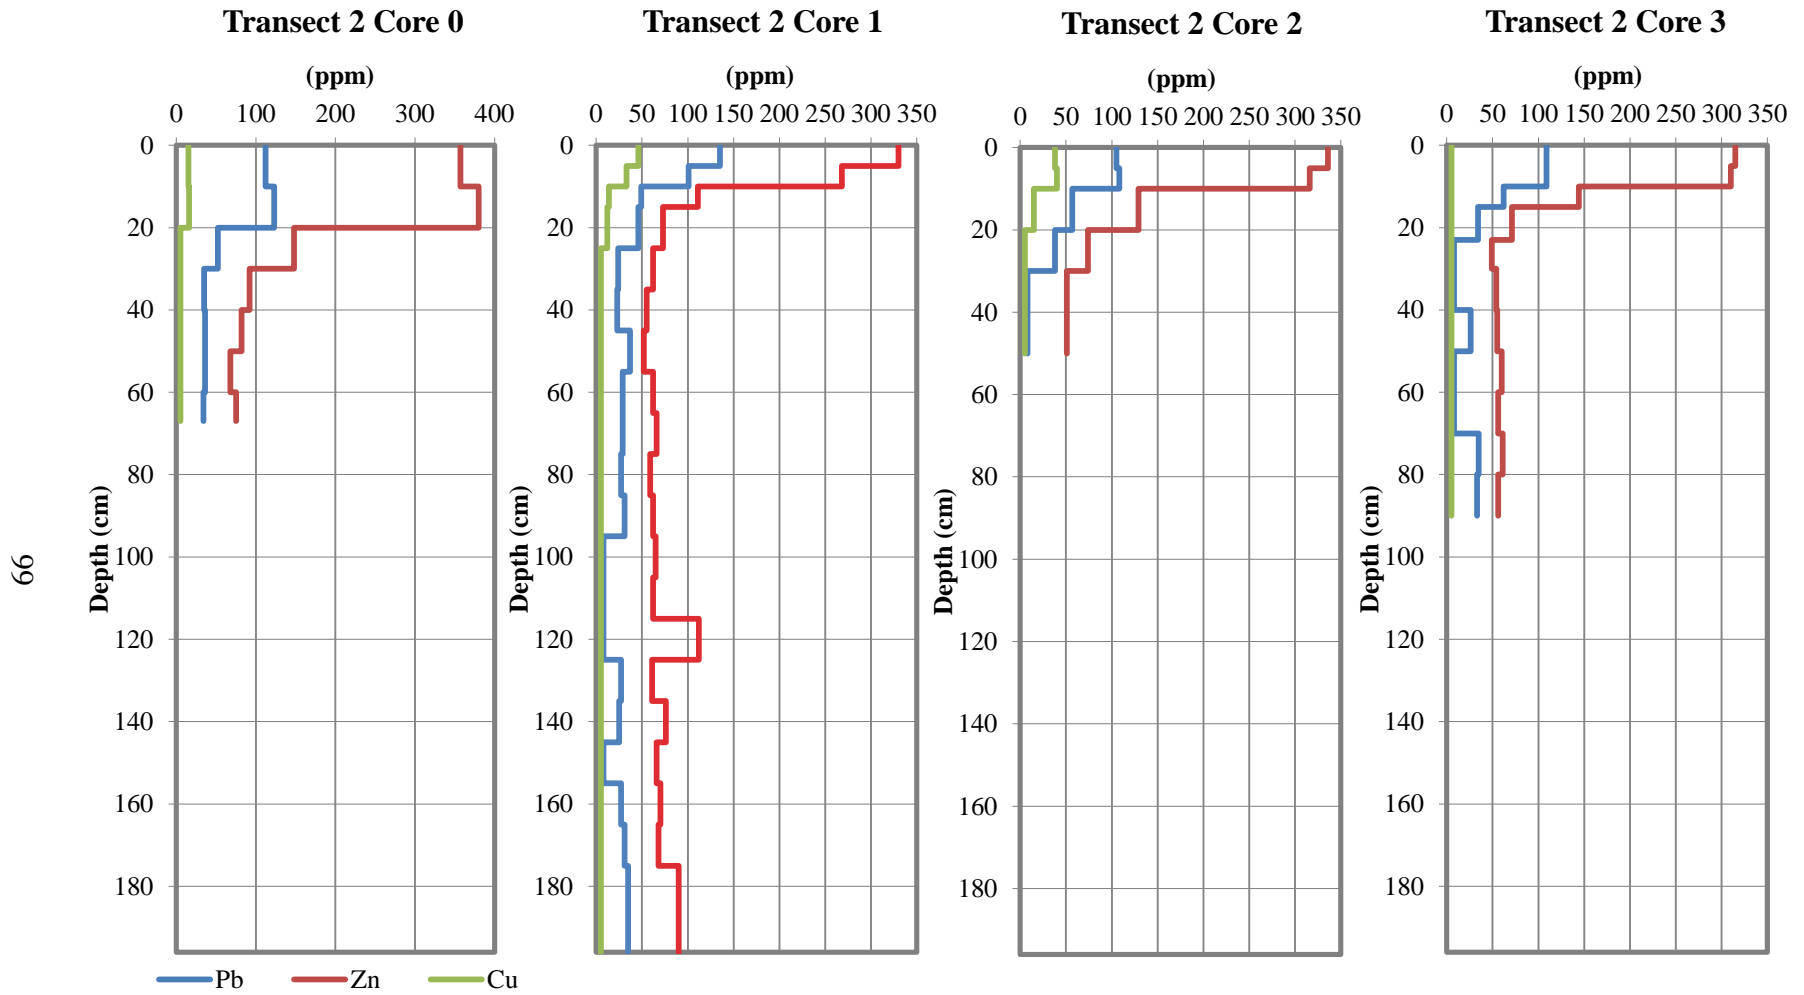
Figure 41. Pb, Zn, and Cu concentrations for cores in Transect 2.

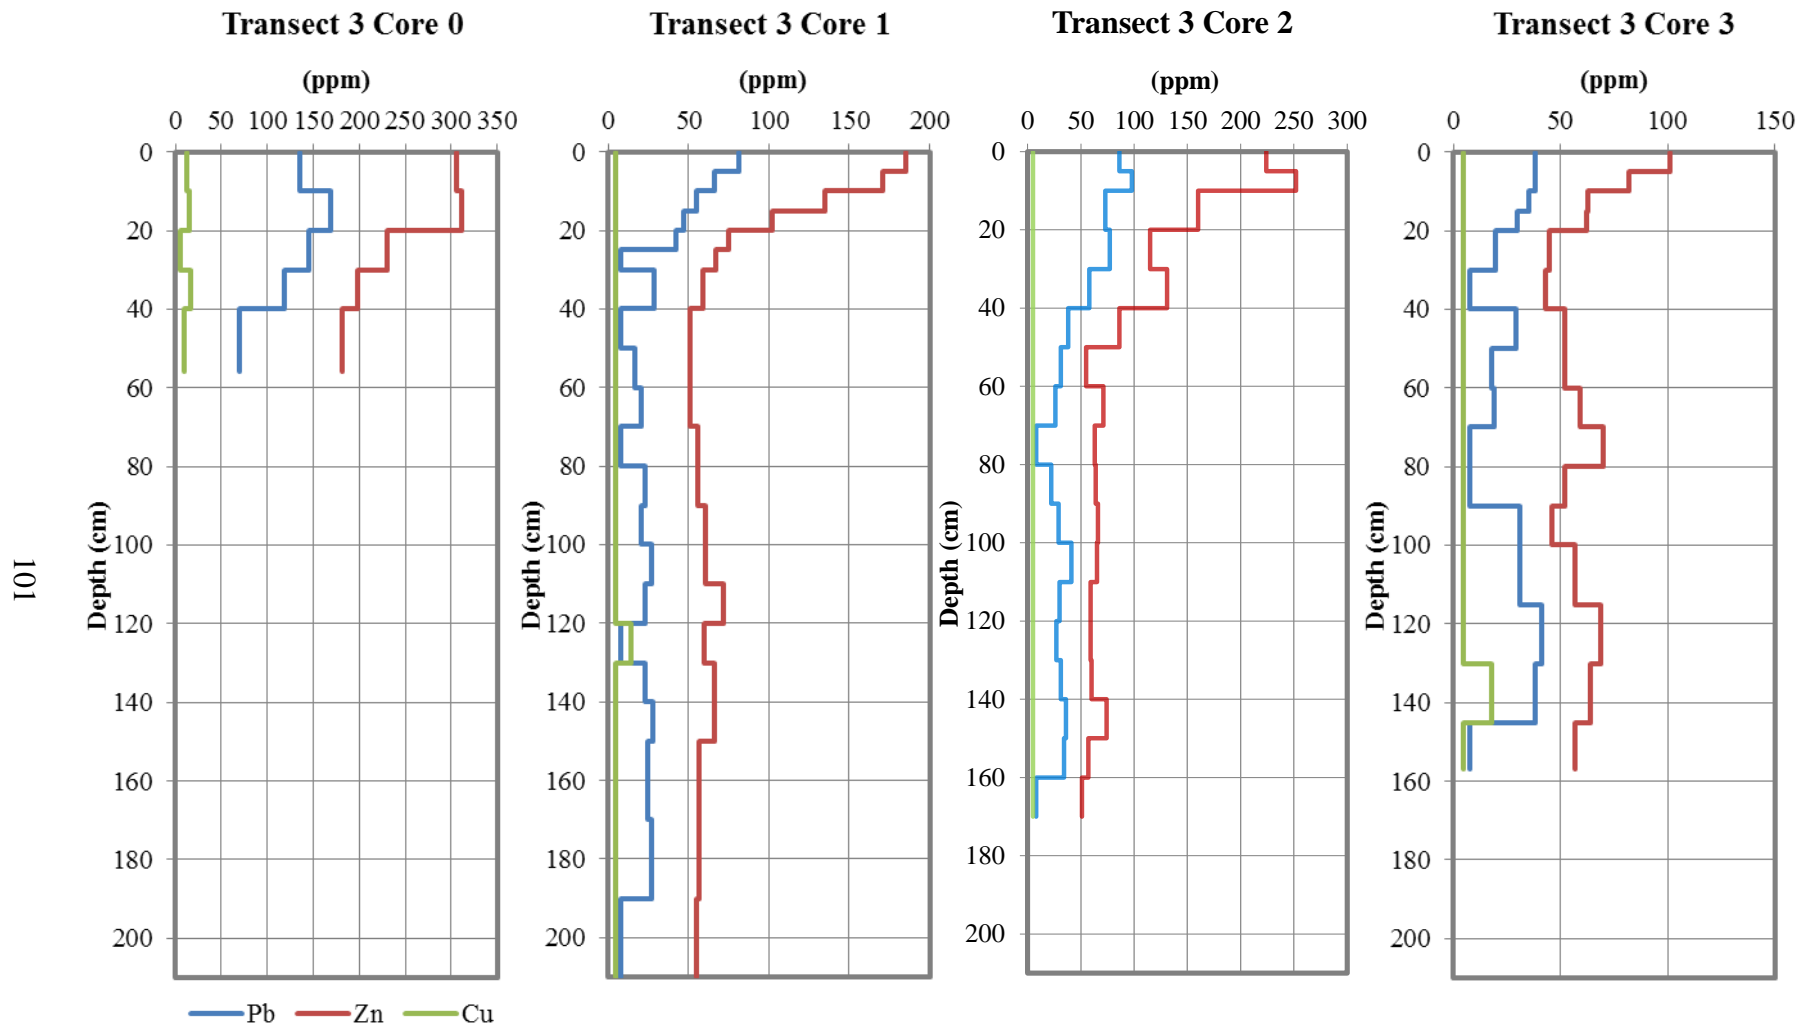
Figure 43. Pb, Zn, and Cu concentrations for cores in Transect 3.

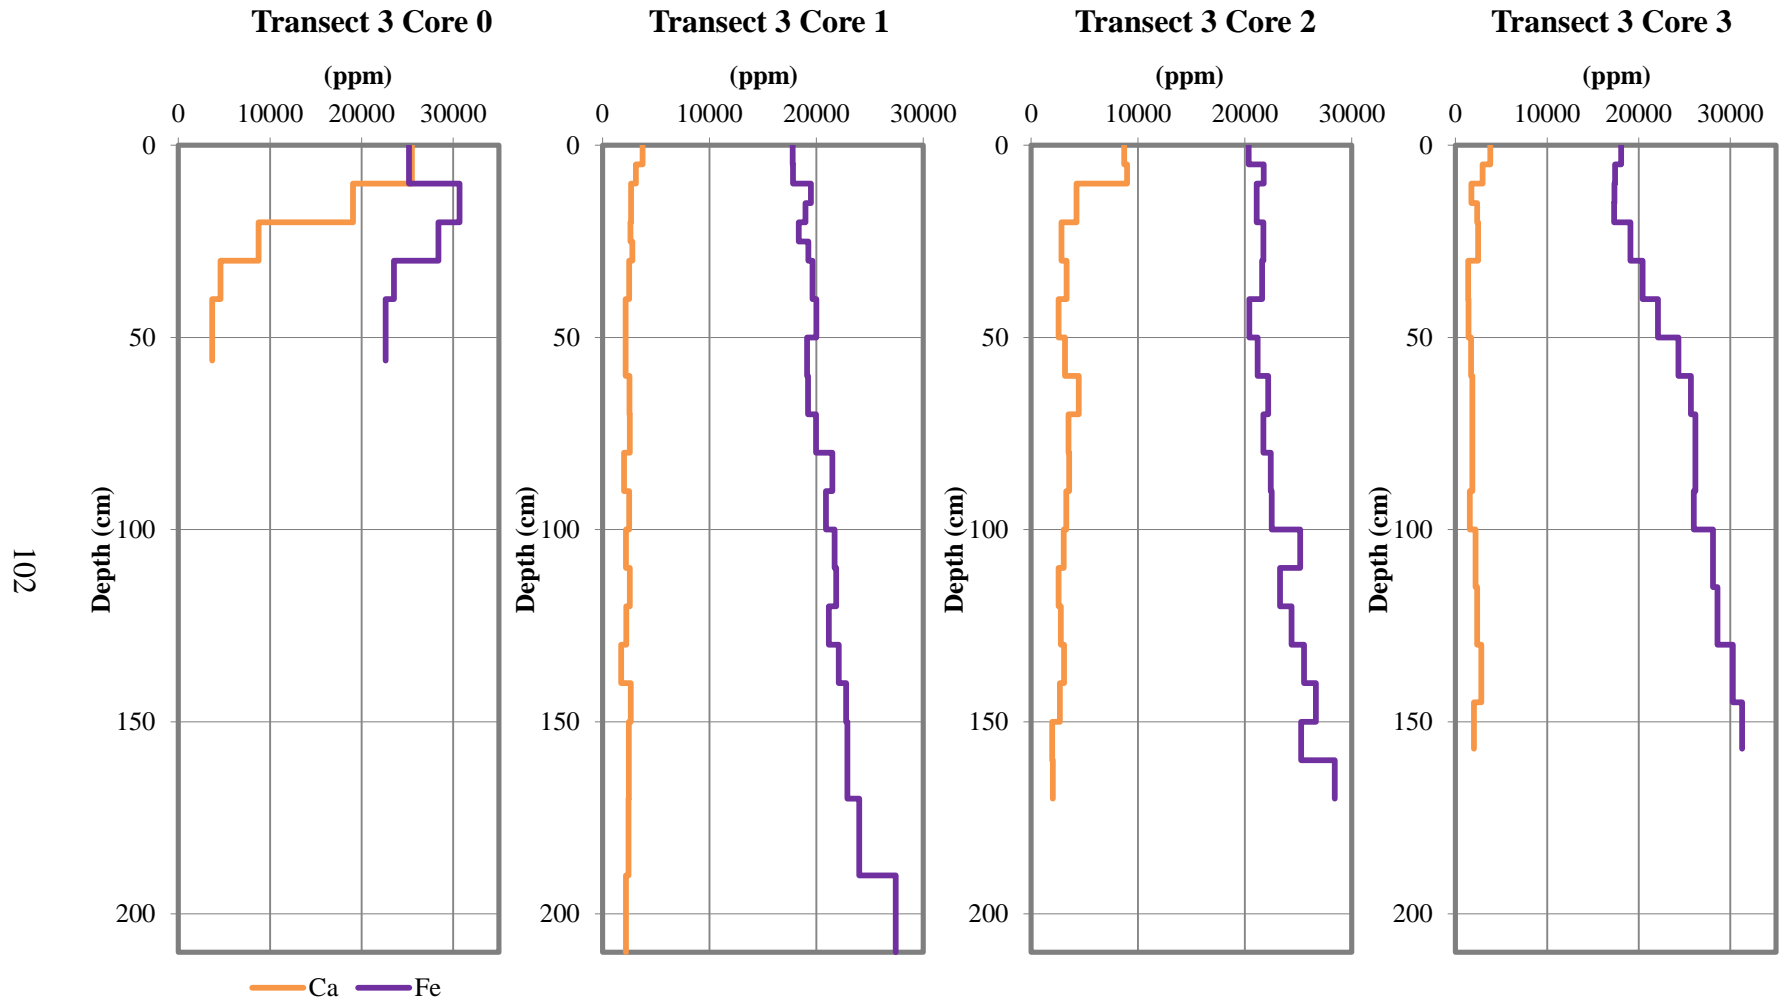
Figure 44. Ca and Fe concentrations for cores in Transect 3.
