**GEOMORPHOLOGY AND METAL CONTAMINATION OF AN URBAN
FLOODPLAIN ALONG WILSON CREEK, SPRINGFIELD, MISSOURI**

A Masters Thesis

Department of Geography, Geology, and Planning

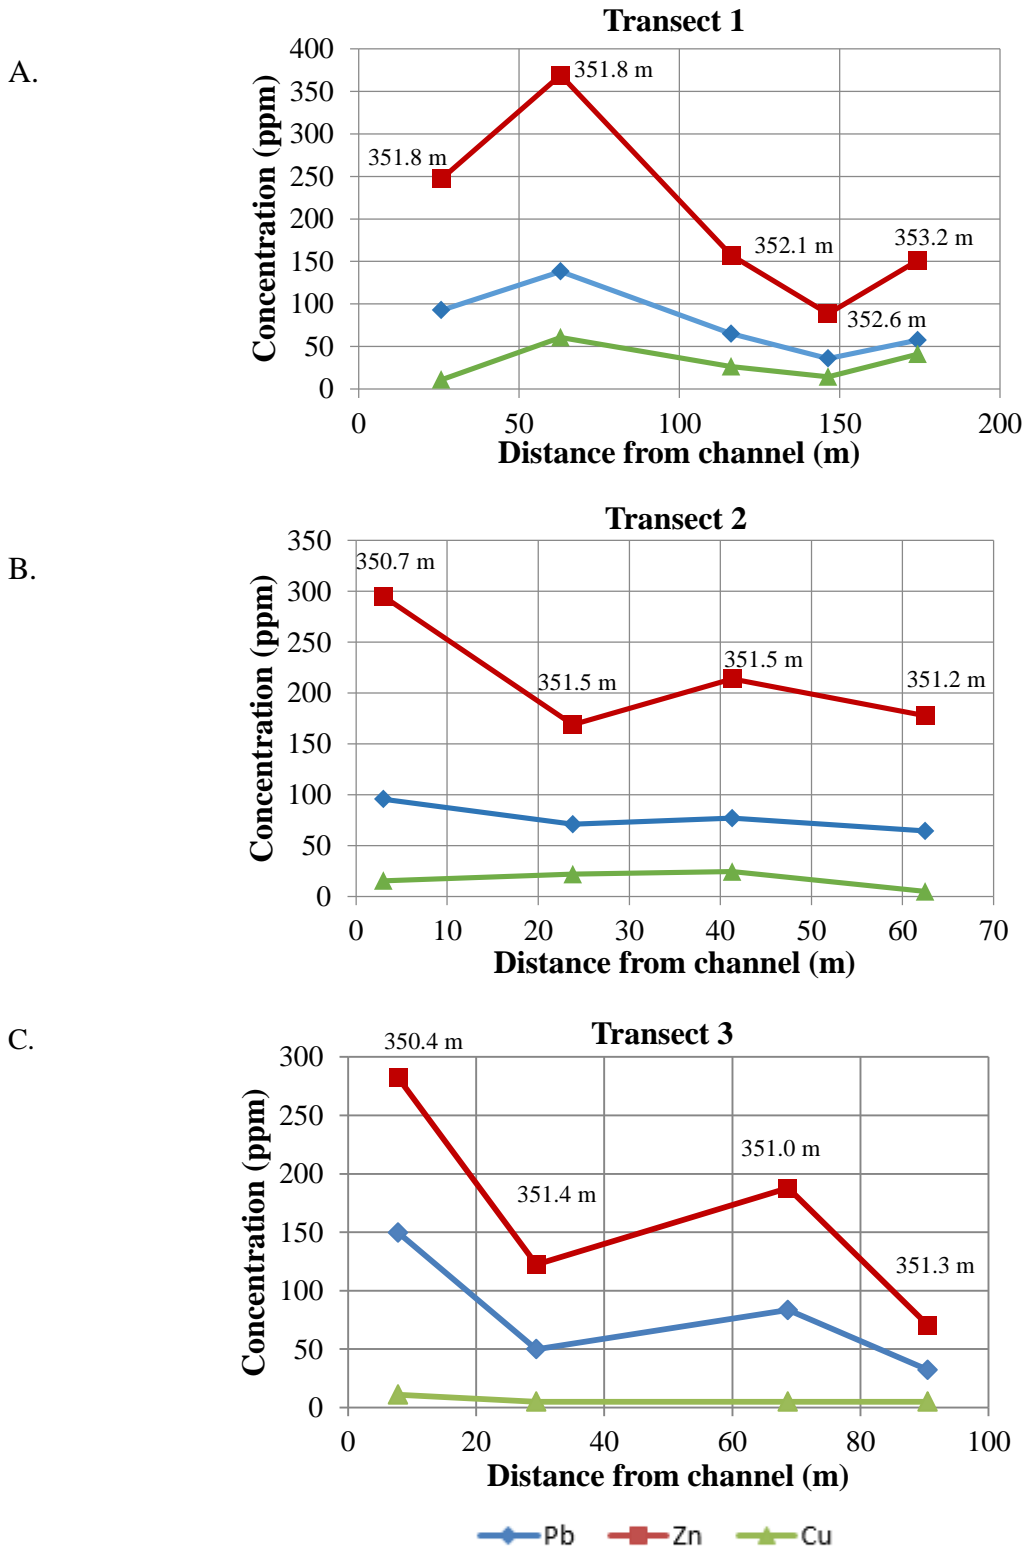
Figure 45. Average concentrations of Cu, Pb, and Zn and proximity to the channel for the top 30 cm of all Transect core samples. Elevation displayed above sample location.

Average surface concentrations within the top 30 cm of sample for each of the three elements did decrease with distance from the channel with the exception of core 5, which increased in concentration for both Pb and Zn (Figure 46). Concentrations for Pb and Zn in Transect 1 core 5 are most likely results of local runoff rather than floodwaters. Concentrations of Ca and Fe were graphed separate from Cu, Pb, and Zn as they are expected to be more naturally occurring than the anthropogenic metals, and should

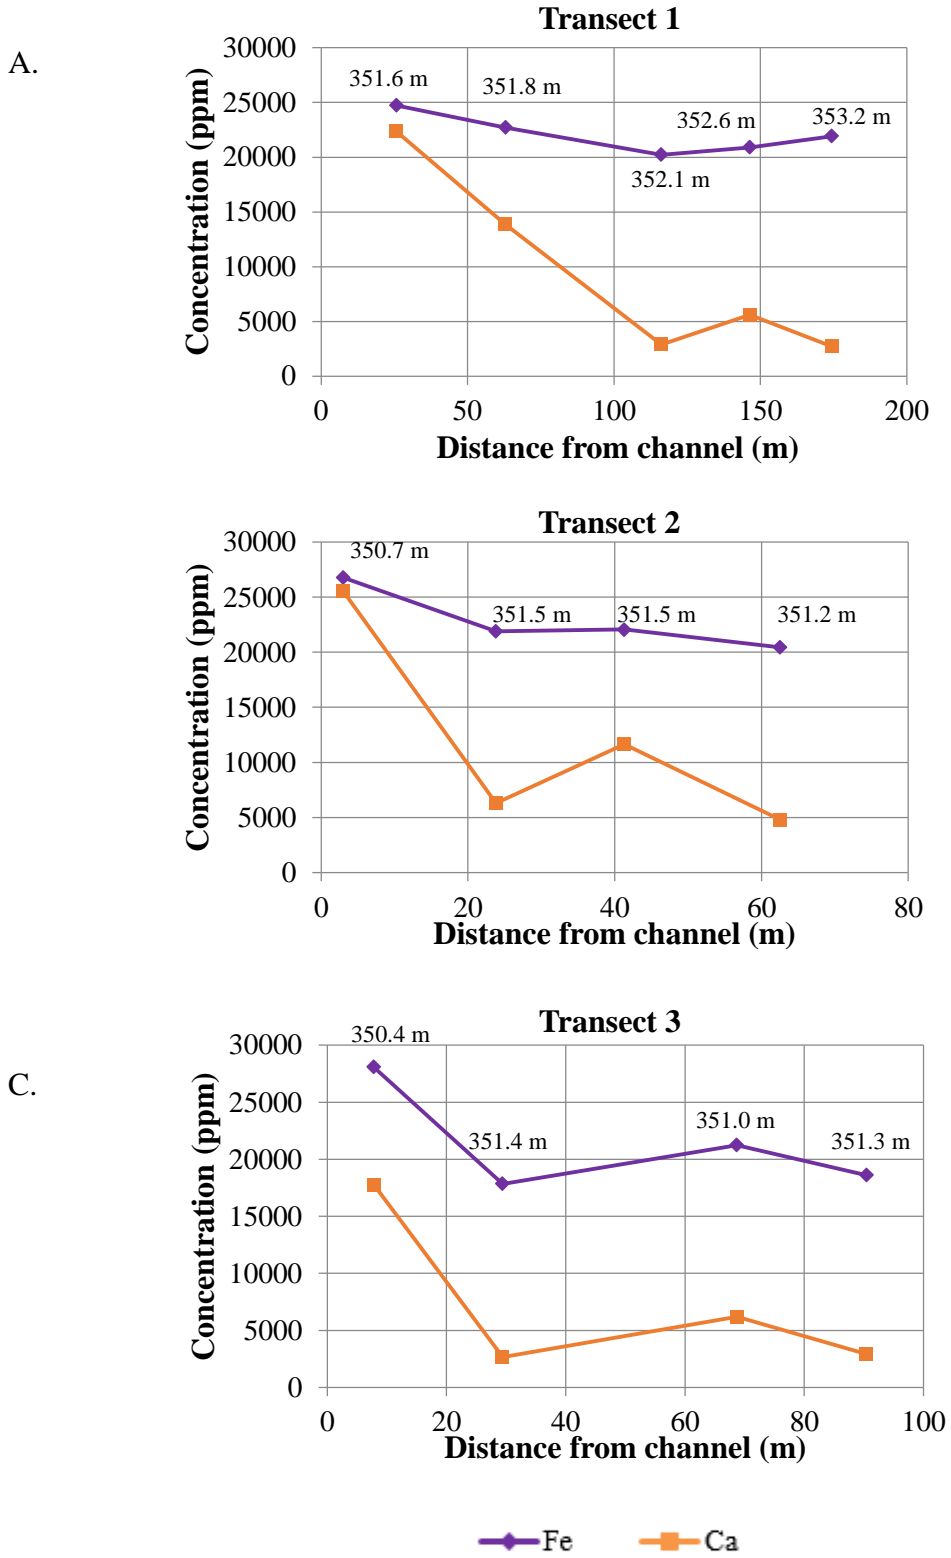
Figure 46. Average concentrations of Ca and Fe and proximity to the channel for the top 30 cm of all Transect core samples. Elevation displayed above sample location.

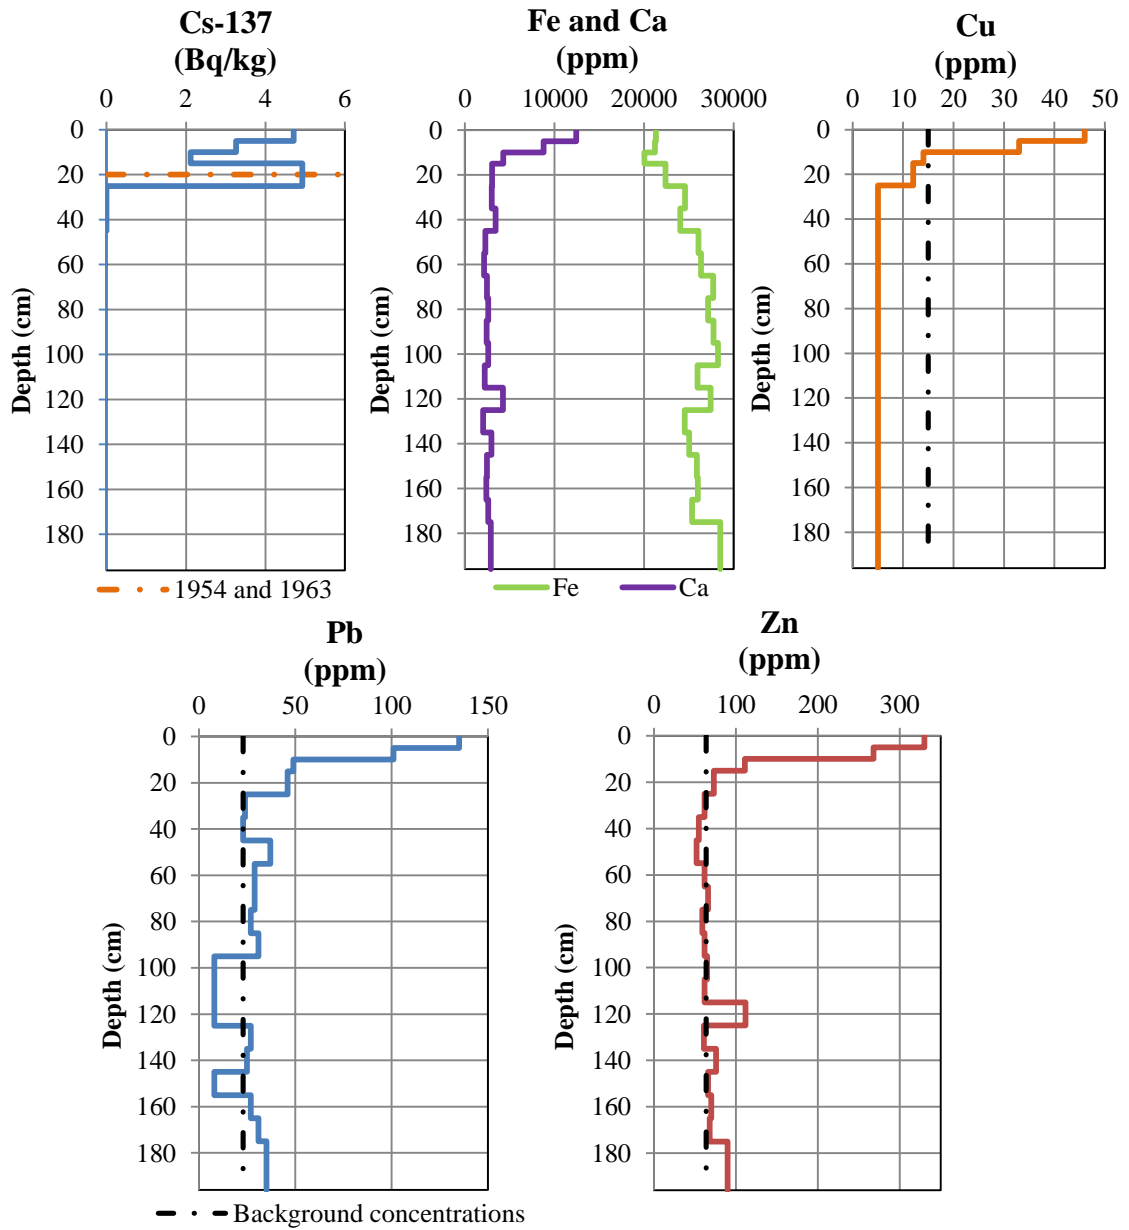
Transect 2 Core 1
 Core Location: 52.1 m
 Total Depth: 196 cm
 Elevation: 351.5 m
 Sample Date: 2/12/13

Figure 50. Fe, Ca, Cu, Pb, and Zinc concentrations with select background levels. Source of background levels: Rogers (2005) and Shade (2003).

levels of Cu, Pb, and Zn were acquired from previous studies in the watershed (Rodger, 2003; Shade, 2005). The background concentration for Cu is 15 ppm, for Pb is 23 ppm, and for Zn is 64 ppm (Rodger, 2003; Shade, 2005). Core 1B-2 from Transect 1 also has high levels of Pb and Zn from 155-187 cm. Levels of Pb at the bottom 20 cm of core 1B-2 are 15-20 times greater than the Pb levels at the last 20 cm of the other two cores. These increased concentrations at depth could indicate contamination from the industrial era of downtown Springfield, MO, or a possible encounter with mineralization.
