Beach Form, Change, and Mangrove Interactions Along Galleon Fish Sanctuary, South Coast Jamaica

A Masters Thesis

Of the Requirements for the Degree
Master of Science, Geospatial Sciences

May 2017

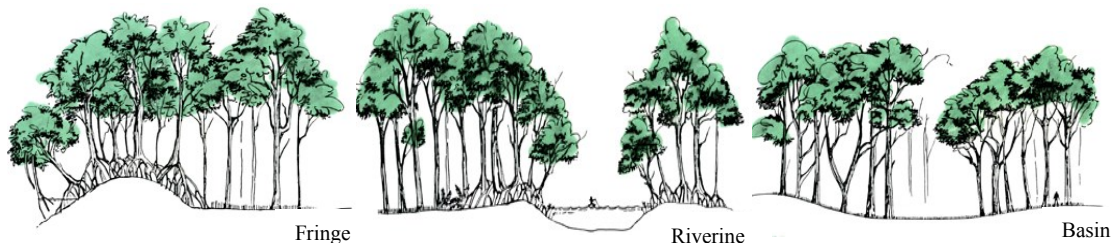
Figure 5: Diagrams of the three main types of mangrove forests, fringe mangrove forests, basin mangrove forests, and riverine mangrove forests (Modified from Hensel et al., 2014).

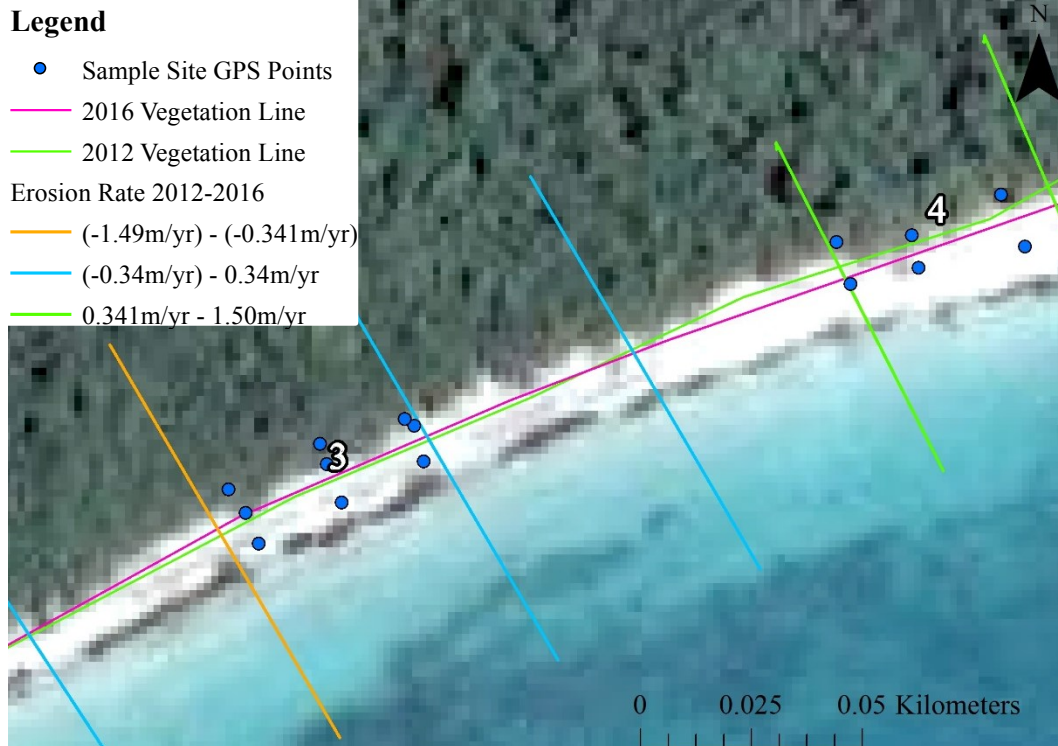
Figure 12: Method used to determine the updated erosion rates for Galleon Fish Sanctuary. The vegetation line for 2012 and 2016 was digitized and the distance between the lines was measured. The base map is from 2016 (Google Earth Pro, 2016).

Recent erosion rates were determined for the years 2012 to 2016. The base map used was the March 2012 satellite image from Zelzer, which has a 0.5 m resolution (2015). A satellite image from Google Earth Pro from March 15, 2016 georectified in ArcMap to the 2012 image (Appendix A). This 2016 image has a 1.6 m resolution. The georectification was done at a 1:500 m scale with 9 control points and a 2nd order polynomial transformation (Hughes et al., 2006). The root mean square error of the georectification was 1.04 m. The vegetation line was then digitized for both years, and the distance between the two vegetation lines was calculated at 50 m transect intervals along the transects (Figure 12) (Murali et al., 2015). The transects used for this study are the same transects used for the Zelzer (2015) study so recent erosion rates could be compared to the historical erosion rates. The vegetation line was used for both the Zelzer study and this study because the water line can be difficult to determine in the satellite imagery and is variable due to tides and storms (Hanslow, 2007). The distance of the vegetation line change was divided by 4 because the satellite images were from March 2012 and March 2016. Negative values indicate erosion, or the vegetation line moving inland, and positive values indicated accretion, or the vegetation line moving seaward.

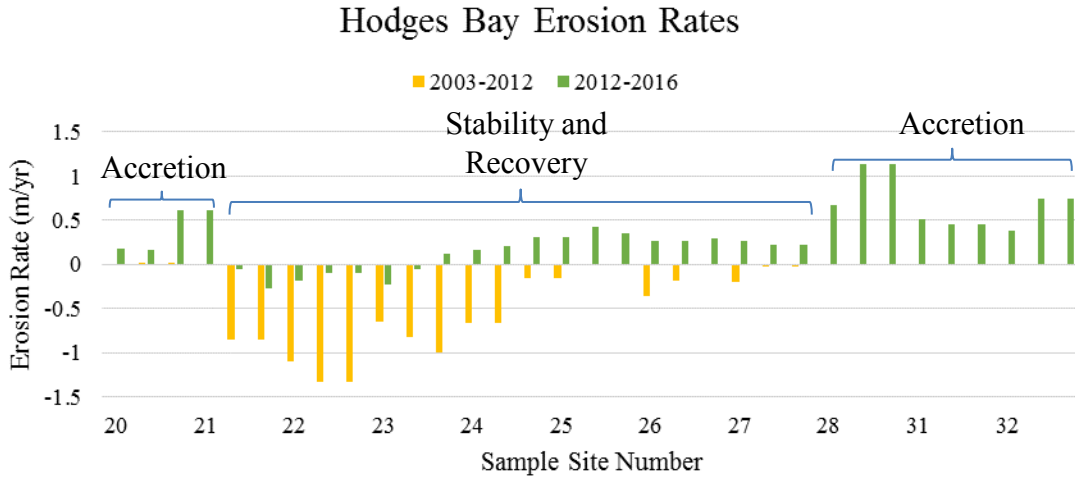
Figure 16: Comparison of beach change rate between the Zelzer (2015) erosion rates and the Geier erosion rates for Hodges Bay. Positive erosion rate indicates accretion. The error is ± 0.34 m/yr.

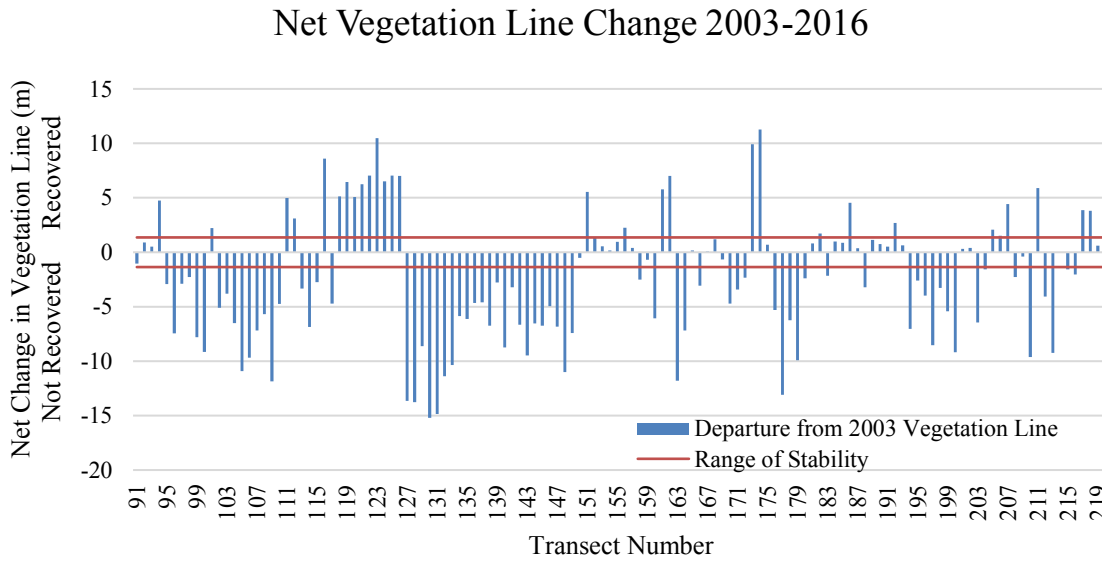
Figure 17: The net vegetation line change from 2003-2016 showing the number of beach transect that have recovered to their 2003 position and those that have not. The error is ± 1.36 m.

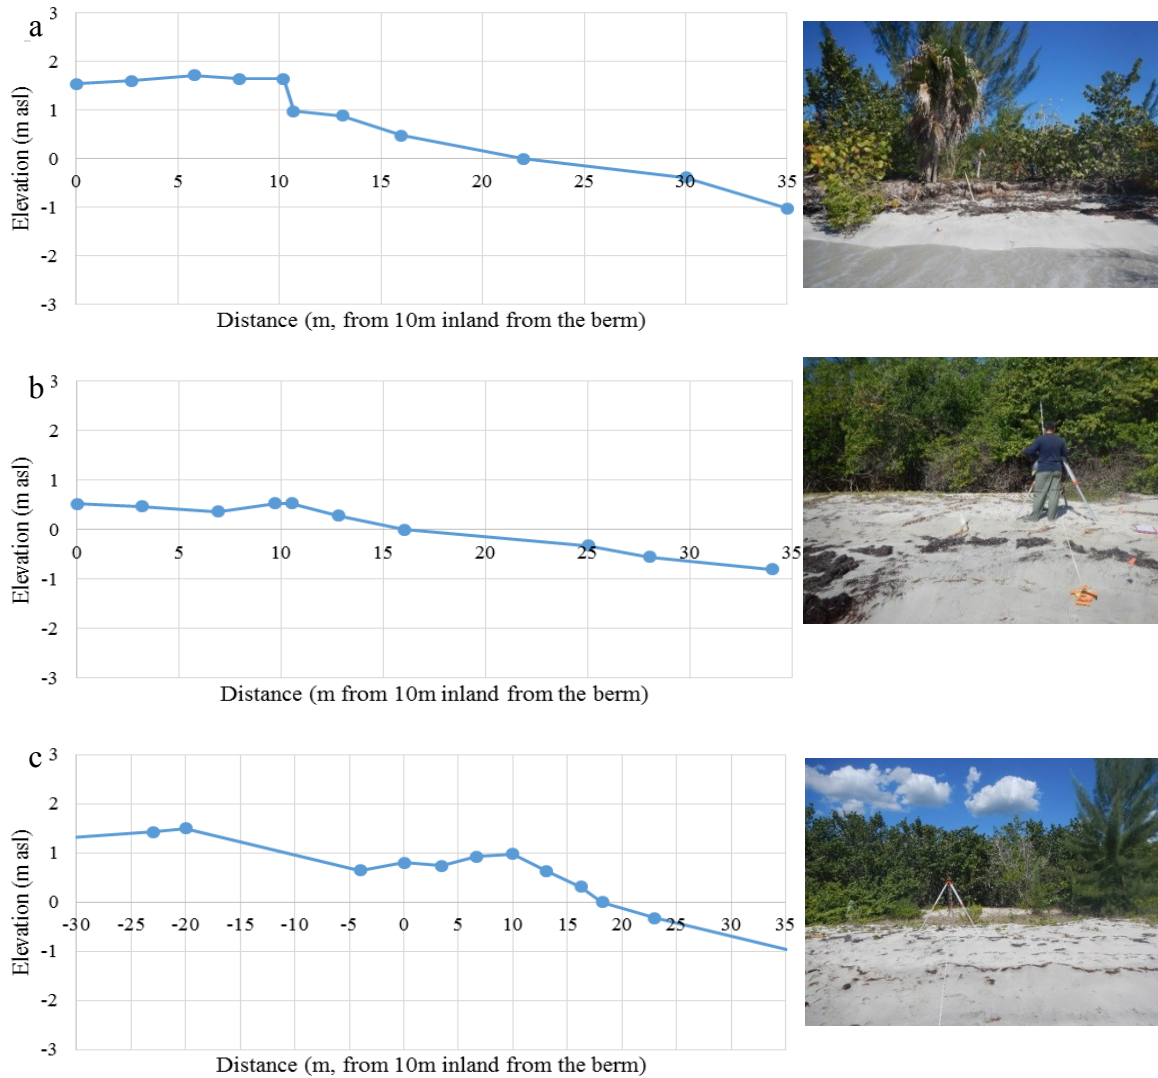
Figure 20: a) Site 16 T-1, an example of an erosional beach with a beach scarp. The erosion rate at this site was -0.38 m/yr. b) Site 27 T-2, an example of a stable beach with a distinct berm and a narrow shoreface. The beach change rate was $+0.06$ m/yr. c) Site 9 T-3, an example of an accretionary beach with a beach ridge. The accretion rate at this site was $+1.29$ m/yr.

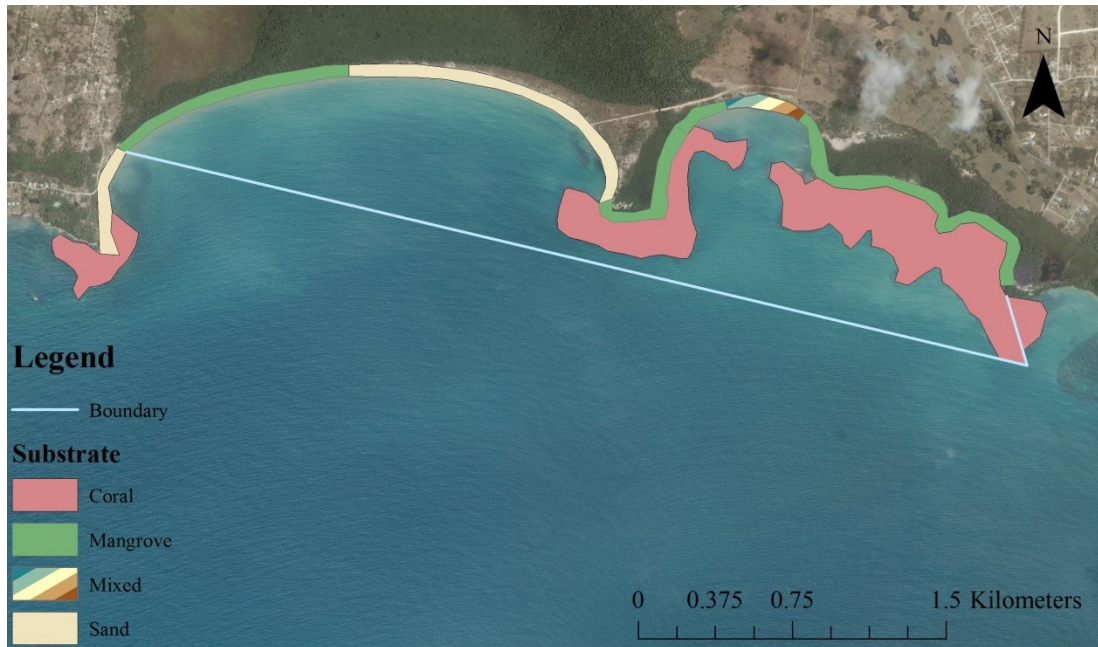
Figure 21: Map of beach type in the Galleon Fish Sanctuary based on field observations. The substrate is based on what was present 10 m landward from the berm. Mixed substrate had alternating sample sites of sand and mangrove.

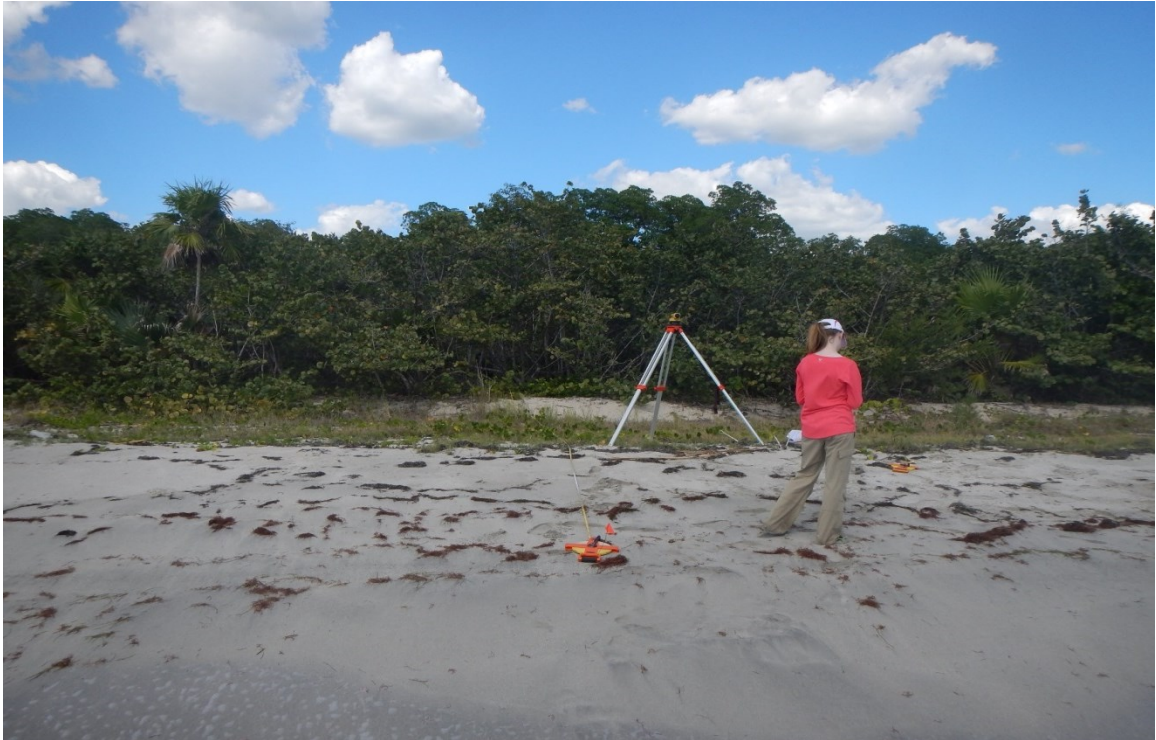
Survey set up with auto level on berm crest, tape pinned with 10 m at berm crest.

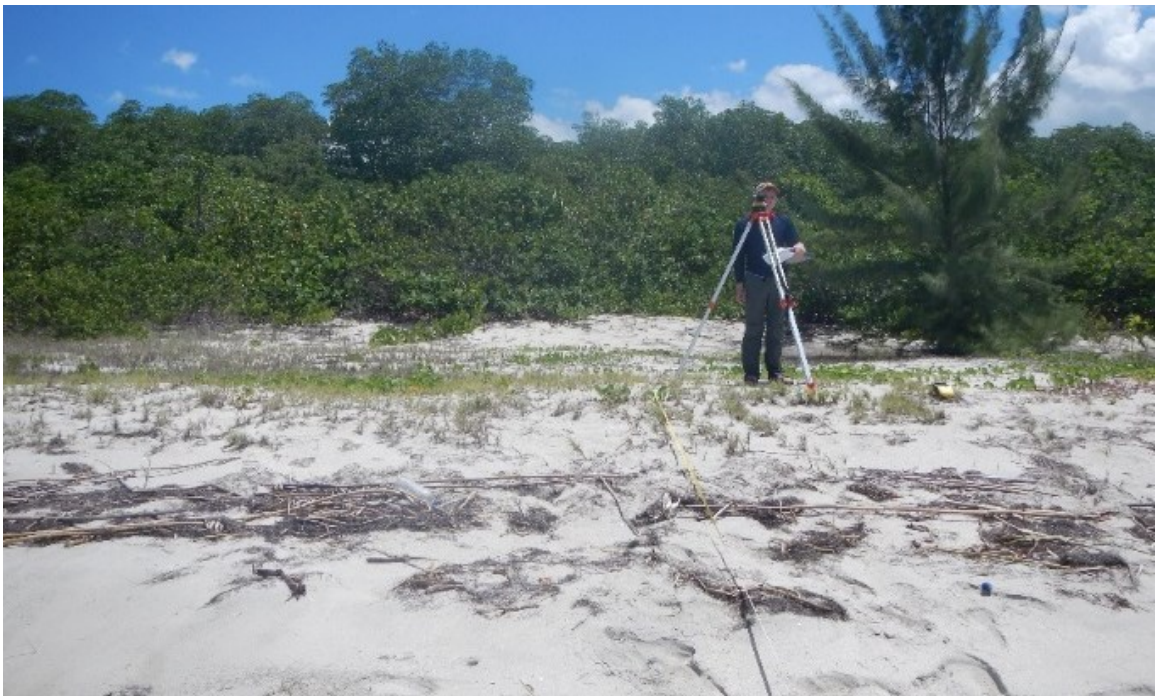
Example of an accretionary beach with a beach ridge.

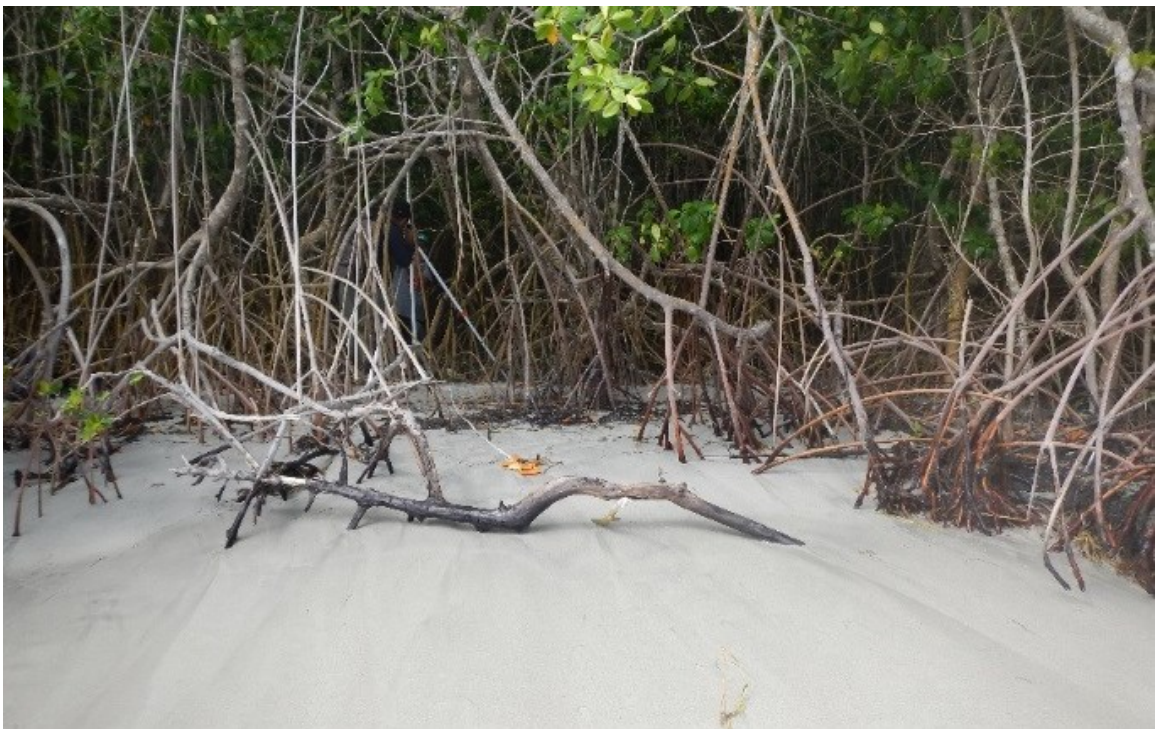
The berm has migrated into the mangrove forest, but there is still beach in front of it.

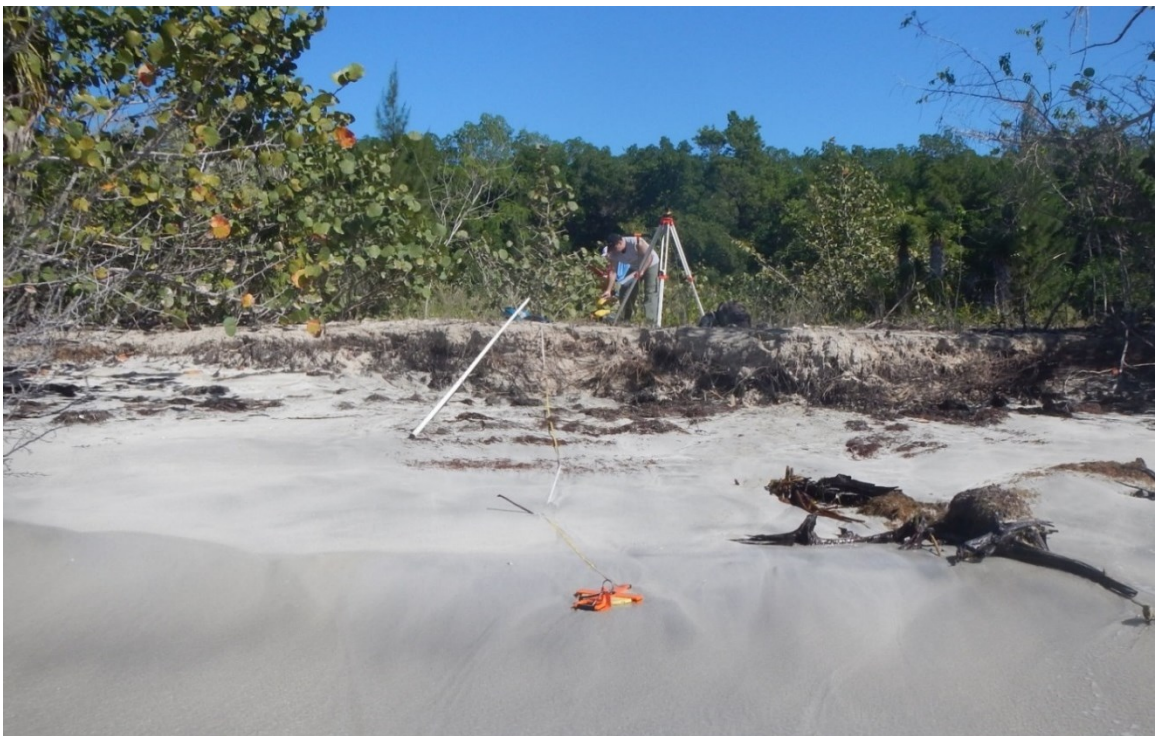
Site 16, Transect 1: An example of an eroding beach with an active scarp.

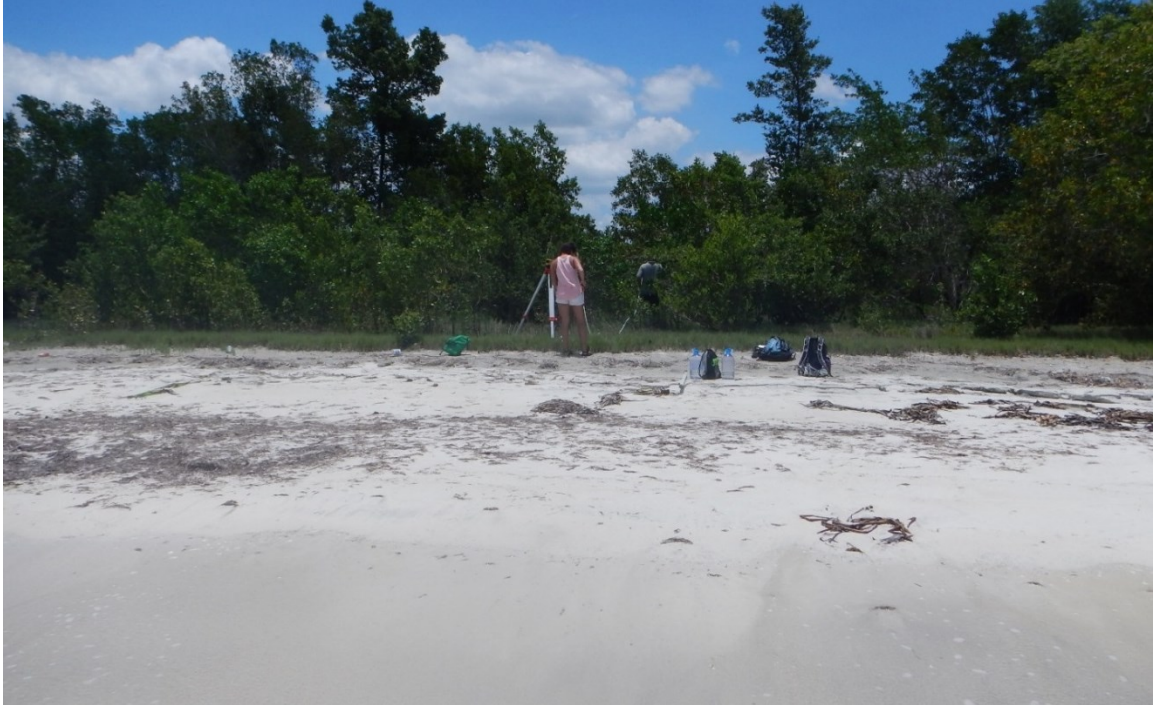
Site 6, Transect 2: Example of a stable beach.

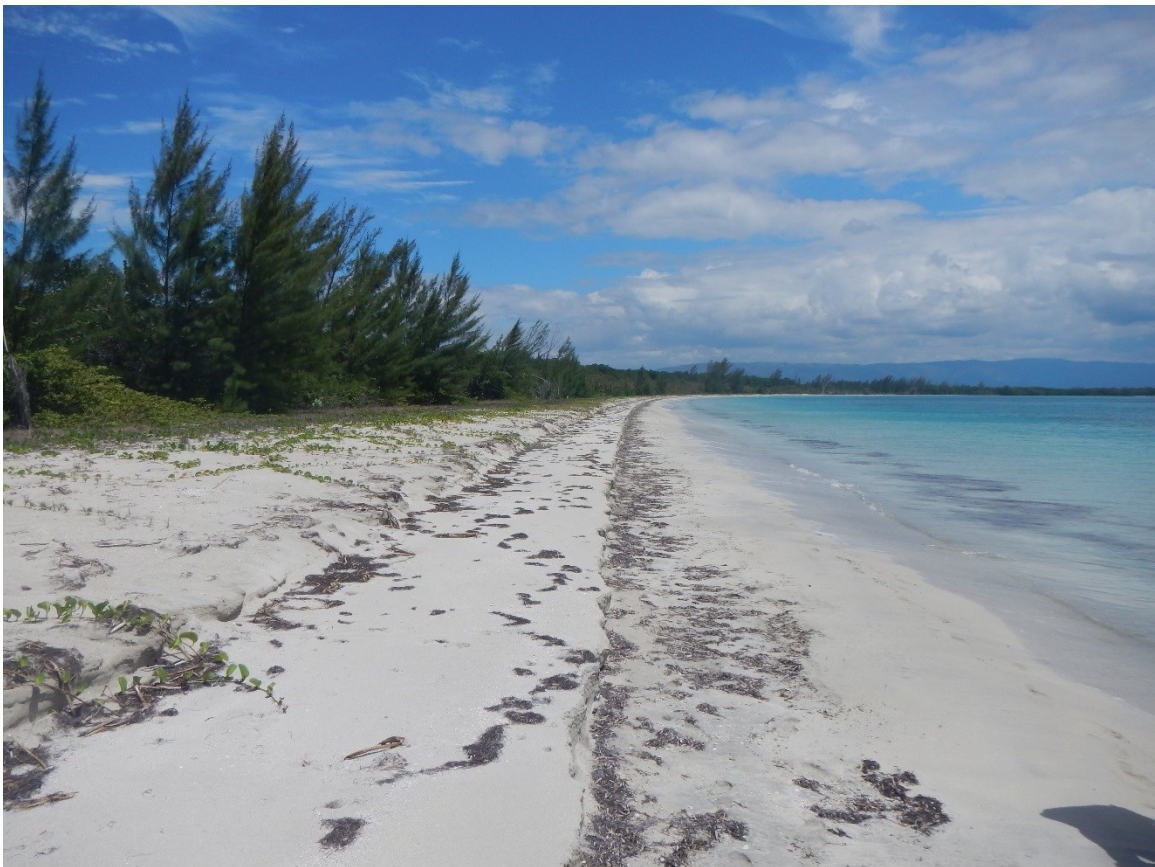
Example of an accretionary beach building out from present berm.
