Using Survey Data and HEC-RAS Modeling to Assess a Riffle-Remediation Structure on the Big River, Bonne Terre, Missouri

A Masters Thesis

Master of Science, Geospatial Sciences in Geography, Geology, and Planning

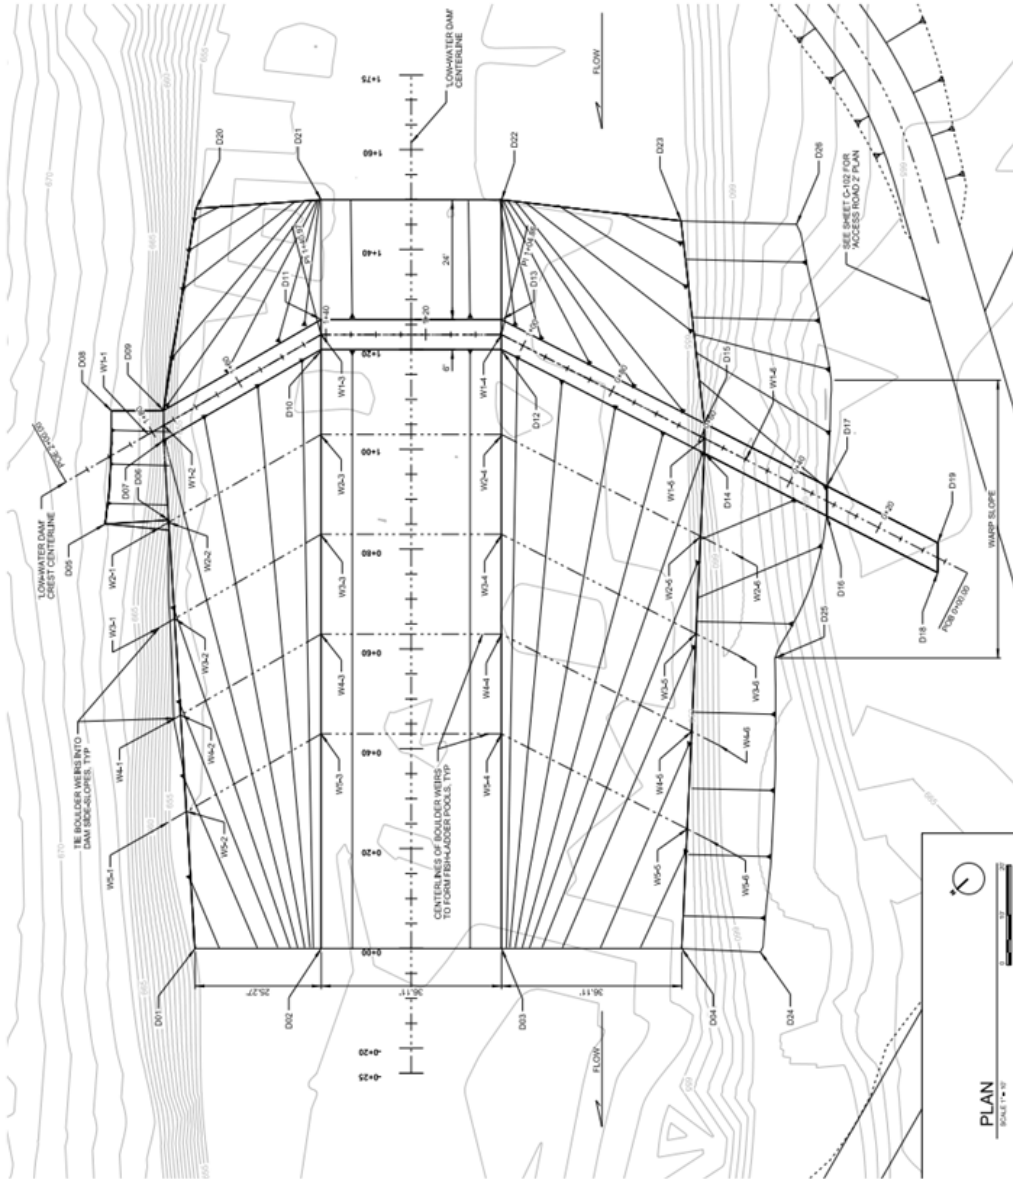
Figure 1 – Riffle structure engineering plans (plan view) (OEWR database).

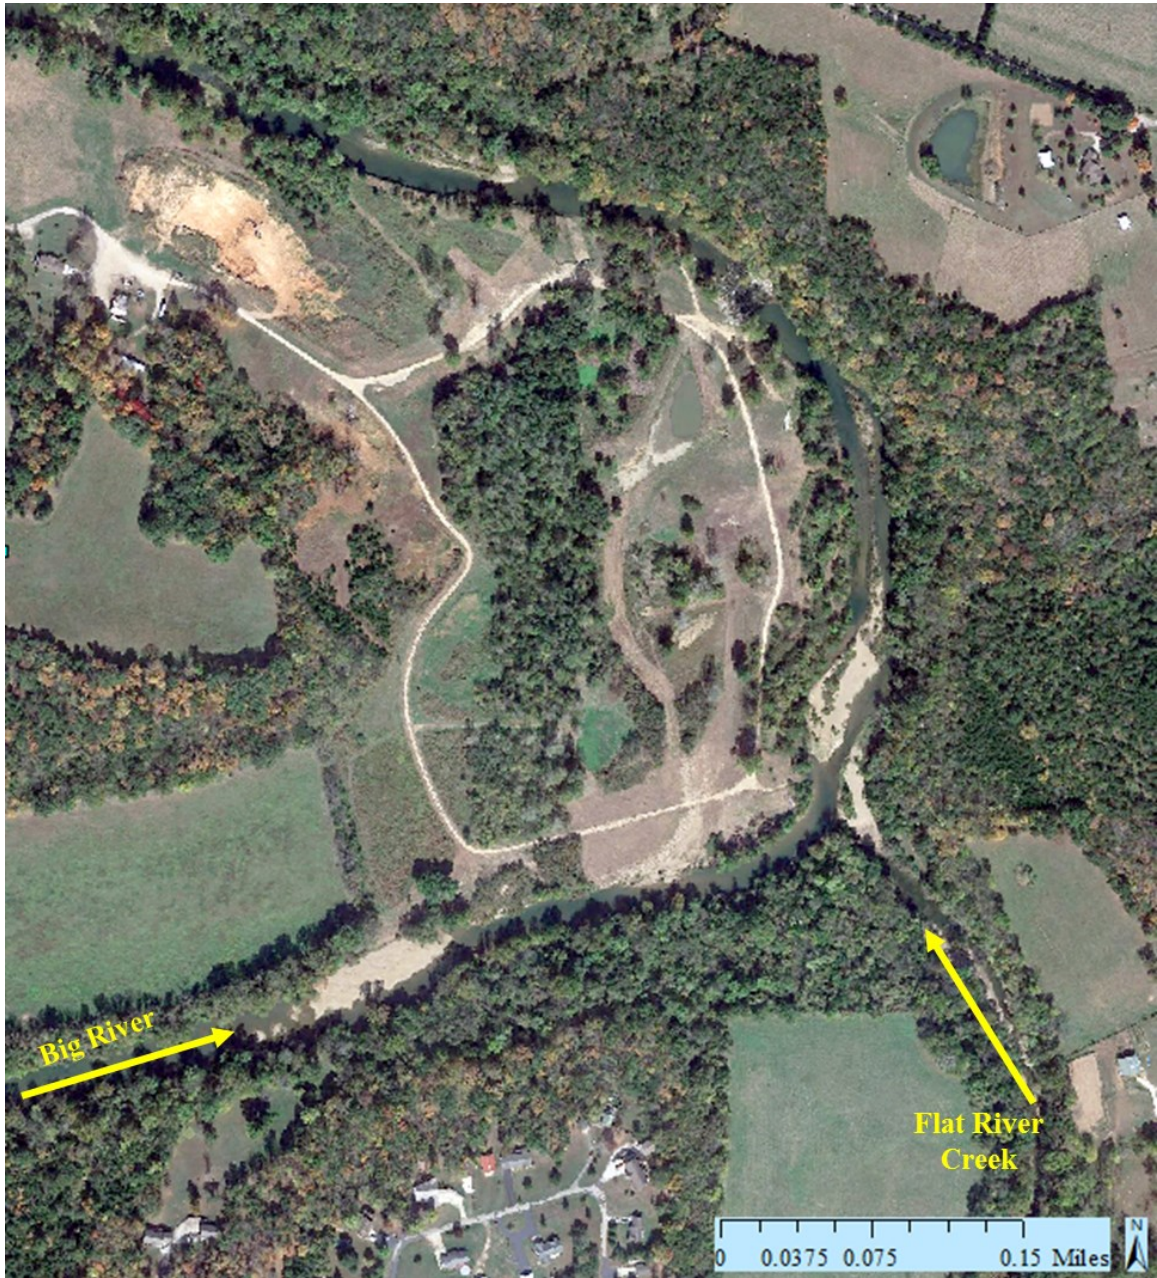
Figure 4 – Aerial image of the study area showing the Big River – Flat River Creek confluence (Modified from OEWR database).

The headwaters of the Big River are located in the St. Francois Mountains, allowing the river to drain approximately 970 square miles (sq. mi.) (Owen et al., 2012). Within the study area, the Big River also has a tributary flowing into it, Flat River Creek. Flat River Creek is located upstream of both the constructed and natural riffles (Figure 4). The drainage area of the study area is approximately 260 sq. mi.

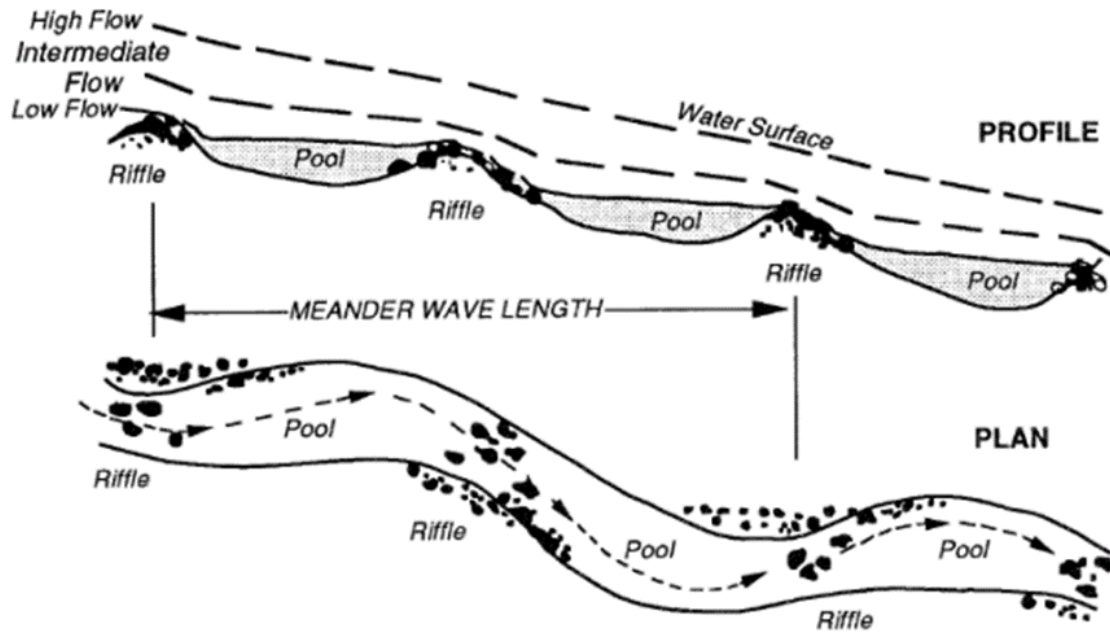
Figure 7 - Profile and plan depictions of a riffle-pool sequence (Newbury and Gaboury, 1993; Radspinner, 2009).

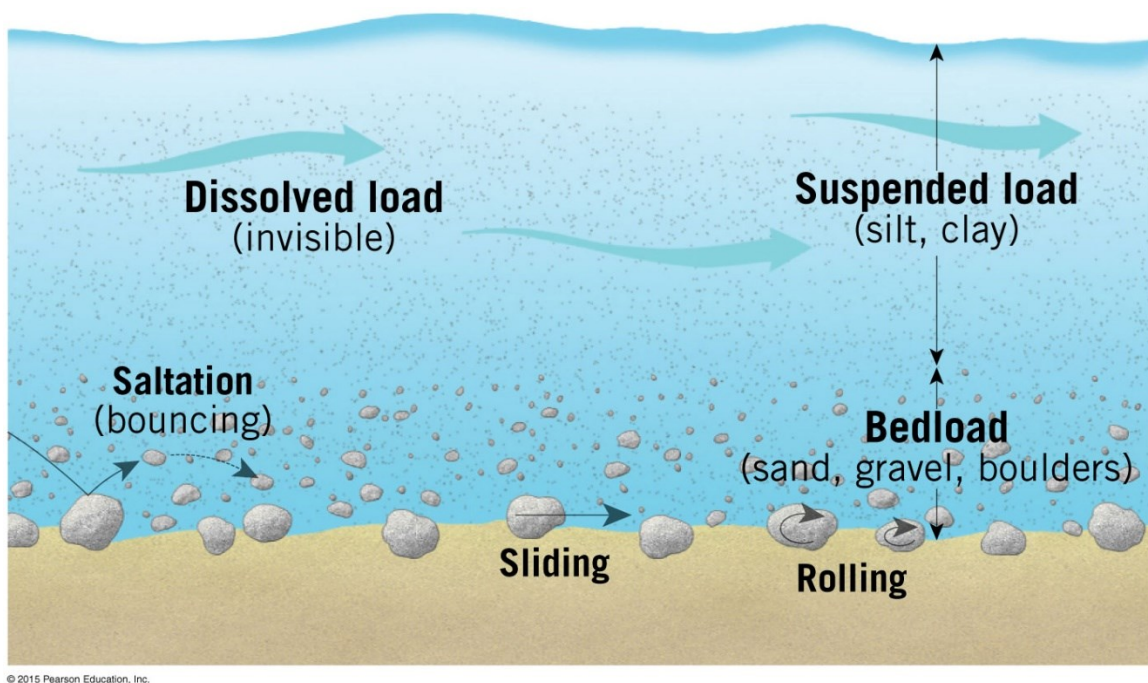
Figure 8 – Methods of sediment transport within a channel (Lutgens and Tarbuck, 2015).

sliding, saltation (leaping), and suspension of particles (Figure 8). Sediment transport within a channel is largely dependent on sediment-water interactions. One property dictating sediment transport within a channel is the size of particles being transported (Hassanzadeh, 2012). Large material, such as cobble to boulder size, require more energy to move. Particle size is typically broken down into categories: clay, silt, sand, gravel, cobble, and boulder.

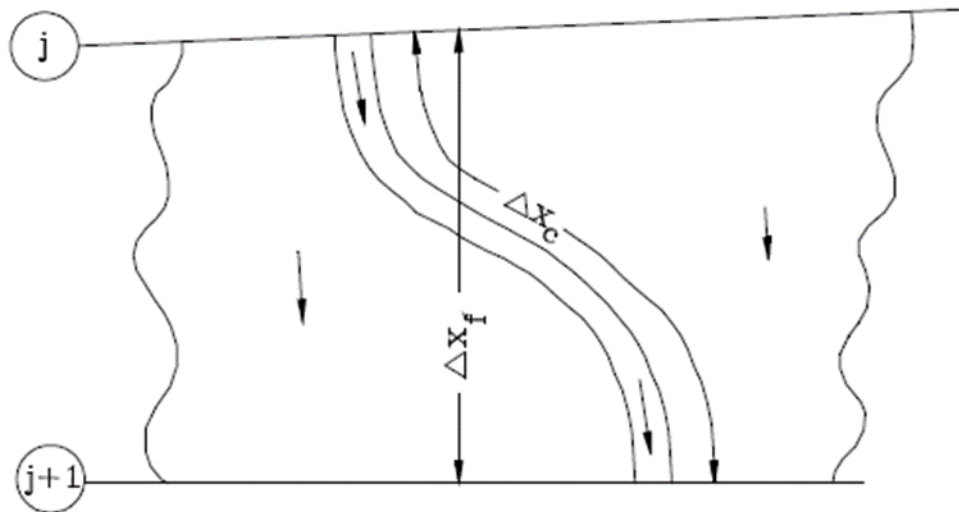
Figure 9 – Relationship between channel and floodplain flows within a 2-D model (Brunner, 2016A).

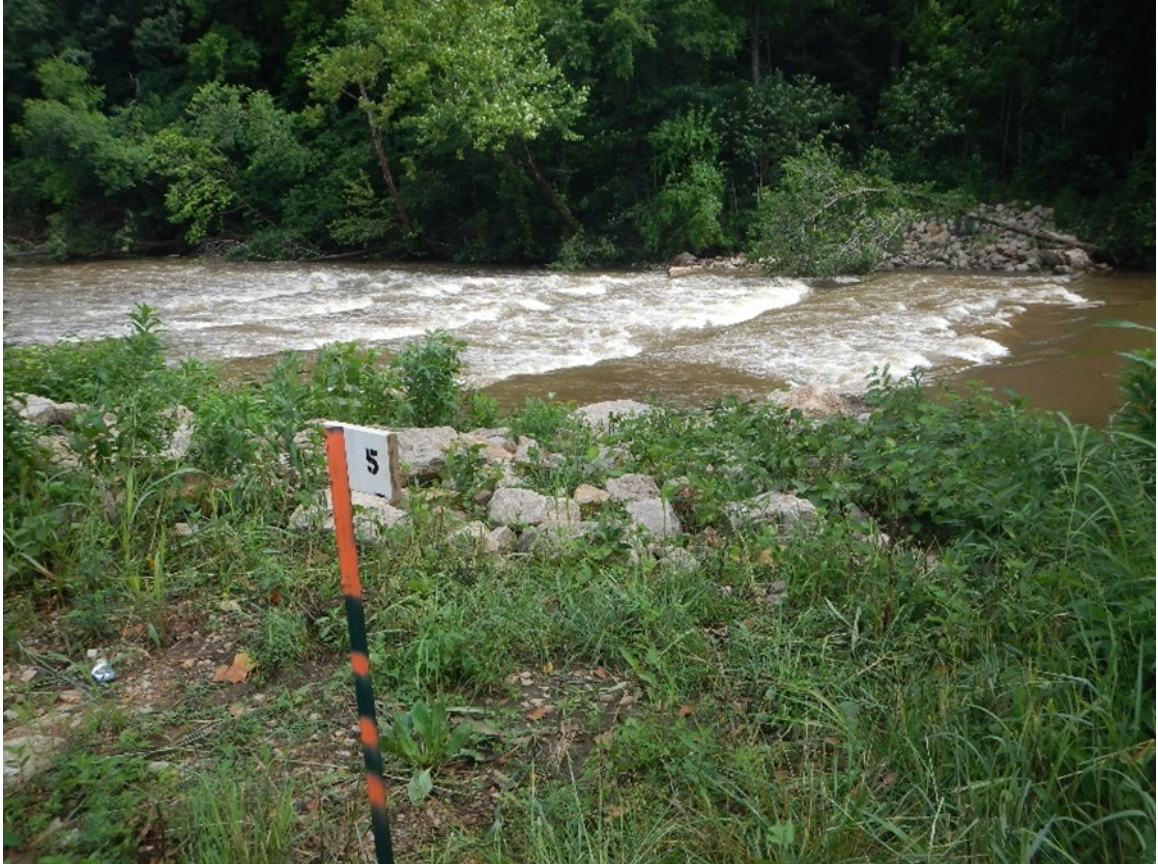
Figure 10 - An example of the posts and numbered signs used to set up survey transects.

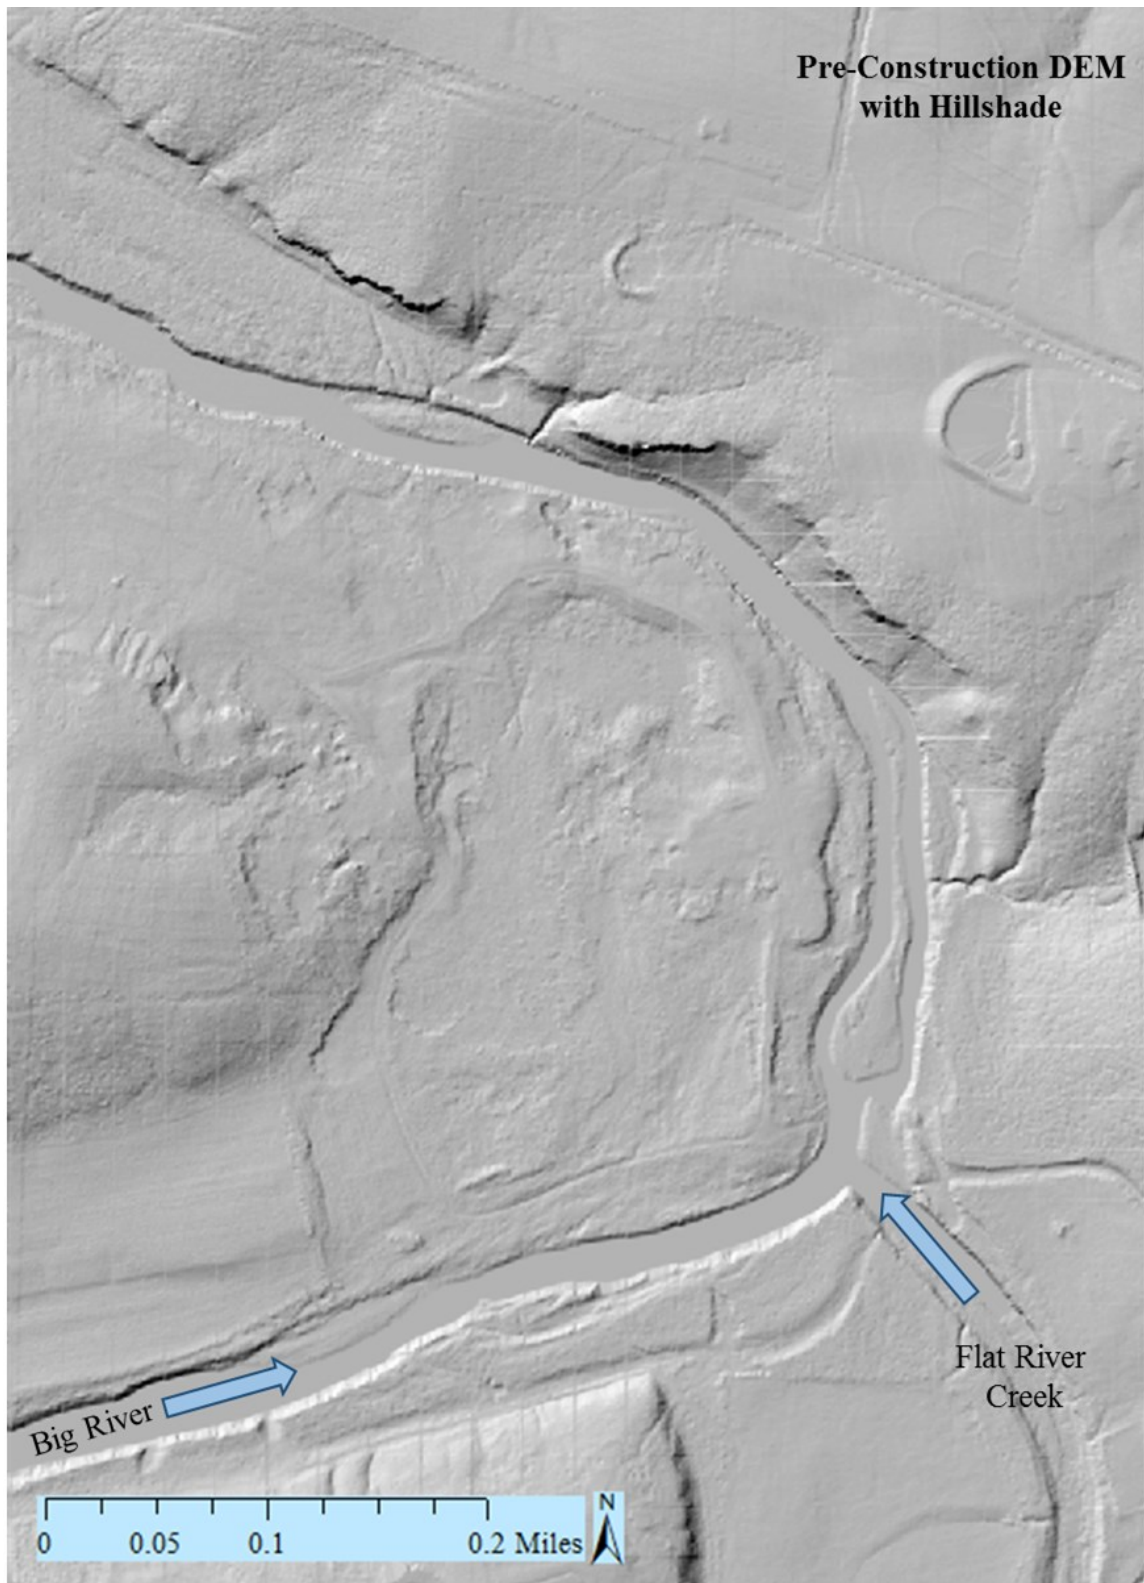
Figure 13 – Pre-construction DEM with hillshade.

The before and after construction DEMs were created to be used in HEC-RAS modeling. To ensure the compatibility of the DEMs with HEC-RAS the DEMs were exported as Tagged Image File Format (TIFF) images. Both the before and after construction DEMs with hillshade can be seen in Figure 13 and 14, respectively.

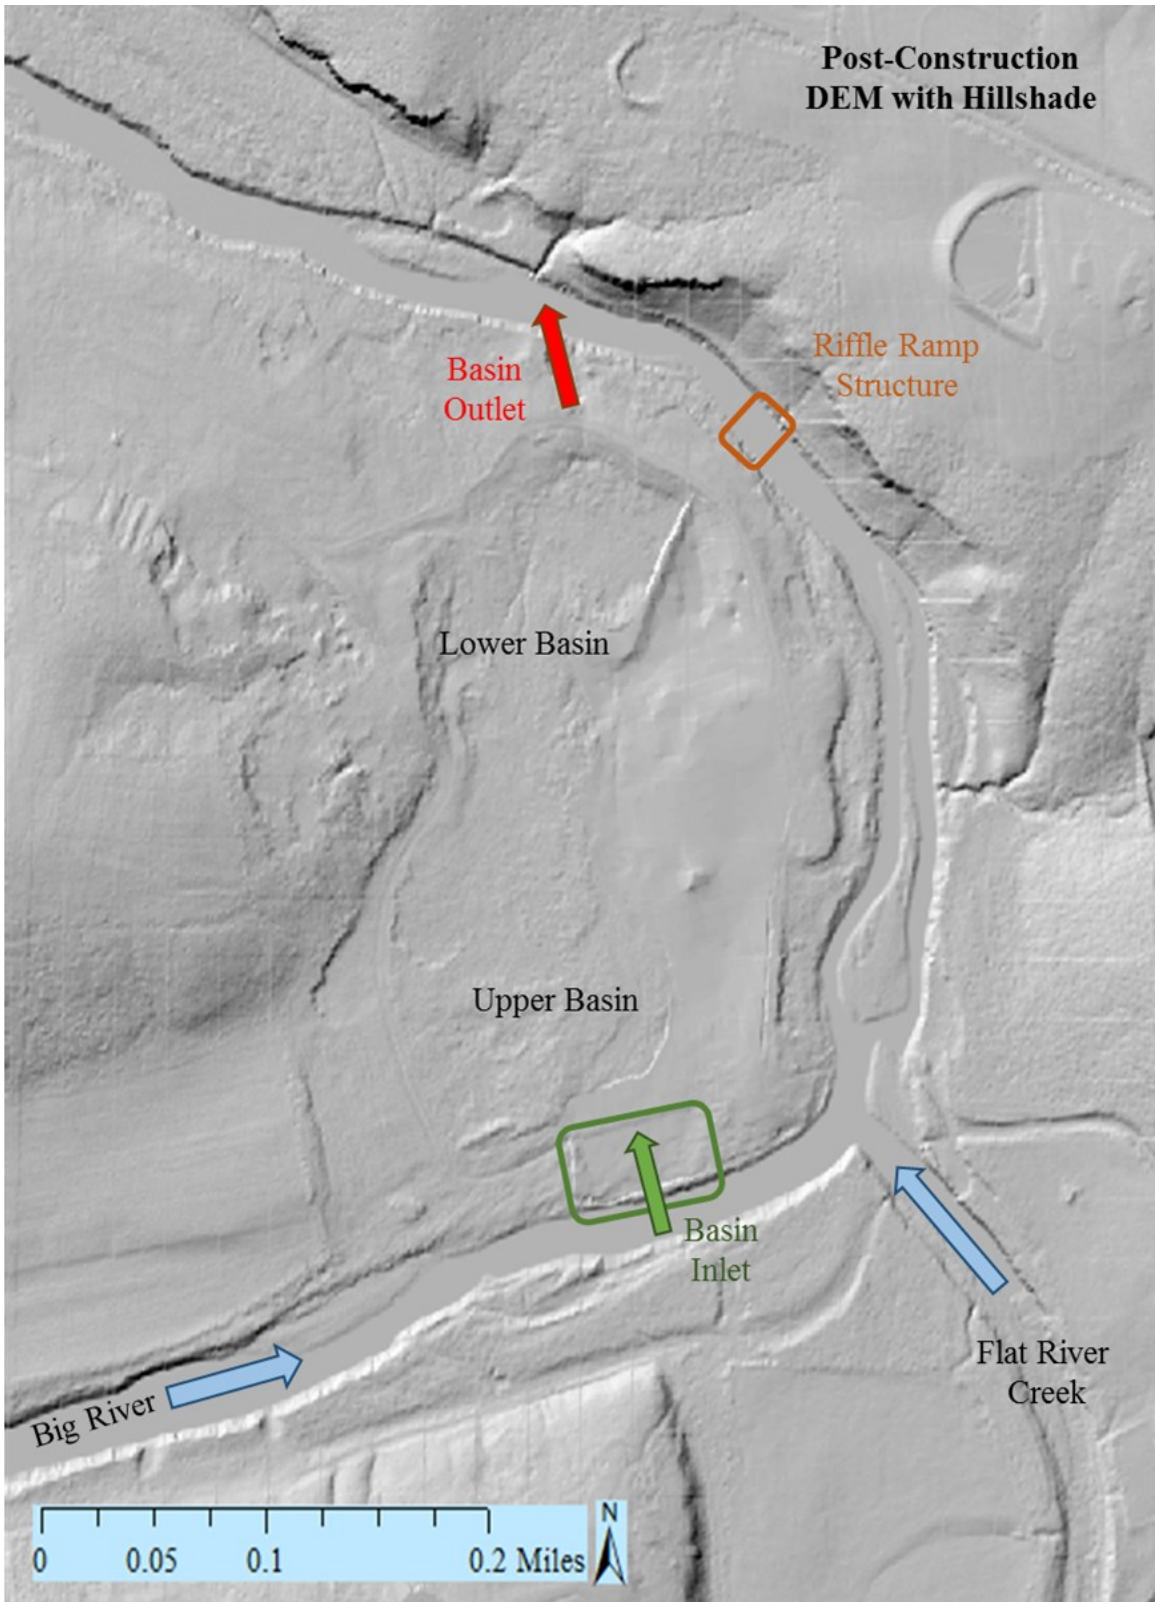
Figure 14 – Post-construction DEM with hillshade.

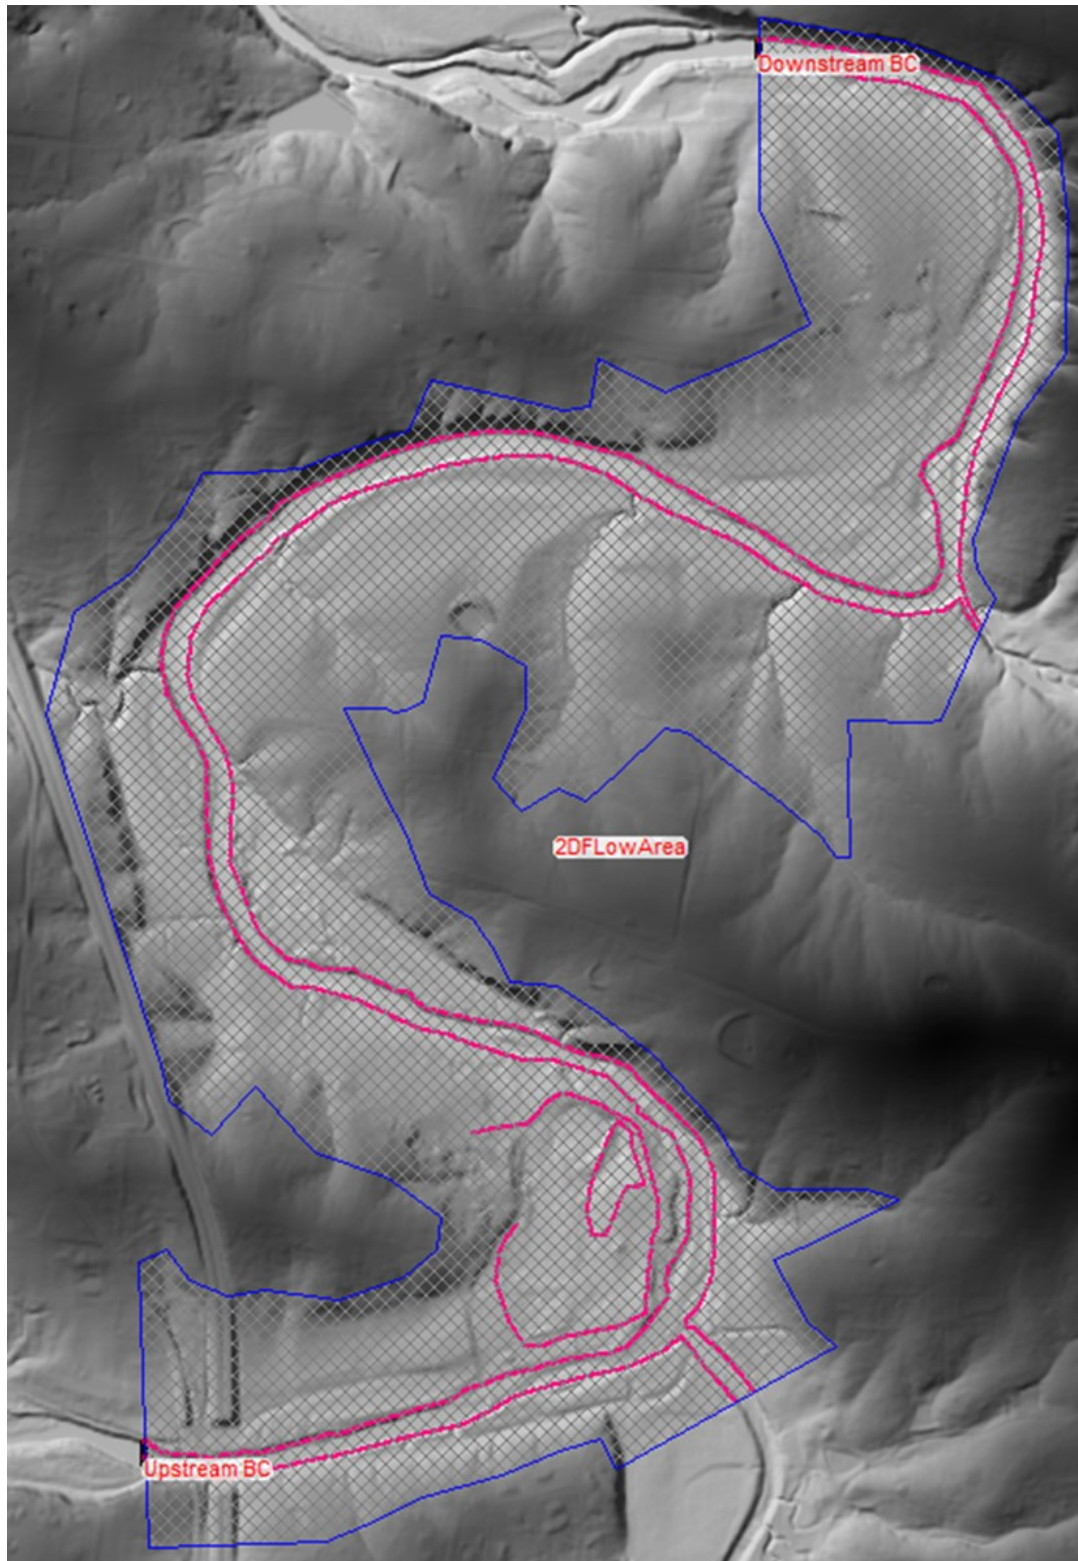
Figure 15 - 2D flow area (blue outline) used in the HEC-RAS modeling of the Big River. Red lines are break lines, which are linear features that are hydraulically important.

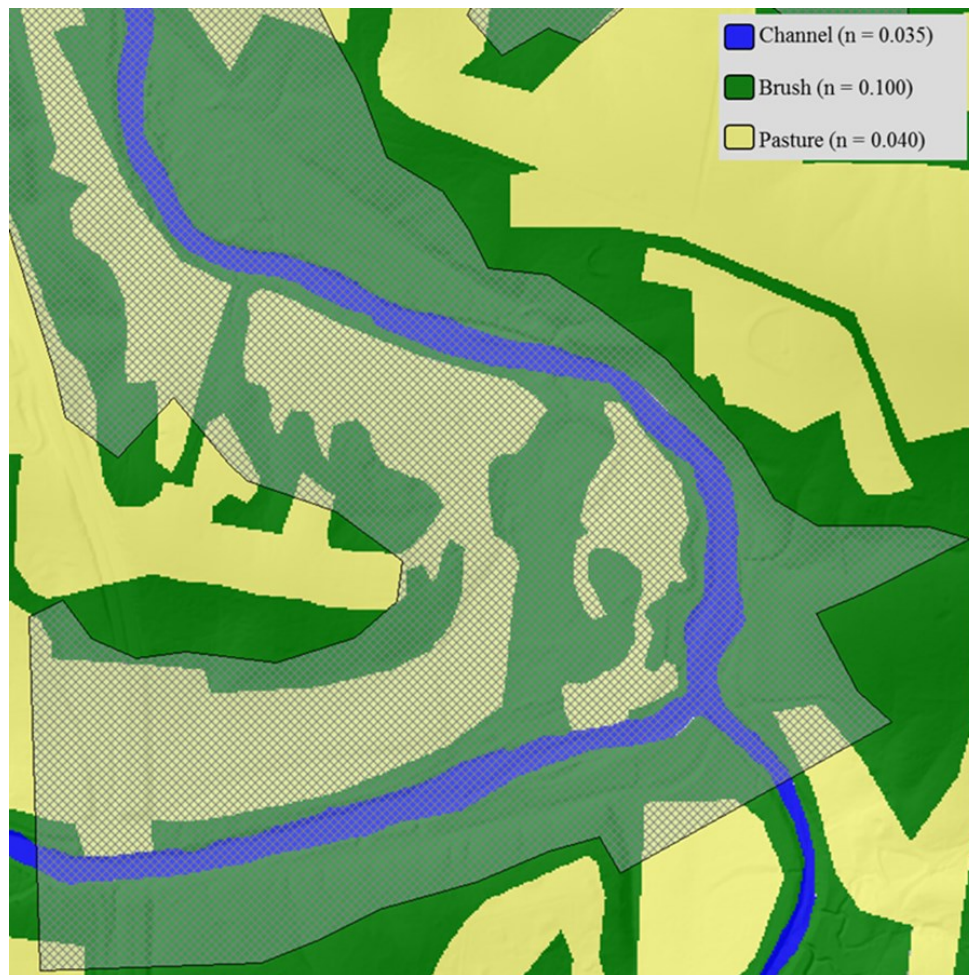
Figure 18 - Land use layer and defined Manning's n layer used for HEC-RAS modeling.

To create a model that matched field observations, a land use layer was imported into RAS Mapper (Figure 18). The land use layer allows the user to assign different Manning roughness coefficients according to land uses within the 2D flow area. To determine the Manning's n value that accurately represents what was observed in the field, the model was run with a known discharge corresponding to a measured water elevation while the Manning's n value in the channel was changed from 0.025, 0.030, 0.035, 0.040, to 0.045 to determine the value that most closely represented field measurements. The Manning's n values modeled were chosen from Chow, 1959.

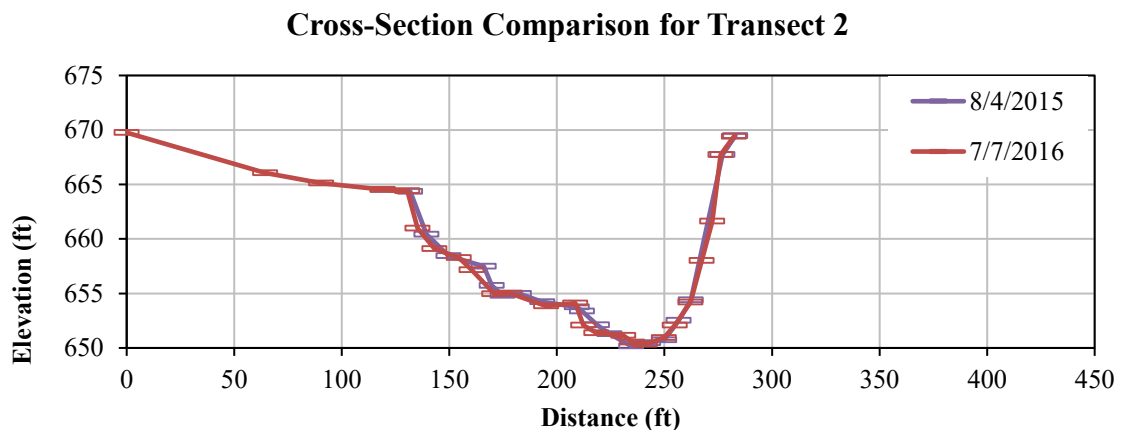
Figure 19 – Example of cross-section survey that showed little to no change along its transect.

No change. The results of the comparisons of collected survey data show and field observations show transects 2, 3, 4, 5, 6, 7, 9, and 15 underwent minor to no changes during the time of the study (Figure 19). Transect 2 is downstream of the riffle structure and Transects 3-5 are on the riffle structure. On Transects 2-5 data supported the hypothesis. The data for transects 6-9 did not support the hypothesis made, deposition did not occur as expected.

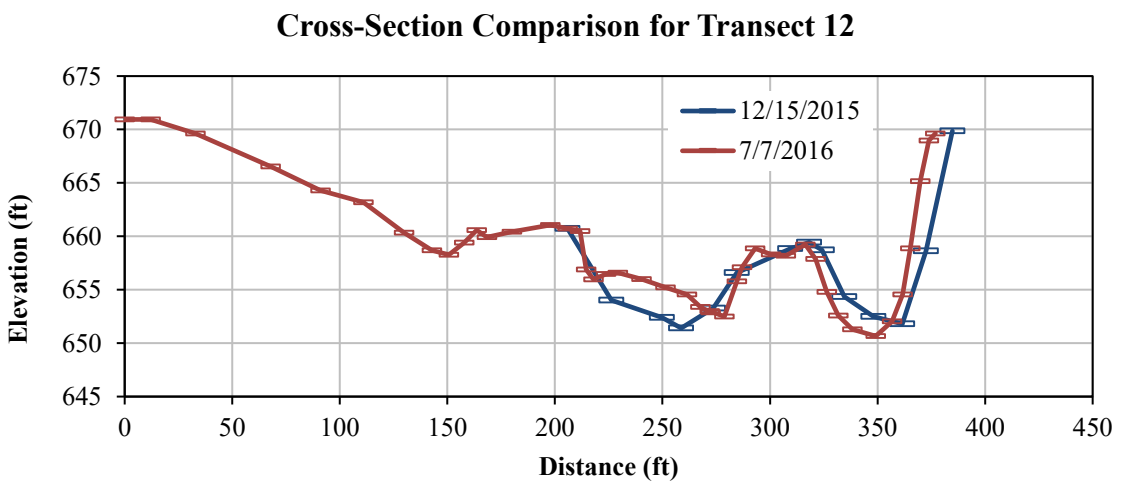
Figure 22 – Example of cross-section survey that showed both erosion and deposition along its transect.

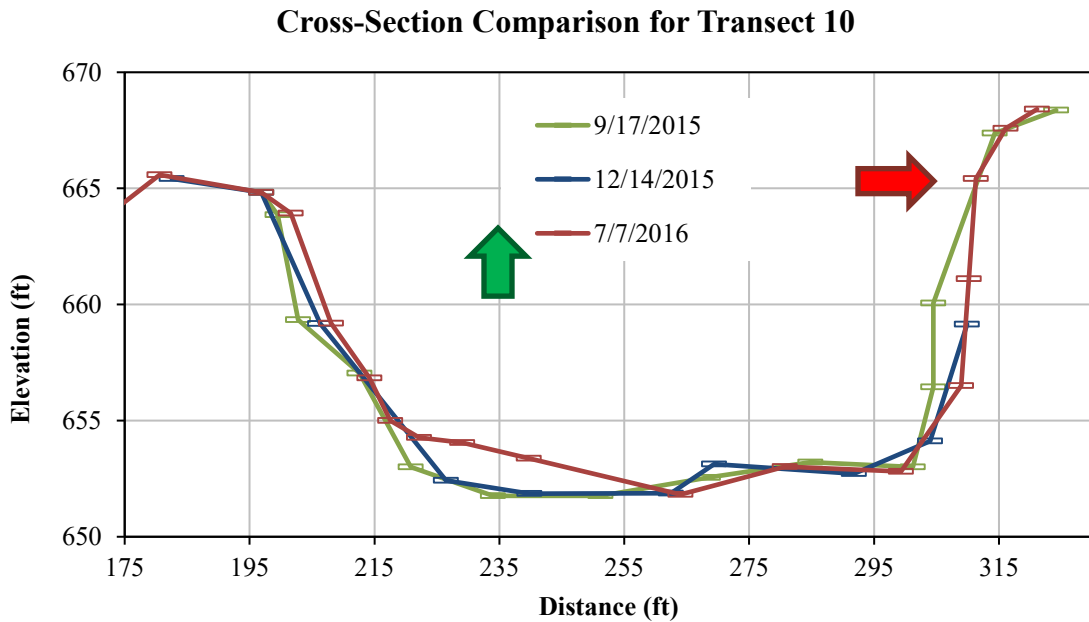
Figure 23 - A comparison of the cross-sectional data used to represent the change that has occurred on Transect 10 where the green arrow indicates deposition and the red arrow indicates erosion.

Comparisons of data. Transect 10 and 13 both tell a clear story of changes that occurred over time that matched what was observed in the field. Transect 10 shows deposition in the chute along the left bank (Figure 23). From September 2015 to July 2016 an average depth of 2 ft of deposition occurred in the chute. The change that occurred between September and December 2015 was minor. In late December 2015, after surveying, a large flood (~20,000 cfs) moved through the study area. That flood could be the contributing factor in the deposition observed between December 2015 and July 2016.

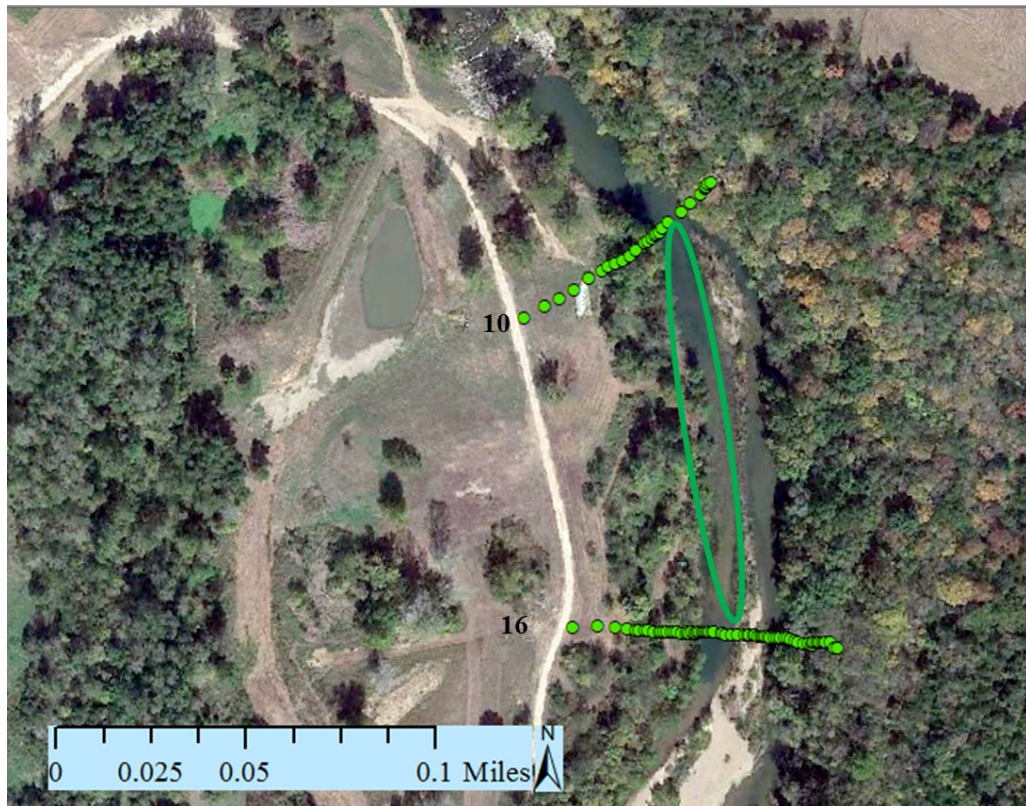
Figure 25 – Area between Transects 10-16 where the majority of deposition occurred (green circle).

Discussion of results. Survey results show the riffle structure has been effective at storing sediment in the channel. The majority of sediment was hypothesized to be stored along Transects 6-8, however the results indicate that approximately 62,000 cubic feet

(ft³) of sediment is being stored in the chute and on bars along Transects 10-16 (Figure 25 and Table 1). It is possible that over a longer period of time deposition would increase downstream toward Transects 6-8. If deposition does not increase downstream, the USEPA will need to adjust dredging plans accordingly. It is possible that significant deposition directly upstream of the structure occurred after construction and installation of the riffle, but before the first round of surveying occurred. Therefore it can be said that the constructed riffle is modestly successful because it is storing sediments, however that storage is not occurring where it was hypothesized to occur. Further monitoring will need to be completed to determine the pattern of deposition and if the riffle structure is a successful remediation technique in the long term.

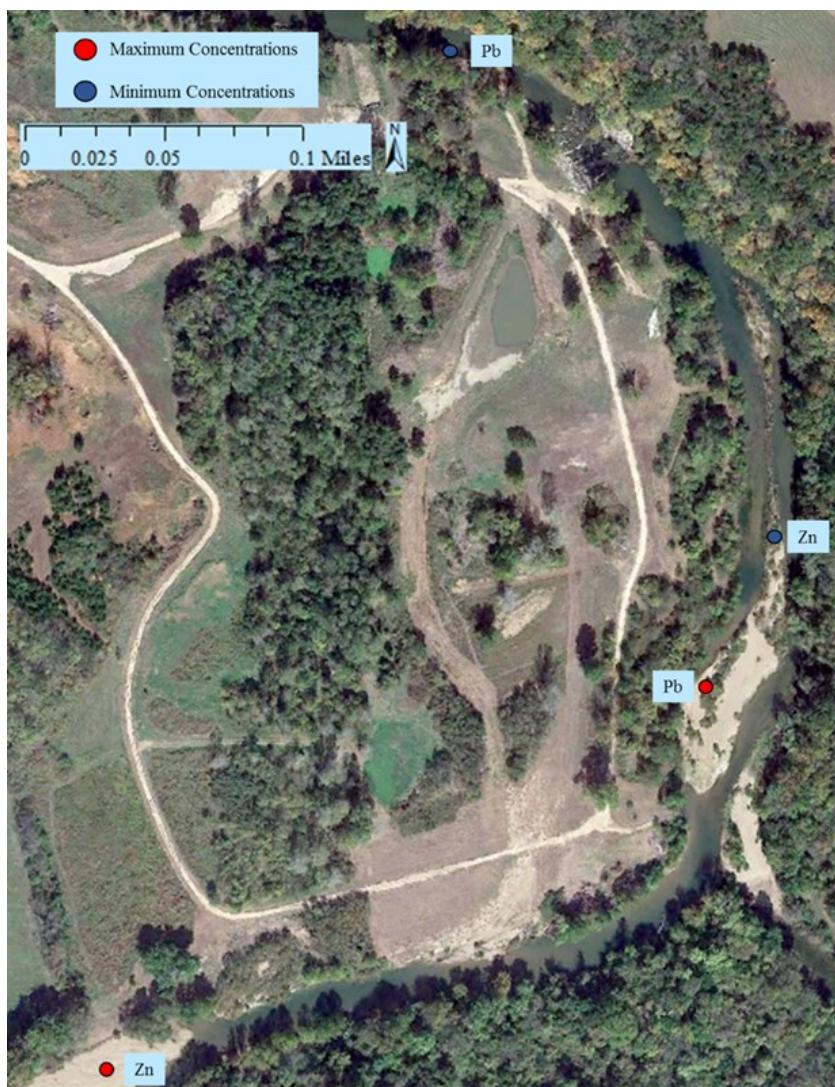
Figure 26 – September 2015 minimum and maximum Pb and Zn locations.

Through XRF analysis the concentrations of Pb and Zn were found for the September 2015 samples. The maximum concentration of Pb (4955 ppm) being collected from mid-bar on Transect 17 and the minimum concentration of Pb (924 ppm) being collected from the bar tail on Transect 1. The maximum concentration of Zn (2800 ppm) was collected from mid-bar on Transect 22 and the minimum concentration of Zn (658 ppm) was collected from the bar tail on Transect 16 (Figure 26).

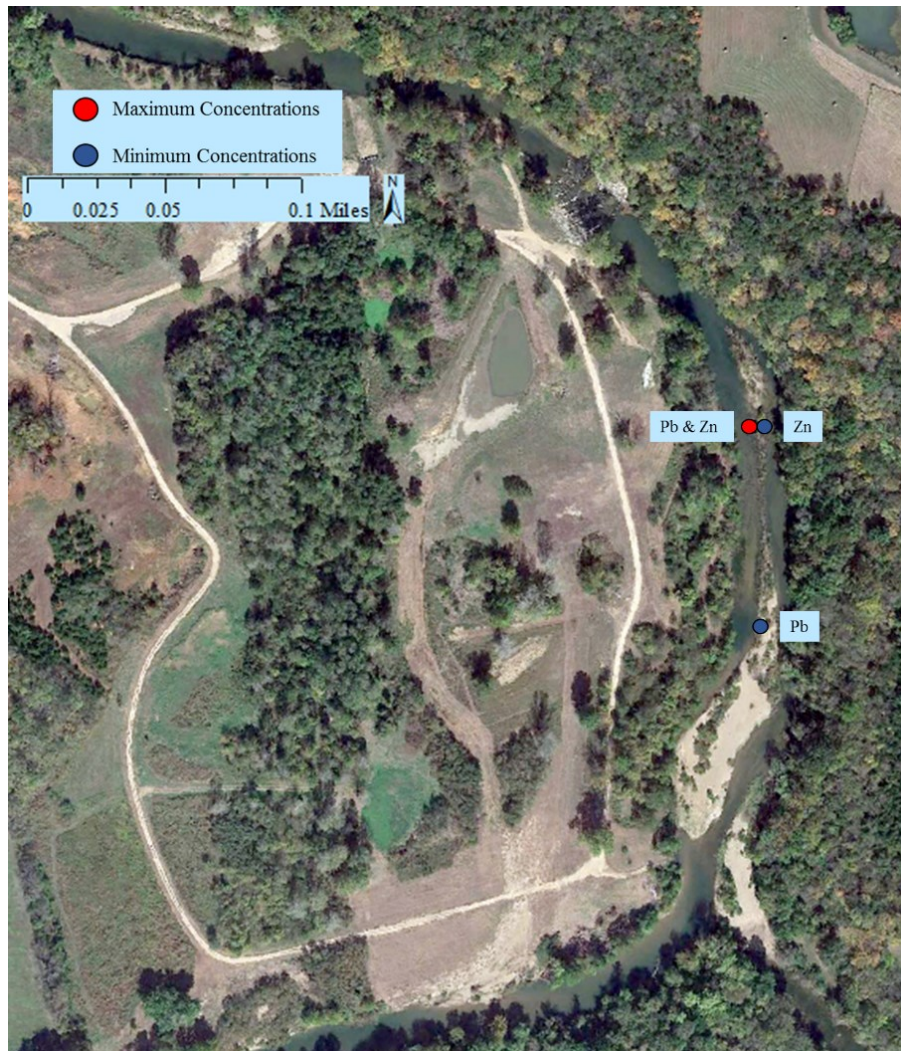
Figure 27 – November 2016 minimum and maximum Pb and Zn locations.

The concentrations of Pb and Zn for November 2016 were found via XRF analysis. The maximum concentration of Pb (2400 ppm) was collected from the center of the chute on Transect 13 and the minimum concentration of Pb (1214 ppm) was collected from the right side of the chute on Transect 16. The maximum concentration of Zn (3126 ppm) was collected from the center of the chute on Transect 13 and the minimum concentration of Zn (792 ppm) was collected from the right side of the chute on Transect 13 (Figure 27).

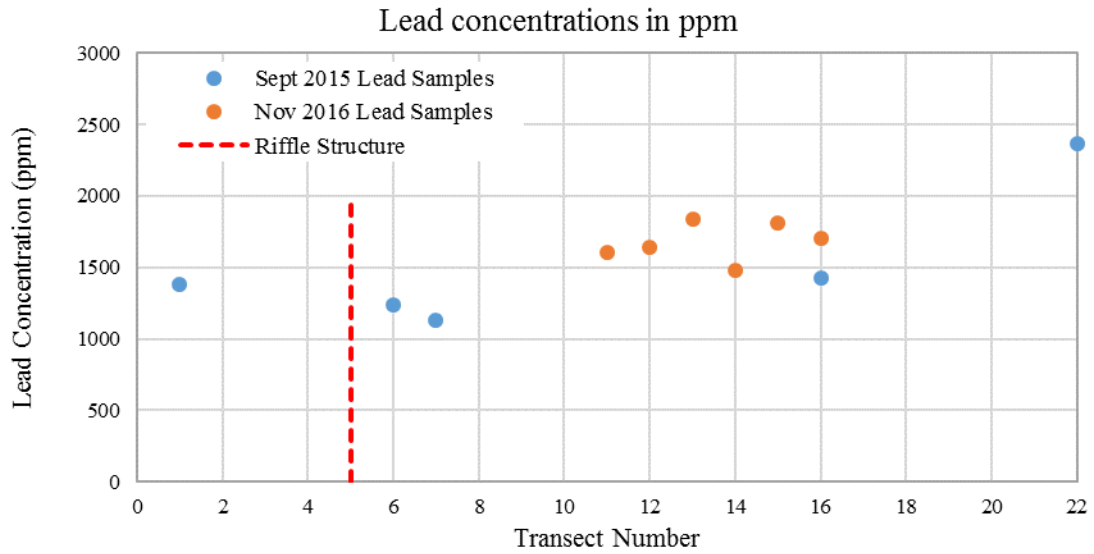
Figure 28 – The concentrations of Pb (ppm) in found in sediment collected from the above transects.

General Discussion. Through geochemical analysis it can be seen that the sediment within the channel is contaminated with Pb and Zn. The lead-contaminated sediment appears to have the greatest concentrations upstream, around Transect 17 and 18 and slowly decreases downstream (Figure 28). The concentrations of Zn (ppm) found in sediment appears to be highest between Transects 18 and 22 (Figure 29).

High levels of lead were found in sediments that were collected from Transects 11-16, where the majority of deposition is occurring. However, the <250 μ m sample comprises approximately 2.3% of the total sediment stored within the channel. Therefore it appears that deposition and lead concentrations are correlated, but the <250 μ m sample represents a relatively low percentage of the total channel sediment.

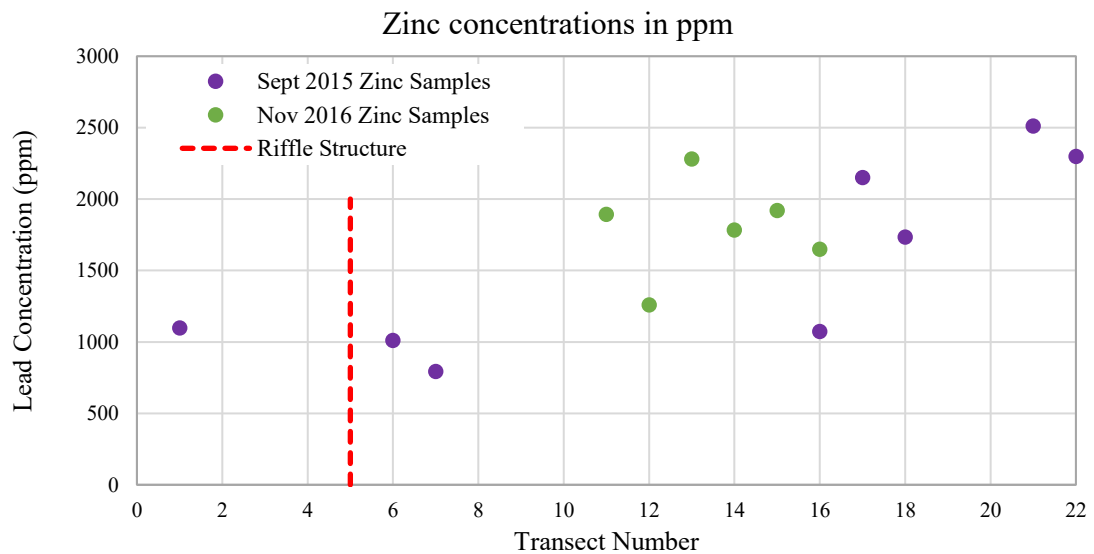
Figure 29 – The concentrations of Zn (ppm) in found in sediment collected from the above transects.

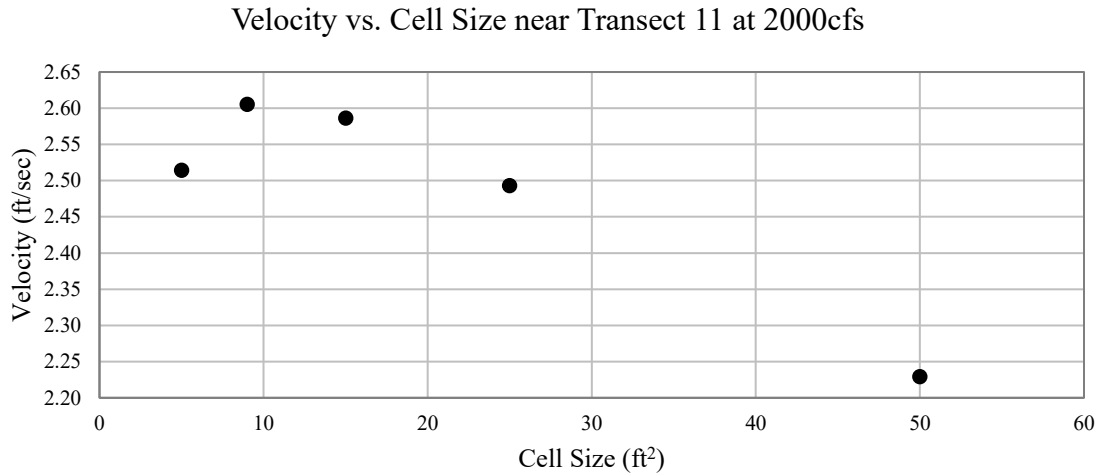
Figure 37 – Velocity and cell size relationship near Transect 11.

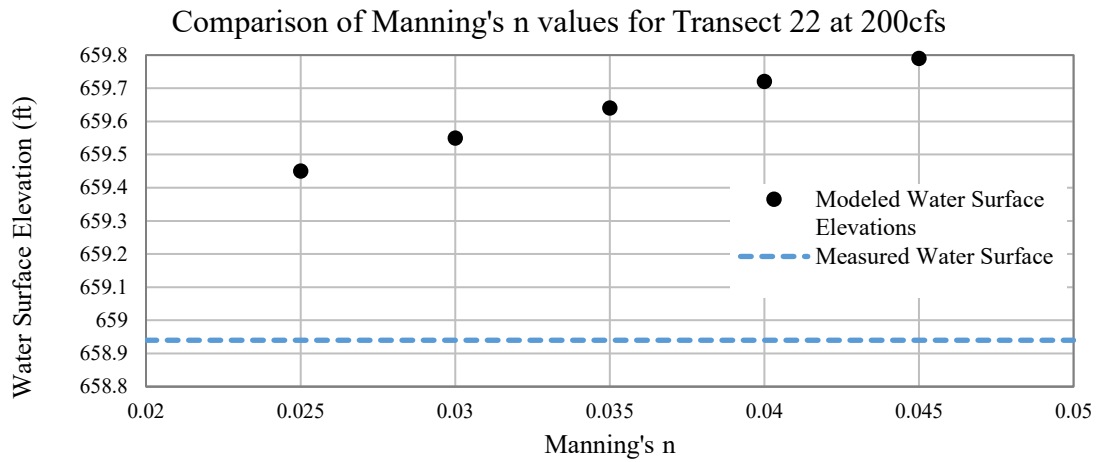
Figure 38 – Water surface elevation and Manning's n relationship at Transect 22.

Manning’s n determination. By running a hydrograph through the model and comparing the water surface elevation versus varying Manning’s n values and comparing those values to the field measured water surface elevations (Figures 38-41), it was found that the water surface elevation steadily increased as Manning’s n increased. Measured water surface values are relatively close to the different water surface elevations

computed by the model. However, due to the possible surveying errors or incomplete definition of bed geometry, no conclusive results were determined. The Manning's n value of 0.035 was used for further modeling. Several sources suggest 0.035 is appropriate (Chow, 1959; Aldridge and Garrett, 1973; FISRWG, 1998; Bedient et al., 2008).

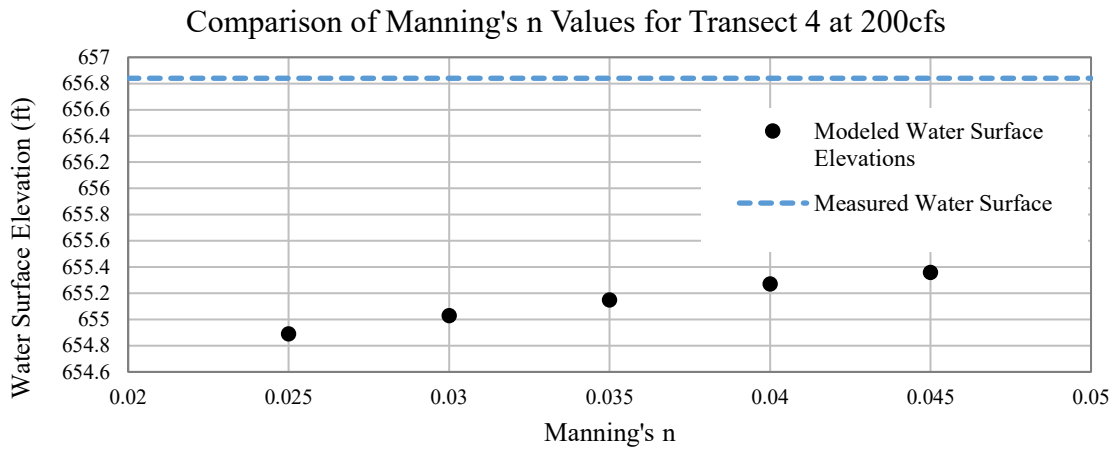
Figure 41 - Water surface elevation and Manning’s n relationship at Transect 4.

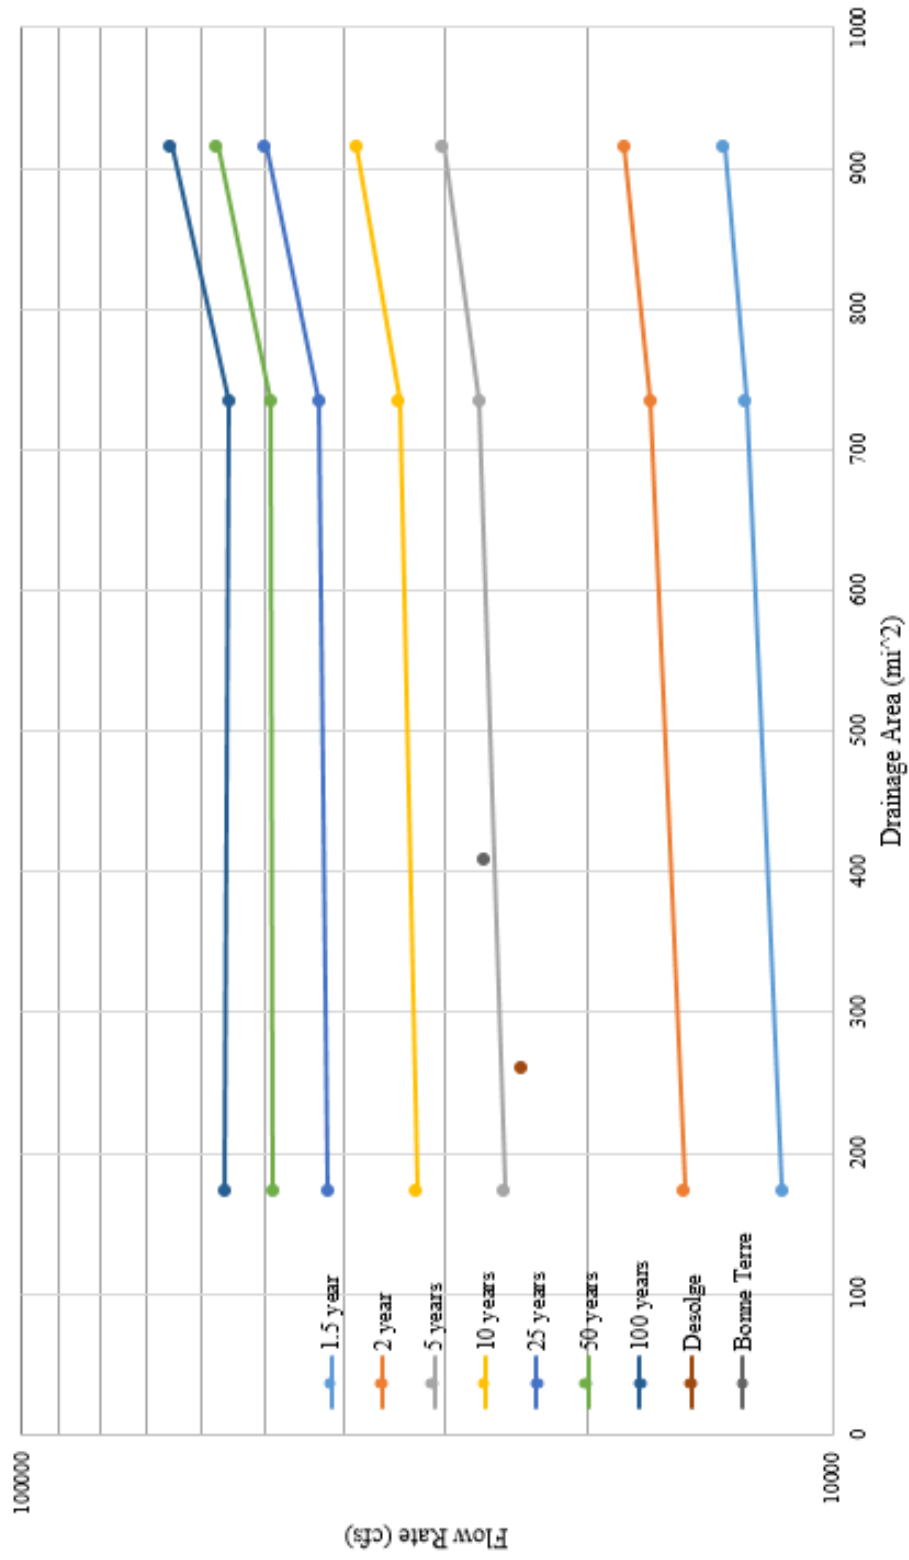
Comparison of Flow Rate vs. Drainage Area at Irondale, Bynesville, & Richwoods

Figure 42 – PeakFQ data used to interpolate the discharge of flood recurrence intervals for the Big River below Desolge.
