Using Survey Data and HEC-RAS Modeling to Assess a Riffle-Remediation Structure on the Big River, Bonne Terre, Missouri

A Masters Thesis

Master of Science, Geospatial Sciences in Geography, Geology, and Planning

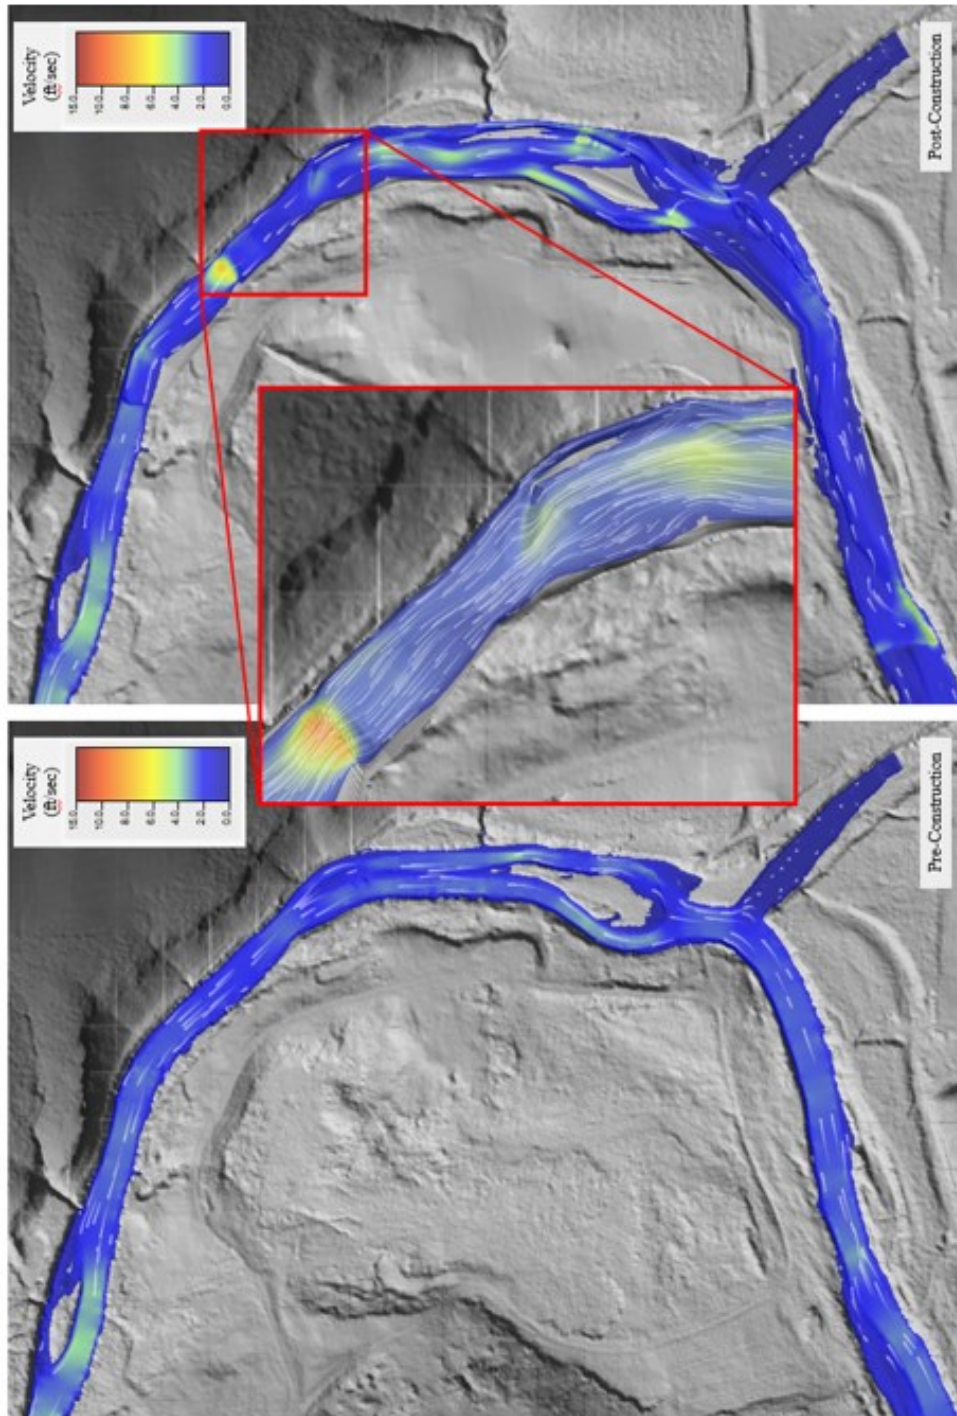
Figure 52 – Simulation highlighting the installed riffle structure is acting as the main control on velocity at 600 cfs in the post-construction simulation.

At 600 cfs a notable difference is observed at the head of the riffle structure (Figure 52). In the post-construction simulation, a velocity hot spot can be seen at the head of the riffle. From the location of the velocity hot spot and the results of the RPD calculations it can be inferred that the riffle structure is the main control on velocity within the channel when flows are contained within the banks.

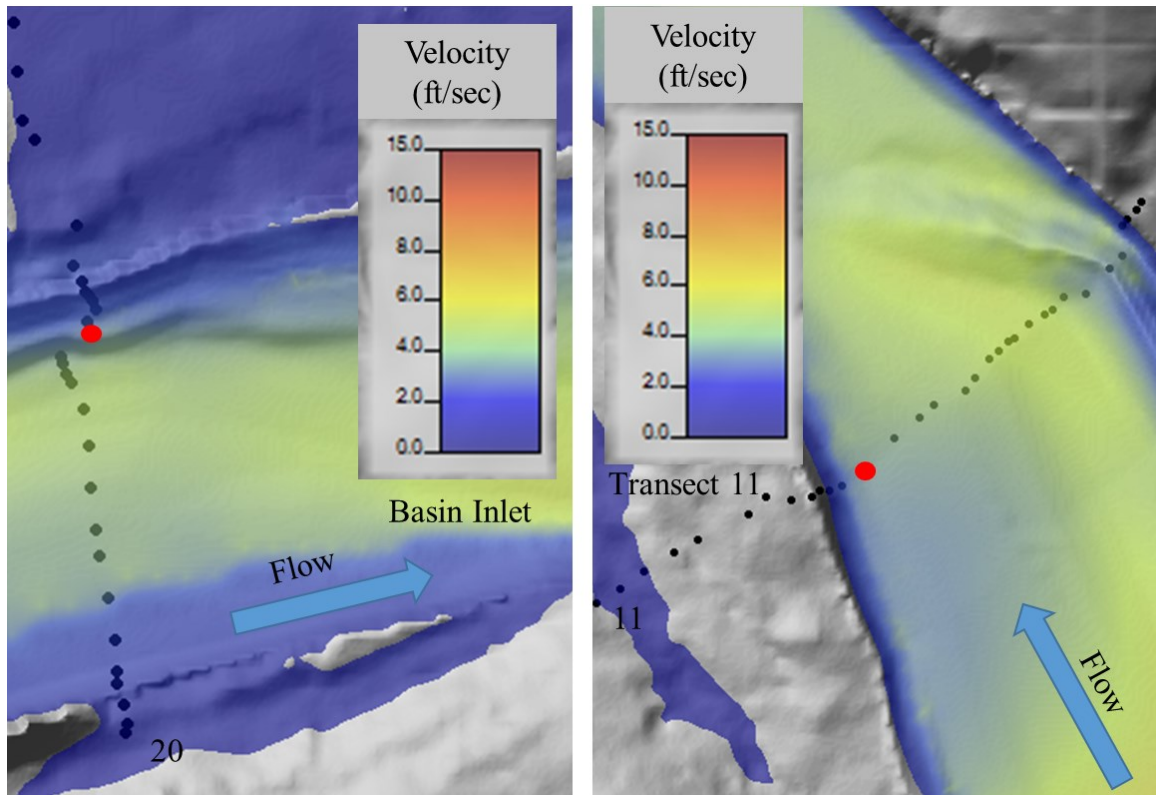
Figure 53 – Velocity measurement locations for pre- & post-construction comparison at 2000 cfs taken from basin inlet and Transect 11 for RPD calculations

To better understand the erosion at the basin inlet the RPDs were calculated for pre- and post-construction simulations. During the 2-year flood simulation (15,425 cfs) the velocities modeled at the basin inlet in the pre- and post-construction simulations

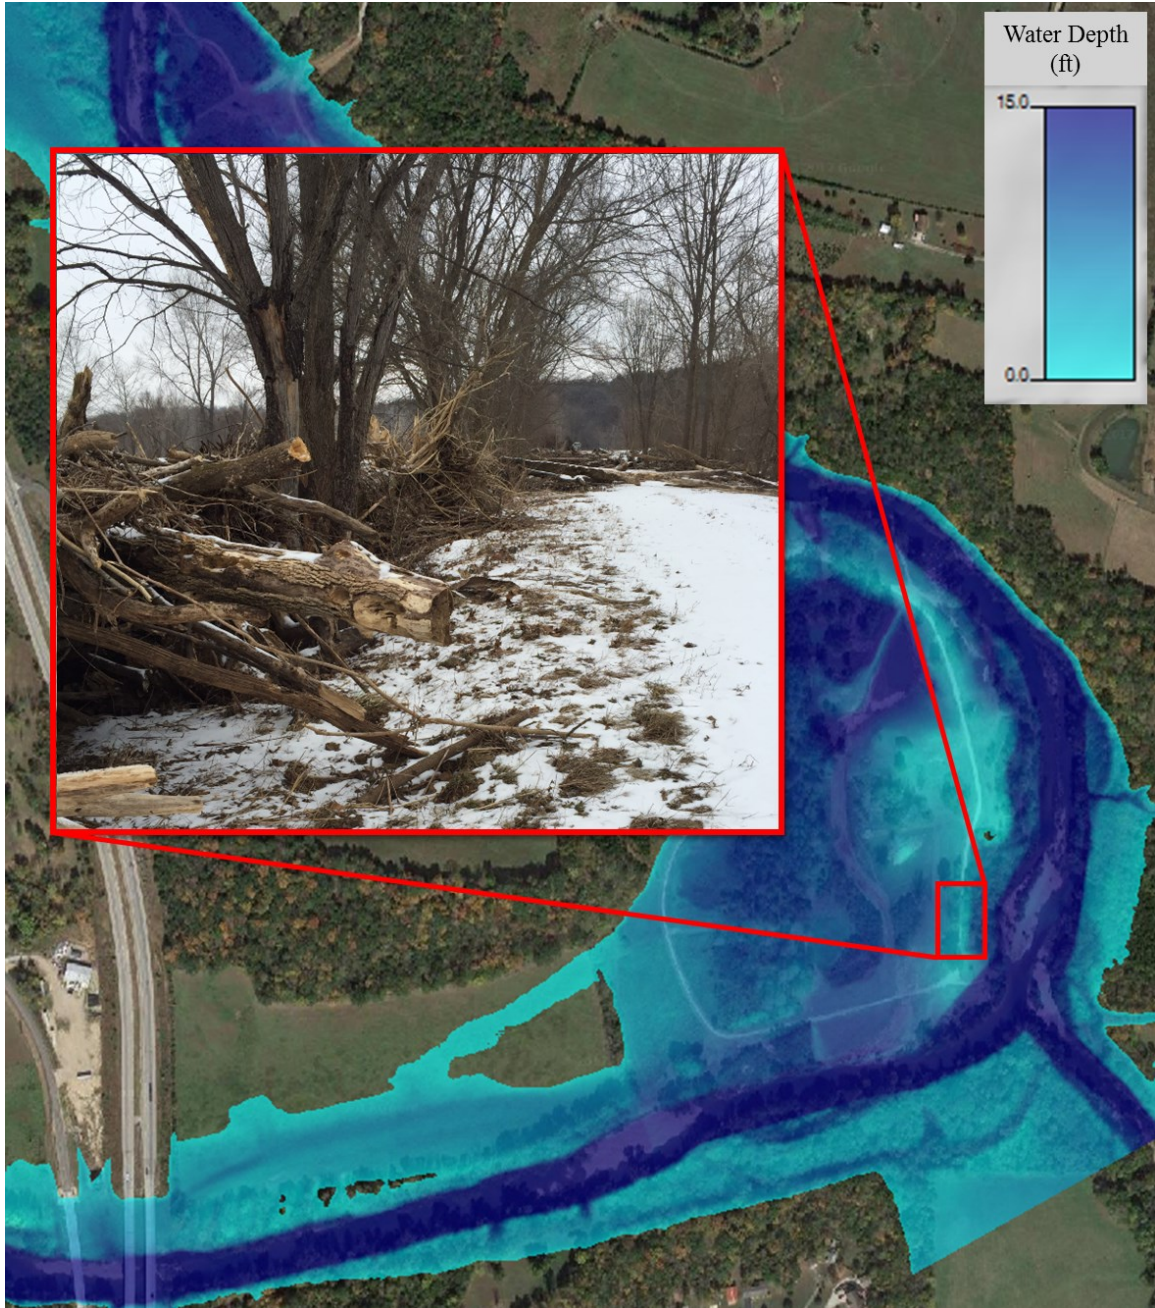
Figure 61 - Simulation of water depth during 5-year flood near large woody debris deposits. Water depth simulation for the 5-year flood (25,560 cfs) shows the location of the log jam that occurred after the December 2015 flood.
