## Geomorphic Response to Catastrophic Flooding in a Karst Mountain Stream System, Brighton-Blue Hole Watershed, Southwest Jamaica

A Master's Thesis

Master of Science, Geospatial Sciences in Environmental Geology

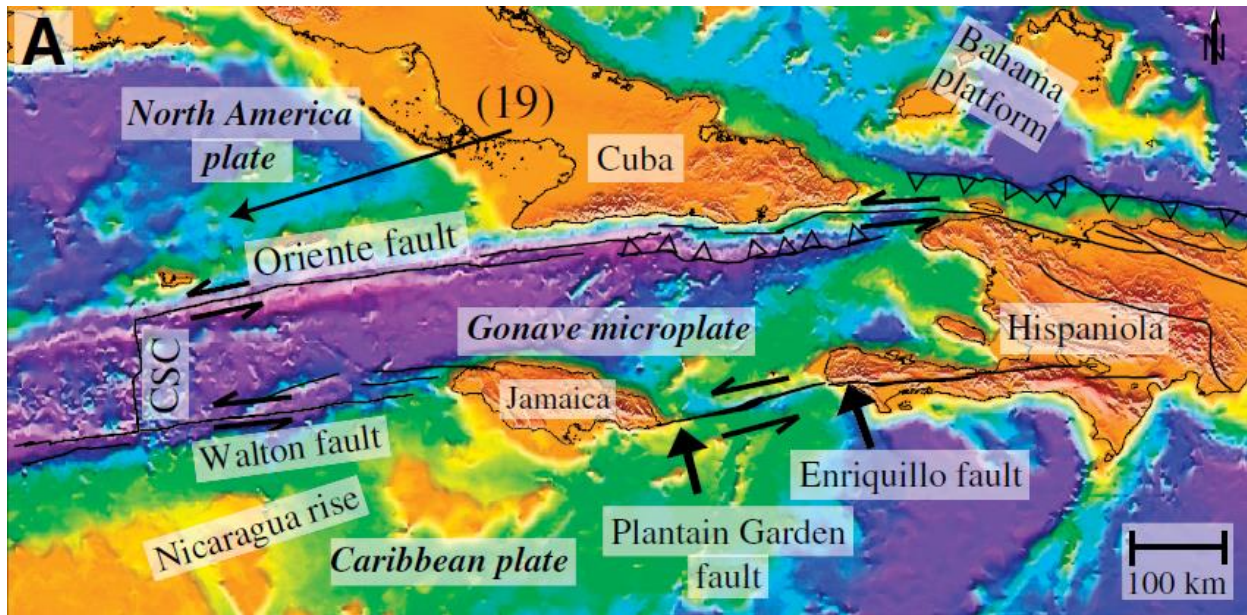
Figure 2. The tectonic setting of Jamaica. Source: Benford et al., 2014

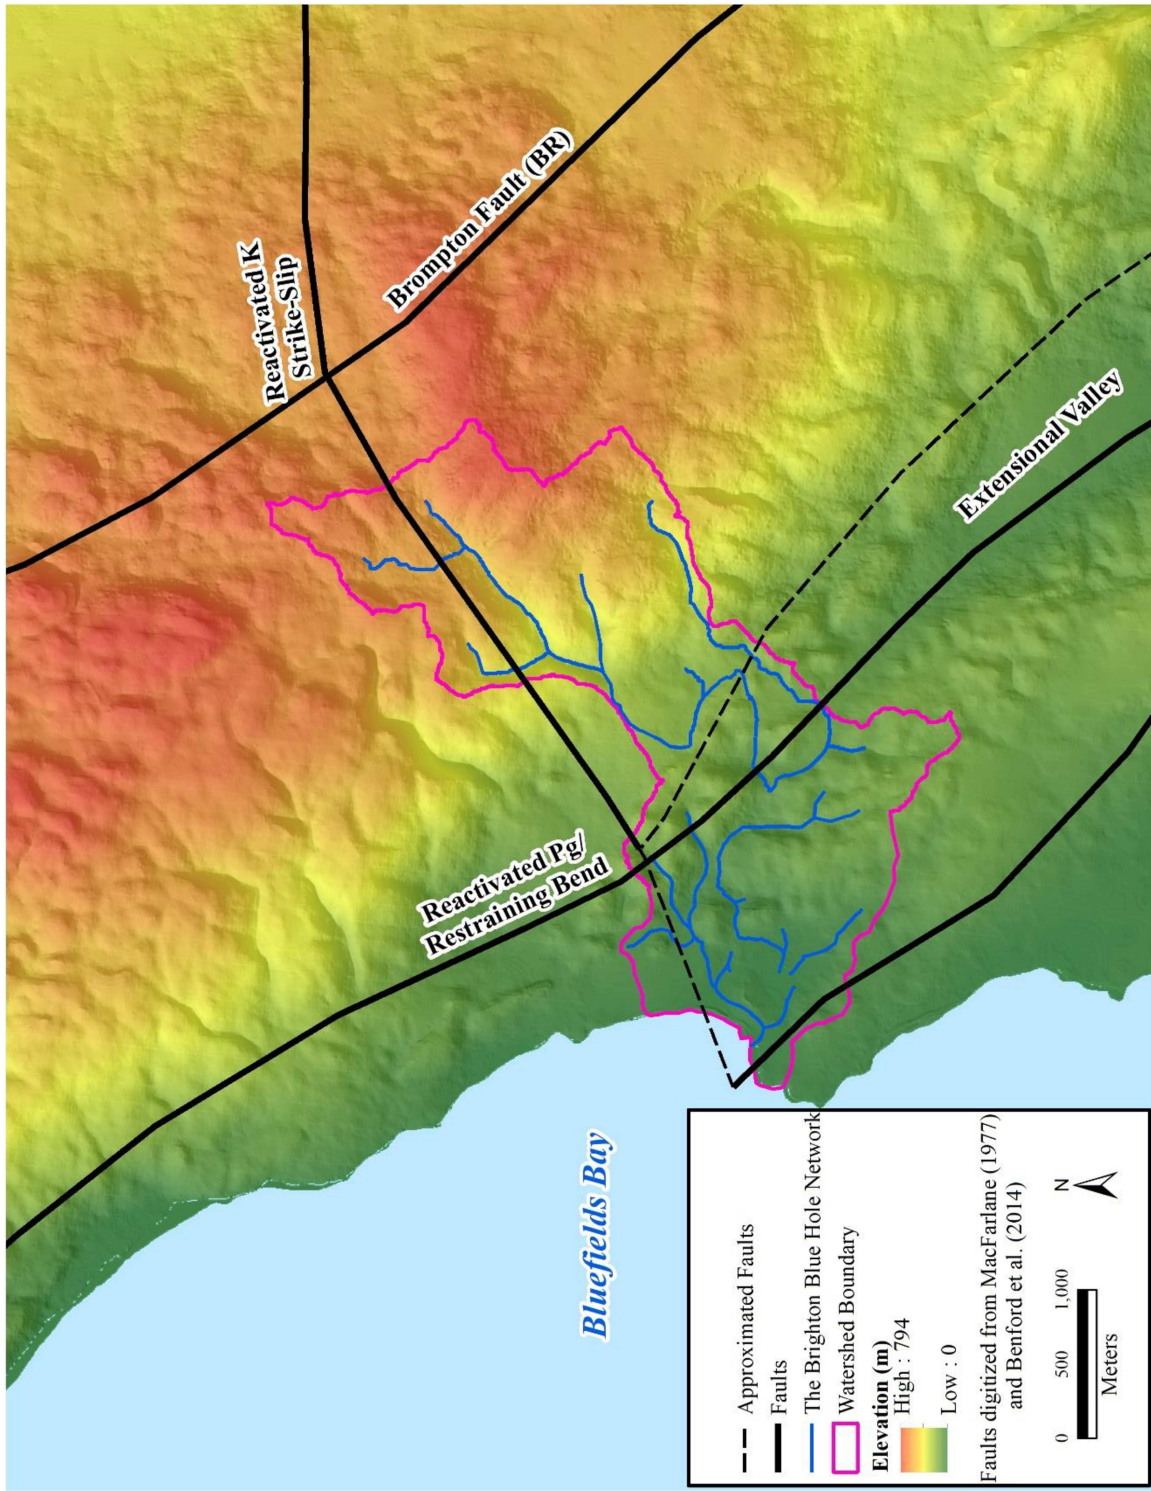
Figure 4. Faults and structural landforms in the BBHW

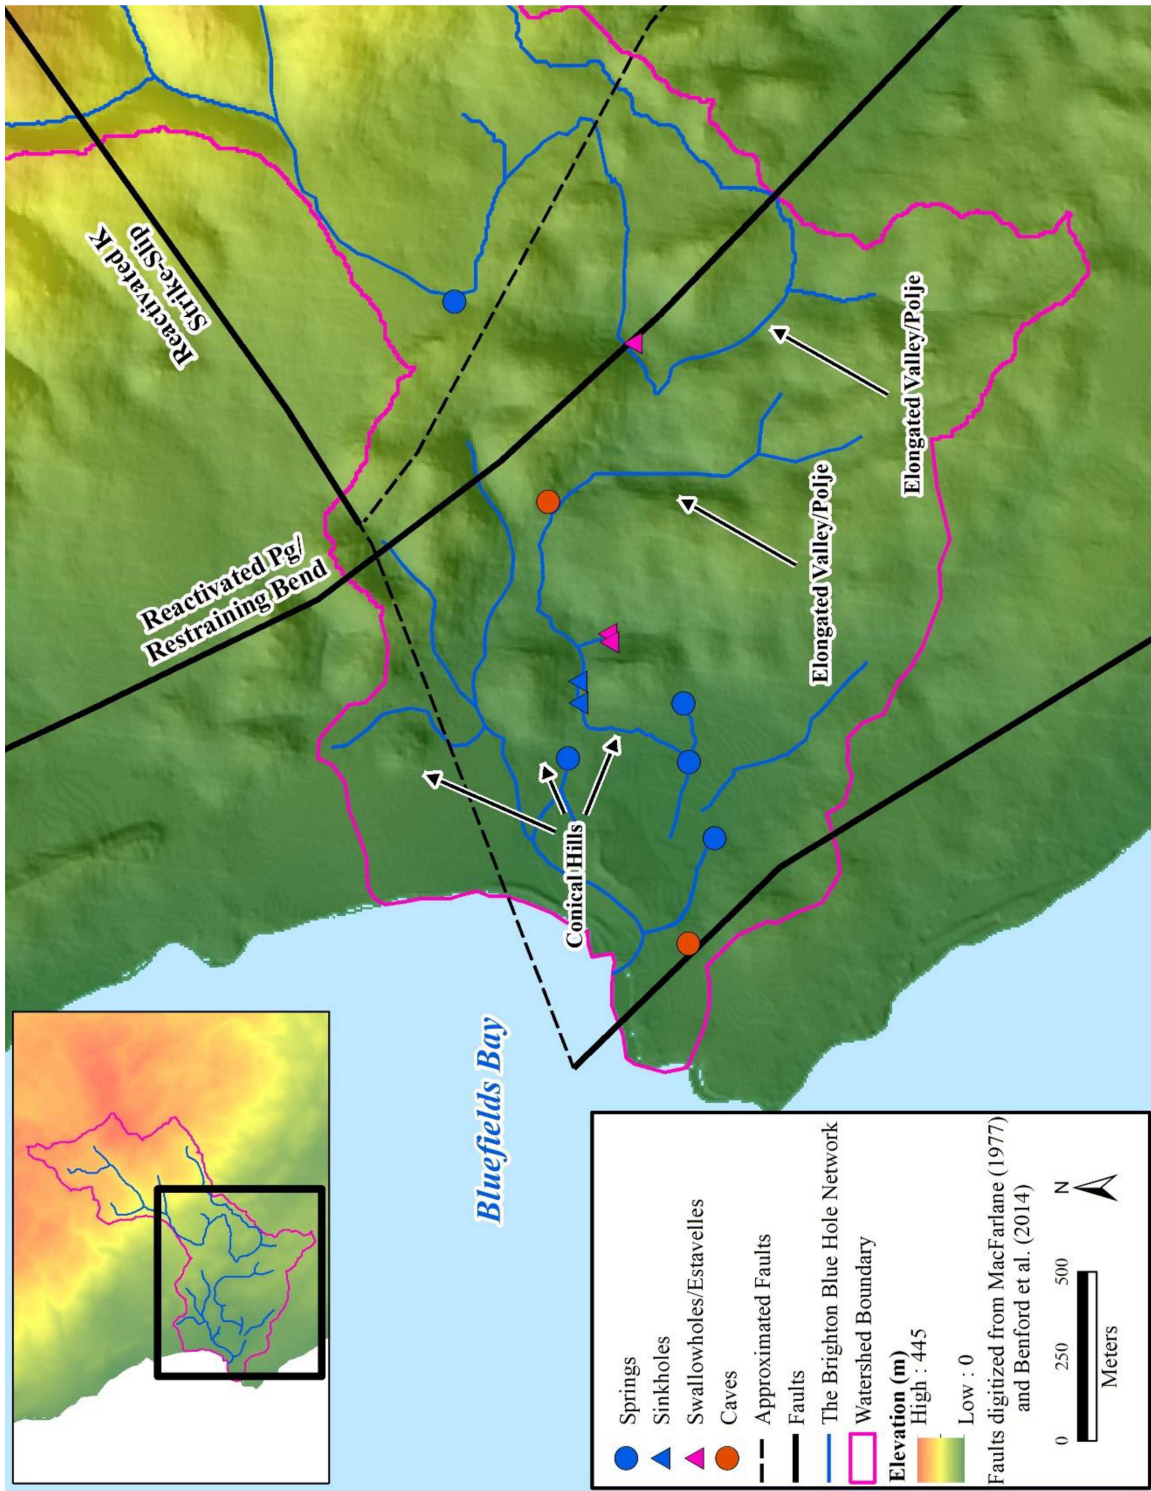
Figure 5. Karst landforms and related tectonics in the BBHW

The heavily dissected Bonny Gate member has led to the formation of a well-developed karst system in the BBHW (Fig. 5). The term “well-developed” is used here to describe a landscape where surface depressions and springs are common. Surface depressions in the BBHW are varied in shape and hydrology. Depressions which are round and enclosed are referred to as sinkholes (Sweeting, 1958; Day, 2010). After a rainfall event, runoff collects in these depressions as it slowly percolates through fractures in the limestone bedrock into underground conduits and the low points of these depressions are commonly devoid of vegetation and some even support small, semi-permanent ponds (Day, 1976). These depressions can become easily denuded during floods due to low infiltration rates (Day, 1976; Day, 2007; Day, 2010). Elongated valleys in BBHW, which have formed parallel to NNW structural trends and represent down-faulted blocks can in some cases be interpreted as polje (Mitchell et al., 2003). These flat-bottomed valleys drain via swallow holes, also called ponors, which are open surface connections to underground conduits by which water can flow directly underground (Mitchell et al., 2003; Lyew-Ayee et al., 2007). These polje are usually long or irregular in shape and during

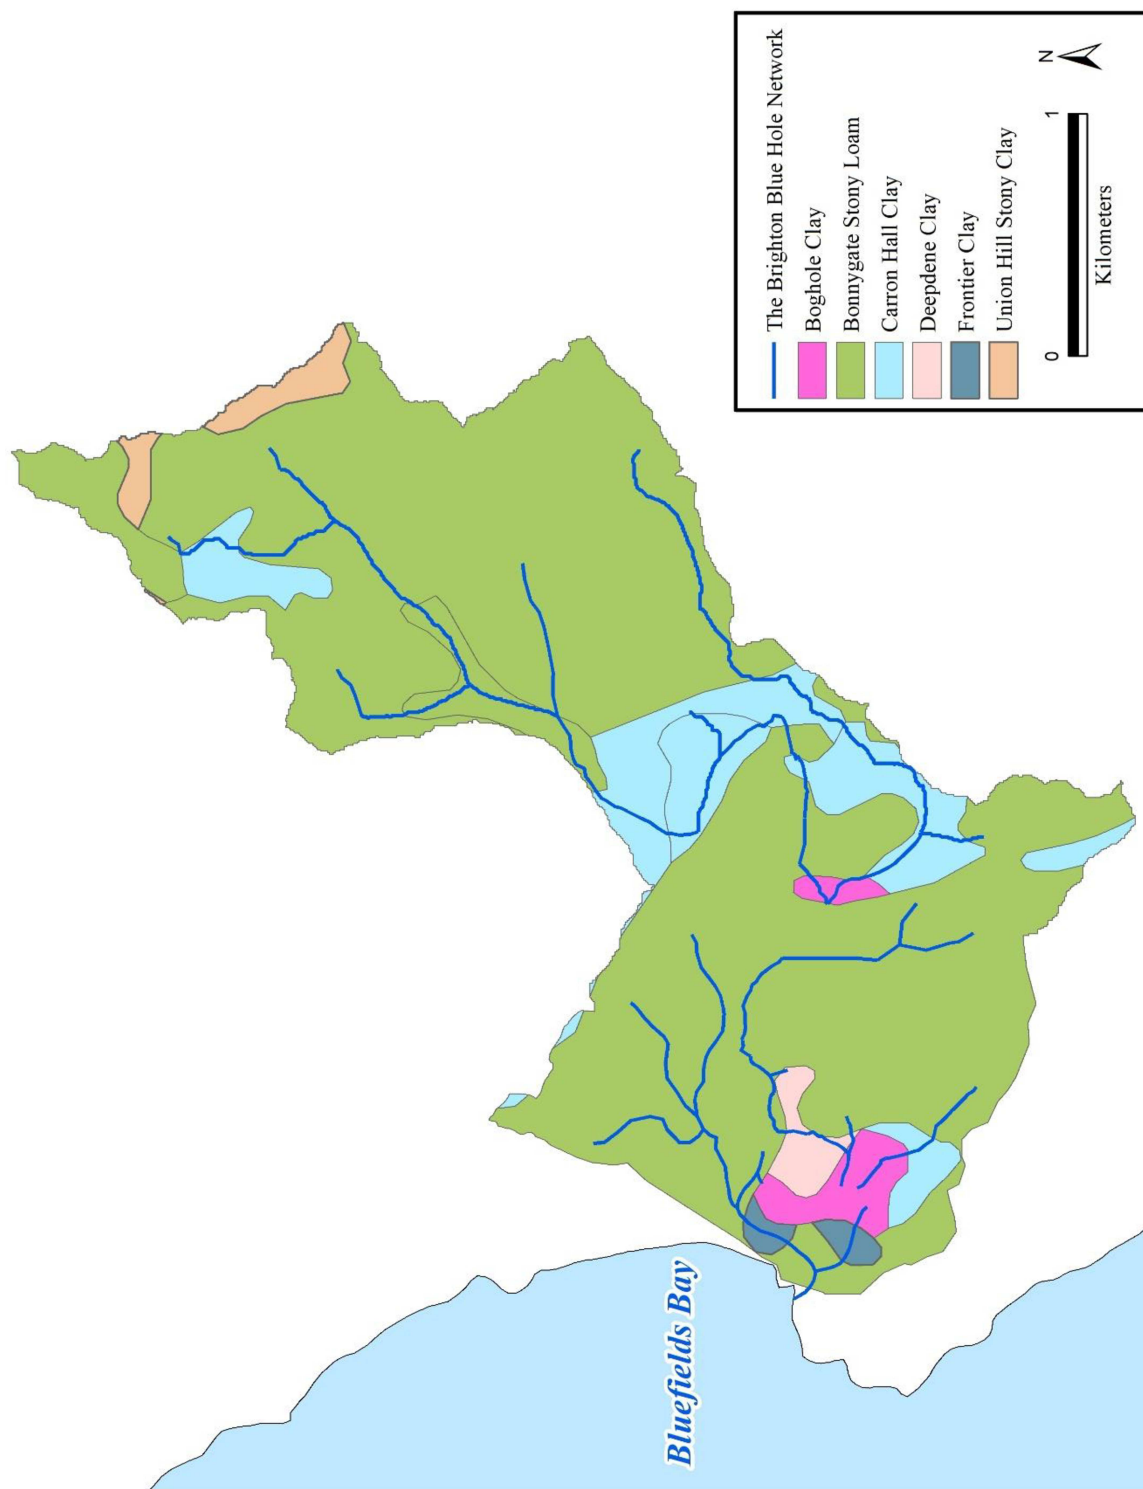
Figure 6. Soil series of the BBHW

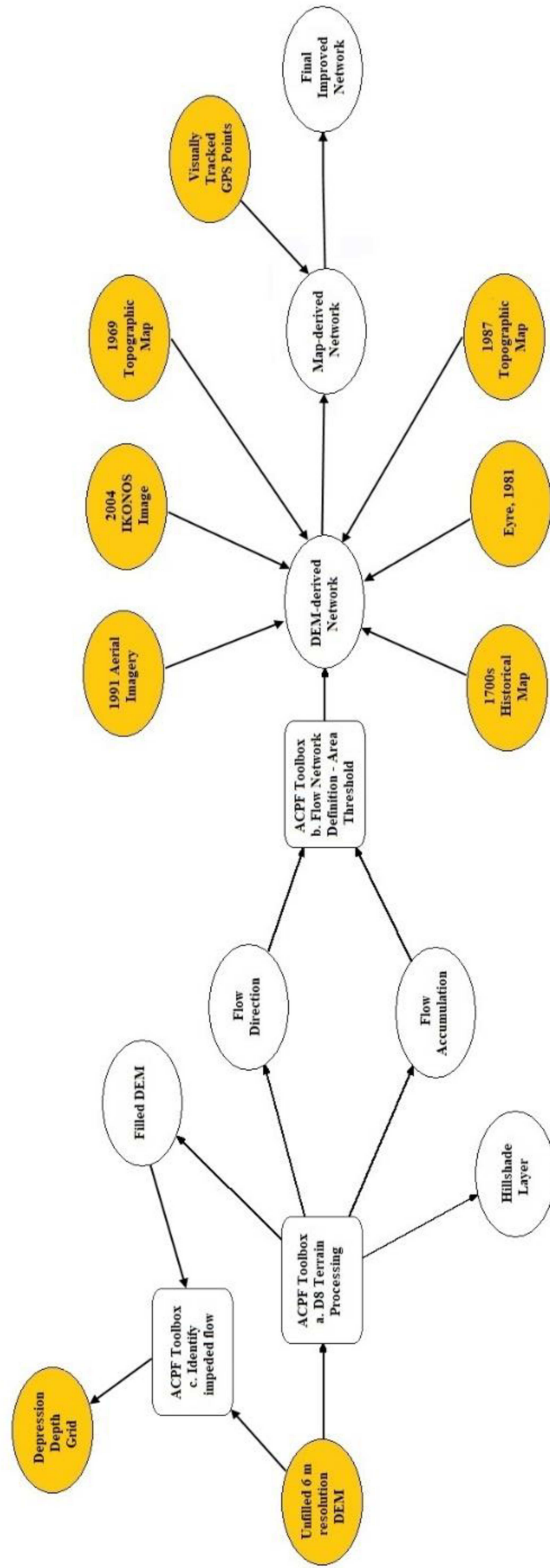
Figure 9. GIS workflow for drainage network generation and improvement

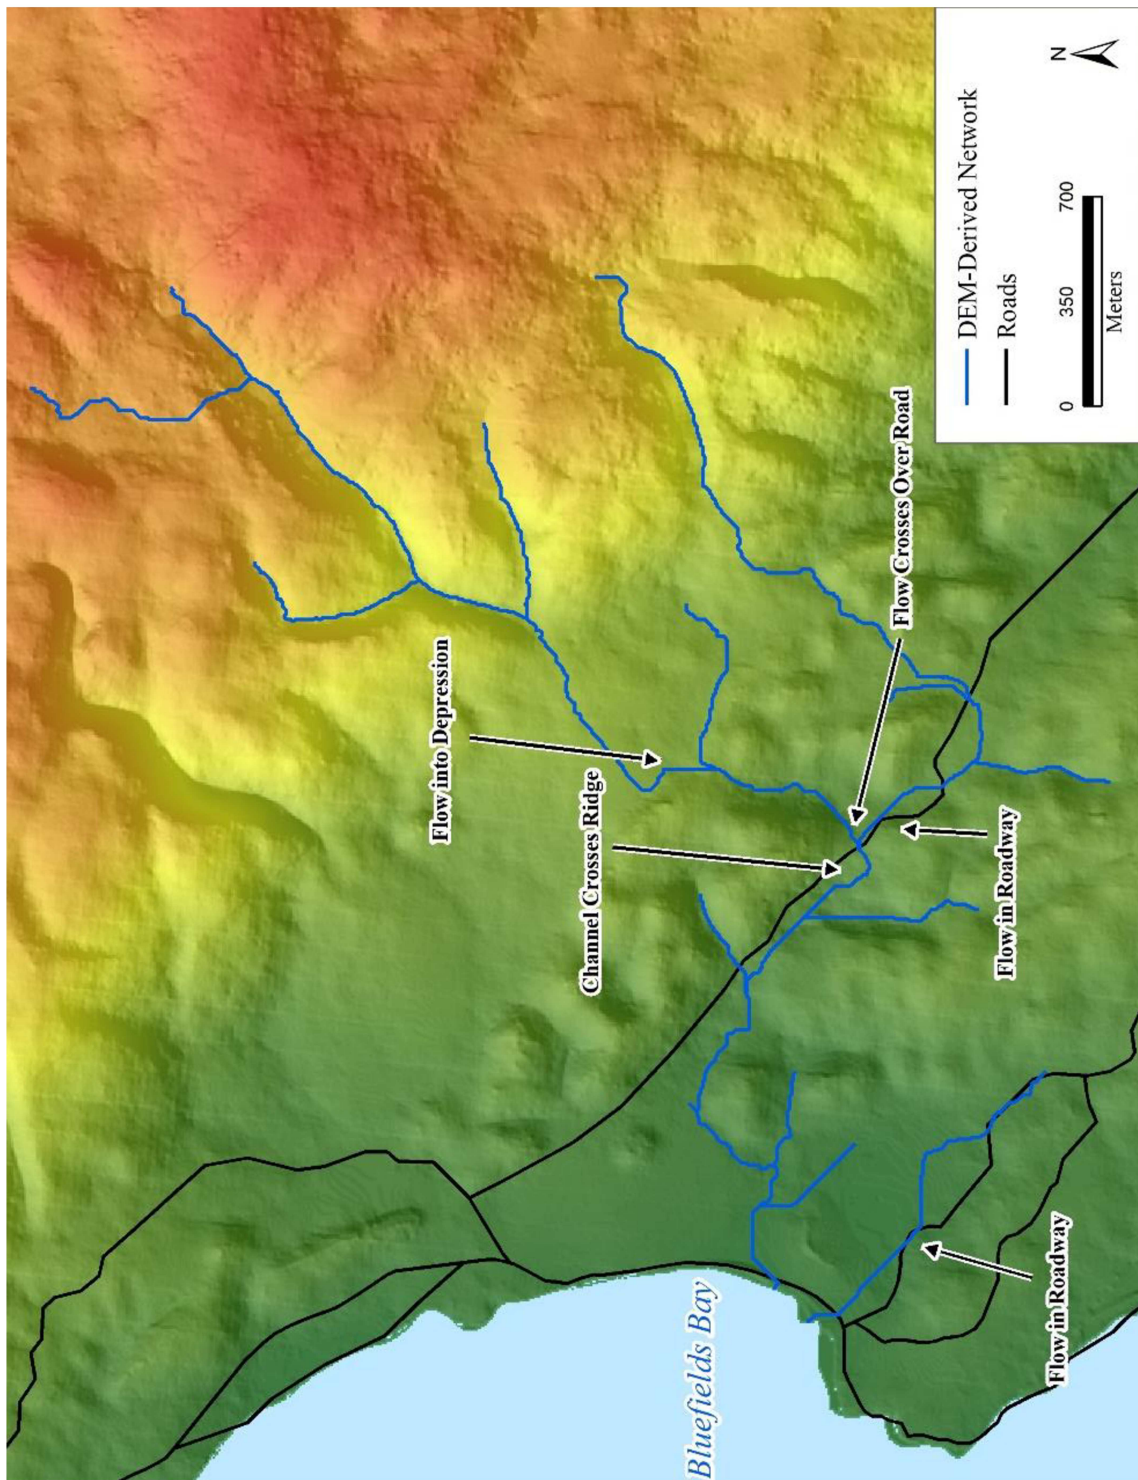
Figure 10. Flow network generated using the ACPF toolbox with selected errors noted

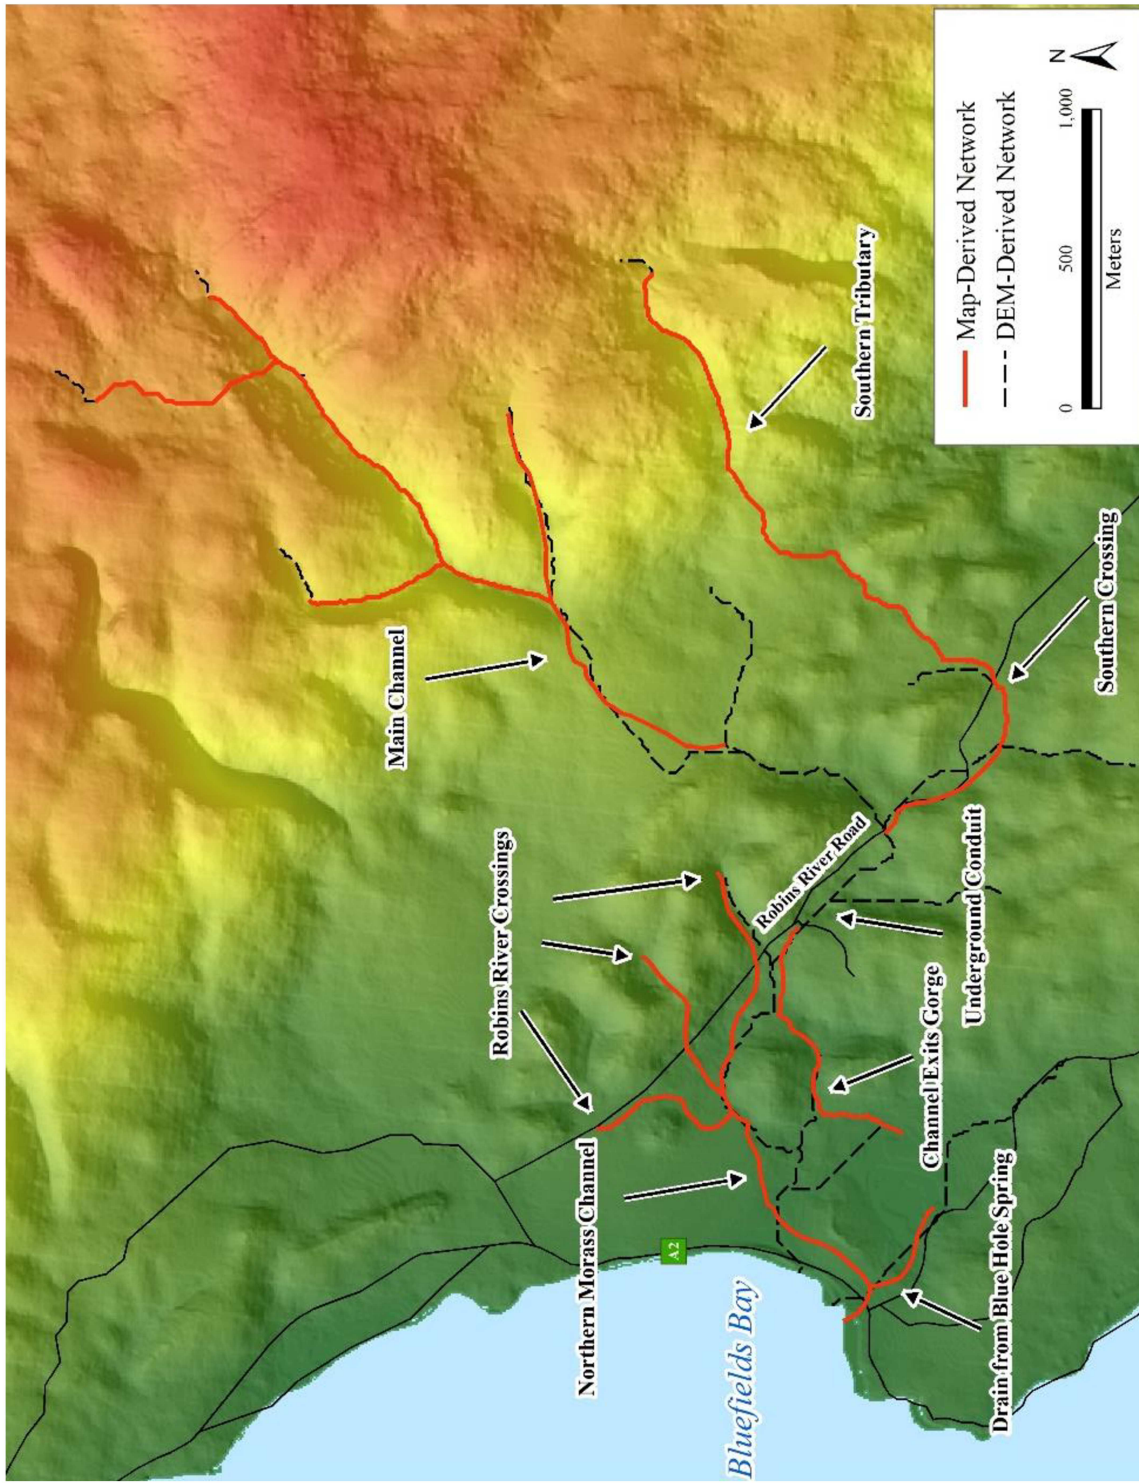
Figure 11. Flow network improvements made using comparisons to GIS raster layers

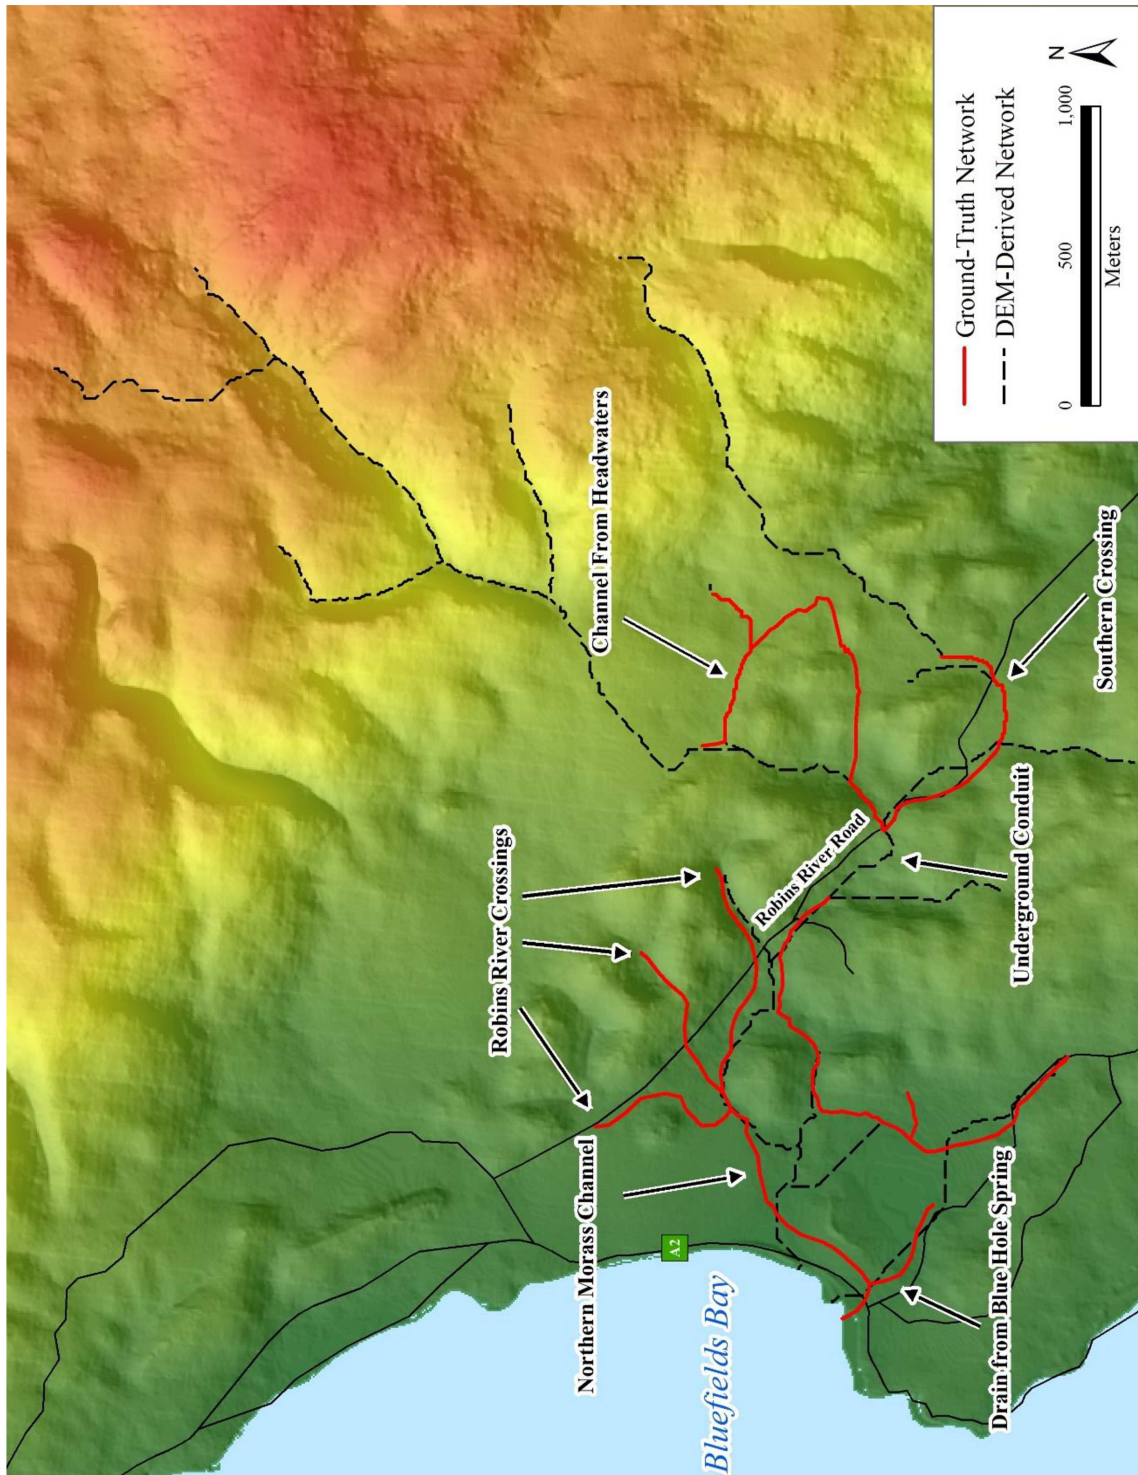
Figure 12. Flow network improvements made using GPS points from field surveys

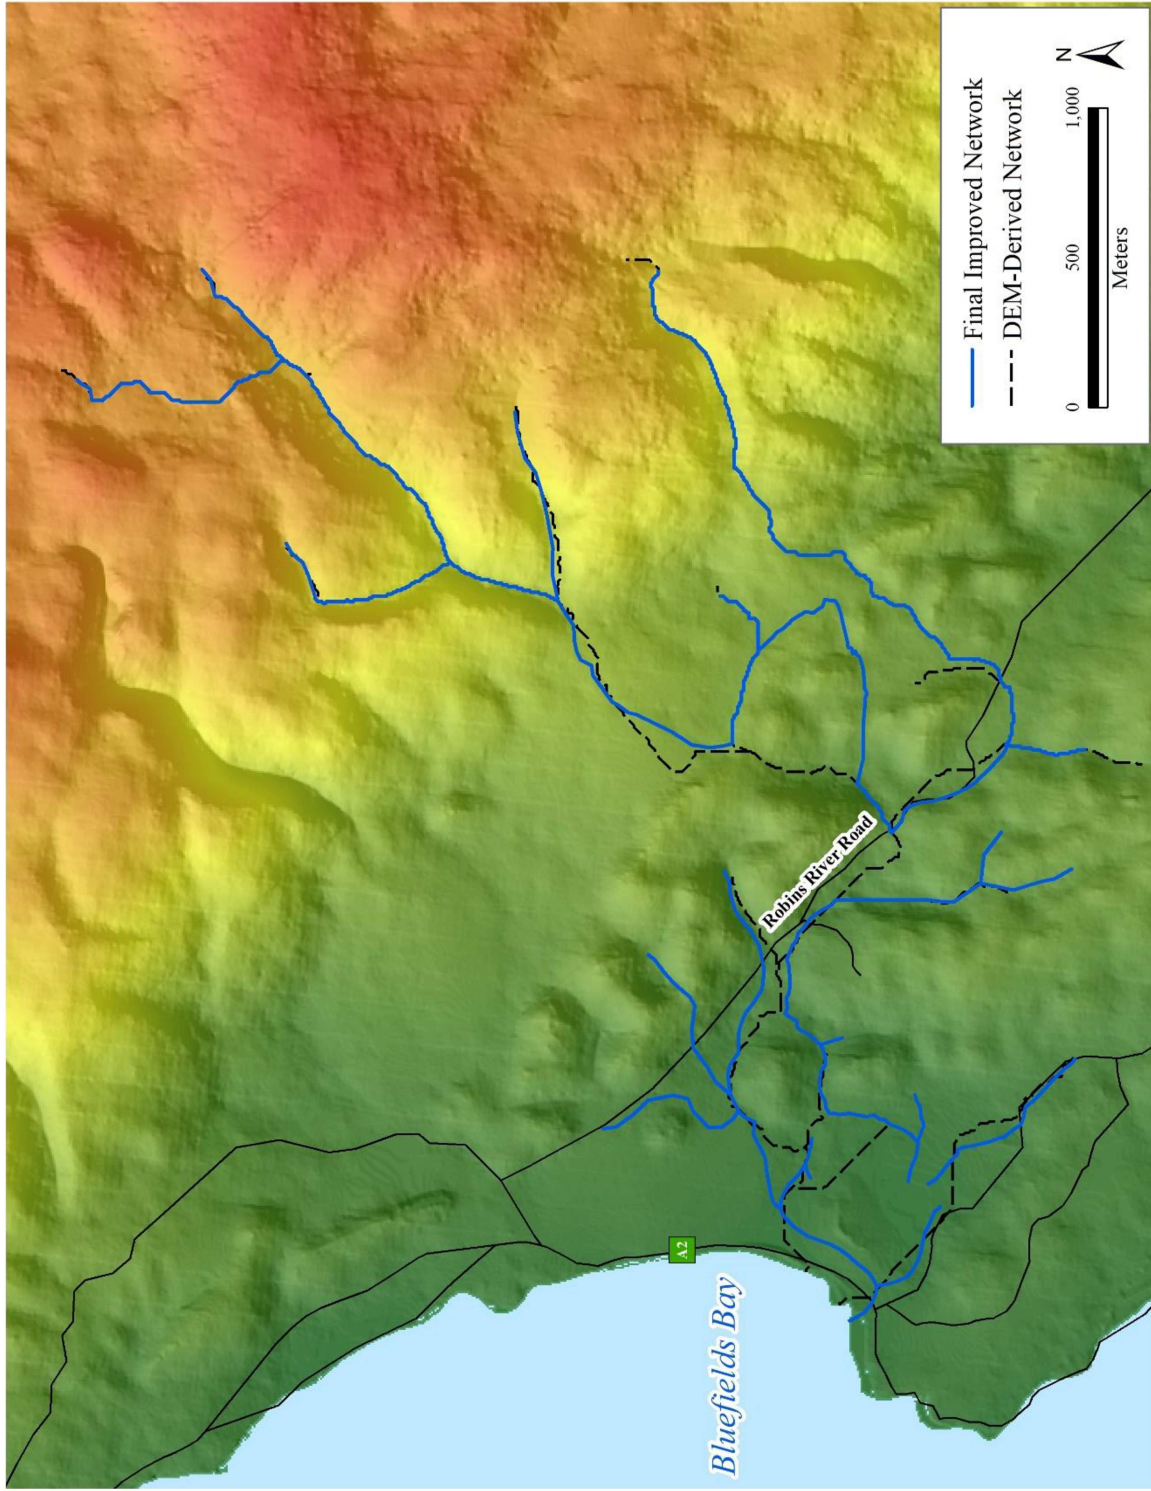
Figure 13. Final, improved flow network

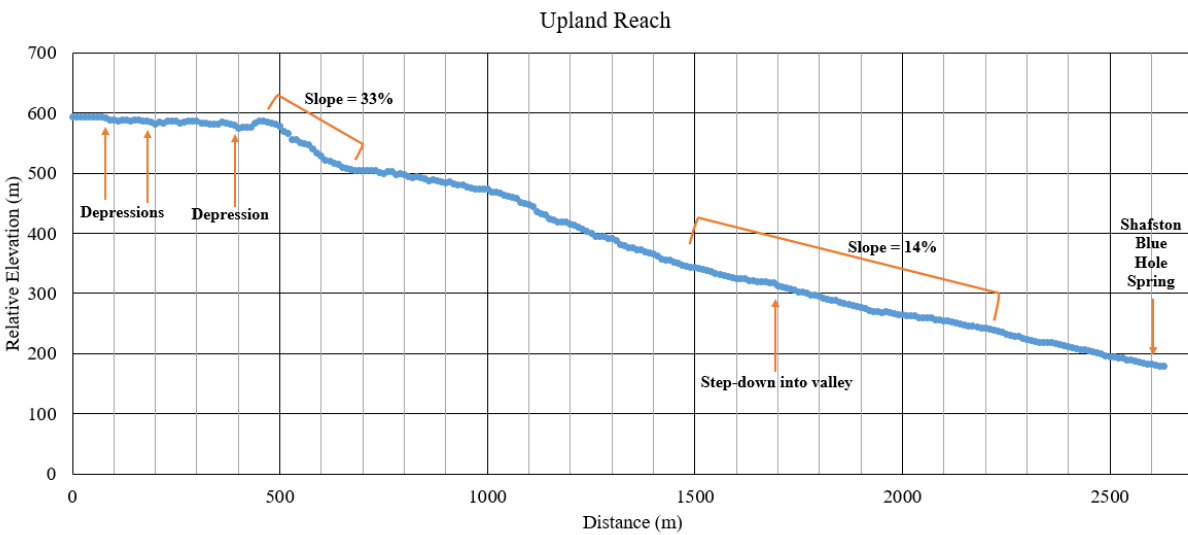
Figure 15. Longitudinal profile of the upland reach of the main channel

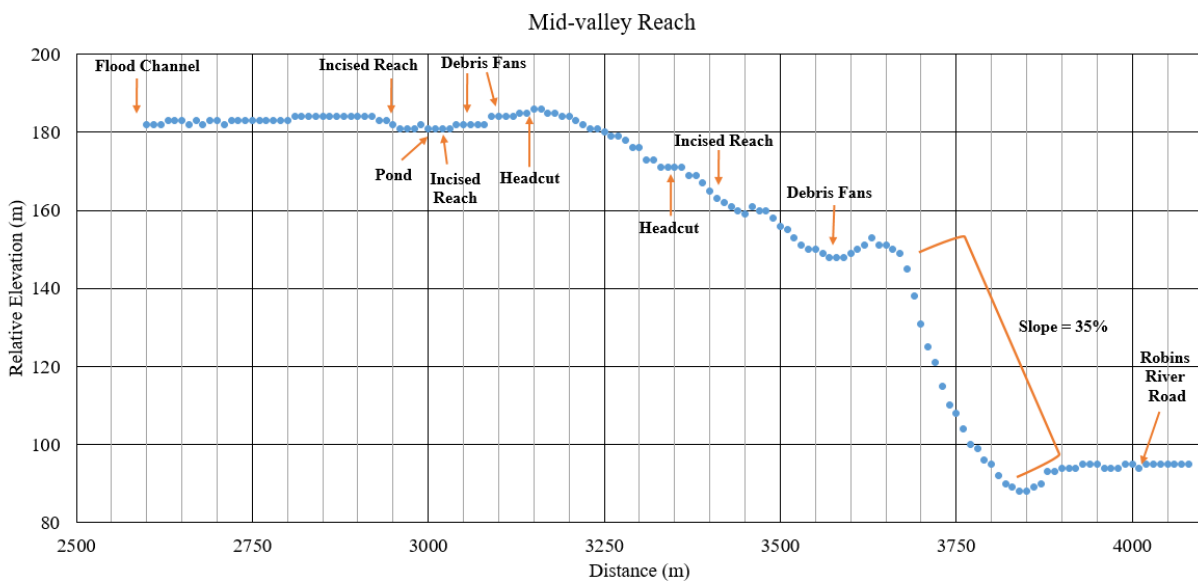
Figure 17. Longitudinal profile of the mid-valley reach of the main channel

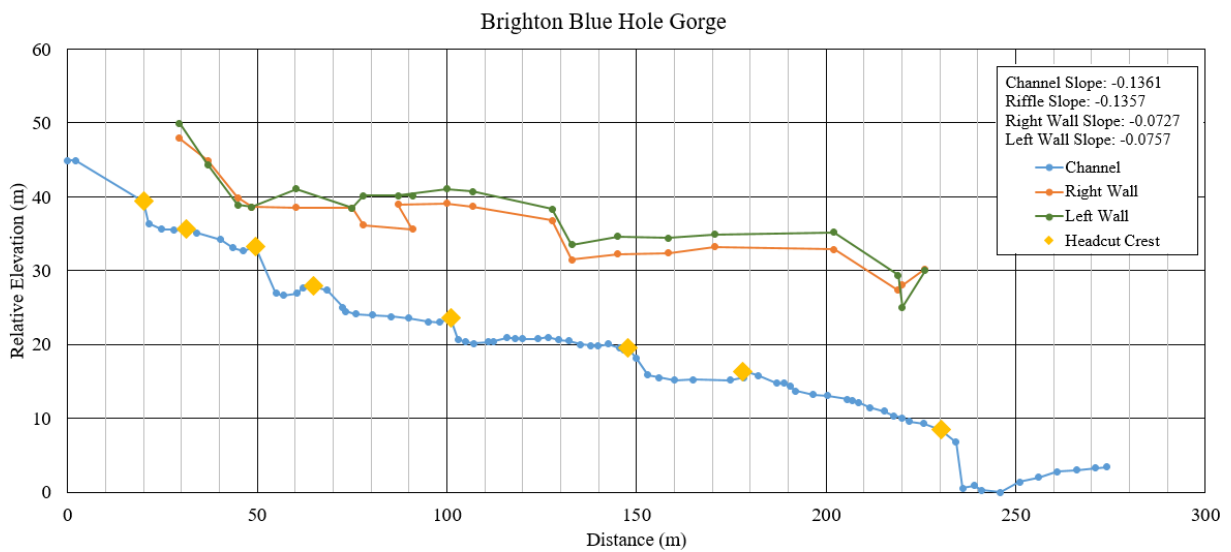
Figure 19. Longitudinal profile of Brighton-Blue Hole Gorge

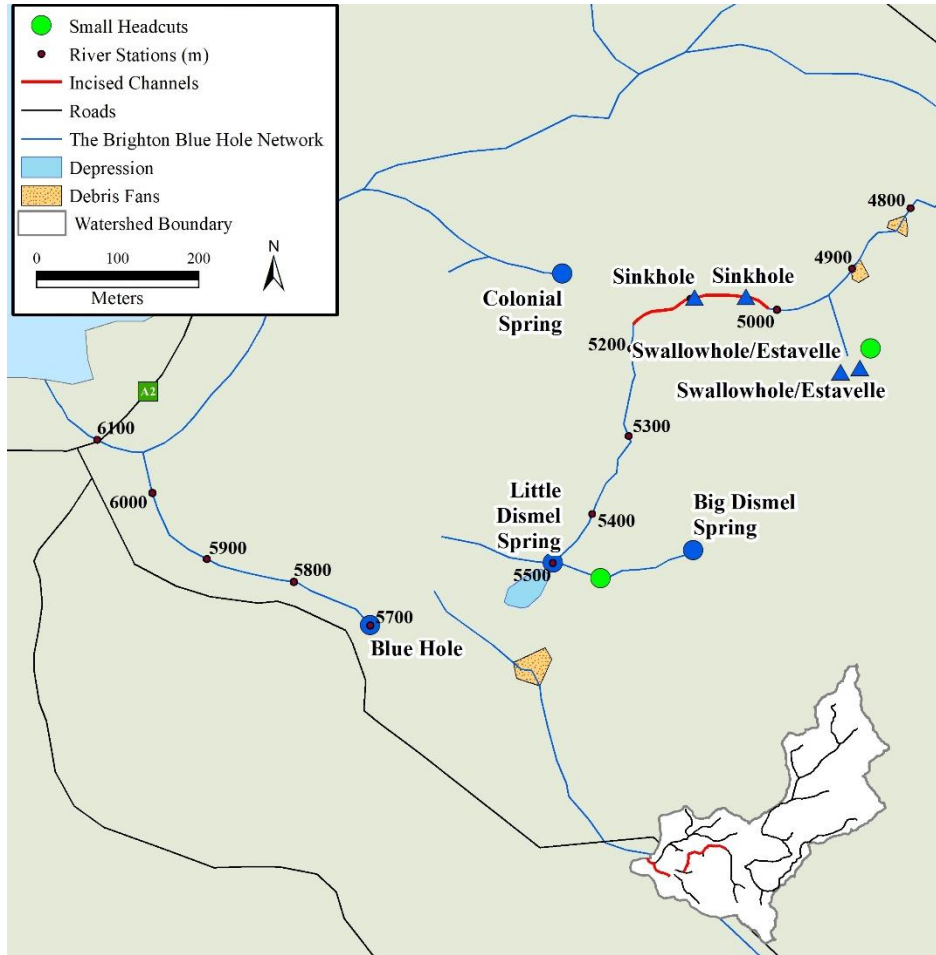
Figure 20. Location map of the coastal reach of the main channel

After the main channel leaves the Brighton-Blue Hole Gorge it flows onto the coastal plain (Fig. 20). There are headcuts much shallower than those found upstream, that are likely associated with migrating headcuts in fine sediment deposits left after the 1979 flood. Shallow

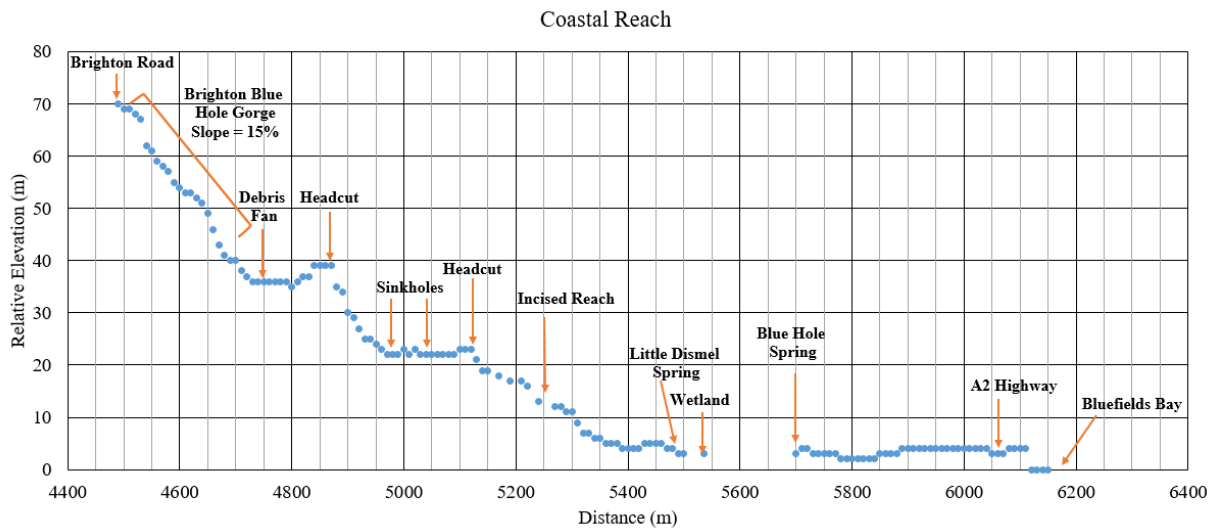
Figure 21. Longitudinal profile of the coastal reach of the main channel

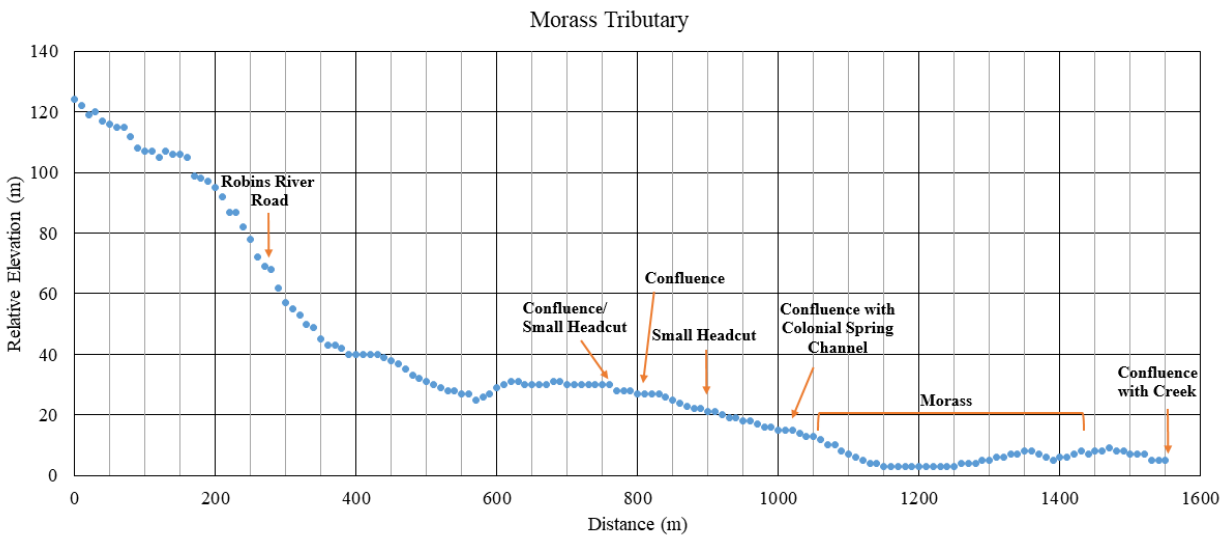
Figure 23. Longitudinal profile of Morass Tributary subwatershed

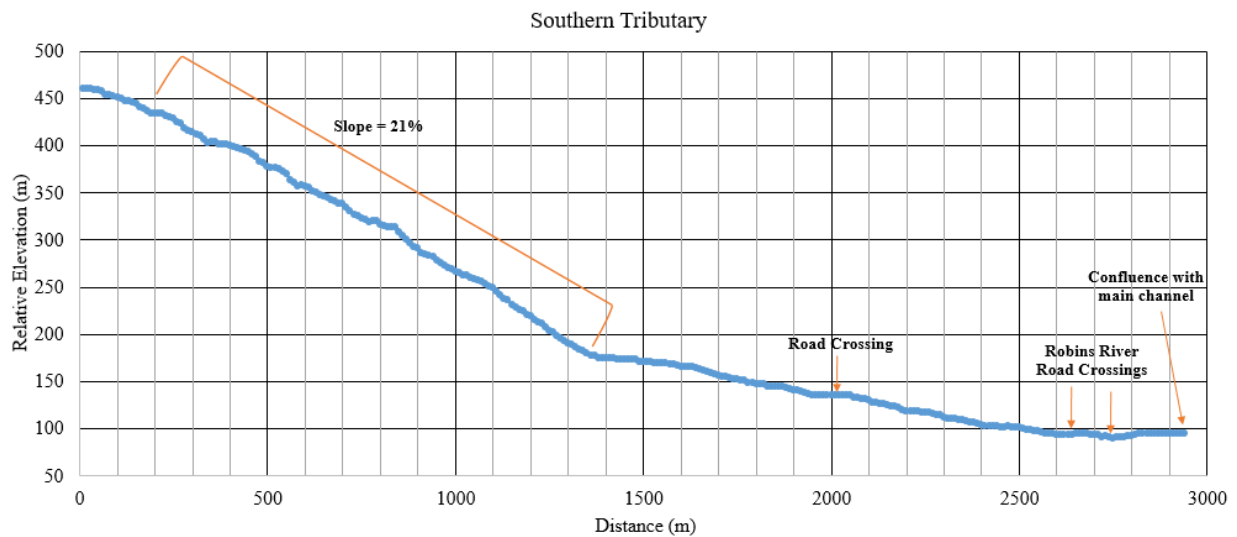
Figure 25. Longitudinal profile of Southern Tributary subwatershed

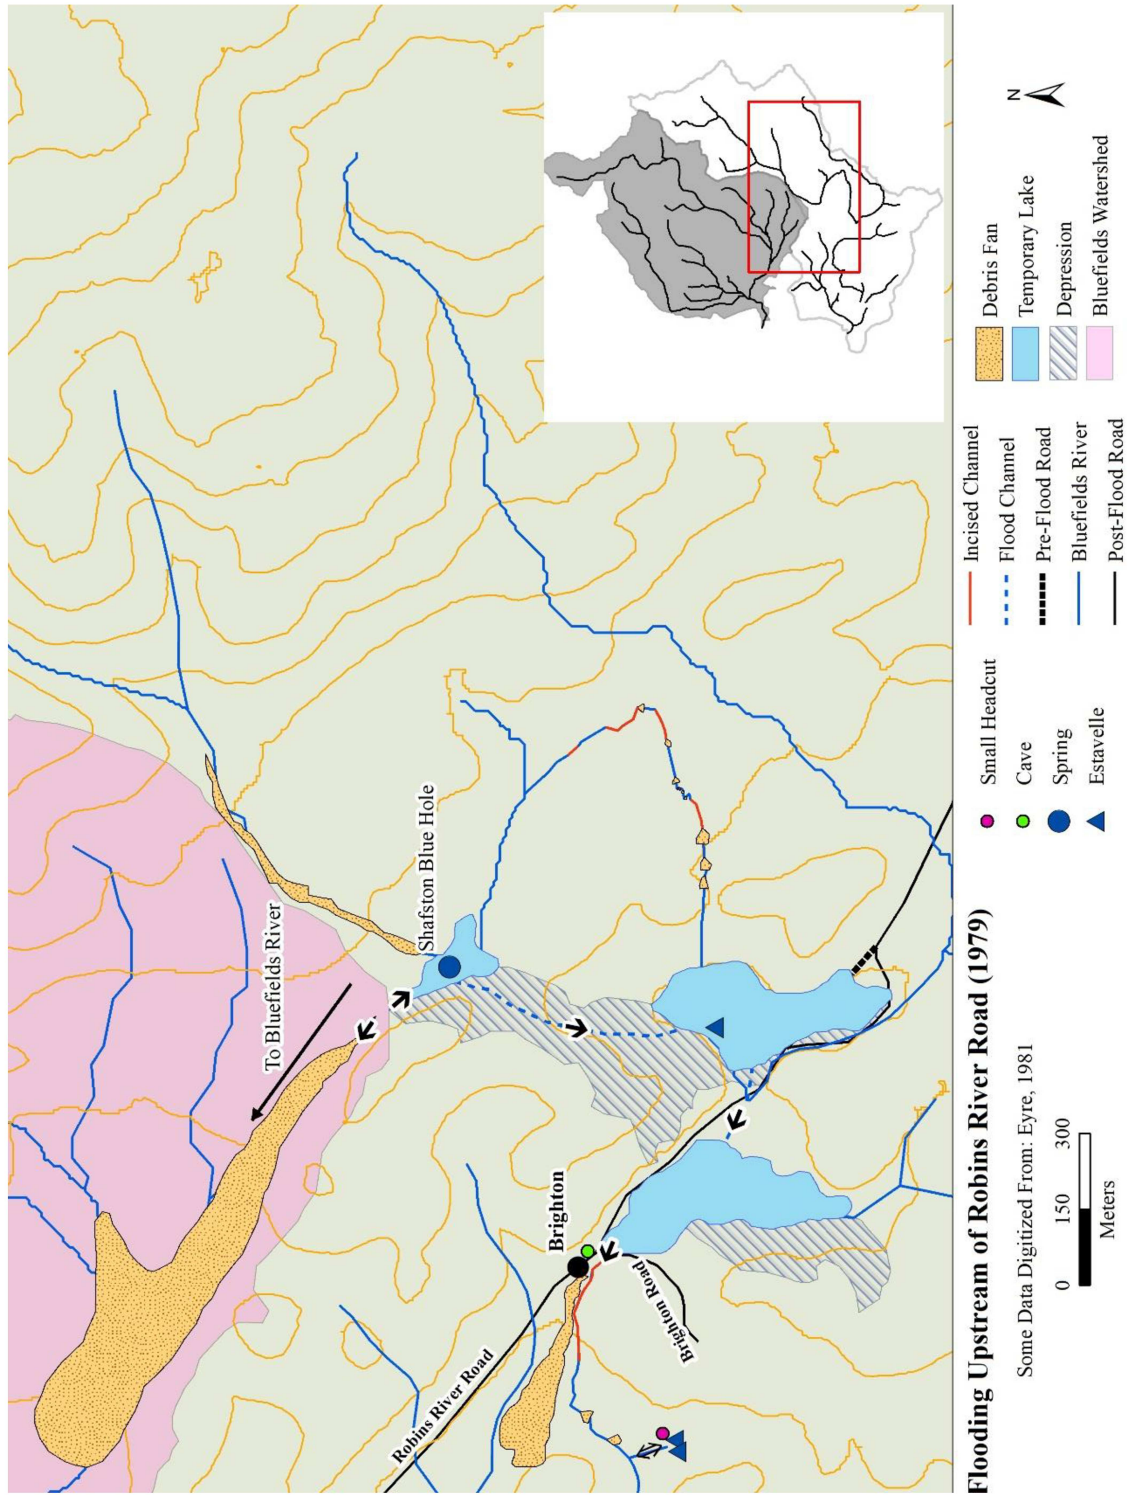
Figure 26. Flooding during the June 12, 1979 flood upstream of the Robins River Road

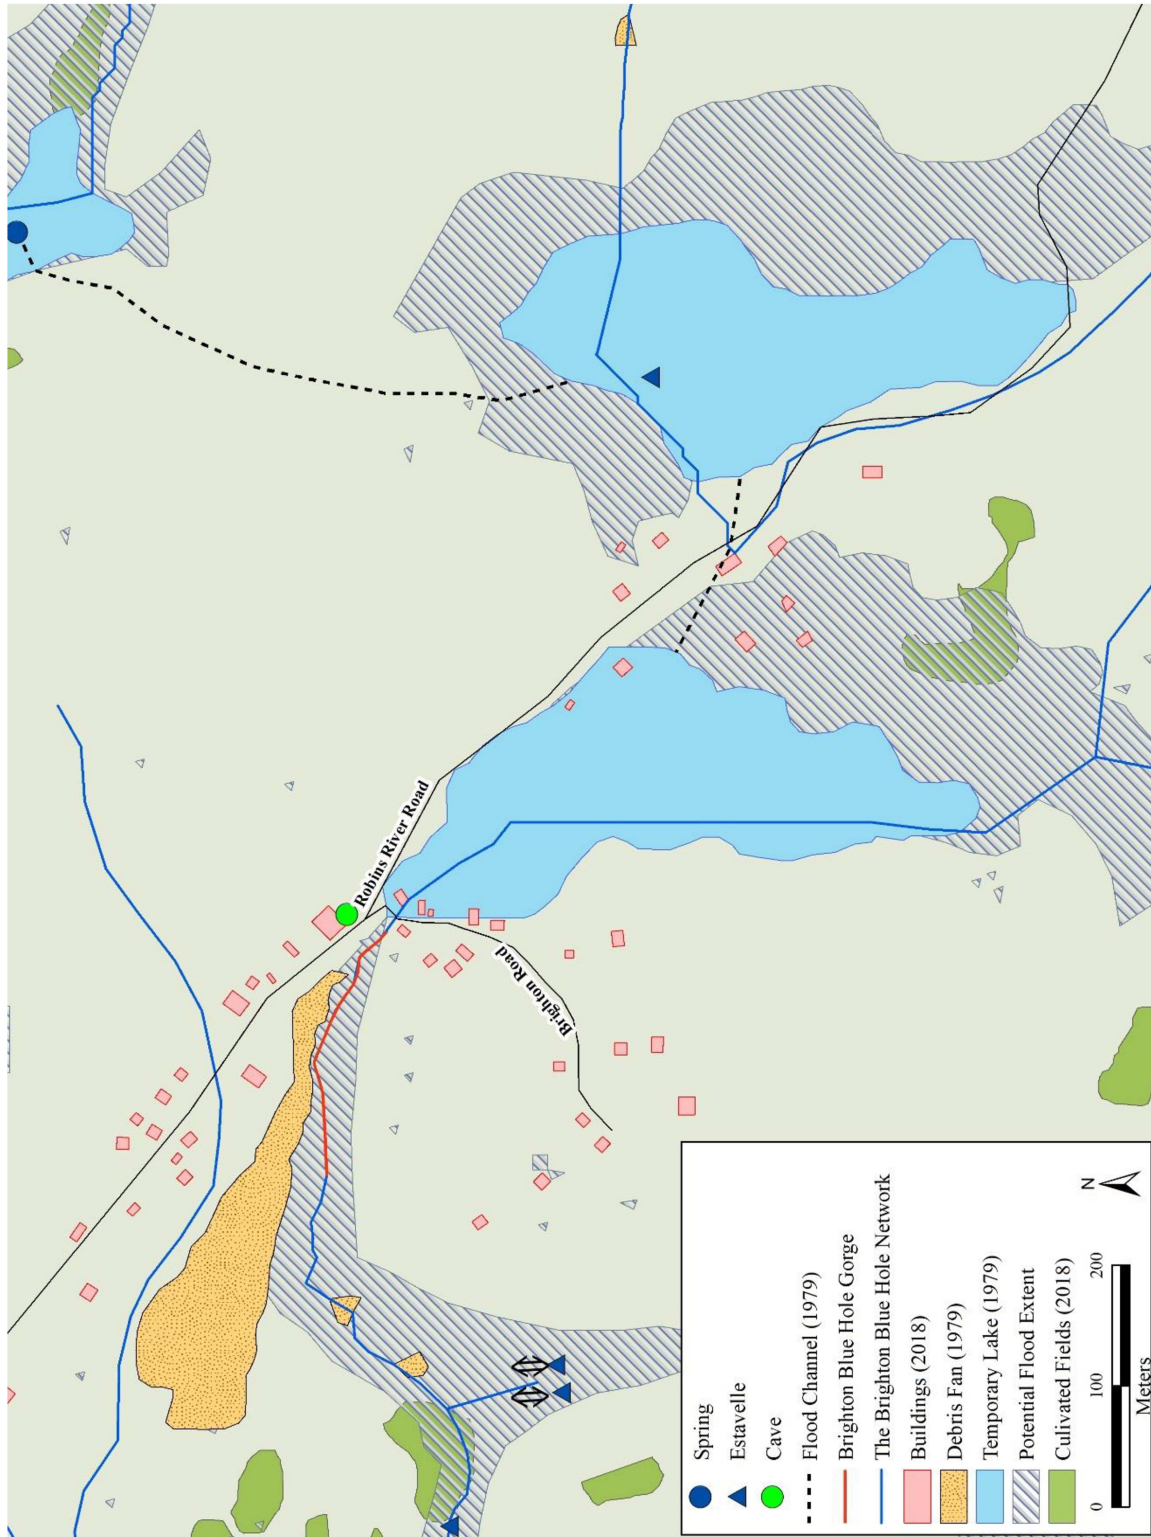
Figure 27. Flood risk map for the village of Brighton
