## Geomorphic Response to Catastrophic Flooding in a Karst Mountain Stream System, Brighton-Blue Hole Watershed, Southwest Jamaica

A Master's Thesis

Master of Science, Geospatial Sciences in Environmental Geology

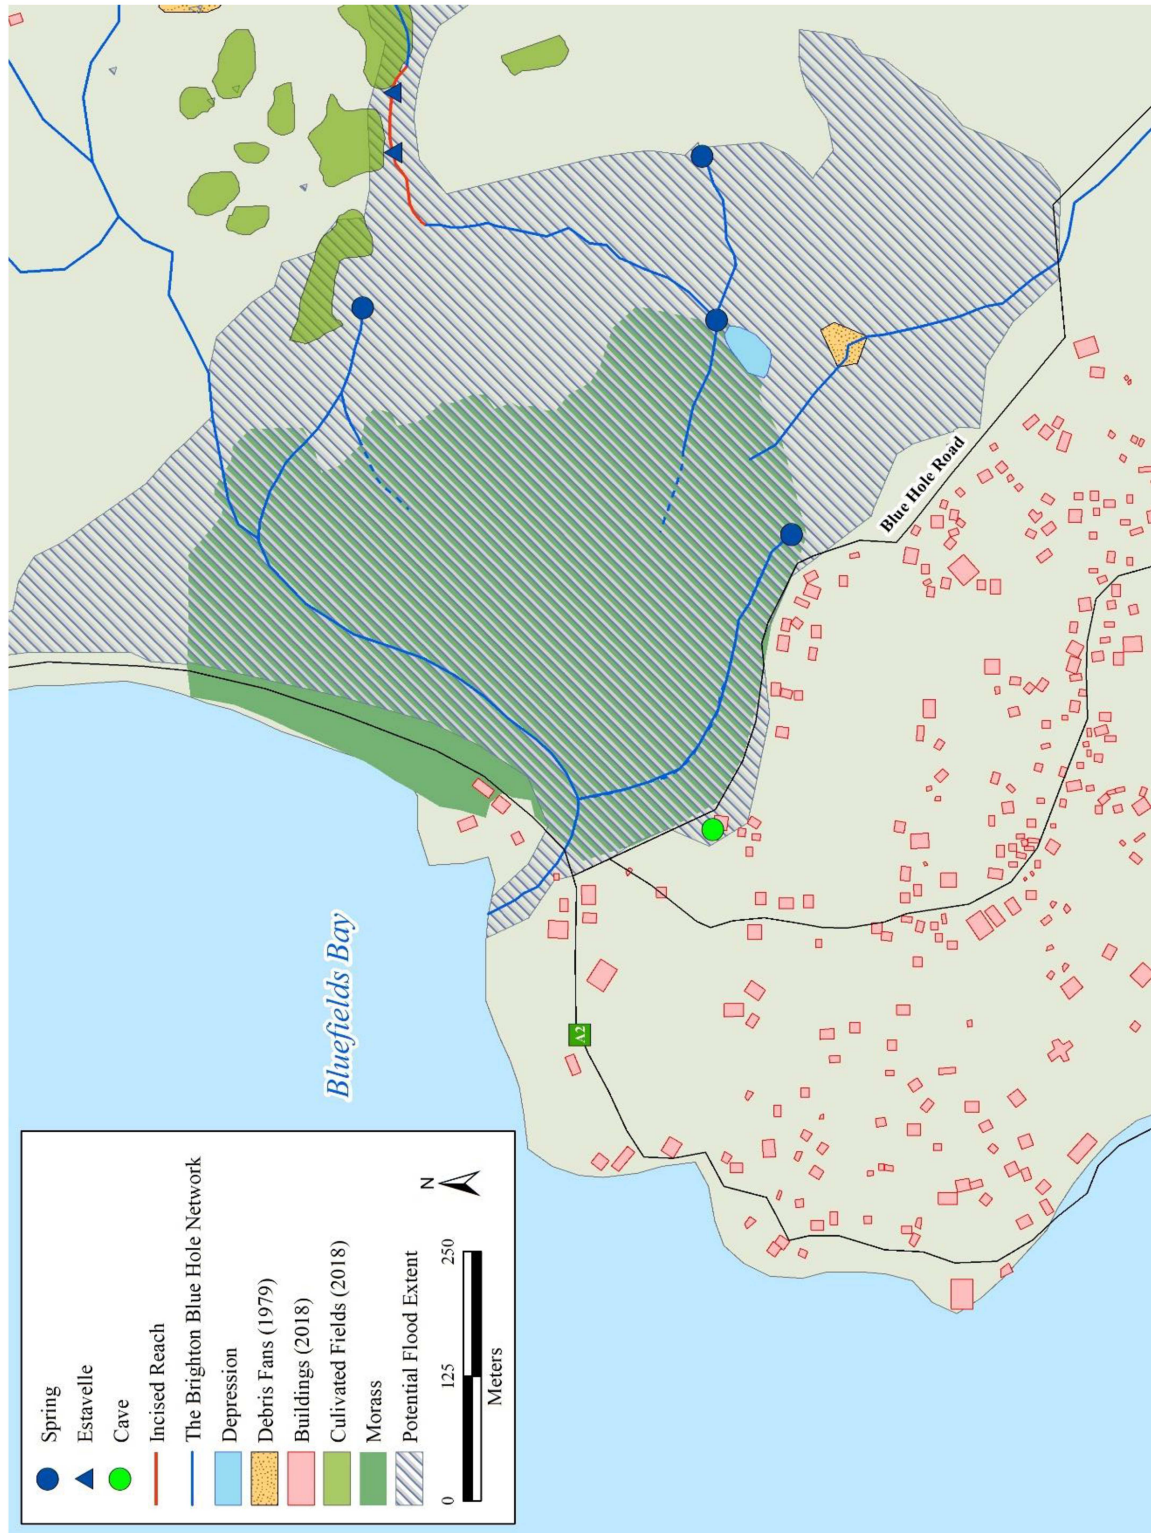
Figure 28. Flood risk map for the village of Belmont

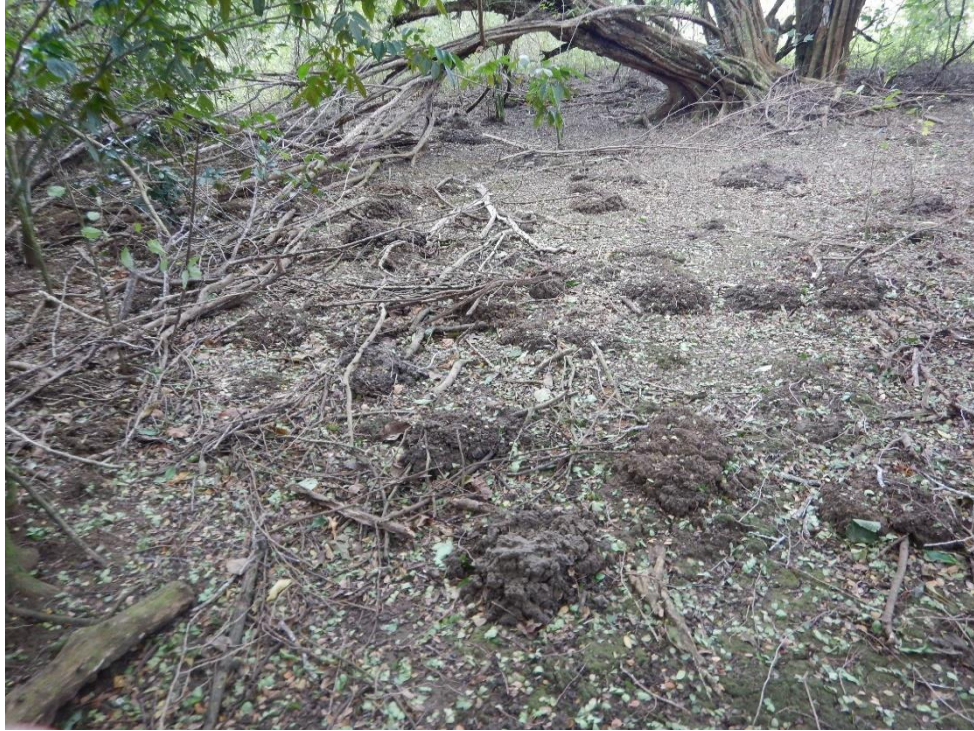
Appendix B-7. Point 4 – Depression, This Area Is Filled with Fine, Clay Sediment That Was Likely Deposited Here During the 1979 Flood

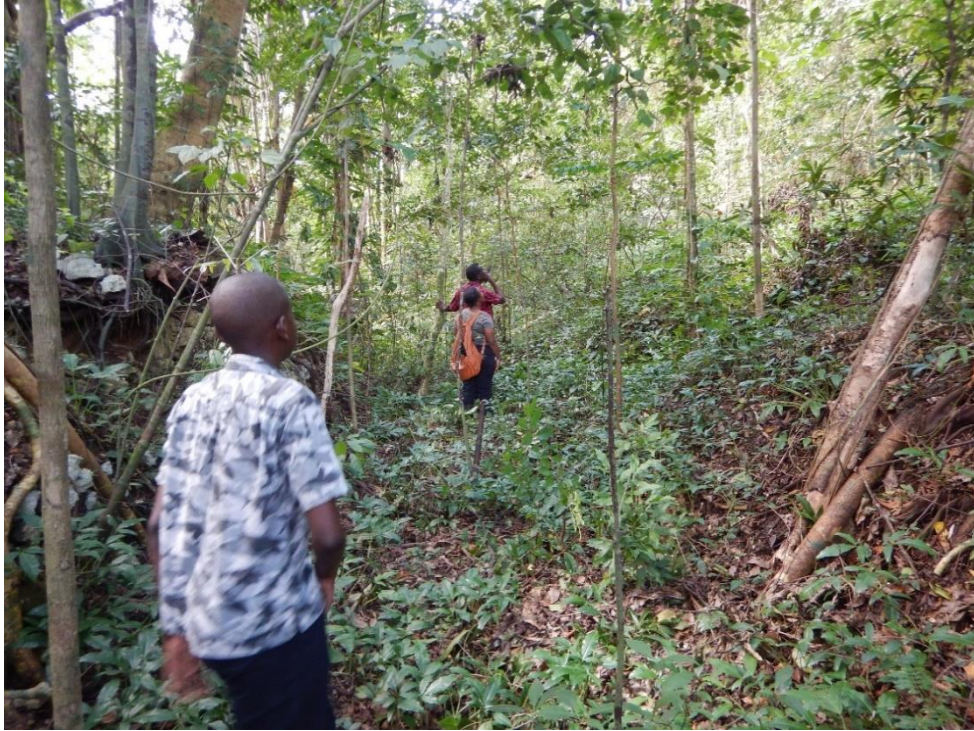
Appendix B-11. Point 8 – Incised Channel Downstream of Lower Sinkhole. This Reach Incised 3 M and Delivered Fine Sediment to the Little Dismel Spring and Wetland

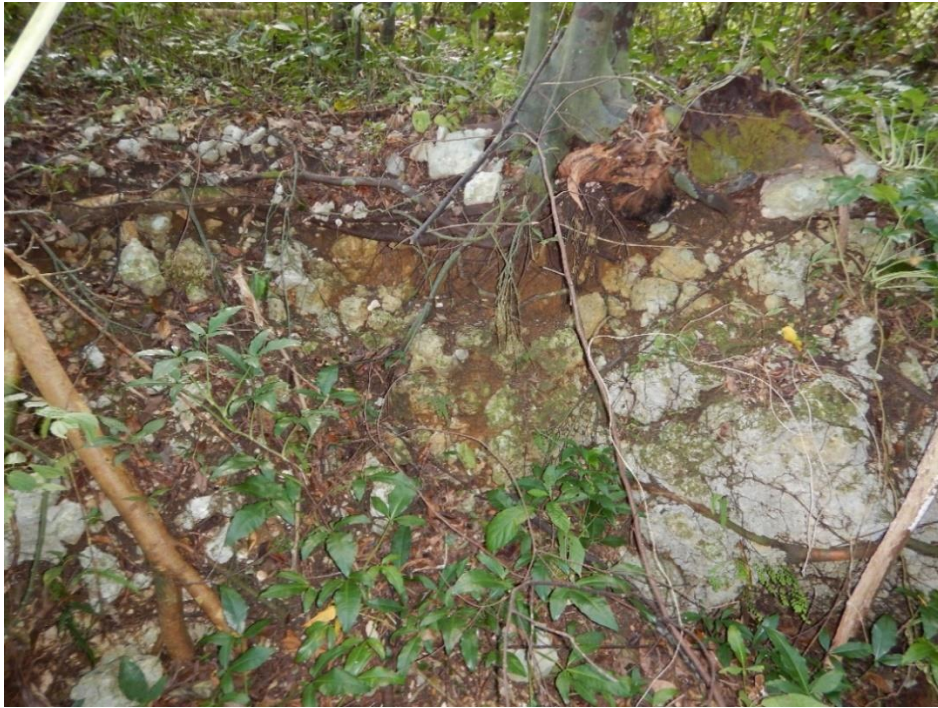
Appendix B-12. Point 9 – Bedrock Wall on Left Bank of Incised Channel, Fine Sediment Within the Channel Was Eroded in 1979

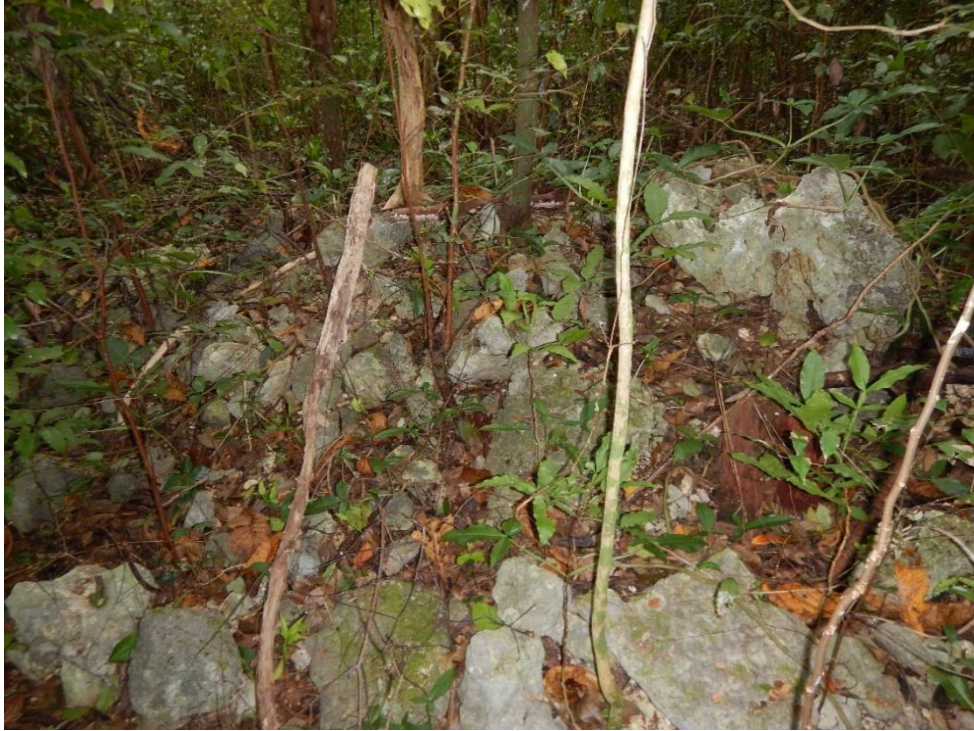
Appendix B-17. Point 14 – Boulder Bar, This Debris Flow Is Made up of Large Boulders Which Were Likely Moved from the Brighton-Blue Hole Gorge 50 m Upstream.

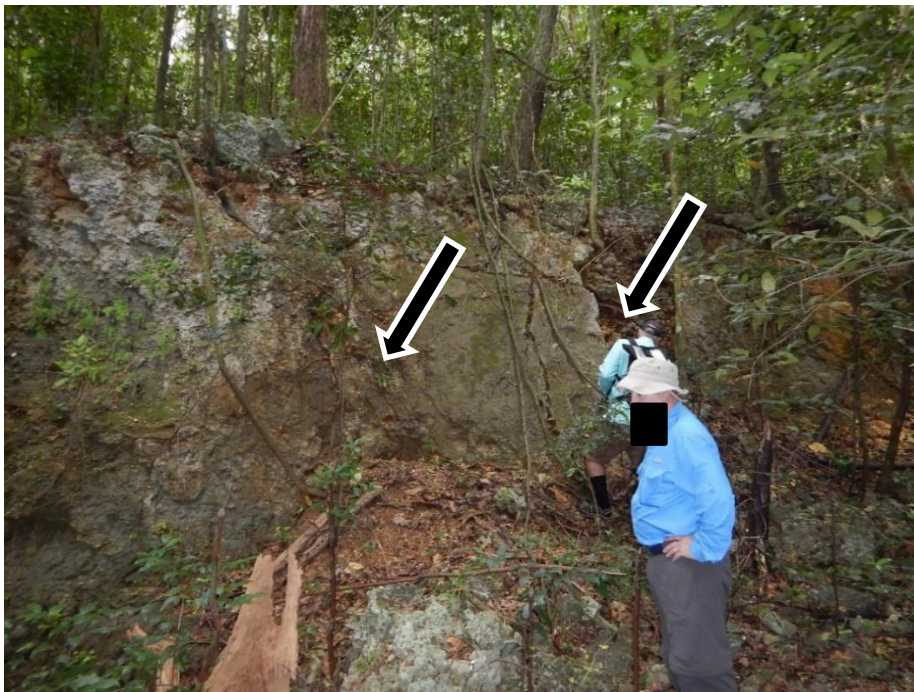
Appendix B-18. Point 15 – The Gorge Wall of the Brighton-Blue Hole Gorge, Noted Fractures Indicate Structural Control of This Landform

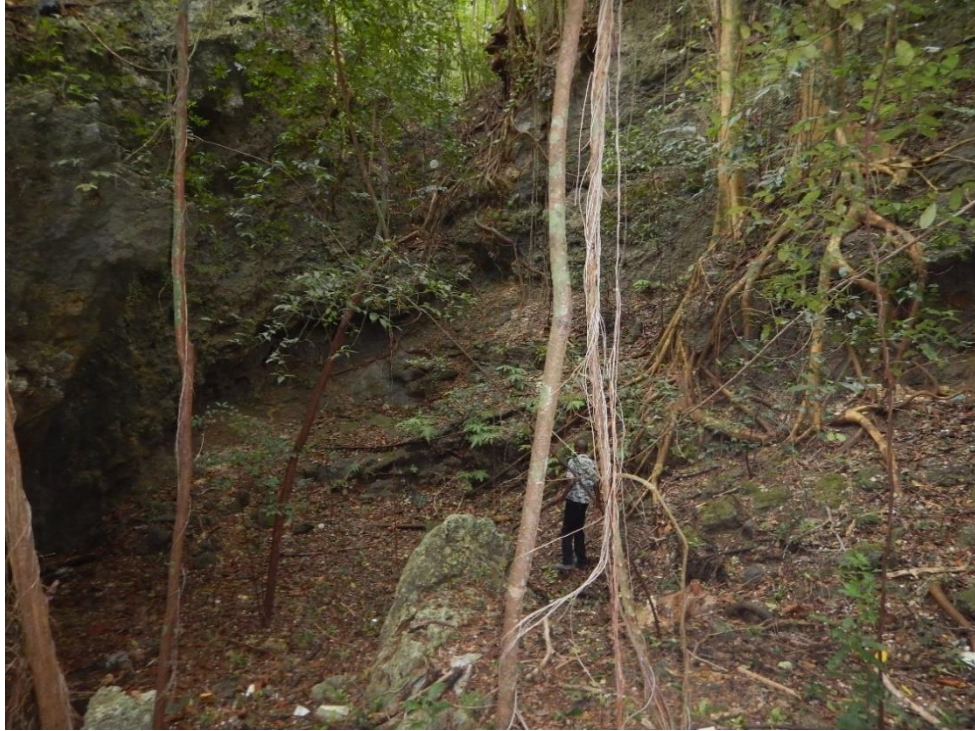
Appendix B-19. Point 16 – Headcut/bedrock Knickpoint Within the Brighton-Blue Hole Gorge Facing Upstream from the Bottom of Pool 7, a Difference of 9 m

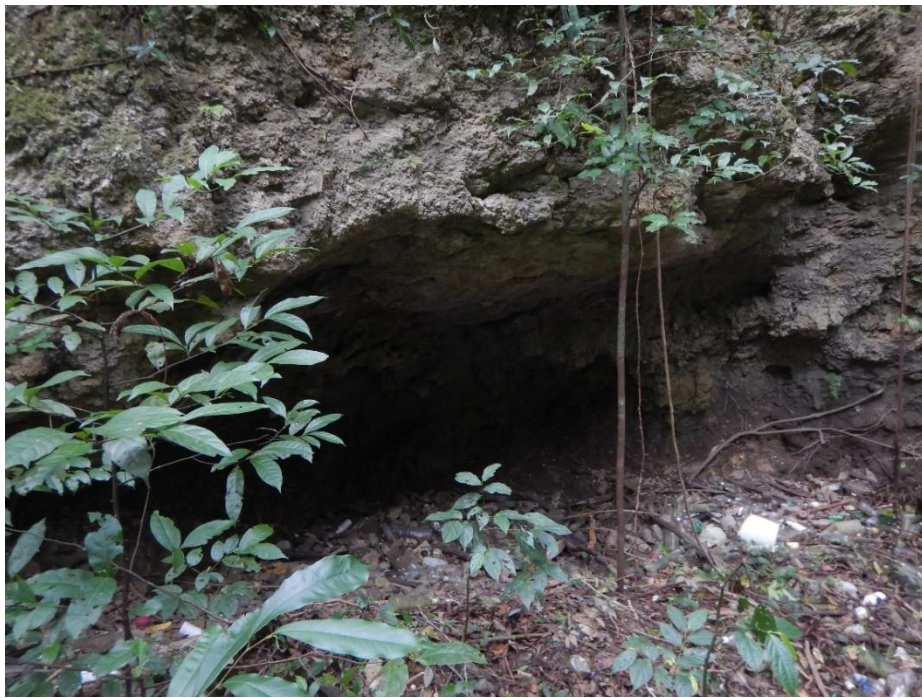
Appendix B-20. Point 17 – A “Scour Cave” on the Wall of the Brighton-Blue Hole Gorge Is an Erosional Feature Which Indicates the Removal of Wall Material Along Fractures

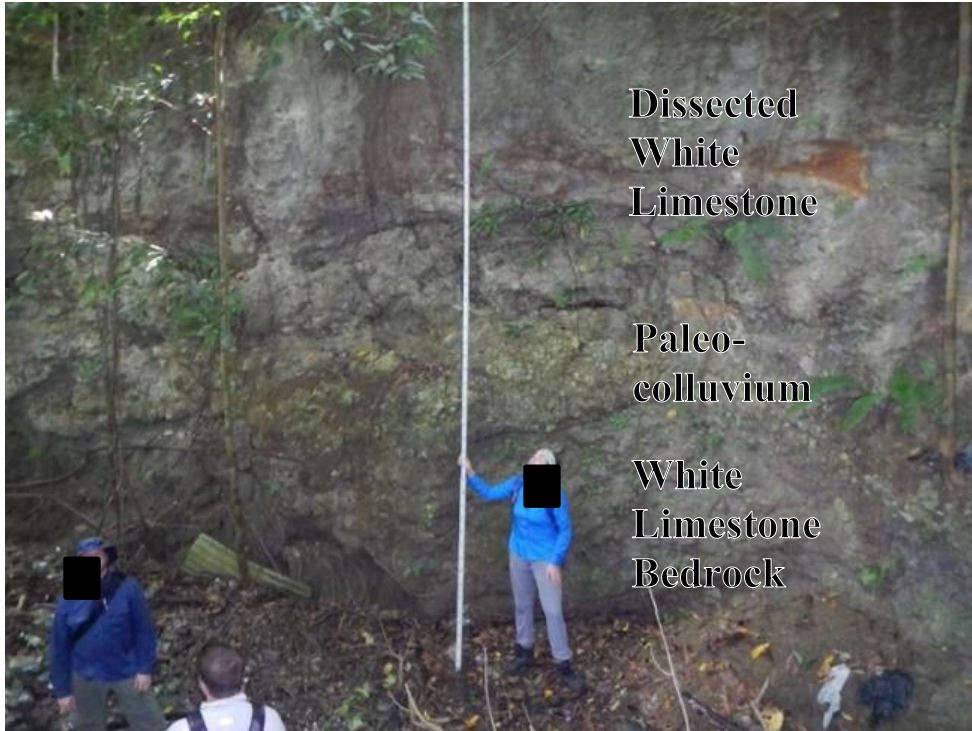
Appendix B-21. Point 18 – Brighton-Blue Hole Gorge Wall, Walls Are Made up of Limestone Bedrock Which Is Difficult to Erode Layered with More Friable Material

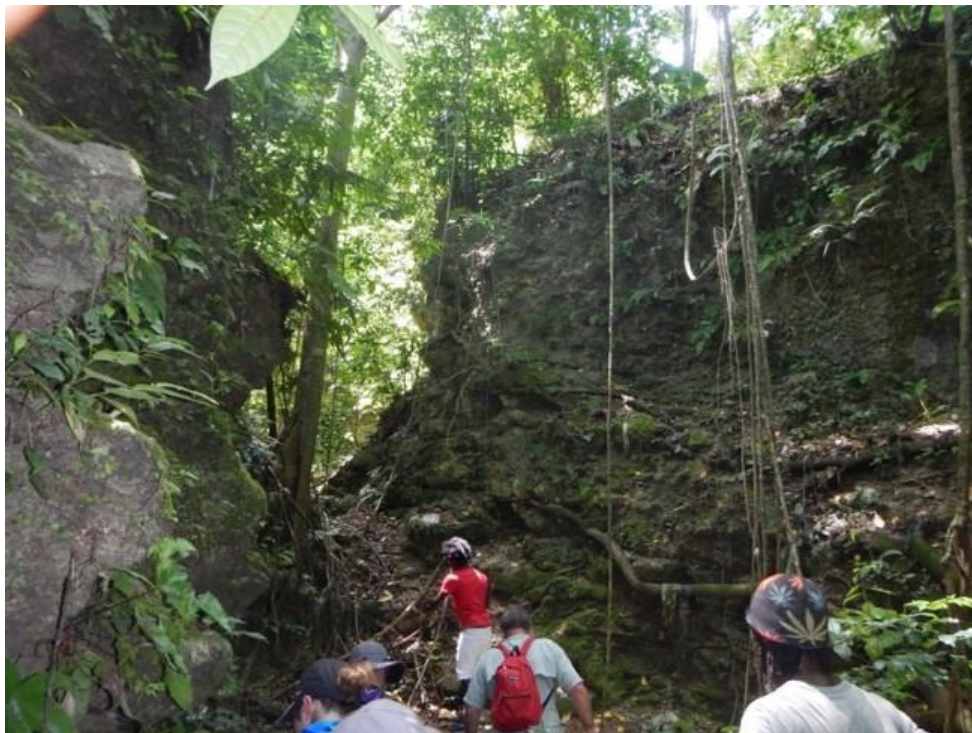
Appendix B-22. Point 19 – Brighton-Blue Hole Gorge Headcut Facing Downstream from the Bottom of Pool 3, a Difference of 5 m

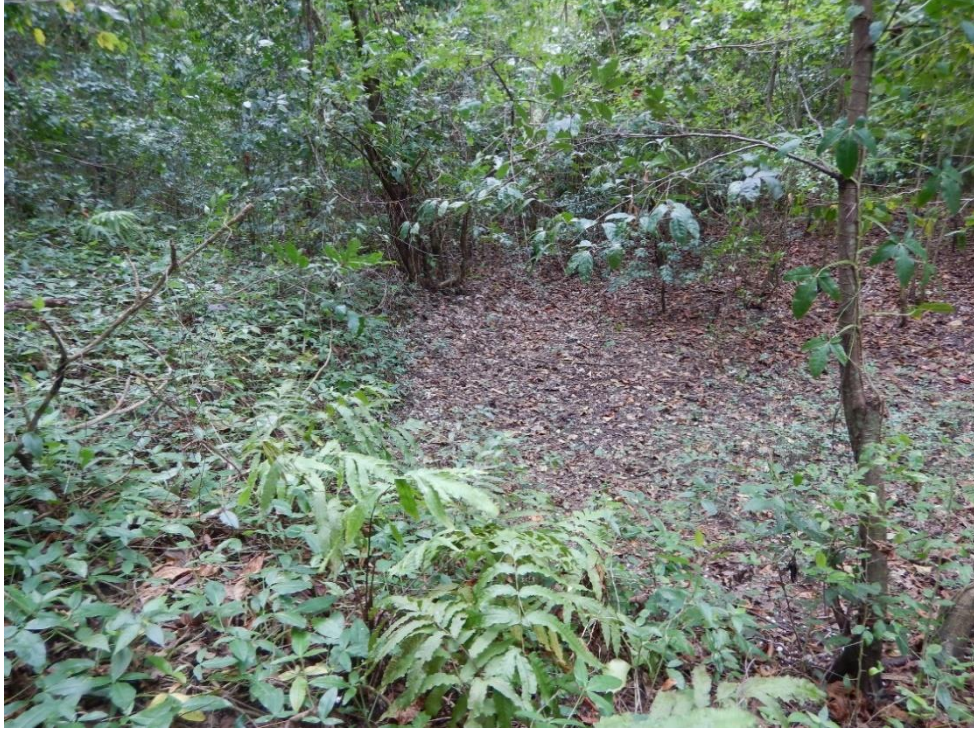
Appendix B-29. Point 24 – Estavelle Directly Upstream of Robins River Road Which Contributed to Overfilling in the Polje Valley It Drains

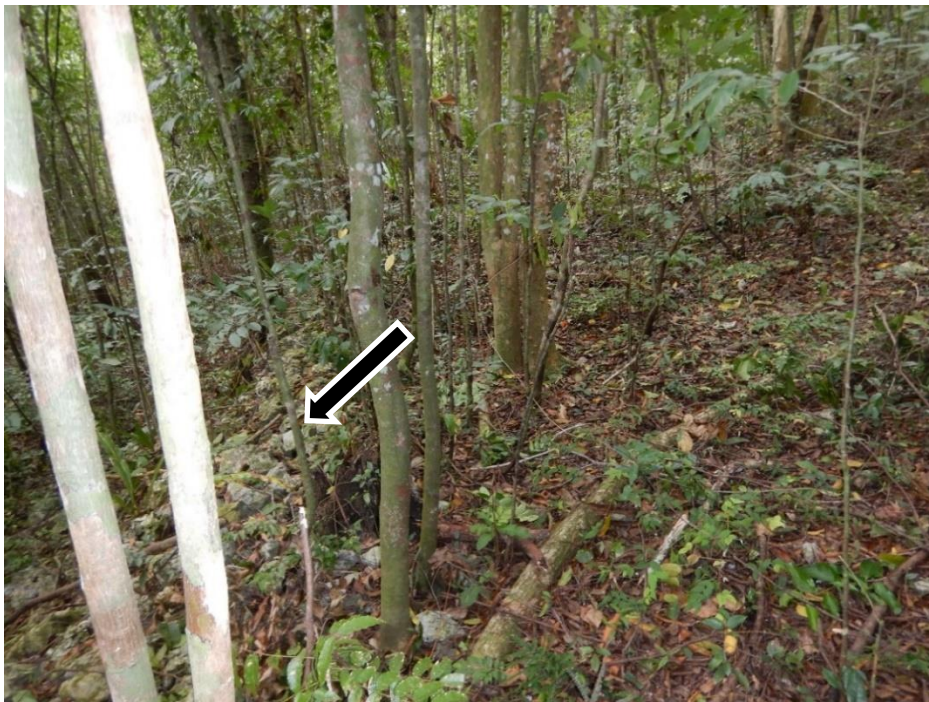
Appendix B-30. Point 25 – Channel/Boulder Bar, the Coarse Material Deposited Here Was Generated by Incised Channels Flowing Through Bonnygate and Union Hall Soils

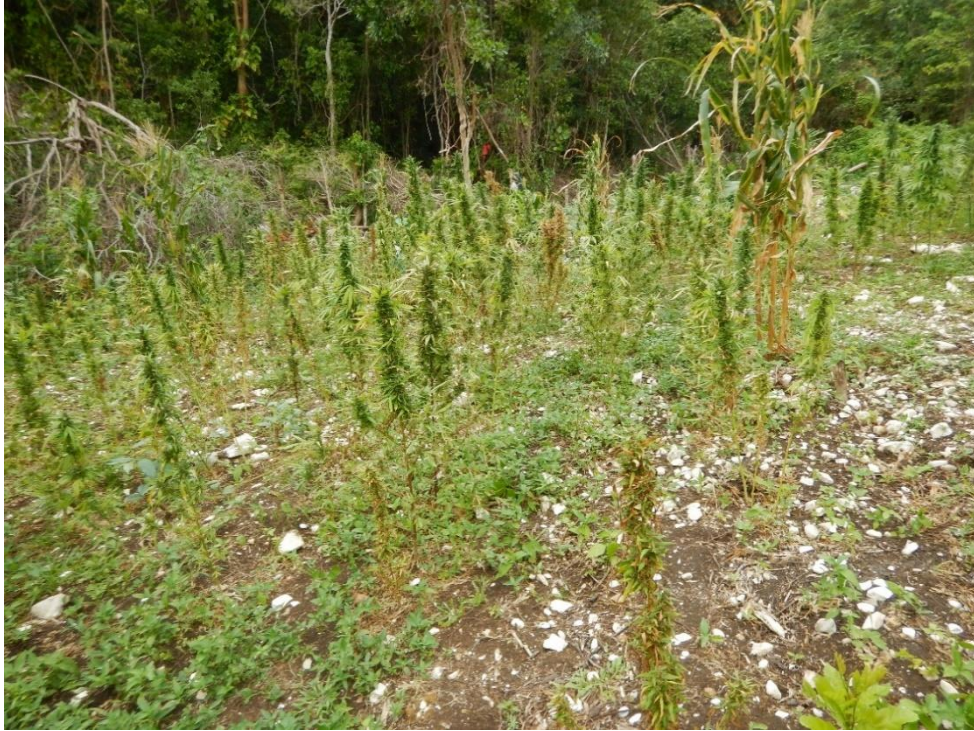
Appendix B-33. Point 28 – A Debris Fan Composed of Unsorted Fine and Coarse Sediment. These Fans Are Used as Isolated Farm Fields Today

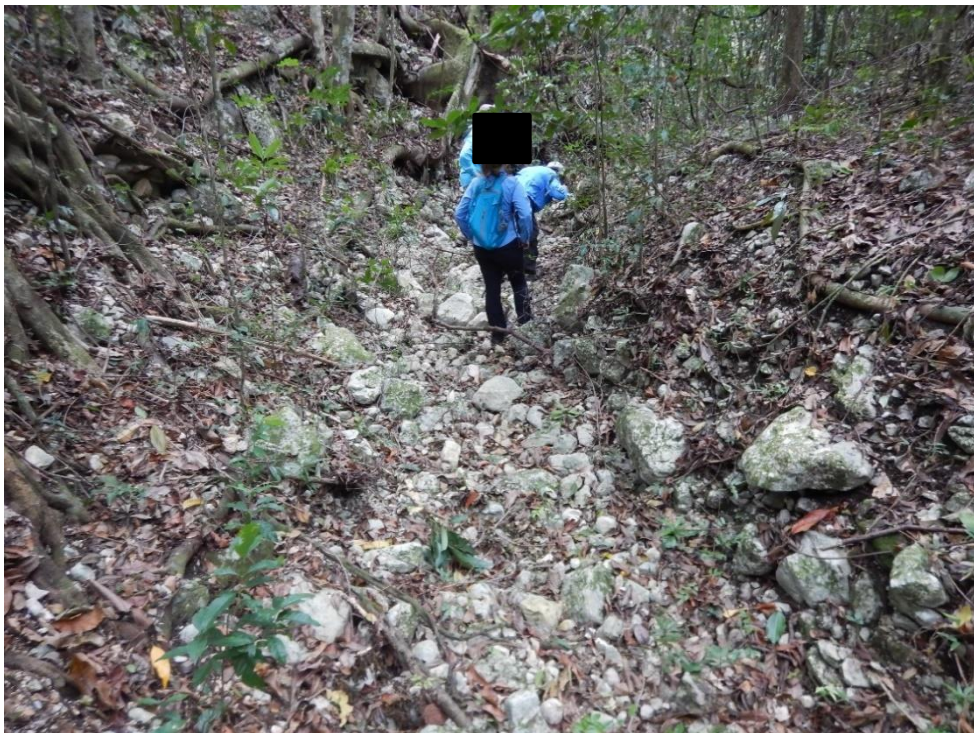
Appendix B-34. Point 29 – Incised Channel in Coarse Material Delivered Large Clasts to Boulder Bars Downstream

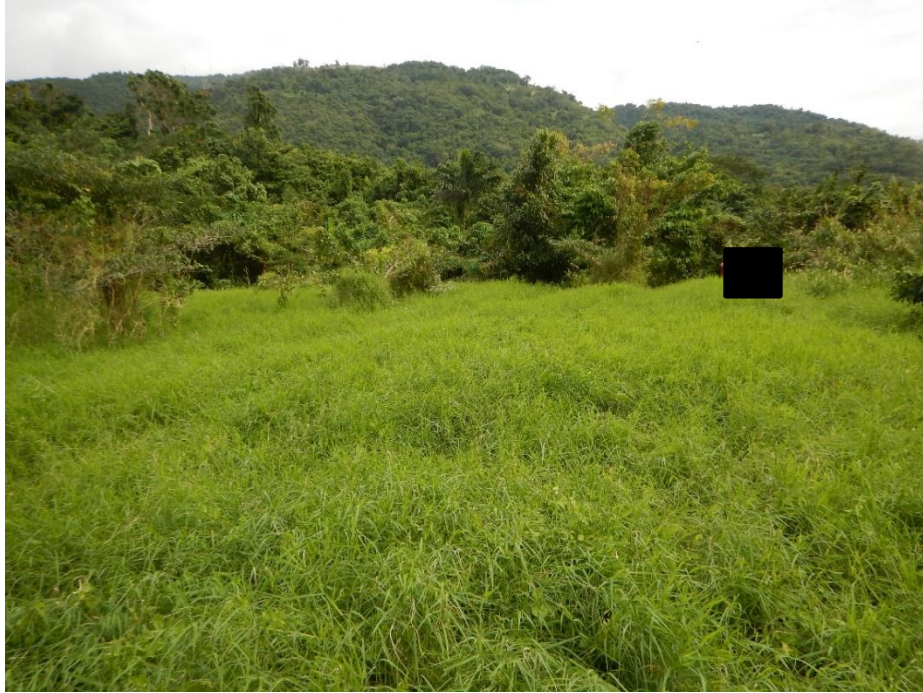
Appendix B-39. Point 34 – The Depression of the Shafston Blue Hole Spring. the Spring Is No Longer Visible at the Surface and May Have Been Filled with Sediment in 1979
