Climate change has increased the frequency of large floods in rivers draining in the Ozark Highlands resulting in higher rates of channel sedimentation, bank erosion, and damage to infrastructure. However, the effects of flood events on riparian forests in the Ozark Highlands are not well understood. This study assesses the effects of a large flood (> 500-year recurrence interval) during April-May 2017 on riparian forests on the North Fork of the White River, Missouri. Two post-flood (August 2017 and March-August 2021) field surveys were conducted to assess patterns of riparian forest damage, mortality, and recovery. Initial post-flood riparian tree mortality was 43% of 511 trees surveyed. Repeat surveys in 2021 showed mortality increased to 79%. Additionally, patterns in canopy cover and forest damage were examined spatially and temporally through ArcGIS and aerial imagery. Post-flood canopy cover was reduced to 17% of the pre-flood extent, increasing to 37% in 2020. Damage patterns are related to landform with recovery rates increasing downstream from head to tail of a large bar-floodplain complex. This information can be used to understand ecological disturbance by floods and to

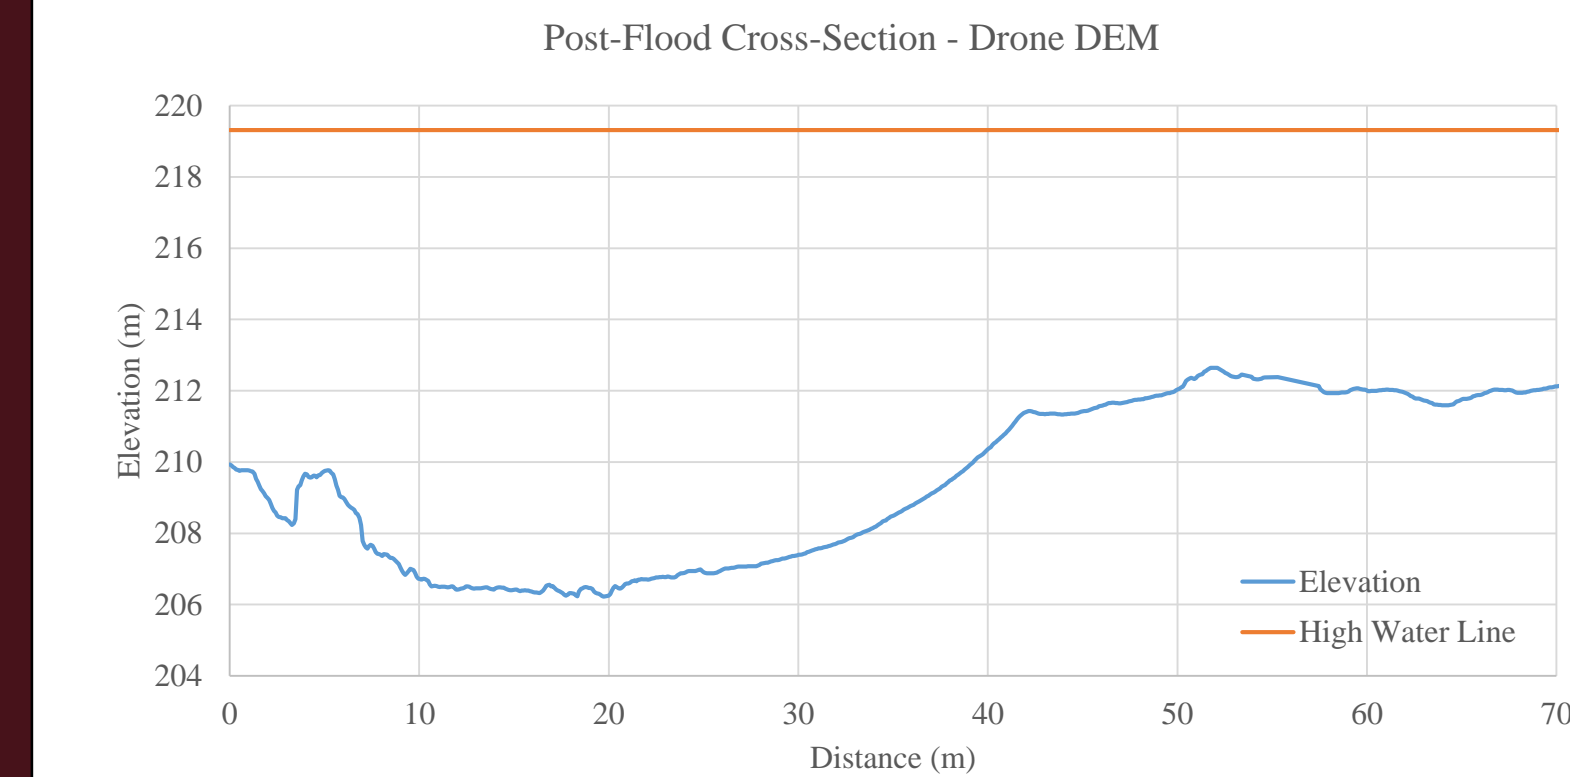
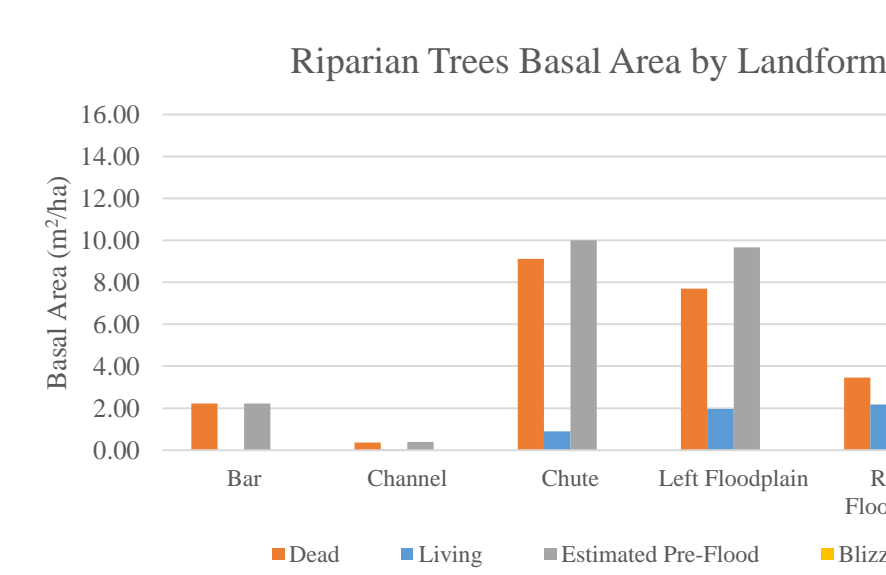
1. Initial post-flood mortality was 43% of the 511 riparian trees surveyed, but increased to 70% in repeat surveys in 2021.
2. Mortality was greatest on the inside of the channel bend (left floodplain) at the bar/floodplain head and decreased downstream.
3. Vegetation cover was reduced by 83% and has increased to 37% of the pre-flood extent.
4. Average DBH did not vary greatly across living or dead trees or by landform, however, living trees had slightly larger diameters in chutes and on the right floodplain compared to dead trees.
5. Basal area was estimated to be reduced by 77% across floodplains and chutes.
