**The Ozarks Environmental and Water Resources Institute (OEWRI)
Missouri State University (MSU)**

**Nonpoint Source Bank Erosion and Load Reduction
Assessment for the Wilson Creek 319 Riparian
Corridor Easement Site, Greene County, Missouri**

OEWRI EDR-15-005

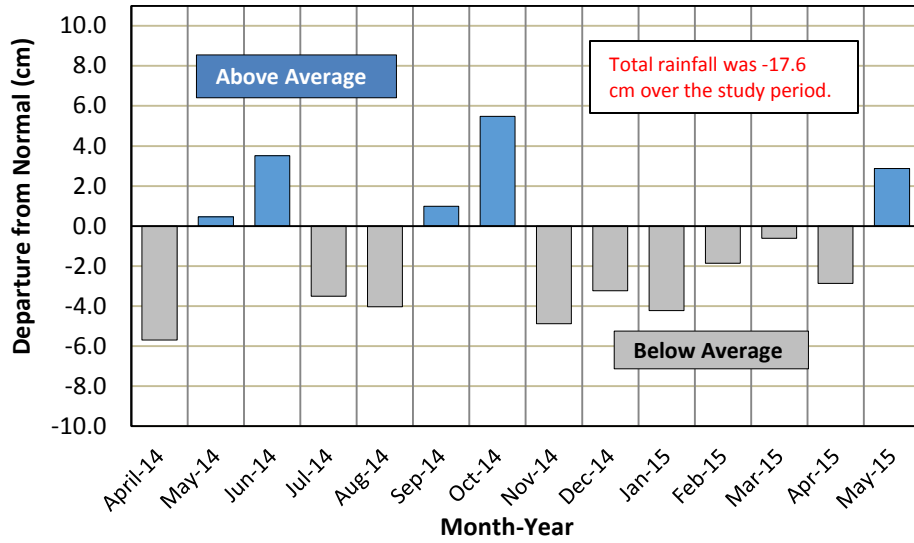
Figure 3. Monthly rainfall departure from normal over study period.

The study period was drier than normal with nearly 18 cm (≈ 7 in) lower rainfall totals than the 30 year average (Figure 3). The months of November 2014-April 2015 were particularly dry, however the area did receive snow fall that was not included in this analysis. Rainfall did exceed the 30-yr average by at least 2 cm in only three months June 2014, October 2014, and May 2015. The study site has intermittent flow, but typically receives runoff $>50\%$ of the time (Table 1). During the study period, seven events occurred that were near the 1-yr flood RI and one flood event occurred that exceeded the 1.5-yr flood RI (Table 2, Figure 4). Discharges near or $>$ than the 1-yr flood RI would be expected to do the most geomorphic work in the river, such as gravel transport, bank saturation-collapse, and bank erosion along the toe. Overall, the study period was drier than normal with small, frequent flood events.

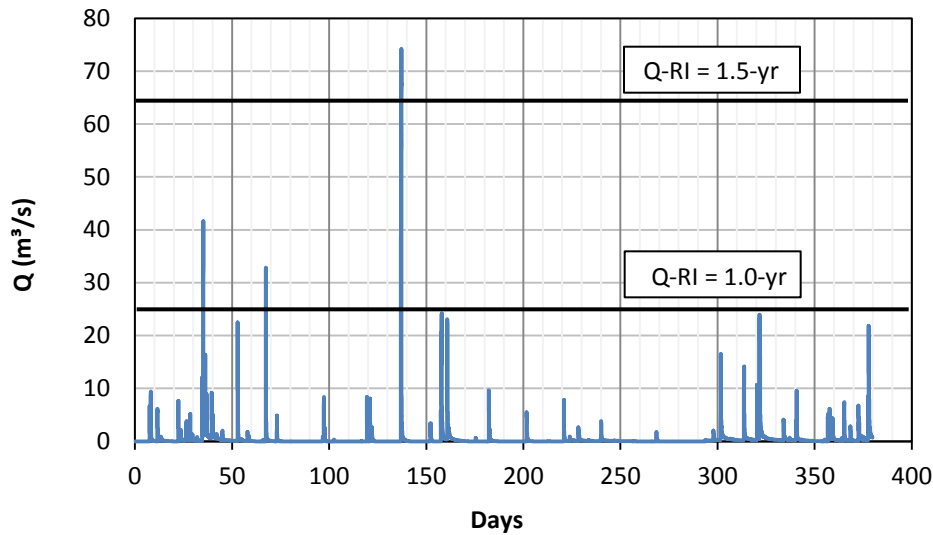
Figure 4. Discharge at USGS station #07052100 at FR 156 over the study period.

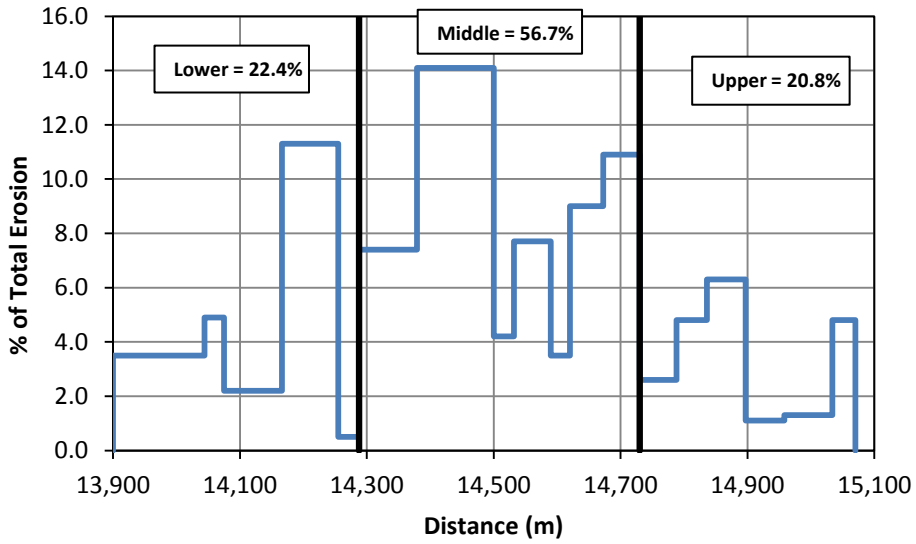
Figure 6. Percent of total erosion for the study reach.

The majority of the total bank erosion occurred in the middle section of the study reach where the channel was not confined by bedrock, however, significant bank erosion was measured throughout the study reach indicting the channel is not stable and still adjusting to upstream hydrologic changes. Total bank erosion for the study period was 564 Mg/yr with 202 kg/yr of phosphorus (P) loss over that time (Table 3). Over the study period bank erosion supplied between 0.09-1.04 Mg/m/yr with an average of 0.52 Mg/m/yr from all pin array segments. Losses of P due to bank erosion ranged from 0.03-0.38 kg/m/yr with an average of 0.21 kg/m/yr. The highest erosion rates, ≈ 1 Mg/m/yr, were measured in the middle of the study reach between stations 14,600-14,700 m (Figure 5). When taking the length of the segment each pin represents, nearly 57% of the erosion occurs in the middle section of the study reach between stations 14,300-14,700 m (Figure 6). Around 21% occurs in the upper section and about 22% occurs in

the lower section of the study reach. However, lateral migration and widening of the channel at both the upper and lower section of the study reach is limited by bedrock. This indicates the entire reach is still adjusting to watershed disturbance and/or to flood magnitude and frequency changes due to climatic shifts in rainfall. While no large floods occurred over the study period, this suggests smaller, more frequent events have the ability to cause significant bank erosion in urbanized watersheds. Erosion was measured along the entire channel though the easement area, but confined in places by bedrock suggesting the stream is still adjusting to upstream disturbance.

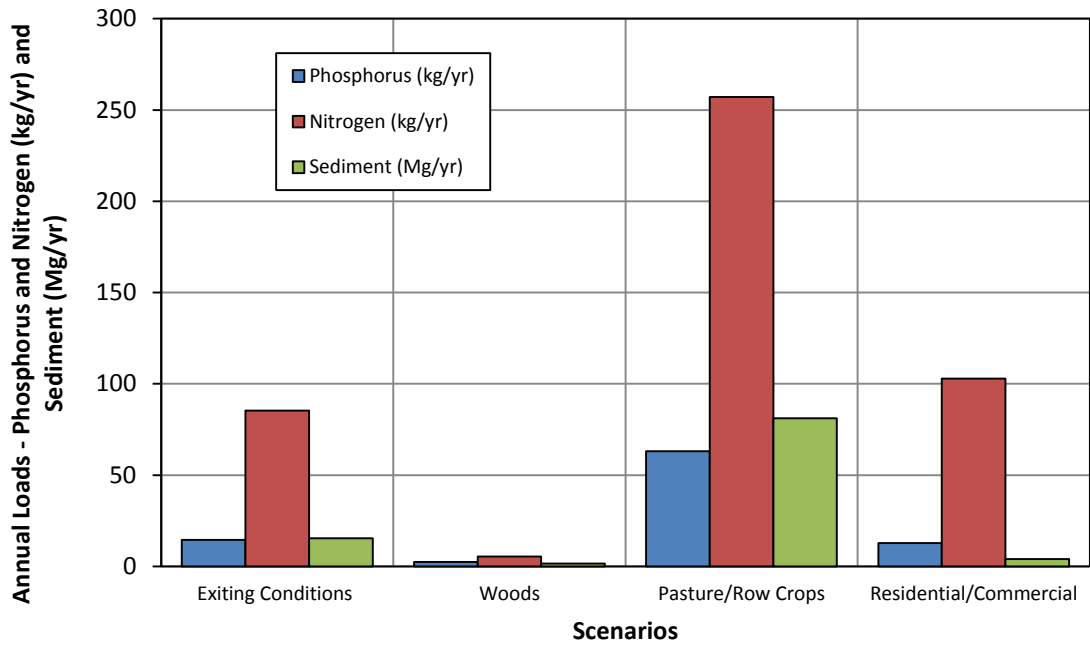
Figure 7. Annual nutrient and sediment loads from easement area from STEPL model.

STEPL results suggest nutrients and sediment leaving the existing easement area is fairly uniform from easements on both sides of the channel. Using the existing land use in the model, the P load is 14.5 kg/yr, the nitrogen (N) load is 85.4 kg/yr, and the sediment load is 15.5 Mg/yr (Table 5, Figure 7). The loads are fairly even between the two easements. This is because the west easement is larger, but has more of the total area in woods than the smaller east side with more pasture. This holds true for all scenarios tested for this study.

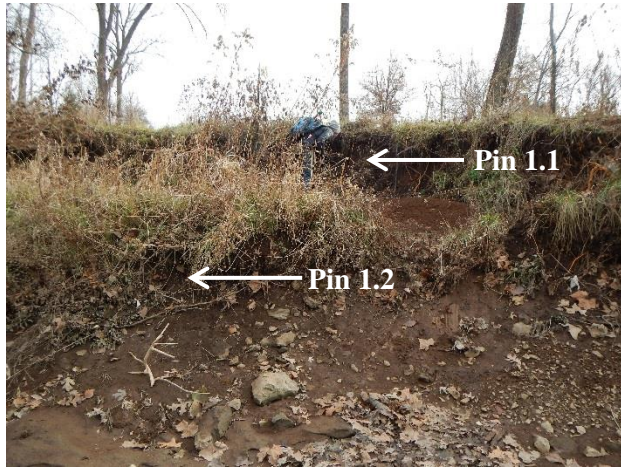
Pin Array 1. Erosion measurements by date.

Pin #	6/20/2014	9/4/2014	10/8/2014	11/10/2014	12/3/2014	1/16/2015	2/25/2015	5/5/2015	Total Erosion (cm)
1.1	0	10	11.5	0	0	0	0	0	21.5
1.2	6	0	1.8	0.2	1	4	2.5	4	19.5
1.3	2	0	0.6	7	0.2	0.5	0	0	10.3
1.4	2	0	0	0	0	0	0.5	0	2.5

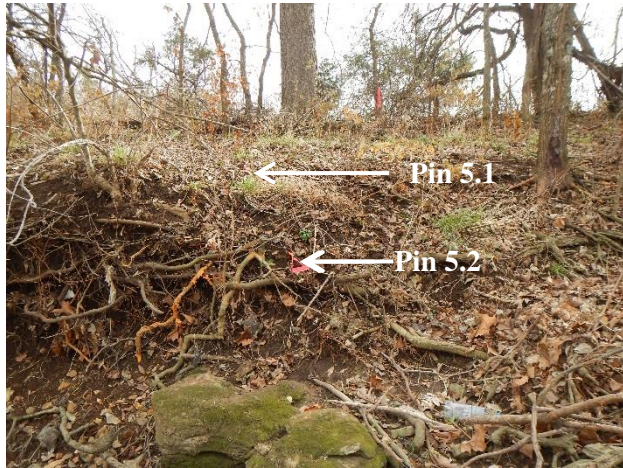
Pin Array 5. Erosion measurements by date.

Pin #	6/20/2014	9/4/2014	10/8/2014	11/10/2014	12/3/2014	1/16/2015	2/25/2015	5/5/2015	Total Erosion (cm)
5.1	1	0	0	5	0	0	0	0	6
5.2	1	0	1.5	0.5	3	0	0	0	6
5.3	11	3	4	0	0	0	0	0	18
5.4	0	0	3	0.8	0.2	0	0	4	8

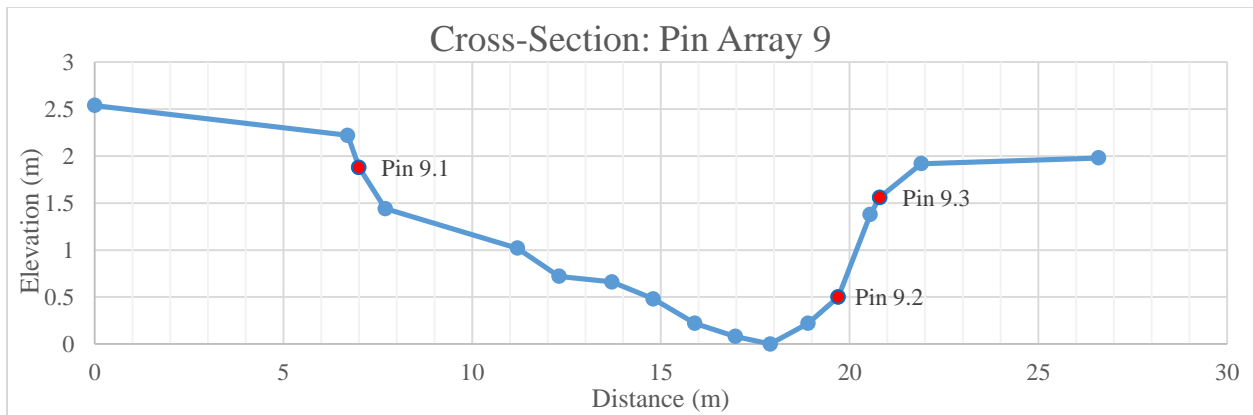
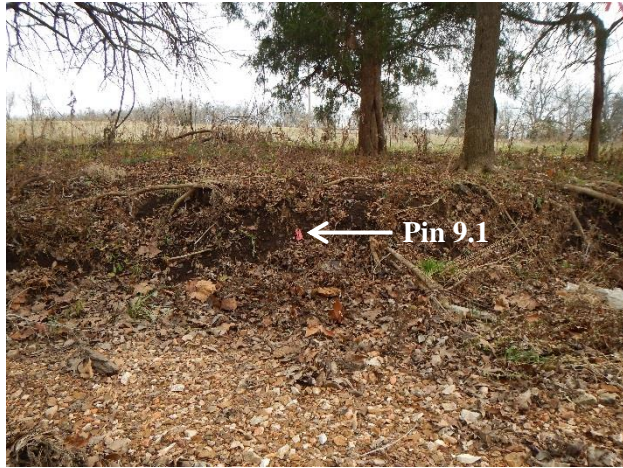
Pin Array 9. Erosion measurements by date.

Pin #	6/20/2014	9/4/2014	10/8/2014	11/10/2014	12/3/2014	1/16/2015	2/25/2015	5/5/2015	Total Erosion (cm)
9.1	5	0	1.6	0	0.2	0	0	2.5	9.3
9.2	4	2	3	1.3	0	0	2	12	24.3
9.3	8	0	3	1	0	3	0	4.5	19.5

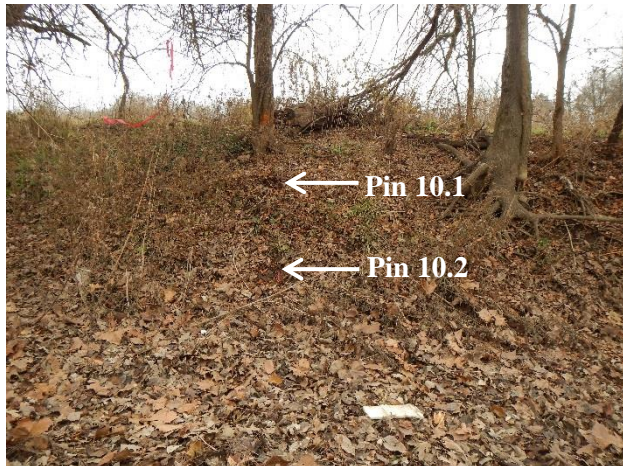
Pin Array 10. Erosion measurements by date.

Pin #	6/20/2014	9/4/2014	10/8/2014	11/10/2014	12/3/2014	1/16/2015	2/25/2015	5/5/2015	Total Erosion (cm)
10.1	0	0	2	0.8	0	0	1	2.5	6.3
10.2	7	0	0	8	0	0	0	0	15
10.3	0	4	3	0	0.3	0.7	4	7	19
10.4	5	9	1	2.3	0	0	2	10	29.3

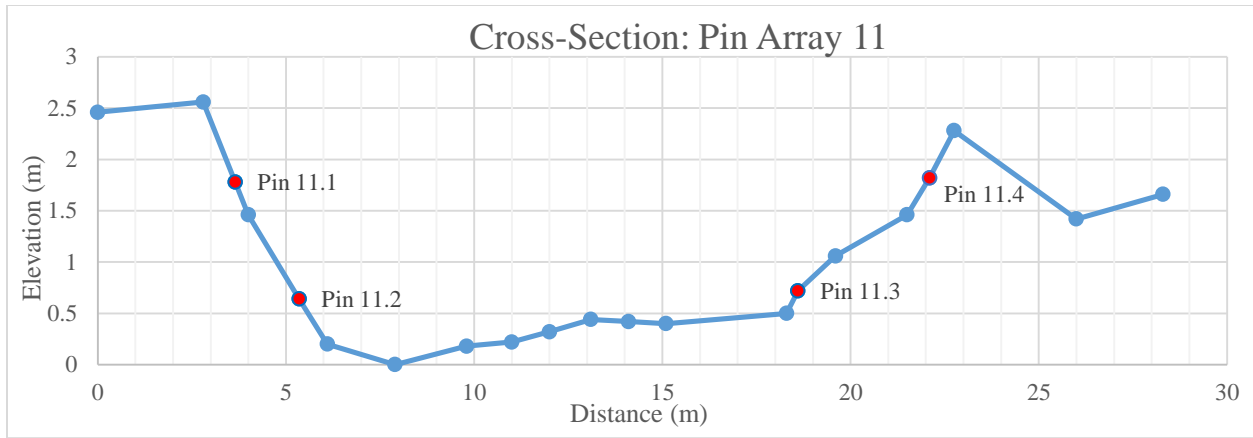
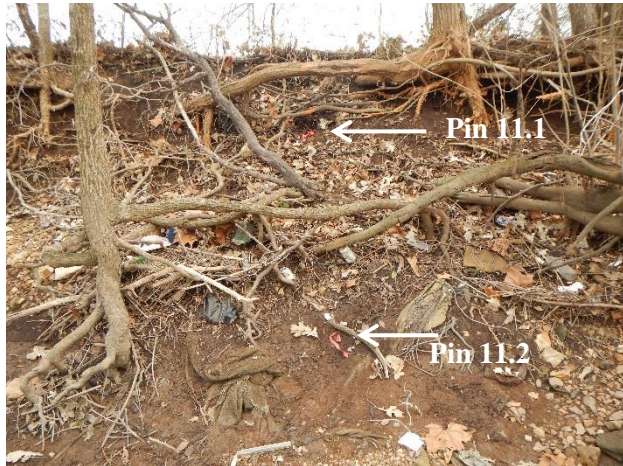
Pin Array 11. Erosion measurements by date.

Pin #	6/20/2014	9/4/2014	10/8/2014	11/10/2014	12/3/2014	1/16/2015	2/25/2015	5/5/2015	Total Erosion (cm)
11.1	0	17	0	3	0	0	0	1.13	21.13
11.2	4	0	0	0	0	0	3	3	10
11.3	5	0	1.7	0.5	0	0.3	0	1	8.5
11.4	3	0	3.3	0.8	0	0	0	3.5	10.6

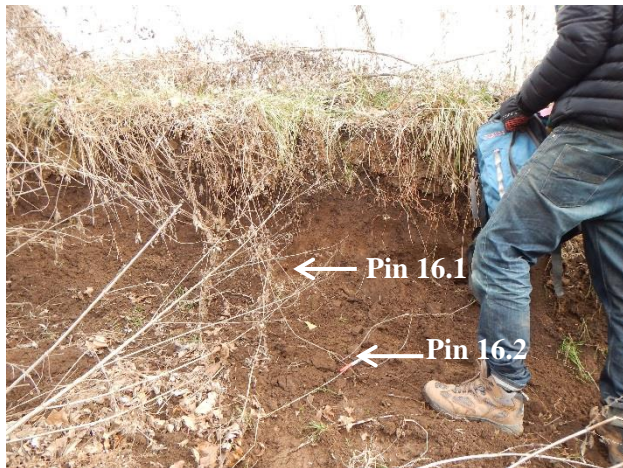
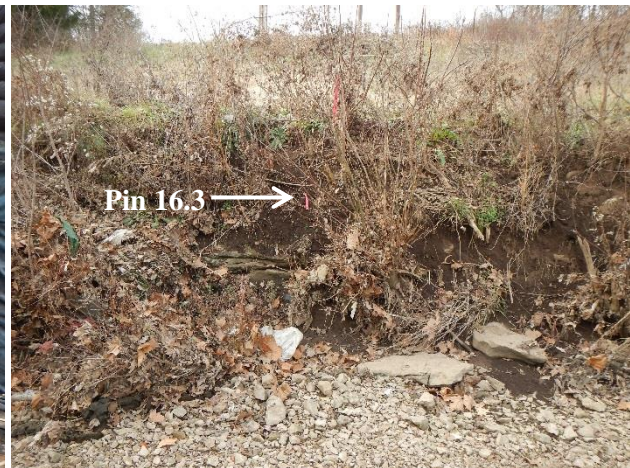
Pin Array 16. Erosion measurements by date.

Pin #	6/20/2014	9/4/2014	10/8/2014	11/10/2014	12/3/2014	1/16/2015	2/25/2015	5/5/2015	Total Erosion (cm)
16.1	24	0	1	0.5	0	4	0	0	29.5
16.2	0	0	2.2	1	0	0	13	4	20.2
