**Ozarks Environmental and Water Resources Institute (OEWRI)
Missouri State University (MSU)**

**Flow and Water Quality Assessment of the
Jordan Creek Underground, Springfield,
Missouri**

FINAL REPORT

February 28, 2019

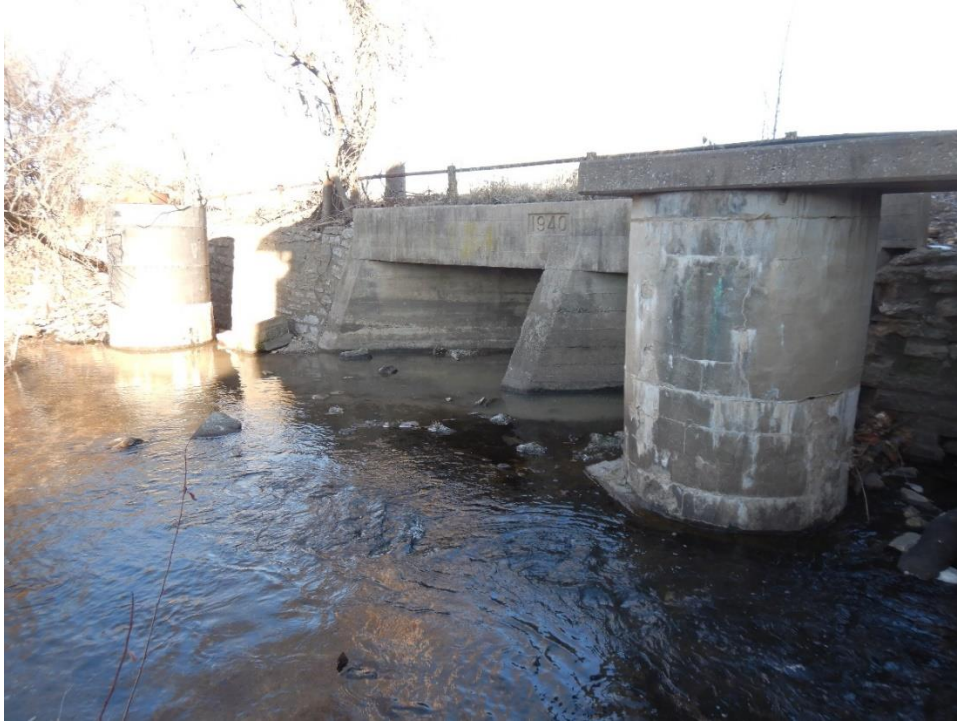
Photo 1. Two sewer manholes and a large culvert located at 876 feet downstream of the underground along the north bank. (Photo taken January 25, 2019)

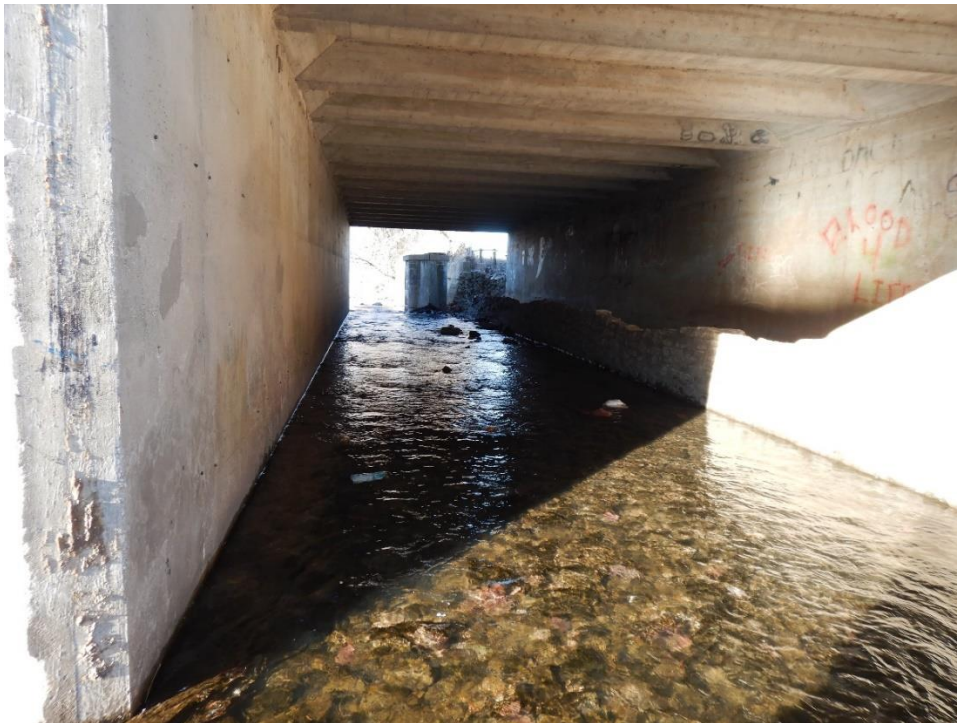
Photo 2. Building over creek located 816 feet downstream of the underground looking upstream. (Photo taken January 25, 2019)

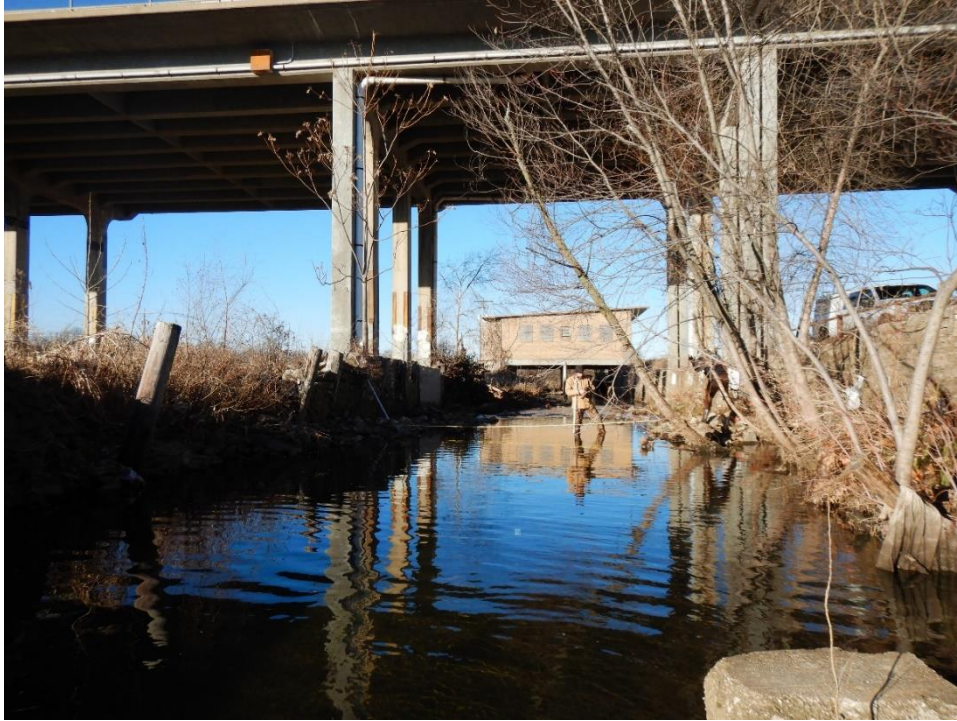
Photo 3. Grant Ave Bridge located 663 feet downstream of the underground looking upstream. (Photo taken January 25, 2019)

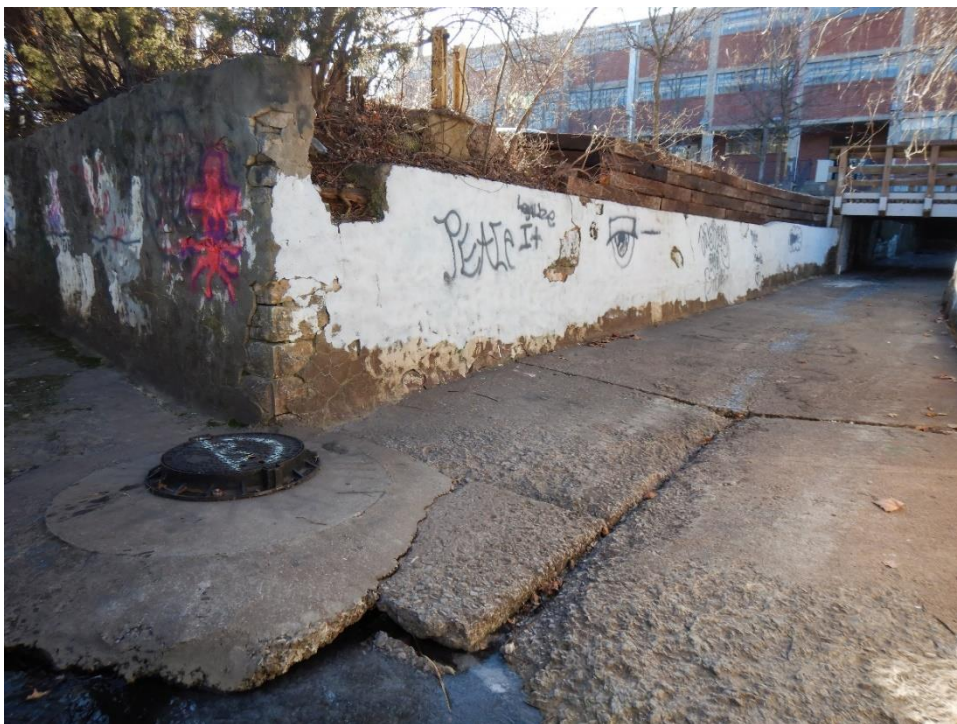
Photo 4. MS4 channel near Main Ave. located 256 ft downstream of the underground on south bank. (Photo taken January 25, 2019)

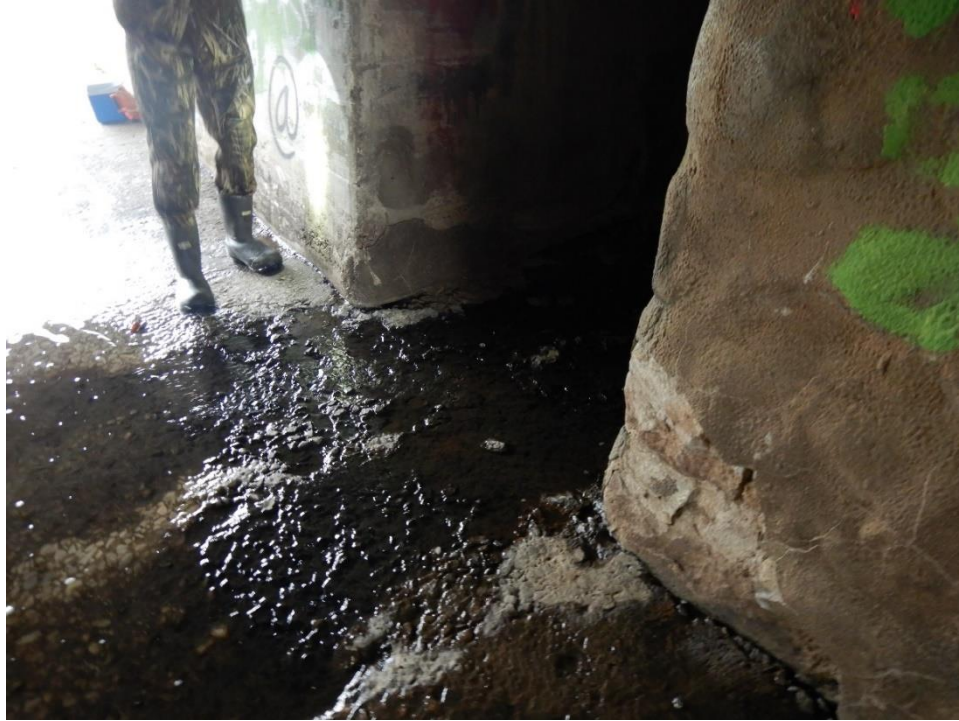
Photo 5. Storm drain under Main Ave Bridge 100 ft downstream of the underground along north bank. (Photo taken January 25, 2019)

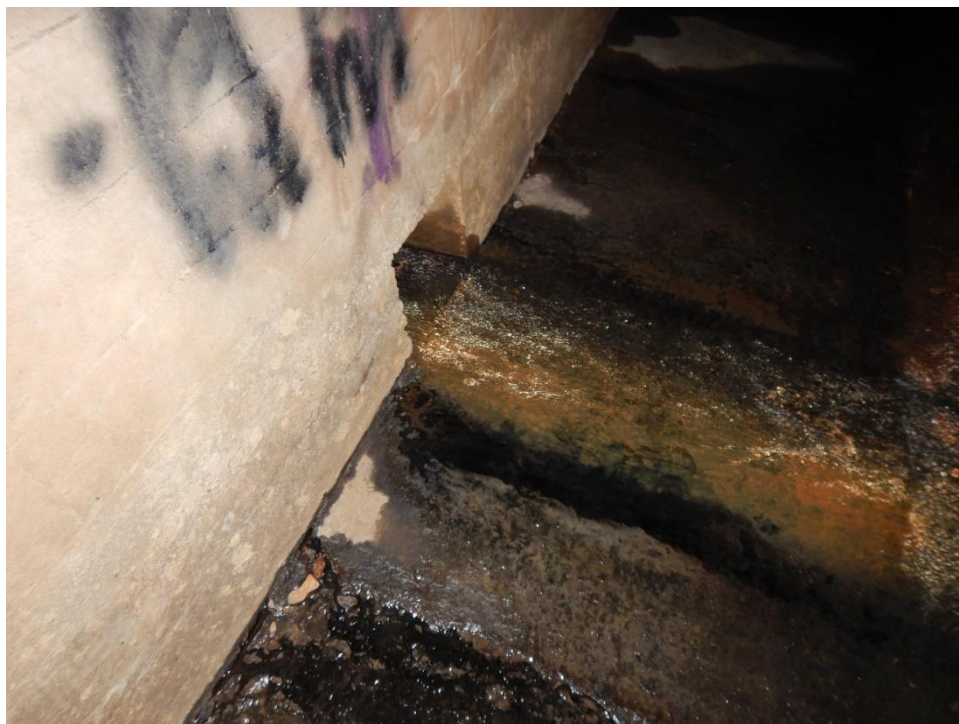
Photo 6. Larger drain at 800 ft in the south culvert along south exterior wall. Several other drains and seeps enter the south culvert downstream of Campbell Ave. (Photo taken January 25, 2019)

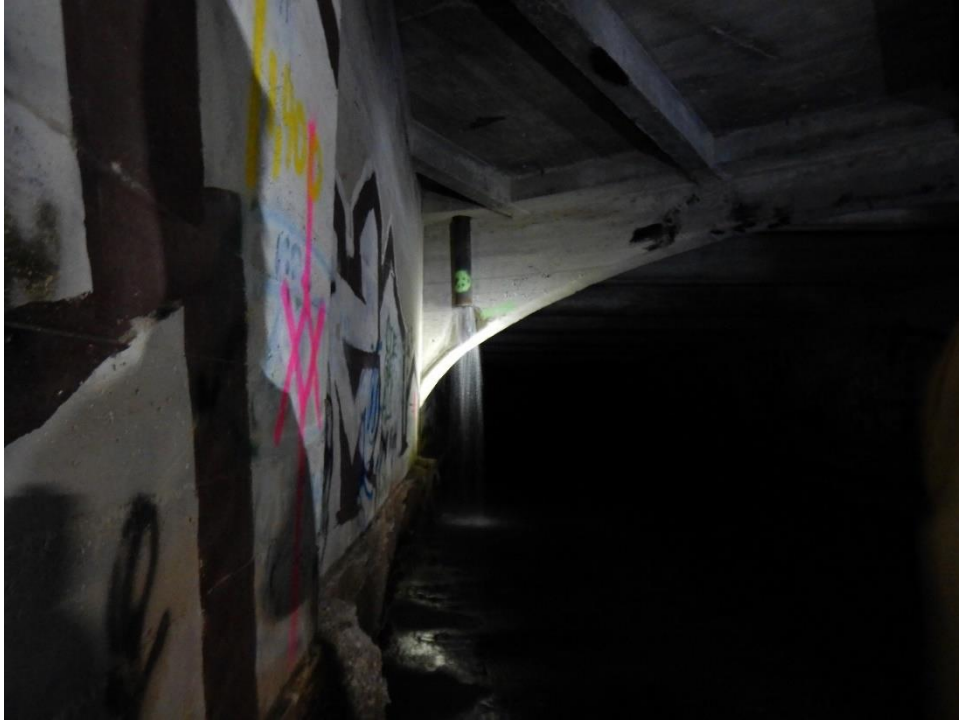
Photo 7. Sump pump at 1,380 feet in the combined culvert on the south side. (Photo taken January 25, 2019)

- 2. There is a possible influx of groundwater from stations 1,400 ft to 1,100 ft within the large single culvert between Robberson and Boonville Ave.** Observations of discharge in this area show a 60% increase in flow between stations 1,100 ft and 1,400 ft in the combined culvert between Robberson and Boonville. Temperature increased and chloride concentrations decreased within this area indicating a groundwater source here rather than an exfiltration source. Possible sources may be Lyman Spring located just south of this location and the “flush pipe” observed at station 1,380 ft.

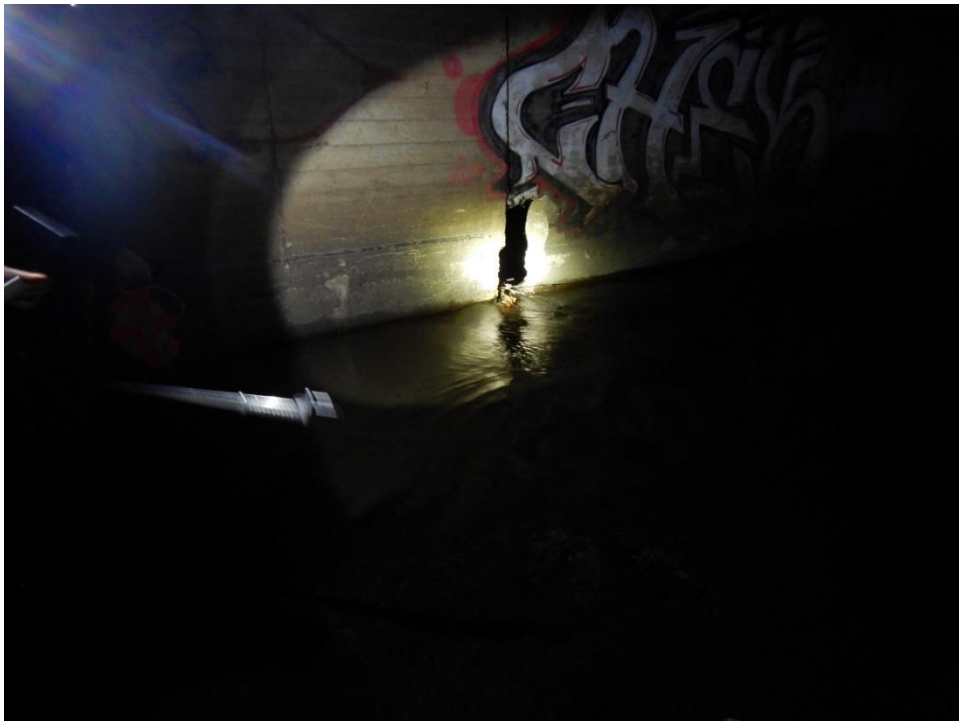
Photo 8. Hole in between north and south culvert walls located at 2,040 feet. (Photo taken January 25, 2019)

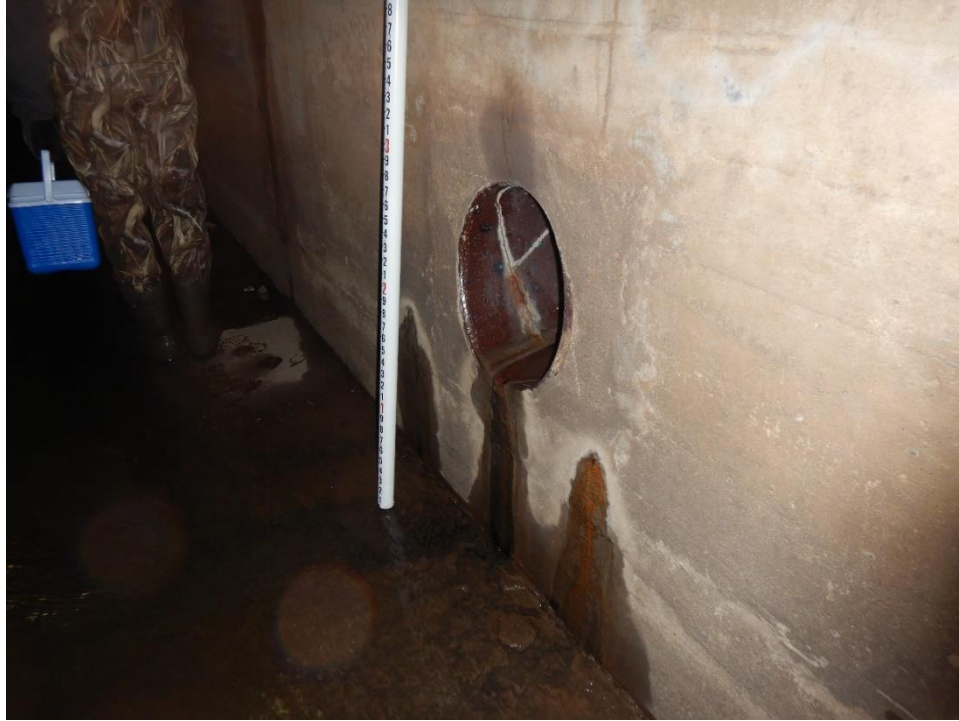
Photo 9. Large drain pipe at 2,200 feet along the north exterior wall of the north culvert. (Photo taken January 25, 2019)

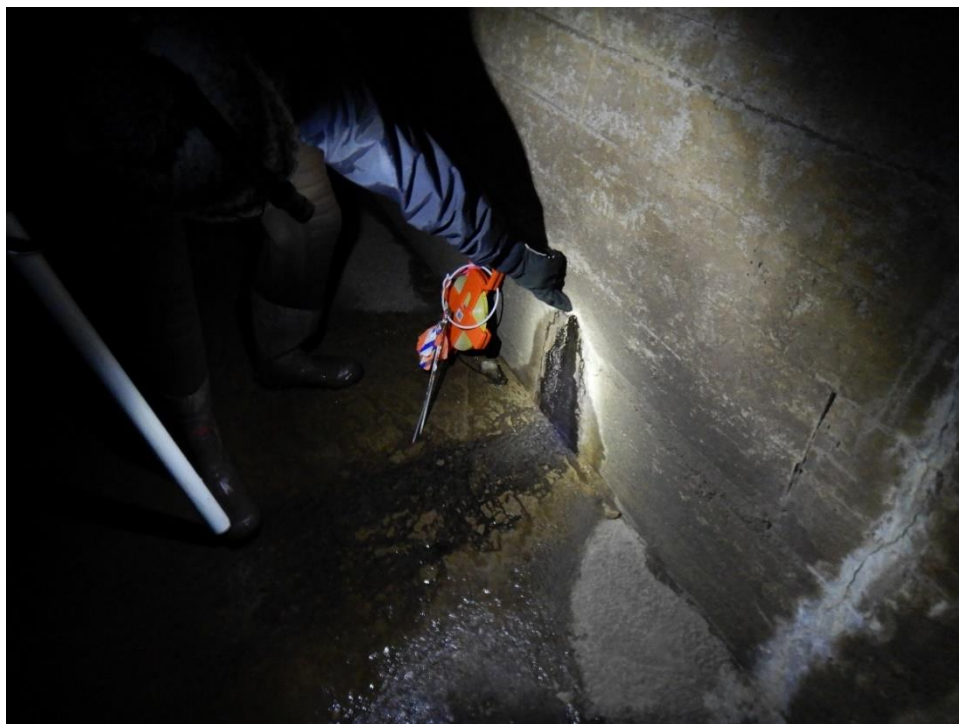
Photo 10. Seep at 2,500 feet on the exterior wall of the north culvert. These types of seeps are common throughout the underground. (Photo taken January 25, 2019)
