**The Ozarks Environmental and Water Resources Institute (OEWRI)
Missouri State University (MSU)**

**Mississippi River Basin Healthy Watersheds Initiative (MRBI)
Watershed Assessment for:**

**Cane Creek Watershed (HUC-071401070404)
Dry Creek Watershed (HUC-071401070406)**

FINAL REPORT

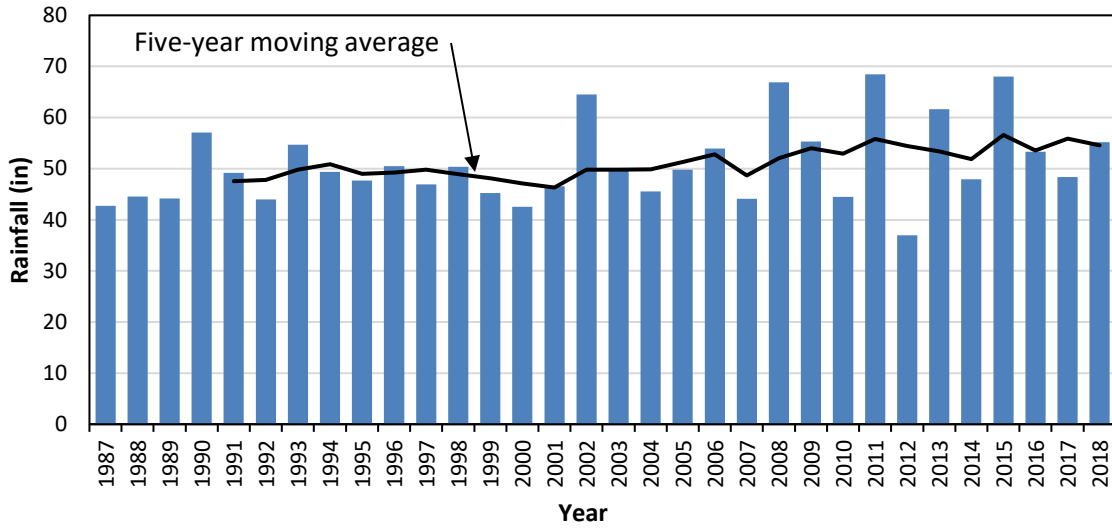
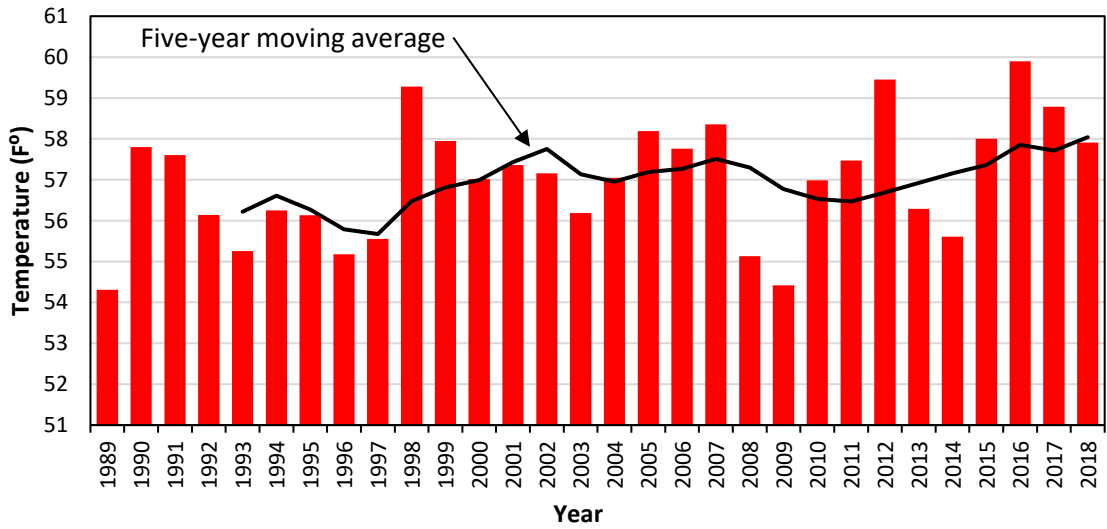
Figure 4. A) Annual total rainfall and B) average annual temperature from 1989-2018 for Marble Hill, MO.

average annual precipitation was around 50 inches per year for the majority of that time (Figure 4A). The exception would be a period with relatively high average annual rainfall from 2009-present, where the five-year moving average was near 55 inches per year. Average annual temperature has varied two degrees since 1989, increasing over the last 30 years, with the lowest average annual temperature seen in 1989 (54.3°F). Annual temperatures showed a relative decrease in the 5-year moving average around 1997, 2004, and 2011 (Figure 4B).

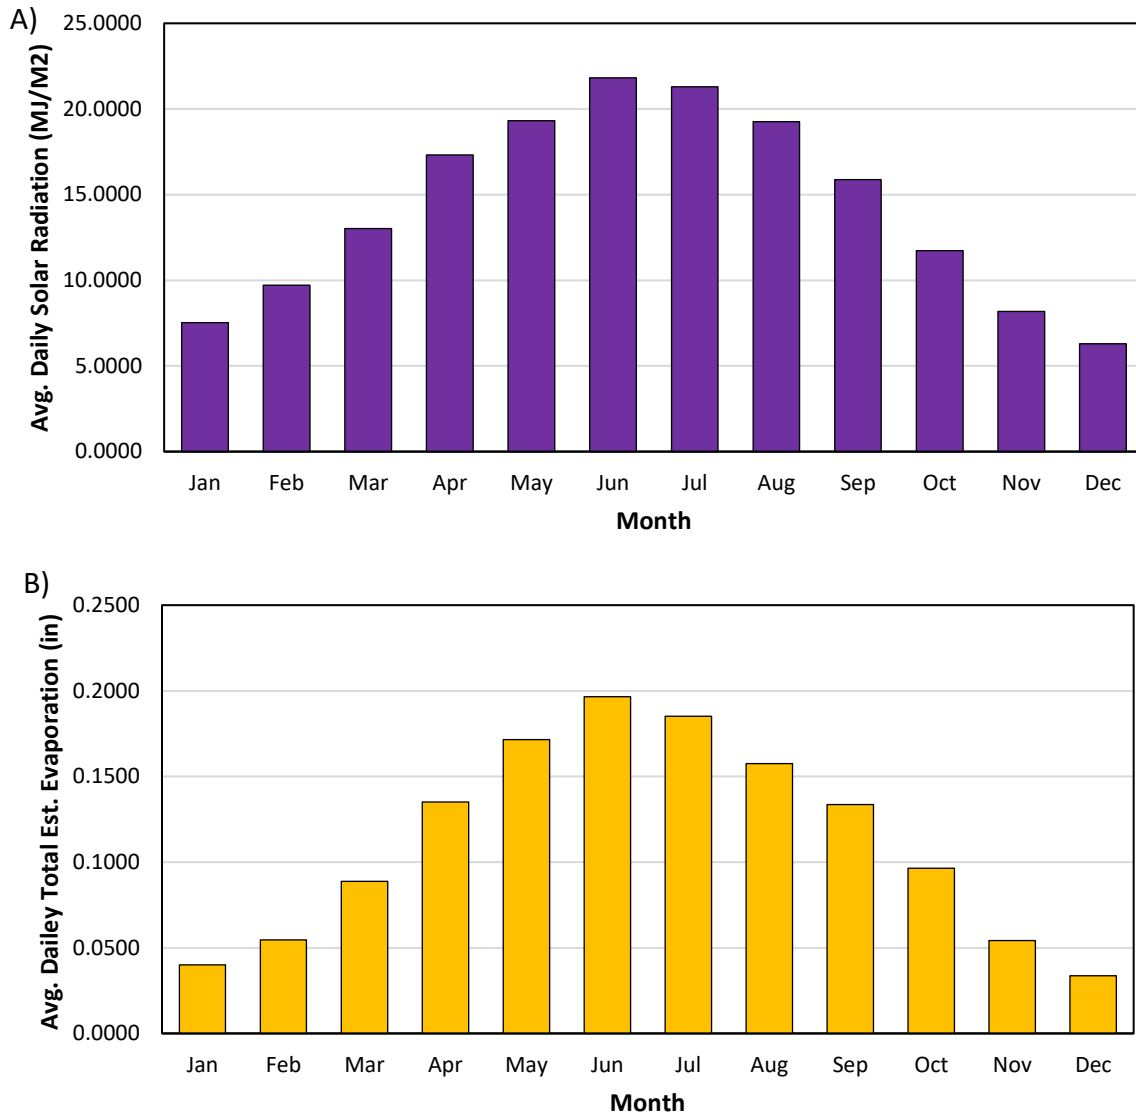
Figure 5. Average daily A) solar radiation (2000-2018) for Delta, Cape Girardeau County MO and B) estimated evaporation (2011-2018) for Portageville, Pemiscot County MO.

Solar radiation and evaporation trends are similar to temperature trends for Marble Hill. From 2000-2018, average daily solar radiation by month ranged from about 6.3 MJ/m² in December up to around 21.8 MJ/m² in June with an average of 14.3 MJ/m² (Figure 5A). From 2011 to 2018, monthly average daily estimated evaporation ranged from around 0.03 inches in December to about 0.20 inches in June with an average of 0.11 inches over the entire year (Figure 5B).

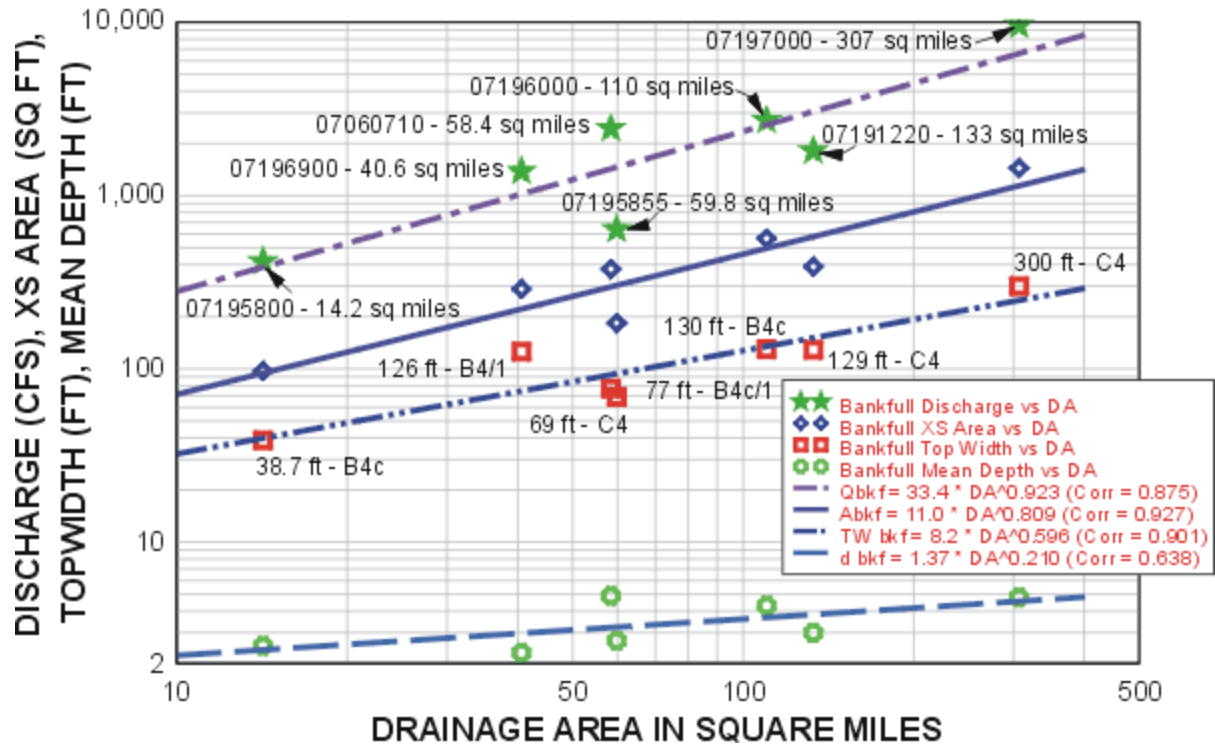
**PRELIMINARY REGIONAL CURVE FOR OZARK PLATEAU
 SPRINGFIELD & SALEM PLATEAUS
 7 USGS GAGES IN ARKANSAS & OKLAHOMA**

Figure 7. Regional Channel geometry curves for Springfield and Salem Plateaus. Source: NRCS-National Water Management Center.

channel geometry of streams in the Cane and Dry Creek for drainage areas less than 400 mi² (USDA 2018a) (Figure 7).

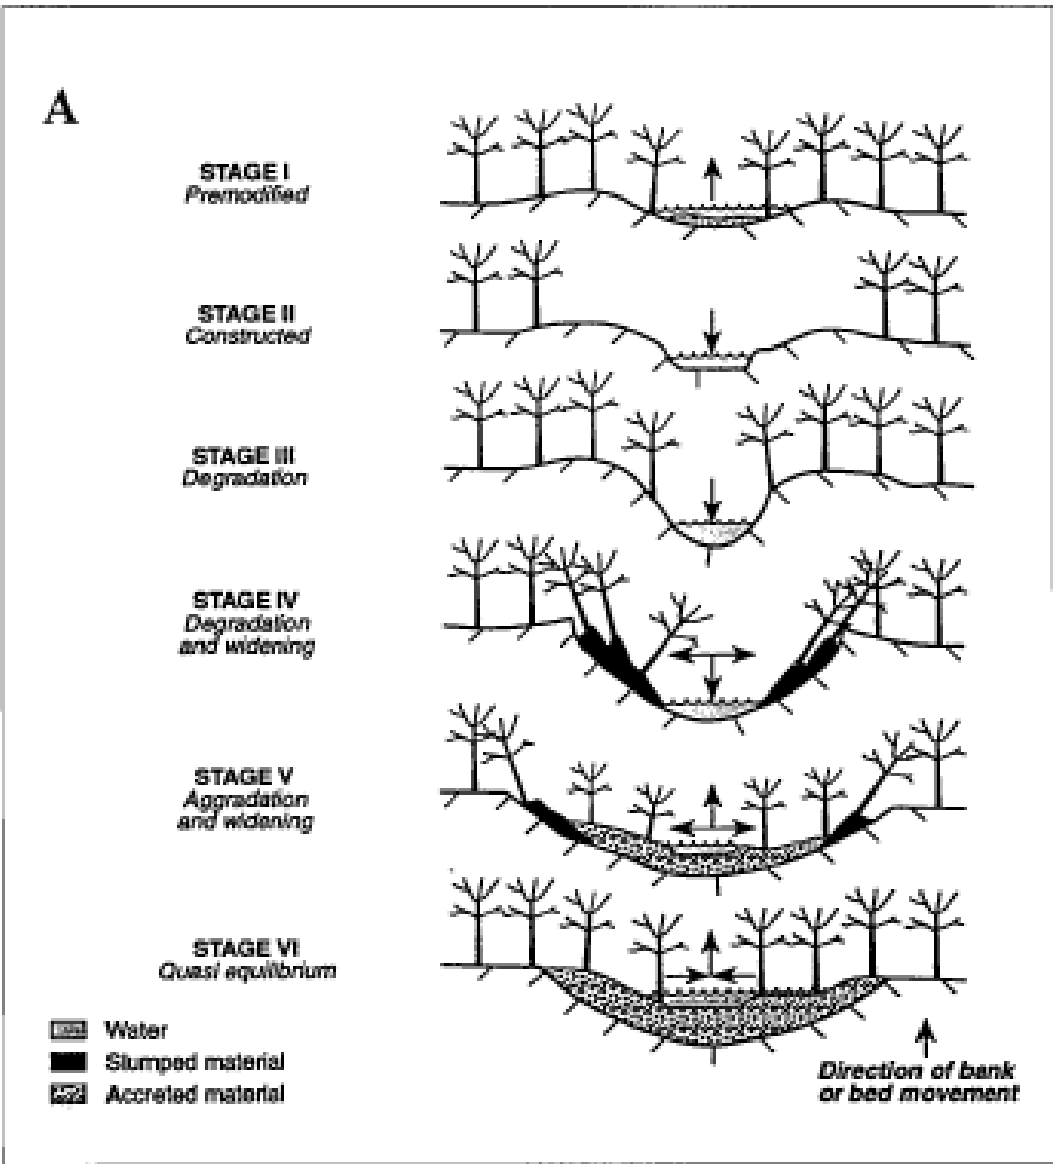
Figure 8. Six Stage Channel Evolution Model for Disturbed Alluvial Channels (Simon and Rinaldi 2000).

On the Mississippi Alluvial Plain, large-scale drainage projects that effectively moved water off of the landscape were accomplished by the construction of a series of connected channelized ditches (Nigh and Schroeder 2002). It is well known that channelized streams adjust to higher slopes and increased stream power by incision and channel widening processes (Simon and Rinaldi 2000). However, over time, aggradation starts to occur, and the stream begins to meander within the constructed banks to create low, bankfull benches where vegetation can start to establish and help stabilize the channel (Figure 8).

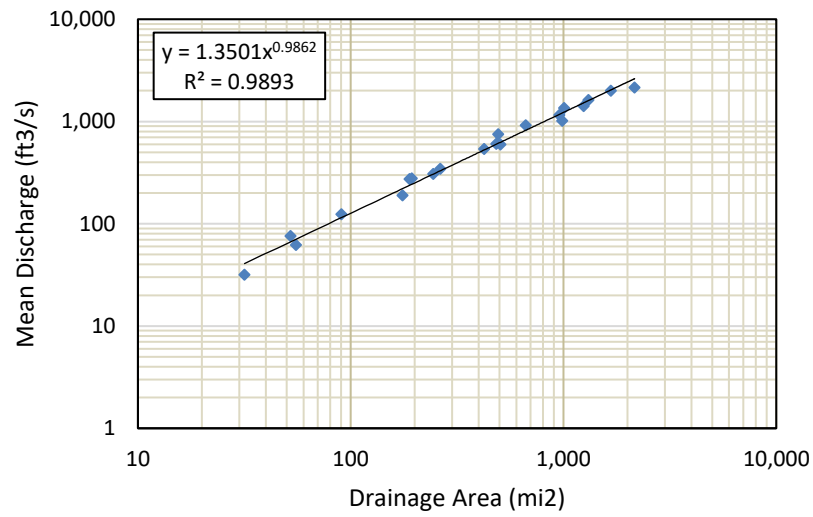
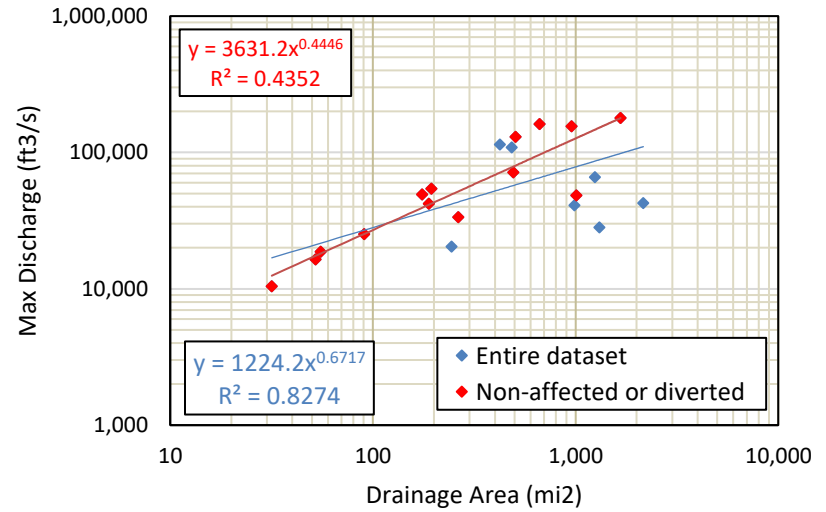
Figure 15. Drainage area and discharge relationships for 21 USGS gaging stations near the study watershed.

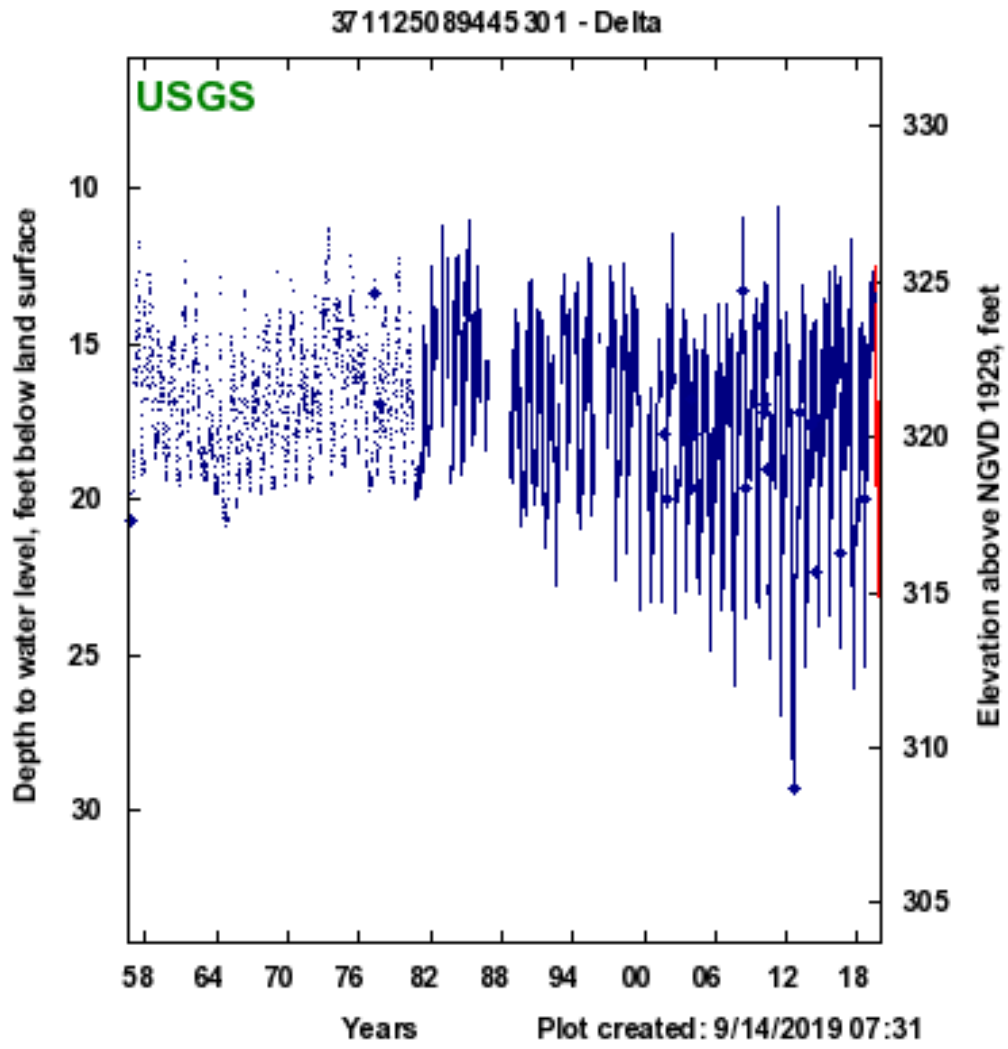
Figure 16. Groundwater level change for Delta (1958-2018).

possible locations would be on Cane Creek at Hwy 51 (UTM Zone 15N Northing: 4,117,881.62 Easting: 769,554.99), Dry Creek at Hwy 91(UTM Zone 15N Northing: 4,118,069.18 Easting: 771,189.44), and/or on The Diversion Channel at State Hwy “N” (UTM Zone 15N Northing: 4,122,324.30 Easting: 779,625.30). Additionally, there is a ground water monitoring station in Delta, approximately 5 miles southeast and outside of the Dry Creek watershed (Site Number: 371125089445301). This well has been operating since 1956 and data from this station shows an overall decline of about 3 feet in ground water levels in this area and becoming more variable since 2000 (Figure 16).
