**CATASTROPHIC VALLEY ENTRENCHMENT AND DEBRIS FAN
FORMATION IN THE BLUEFIELDS RIVER, WESTMORELAND JAMAICA**

A Masters Thesis

William Patrick Dryer

July 2010

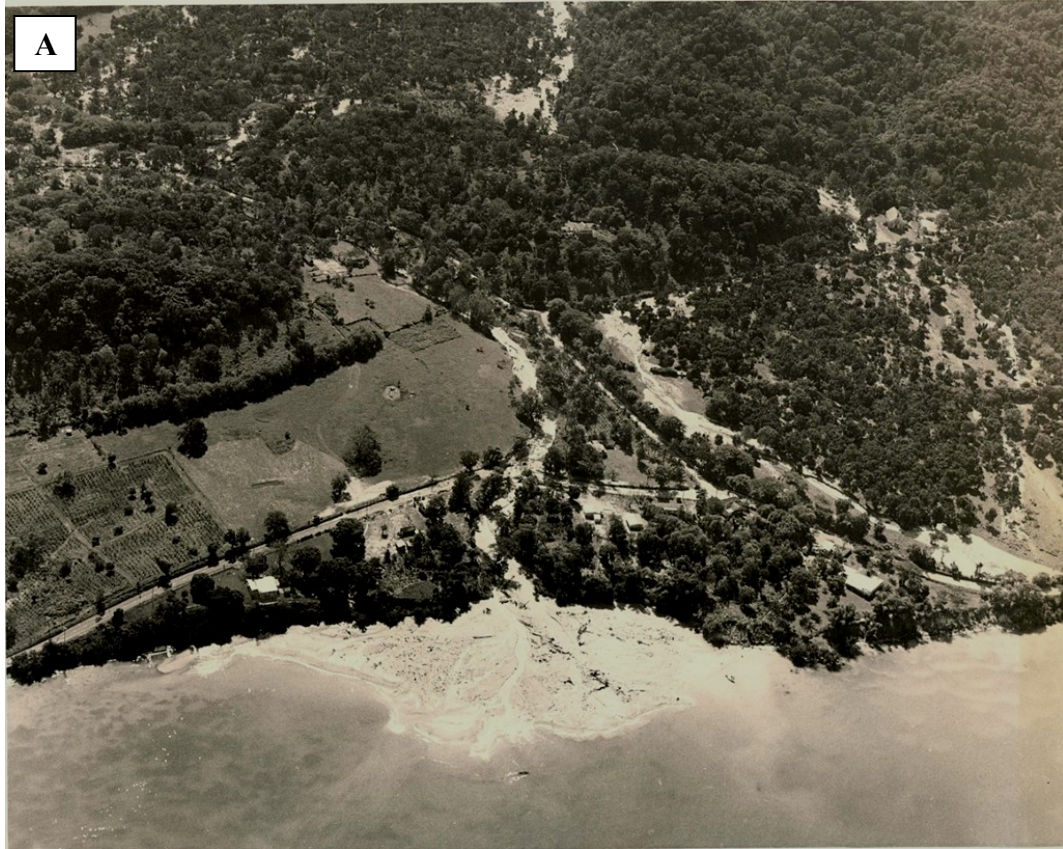
Figure 10. Flood Effects. The debris fan deposited at the mouth of the Bluefields River on 12, 1979 (A) and incision within 7 days following the debris flow (B) (Jones, 1981.)

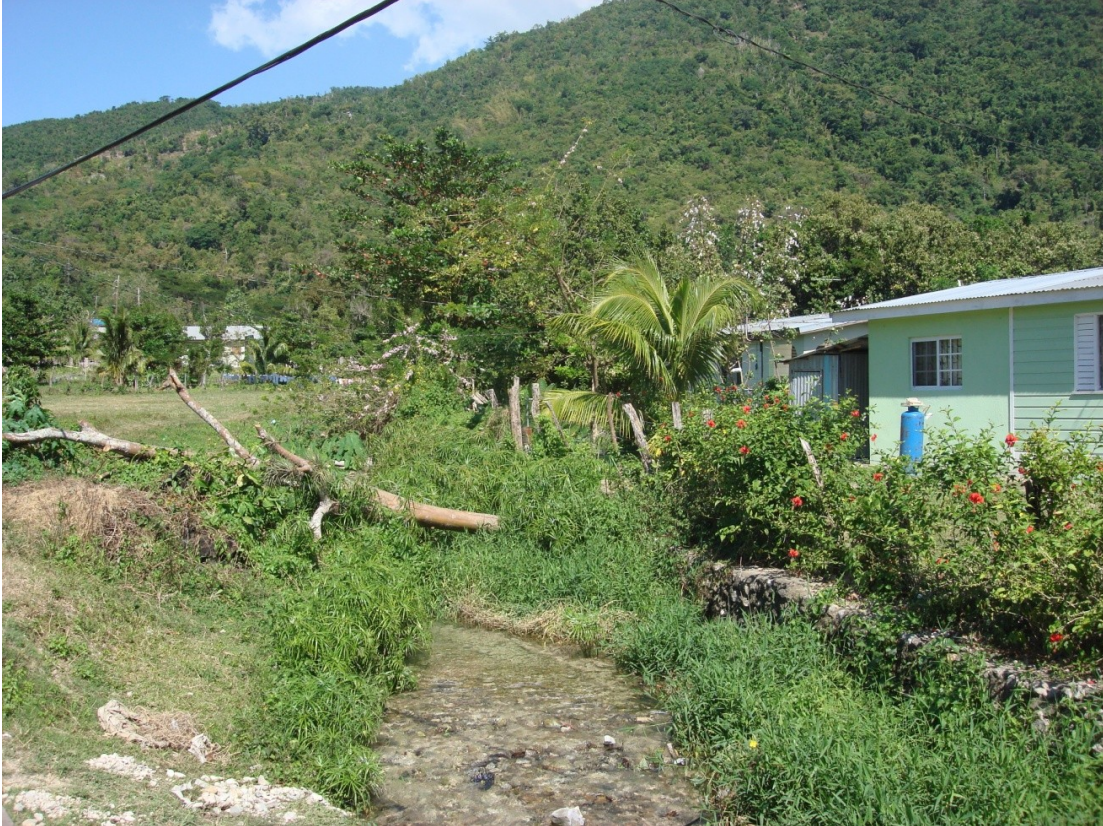
Figure 17. Upstream from River Top Bridge.

To calculate the amount of sediment removed from the Bluefields River by incision following the 1979 debris flow and flooding, cross sections were used as a typical channel profiles for each reach. The channel geometry of the Bluefields River above the River Top bridge (obtained by measuring the active channel width and bank heights) was used as a reference reach of the pre-flooding channel geometry (Figure 17). After the surveys were rectified they were exported to Hydraflow® to determine cross

Historical Bridge Elevations. The road surface, abutment, and culvert elevations of the two bridges that were washed out during the 1979 flood are used here to determine the incision depths along the Bluefields River. The roads that crossed the Bluefields River before 1979 were used by living witnesses living in the area who indicated that bed elevations ranged from 1 m to 2 m below the road surface of the bridges (Table 4). The old Great House bridge was constructed with London red bricks from the ballast of British ships. The base of the bridge abutments for the bridge is now high above the present bed elevation (Figure 28). The depth of the pre-1979 channel bed below the coastal highway is also documented with field, photographic, and witness evidence (Table 4; Figure 10). The present-day River-Top bridge was in-place before the 1979 flood, but did not get washed out. The channel bed on the upstream side of the bridge is about 1.5 m below the road (Figures 17 & 18).

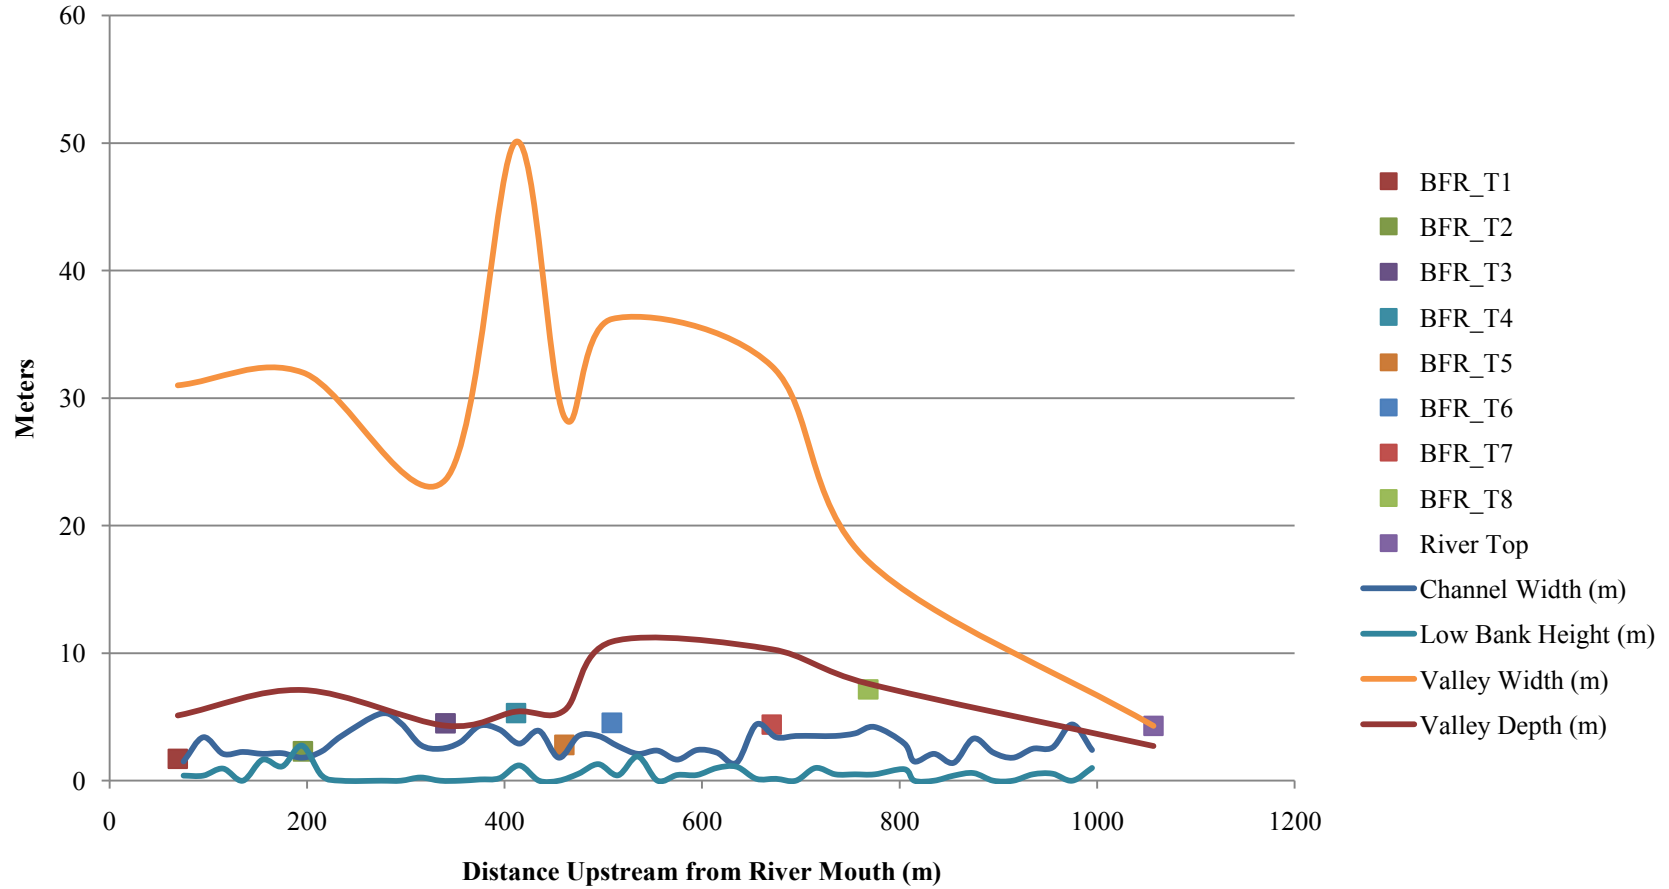
Figure 22. Present-Day Channel Geometry in the Bluefields River.

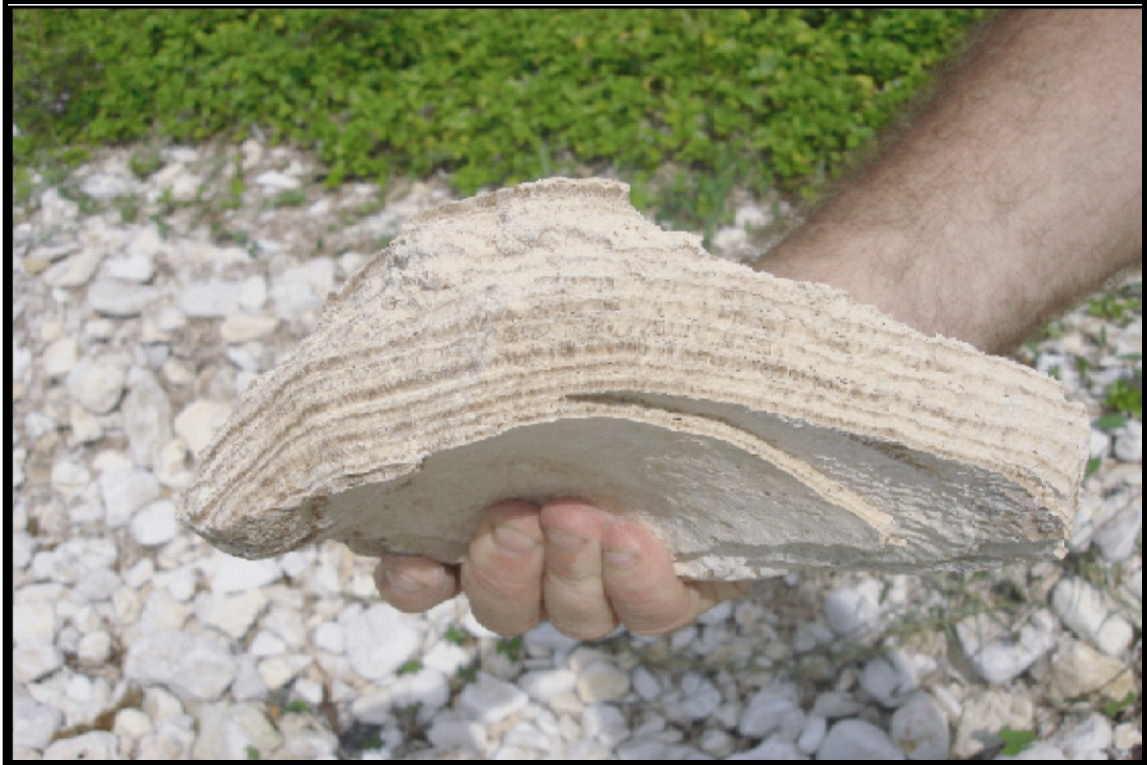
Figure 23. Tufa Clast in Beach Deposits on the Debris Fan.

It is apparent that tufa deposits were present along the pre-1979 Bluefields River (Figure 27). Larger cobble- and boulder-sized clasts are found in the debris fan of the Bluefields River along the bay (Figure 23). It is probable that the coated clasts were eroded from the previous river bed position and deposited in the fan by the 1979 debris flood. After catastrophic incision following the debris flow in the Bluefields River, some tufa deposits were preserved along the upper banks, high above the present channel bed. The combination of the tufa deposit location and cross-sectional surveys can be used to determine the pre-flooding channel geometry of the Bluefields River (Figure 27). At transect 7, fluvial tufa deposits are about seven meters above the present thalweg (Figure 27).

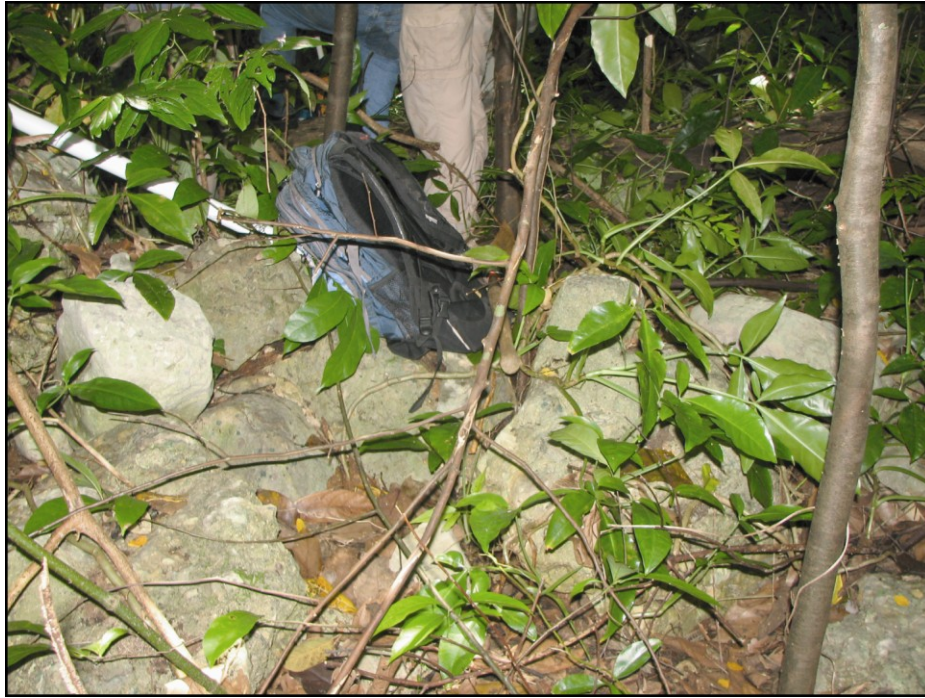
Figure 25. Boulder Bar in the Bluefields River. The boulder bar is located at the confluence of the Bluefields River and the Goat Gulley tributary is evidence of the debris flow on June 12, 1979.

Boulder Bar. At the confluence of the Bluefields River and the Goat Gulley tributary, several boulder bar features are present that indicate the influence of an

extremely energetic flood that was generated from the Goat Gulley drainage system (Figure 25). Colluvium from the mountain side and boulders/cobbles were transported from the Goat Gulley tributary during the debris flow.

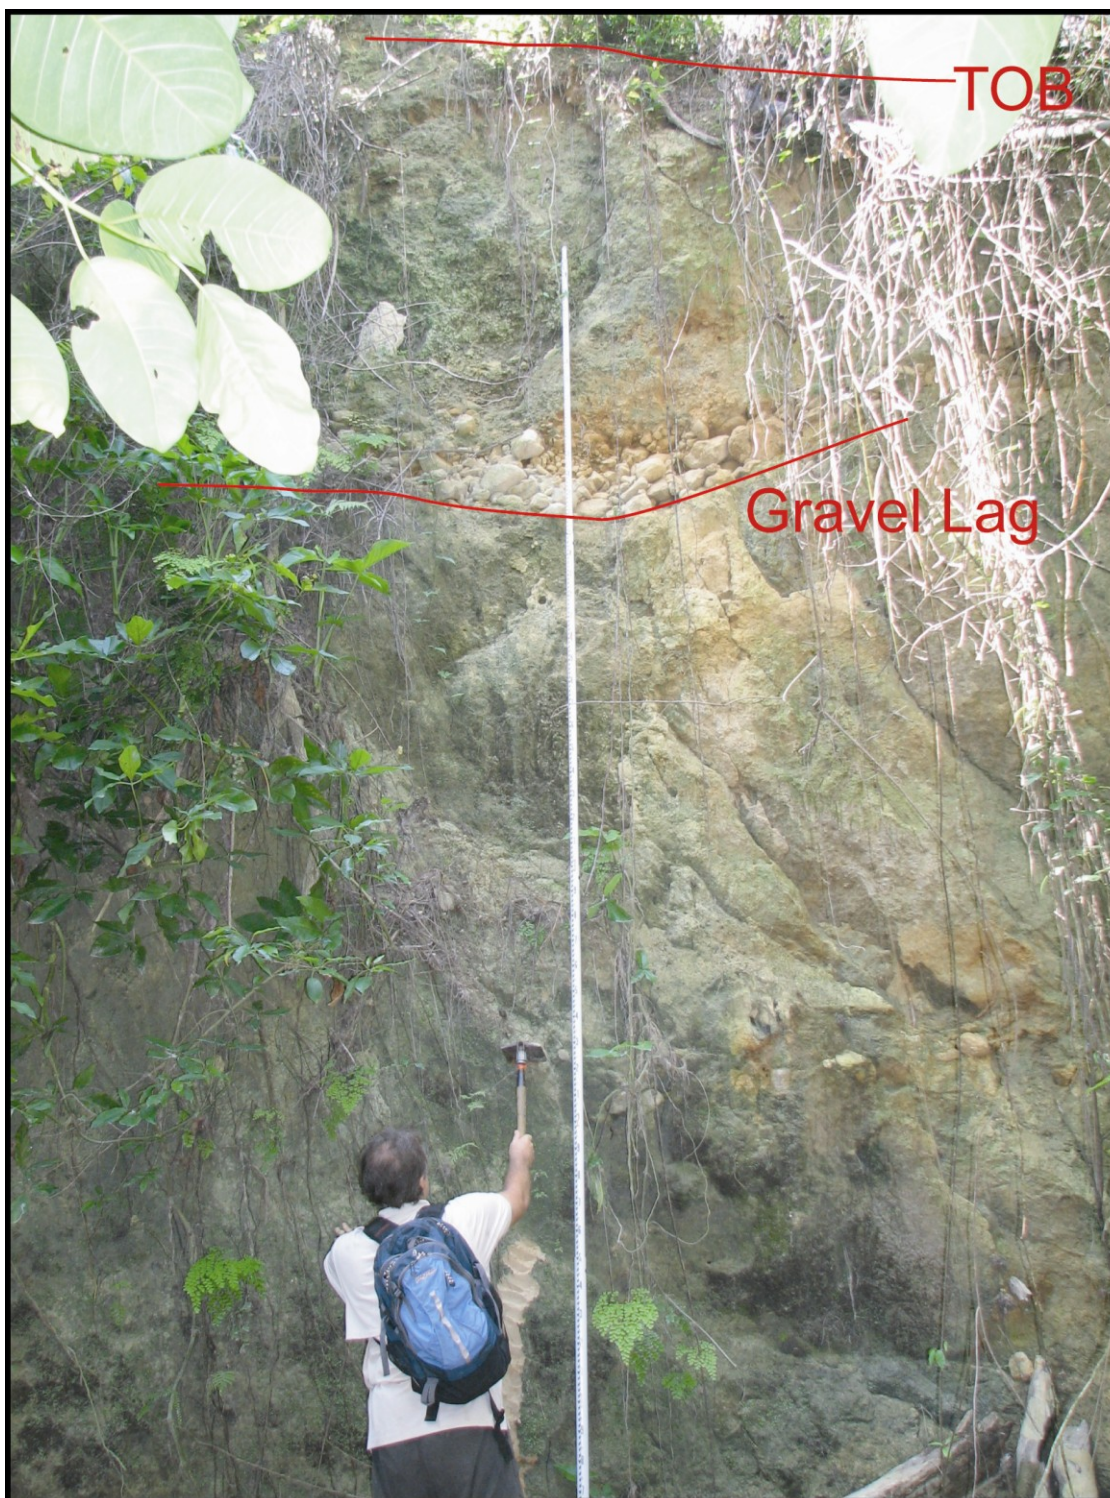
Figure 26. Geomorphic Evidence of Incision in the Bluefields River. The gravel lag is evidence of a former channel bed. Note: Paleo-channel bed is two meters below valley floor and six meters above the current thalweg at river meter 577.

“Hanging” Channel Lag Deposits. Hanging gravel lag deposits can be found in several places in high bank exposures marking the pre-1979 elevation of the Bluefields River bed (Figure 26). The incision into the streambed following the flood and debris flow has exposed the gravel lag or previous channel bed (Figure 26). The gravel lag deposits are typically found one to three meters below the high bank edge or valley floor. Hanging bed deposits are found nearly 9 m above the present thalweg in the middle reaches of the Bluefields River.

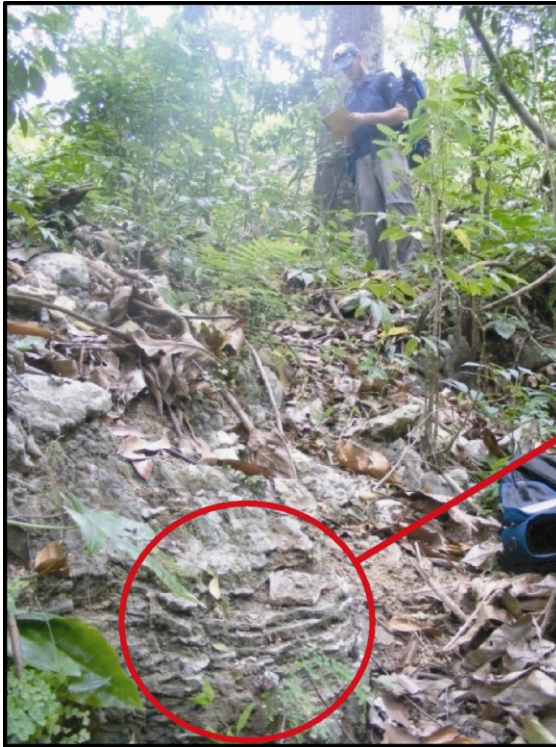
Figure 27. Tufa Deposits. The tufa deposits can be used to estimate the pre-flooding geometry of the Bluefields River. Notes: There is nearly eight meters of incision at river meter 670.6 that can be determined by combining the cross sections with the locations of fluvial tufa deposits.

Fluvial Tufa Deposits. The elevation of tufa deposits can also indicate previous channel bed elevations (Figure 27). Tufa coatings or concretions tend to be deposited on or near the channel bed where carbon dioxide is released to the atmosphere or removed by photosynthesis from karstic spring- or ground water- fed streams in like the Bluefields River. As the carbon dioxide of the stream water decreases, calcium carbonate or limestone crystallizes on the bed materials, lower banks, vegetation, or any hard surface (even plastic containers). If the channel bed elevation stays stable for a long period, thick coatings of tufa will become concentrated along the location of the channel bed and these

can be recognized both at the location of the present bed (Figure 24) and as paleo-channel indicators higher up on the valley wall (Figure 27).

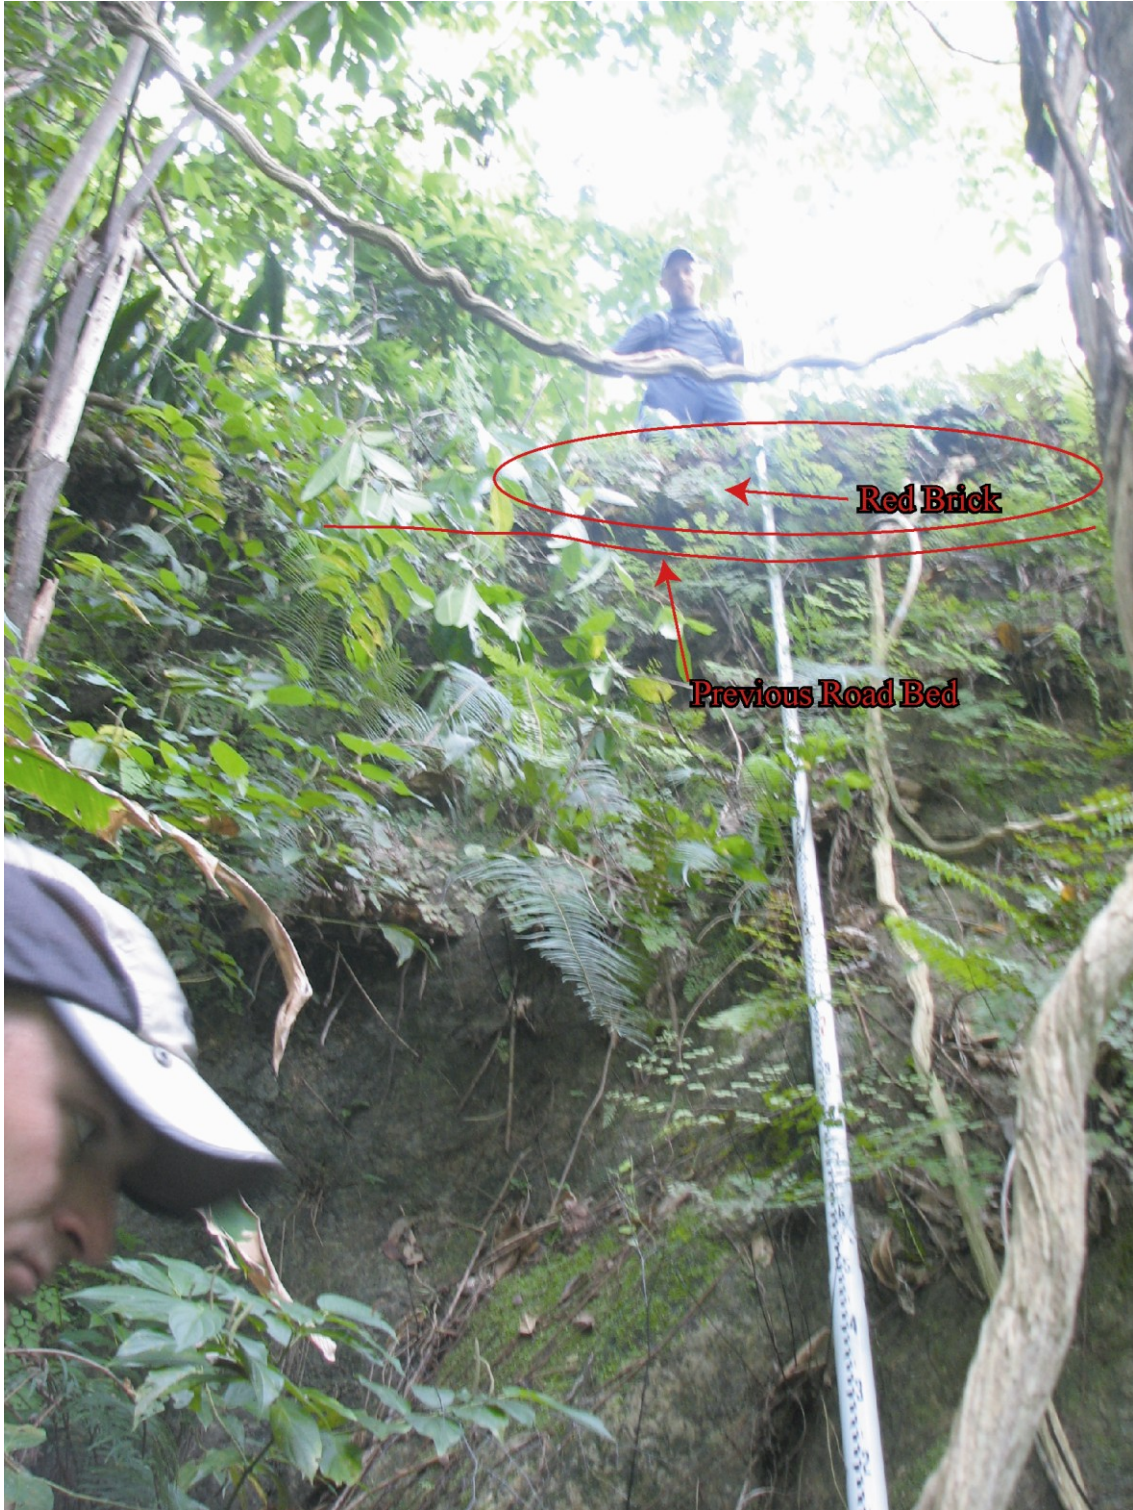
Figure 28. Old Great House Road bridge elevation. Notes: Previous road elevation of the bridge is about four meters above the present channel thalweg. Oral history accounts indicate that the bridge structure was about one meter above the bed at river meter 607.

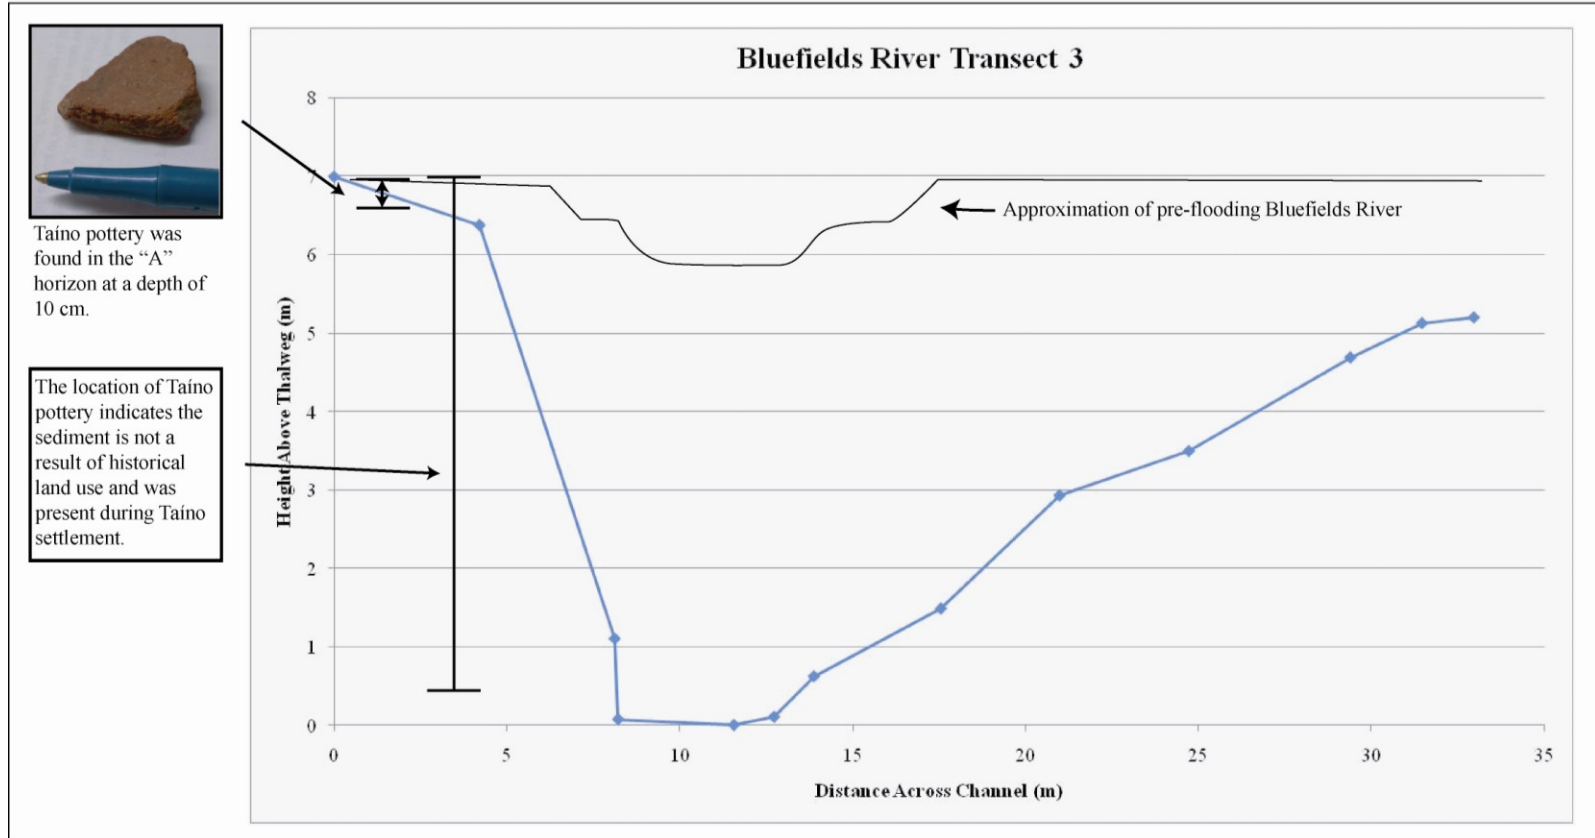
Figure 33. Land Use Changes and Impacts on Sedimentation. Pottery from the Taíno settlement was found on the tops of the banks indicating historical land use changes had little effect on sedimentation at this location.
