**GRAVEL SEDIMENT SOURCES AND BAR DISTRIBUTION WITHIN THE  
MAIN STEM OF UPPER BULL CREEK SOUTHWEST MISSOURI**

A Masters Thesis

Missouri State University

December 2013

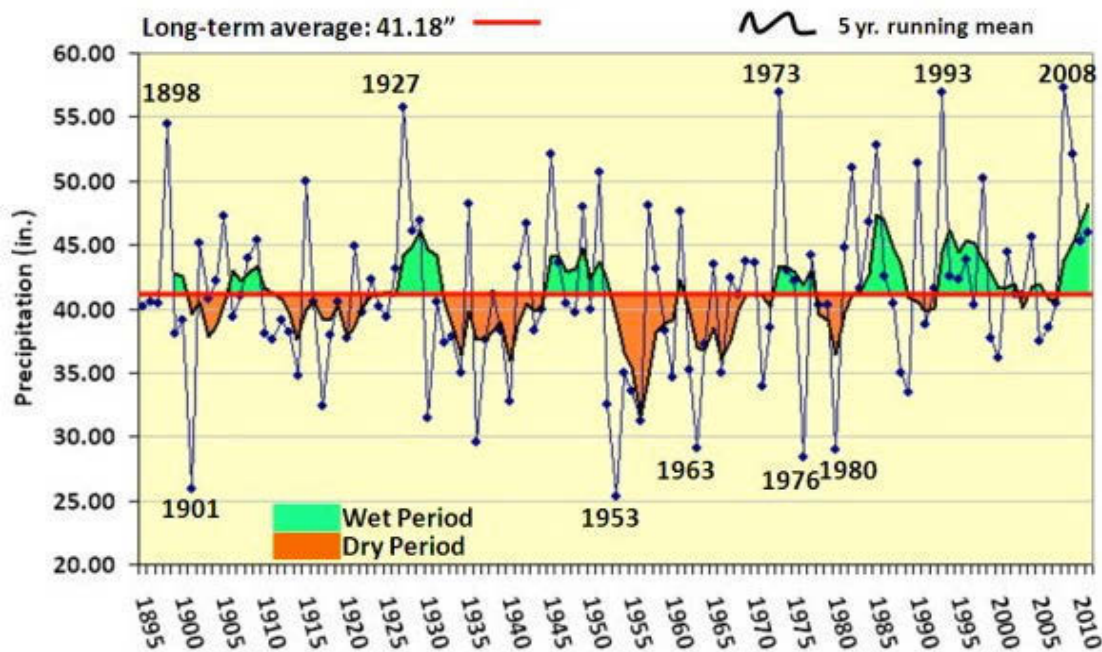
Figure 4. Missouri Annual Average Precipitation (1895-2011). Source: University of Missouri Climate Center, 2011

While presently in a wet period, the state of Missouri has a highly variable climate with varying lengths of wet and dry periods (Figure 4). Ozark, Missouri has a 65-year record with a mean annual precipitation of 100 cm a year (Figure 5). The maximum annual precipitation recorded is 154 cm in 1993 whereas the minimum record was approximately 44 cm in 1948. (University of Missouri Climate Center, 2012). Within the Bull Creek 17-year discharge record, the recent high peak in 2008 state and local precipitation data can be observed also within the Bull Creek mean annual and maximum annual discharge (Figure 6).

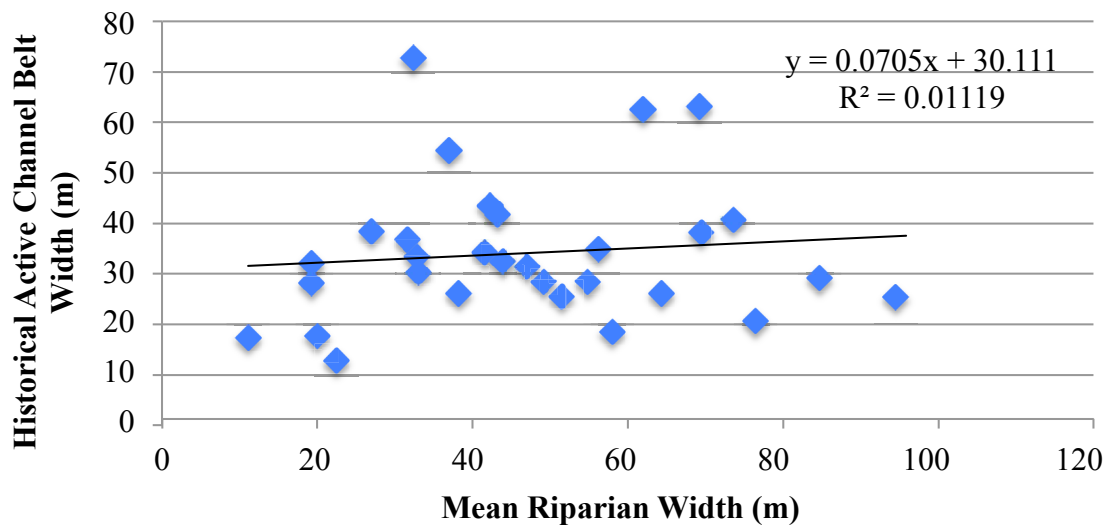
Figure 16. Historical mean riparian width relationship to the historical active channel.

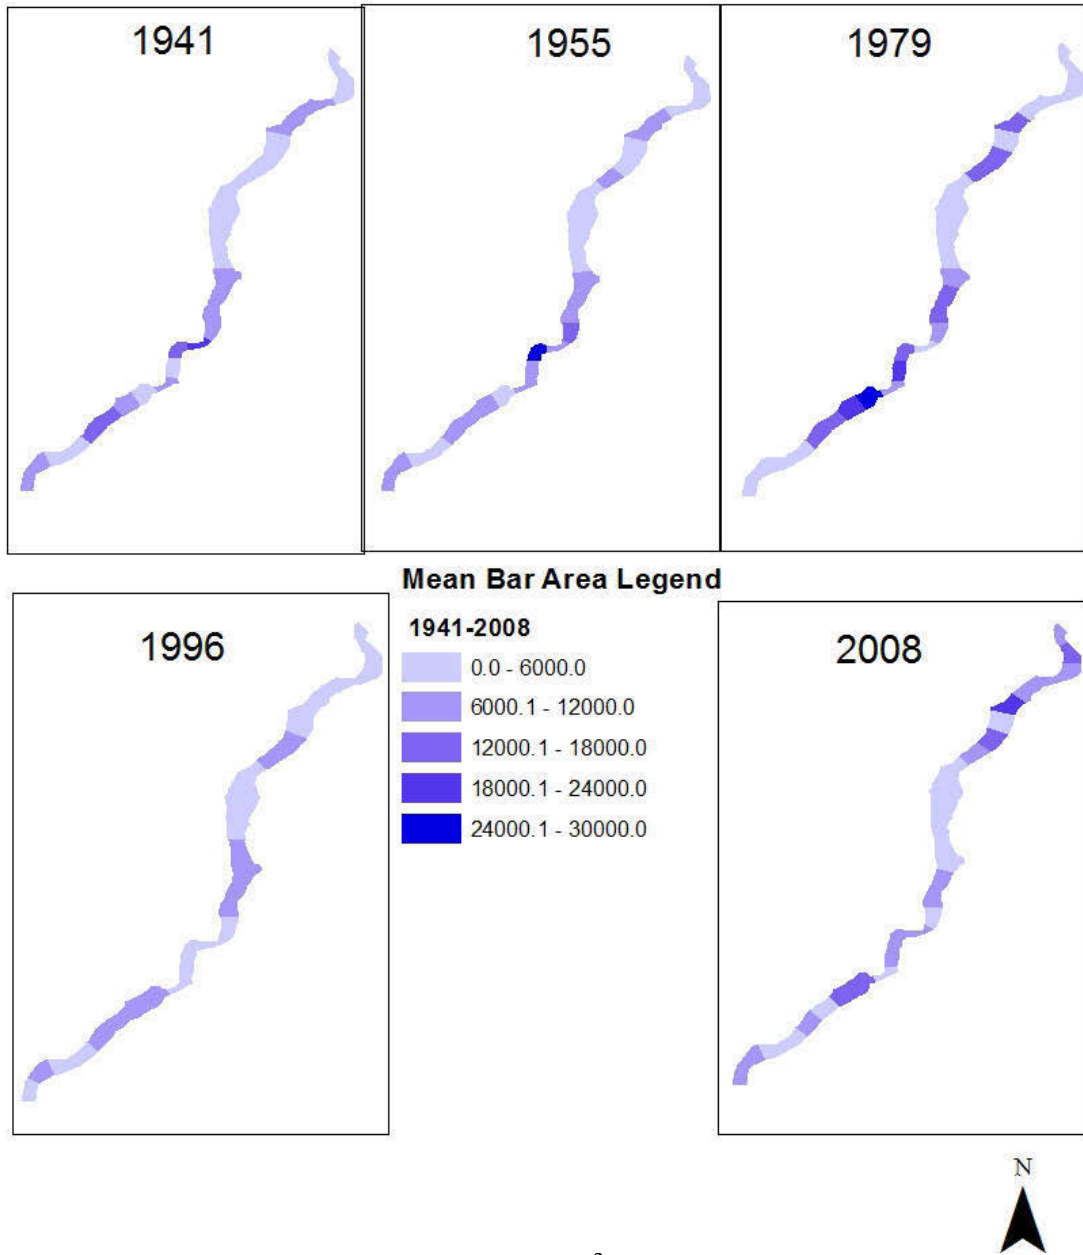
Valley-Cell Mean Gravel Bar Area  
Q - Corrected

Figure 17: Valley-cell mean gravel bar area (m<sup>2</sup>) by year.

Overall, between all the years studied, 1979 is the year with the largest overall main stem gravel bar area (Figure 17). The aerial photograph for 1979 was during winter leaf-off conditions like 1996 and 2008 photographs (Table 3). Point-to-point error is the same as the 1941 photograph and similar to 1955. Also the time between a flood prior to the photograph date are similar in all photos and do not suggest that 1979 would have an elevated gravel bar area due to these factors.

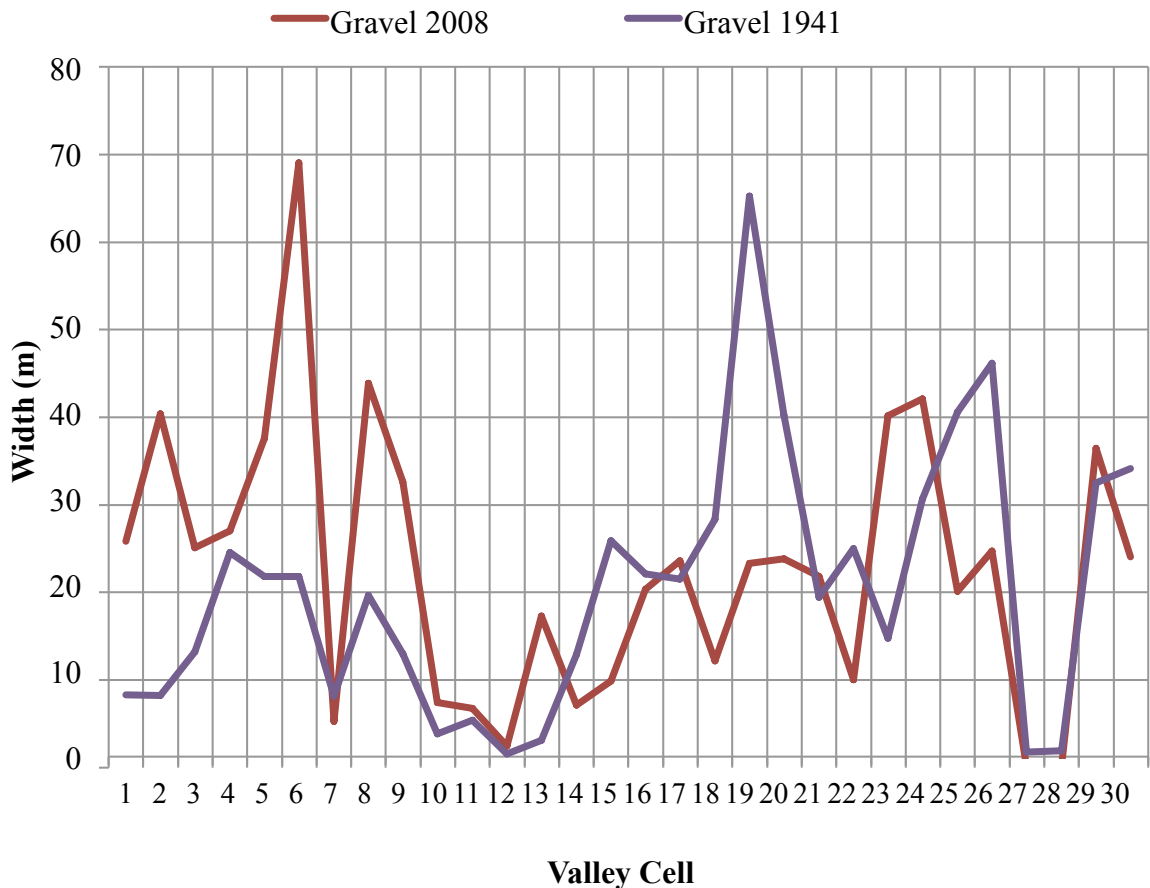
Figure 18. Downstream trends in gravel bar width for years 1941, and 2008.

Furthermore, gravel bar widths have increased recently in the upper segment and decreased from historical widths in the lower segment (Figure 18). The year of 1979 is contrary to Jacobson's (1995) findings on Ozarks' streams, which gravel sediment moved through larger watershed between 1920 and 1940. Under that hypothesis the peak in gravel bar area should be no later than 1941. Thus, gravel supply could have been elevated by other means of disturbance such as climate changes, land use changes, or combinations of these factors.

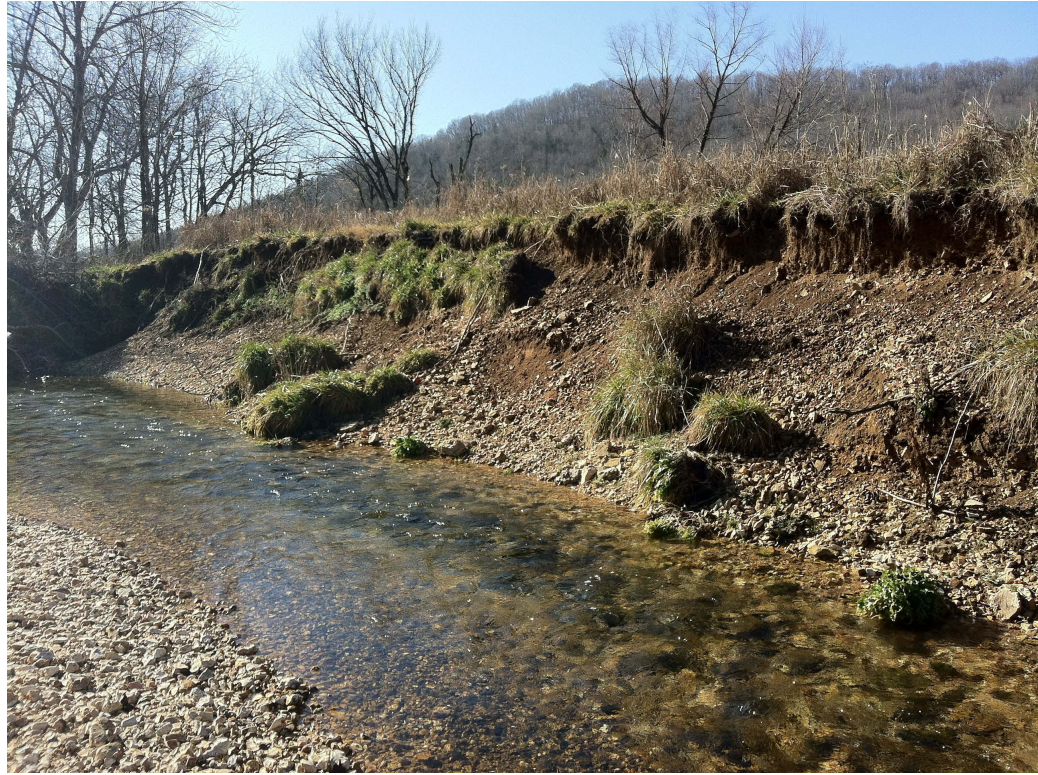
**Gravel Remobilization.** At channel reaches of increased gravel deposition and HCB widths, bank erosion can remobilize buried paleo-bar deposits stored over the historical period. Similarly, the migrating channel can erode into gravelly colluvium flood plain sediments and introduce gravel and fine sediments back into transport (Figure 21). Finally, the remobilization of in-channel gravel bars during large floods allows this sediment to migrate toward other downstream disturbance locations for temporary storage. Martin and Pavlowsky (2011) found that mid channel gravel bars seemed to form downstream of disturbance reaches that had remobilized gravel deposits through channel extension and bed or bank erosion. This suggests disturbance reaches are both a sink and a source of gravel sediment within the main stem of Bull Creek.

Figure 21. Gravel released from back erosion. (A) VC 11-12 across from recent channel widening due to mega-bar formation. (B) Mobile diagonal/point bar at VC 5.....50

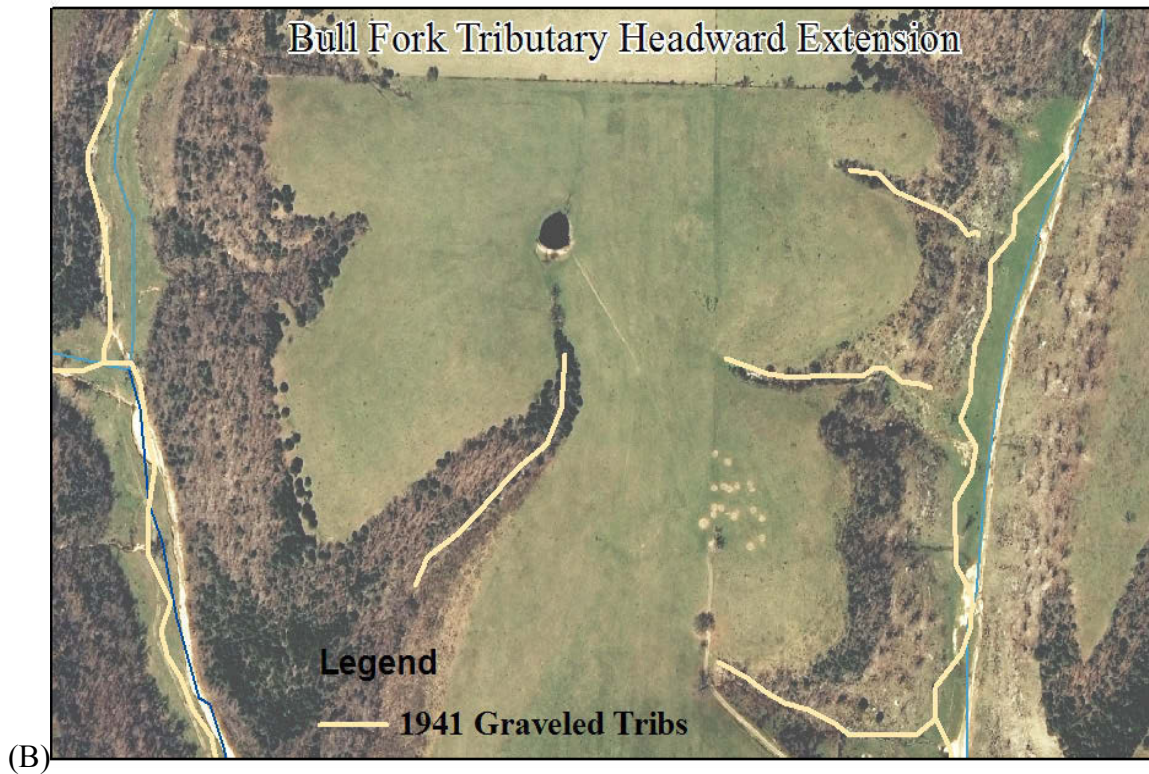
Figure 22. Upland tributary gravel length in (A) 1941 and (B) recovery in 2008.

1941. The West Fork displayed gravel mostly in the upper reaches. The middle tributary, Bull Fork, displayed gravel predominantly around the middle reaches. While the Chadwick ATV property shows only two small tributaries and the main stem of Peckout Hollow. Furthermore, nearly zero tributary gravel is seen on the west side of the main stem of Bull Creek (Figure 23). In general, a large majority of gravel length present is located within upland 1<sup>st</sup> order tributaries in 1941 that extend into the upland fields containing Poynor or Clarksville soil series (Figure 22A). These upland soils contain 5-30% chert cobbles larger than three inches and 40-75% smaller chert fragments that increase in percentage with depth (Table 1). Tributary gravel signatures seen in aerial photographs support the hypothesis by Jacobson and Primm's (1994) of a historical gravel sources originating from head ward extension of first order tributaries receiving land clearing.

2008. Within the West Fork, gravel is found in the mostly the main channel and upper reaches of the tributary. Bull and West forks have gravel throughout the main stems of the primary tributaries as well as being dispersed throughout the main stem. The Chadwick ATV area has four tributaries with gravel and Peckout has gravel evident in the upper primary tributaries. Furthermore, the west side of the main stem has two tributaries that display gravel length and area (Figure 23).

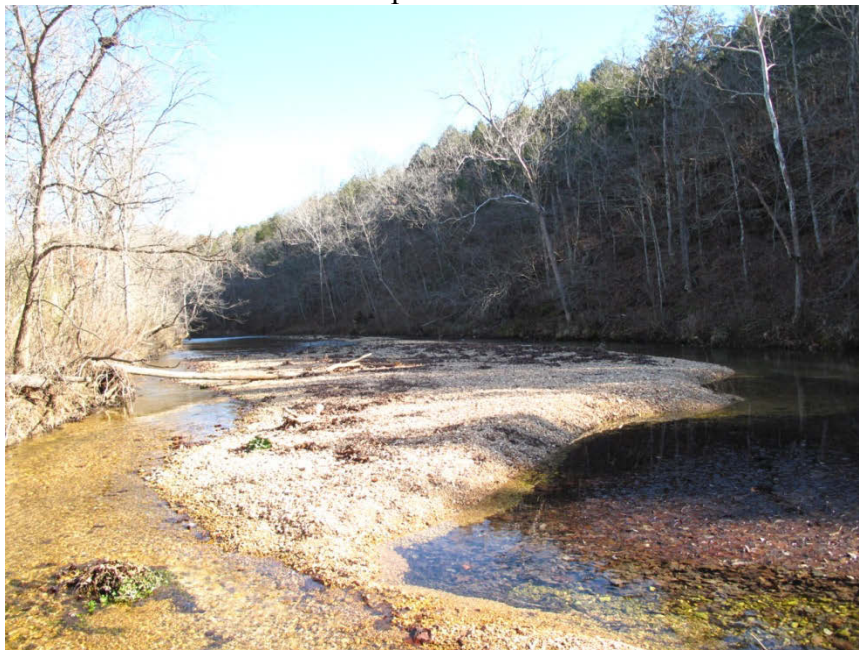
Mega bar of loose gravel directly above cross section one at FS5-6.

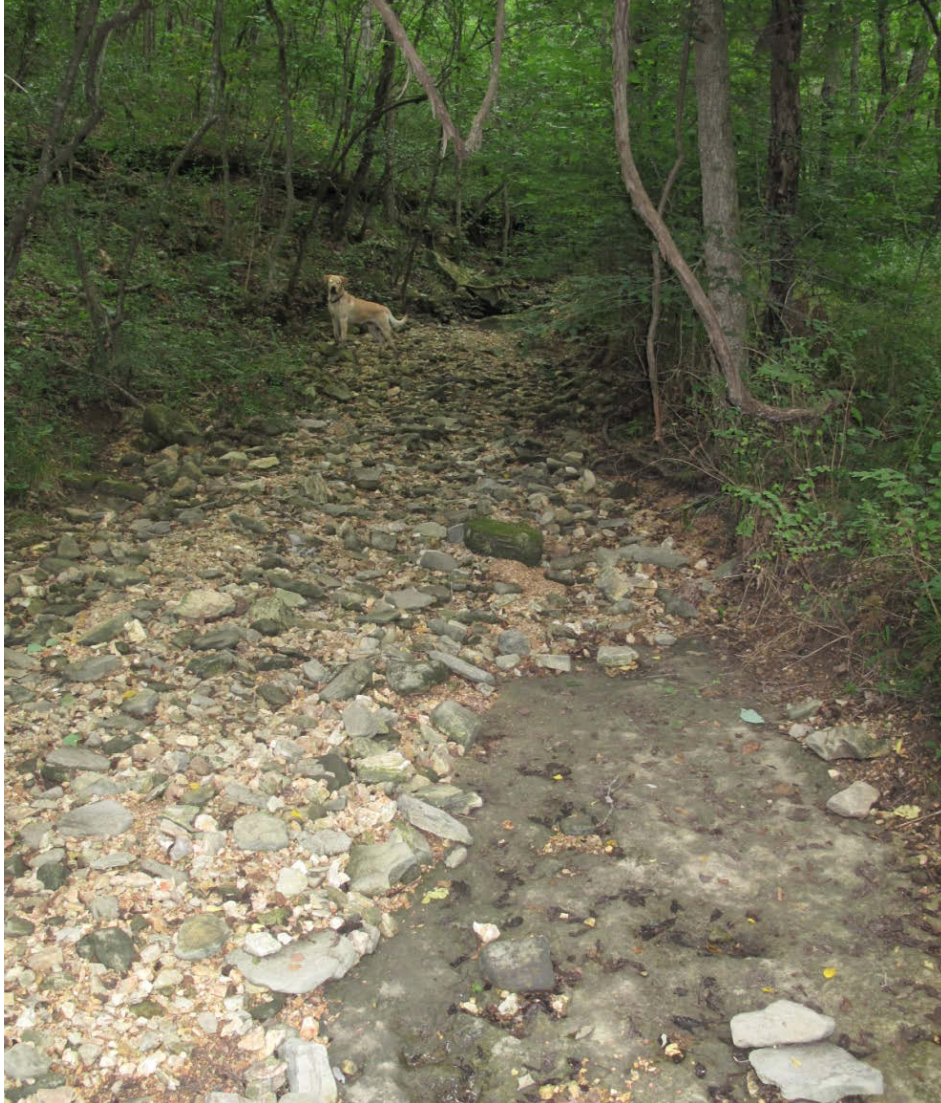
Tributary west of FS11-12, mostly cobble and bedrock with little gravel present.

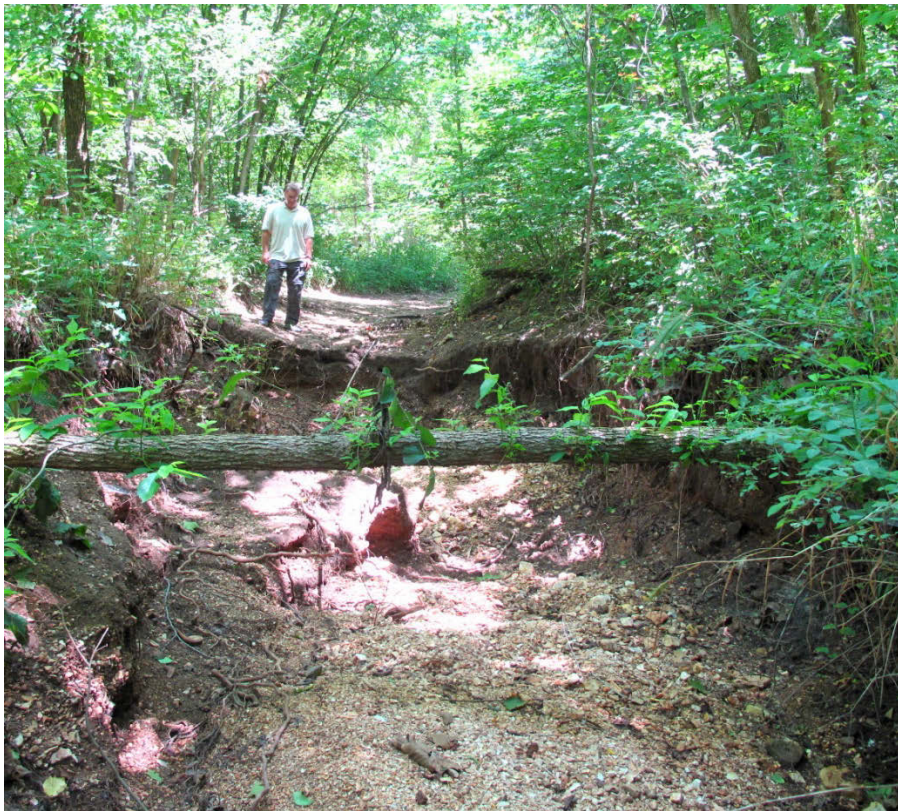
Dr. Pavlowsky at a headcut found within a ATV trail along Peckout Hollow.

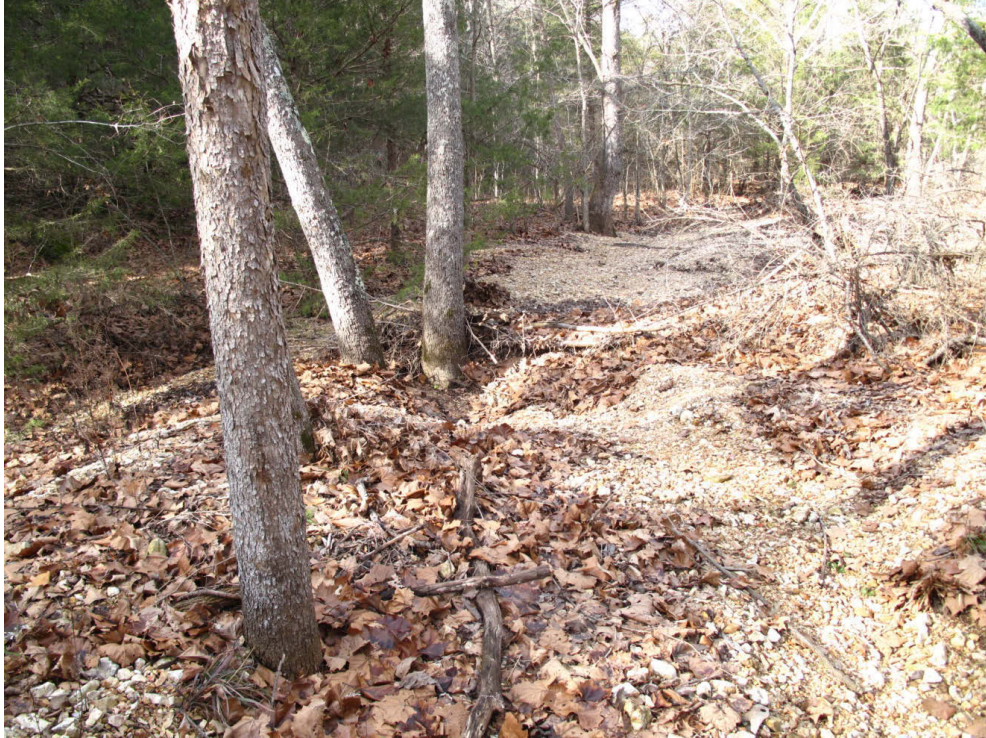
Tributary northwest of FS25-26 with excess gravel burying sycamore trees
