Geomorphic Effects of Engineered Log Structures and Response to a Catastrophic Flood Event in a Missouri Ozarks River

**GEOMORPHIC EFFECTS OF ENGINEERED LOG STRUCTURES AND RESPONSE
TO A CATASTROPHIC FLOOD EVENT IN A MISSOURI OZARKS RIVER**

A Master's Thesis

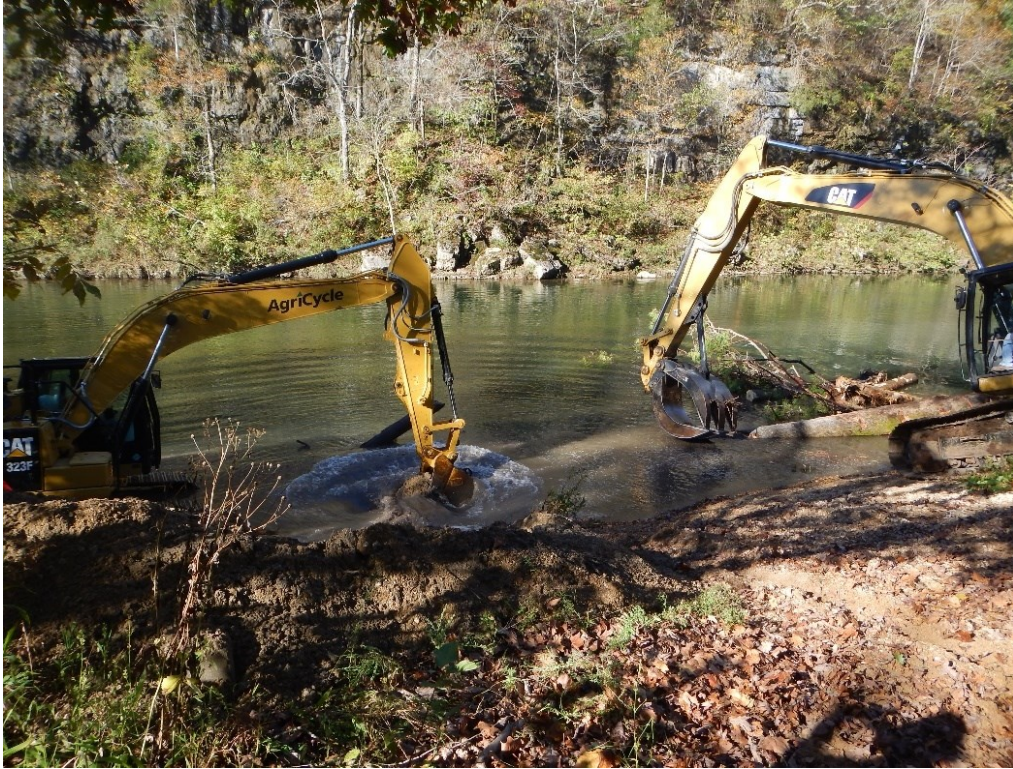
Figure 5. Construction of ELS 1. Excavator digging a trench in the bed for key piece placement.

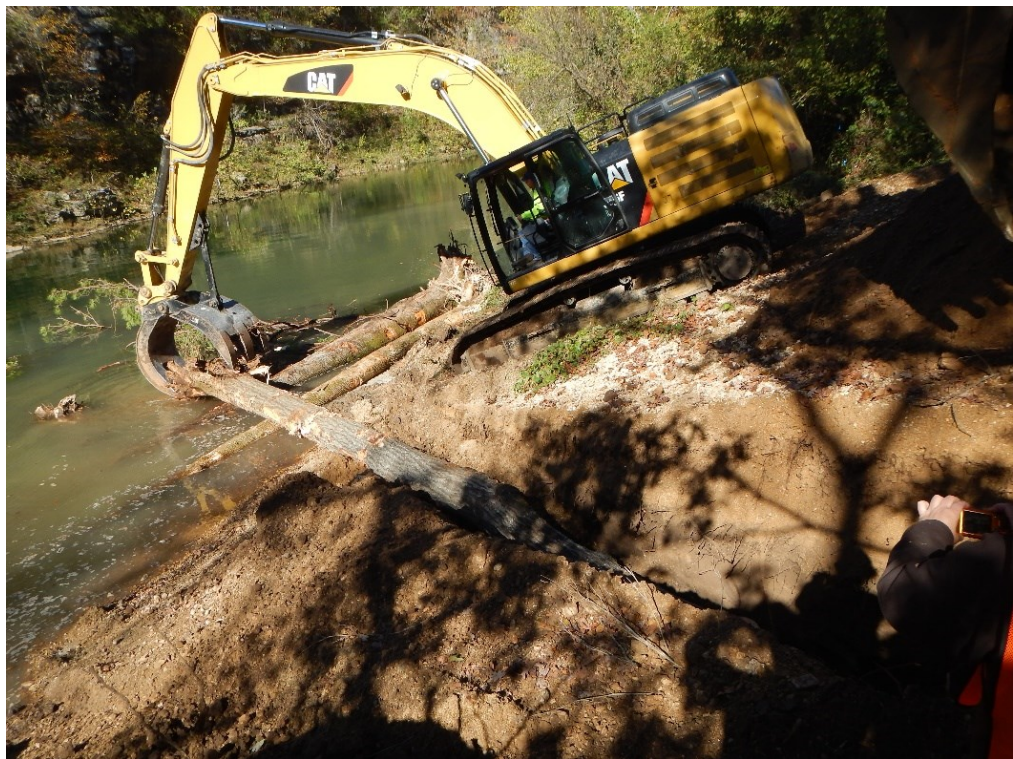
Figure 6. Excavator placing logs in a trench perpendicular to flow positioned over key pieces.

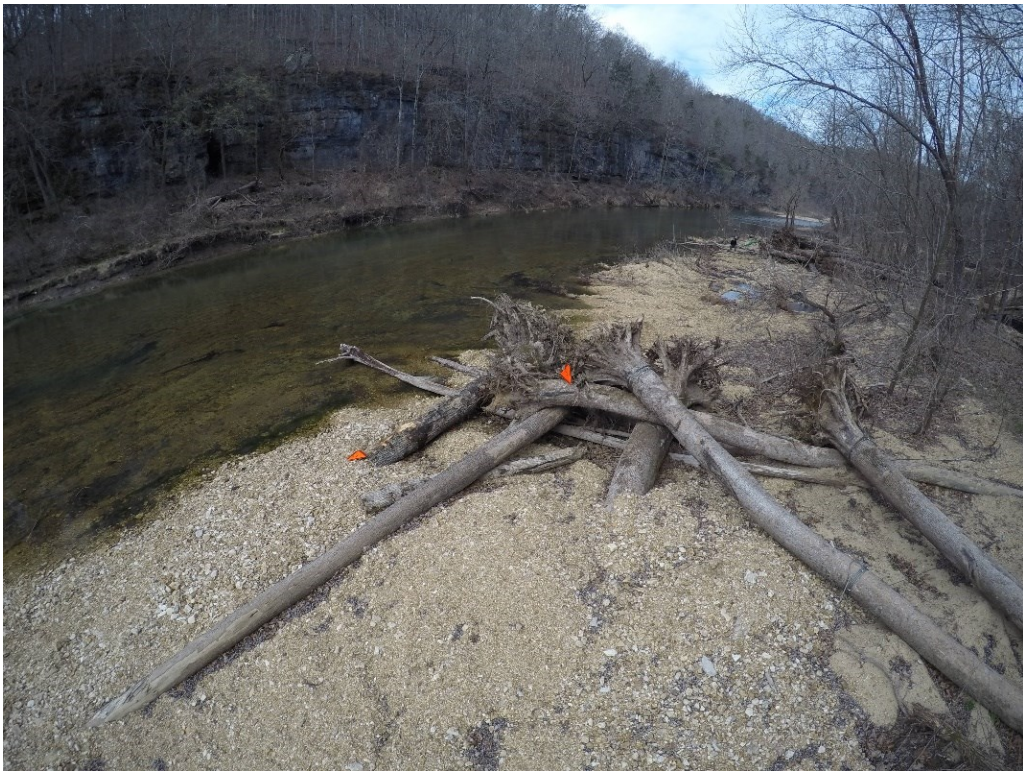
Figure 10. ELS 4 in foreground and ELS 3 in background. Flow direction from right to left and burial of key pieces with root fans oriented upstream.

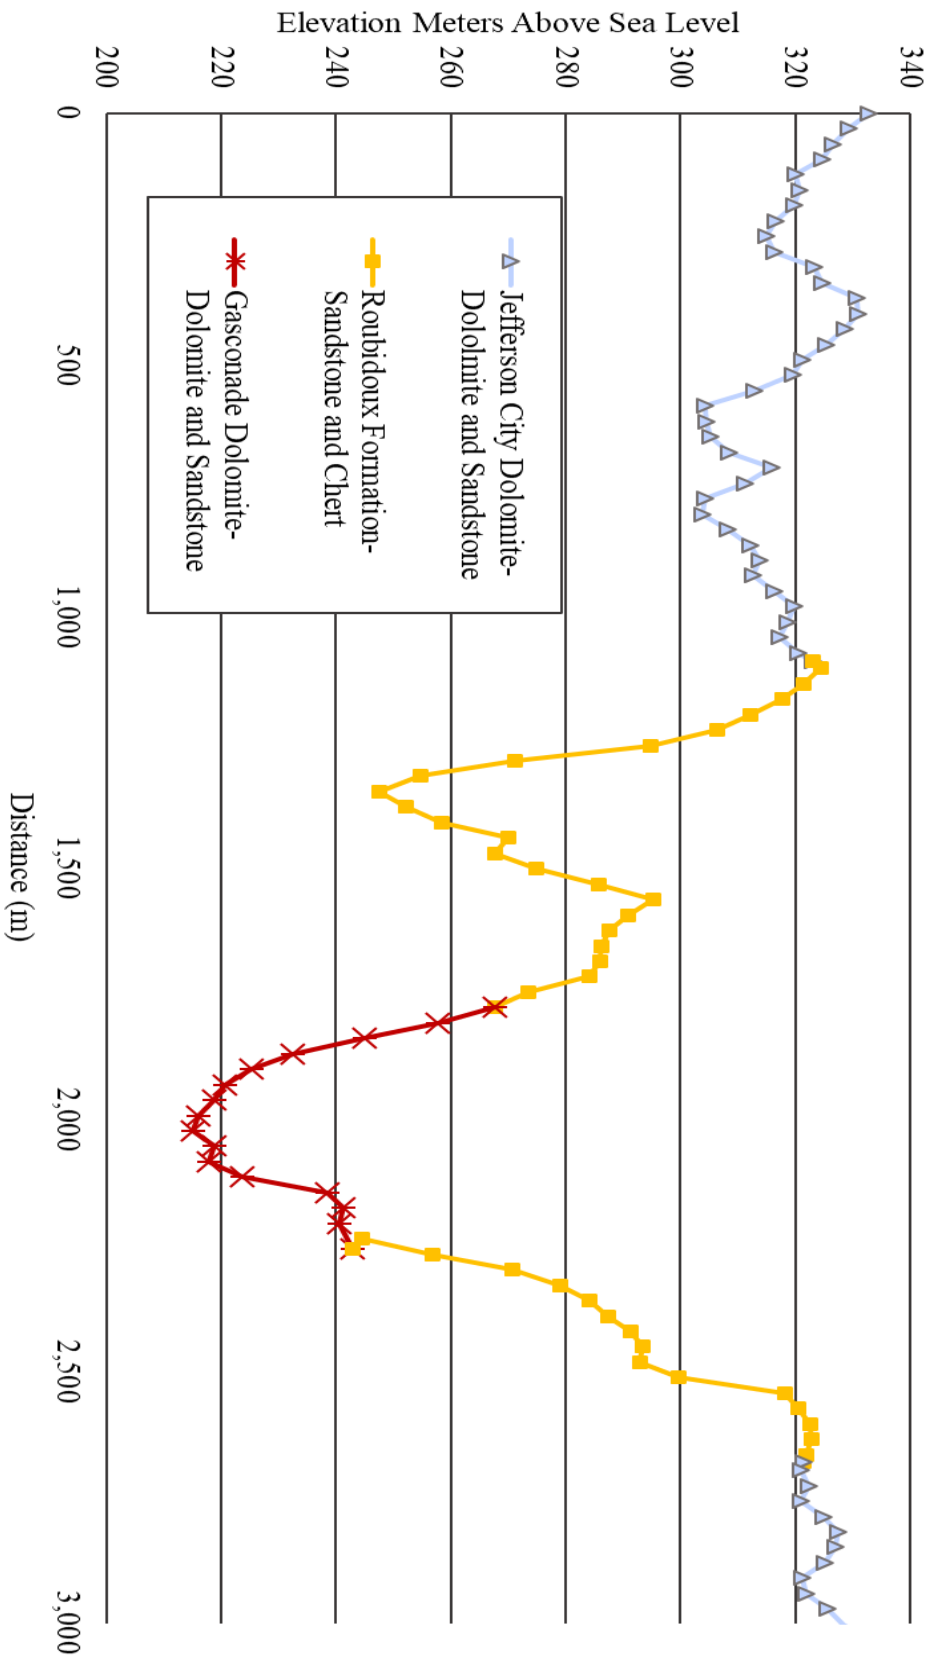
Figure 13. Cross-section of geologic composition.

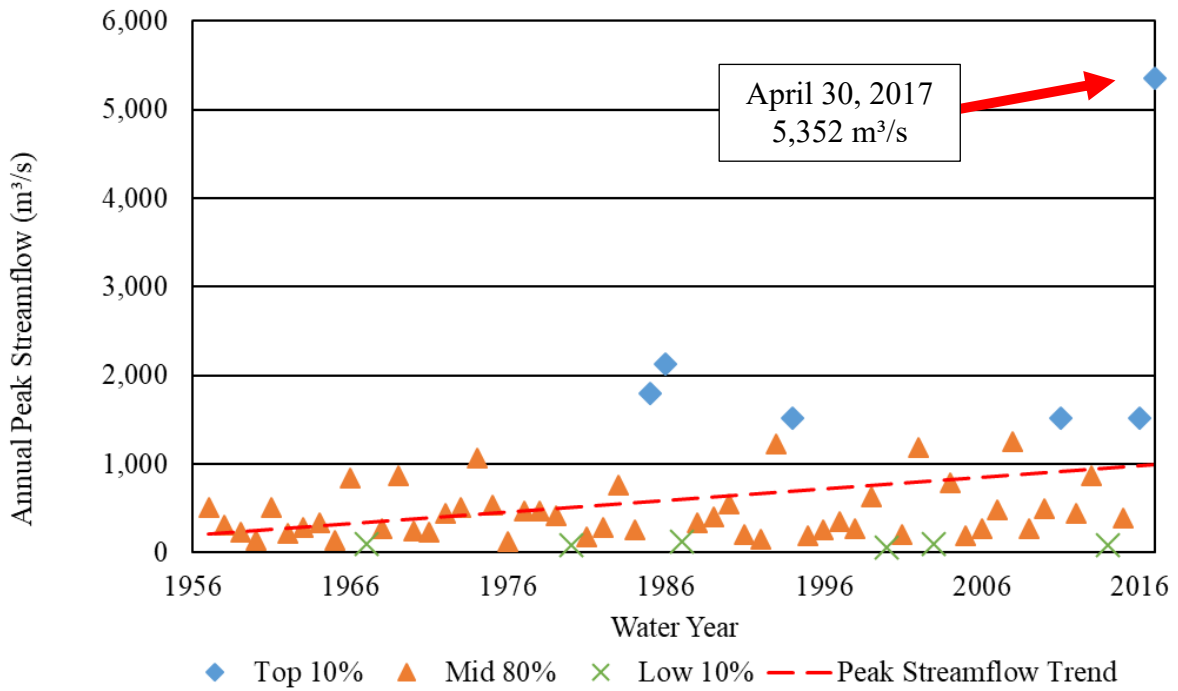
Figure 18. Annual peak streamflow from North Fork River from 1956-2017 (USGS, 2018).

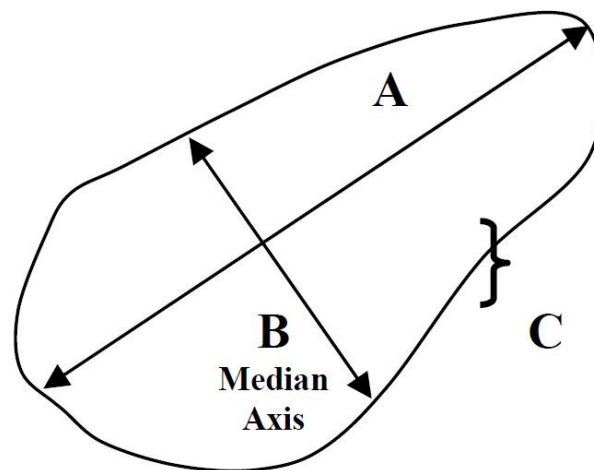
Figure 25. Example of median axis of pebble that is measured for substrate survey (Kline et al., 2009).

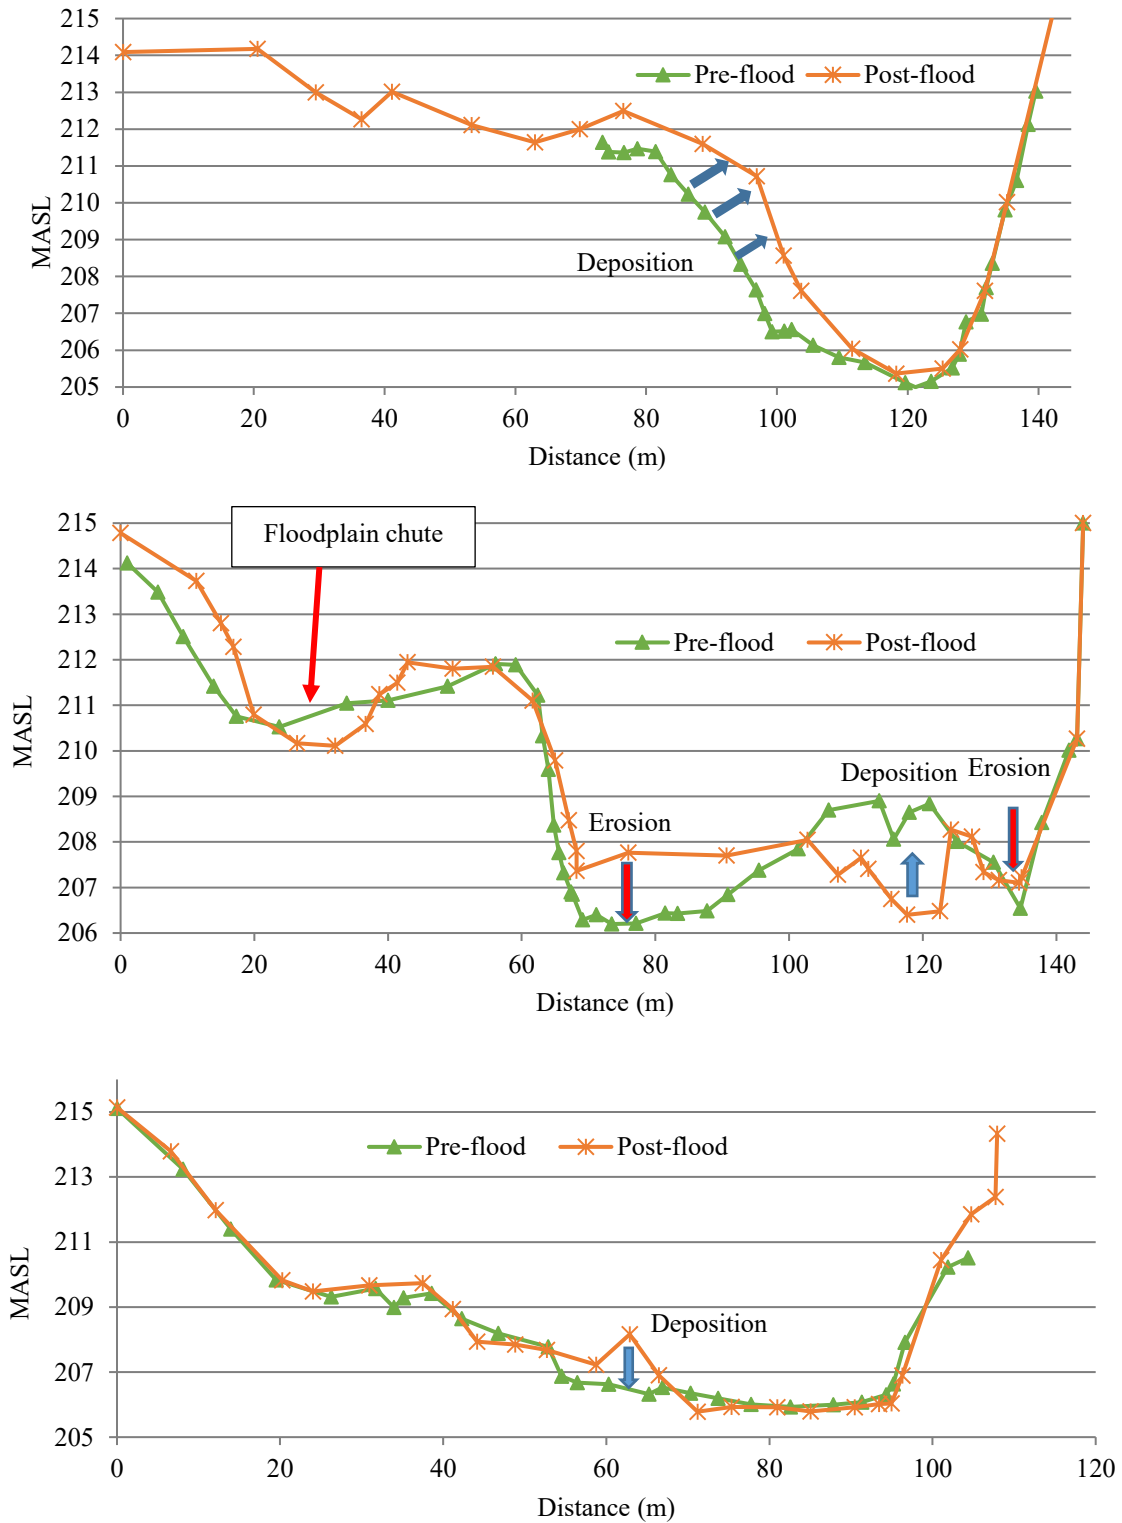
Figure 39. Cross-sectional survey comparisons at ELS 1 (top), ELS 2 (middle), and ELS 3 (bottom).

Channel Cross-sections. The pre-flood cross-section at ELS 1 had a bankfull width of 53 m and a maximum bank height of 6 m. The cross-sectional area was 194 m² with a wetted perimeter of 55 m and a hydraulic radius of 3.52 m (Table 9). The post-flood comparison at ELS 1 shows deposition on the left bank where ELS 1 was buried by sedimentation during the extreme flood event. Aggradation at this cross-section caused the bank edge to move instream toward river-right 7.2 m (Figure 39). The increase in bed elevation at the bank toe was 4.2 m due to slip face deposition of sediment over ELS 1. After the extreme flood event there was no visual evidence of ELS 1 in the field and the survey results are consistent with total burial of the structure.

At ELS 3 the flood caused sand deposition on the left bank to the level of the floodplain (Figure 39). Structure ELS 3 is located on the head of the lateral bar where flow separates into a chute channel on the left and main channel to the right. The flood deposited a bar downstream of ELS 3 which is typically seen on the downstream side of a log jam obstruction (Keller and Swanson, 1979; Gurnell et al., 2002). This bar deposition was between ELS 3 and ELS 4 and it increased the bar elevation by 1.84 m (Figure 39). A scour pool 0.57 m deep formed on the instream side of ELS 3 behind a large tree and rootwad that was lodged against ELS 3. Chute channel deposition of sand and LWD made it impossible to resurvey the pre-flood ELS 4 cross-section line (Figure 40).

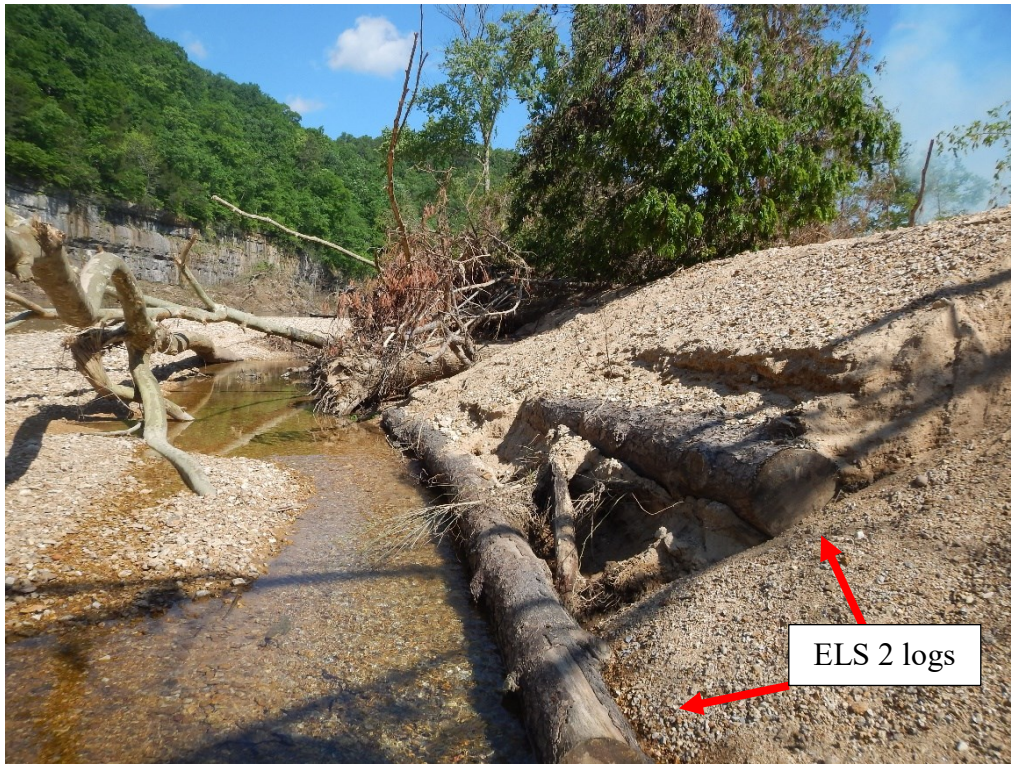
Figure 43. Deposition caused by April Flood at ELS 2 where bank angle lowered. Arrows show cut ends of logs in ELS 2.
