**The Ozarks Environmental and Water Resources Institute (OEWRI)
Missouri State University (MSU)**

Mississippi River Basin Healthy Watershed Initiative (MRBI)
Watershed Assessment for:

**Upper Apple Creek Watershed (HUC12# 071401050401)
Middle Apple Creek Watershed (HUC12# 071401050403)**

**Deliverable # 1 – Inventory of the Watershed
Deliverable # 2 – Resource Analysis of the Watershed
Deliverable # 3 – Identification of Conservation Needs
on Vulnerable Acres**

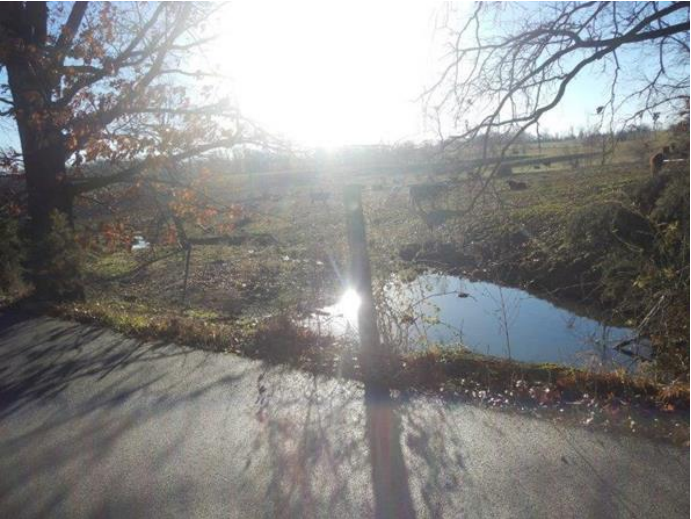
<p><u>Site # 3: Downstream</u></p>

Channel condition	10	
Hydrologic alteration	10	
Riparian zone	1	
Bank stability	5	
Canopy cover	1	
Manure presence	1	
<p>Overall Score</p> <p>4.7</p>		
<p><u>Site # 4: Upstream</u></p>

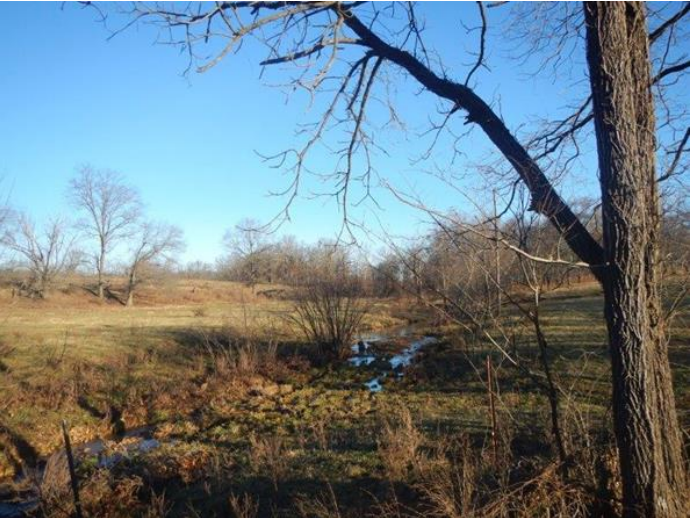
Channel condition	10	
Hydrologic alteration	10	
Riparian zone	5	
Bank stability	9	
Canopy cover	4	
Manure presence	3	
<p>Overall Score</p> <p>6.8</p>		
<p><u>Site # 16: Downstream</u></p>

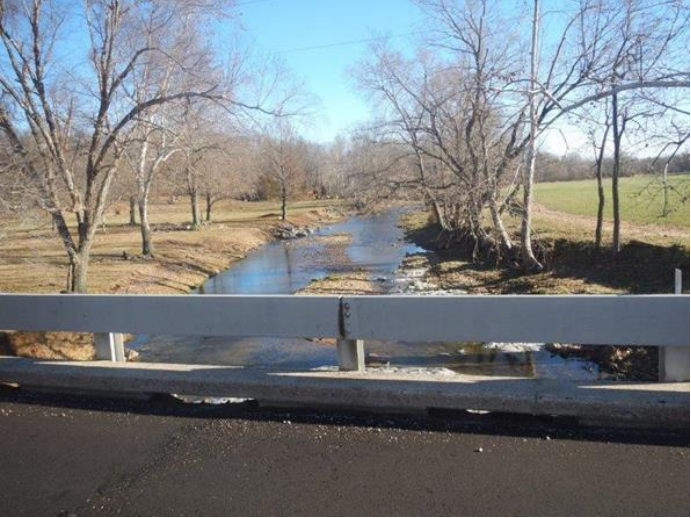
Channel condition	10	
Hydrologic alteration	10	
Riparian zone	4	
Bank stability	6	
Canopy cover	3	
Manure presence		
<p>Overall Score</p> <p>6.6</p>

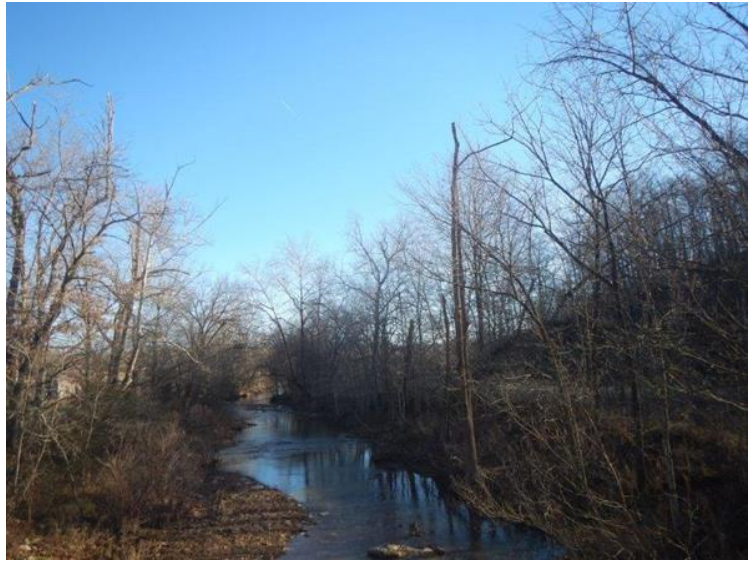
Site # 23: Downstream

Channel condition	<input type="text" value="10"/>	Overall Score 8.6
Hydrologic alteration	<input type="text" value="10"/>	
Riparian zone	<input type="text" value="8"/>	
Bank stability	<input type="text" value="8"/>	
Canopy cover	<input type="text" value="7"/>	
Manure presence	<input type="text"/>

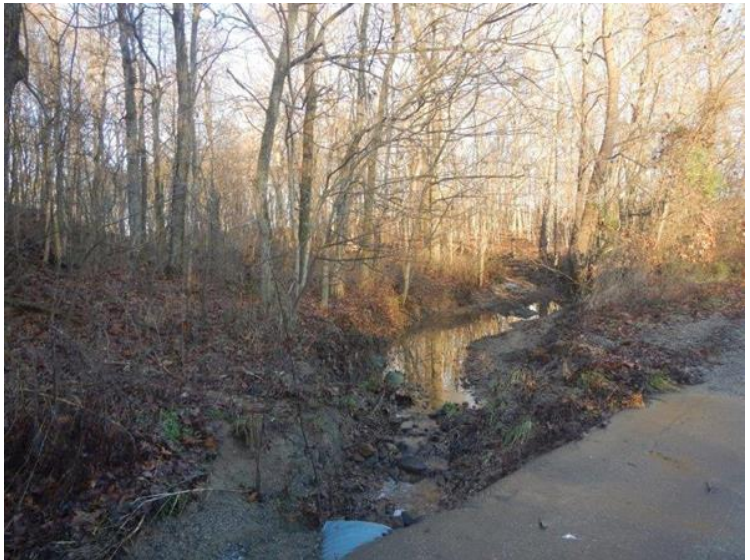
Site # 36: Upstream

Channel condition	<input type="text" value="10"/>	Overall Score 9.8
Hydrologic alteration	<input type="text" value="10"/>	
Riparian zone	<input type="text" value="10"/>	
Bank stability	<input type="text" value="9"/>	
Canopy cover	<input type="text" value="10"/>	
Manure presence	<input type="text"/>

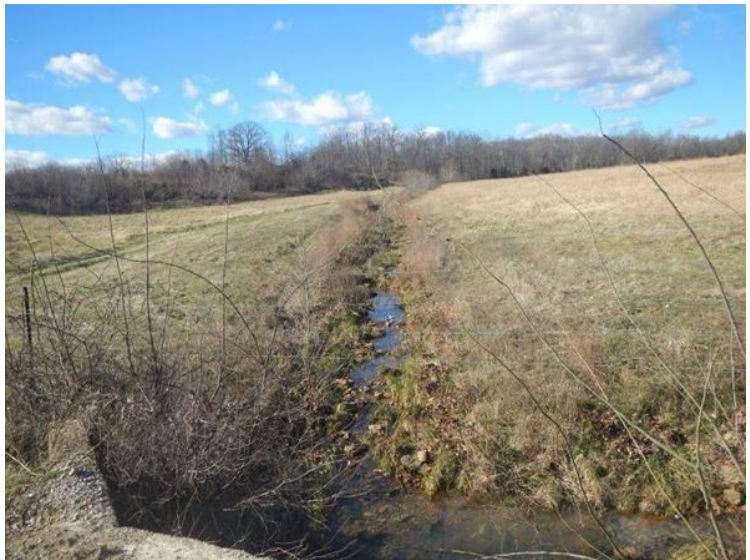
Site # 39 : Upstream

Channel condition	<input type="text" value="3"/>	Overall Score 5.8
Hydrologic alteration	<input type="text" value="10"/>	
Riparian zone	<input type="text" value="6"/>	
Bank stability	<input type="text" value="10"/>	
Canopy cover	<input type="text" value="1"/>	
Manure presence	<input type="text" value="5"/>

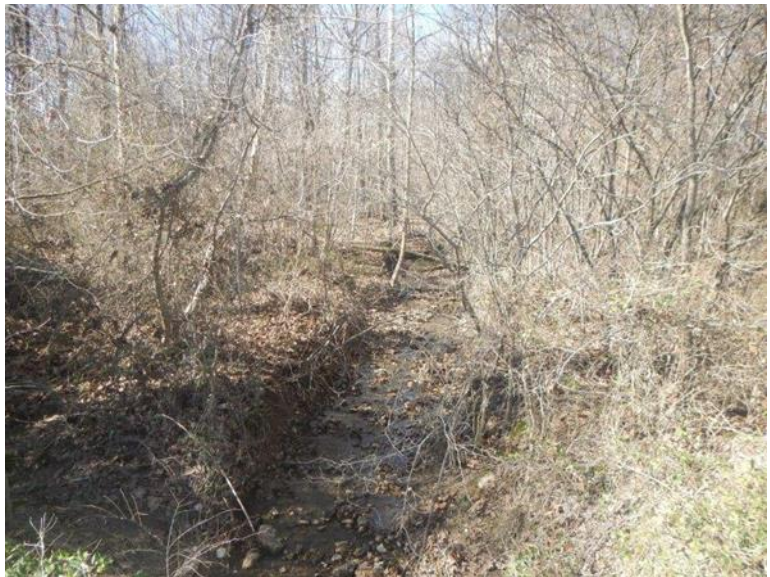
Site # 55: Downstream

Channel condition	<input type="text" value="10"/>	Overall Score 10.0
Hydrologic alteration	<input type="text" value="10"/>	
Riparian zone	<input type="text" value="10"/>	
Bank stability	<input type="text" value="10"/>	
Canopy cover	<input type="text" value="10"/>	
Manure presence	<input type="text"/>

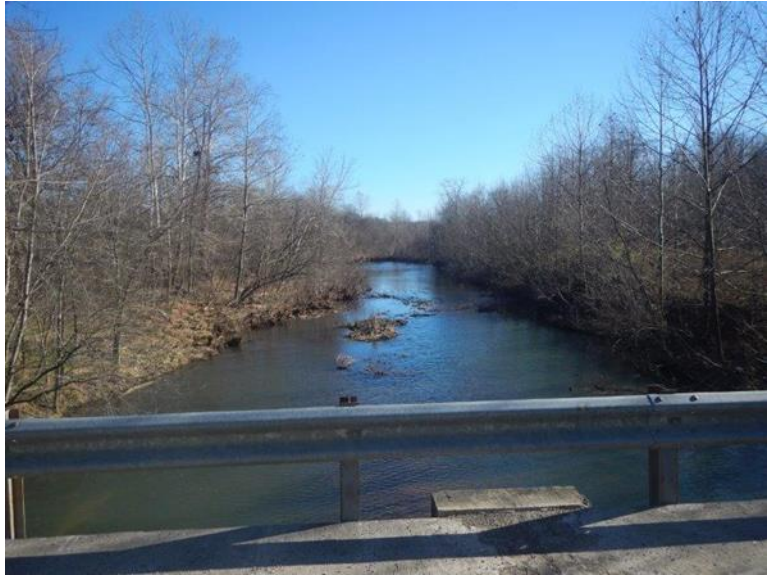
Site # 65: Upstream

Channel condition	<input type="text" value="10"/>	Overall Score 6.2
Hydrologic alteration	<input type="text" value="10"/>	
Riparian zone	<input type="text" value="1"/>	
Bank stability	<input type="text" value="3"/>	
Canopy cover	<input type="text" value="7"/>	
Manure presence	<input type="text"/>

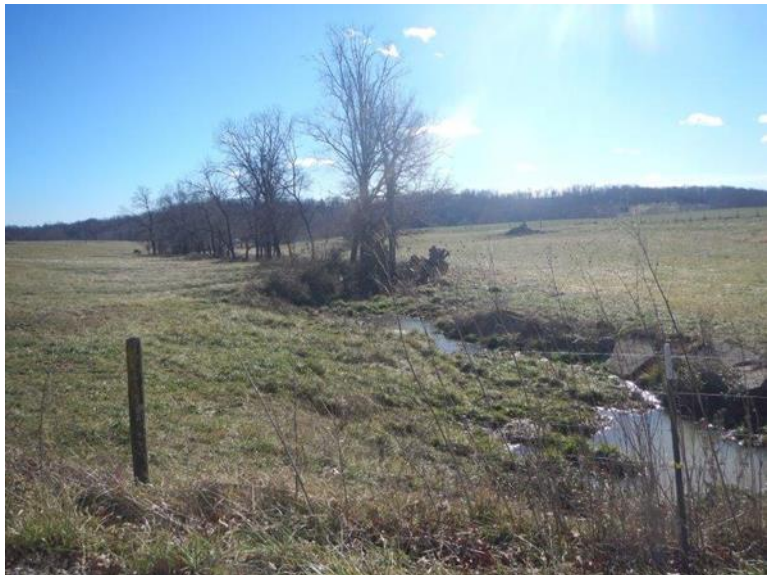
Site # 67: Downstream

Channel condition	<input type="text" value="10"/>	Overall Score 5.8
Hydrologic alteration	<input type="text" value="7"/>	
Riparian zone	<input type="text" value="4"/>	
Bank stability	<input type="text" value="5"/>	
Canopy cover	<input type="text" value="4"/>	
Manure presence	<input type="text" value="5"/>

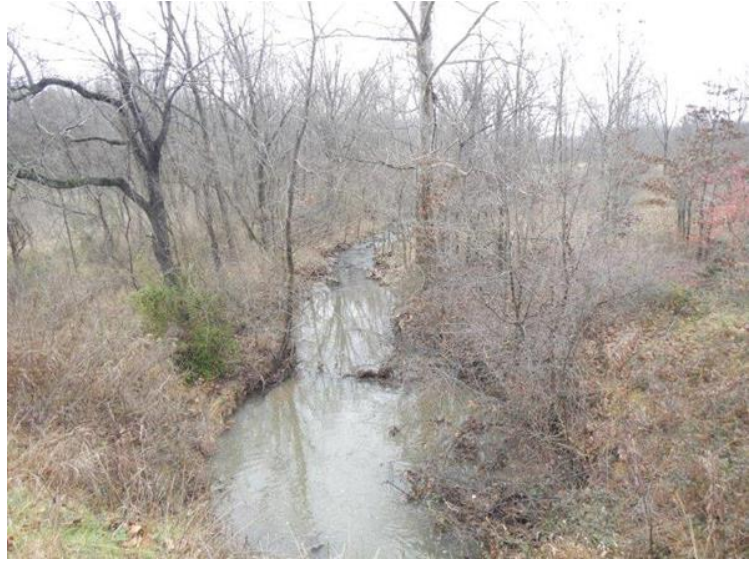
Site # 72: Upstream

Channel condition	10	Overall Score 6.3
Hydrologic alteration	8	
Riparian zone	5	
Bank stability	4	
Canopy cover	6	
Manure presence	5

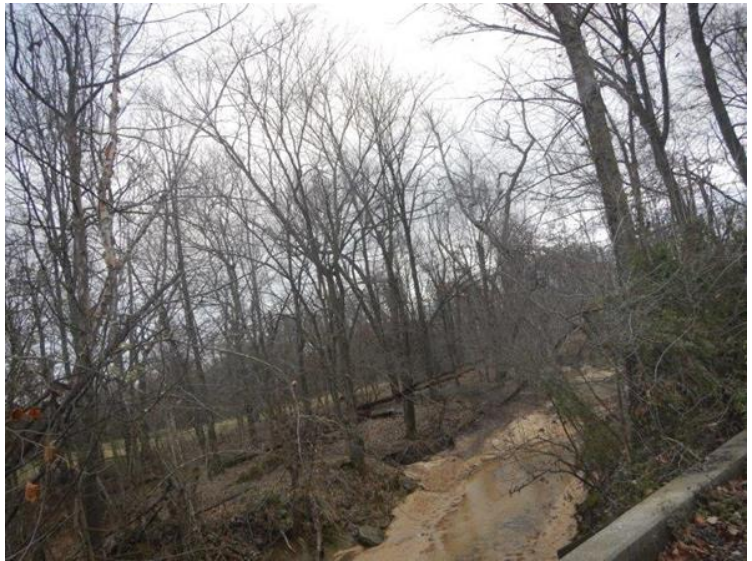
Site # 72: Downstream

Channel condition	10	Overall Score 7.3
Hydrologic alteration	8	
Riparian zone	8	
Bank stability	6	
Canopy cover	7	
Manure presence	5

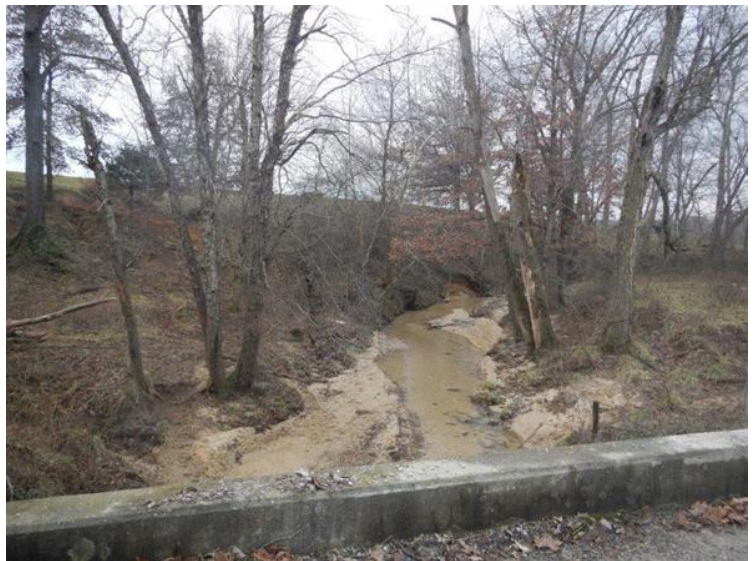
Site # 76: Downstream

**Overall
Score**
7.0

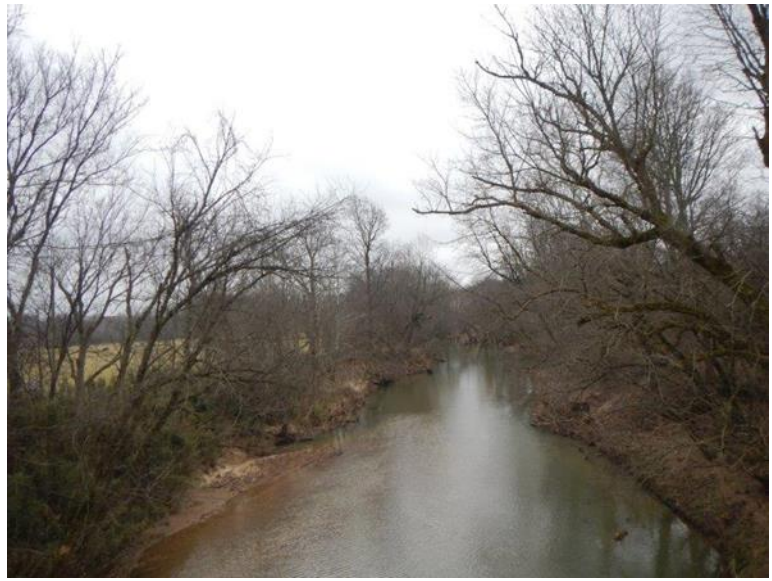
Site # 77: Downstream

**Overall
Score**
6.2

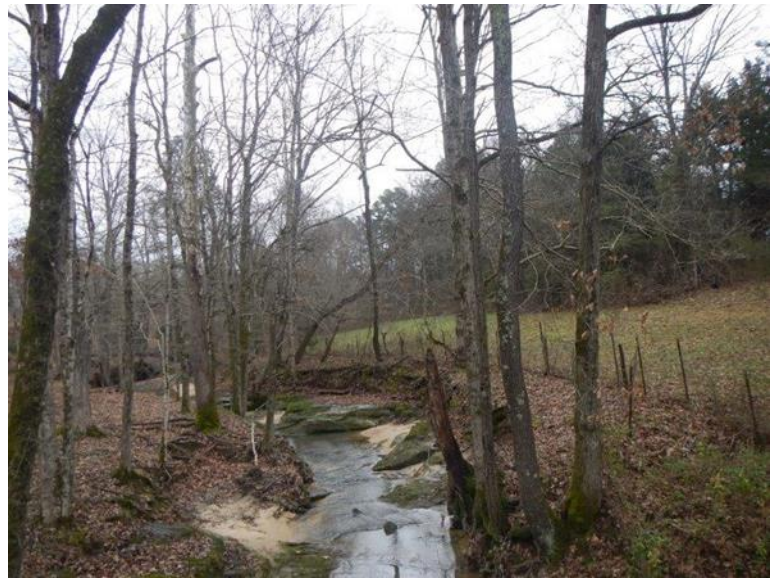
Site # 83: Downstream

**Overall
Score**
7.6

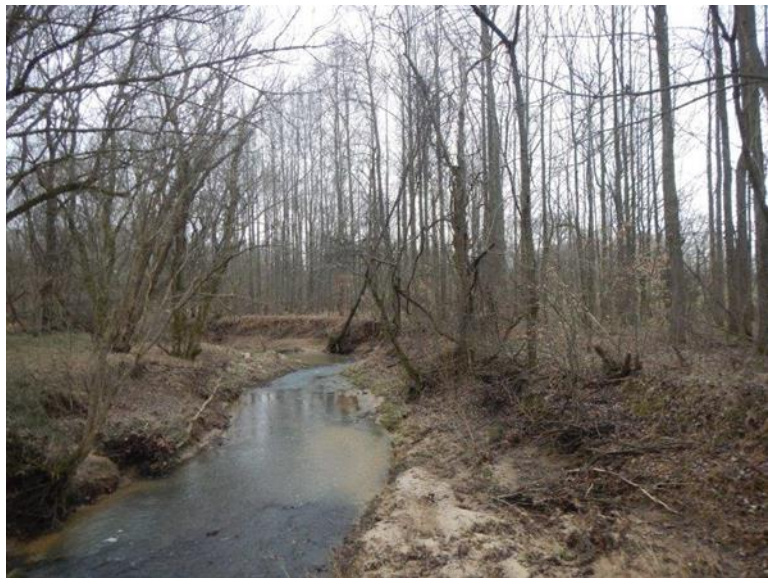
Site # 90: Downstream

Channel condition	10	Overall Score 5.7
Hydrologic alteration	7	
Riparian zone	6	
Bank stability	3	
Canopy cover	4	
Manure presence	4

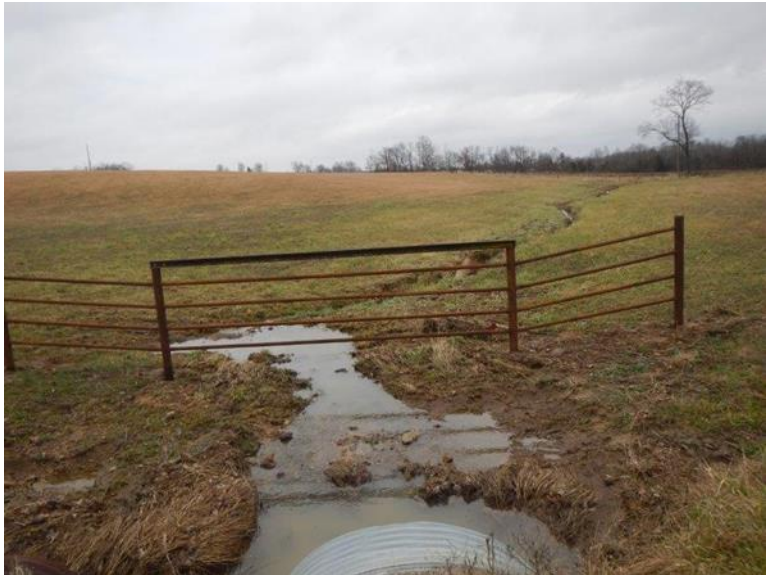
Site # 96: Downstream

Channel condition	10	Overall Score 5.8
Hydrologic alteration	10	
Riparian zone	1	
Bank stability	8	
Canopy cover	1	
Manure presence	5

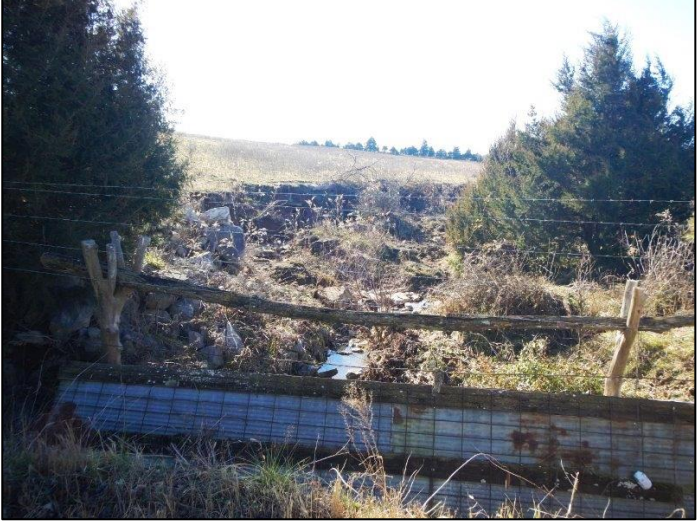
<u>MAC Site # 33: Upstream</u>

Channel condition	3	
Hydrologic alteration	6	
Riparian zone	4	
Bank stability	2	
Canopy cover	1	
Manure presence	5	
		Overall Score 3.5
<u>MAC Site #104: Upstream</u>

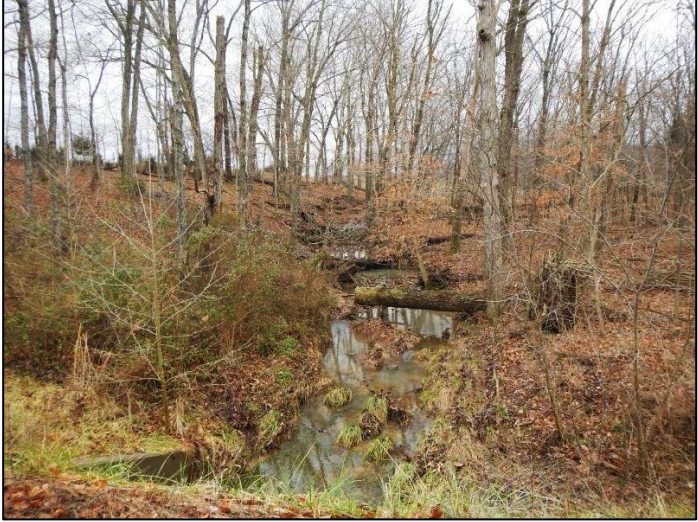
Channel condition	10	
Hydrologic alteration	10	
Riparian zone	10	
Bank stability	10	
Canopy cover	10	
Manure presence	5	
		Overall Score 9.2
<u>MAC Site # 137: Upstream</u>

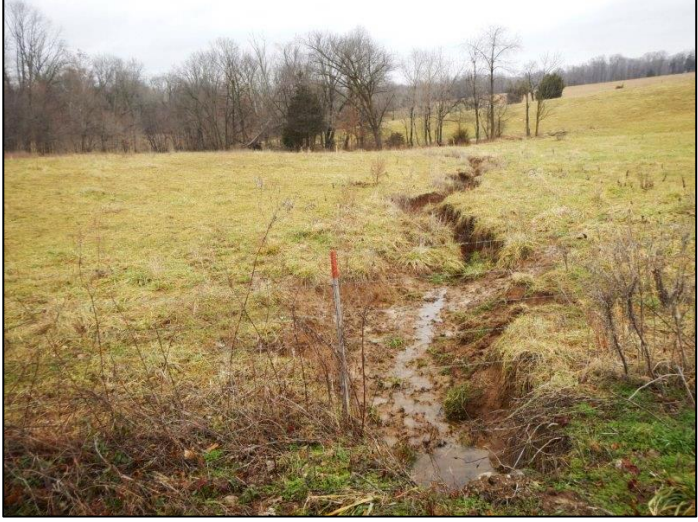
Channel condition	1	
Hydrologic alteration	1	
Riparian zone	2	
Bank stability	1	
Canopy cover	1	
Manure presence	5	
		Overall Score 1.8

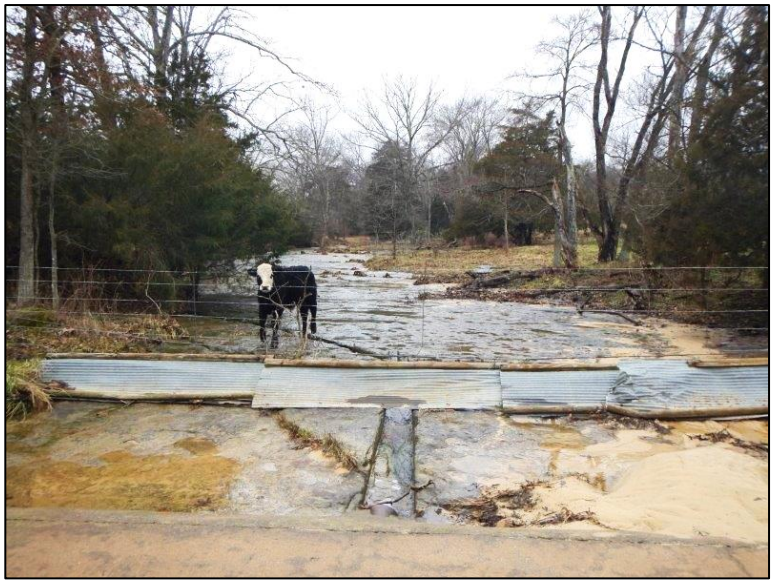
MAC Site # 86: Upstream

Channel condition	9
Hydrologic alteration	8
Riparian zone	3
Bank stability	10
Canopy cover	3
Manure presence	5

Overall Score
6.3

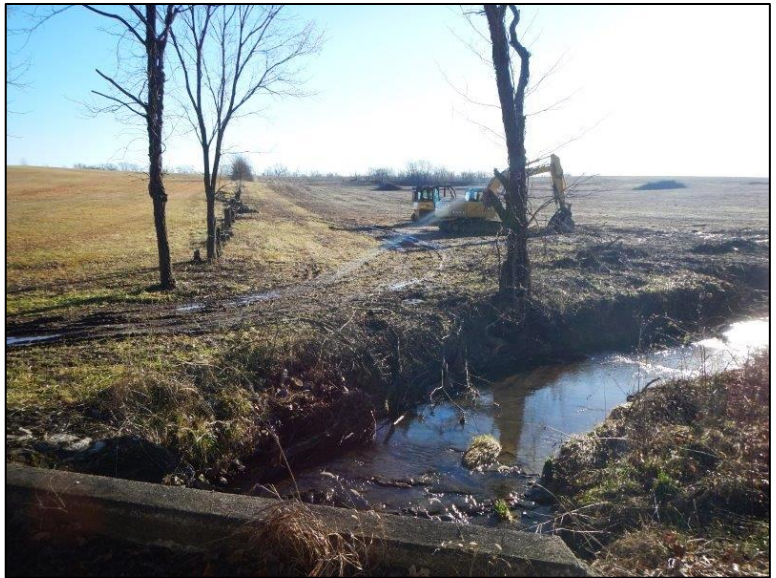
MAC Site # 38: Upstream

Channel condition	7
Hydrologic alteration	7
Riparian zone	1
Bank stability	3
Canopy cover	1
Manure presence	0

Overall Score
3.8

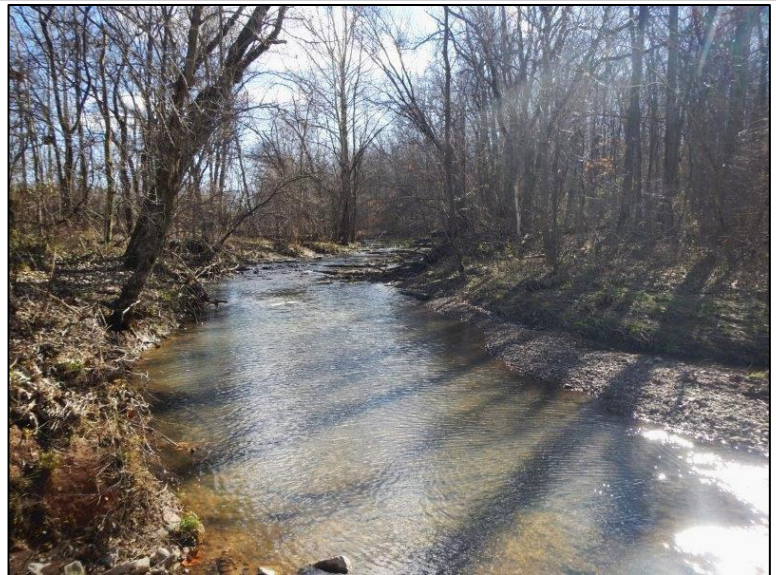
MAC Site # 74: Upstream

Channel condition	6
Hydrologic alteration	3
Riparian zone	1
Bank stability	3
Canopy cover	1
Manure presence	5

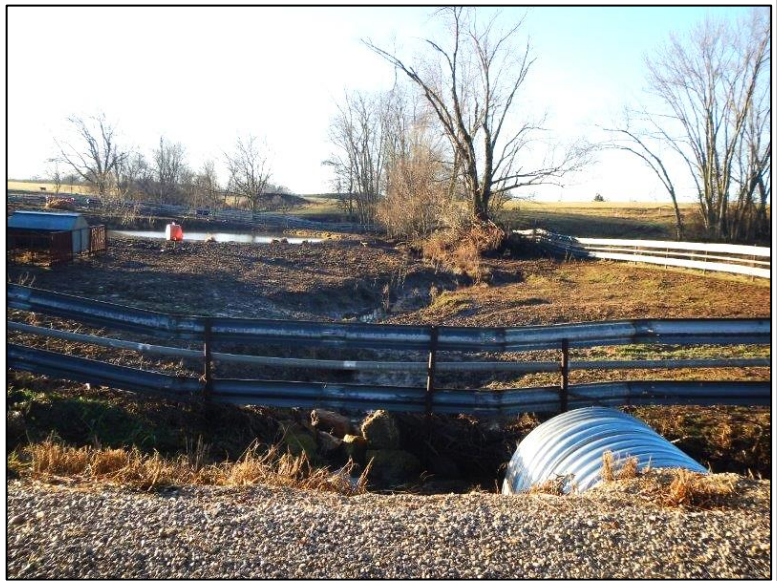
**Overall
Score**
3.2

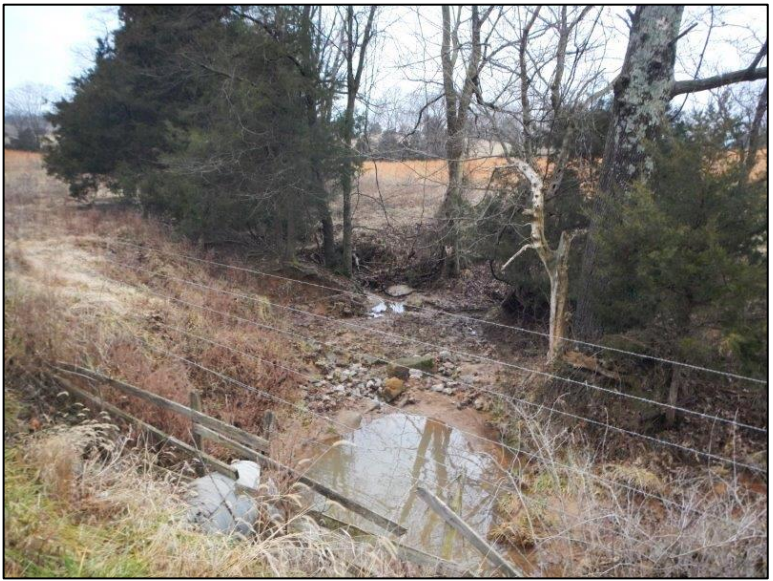
MAC Site # 128: Downstream

Channel condition	5
Hydrologic alteration	8
Riparian zone	6
Bank stability	3
Canopy cover	5
Manure presence	5

Overall Score
5.3

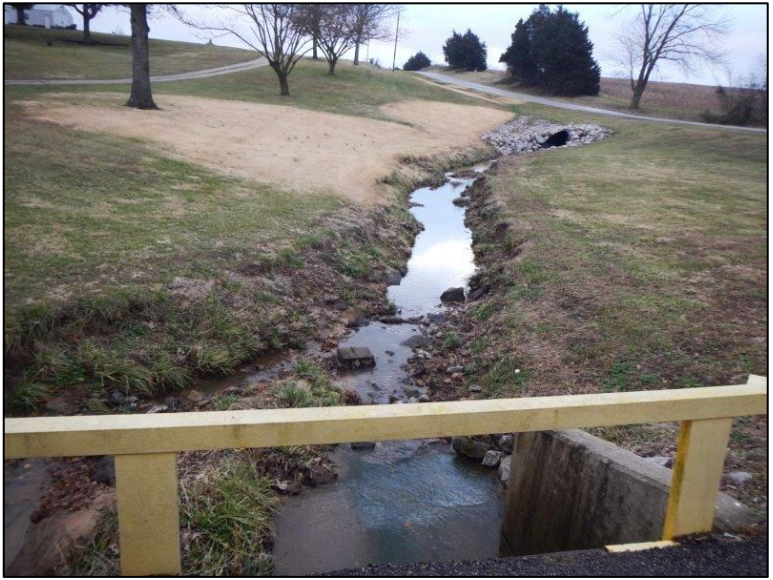
MAC Site # 92: Downstream

Channel condition	3
Hydrologic alteration	8
Riparian zone	1
Bank stability	5
Canopy cover	1
Manure presence	0

Overall Score
3.6

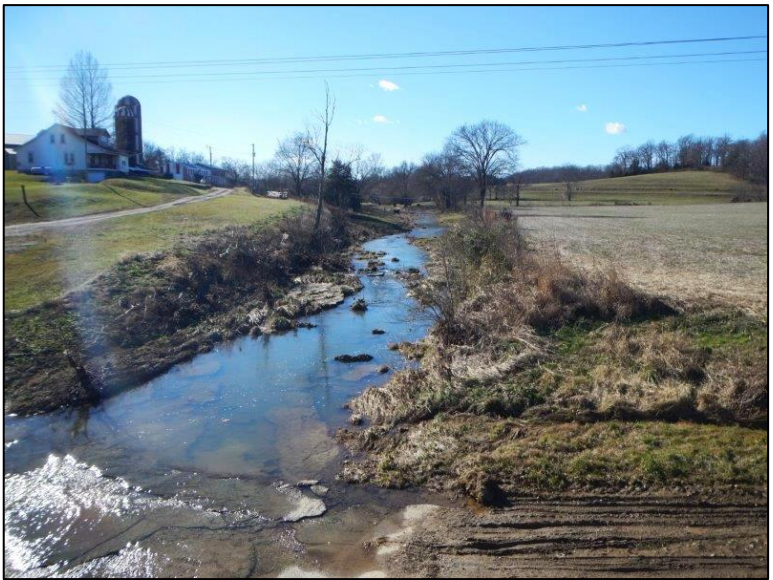
MAC Site # 3: Downstream

Channel condition	5	Overall Score 3.2
Hydrologic alteration	3	
Riparian zone	3	
Bank stability	5	
Canopy cover	3	
Manure presence	0

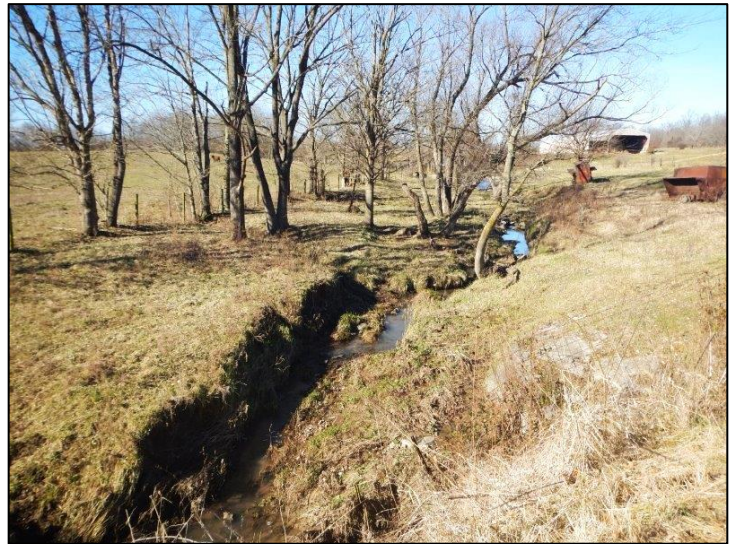
MAC Site # 68: Upstream

Channel condition	7	Overall Score 4.3
Hydrologic alteration	8	
Riparian zone	1	
Bank stability	4	
Canopy cover	1	
Manure presence	5

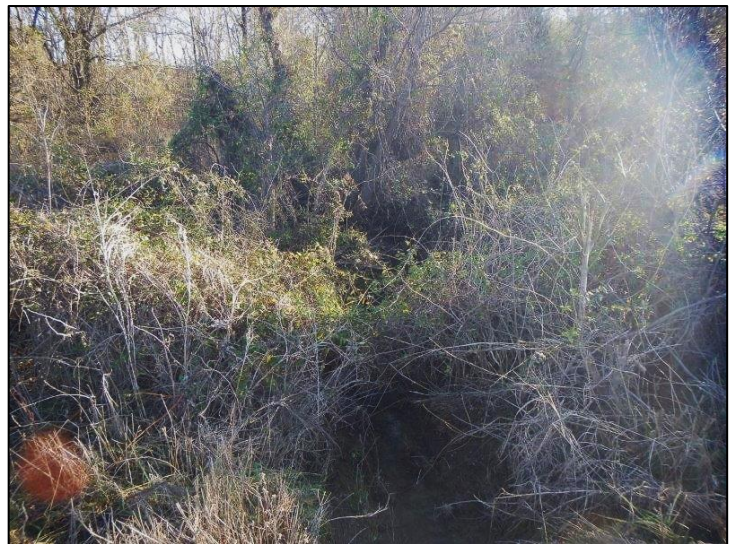
MAC Site # 114: Upstream

Channel condition	1	Overall Score 3.2
Hydrologic alteration	6	
Riparian zone	1	
Bank stability	7	
Canopy cover	1	
Manure presence	0
