**The Ozarks Environmental and Water Resources Institute (OEWRI)  
Missouri State University (MSU)**

**National Water Quality Initiative (NWQI)  
Watershed Assessment for:**

**Headwaters Petite Saline Creek  
Watershed (HUC-103001020401)**

**Deliverable # 1 – Inventory of the Watershed  
Deliverable # 2 – Resource Analysis of the Watershed  
Deliverable # 3 – Final Report: Identification of  
Conservation Needs on Vulnerable Acres**

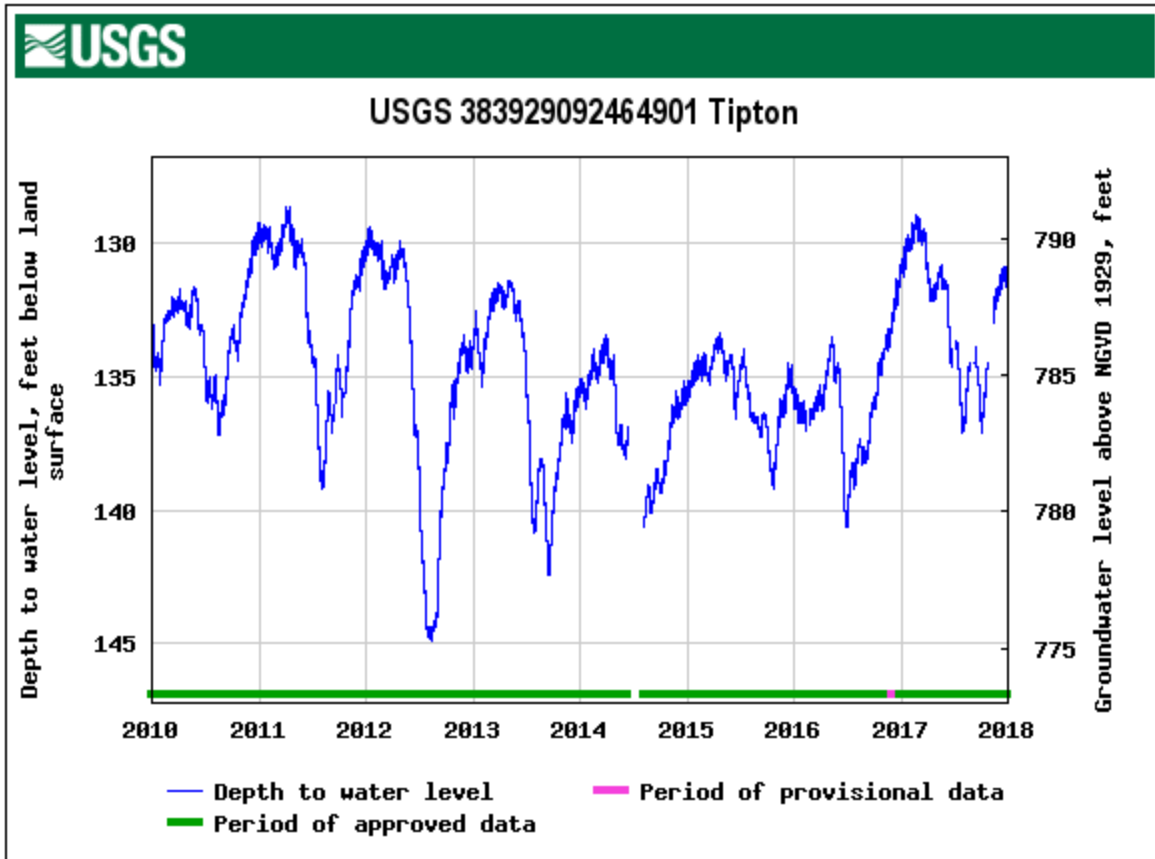
Figure 16. Ground water level change for Tipton (2010-2017).

There are no United States Geological Survey (USGS) gaging stations within the Headwaters Petite Saline Creek watershed. The closest gaging station on Petite Saline Creek is approximately 17 miles downstream at Highway U near Boonville, Missouri (USGS Gaging Station #06909950). To be able to predict discharge within the study watershed, 23 nearby USGS gaging stations were used to complete drainage area based regression equations to be able to estimate discharge from different size watersheds within the study area (Figure 15). A list of the USGS gaging stations used for this analysis can be found in Appendix B. If resources became available to install gaging stations within the watershed, a possible location would be on Petite Saline Creek at Bellair Road near the confluence with Baslee Branch (E: 512,053, N: 4,298,988 UTM Zone15N). Additionally, there are no ground water monitoring stations within the study watershed. The closest ground water monitoring site is located 2.5 miles to the southeast of the watershed in Tipton (Site Number: 383929092464901) that has been in operation since 2009. Data from this station shows that the water table can fluctuate 10-15 feet annually (Figure 16). Also, it appears after a downward trend in water levels from 2009-2012 the average water level appears to be rising since 2012.

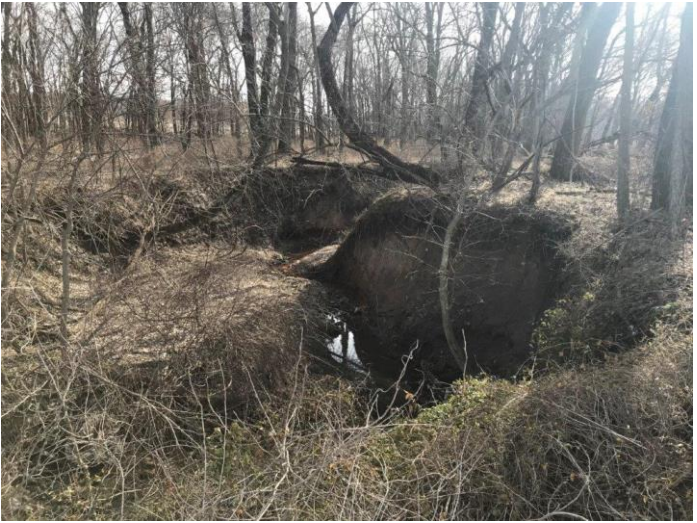
<b>Site # 51: Downstream</b>

Channel condition	1	
Hydrologic alteration	1	
Riparian zone	8	
Bank stability	1	
Canopy cover	10	
Manure presence		
<b>Overall Score</b>		4.2
<b>Site # 47: Downstream</b>

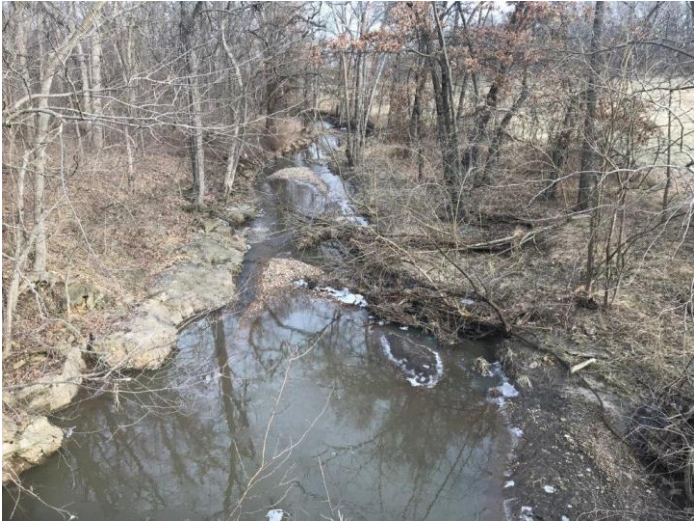
Channel condition	8	
Hydrologic alteration	8	
Riparian zone	5	
Bank stability	8	
Canopy cover	10	
Manure presence		
<b>Overall Score</b>		7.8
<b>Site # 1: Upstream</b>

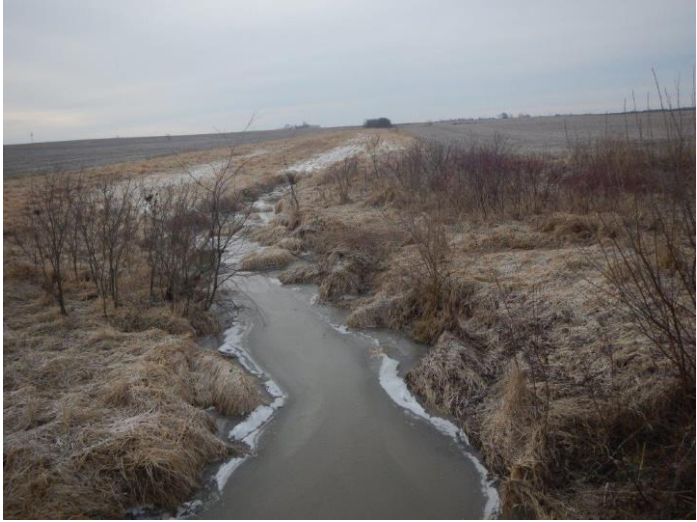
Site # 24: Downstream

Channel condition	<input type="text" value="10"/>	<b>Overall Score</b> 6.7
Hydrologic alteration	<input type="text" value="9"/>	
Riparian zone	<input type="text" value="5"/>	
Bank stability	<input type="text" value="8"/>	
Canopy cover	<input type="text" value="3"/>	
Manure presence	<input type="text" value="5"/>

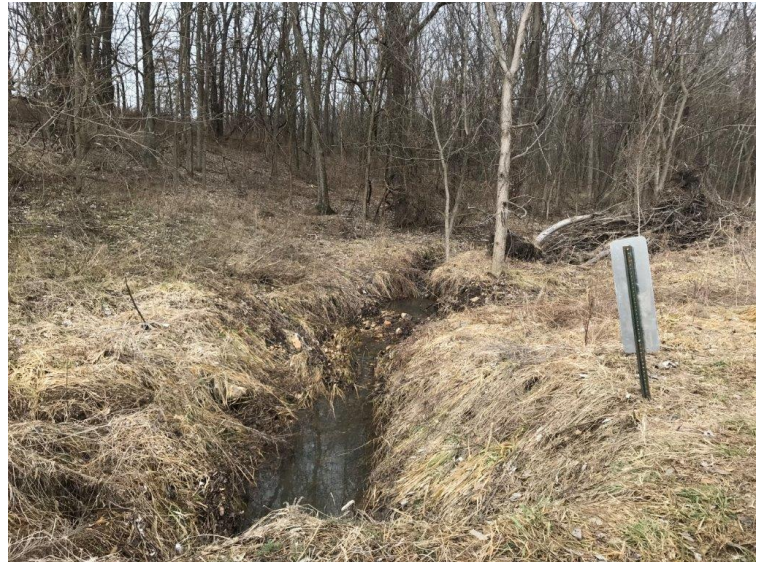
Site # 61: Downstream

Channel condition	<input type="text" value="3"/>	<b>Overall Score</b> 6.0
Hydrologic alteration	<input type="text" value="9"/>	
Riparian zone	<input type="text" value="10"/>	
Bank stability	<input type="text" value="9"/>	
Canopy cover	<input type="text" value="2"/>	
Manure presence	<input type="text" value="3"/>

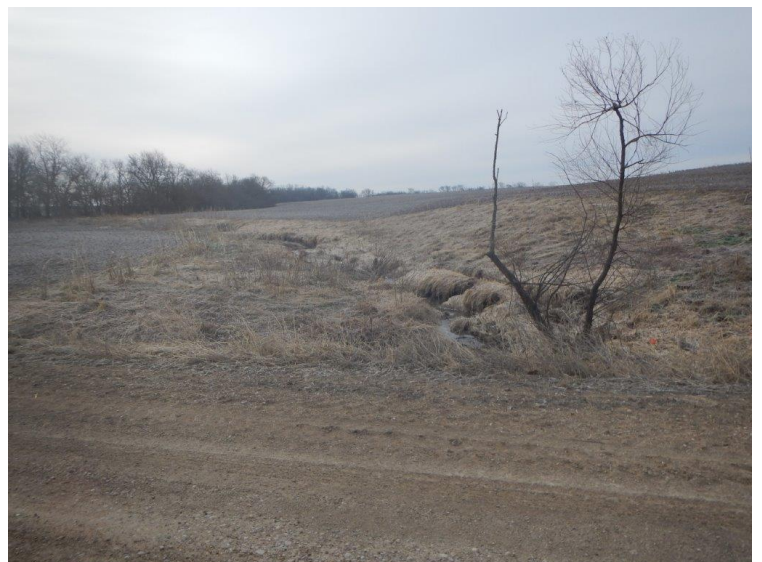
Site # 27: Upstream

Channel condition	<input type="text" value="10"/>
Hydrologic alteration	<input type="text" value="7"/>
Riparian zone	<input type="text" value="8"/>
Bank stability	<input type="text" value="8"/>
Canopy cover	<input type="text" value="8"/>
Manure presence	<input type="text"/>

**Overall Score**  
8.2

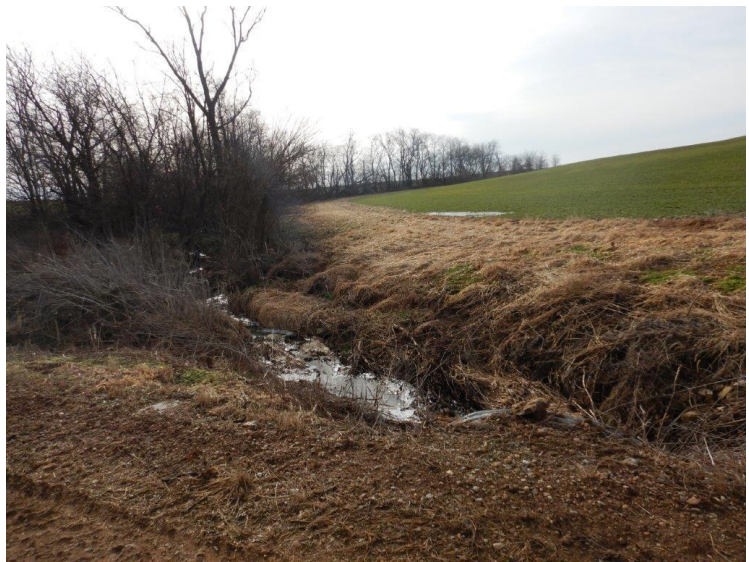
Site # 68: Upstream

Channel condition	<input type="text" value="5"/>
Hydrologic alteration	<input type="text" value="10"/>
Riparian zone	<input type="text" value="5"/>
Bank stability	<input type="text" value="3"/>
Canopy cover	<input type="text" value="3"/>
Manure presence	<input type="text"/>

**Overall Score**  
5.2

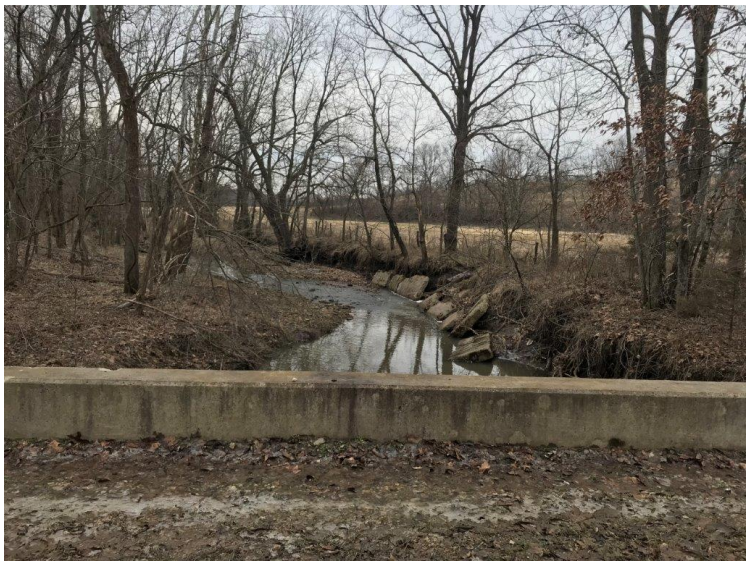
Site # 79: Downstream

Channel condition	<input type="text" value="10"/>
Hydrologic alteration	<input type="text" value="5"/>
Riparian zone	<input type="text" value="10"/>
Bank stability	<input type="text" value="3"/>
Canopy cover	<input type="text" value="7"/>
Manure presence	<input type="text" value="1"/>

**Overall Score**  
6.0

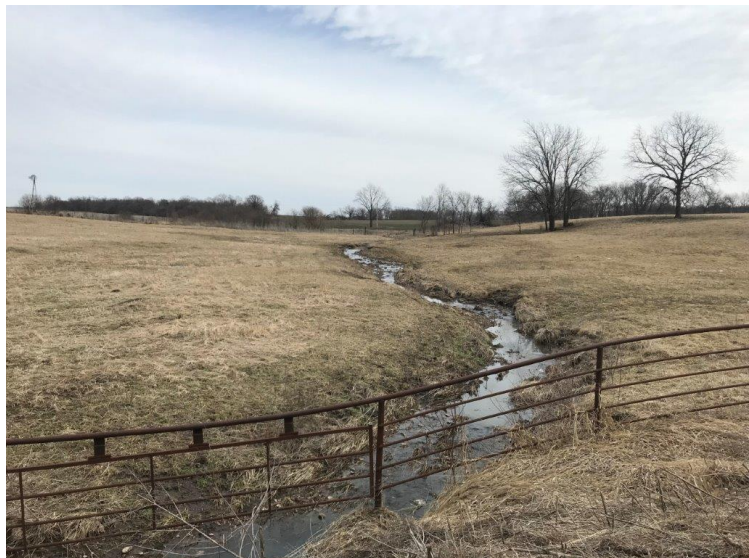
Site # 46: Downstream

Channel condition	<input type="text" value="1"/>	<b>Overall Score</b> 2.8
Hydrologic alteration	<input type="text" value="1"/>	
Riparian zone	<input type="text" value="1"/>	
Bank stability	<input type="text" value="10"/>	
Canopy cover	<input type="text" value="1"/>	
Manure presence	<input type="text"/>

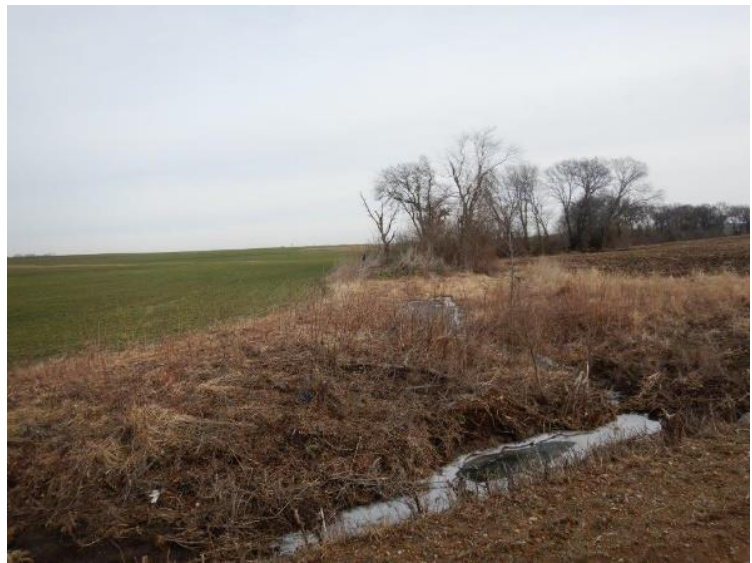
Site # 57: Upstream

Channel condition	<input type="text" value="1"/>	<b>Overall Score</b> 1.2
Hydrologic alteration	<input type="text" value="1"/>	
Riparian zone	<input type="text" value="0"/>	
Bank stability	<input type="text" value="3"/>	
Canopy cover	<input type="text" value="1"/>	
Manure presence	<input type="text" value="1"/>

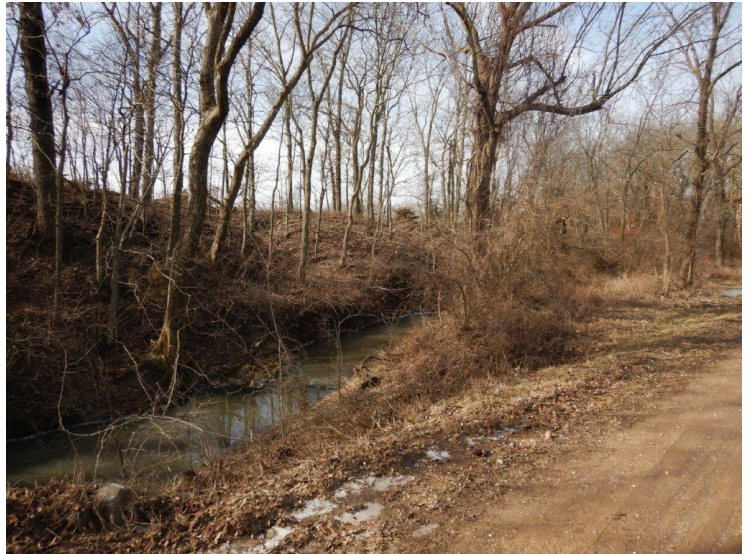
Site # 38: Upstream

Channel condition	<input type="text" value="3"/>	<b>Overall Score</b> 3.8
Hydrologic alteration	<input type="text" value="5"/>	
Riparian zone	<input type="text" value="4"/>	
Bank stability	<input type="text" value="5"/>	
Canopy cover	<input type="text" value="2"/>	
Manure presence	<input type="text"/>

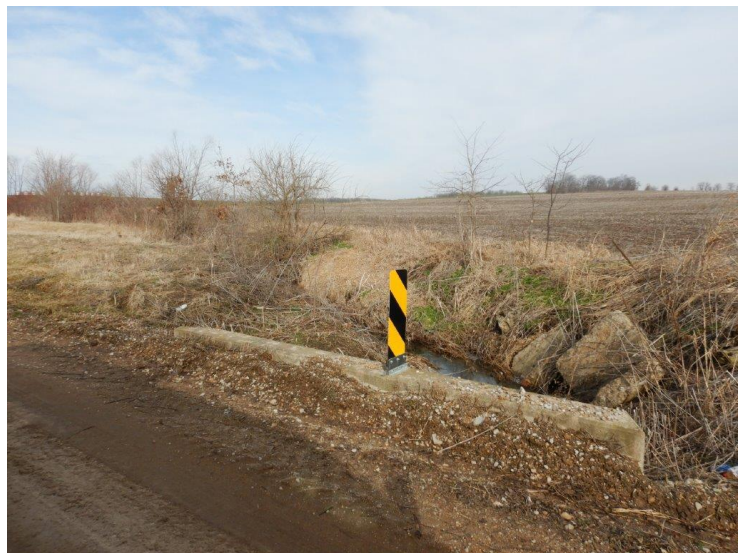
Site # 30: Downstream

Channel condition	<input type="text" value="10"/>	<b>Overall Score</b> 9.0
Hydrologic alteration	<input type="text" value="8"/>	
Riparian zone	<input type="text" value="9"/>	
Bank stability	<input type="text" value="9"/>	
Canopy cover	<input type="text" value="9"/>	
Manure presence	<input type="text"/>

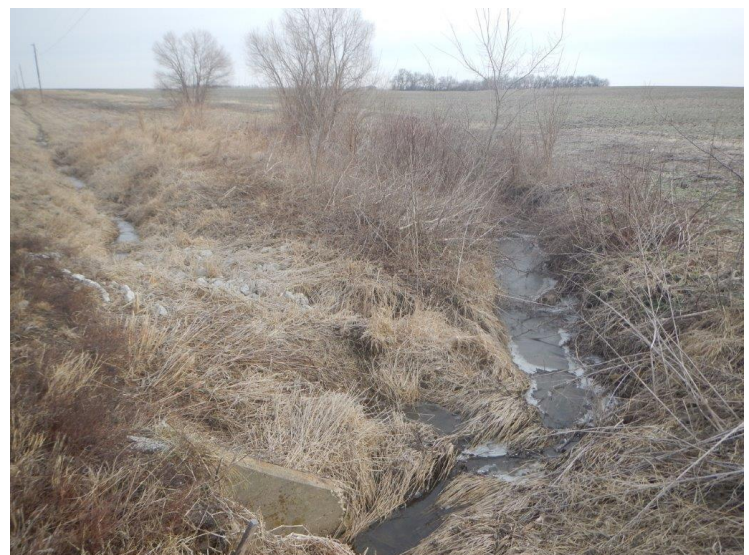
### Site # 2: Upstream

Channel condition	9
Hydrologic alteration	8
Riparian zone	2
Bank stability	7
Canopy cover	1
Manure presence

**Overall Score**  
5.4

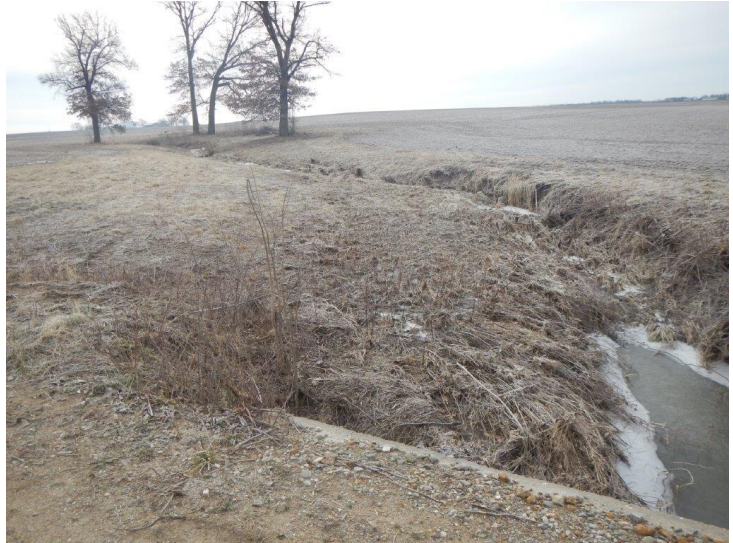
### Site # 2: Downstream

Channel condition	10
Hydrologic alteration	7
Riparian zone	1
Bank stability	10
Canopy cover	1
Manure presence

**Overall Score**  
5.8

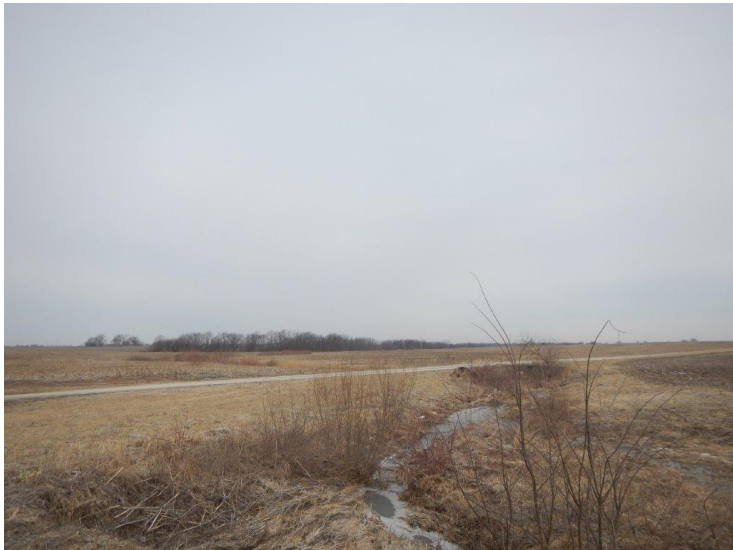
### Site # 13: Upstream

Channel condition	10
Hydrologic alteration	3
Riparian zone	1
Bank stability	3
Canopy cover	7
Manure presence	5

**Overall Score**  
4.8
