**The Ozarks Environmental and Water Resources Institute (OEWRI)  
Missouri State University (MSU)**

**Mississippi River Basin Healthy Watersheds Initiative (MRBI)  
Watershed Assessment for:**

**Long Branch Watershed (HUC-10280103204)  
Spring Branch-Elk Creek Watershed (HUC-102801031302)  
Turkey Creek Watershed (HUC-102801031301)**

**Deliverable # 1 – Inventory of the Watershed  
Deliverable # 2 – Resource Analysis of the Watershed  
Deliverable # 3 – Identification of Conservation Needs  
on Vulnerable Acres**

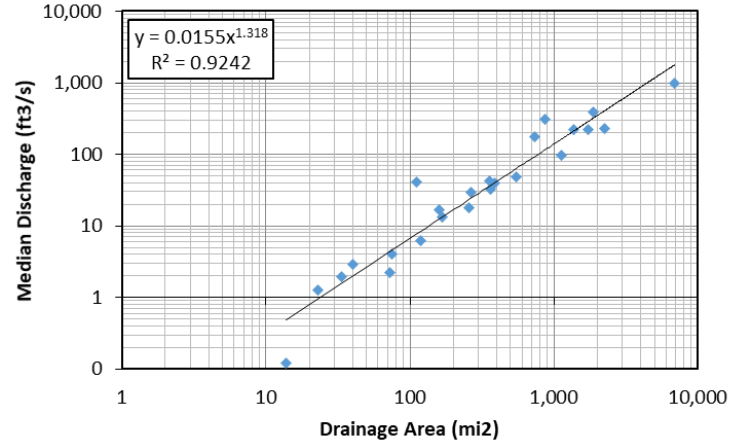
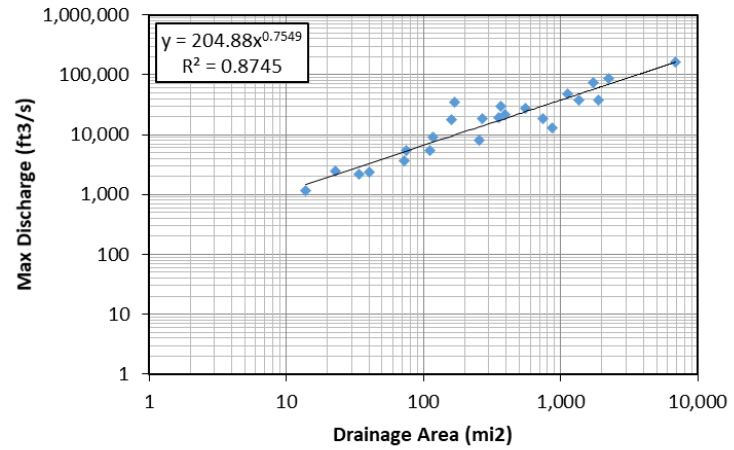
Figure 13. Drainage area and discharge relationships for 24 USGS gaging stations near the study watershed.

used to complete drainage area based regression equations to be able to estimate discharge from different size watersheds within the study area (Figure 13). A list of the USGS gaging stations can be found in Appendix B. If resources became available to install one gaging station within each watershed, possible locations would be on Long Branch at Heathy Road (UTM Zone 15N Northing: 4,409,882.17 Easting: 493,879.17), on Turkey Creek at Ginger Road (UTM Zone 15N Northing: 4,399,061.06 Easting: 486,381.87), and/or on Elk Creek at Iguana Road (UTM Zone 15N Northing: 4,395,106.31 Easting: 491,376.30). Additionally, there is a ground water monitoring station in Mendon, approximately 3 miles south and outside of the Spring Branch-Elk Creek watershed (Site Number: 393544093075601). This well has been operating since 2009 and data from this station shows an overall decline in ground water levels in this area and can vary as much as 15 feet (Figure 14).

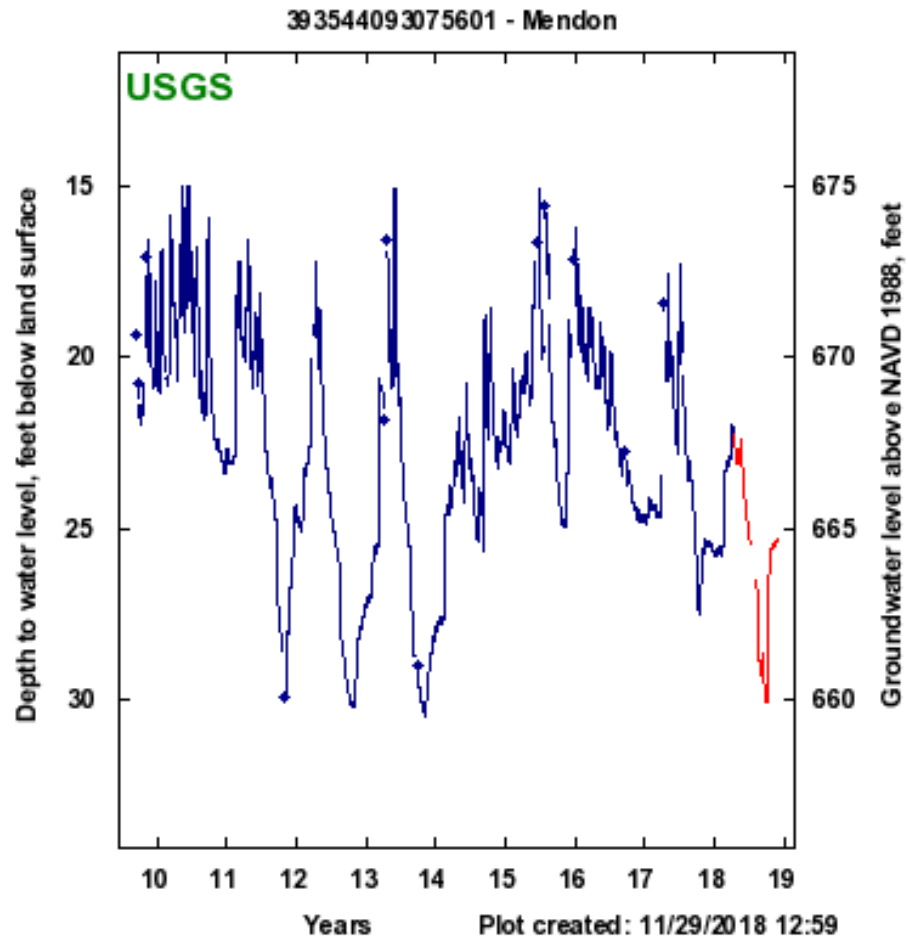
Figure 14. Ground water level change for Mendon (2009-2018).

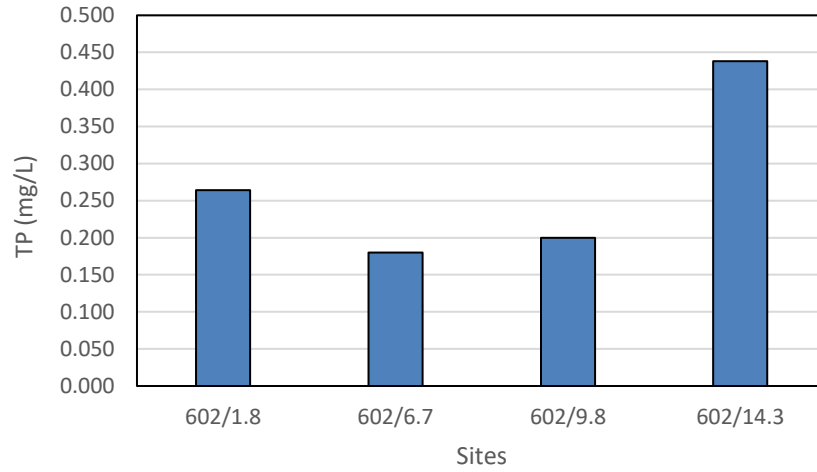
Figure 16. Average concentrations of TP, TN, and TSS for the Long Branch watershed

Total phosphorus concentrations within the Long Branch Creek watershed are elevated compared to established reference concentration for the ecoregion, but nitrogen concentrations are relatively close to the reference condition. Ambient water quality criteria suggested reference conditions for these streams are 0.71 mg/L TN and 0.092 mg/L TP based on the 25<sup>th</sup> percentile value for streams within the Central Irregular Plains region (Table 12, USEPA 2000). This sample set shows that Long Branch Creek has mean total phosphorus concentrations two to five times higher than regional reference condition. However, average total nitrogen concentrations at three of the four sites in the watershed are lower than the reference condition and the other site is only slightly higher. These data suggest conservation practices that can reduce phosphorus in runoff can be important component in improving and protecting water quality in these watersheds. As stated earlier, a healthy watershed plan was established for the Lower Grand River watershed in 2016 that specifically states that reduction of streambank and soil erosion, sediment, nutrients, and bacteria from agricultural nonpoint sources was important to maintain and improve water quality within the watershed (MDNR 2016).

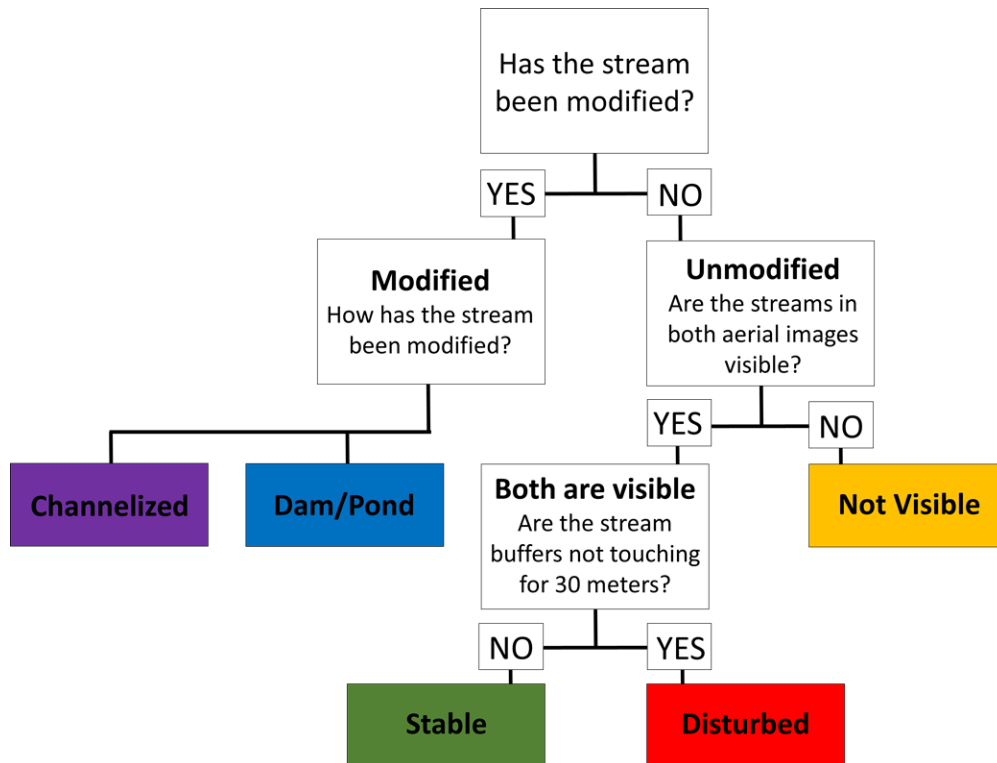
Figure 17. Flow chart showing decision tree for classifying stream channels from aerial photo analysis.

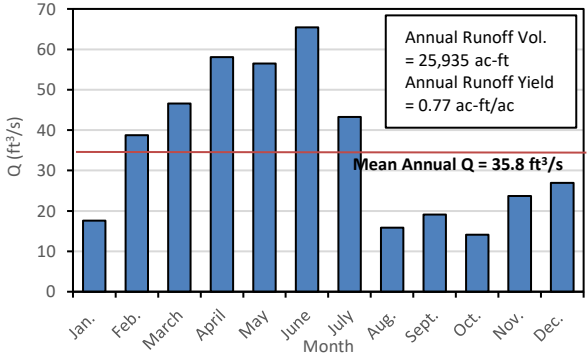
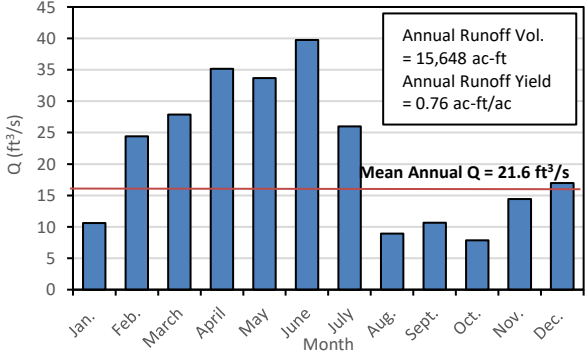
Figure 22. Mean monthly discharge and runoff percentage for the A), B) Long Branch the C), D) Turkey Creek, and E), F) Spring Branch-Elk Creek watersheds.

Annual and monthly runoff rates for the selected Lower Grand watersheds were estimated using equations developed from 24 USGS gaging stations in the region. Monthly runoff rates are important for understanding the seasonal variability and how rainfall-runoff relationships correspond to land management and annual runoff rates will be used to help validate the STEPL model hydrology results. A list of the equations used for this analysis of monthly mean discharge values can be found in Appendix G. Mean annual discharge for the Long Branch watershed is 32.5 ft<sup>3</sup>/s, 21.6 ft<sup>3</sup>/s for Spring Branch-Elk Creek, and 35.8 ft<sup>3</sup>/s for Turkey Creek (Figure 22). Total runoff volume for the Long Branch watershed was 23,545 ac-ft, 15,648 ac-ft for Spring Branch-Elk Creek, and 25,935 ac-ft for the Turkey Creek watershed. For all watersheds, average discharge peaks in the month June and is the lowest in October. Average runoff as a percentage of rainfall for the Long Branch watershed was 22.1%, Turkey Creek was 22.2%, and 22.0% for Spring Branch-Elk Creek. Monthly mean runoff as a percentage of rainfall is highest in the late winter and early spring and lowest in the late summer and early fall

ranging from less than 8% in August to 40-43% in February. The remainder of the rainfall is either lost to evapotranspiration or moved through the soil into groundwater storage through infiltration (USDA, 2009b). These estimates are comparable with existing literature that state evapotranspiration rates for Missouri range from 60–70% (Sanford and Selnick 2013).

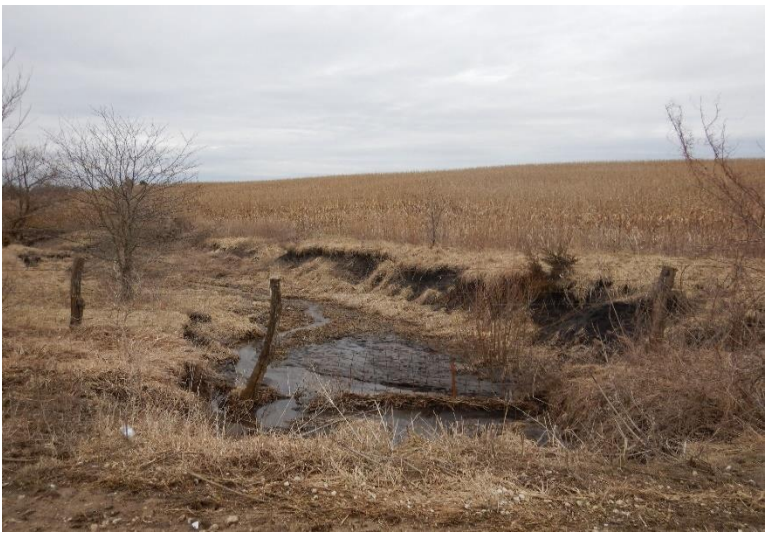
<b>Site # 154: Downstream</b>

Channel condition	10	
Hydrologic alteration	5	
Riparian zone	1	
Bank stability	7	
Canopy cover	1	
Manure presence		
<b>Overall Score</b>		4.8

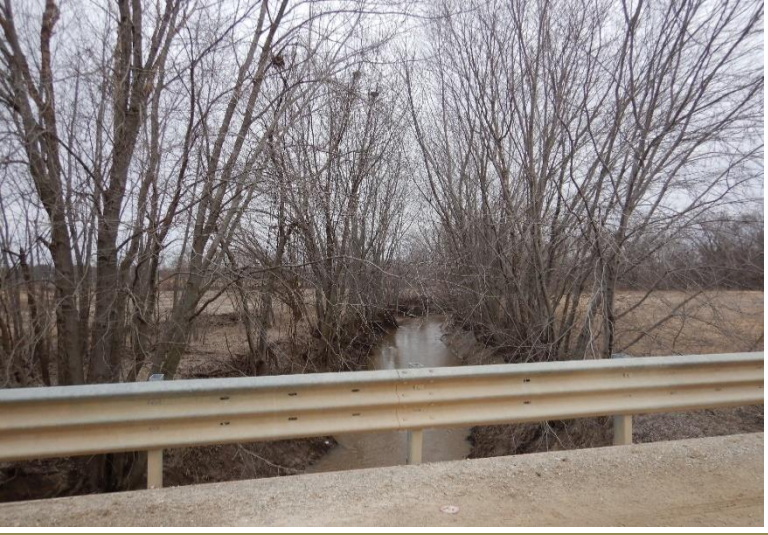
<b>Site # 101: Upstream</b>

Channel condition	3	
Hydrologic alteration	3	
Riparian zone	3	
Bank stability	3	
Canopy cover	5	
Manure presence		
<b>Overall Score</b>		3.4

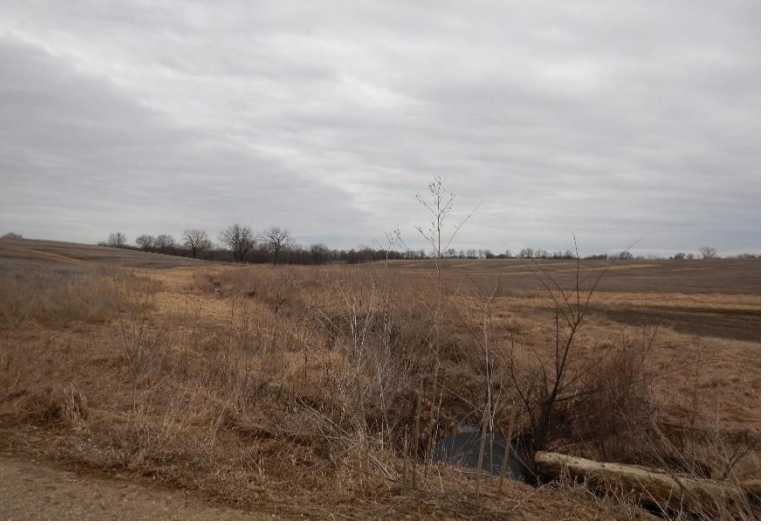
<b>Site # 116: Downstream</b>

Channel condition	5	
Hydrologic alteration	10	
Riparian zone	10	
Bank stability	7	
Canopy cover	3	
Manure presence		
<b>Overall Score</b>		7.0

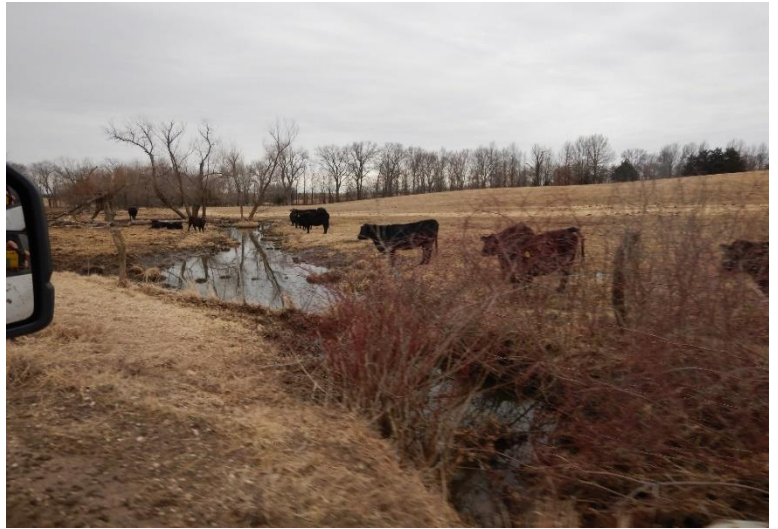
Site # 53: Downstream

Channel condition	10
Hydrologic alteration	9
Riparian zone	1
Bank stability	7
Canopy cover	1
Manure presence	1

**Overall  
Score  
4.8**

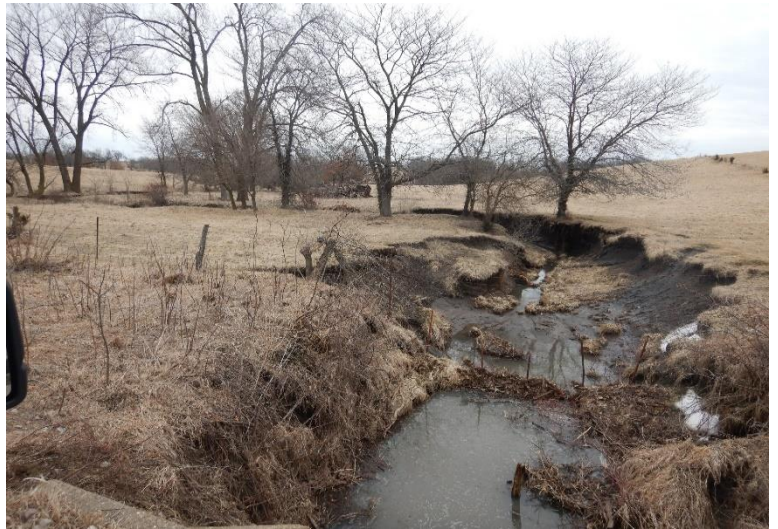
Site # 57: Downstream

Channel condition	10
Hydrologic alteration	3
Riparian zone	1
Bank stability	1
Canopy cover	1
Manure presence	5

**Overall  
Score  
3.5**

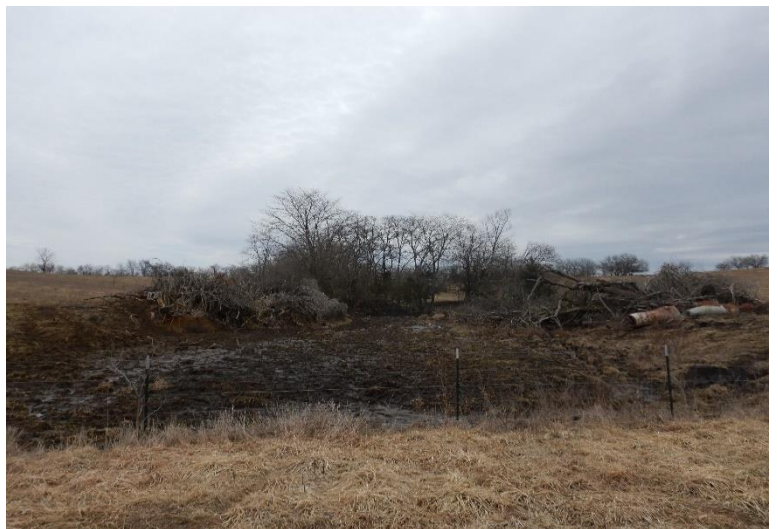
Site # 157: Upstream

Channel condition	1
Hydrologic alteration	1
Riparian zone	1
Bank stability	1
Canopy cover	1
Manure presence	1

**Overall  
Score  
1.0**

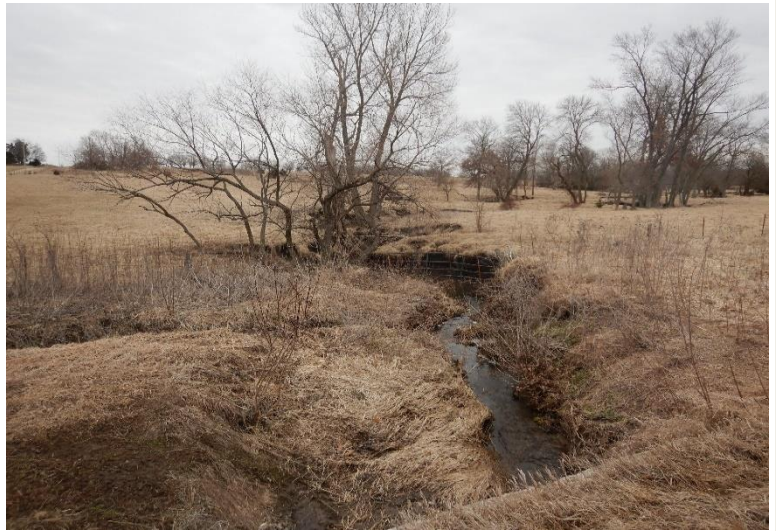
Site # 101: Downstream

Channel condition	10
Hydrologic alteration	5
Riparian zone	1
Bank stability	3
Canopy cover	1
Manure presence	3

**Overall  
Score  
4.0**

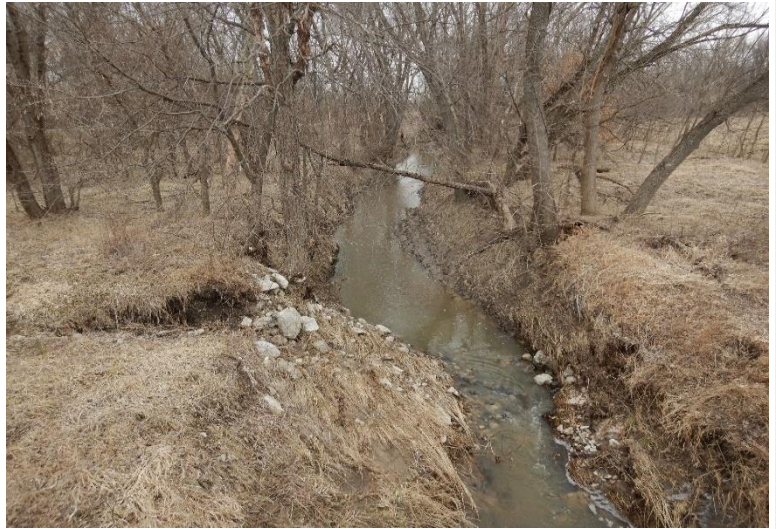
Site # 12: Upstream

Channel condition	10
Hydrologic alteration	5
Riparian zone	8
Bank stability	5
Canopy cover	10
Manure presence	5

**Overall  
Score  
7.0**

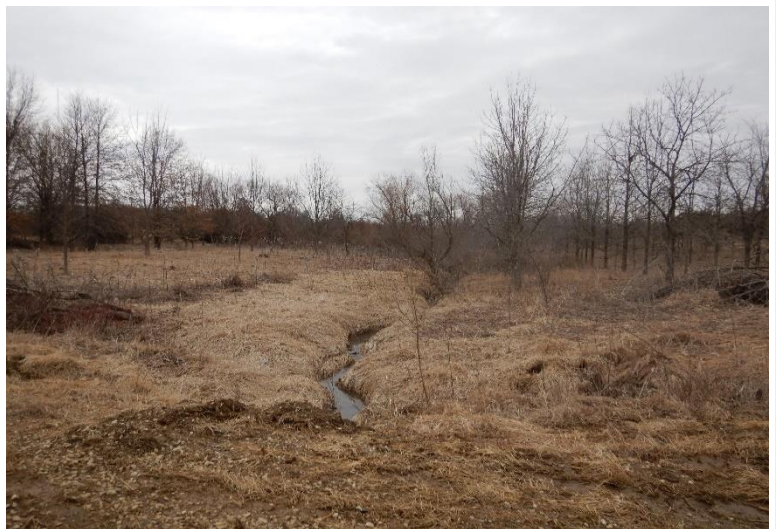
Site # 12: Downstream

Channel condition	10
Hydrologic alteration	10
Riparian zone	10
Bank stability	10
Canopy cover	3
Manure presence	0

**Overall  
Score  
8.6**

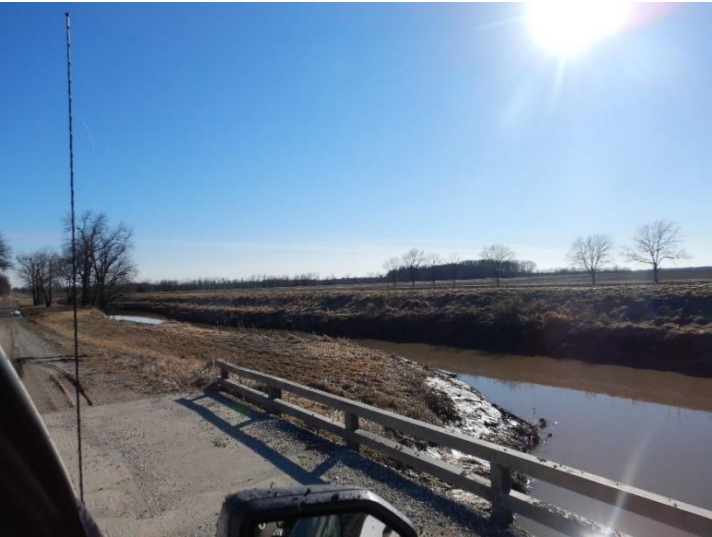
<b>Site # 2: Downstream</b>		<div style="border: 1px solid black; padding: 5px; width: fit-content; margin: auto;"> <b>Overall Score 2.2</b> </div>

Channel condition	1		
Hydrologic alteration	5		
Riparian zone	1		
Bank stability	3		
Canopy cover	1		
Manure presence			
<b>Site # 22: Downstream</b>		<div style="border: 1px solid black; padding: 5px; width: fit-content; margin: auto;"> <b>Overall Score 2.3</b> </div>

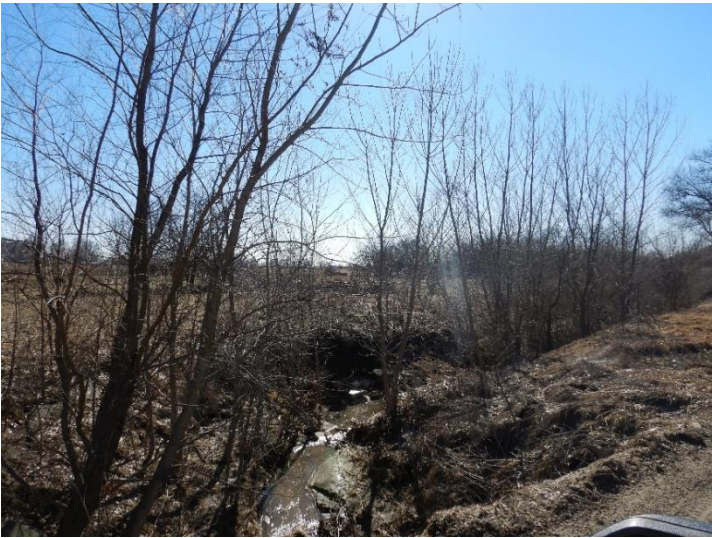
Channel condition	3		
Hydrologic alteration	1		
Riparian zone	3		
Bank stability	3		
Canopy cover	3		
Manure presence	1		
<b>Site # 25: Upstream</b>		<div style="border: 1px solid black; padding: 5px; width: fit-content; margin: auto;"> <b>Overall Score 10</b> </div>

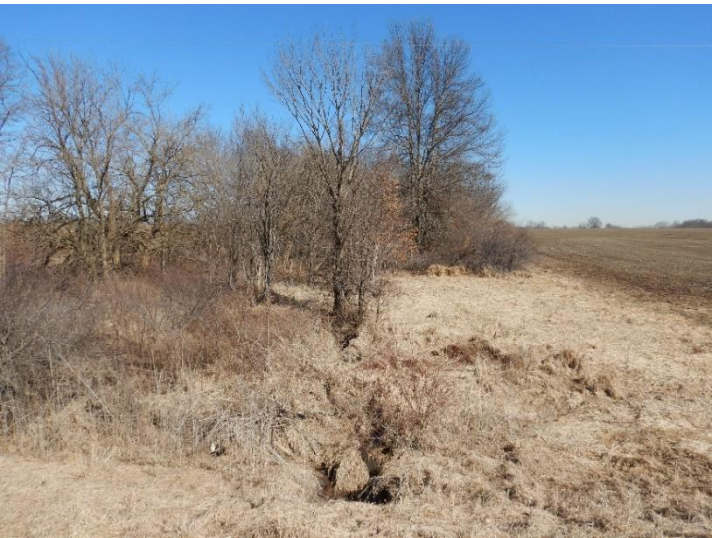
Channel condition	10		
Hydrologic alteration	10		
Riparian zone	10		
Bank stability	10		
Canopy cover	10		
Manure presence

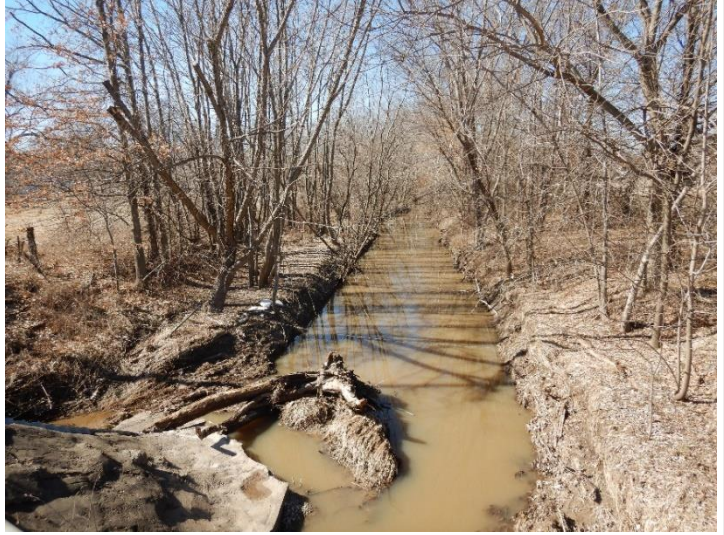
Site # 72: Upstream

Channel condition	<input type="text" value="3"/>
Hydrologic alteration	<input type="text" value="10"/>
Riparian zone	<input type="text" value="3"/>
Bank stability	<input type="text" value="7"/>
Canopy cover	<input type="text" value="10"/>
Manure presence	<input type="text"/>

**Overall  
Score**  
6.6

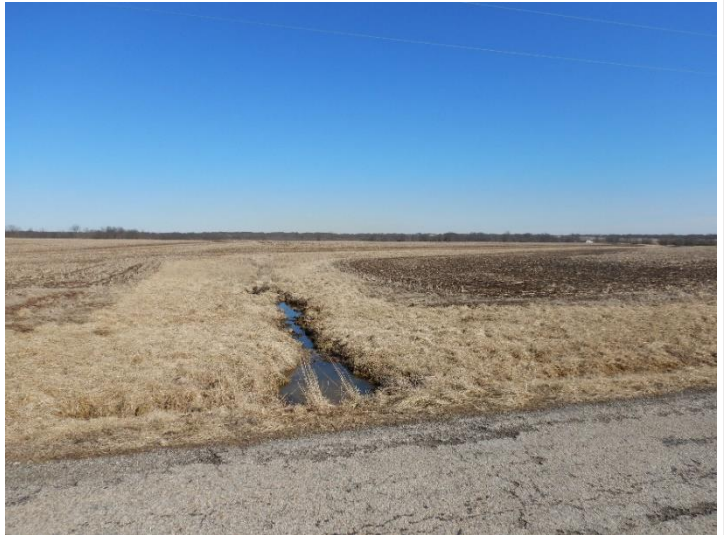
Site # 5 Upstream

Channel condition	<input type="text" value="5"/>
Hydrologic alteration	<input type="text" value="7"/>
Riparian zone	<input type="text" value="7"/>
Bank stability	<input type="text" value="7"/>
Canopy cover	<input type="text" value="7"/>
Manure presence	<input type="text"/>

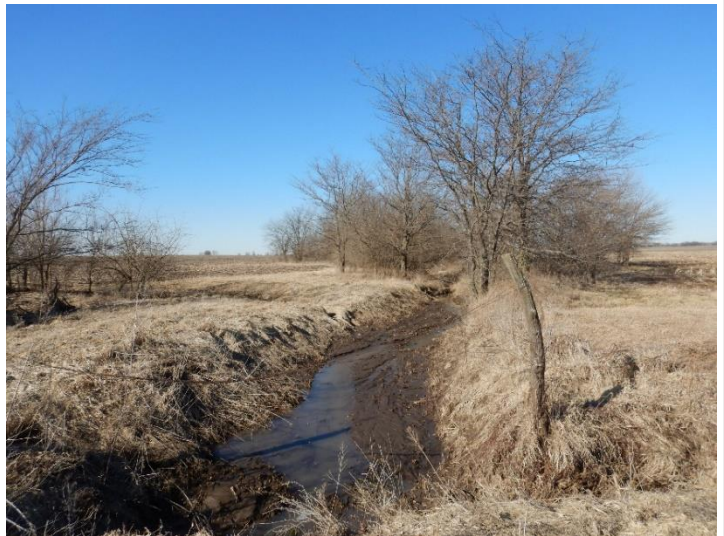
**Overall  
Score**  
6.6

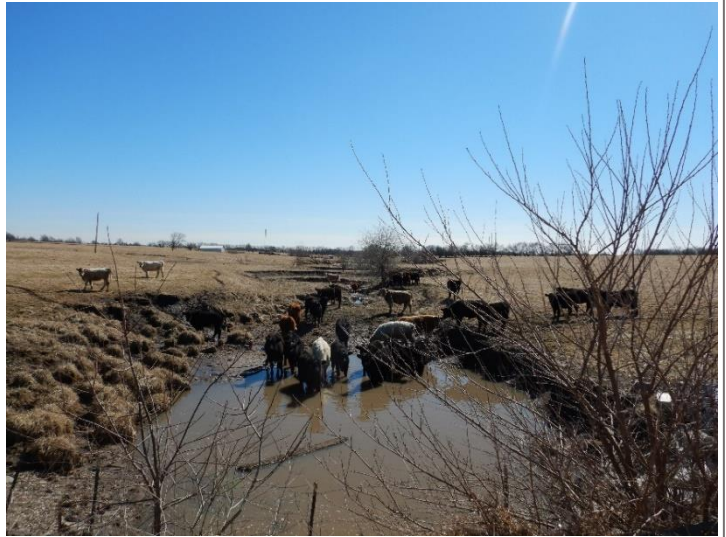
**Site # 81: Downstream**

Channel condition	<input type="text" value="10"/>
Hydrologic alteration	<input type="text" value="3"/>
Riparian zone	<input type="text" value="1"/>
Bank stability	<input type="text" value="3"/>
Canopy cover	<input type="text" value="1"/>
Manure presence	<input type="text" value="1"/>

**Overall Score**  
3.2

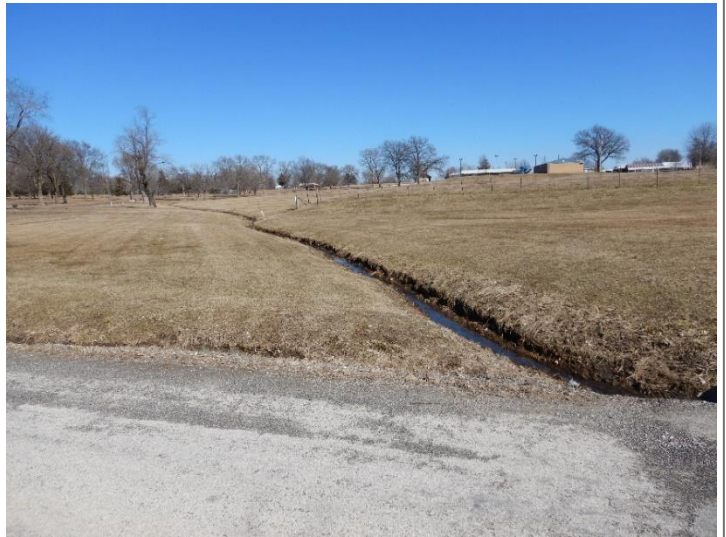
**Site # 29: Downstream**

Channel condition	<input type="text" value="10"/>
Hydrologic alteration	<input type="text" value="10"/>
Riparian zone	<input type="text" value="1"/>
Bank stability	<input type="text" value="10"/>
Canopy cover	<input type="text" value="1"/>
Manure presence	<input type="text"/>

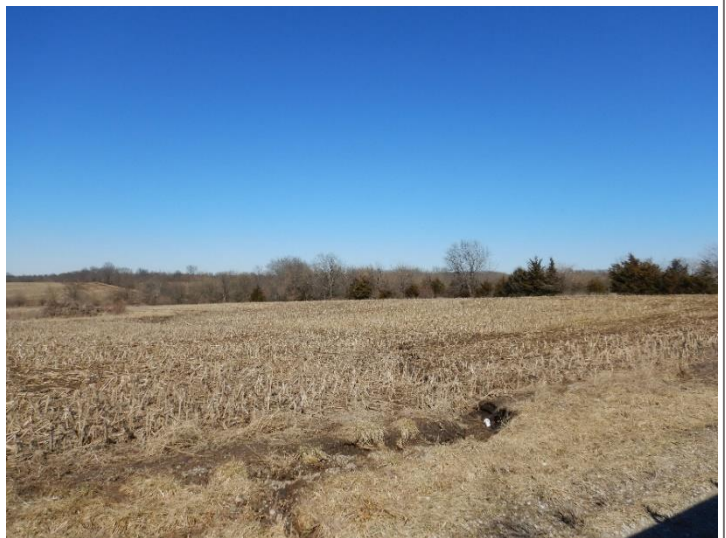
**Overall Score**  
6.4

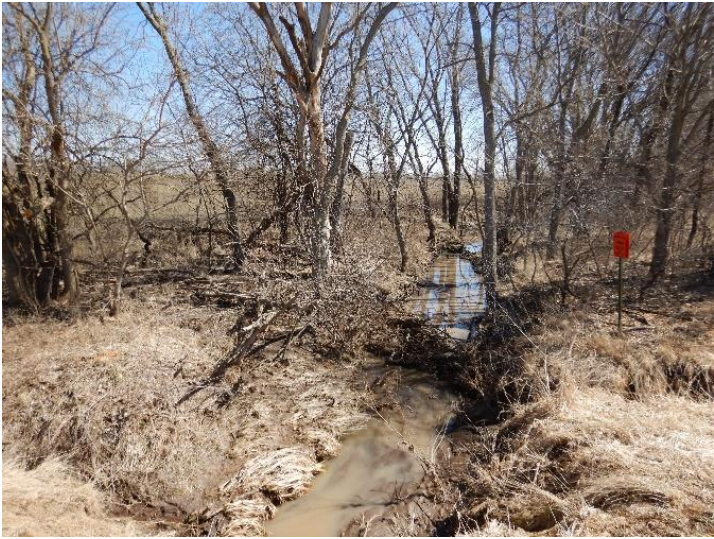
<b>Site # 6: Downstream</b>

Channel condition	10	
Hydrologic alteration	7	
Riparian zone	10	
Bank stability	7	
Canopy cover	7	
Manure presence		
<b>Overall Score</b> 8.2		
<b>Site # 6: Upstream</b>

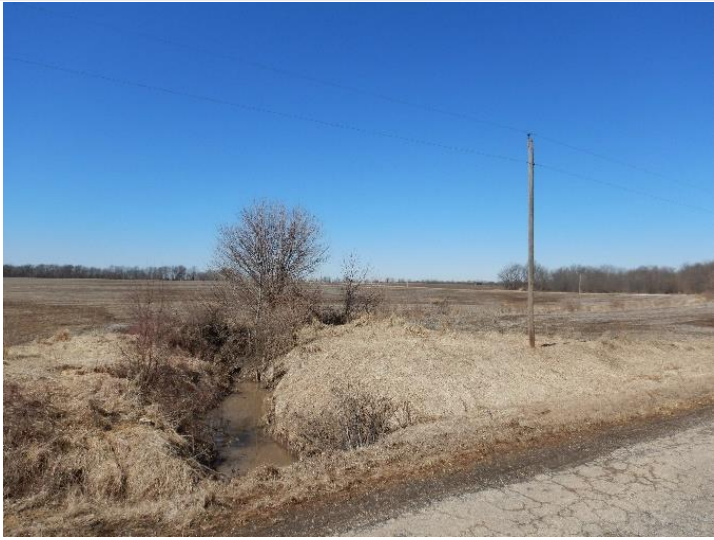
Channel condition	2	
Hydrologic alteration	3	
Riparian zone	3	
Bank stability	3	
Canopy cover	0	
Manure presence		
<b>Overall Score</b> 2.6		
<b>Site # 59: Downstream</b>

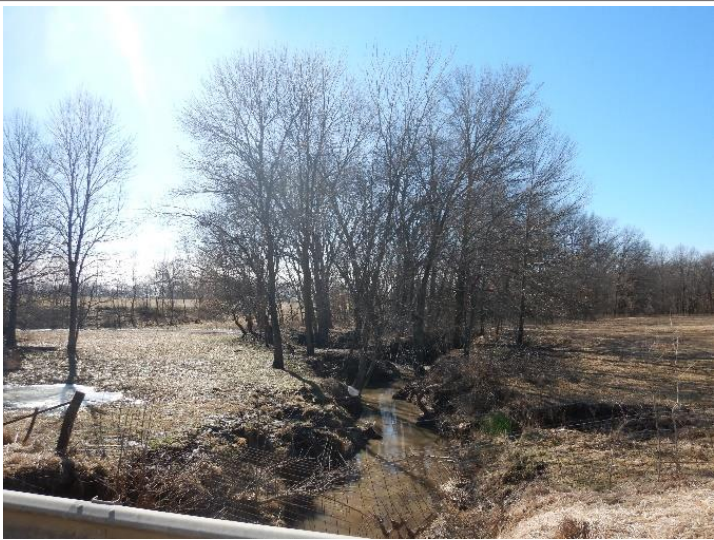
Channel condition	8	
Hydrologic alteration	5	
Riparian zone	3	
Bank stability	2	
Canopy cover	5	
Manure presence	5	
<b>Overall Score</b> 4.7

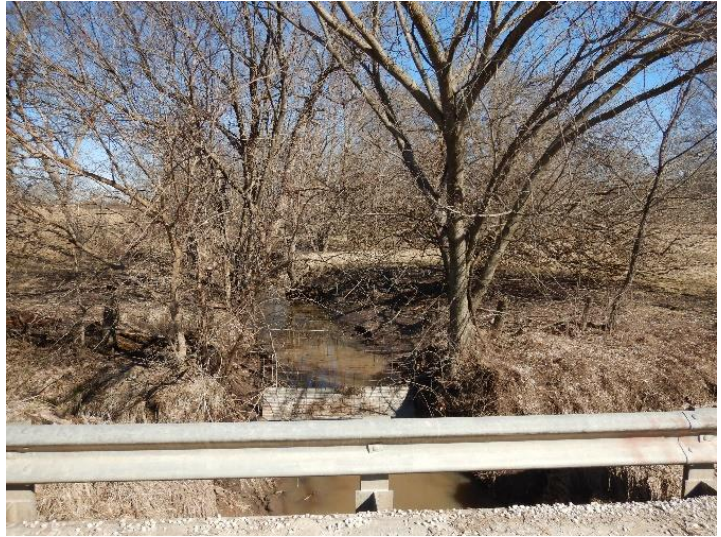
Site # 59: Upstream

Channel condition	<input type="text" value="8"/>
Hydrologic alteration	<input type="text" value="6"/>
Riparian zone	<input type="text" value="3"/>
Bank stability	<input type="text" value="5"/>
Canopy cover	<input type="text" value="7"/>
Manure presence	<input type="text" value="5"/>

**Overall  
Score  
5.7**

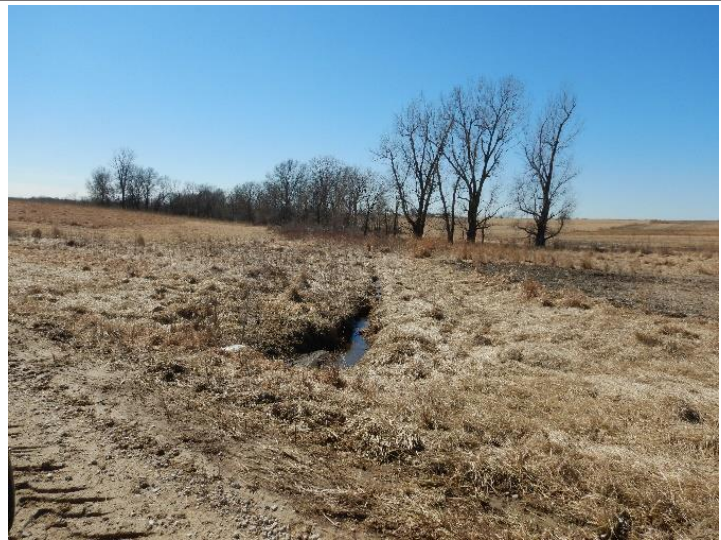
Site #99: Downstream

Channel condition	<input type="text" value="7"/>
Hydrologic alteration	<input type="text" value="10"/>
Riparian zone	<input type="text" value="10"/>
Bank stability	<input type="text" value="10"/>
Canopy cover	<input type="text" value="1"/>
Manure presence	<input type="text"/>

**Overall  
Score  
7.6**

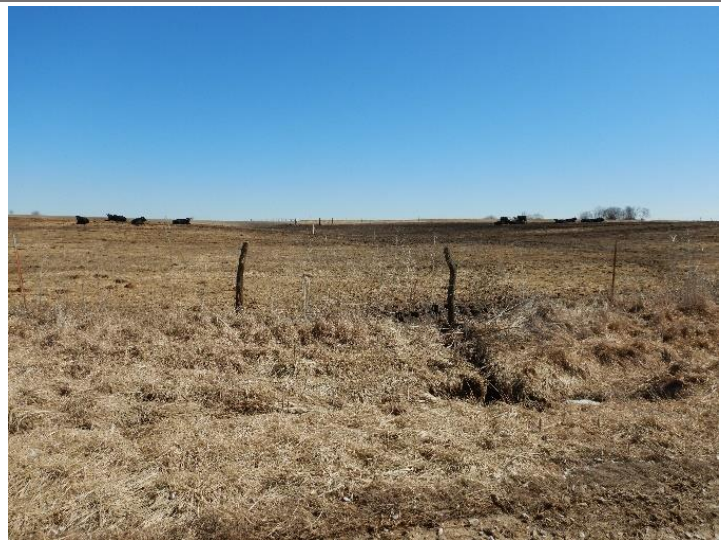
Site # 99: Upstream

Channel condition	<input type="text" value="1"/>
Hydrologic alteration	<input type="text" value="1"/>
Riparian zone	<input type="text" value="1"/>
Bank stability	<input type="text" value="5"/>
Canopy cover	<input type="text" value="1"/>
Manure presence	<input type="text" value="1"/>

**Overall  
Score  
1.7**

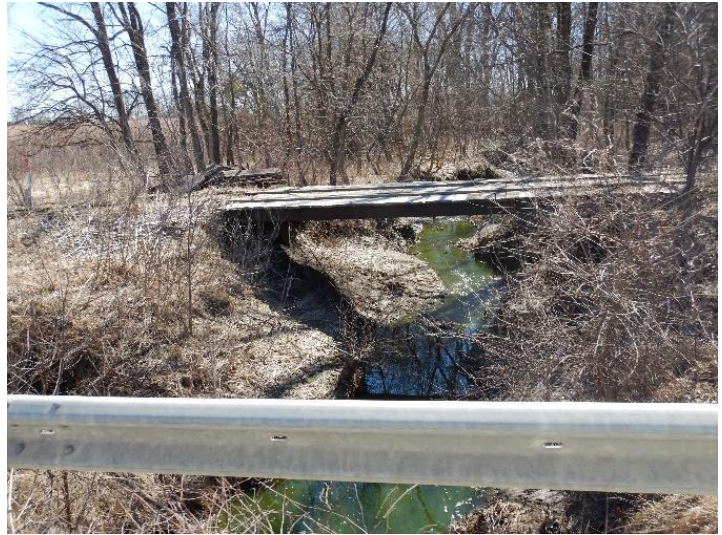
Site # 45: Downstream

Channel condition	<input type="text" value="10"/>
Hydrologic alteration	<input type="text" value="7"/>
Riparian zone	<input type="text" value="9"/>
Bank stability	<input type="text" value="8"/>
Canopy cover	<input type="text" value="9"/>
Manure presence	<input type="text"/>

**Overall Score**  
8.6

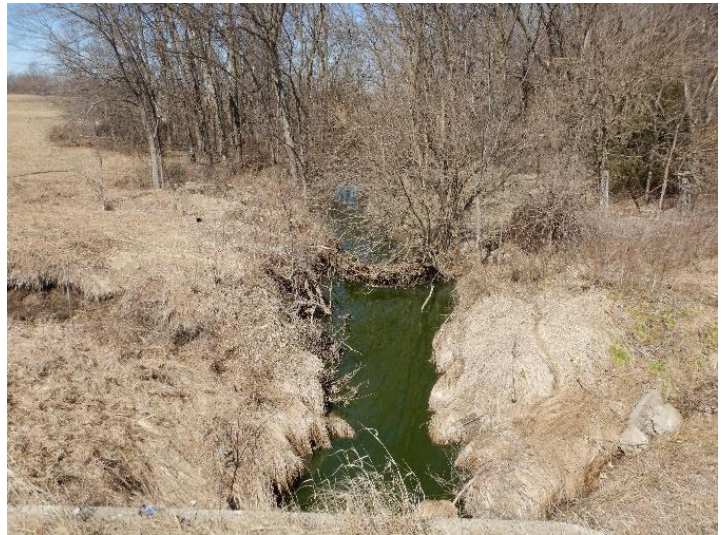
Site #45: Upstream

Channel condition	<input type="text" value="10"/>
Hydrologic alteration	<input type="text" value="8"/>
Riparian zone	<input type="text" value="9"/>
Bank stability	<input type="text" value="9"/>
Canopy cover	<input type="text" value="9"/>
Manure presence	<input type="text"/>

**Overall Score**  
8.6

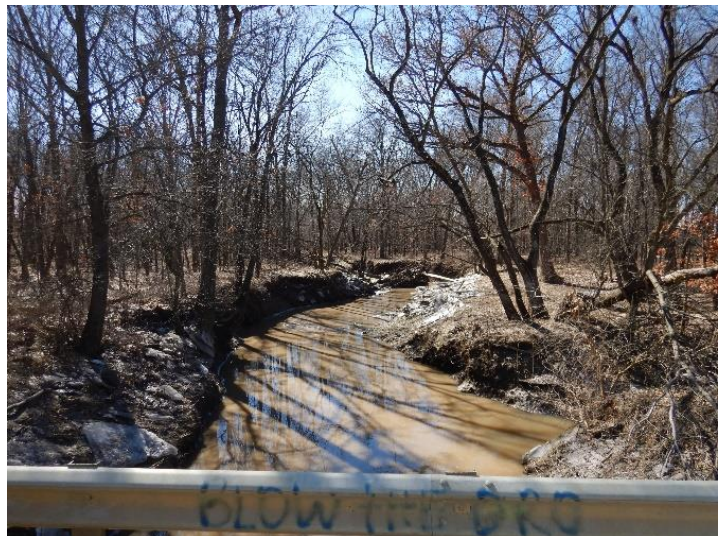
Site # 19: Downstream

Channel condition	<input type="text" value="10"/>
Hydrologic alteration	<input type="text" value="3"/>
Riparian zone	<input type="text" value="10"/>
Bank stability	<input type="text" value="2"/>
Canopy cover	<input type="text" value="10"/>
Manure presence	<input type="text"/>

**Overall Score**  
7.0

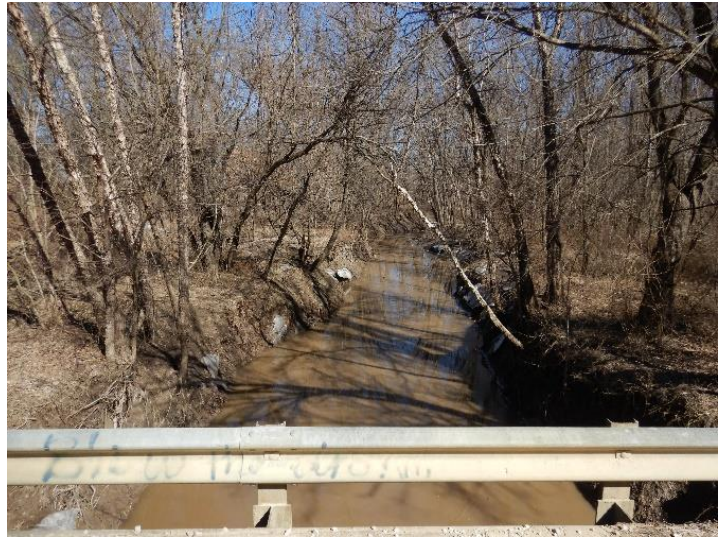
### Site # 19: Upstream

Channel condition	<input type="text" value="10"/>
Hydrologic alteration	<input type="text" value="3"/>
Riparian zone	<input type="text" value="10"/>
Bank stability	<input type="text" value="3"/>
Canopy cover	<input type="text" value="10"/>
Manure presence	<input type="text"/>

**Overall Score**  
7.2

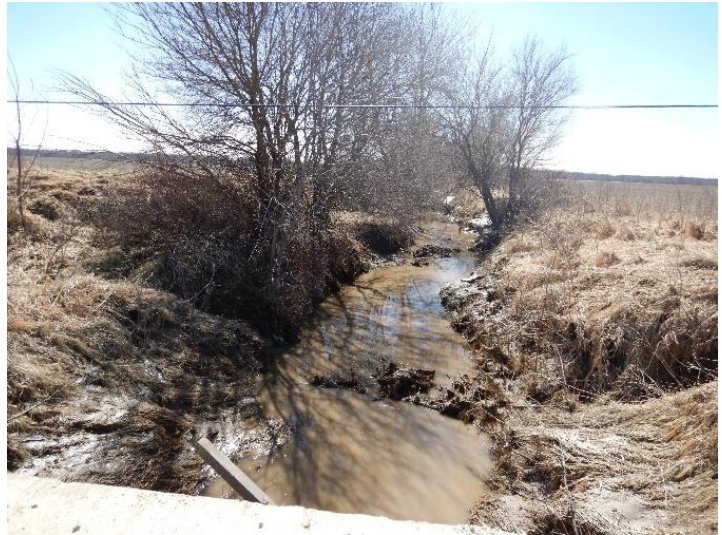
### Site #1: Downstream

Channel condition	<input type="text" value="10"/>
Hydrologic alteration	<input type="text" value="4"/>
Riparian zone	<input type="text" value="8"/>
Bank stability	<input type="text" value="5"/>
Canopy cover	<input type="text" value="7"/>
Manure presence	<input type="text"/>

**Overall Score**  
6.8

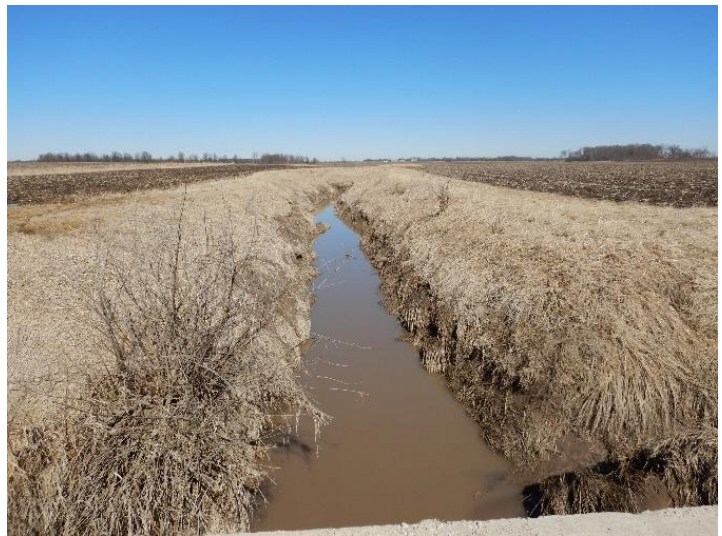
### Site # 1: Upstream

Channel condition	<input type="text" value="1"/>
Hydrologic alteration	<input type="text" value="2"/>
Riparian zone	<input type="text" value="8"/>
Bank stability	<input type="text" value="6"/>
Canopy cover	<input type="text" value="3"/>
Manure presence	<input type="text"/>

**Overall Score**  
4.0
