Geomorphic Disturbance and Anthropogenic Modifications in Big Barren Creek, Mark Twain National Forest, Southeast Missouri

A Masters Thesis

Master of Science, Geospatial Sciences in Geography, Geology, and Planning

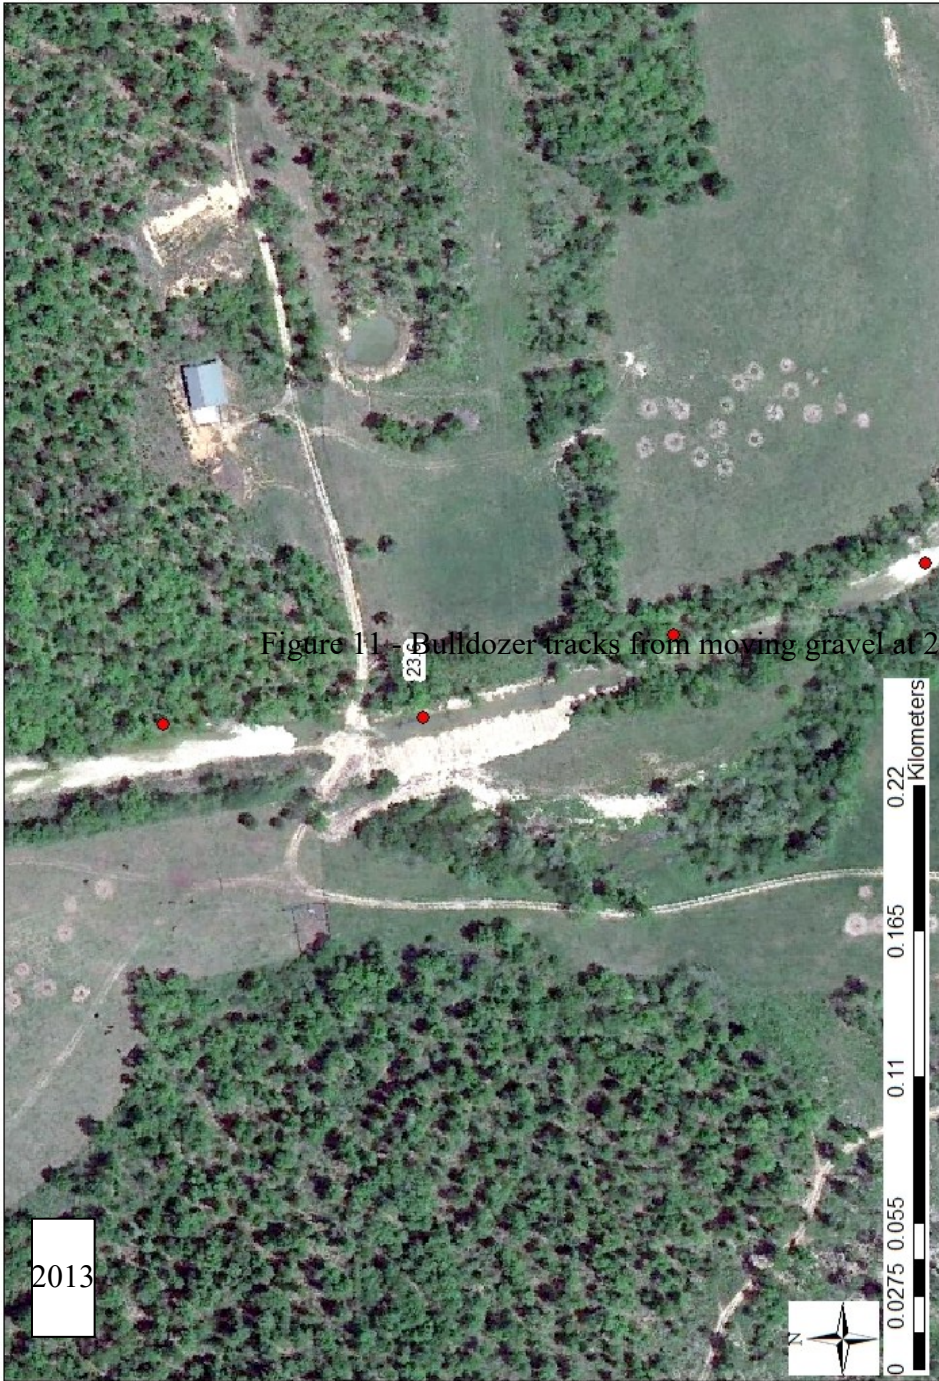
Figure 11. Bulldozer tracks from moving gravel at 23.6 (2013).

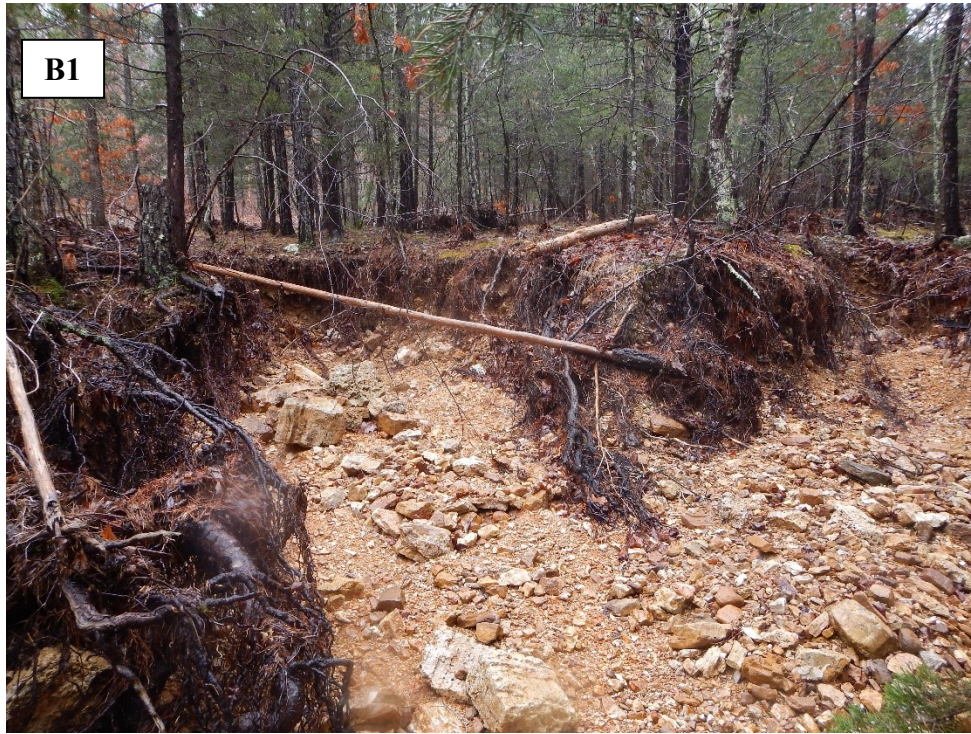
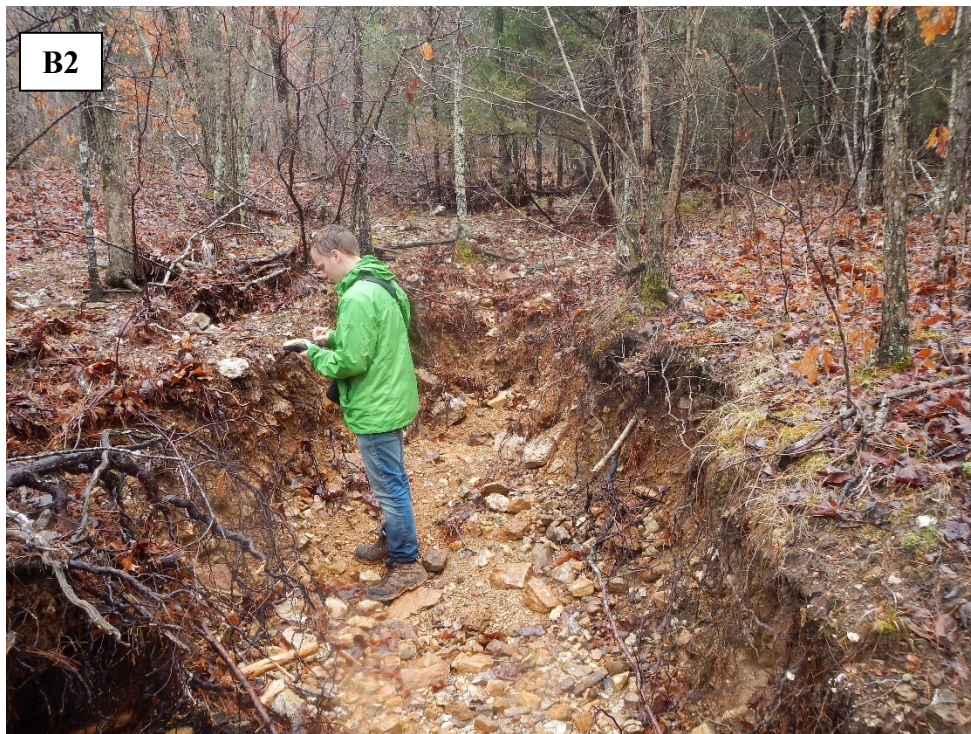
Figure 15B- Headcuts and headcut incision at 37.7 km. B1&2: Ground-truthing photos (2016) looking upstream of headcut at 37.7 km denoted by a purple triangle in Figure 16A.

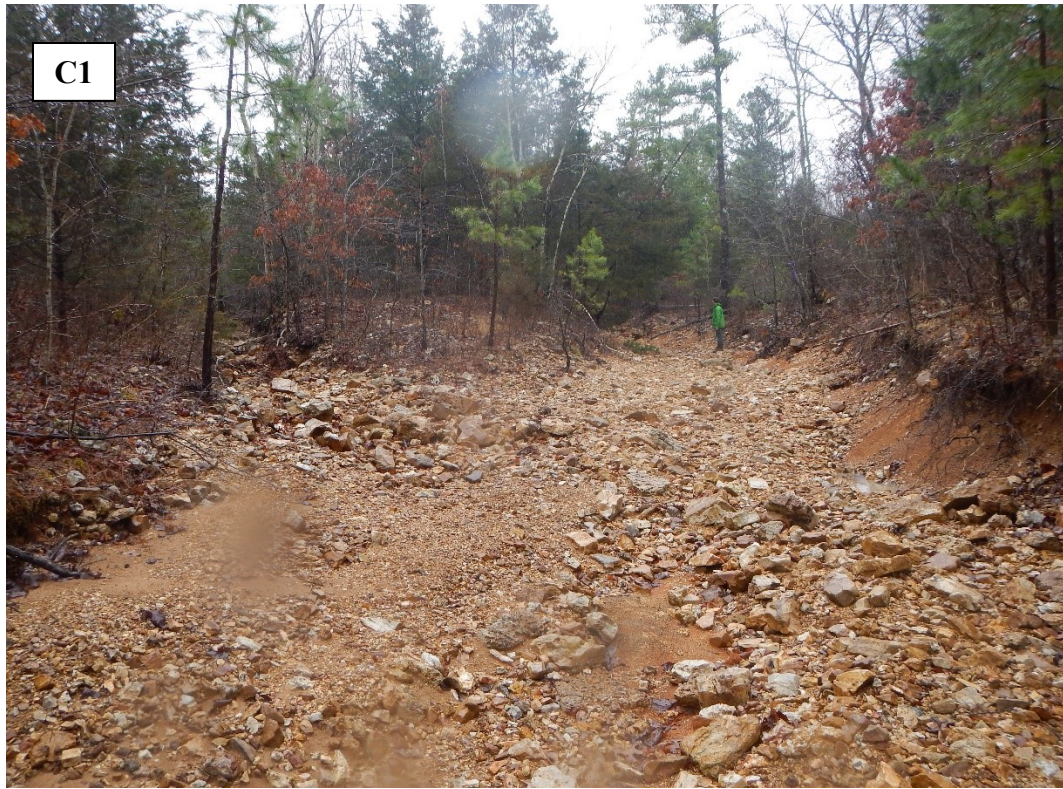
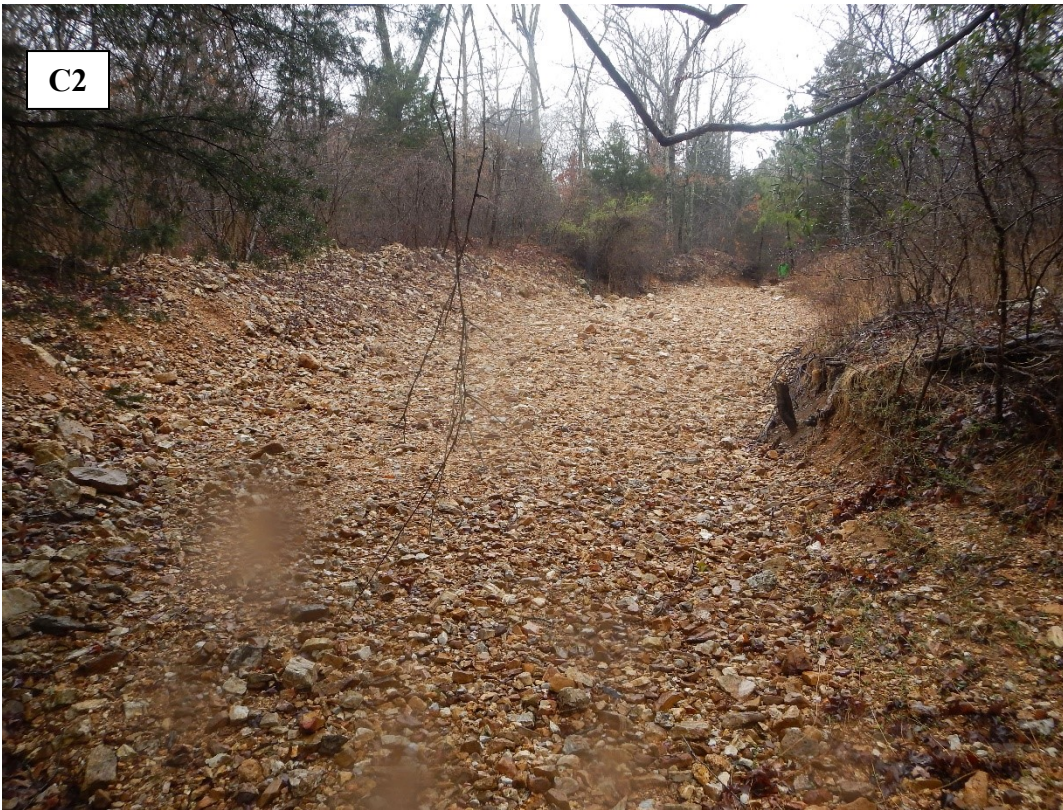
Figure 15C - Sediment pulses at 37.7 km. C1: Ground-truthing photos (2016) of sediment pulse looking upstream to headcut at 37.7 km. C2: Photo (2016) of sediment pulse looking downstream of headcut at 37.7 km.

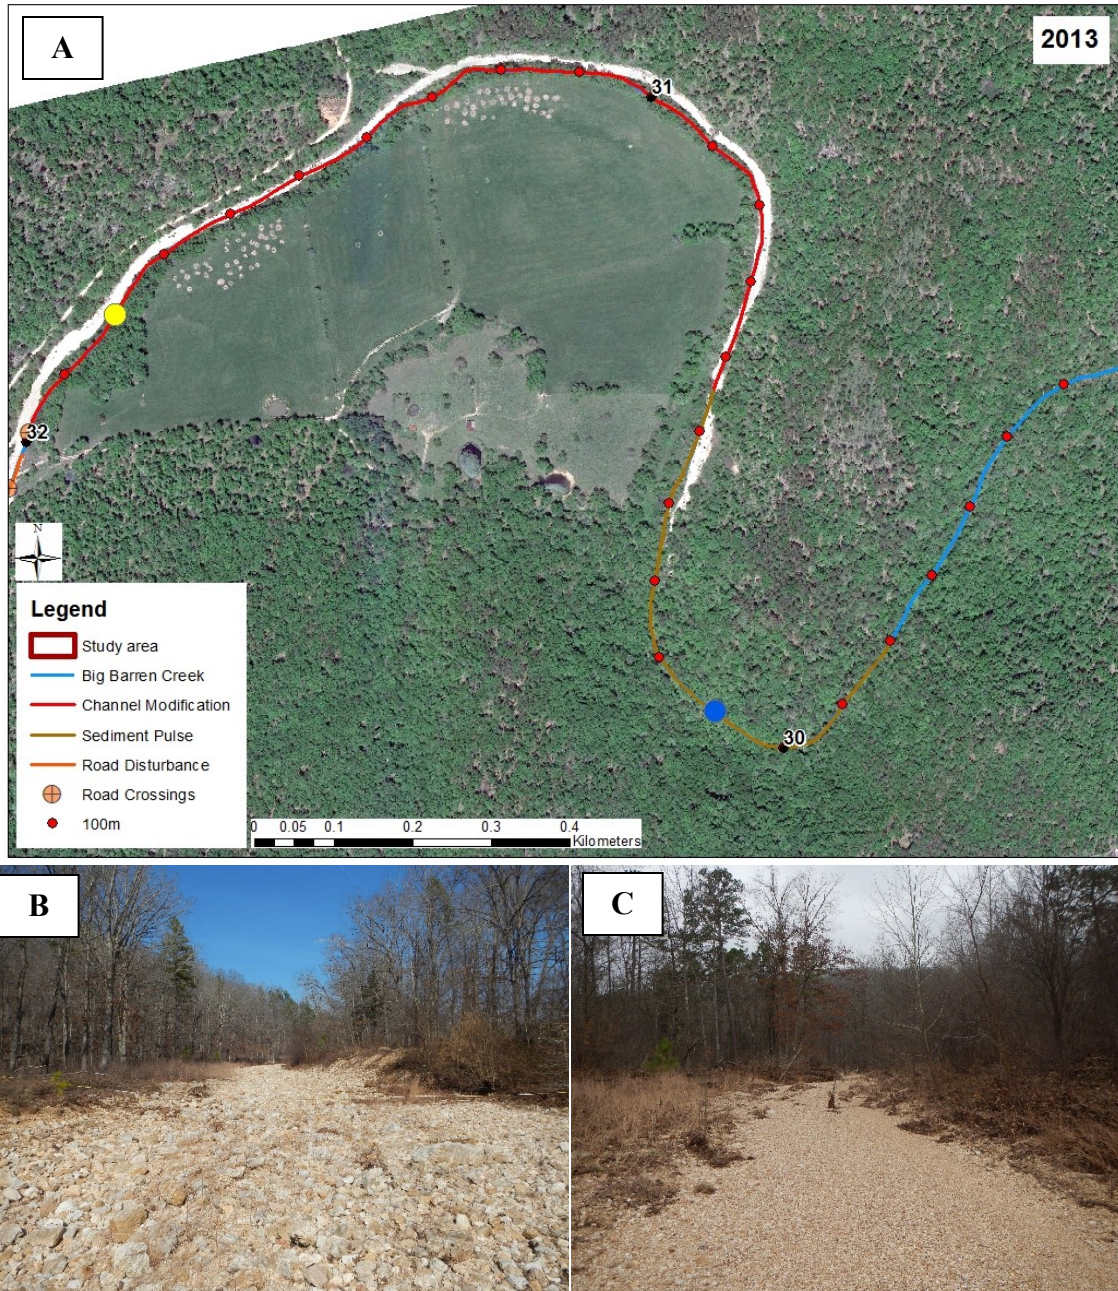
Figure 16 - Map of channelization from 37.7 to 37.1 km. A: Aerial photo (2013) of channelized segment 34.0 to 30.55 km and subsequent sediment pulse to 29.8 km. B: Ground-truthing photo (2016) of channelization 31.8 km denoted as yellow circle in A. C: Ground-truthing photo (2016) of sediment pulse at 30.1 km denoted by blue circle in A.

deposition (Cui et al., 2003) (Figure 16). Conditionally, sediment pulses are stable because mobile sediment such as sand and fine gravel are deposited over a stable bed, but worsening or repeat disturbance, such as continued headward migration of a headcut, can lead to increased downstream sediment transport and instability caused by aggradation (Cui et al., 2003). Other active segments of Big Barren Creek were identified on aerial photographs as areas with accumulated alluvium from eroded banks that show incision and widening that was not directly related to a disturbance source (Washington State Department of Natural Resources, 2004) (Figure 18).

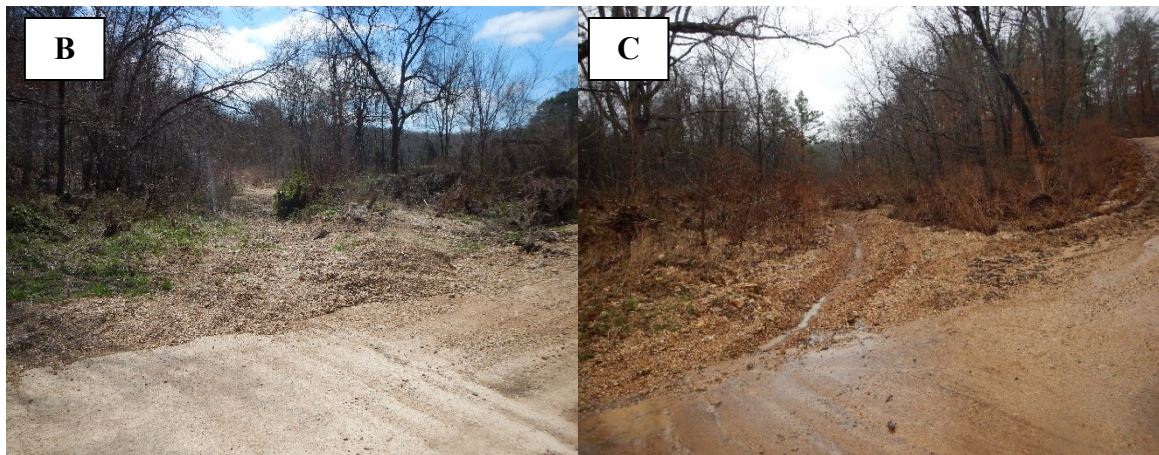
Figure 17 - Map of Ozark roads and road crossings around 34.0 km. A: Aerial (2013) of road crossing from 34.1 to 33.9 km. B: Ground-truthing photo (2016) of road crossing looking upstream of County Road J-173 at 34.05 km denoted by the orange circle on above figure. C: Photo (2016) looking downstream of road crossing at 34.05 km.

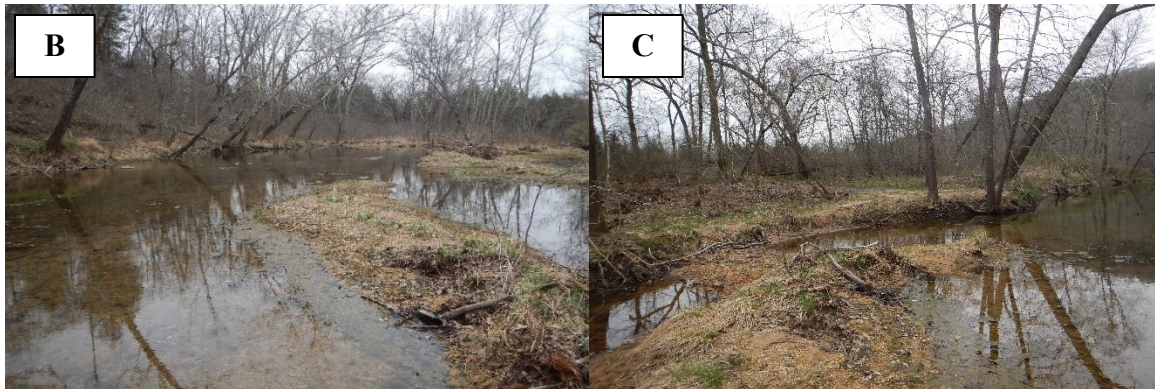
Figure 18 - Map of other active segments caused by the effect of backwater from beaver dams and downstream crossings. A: Aerial photographs (2013) of active areas from 20.8 to 19.9 km. B: Ground-truthing photograph (2016) looking upstream of an active segment at 20.6 km denoted by the dark pink circle in above figure. C: Photo (2016) looking downstream of other active segment at 20.6 km.

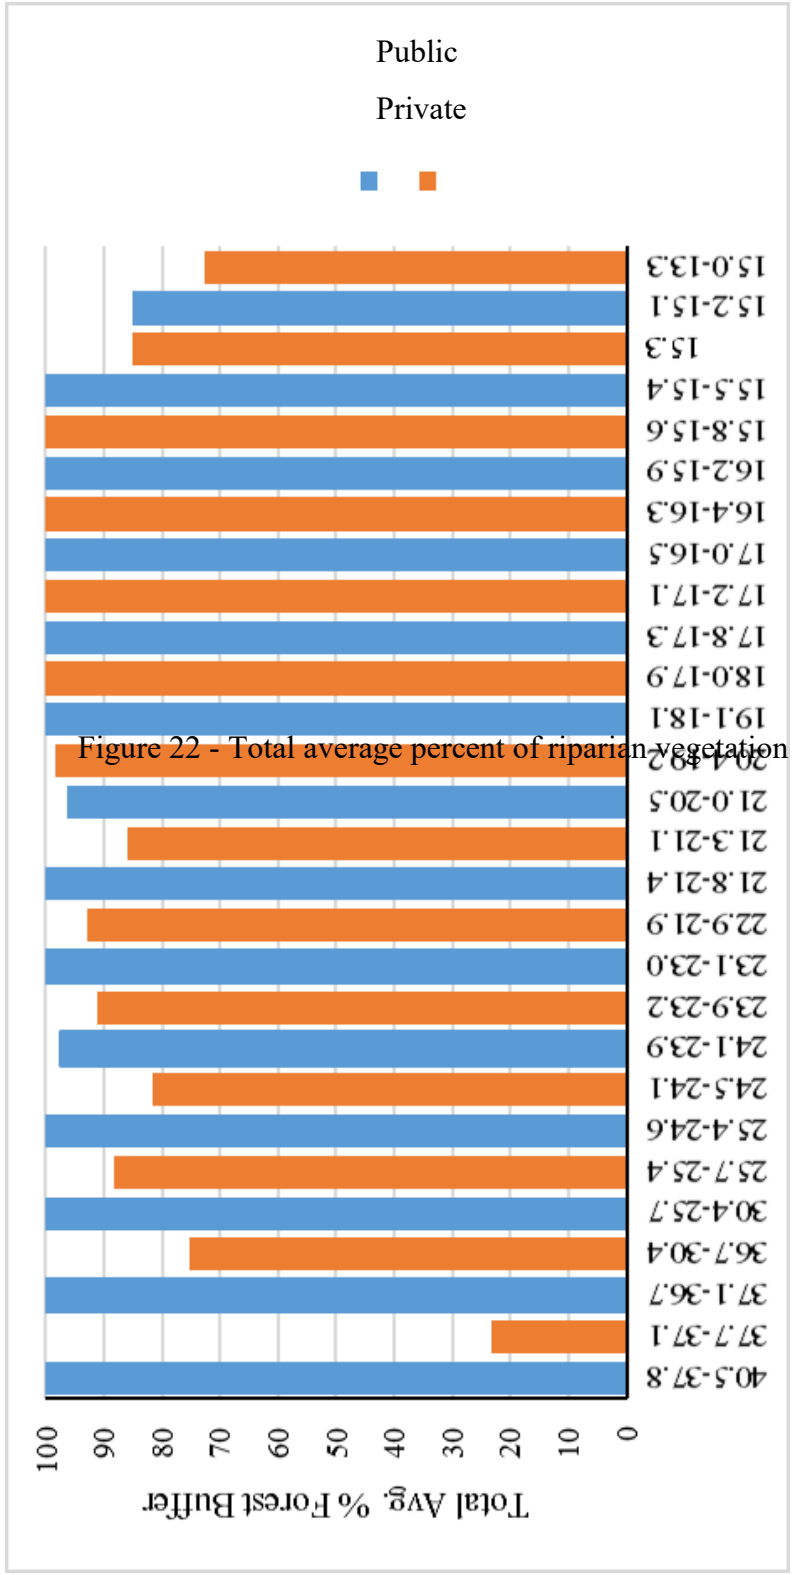
Figure 22 - Total average percent of riparian vegetation by river-kilometer by ownership.

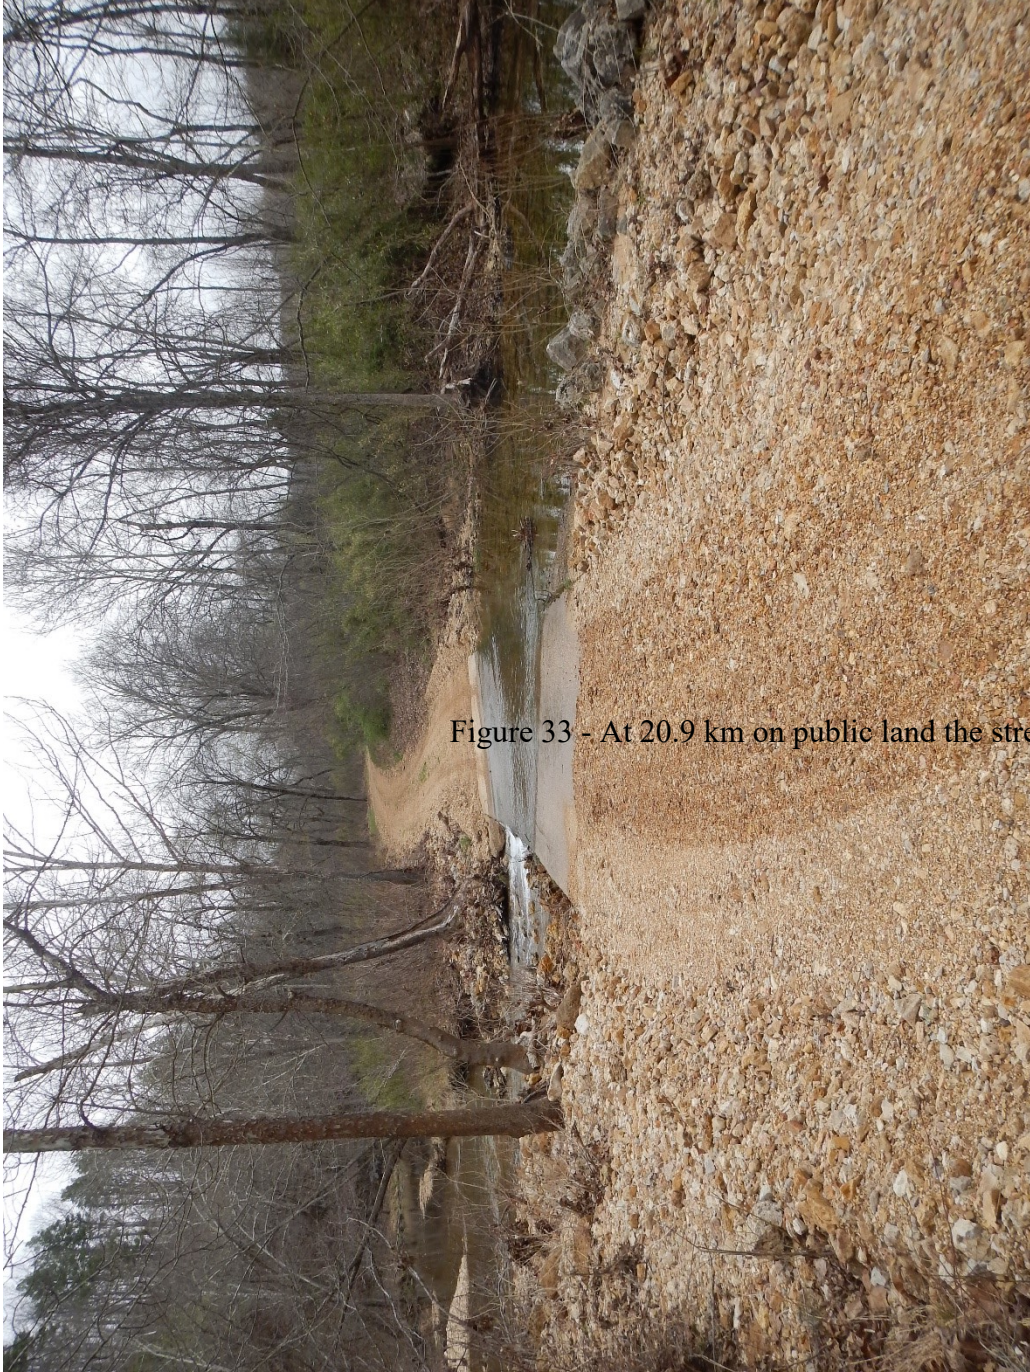
Figure 33 - At 20.9 km on public land the stream bed is part of a road
