Beach Erosion and Recovery Since Hurricane Ivan in 2004 Along a Headland-Bay Coast in Treasure Beach, Jamaica

A Master's Thesis

Master of Science, Geography

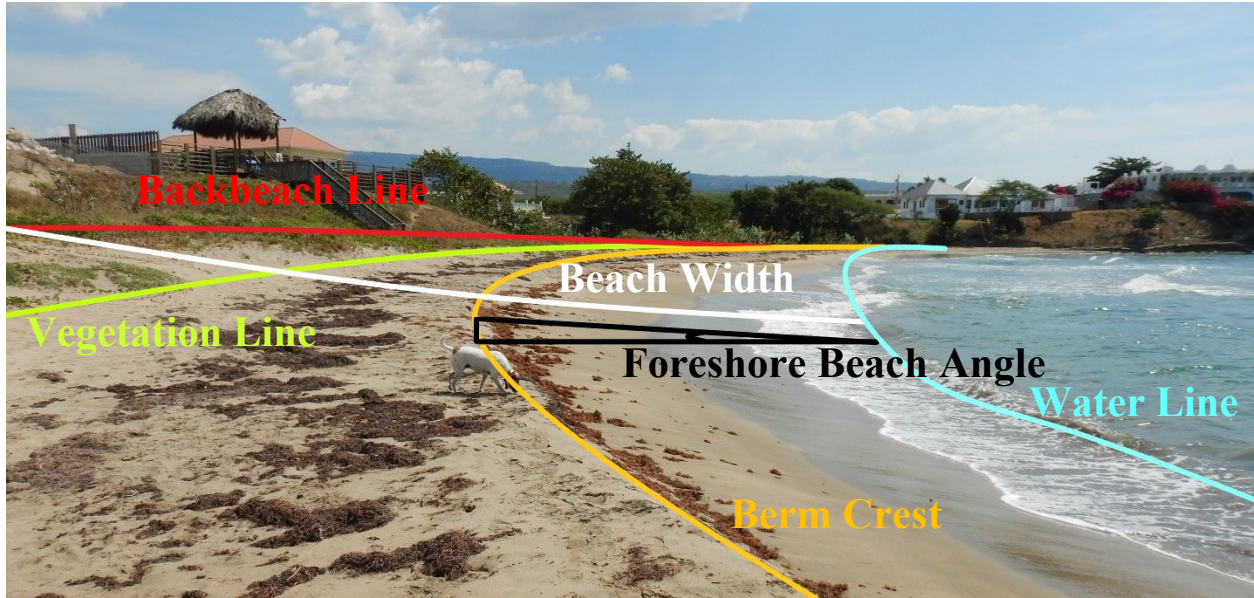
Figure 10. Example of beach lines used in beach change analysis.

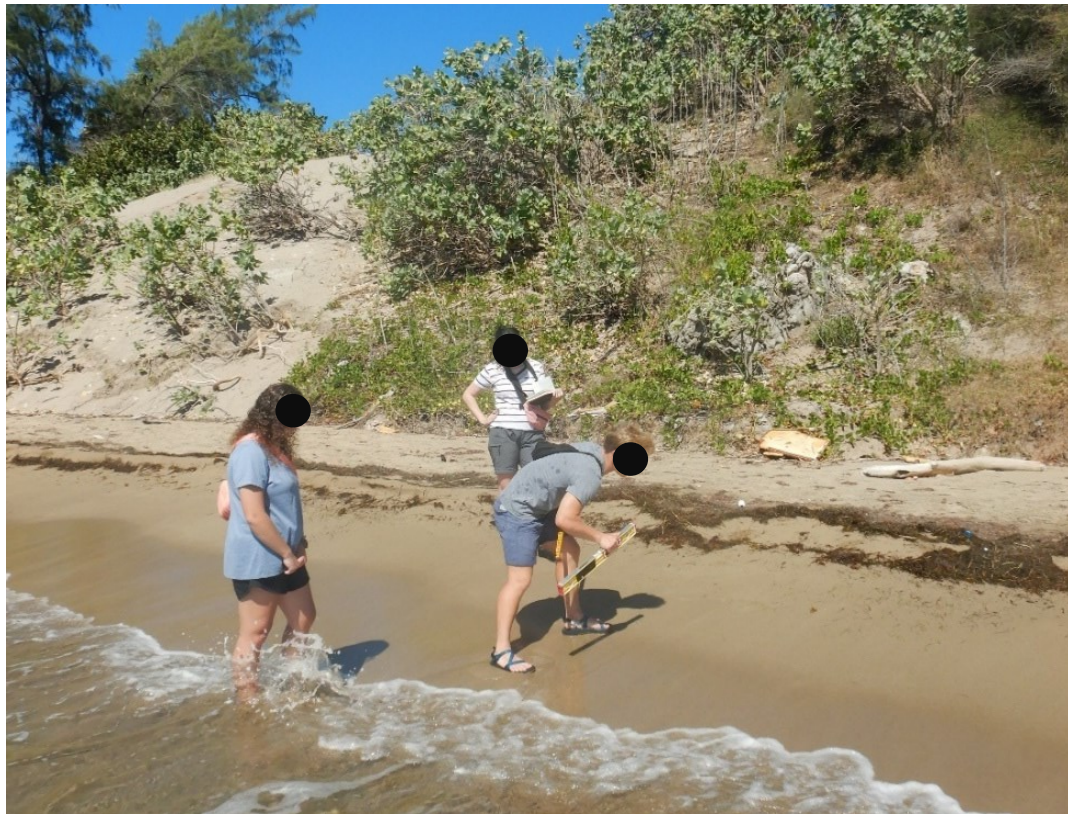
Figure 11. Measuring beach slope angles on the foreshore.

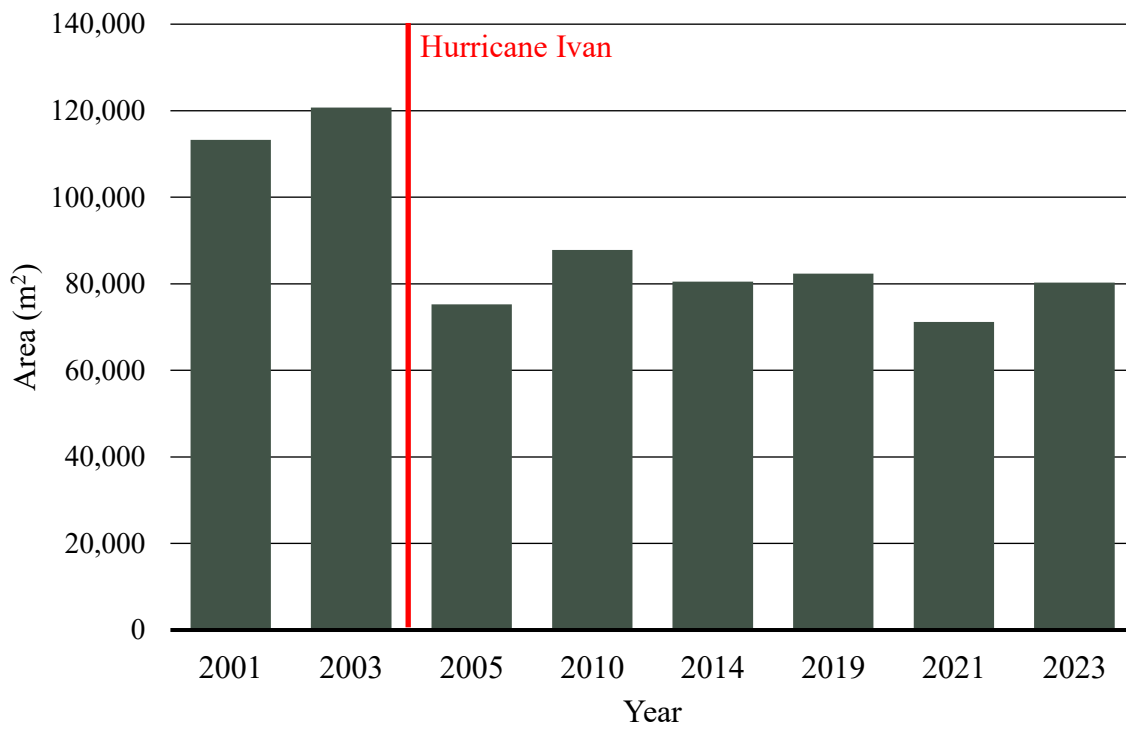
Figure 19. Total sandy beach area for all sandy pocket beaches from 2001 to 2023.

Beach area changes did not occur similarly for a given year of observation at all bays. However, as noted above, similar trends over time were noted overall for the response in beach area to Hurricane Ivan and during the recovery period for five or possibly six of the bays (Figure 19). The specific processes and mechanisms responsible for beach area differences among beaches is beyond the scope of this study. However, longshore sediment transport and budget factors and variations in storm wave approach and energy dissipation can influence beach erosion in the Caribbean (Inman & Jenkins, 2003; Jena, et al., 2001). Great Bay is the only beach with a higher sandy beach area in 2023 than 2001. For example, direct wave approach into Great Bay is limited greatly by Great Pedro Bluff. Further, Billy's Bay is located furthest from Great Pedro Bluff and just updrift from more rocky beaches influenced by apparent higher rates of longshore transport.

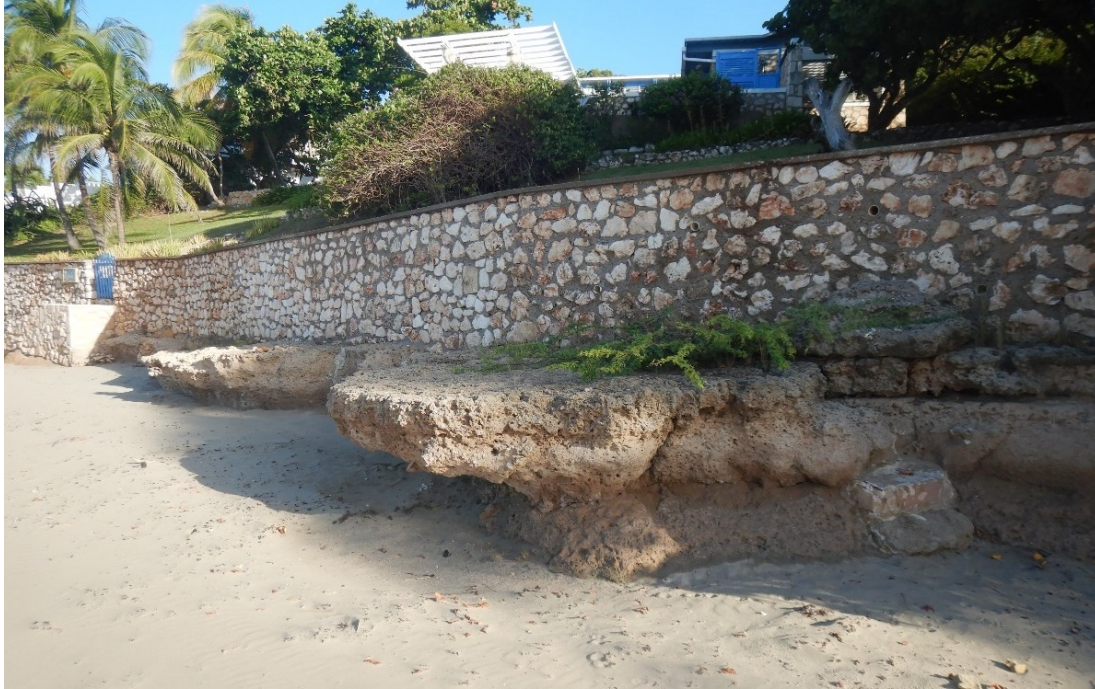
Figure 23. An example of an eroding beach in front of a stone wall at Calabash Bay (03/18/2021).

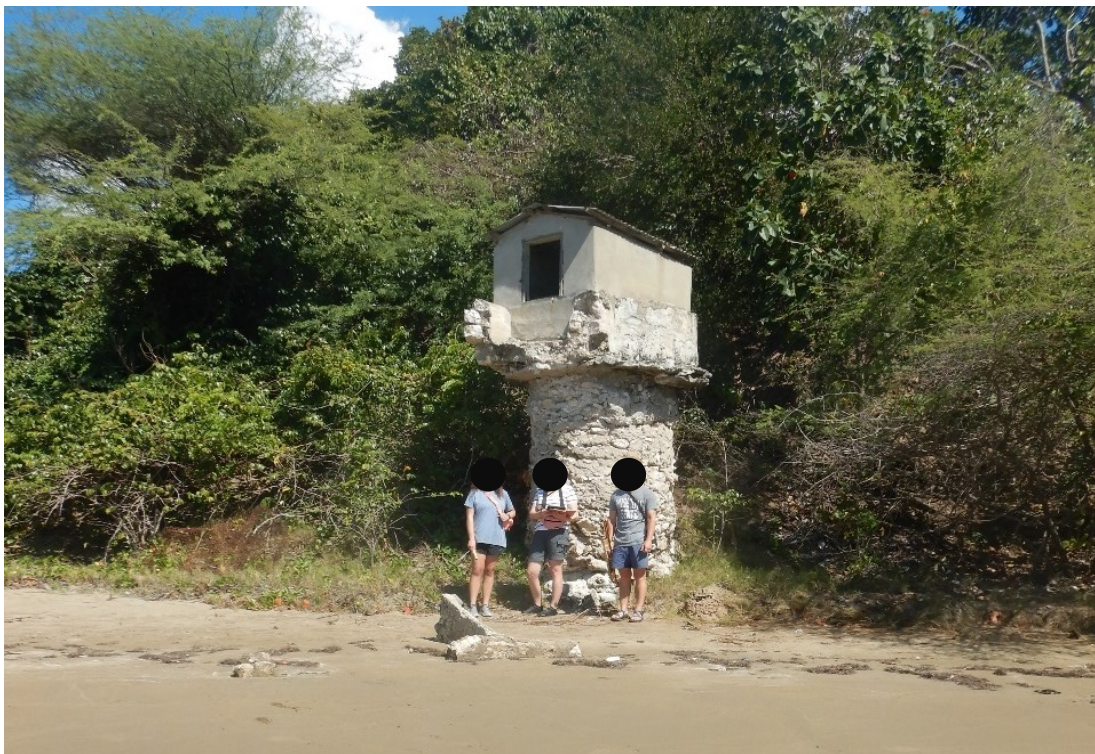
Figure 24. Example of an eroding beach, exposing a well house and pit wall at Billy's Bay (01/12/2021).

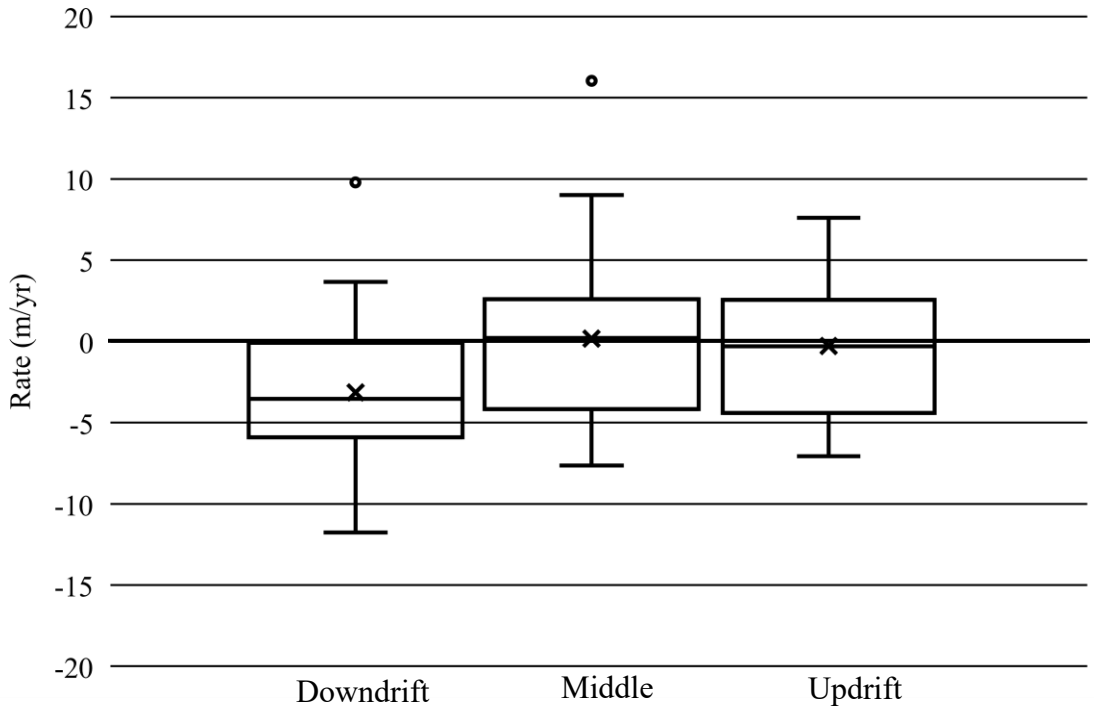
Figure 27. Erosion and accretion variability according to drift sections for all the sandy beaches from 2003 to 2005. There are 34 downdrift transects, 29 middle transects, and 29 updrift transects.

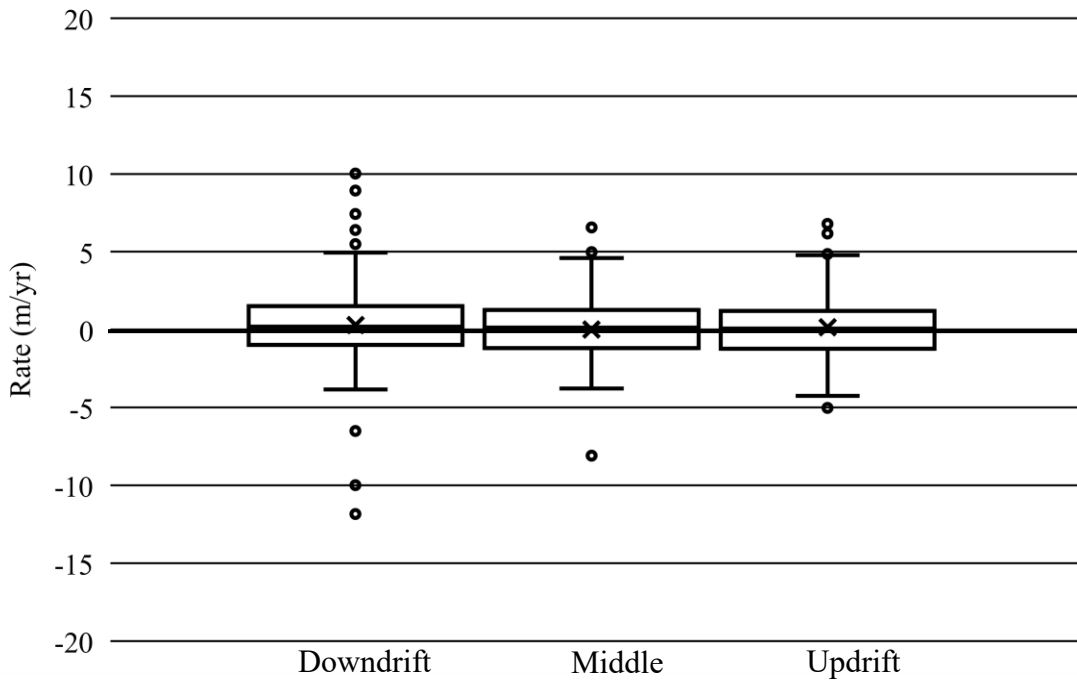
Figure 32. Erosion and accretion variability according to drift sections for all the sandy beaches with nearshore rock or coral reef protection from 2005 to 2023. There are 100 downdrift, 102 middle, and 115 updrift transects.

transects at protected locations during Hurricane Ivan (Figure 31). Further, during the post-Ivan period from 2005 to 2023, the three drift segments tended to respond similarly with almost no average change with downdrift transects but having a wider range of beach changes from -10 to +10 m/yr while the updrift locations only ranged from -5 to +5 m/yr (Figure 32). This study focused attention on the updrift and downdrift bay segments as possibly being affected by the variable influence of headland obstruction, storm wave attack, and attachment or deflection of sediment in longshore drift. Nearshore protection can be barrier to wave attack and provide conditions for sediment deposition (Russell, 1959; Aubrey & Ross, 1985; Komar, 1998). However, in Treasure Beach shore protection may be an indicator of beach segments that are more sensitive to erosion that can create conditions for either beach erosion or deposition within a bay (Appendix J and K). More research is needed to classify drift sections of each pocket beach according to wave energy, while keeping beach changes and bathymetric irregularities in mind.

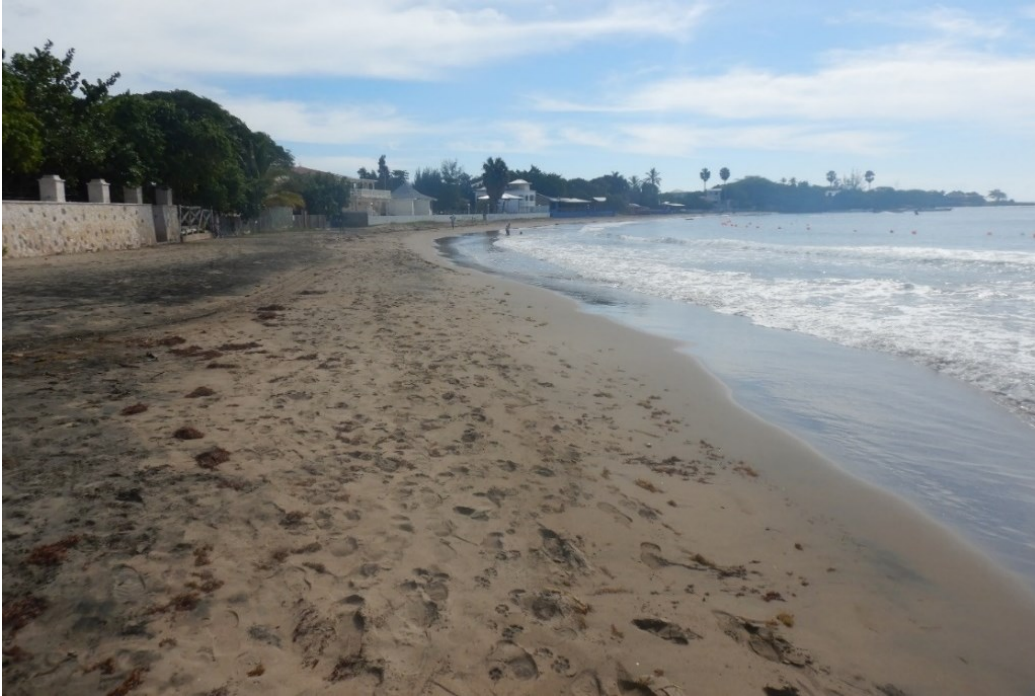
Embayed sandy pocket beach at Frenchman's Bay.

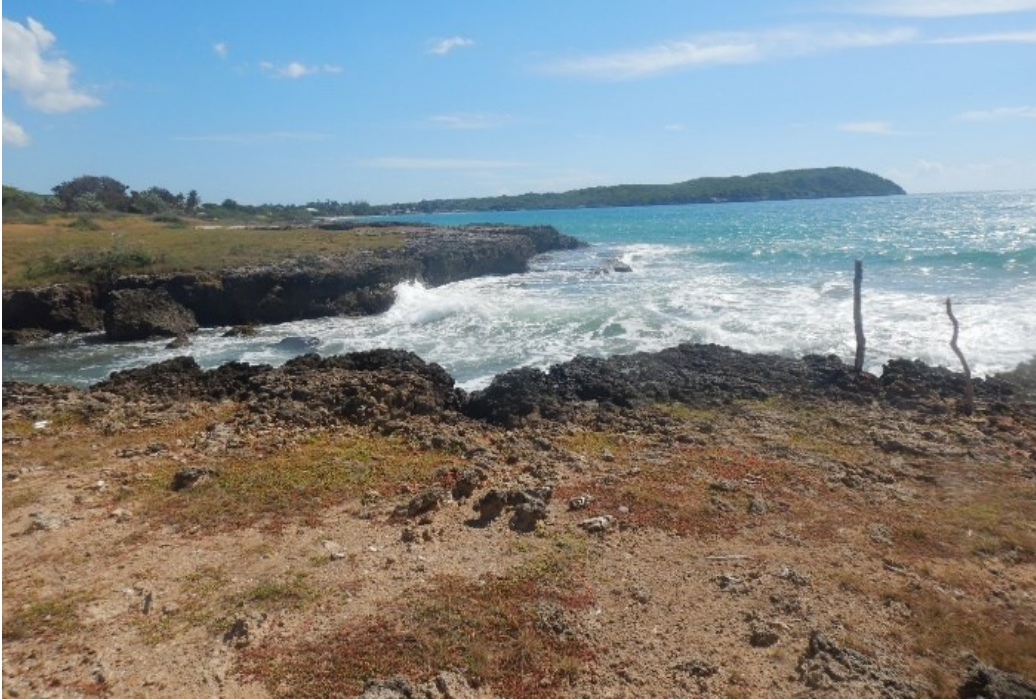
Rock headlands of small, embayed pocket beach at Old Wharf, and Great Pedro Bluff in the back.

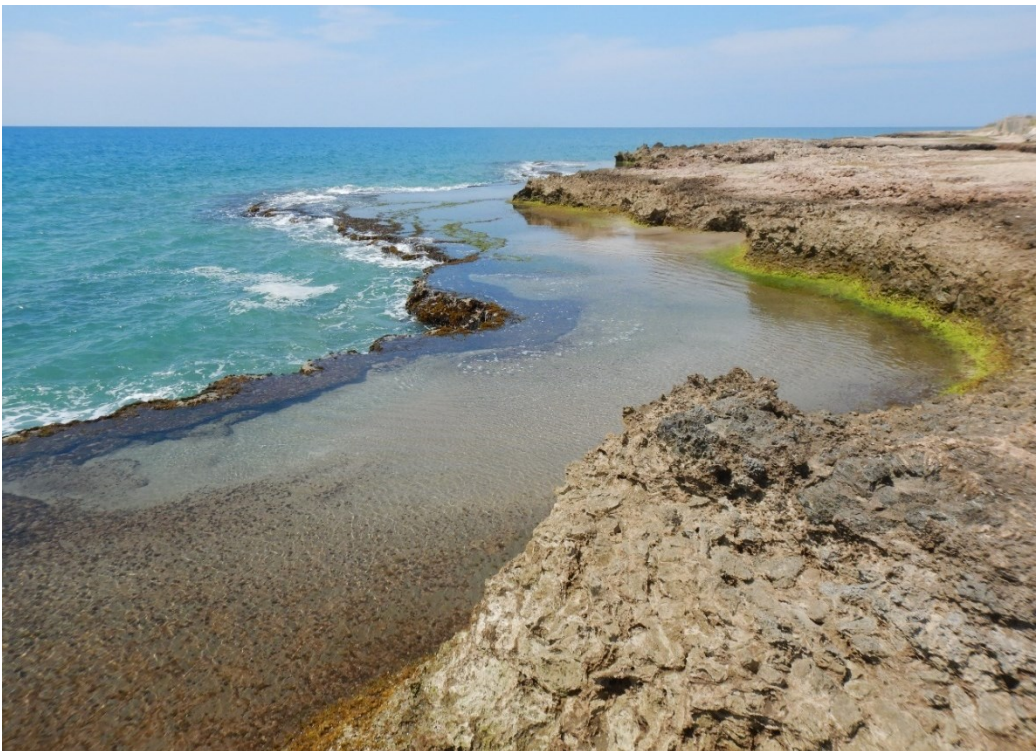
Wave cut platform and intertidal rock pool at Old Wharf.

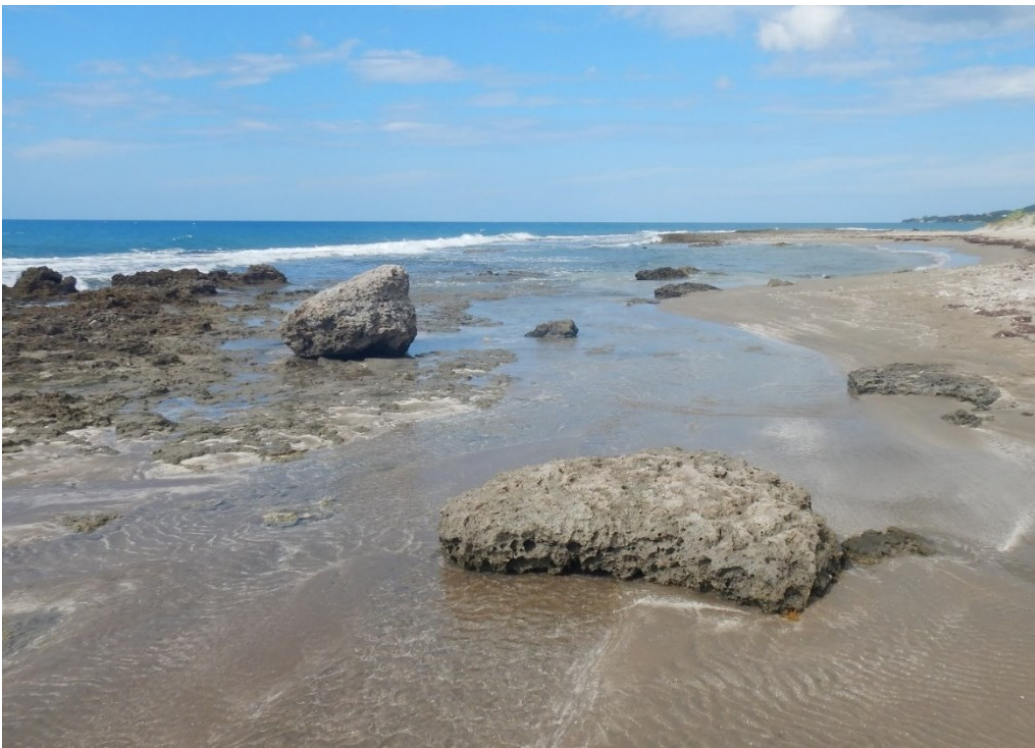
Sandy beach on rock pavement with intertidal rock outcrops at Calabash Bay (sand on rock classification).

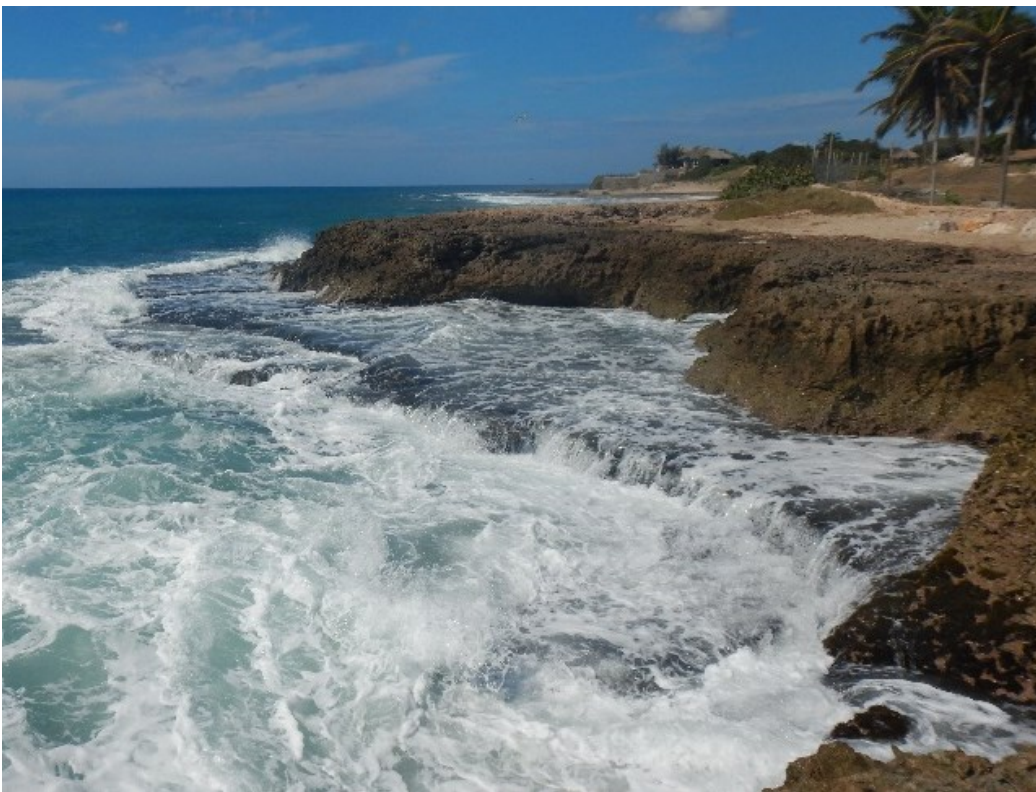
Sand on beach rock platform, with wave cut platform, Old Warf (sand on rock classification).

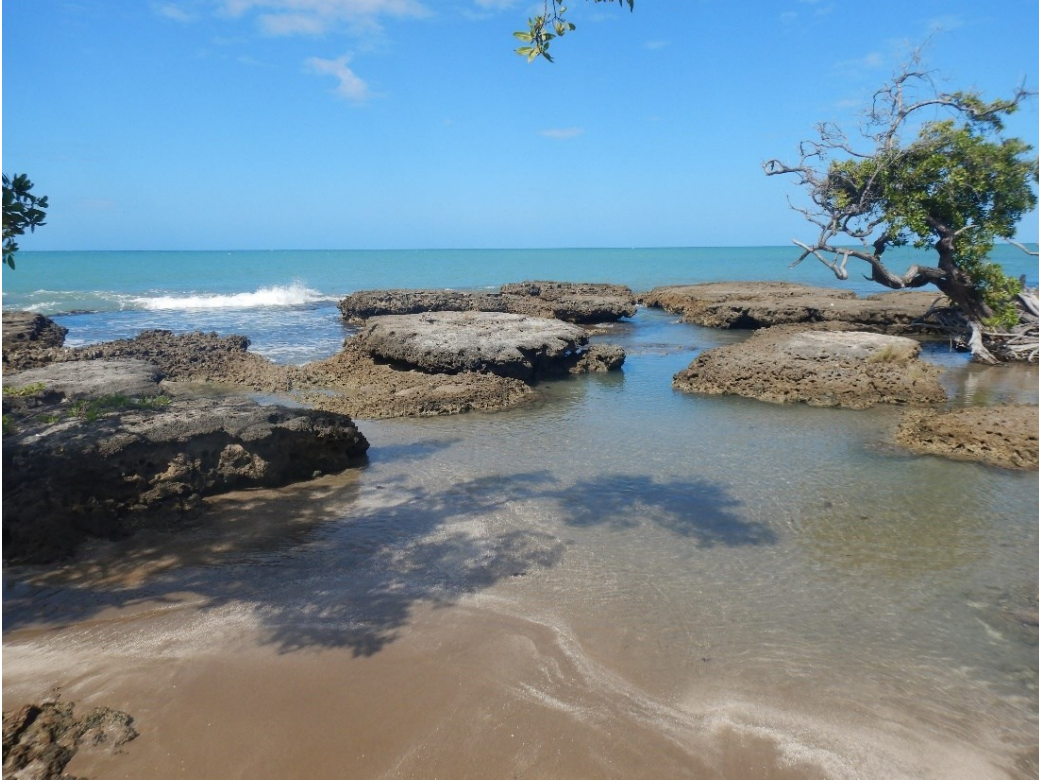
Sandy beach behind rock and old coral reef outcrops at Billy's Bay (sand and rock classification).

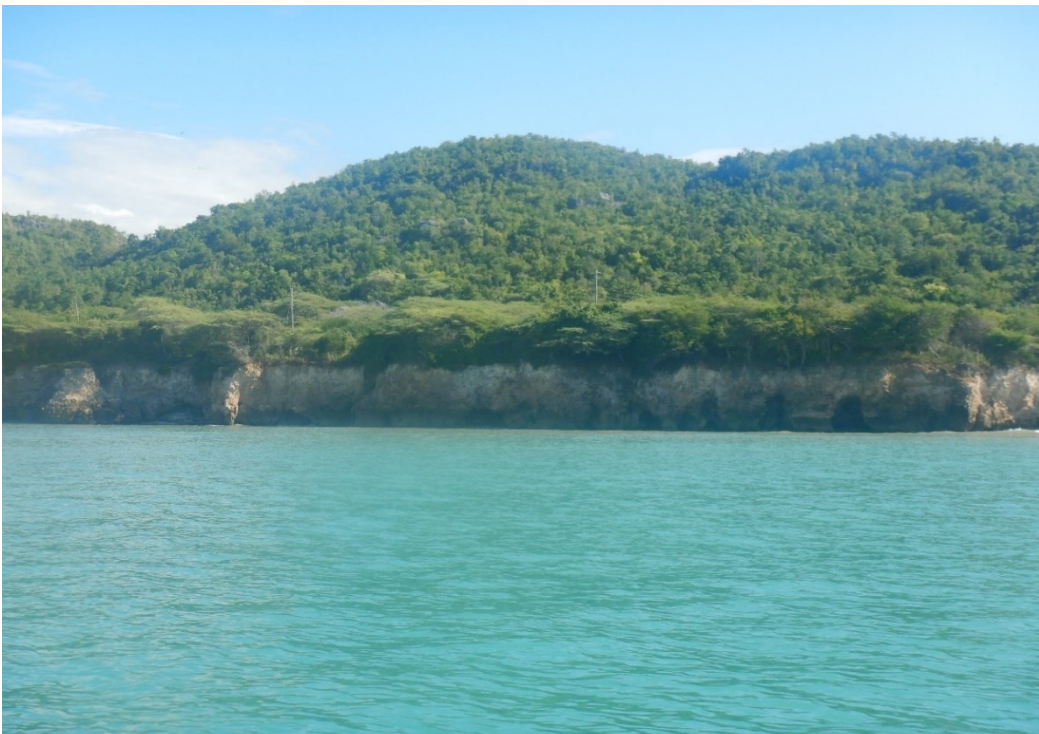
Rock bluff with no beach at Starvegut Bay (rock bluff classification).

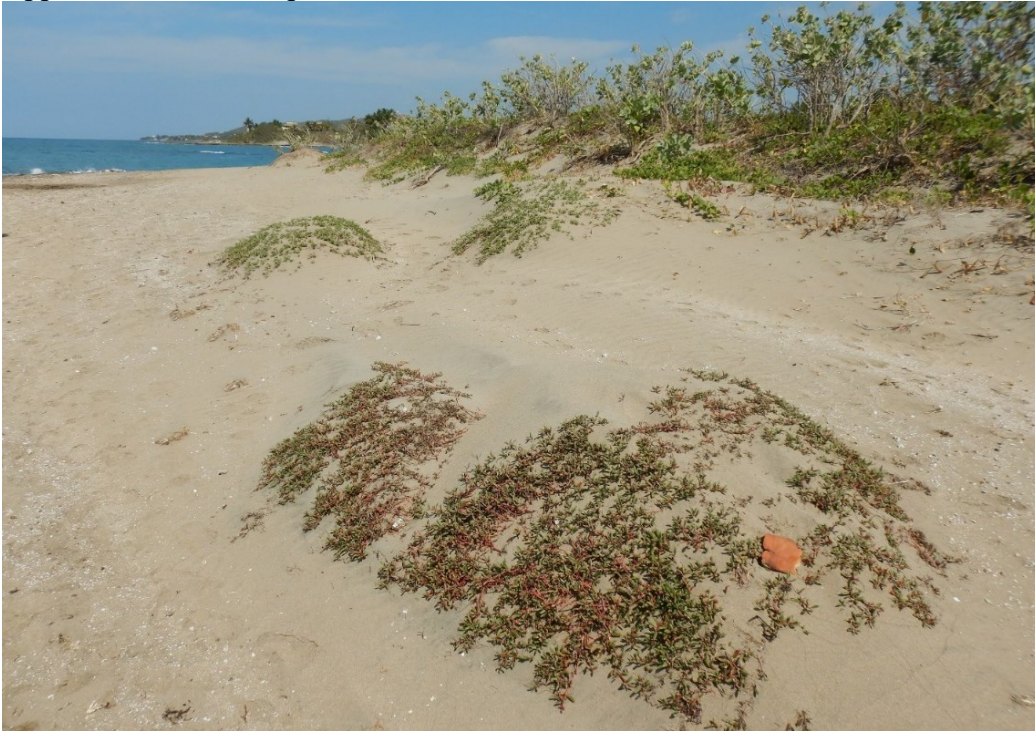
Vegetation encouraging sand dune formation, with shrubs on the backbeach at Old Wharf.

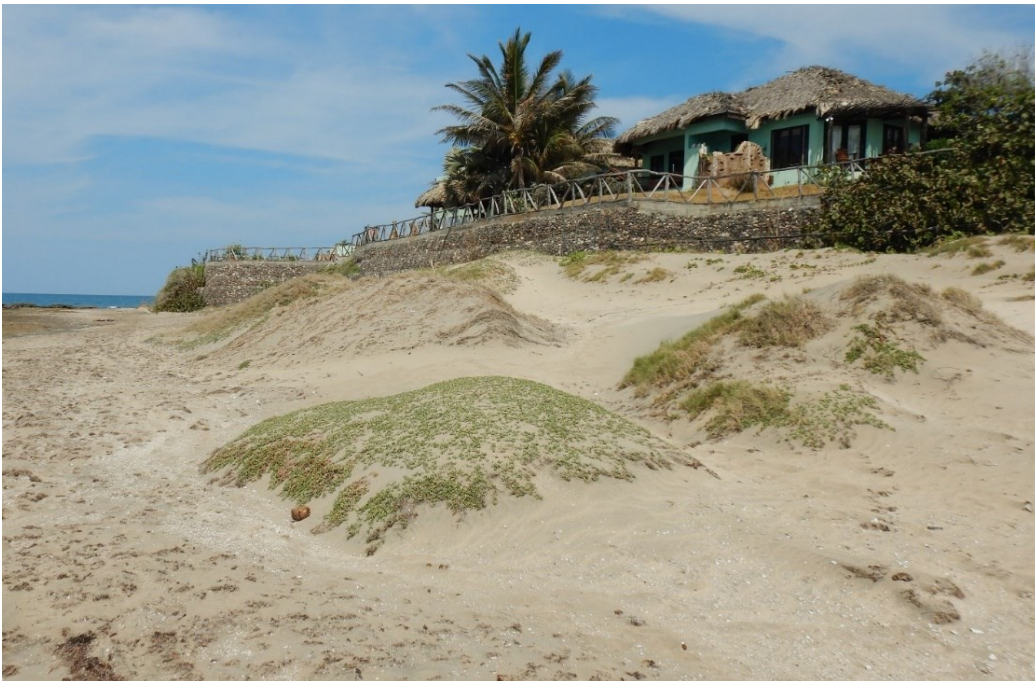
Sand dunes covered with creeping vegetation on the beach, with a stone wall on the backbeach at Old Wharf.

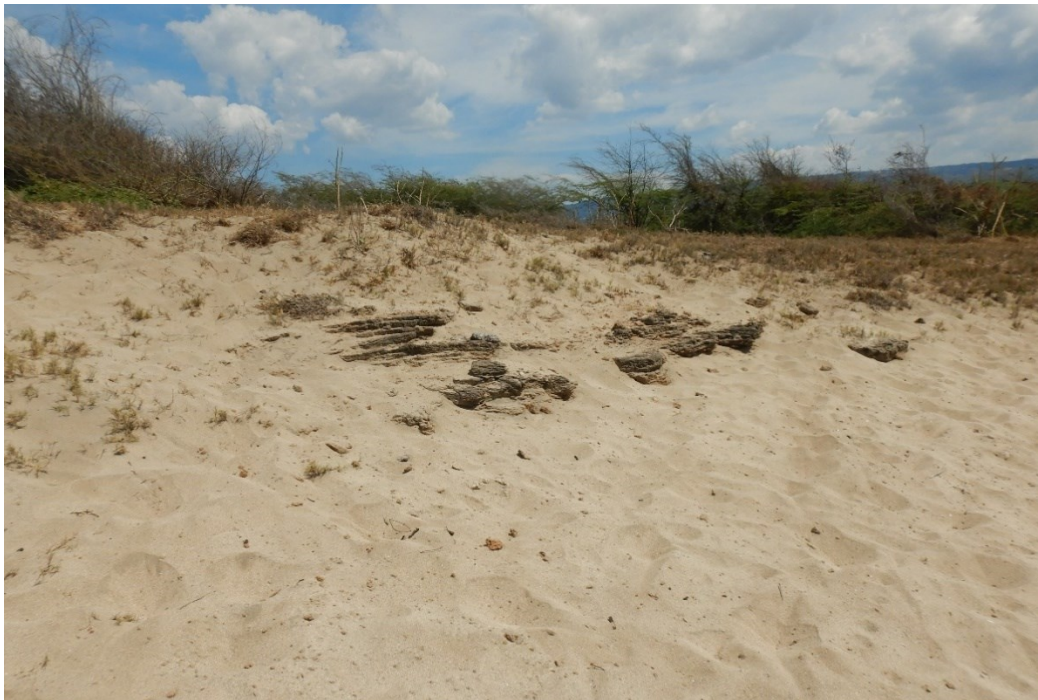
Aeolian rock on the back beach encouraging dune formation at Old Wharf.

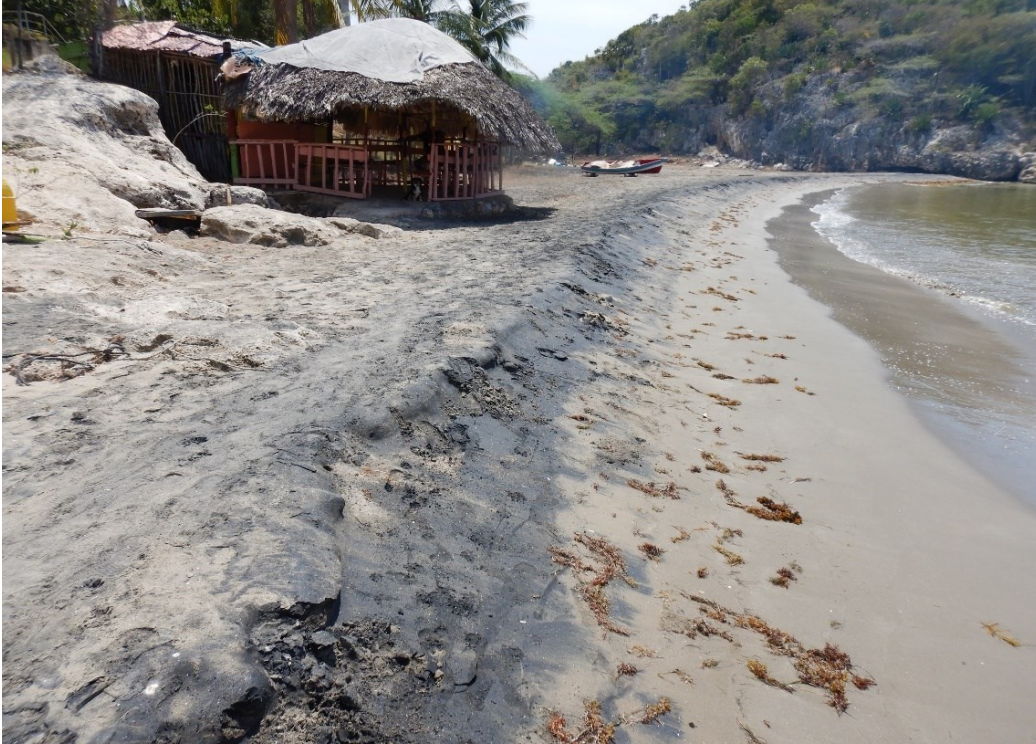
Example of a beach with low wave energy and berm formation on the foreshore at Great Bay.

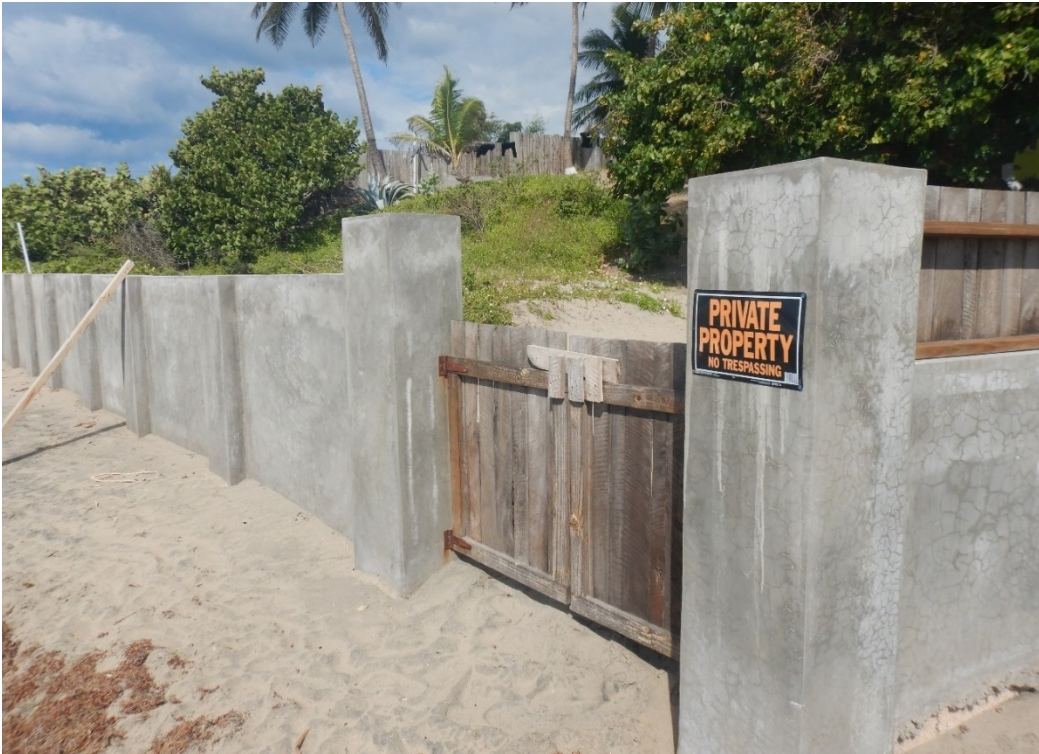
Cement wall built on the back beach at Old Wharf.

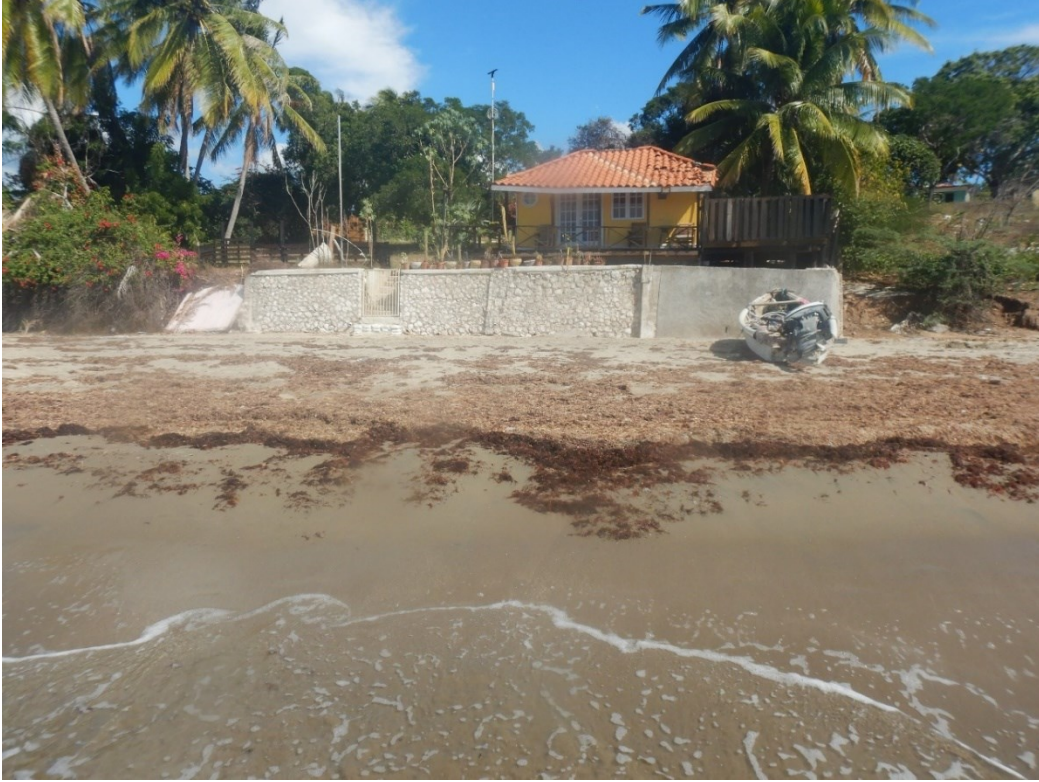
Narrow beach with cement and stone wall on the backbeach at Great Bay.

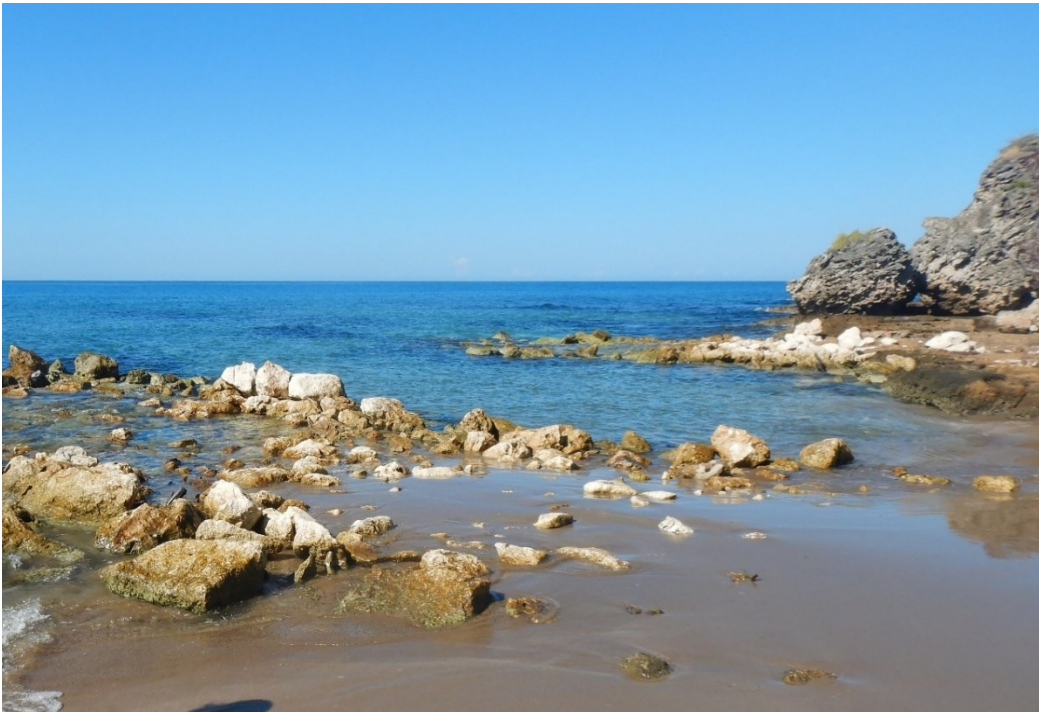
Two groins built with rocks at Mahoe Bay.

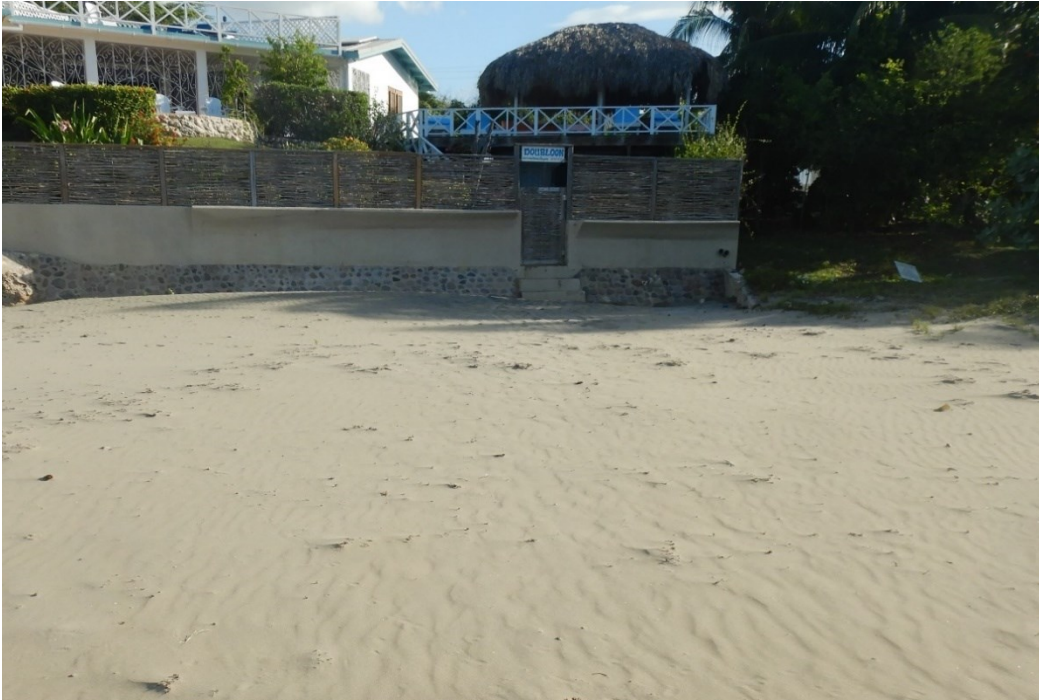
Cement and wood wall preventing beach propagation at Calabash Bay.

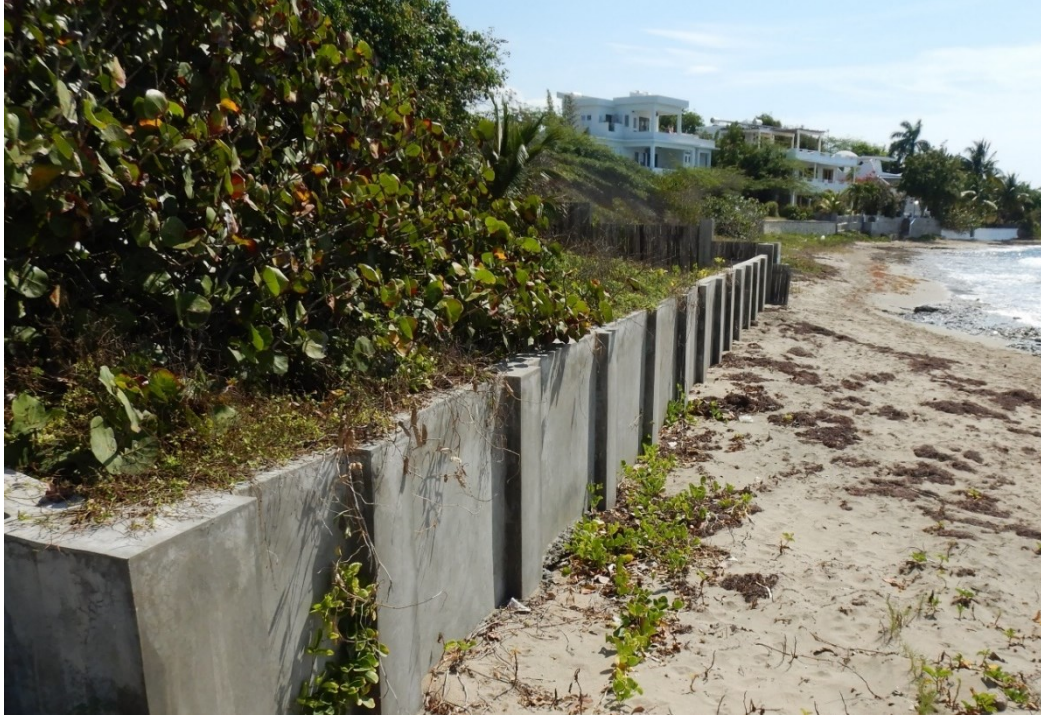
A narrow beach with a concrete wall on the backbeach, preventing beach propagation at Calabash Bay.

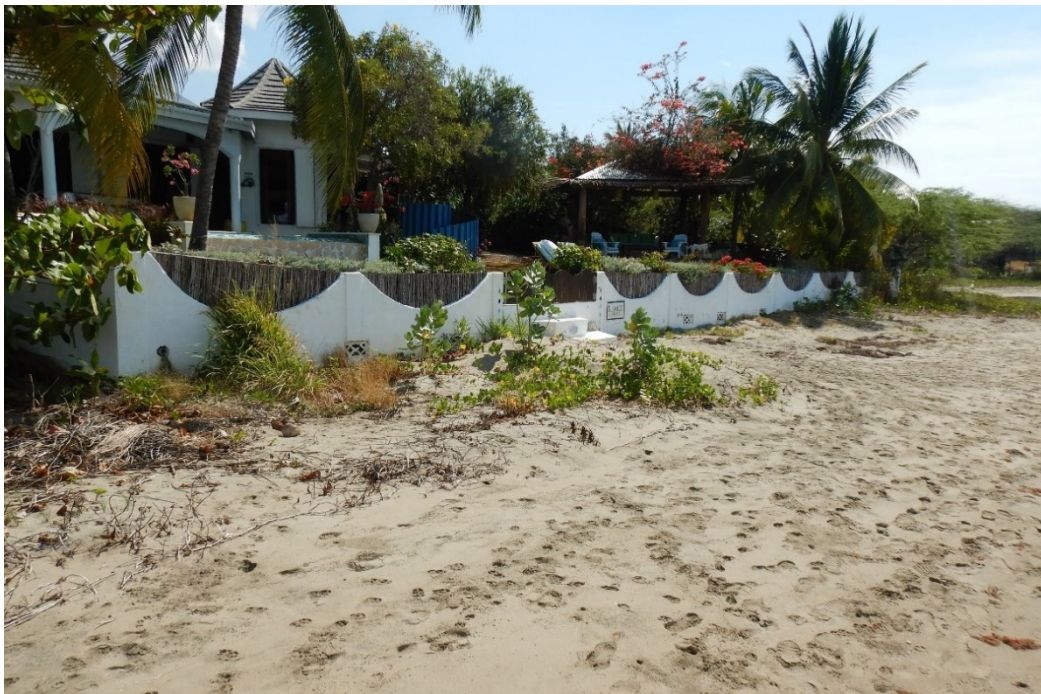
Cement and wood wall at Calabash Bay.

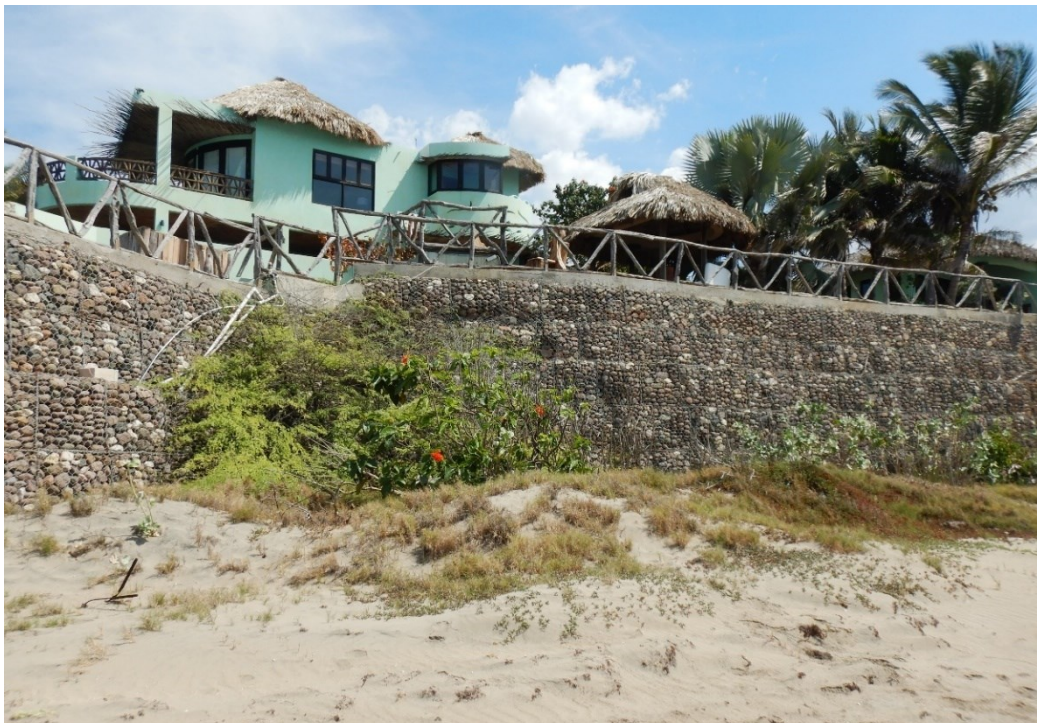
Stone wall encouraging dune formation on the backbeach at Old Wharf.

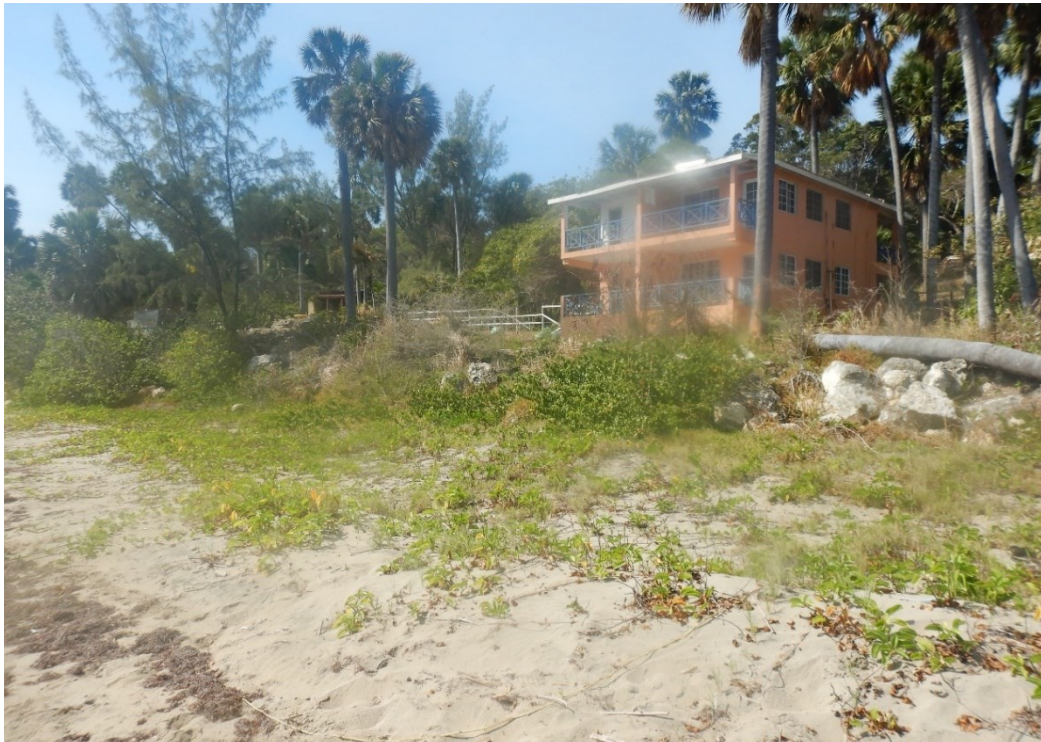
Rip-rap on the backbeach at a beach house at Billy's Bay.

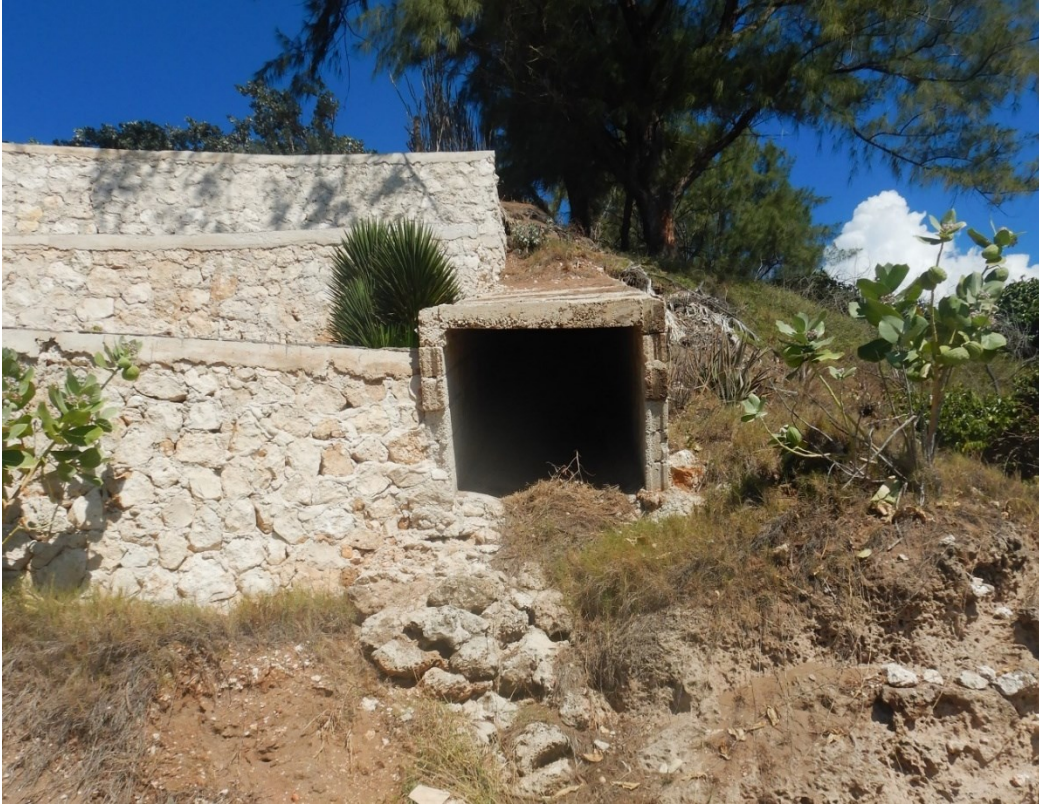
Drainage system draining on the beach at Billy's Bay.
