ABSTRACT

Anthropogenic climate change is causing sea level rise and shoreline changes that threaten the environment and economy of coastal communities in Caribbean Island nations. To assess this risk, this study quantifies shoreline changes at Treasure Beach in St. Elizabeth Parish on the south coast of Jamaica since Hurricane Ivan in September 2004. Over 11 km of shoreline are assessed with about half being sandy beaches ranging from <100 to 700 m in length with the remainder lined by rock headlands and beach rock outcrops. Multiple years of aerial photographs and satellite imagery are used along with field profiles to evaluate beach erosion and deposition trends at the seasonal, storm event, and decadal scales. Preliminary results indicated that beach widths vary annually and over 5–10-year periods. Shoreline changes along Treasure Beach at 50 m intervals averaged -0.5 m/yr (erosion) from 2013 to 2016. Maximum erosion rates of -5 m/yr were observed with maximum deposition rates of 2 m/yr. Both sand deposition and erosion occurred during storm events. However, by 2016 only about 40% of the sand beach length had recovered to its original location prior to Hurricane Ivan in 2004.

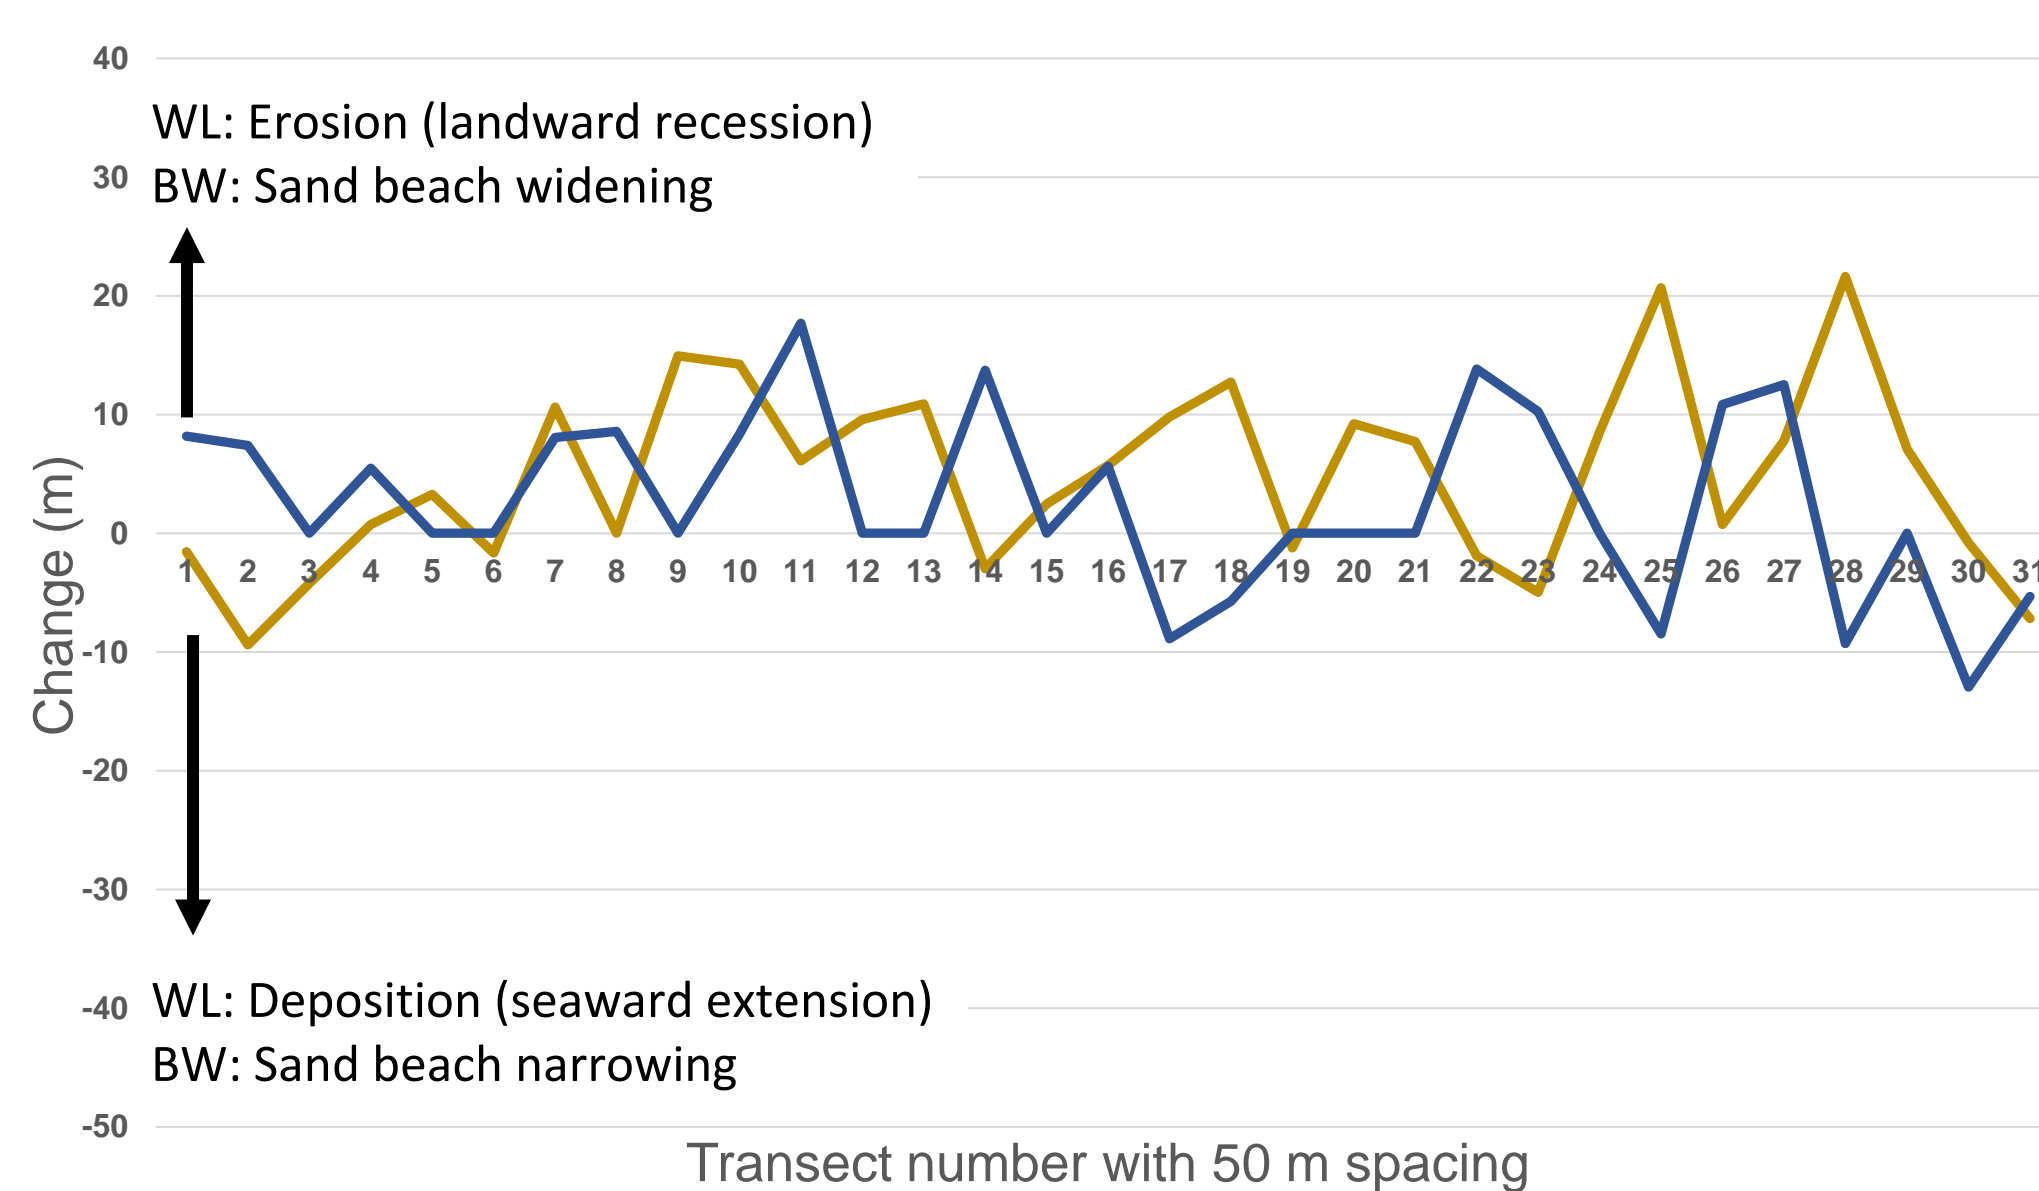
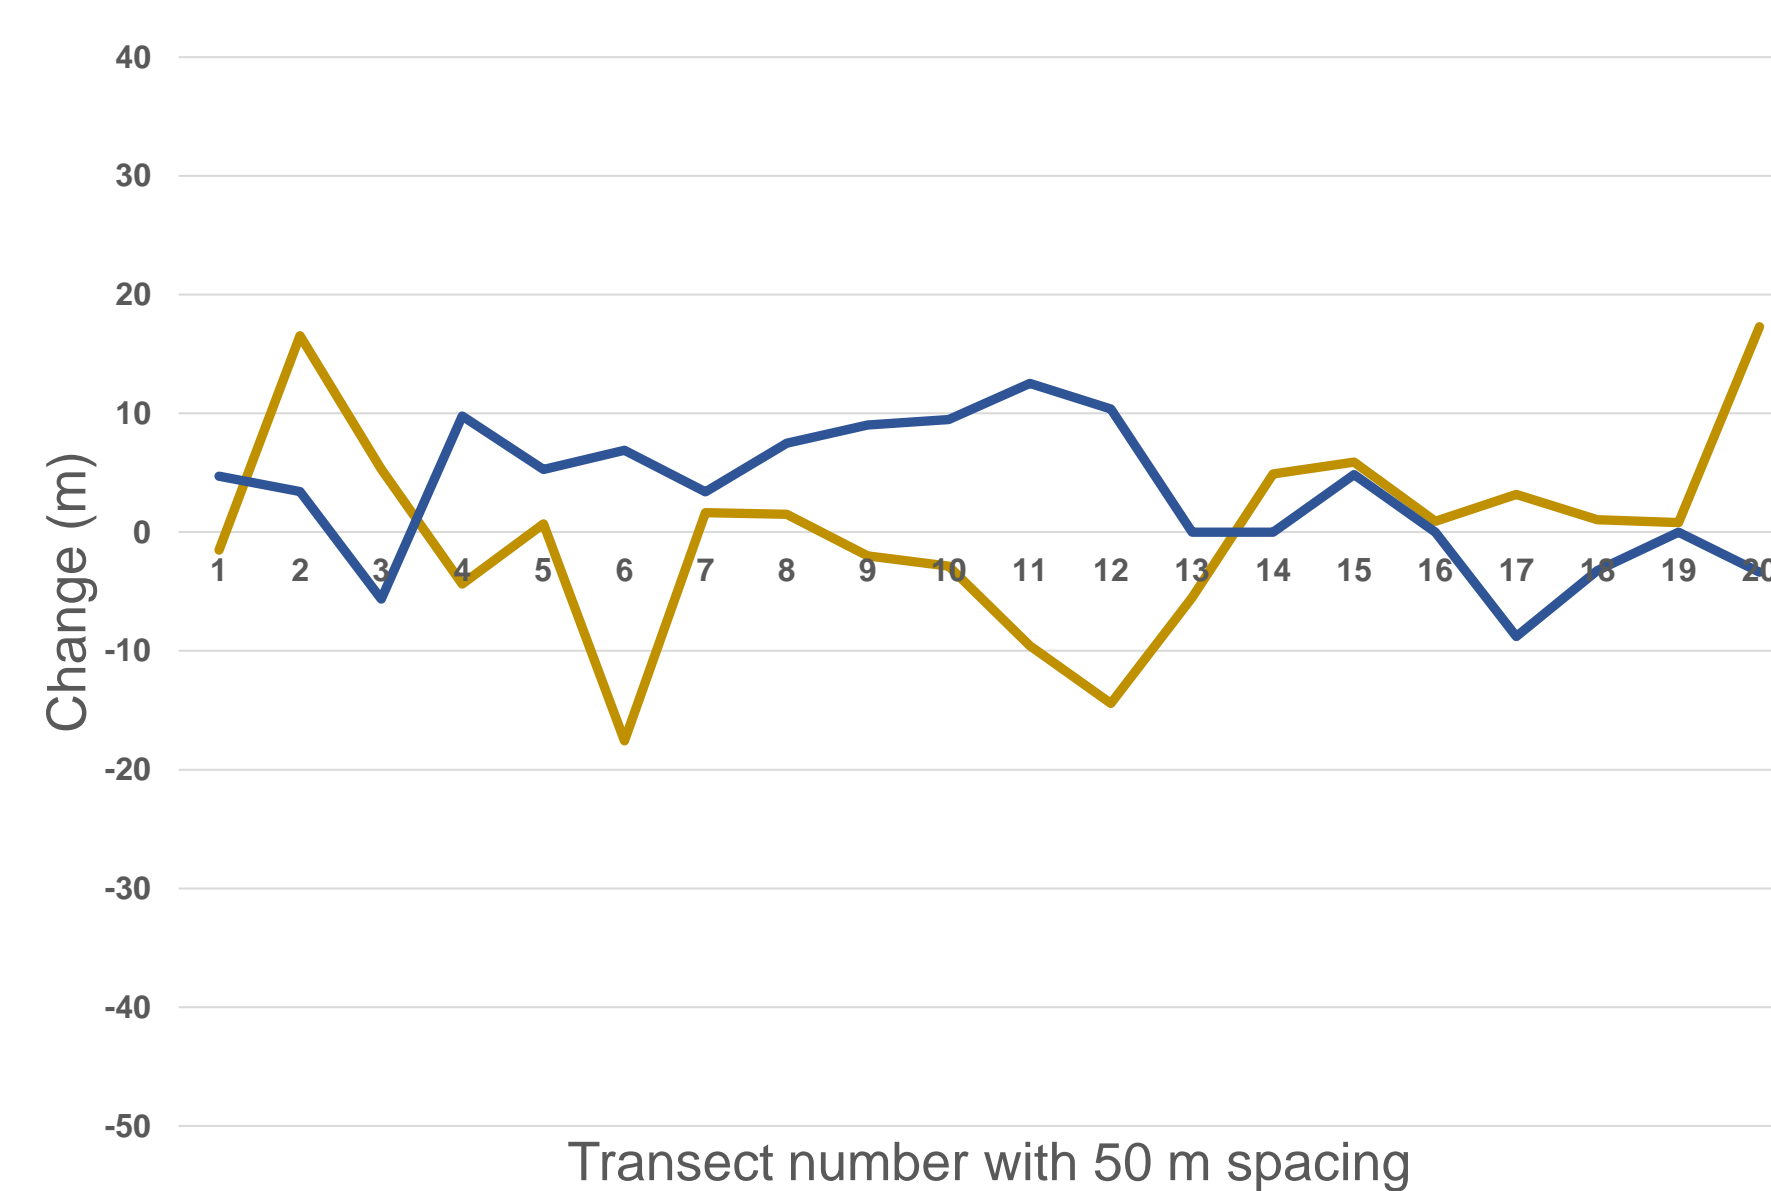
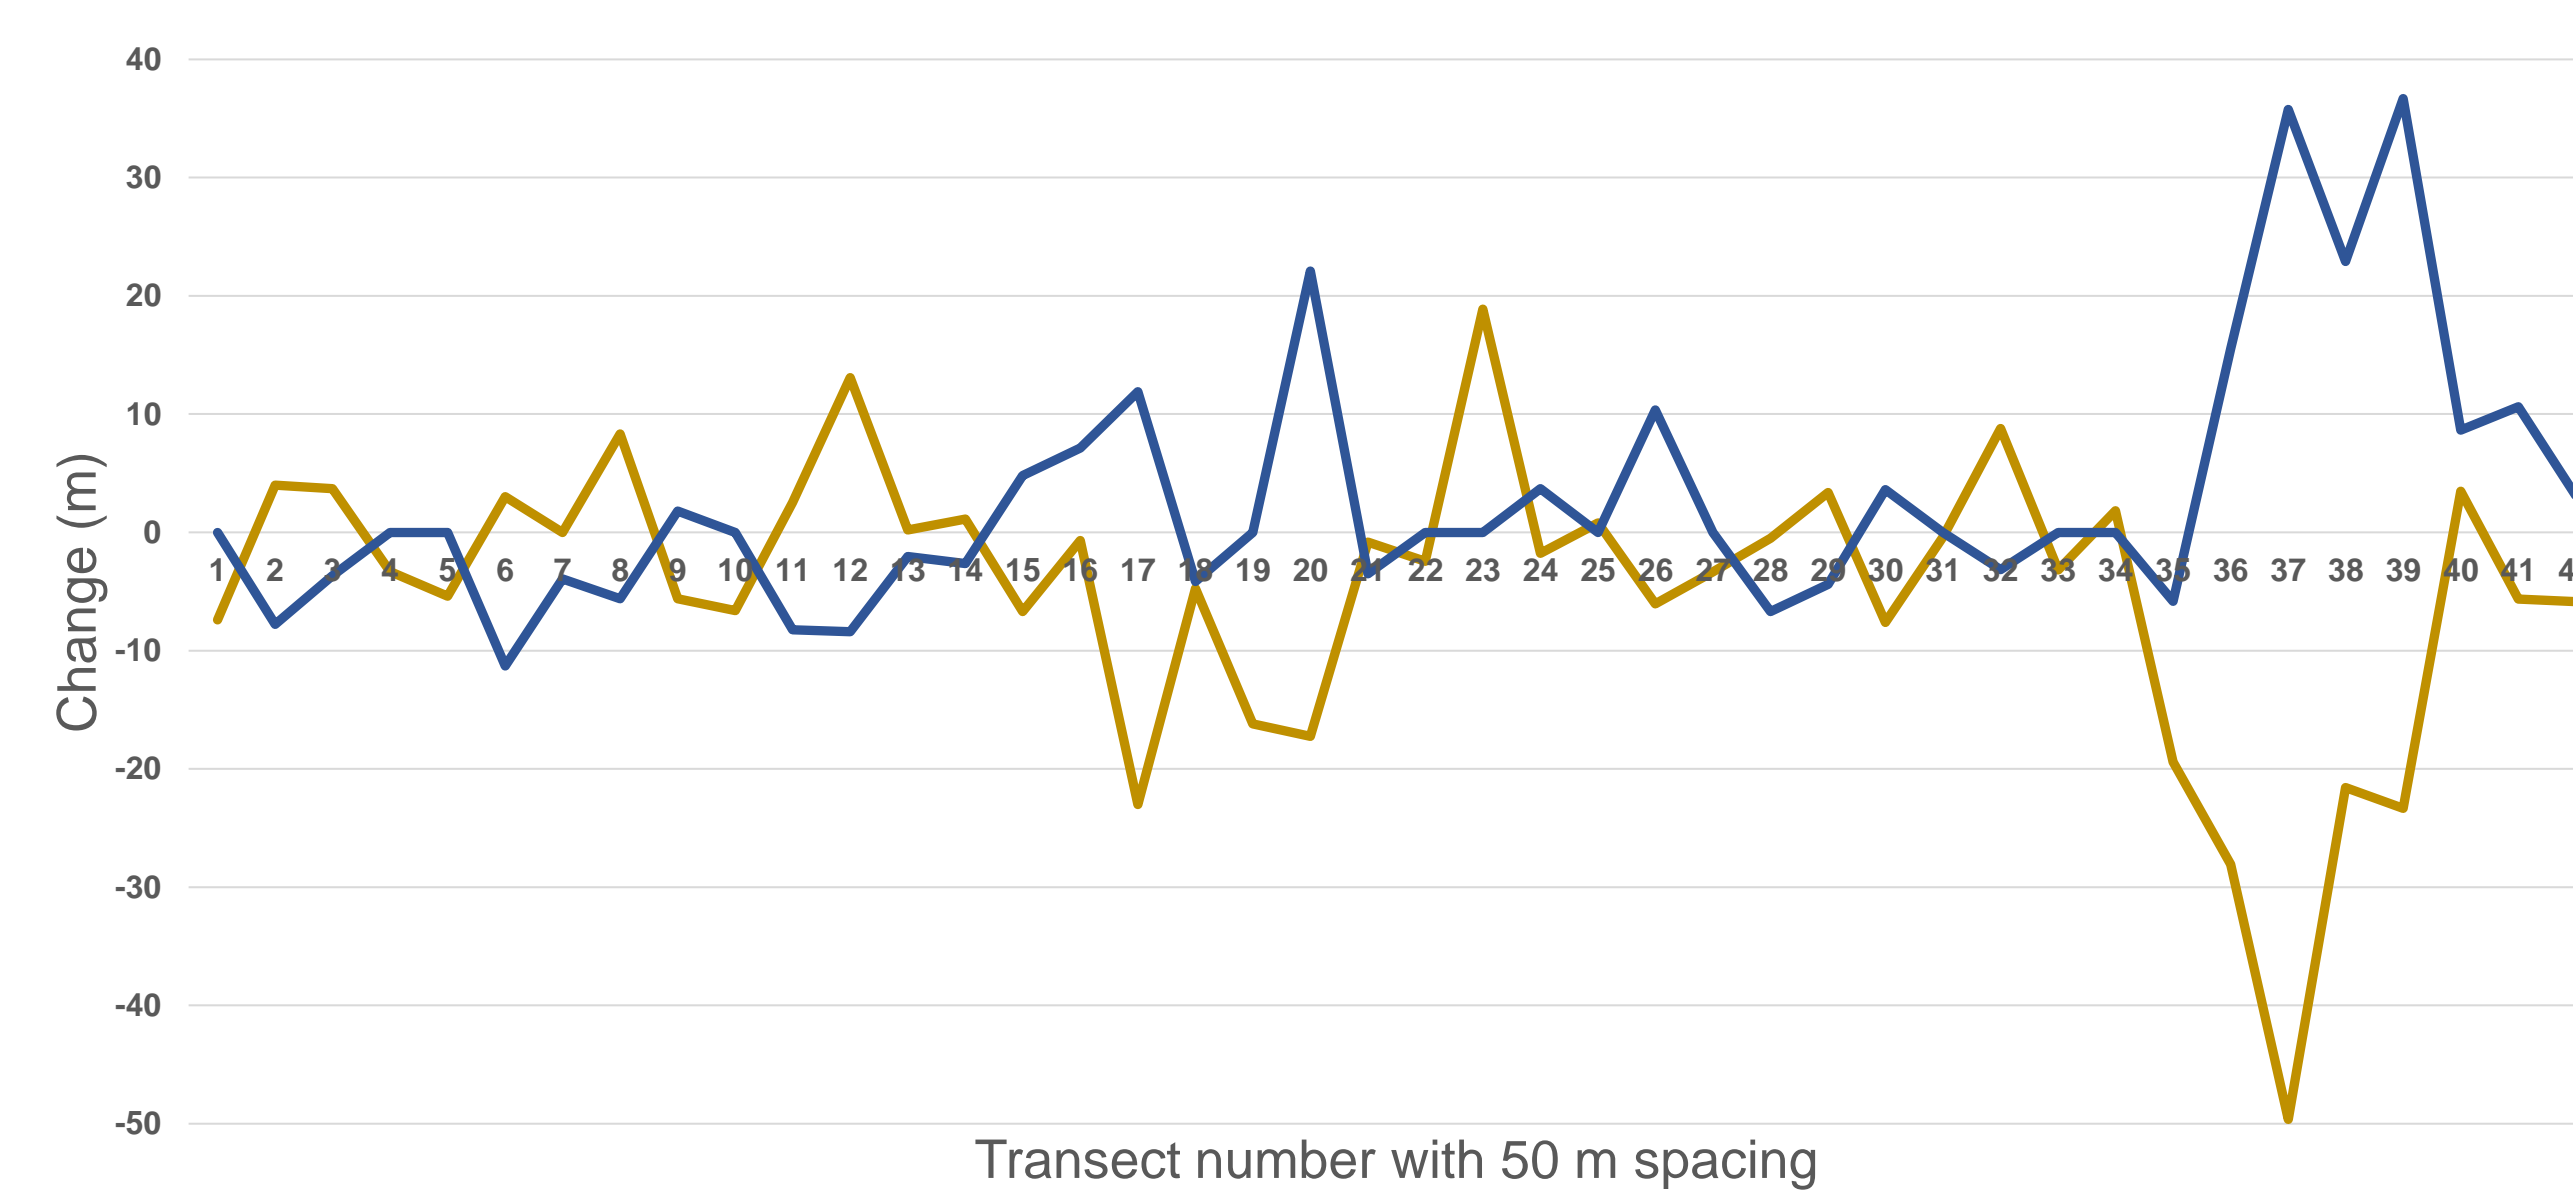
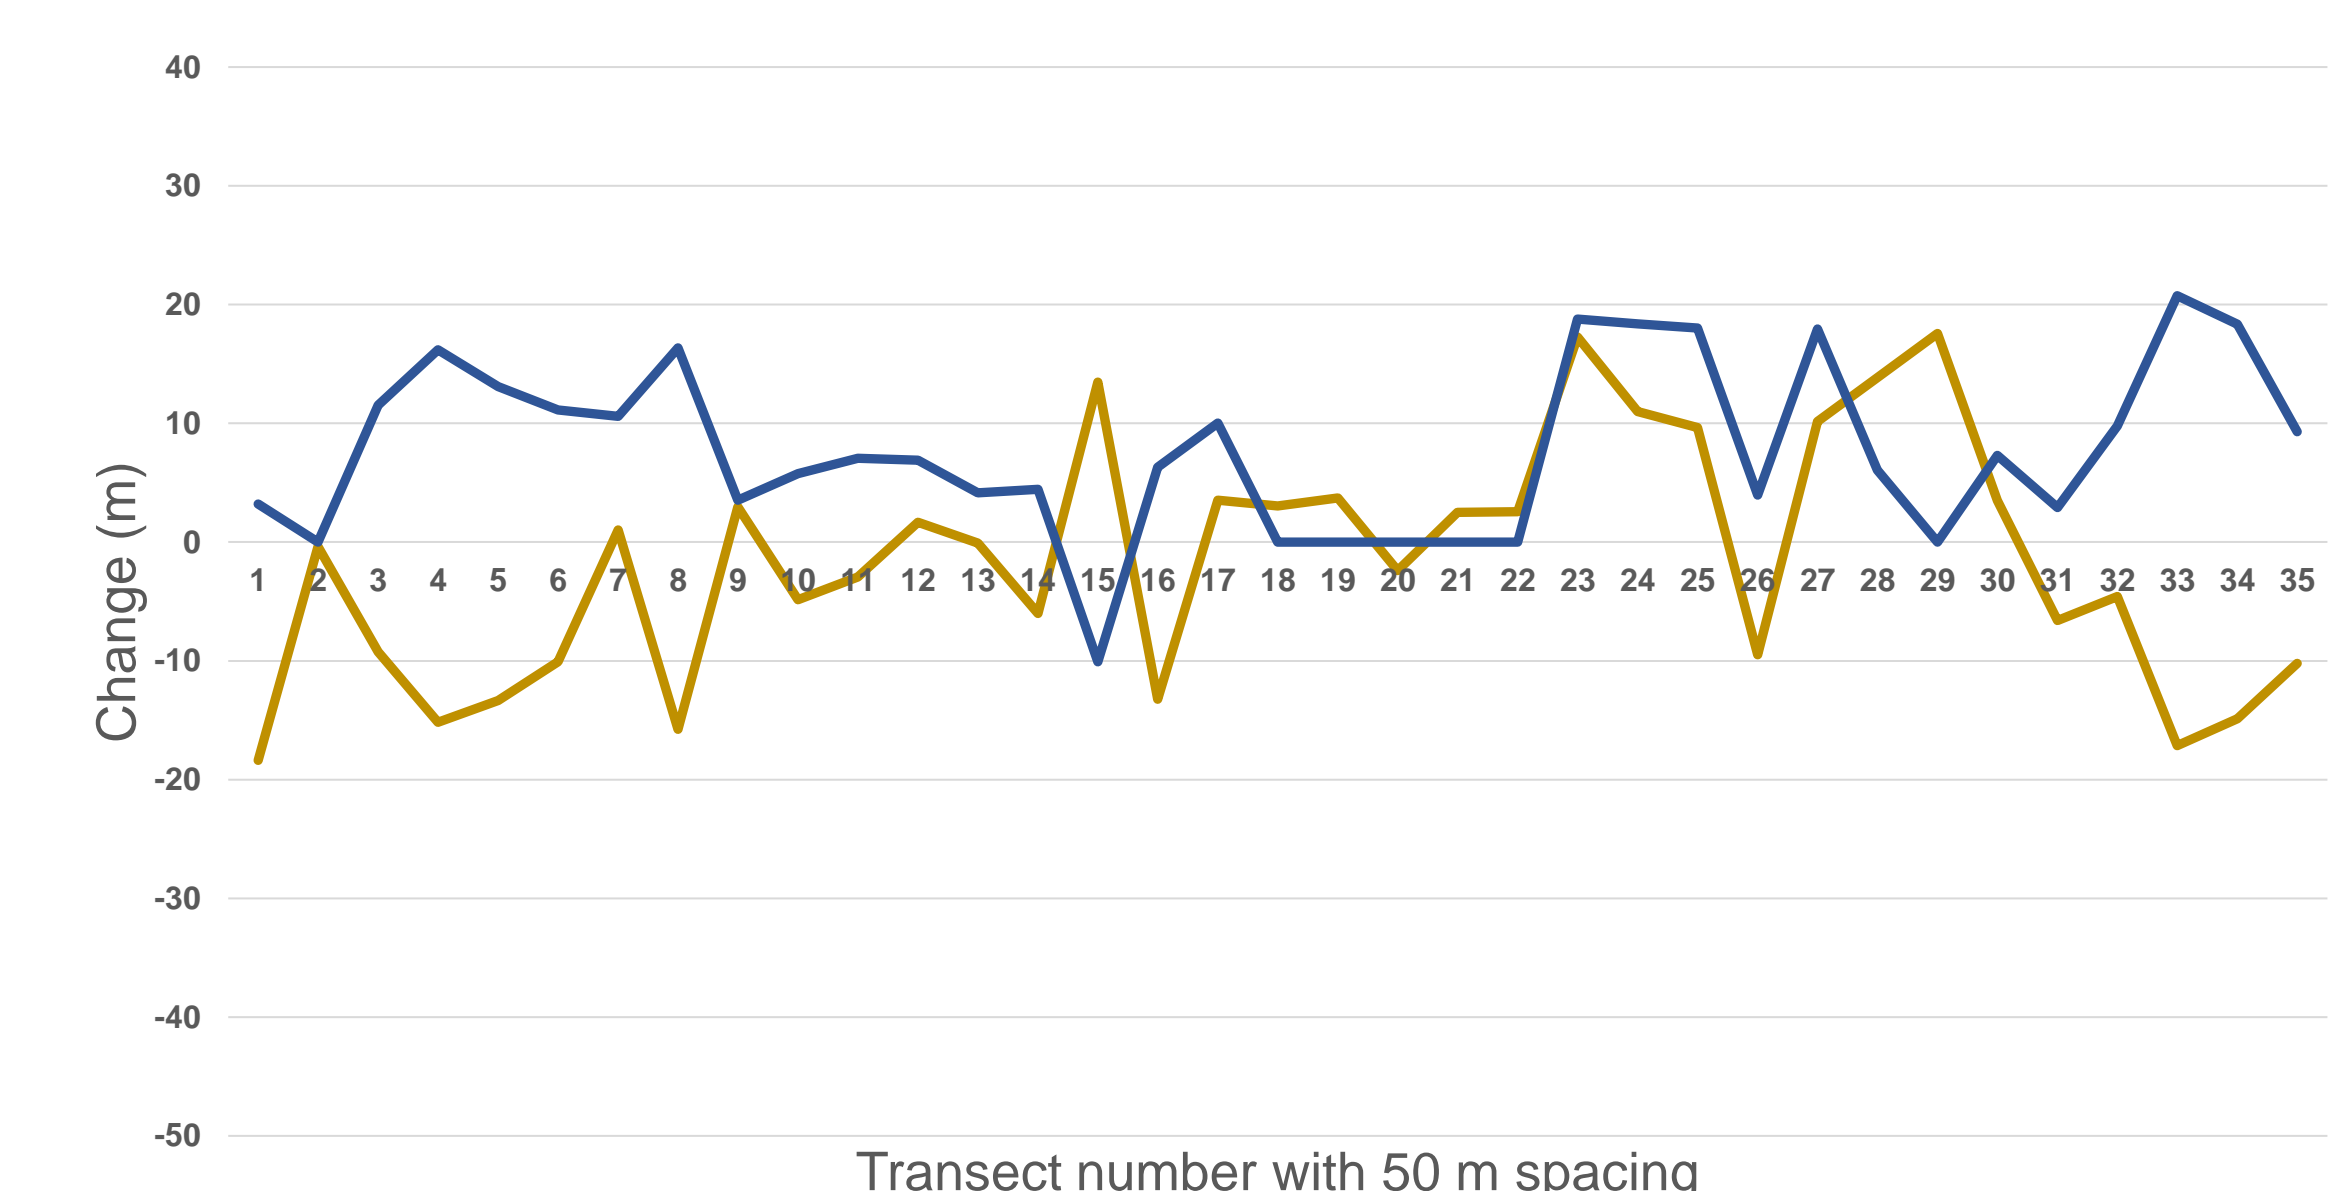
Beach Erosion and Deposition Trends for Treasure Beach

Water line recession (shoreline erosion) occurred at 80% of the 128 transects evaluated. On average, sandy beaches at Calabash, Frenchman's, and Billy Bays moved 2.6-3.3 m landward over 20 years (0.13-0.17 m/yr). Pedro Bay produced the highest erosion rates with an average beach loss of 7.8 m (0.39 m/yr). Calabash Bay experienced the largest reduction of beach width with an average narrowing of almost 5 m during the 20-year period. Pedro Bay lost 1.6 m of beach width on average, while there was no change at Frenchman's Bay (0.1 m gain) and a relatively large gain in beach width at Billy Bay (+4.8 m). In general, if beach migration rate is slower than a rising sea level, beaches get narrower (Martins and Pereira, 2014). However, beach width as measured here using vegetation lines can be influenced by several factors including rate of beach erosion, degree of over-wash during storms, vegetation recovery, and human manipulation. Future work will utilize additional years of higher resolution imagery and aerial photographs, assess the effects of errors on erosion estimates, and use field work to evaluate effects of geomorphic controls and human factors on beach widths and beach processes overall. The average error for rectified images used for 2021 is 2.6 m and the range of residuals for the images is 0.1 to 5.8. The average error for rectified images used for 2001 is 1.8 m and the range of residuals is 0.0 to 6.3. Previous survey of beach faces at Treasure Beach show that the maximum daily tidal range of 0.2-0.3 m in Jamaica could create water line movement of 1.7-2.7 m suggesting that errors due to tidal stage are typically <1.5 m.
