Geomorphic Analysis of the Main Channel of the Golf Club of Kansas Site in Lenexa, Kansas

By: Dr. Robert T. Pavlowsky
May 22, 2007

This report describes the geomorphic condition and stability of the main stream channel draining the Golf Club of Kansas Site in Lenexa, Kansas. It is prepared for Olsson Associates by Dr. Robert T. Pavlowsky of the Ozarks Environmental and Water Resources Institute at Missouri State University. The information provided in this report was provided by on-line sources, Olsson Associates, and fieldwork at the site by Pavlowsky and three staff on April 11-12, 2007. This report provides data and professional opinion to support the restoration planning and channel design for the site.

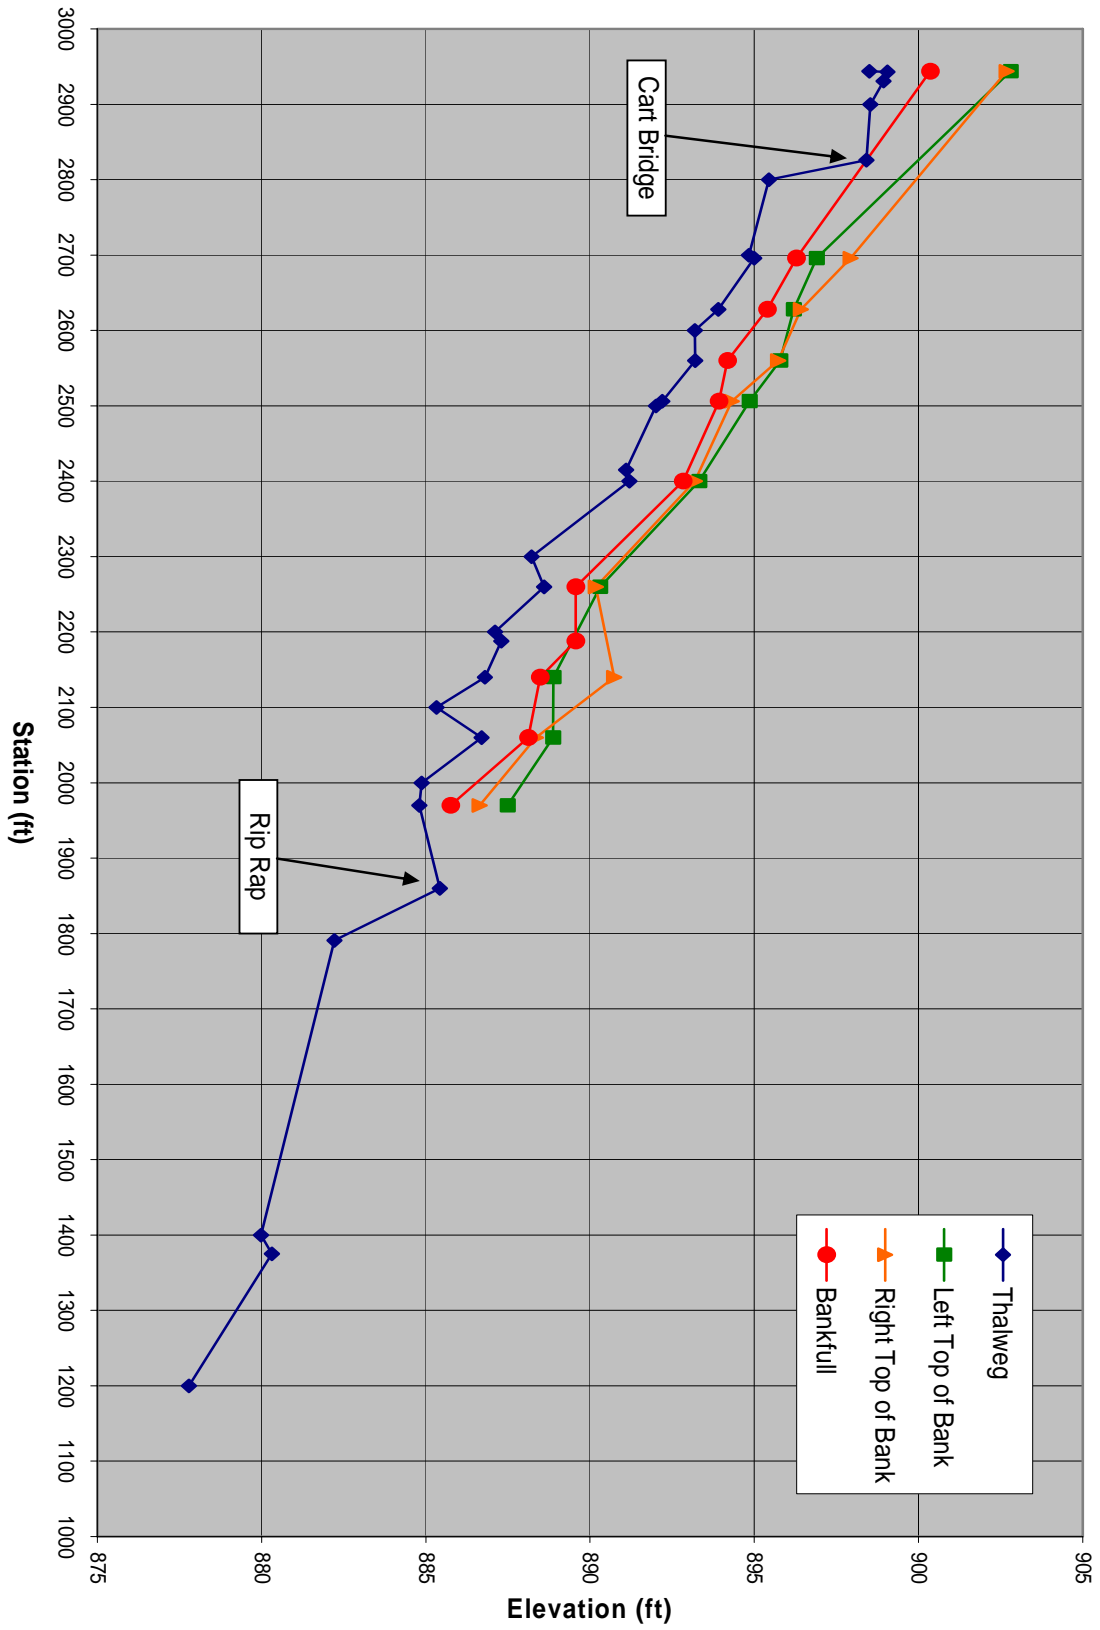
Figure 4. Longitudinal profile for the reference reach.

Since the majority of the channel length on the site was disturbed far beyond its natural form, it was decided that a reference reach approach would be used to determine the size and shape of the new channel. Twelve cross-sections at riffle crests from an on-site reach which had an intact riparian corridor and two cross-sections from the upstream natural area were examined in order to estimate dominant channel dimensions (Figure 3). A longitudinal profile of the bed thalweg, bankfull stage, and top of bank was used to determine slope (Figure 4). The MSU profile correlated very well with the survey performed by Olsson Associates with the reference reach having a mean slope of around 1.3 to 1.5%. Riffle beds had an average slope of around 4%.
