The Ozarks Environmental and Water Resources Institute (OEWRi)

PRE-CONSTRUCTION REPORT FOR THE WARD BRANCH STREAM RESTORATION PROJECT

November 14, 2007

OEWRi EDR-07-004

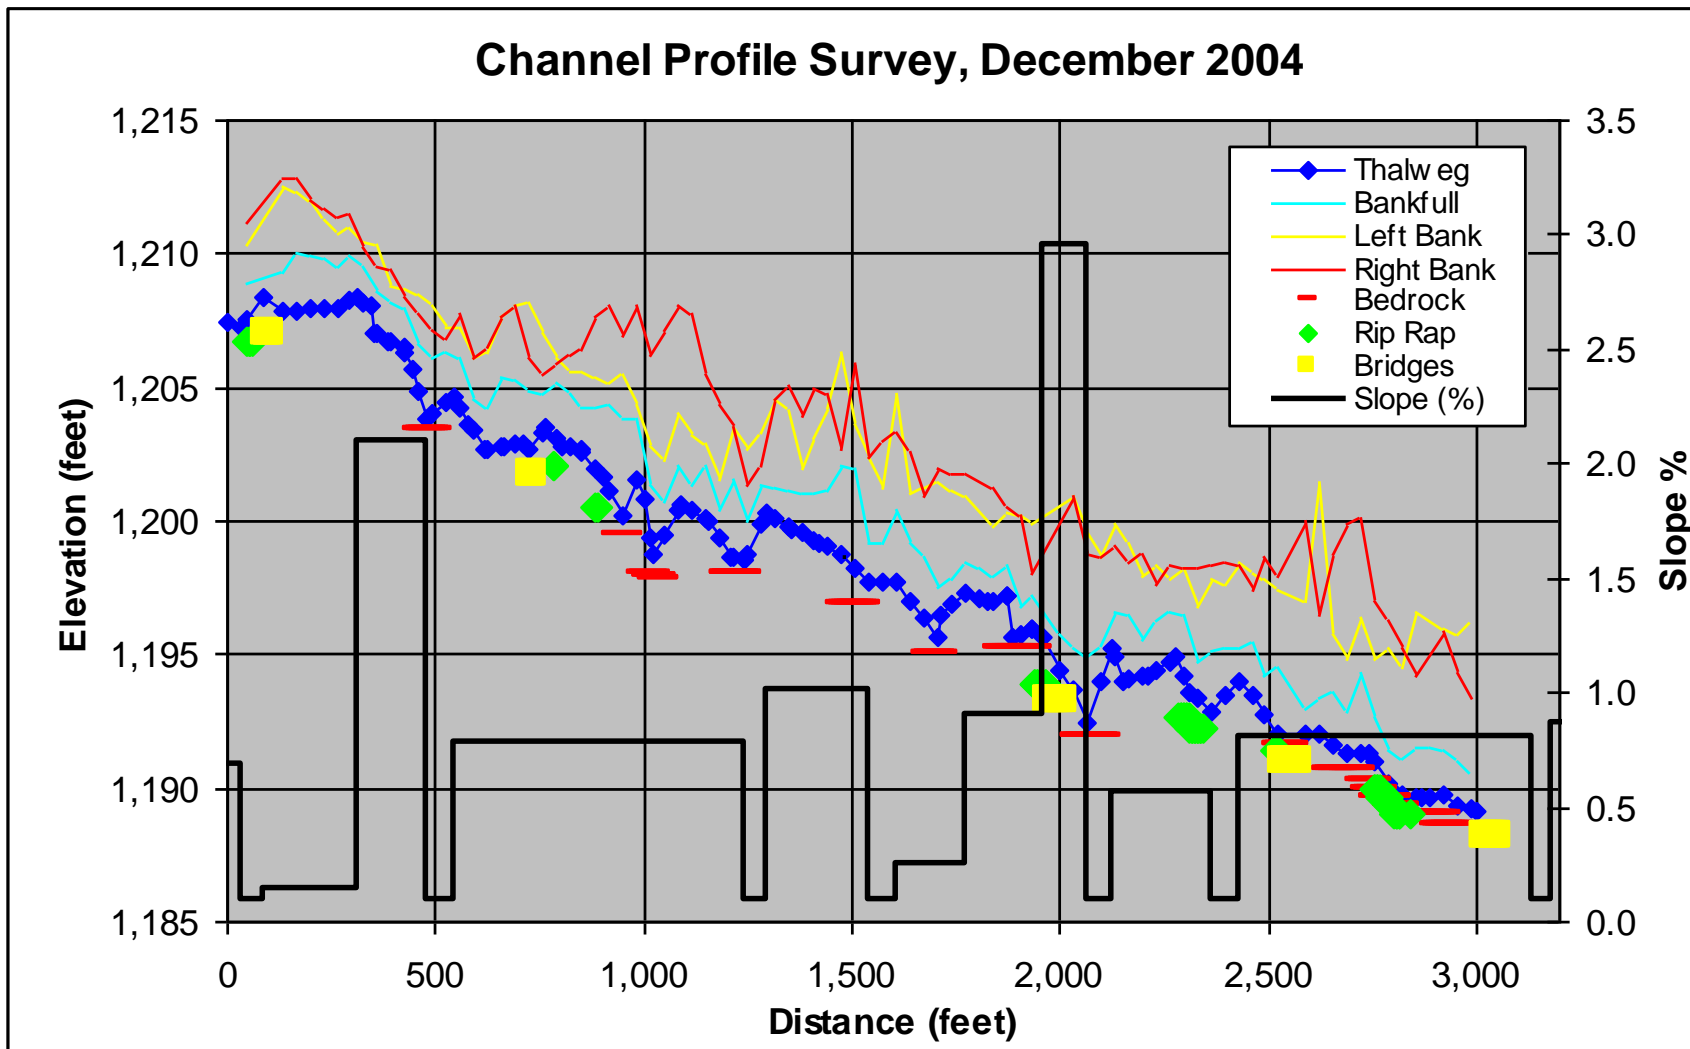
Figure 3. Longitudinal Profile

The channel survey begins (0 feet) at the downstream face of the Republic Road culvert at a pool. A riffle crest at approximately 300 feet marks the beginning of a relatively steep reach that extends to 500 feet (Figure 3 and Photos 1 and 2). The slope exceeds 2% through this section and bank heights are relatively low. Bedrock does begin to appear in the channel at 500 feet along the profile suggesting bedrock may be controlling the headcut elevation along this section. Downstream of 500 feet station, bank heights and pool depths begin to rise indicating either a headcut moved through this reach due to bedrock elevation change or the channel was able to cut through fill material or colluvium increasing the bank height due to increased flooding from urban runoff or historical land clearing and row cropping activities. Downstream bedrock appears at a lower elevation along the high right bank between 800 and 1,200 feet along the profile limiting further downcutting. This 400 foot long vertical right bank along the west side of the stream is approximately 6 foot in height (Photo 3).

A plane bed section with little contrast between pool and riffle topography occurs between 1,200 and 1,600 feet and has low to moderately high banks. This indicates excess bed sediment loading into the reach due to upstream bank erosion releasing gravel to the channel. Downstream of 1,600 feet the profile remains relatively consistent until 2,000 feet at the first subdivision bridge. Immediately downstream of the bridge a scour hole has formed and increased the slope locally (almost 3%) (Photo 4). The vertical adjustment of the stream below the bridge is also limited due to bedrock that is again visible along the bed at the scour hole location. A reality consistent riffle/pool sequence alternating from the right to left low terrace bank in the section between the bridges indicates a quasi equilibrium through this reach. Downstream of the second subdivision bridge the stream is pinned up against a high right bank that is eroding, but vertical adjustment is again controlled by bedrock that is visible along the bed throughout the remainder of the study reach. Appendix A shows the longitudinal profile data collected.

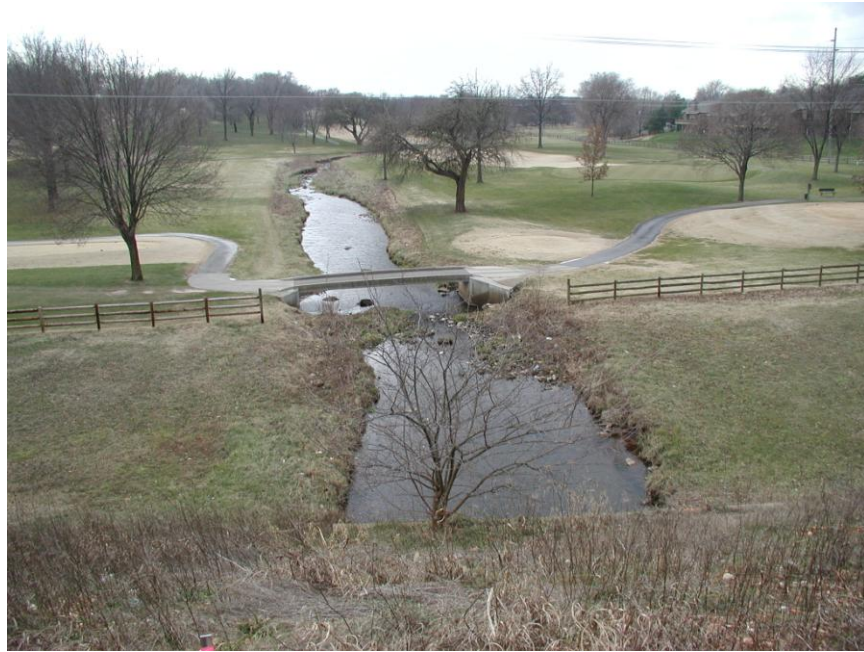
Photo 1. Looking south at Republic Road

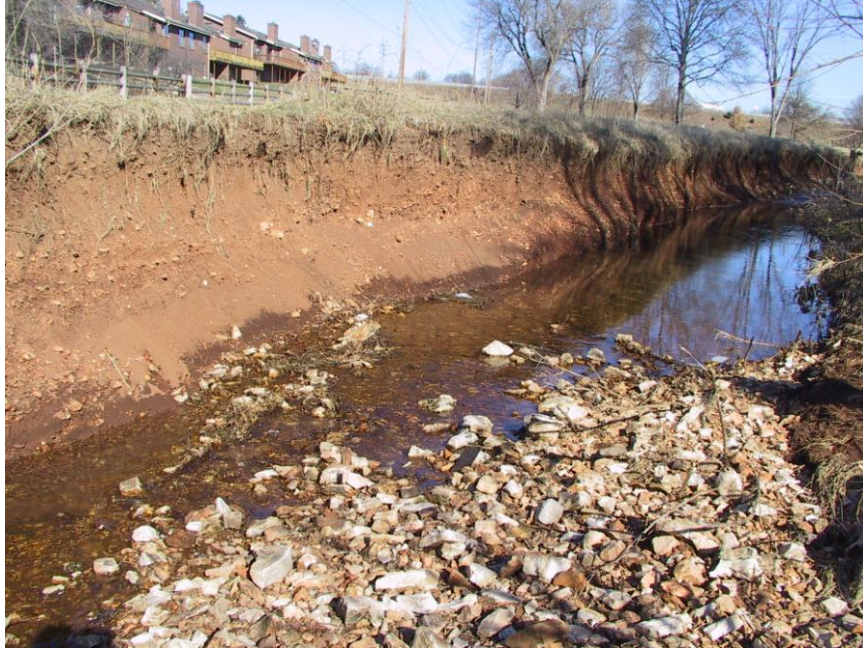
Photo 3. High bank at station 1,000 feet

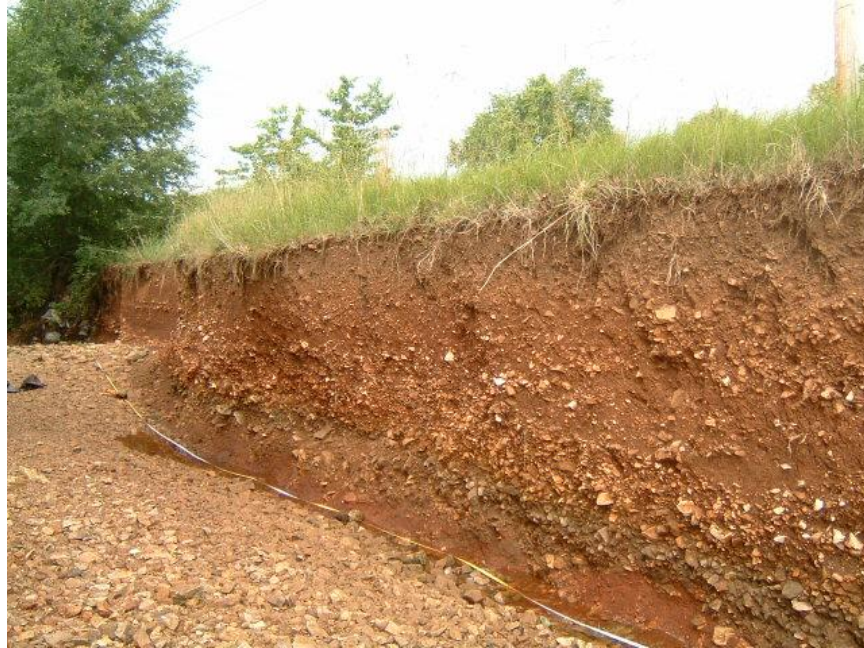
Much of the bank materials exposed at cutbanks along the reach were of mixed origin consisting of alluvium, colluvium and fill material (Photo 5). In general, bank material analysis shows fine grain material (≤ 2 mm) made up around 75% of the bank material while coarse grained material accounted for approximately 25%. However, in some horizons coarse materials accounted for as high as 85% of the bank material. The majority of the coarse grain fraction is coarse gravel size material between 16 and 32 mm in size. On average, fine grained bank material through the reach on average consisted of 31% clay, 43% silt and 26% sand. Individual horizons with higher clay content (>40%) were found in the lower part of the profile at stations 888 and 938 feet where limestone residuum is exposed due to channel incision. More specific bank material is discussed in the bank erosion section of this report.

Photo 5. Typical bank material through reach

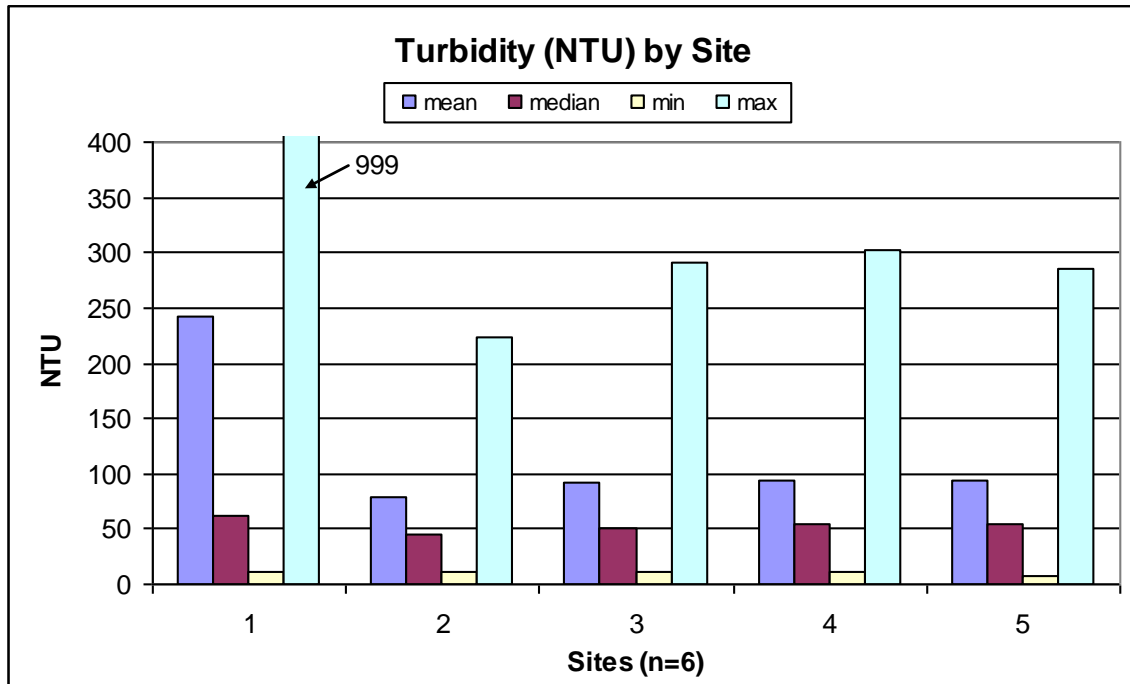
Figure 46. Turbidity Data by Site

Mean turbidity concentrations are <100 NTU for all of the sites except Site 1 (Figure 46). Median concentrations are near 50 NTU for all of the sites which means high readings in the data set are raising the mean concentrations. A very high concentration of 999 NTU was collected at site 1 which is >3 times higher than any of the other sites. Generally, maximum concentrations fall between 200 and 300 NTU for the other sites. The October 31, 2005 sampling shows high turbidity at all sampling locations, indicating high suspended sediment associated with this event. Minimum concentrations were below 12 NTU for all sites. The extreme values collected for site 1 make it unclear if there is any downstream pattern in turbidity.

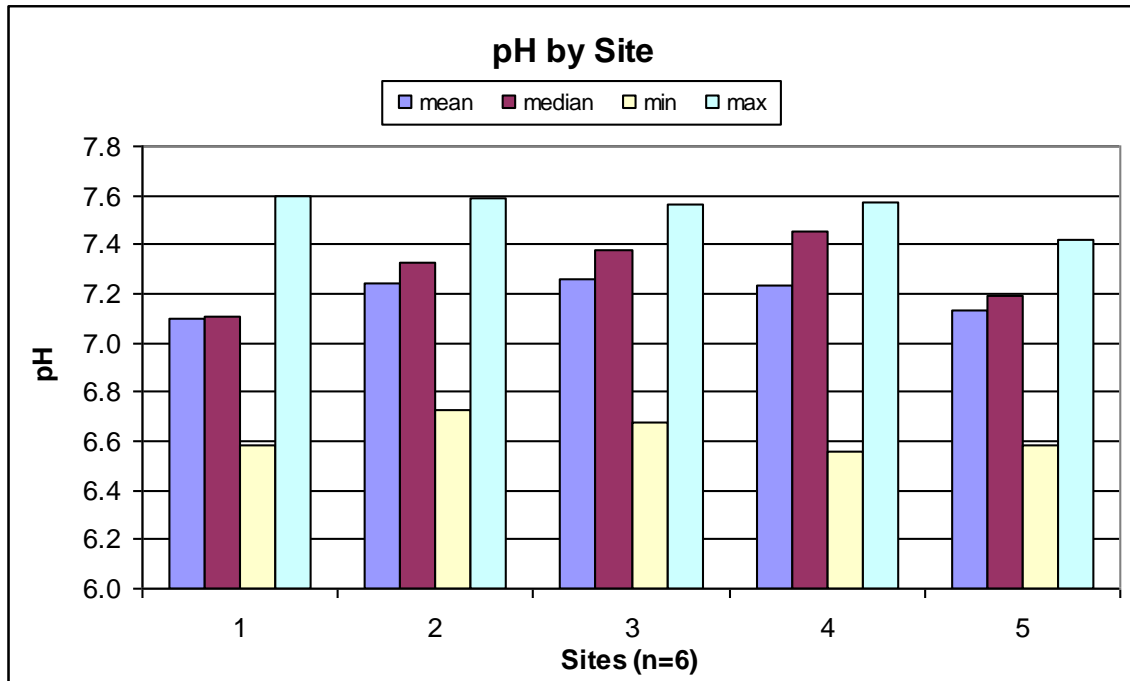
Figure 47. pH Data by Site

Mean and median pH values range from 7.1 to 7.5 with the highest maximum value being 7.6, which is to be expected in this area (Figure 47). Minimum pH values for the sampling period were 6.6 to 6.7 during the October 31, 2005 sampling.

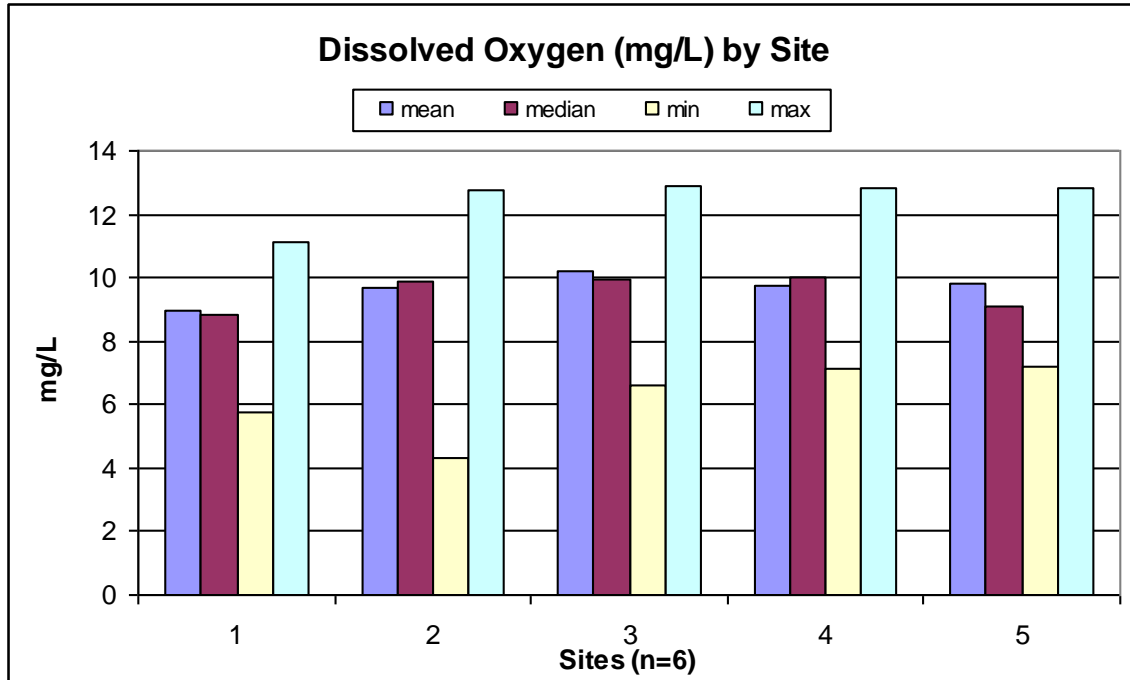
Figure 48. Dissolved Oxygen Data by Site

The mean dissolved oxygen (DO) concentrations through the reach were between 8 and 10 mg/L (Figure 48). Mean and median DO data are similar suggesting the average concentration has not been influenced by extreme values. The maximum concentrations were >12 mg/L and minimum concentrations came in below 7 mg/L, with Site 2 being as low as 4 mg/L during one sample collection. No downstream pattern exists when looking at mean concentration. All maximum concentrations recorded occurred during the October 31st of 2005 sampling.

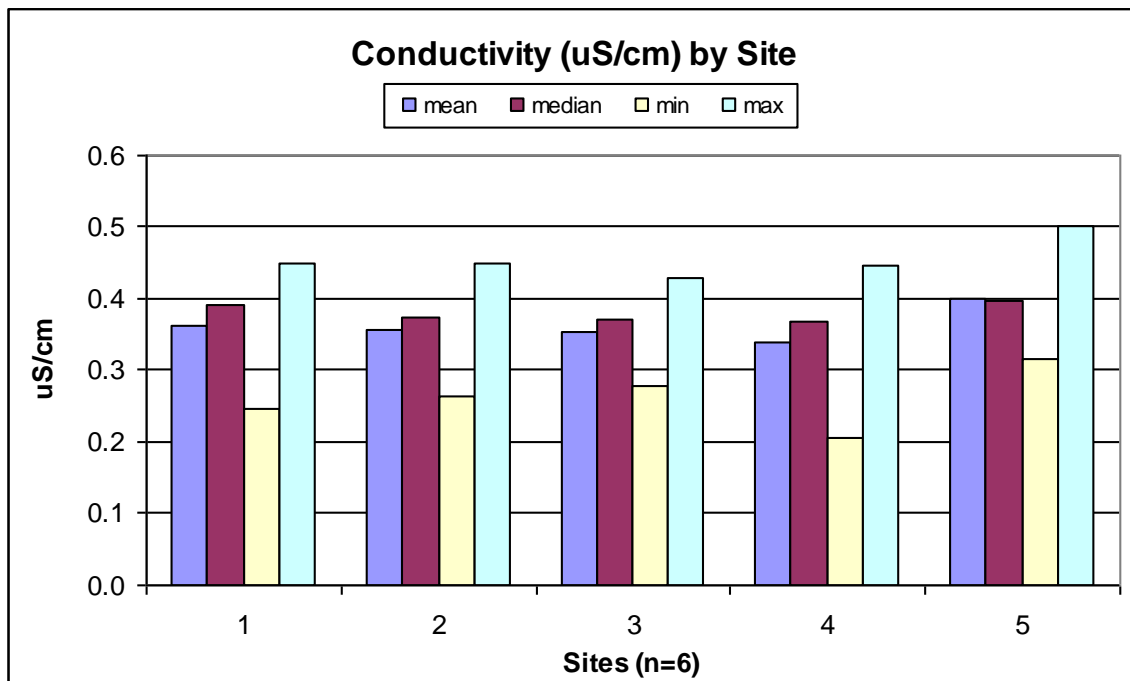
Figure 49. Specific Conductivity Data by Site

Mean conductivity readings for all 5 sites are between 0.3 and 0.4 uS/cm (Figure 49). Median readings are similar suggesting extremes are not influencing the average concentrations. Maximum readings were slightly higher coming in between 0.4-0.5 uS/cm. Minimum values for all of the sites ranged from 0.2-0.3 uS/cm and all but one was recorded during the October 31, 2005 sampling. No downstream pattern in conductivity exists in this dataset.

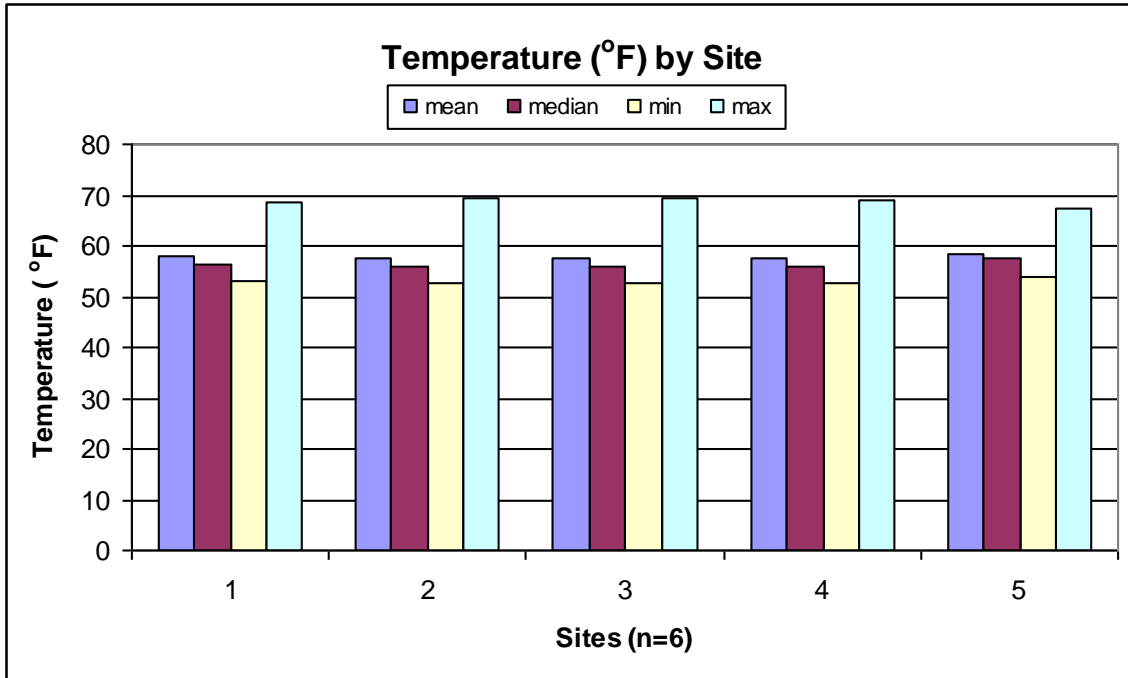
Figure 50. Temperature Data by Site

Mean, median, and minimum temperature values for all 5 sites are between 52-59 °F (Figure 50). Maximum temperature readings were near 70 °F on the September 15, 2005 sampling.

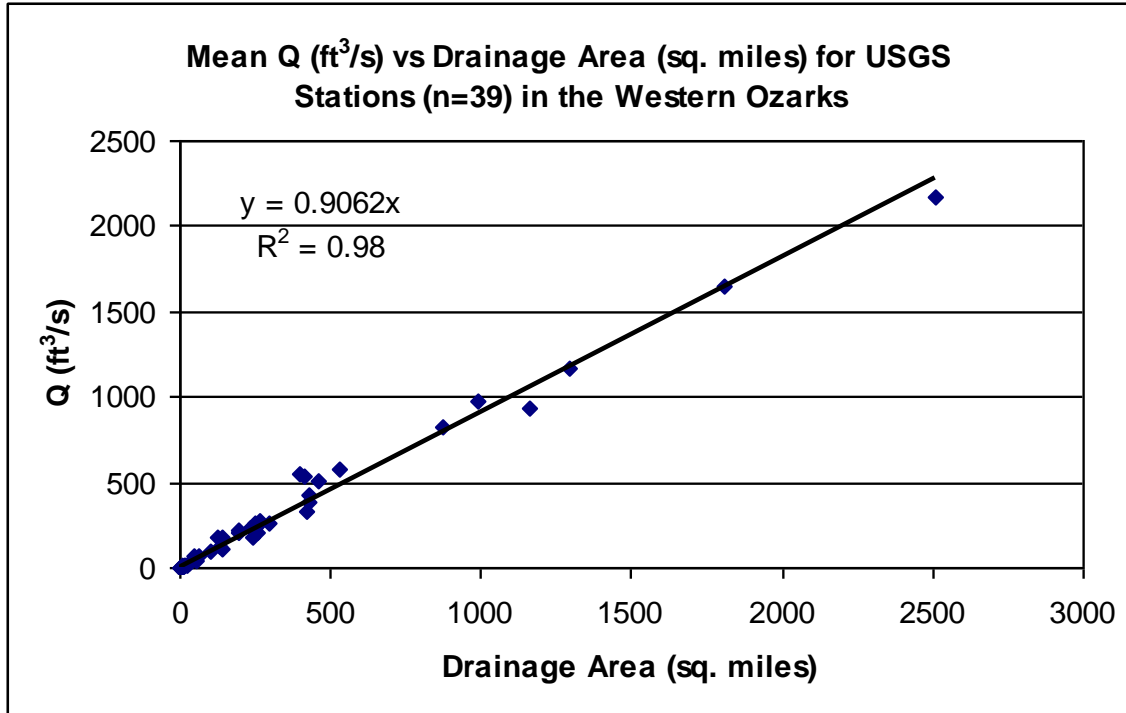
Figure 56. Mean Discharge Regional Regression Curve

The mean annual Q for each of these sites was estimated using the regression equation developed from 39 USGS gaging stations in the western Ozarks (Figure 56 and Table 6). Mean Q ranged from 24.5 – 51 ft³/s for these sites. The daily Q was multiplied by 32 days, which is the estimated days of stream flow, to get the annual Q. Since the difference in drainage area between sites 2, 3, and 4 ranges from 2.44 to 2.48 square miles and is so small it is useless to compare these sites. For comparison purposes the average of these three sites is a better representation of the data.
