**Geomorphic Assessment of City Center Athletic Club
Development Impacts on Existing Stream Channel
Stability, Lenexa, KS.**

**Final report to Olsson Associates for
the City of Lenexa, Kansas**

OEWRI TR-09-001

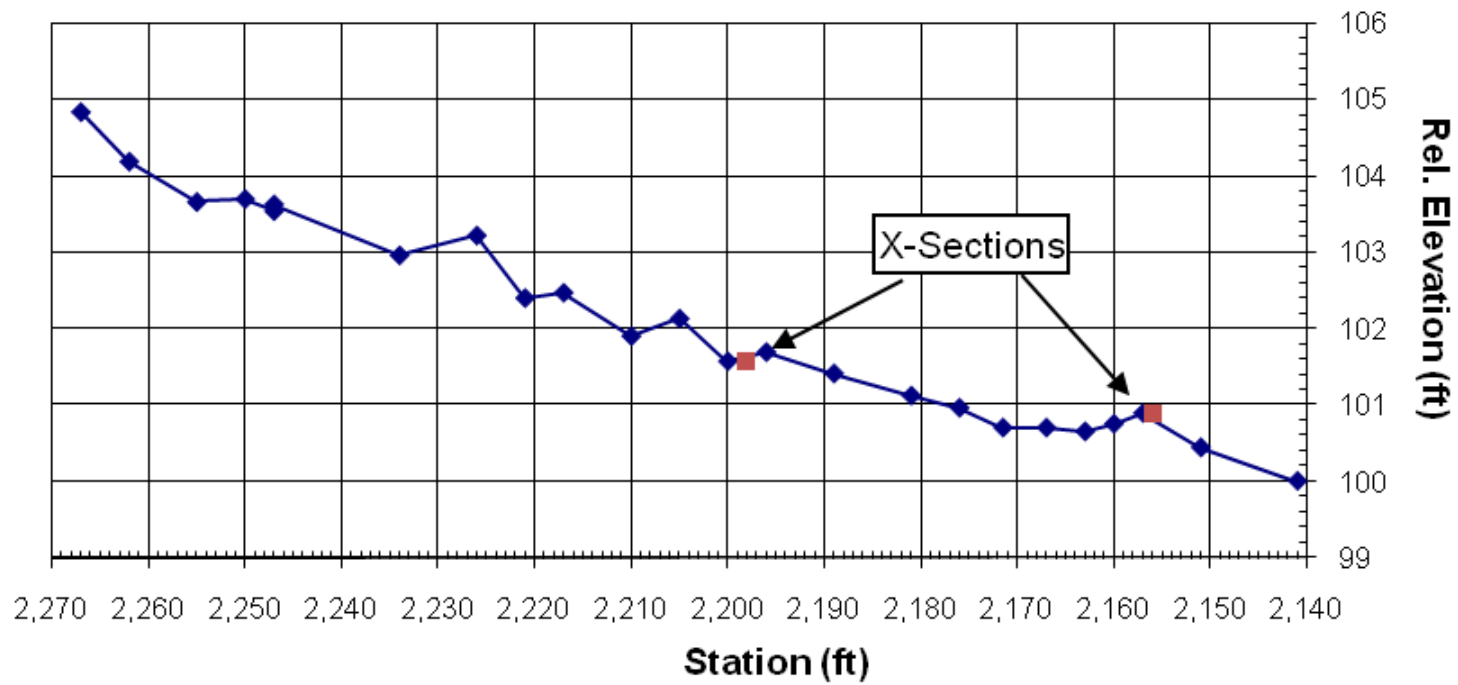
Figure 3. On-site Longitudinal Profile for Typical Reach

The “typical” on-site channel morphology and sediment mobility was evaluated in subreach 3a above the influence of the rubble dam. The mean slope of the reach is approximately 3.5% with riffle slope ranging from 3.4% and 5.3% at the cross-sections (Figure 3). The mean bankfull dimensions at these sections are 9.1 ft wide by 0.7 ft deep at the thalweg (Figures 4 and 5). Mean boundary shear stress estimates in the reach range from 1.07-1.17 lbs/ft² which can transport between the 84 mm to the 171 mm size fraction based on empirical relationships. This sediment distribution is in the small to large cobble range that matches the measured bed sediment in the reach containing a range of substrate from cobble to flat boulders (Table 3).

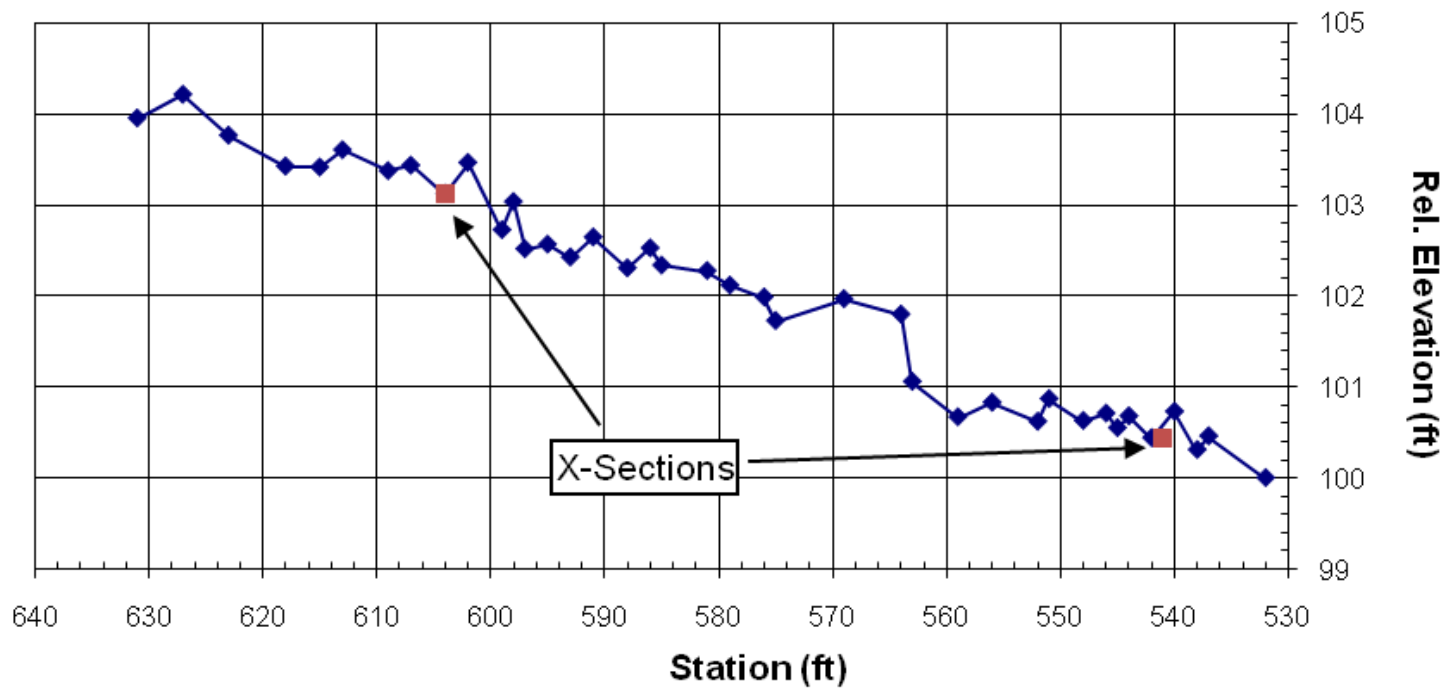
Figure 6. Off-site longitudinal profile downstream of rubble dam.

The analysis of “typical” off-site channel morphology and sediment mobility was conducted in subreach 9 below the rubble dam. The mean slope of this reach is 4.2% with riffle slopes at cross-section locations ranging from 4.2% to 4.4% (Figure 6). The mean bankfull dimensions at these sections are 6.6 ft wide by 0.7 ft deep at the thalweg of the channel (Figure 7 and 8). Mean boundary shear stress estimates in the reach range from 1.22-1.39 lbs/ft² which can transport between the 96 mm to the 193 mm size fraction based on empirical relationships. This sediment distribution is in the small to large cobble range matching the measured bed sediment in this reach (Table 3).
