Ozarks Environmental and Water Resources Institute (OEWRI)

Geomorphic Assessment of Galloway Branch in Sequiota Park, Springfield, Missouri

April 24, 2009

OEWRI TR-09-002

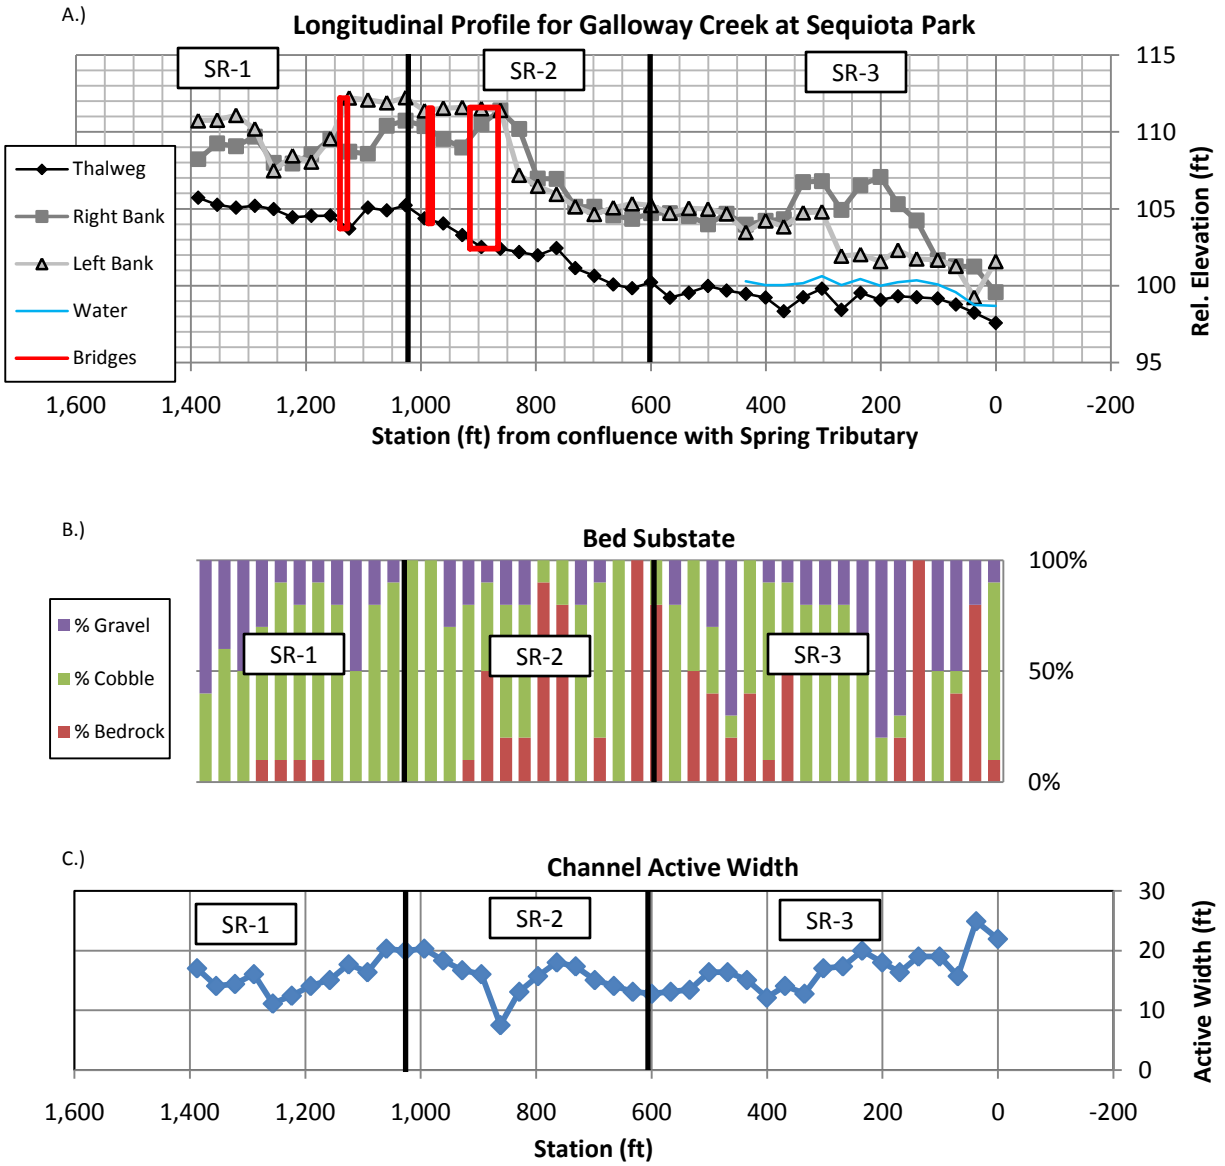
Figure 5. Project Reach Data A.) Longitudinal Profile B.) Bed Substrate C.) Active Channel Width

Overall, the reference reach is similar to project reach. The project reach has a sinuosity of <1.10 and overall slope of 0.004 with local bedrock-controlled areas being steeper at 0.012 (Figure 5a). The active or bankfull width is similar or slightly smaller compared to the reference reach and averages 16 ft, typically ranging from 13 to 19 ft. This is expected since the channel width of the project reach is constricted due to influence of past wall construction to channelize the stream. The total channel bank height is a bit larger than the reference reach, again due to the influence of the wall constriction. Total bank height averages 5 ft and ranges from 4 to 7 ft in the project reach. The walls confine flood flows that would normally go over the bank tops occurring in the reference reach.

The bed substrate of the project reach is generally similar to the reference reach. Visual estimates of bed material size produce a size distribution of 30% gravel, 50% cobble, and 20% bedrock (Figure 5b). However, much of the bed gravel is deposited thinly over bedrock so that the effective bedrock substrate covers more than 50% of the project reach. In several places in the project reach, bedrock exposures consist of exposed karst pinnacles up to three feet in height, act as significant obstacles to flow, and contribute to high levels of bed roughness. Any modifications to the existing channel must take into consideration the influence of the bedrock on channel processes as well as construction costs. The project reach represents a severe example of uneven bedrock substrate even for the Ozarks.

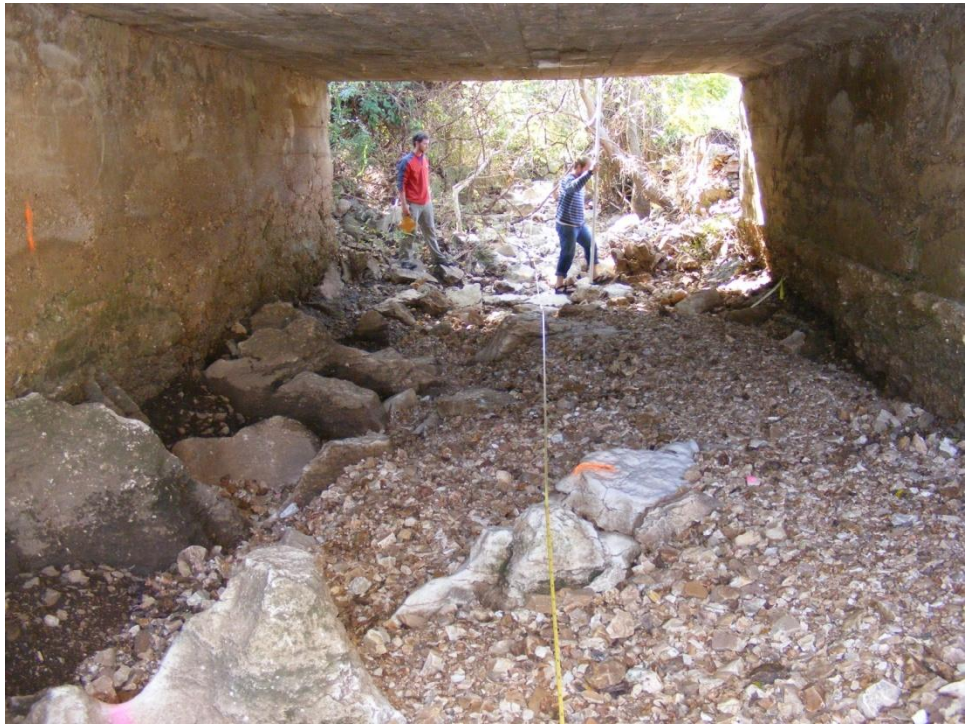
Photo 6. Looking downstream at SR-2 near station 900 feet (10/16/2008)

Subreach #2- This reach is severely affected by bedrock control, rough bedrock pinnacles are exposed throughout and its slope is 3 to 5 times greater than subreaches 1 and 2 (Table 9; Photo 6, 7, 9, 18, 27). Subreach #2 runs from stations 600 to 1,025 ft on the MSU longitudinal profile. It has a slope of about 1% and active width of 16 ft. Bedrock in this reach is relatively rough and pinnacle-shaped with depressions and pits trapping patches of gravel and cobble material (Photo 5, 8, 28, 29). Substrate size is variable and controlled by bed roughness, falling limb trapping, and local source inputs. Maximum mobile clast diameter is >300mm.

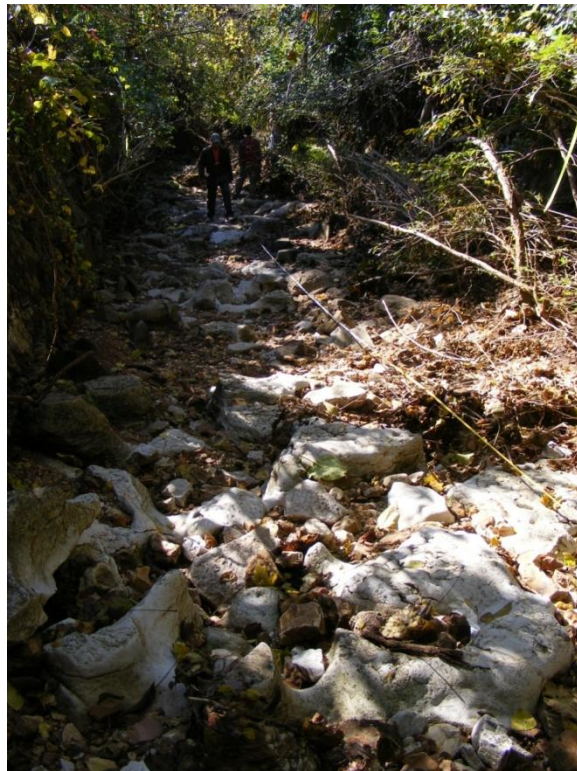
Photo 10. Looking downstream toward SR-1 near station 560 feet (10/16/2008)

Subreach #1- The reach runs from stations 100 to 600 ft on the MSU longitudinal profile. It has a slope of about 0.3% and active width of 15 ft. Bedrock in this reach is relatively smooth with some rough spots and covered by a thin veneer or patches of gravel and cobble material (Photo 10, 11, 12, 13, 14, 15, 16, 17). The D50 for this reach is about 20 mm, D84 about 60 mm,

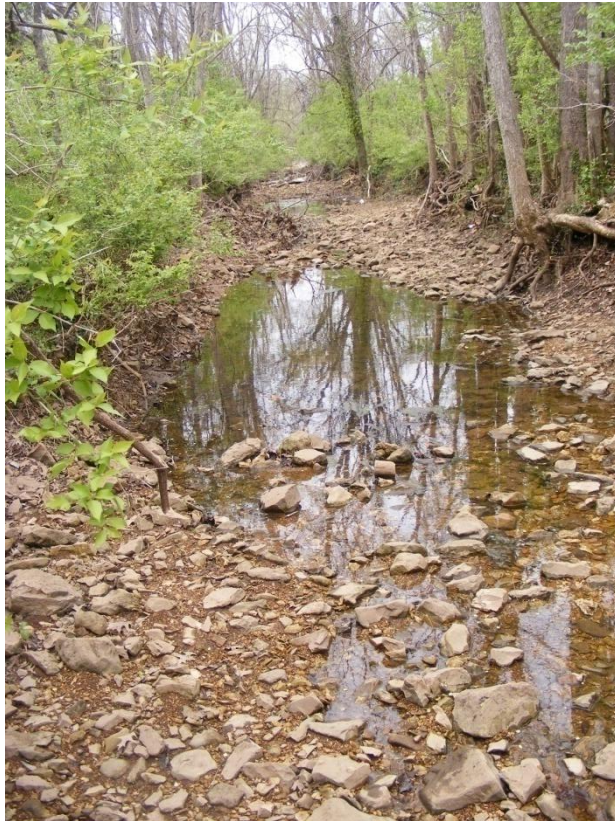
Photo 18. Reference reach A upstream of Lacuna looking upstream (4/6/09)

(1) Reference Reach Morphology. Two reference reaches (A & B) were surveyed to help better understand the typical channel conditions that might be expected in the project area if channelization and other disturbances were not present (Figure 1; Photo 18, 19 of A; Photo 20, 21, 22 of B). The reference reaches are located immediately upstream of Sequiota Park on either side of the Lacuna bridge-crossing. The culvert bridge at Lacuna has a high floor that acts as a bed obstacle which effectively disconnects the beds of the two reference reaches until stages approach bankfull. In addition, the bridge collects large woody debris on the upstream side and can block flow to a degree. Apparently, bed load can move through the culvert easily at higher flows since ample channel bed deposits are located immediately below the bridge. Longitudinal profiles for reaches A and B have a riffle spacing of 122 ft (6x Wbf), residual pool depth of 1.2 ft, and reach slopes between 0.004 to 0.008 (Tables 2 & 4; Figures 1 & 2). The channel is bedrock-controlled with low sinuosity (<1.1). For the most part, these are losing stream sections that rarely contain baseflow, although water will collect in pools in low
