Geomorphic Analysis of Lackman Tributary, Lenexa, KS.

Final report to Olsson Associates for the City of Lenexa, Kansas

December 17, 2009

OEWRI TR-09-004

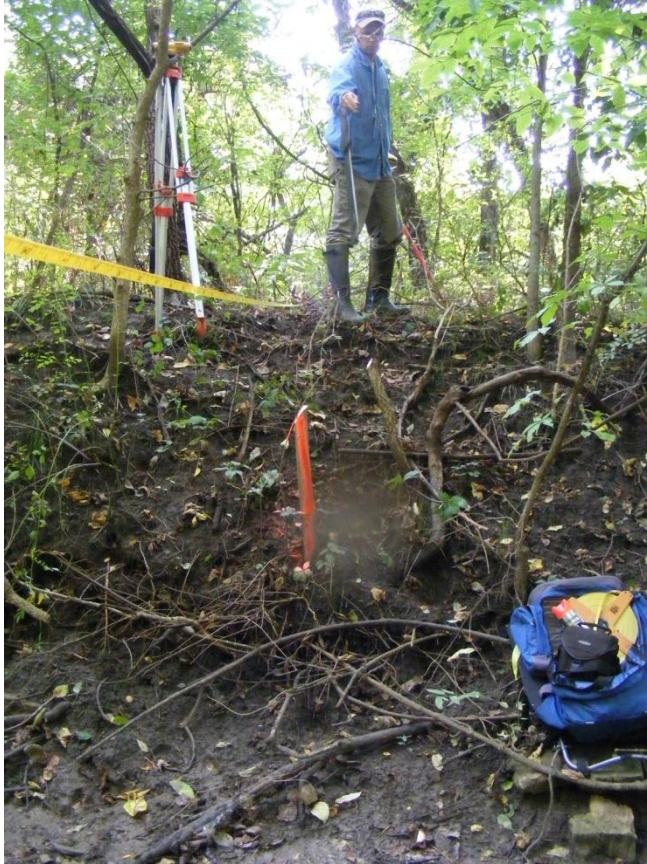
Photo 44. R14 – xs 15 St. 1,530 ft left bank (Sept. 2009)

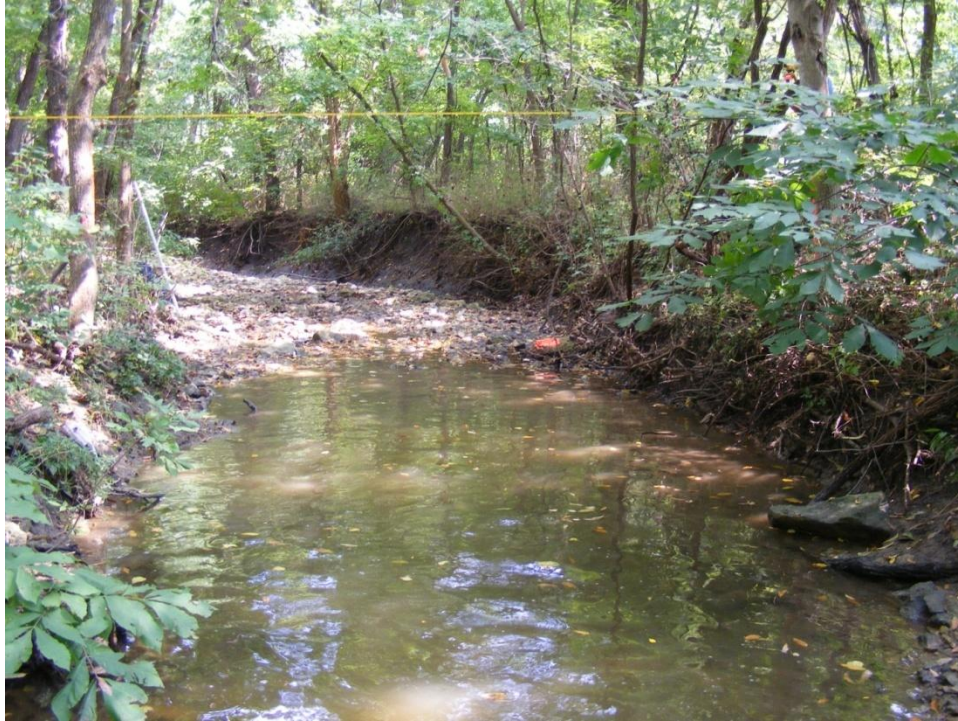
Photo 46. R15-A xs 16 St. 890 ft looking upstream (Sept. 2009)

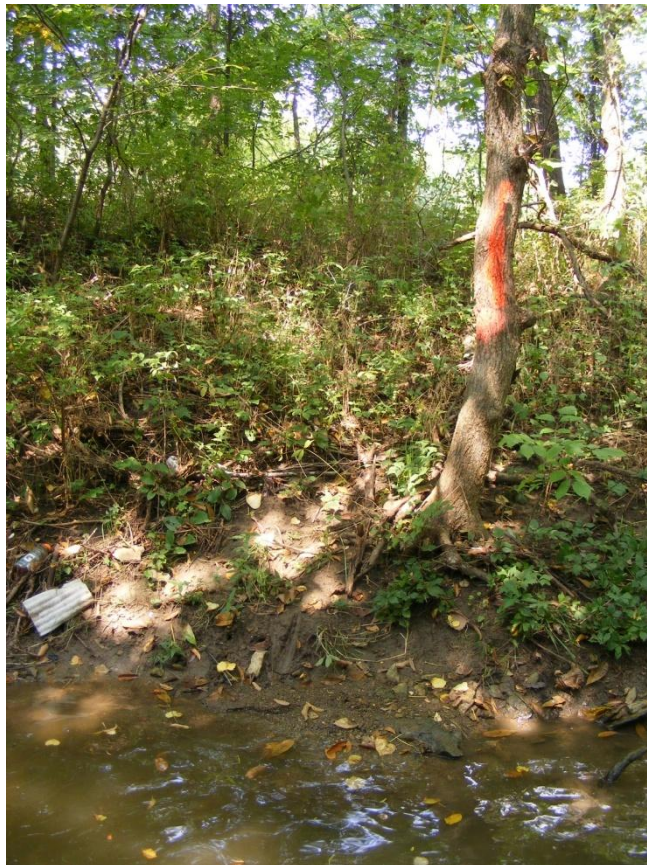
Photo 47. R15-A – xs 16 St. 890 ft looking downstream (Sept. 2009)

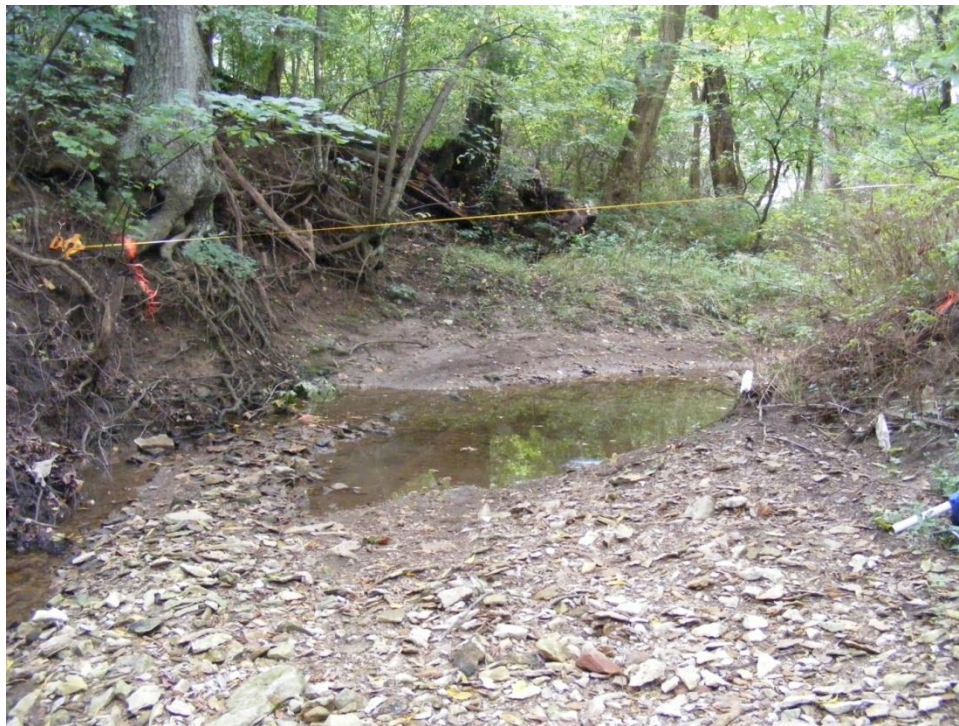
Photo 49. R15-A xs 16 St. 890 ft right bank (Sept. 2009)

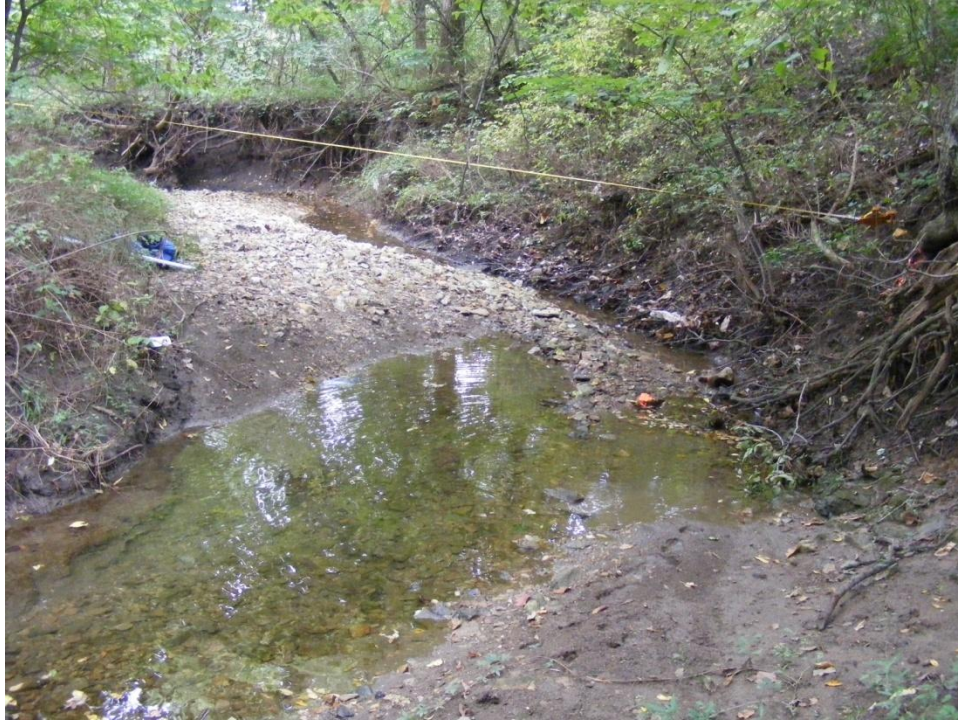
Photo 50. R15-B xs 17 St. 320 ft looking upstream (Sept. 2009)

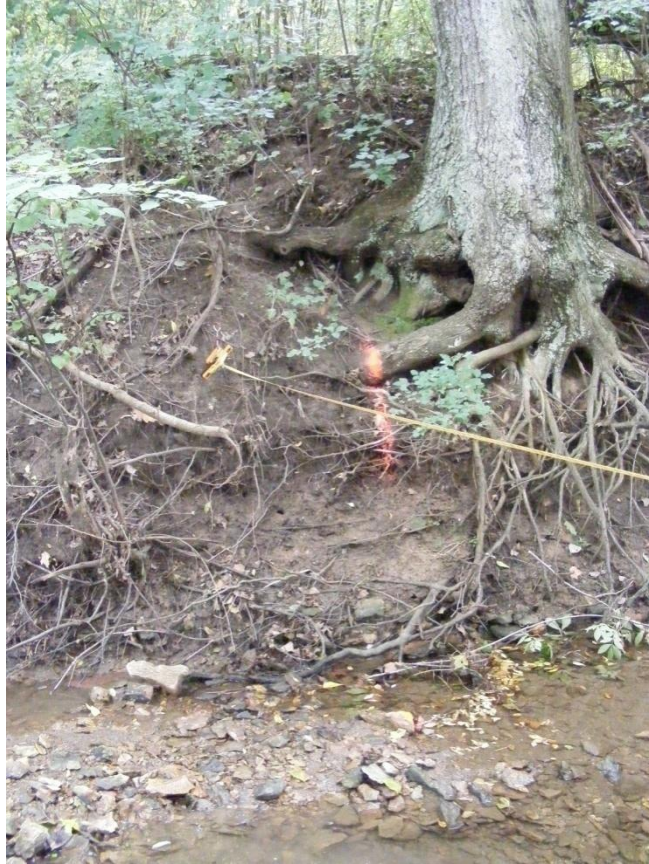
Photo 52. R15-B xs 17 St. 320 ft left bank (Sept. 2009)
