**The Ozarks Environmental and Water Resources Institute (OEWRI)
Missouri State University (MSU)**

FINAL REPORT

**Nonpoint Source Bank Erosion and Water Quality
Assessment, James River at River Bluff Farm, Stone
County, Missouri**

August 16, 2013

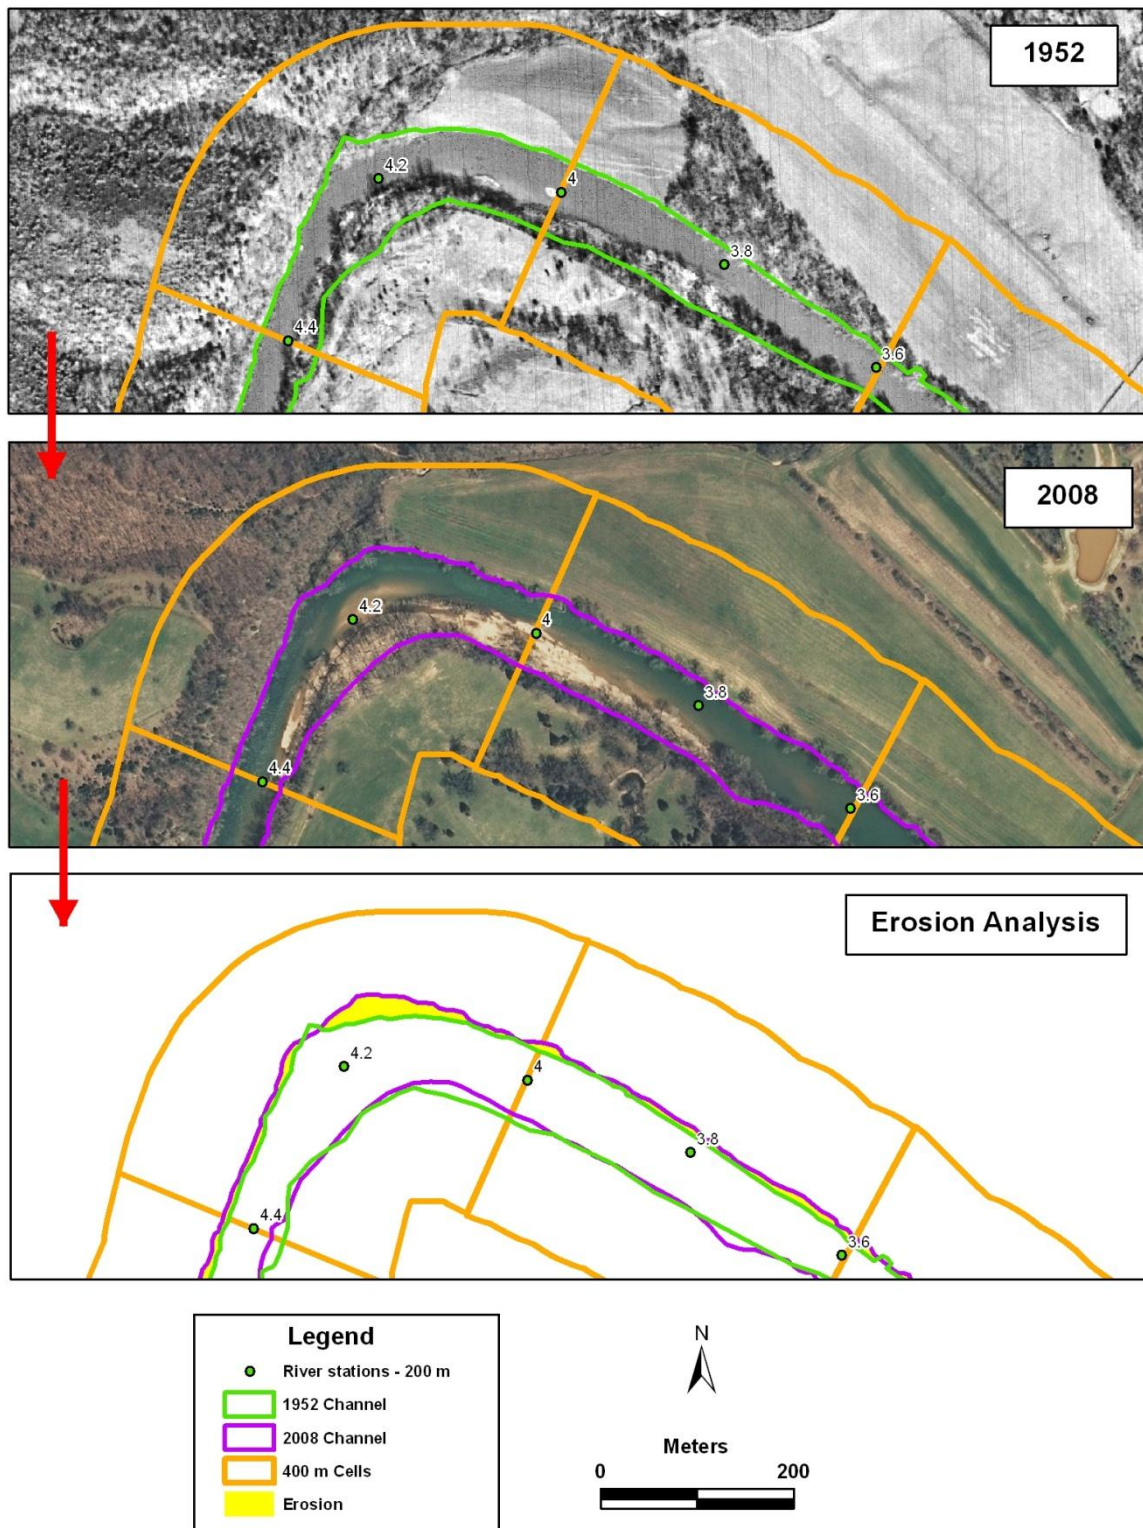
Figure 3. Aerial photo methods to define area of erosion since 1952.

USGS aerial photos from 2008 were used as the base for rectification of 1952 historical aerial photography using a second-order polynomial transformation of 8 ground control points per image (Hughes et al., 2006). Root mean square error was 1 m for all photos with average test point error <2 m. Both banks were digitized for each photo series in ArcGIS for overlay analysis. A 400 m channel cell polygon feature was created with the location of the field-based assessment at the center of the cell (Figure 3). An average erosion rate between each photo series was calculated in each cell by creating an area of erosion within each using the digitized banks from each photo year and dividing that by the cell length. Bank erosion had to exceed the test point error of 2 m to be valid using this method.

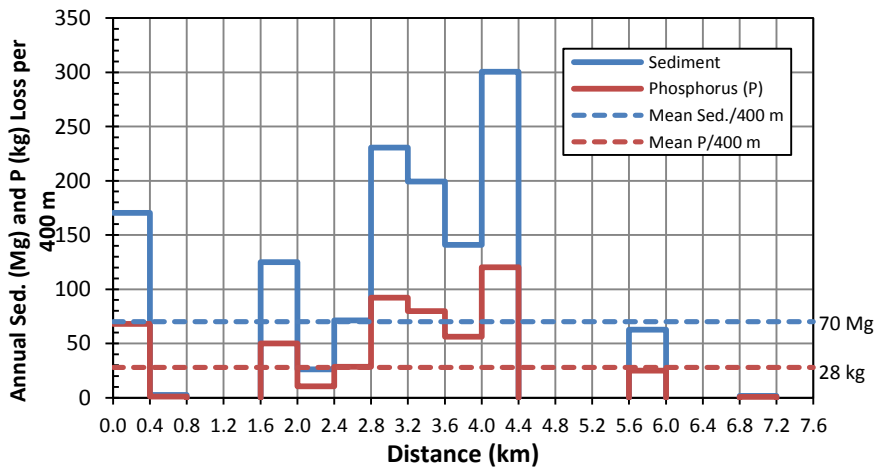
Figure 5. Annual sediment and P loss from bank erosion in study reach.

The majority of bank erosion along the easement property is concentrated in the middle section of the study reach from 1.6-4.4 km, while erosion in the remainder of the reach was relatively low. Total bank erosion estimated from the aerial photos and field measurements along the property by 400 m cell varied from 0 along the bluffs to 12,937 m³ (16,818 Mg) in the cell between 4-4.4 km since 1952 (Table 2). Average erosion for the reach over the last 56 years was 3,017 m³ and 3,921 Mg per cell. Total erosion for the entire 7.6 km reach was 57,314 m³ and 74,508 Mg over the last 56 years. Annual sediment loss ranged from 0-300 Mg/yr by cell for an average of 70 Mg with about 65% coming from the area between 1.6-4.4 km (Figures 5 and 6). Annual sediment eroded per unit length of stream varies from 0-0.75 Mg/m/year by 400 m cell with an average of 0.18 Mg/m/yr.

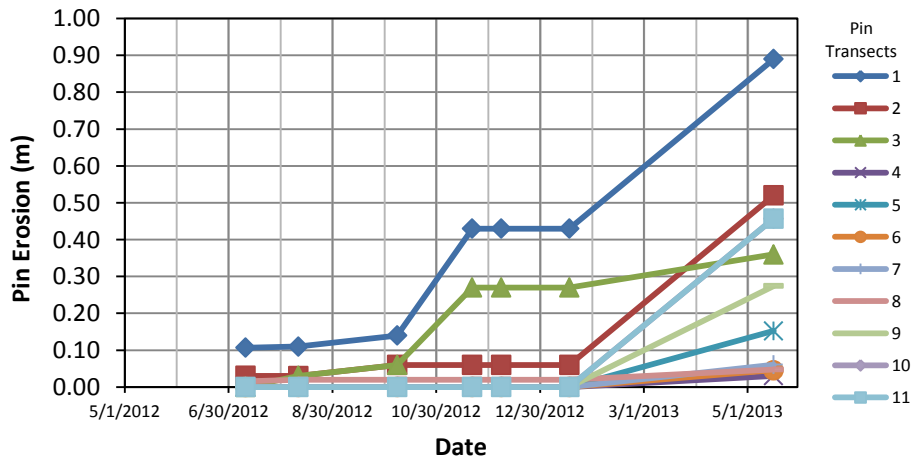
Figure 9. Cumulative erosion at pin transects.

The rainfall-runoff pattern in the river is reflected in the timing and magnitude of bank erosion in the study reach. Very little erosion occurred up to when the pins were checked on the 21st of November (Figure 9). Since the bank at this location was nearly vertical, the erosion that did

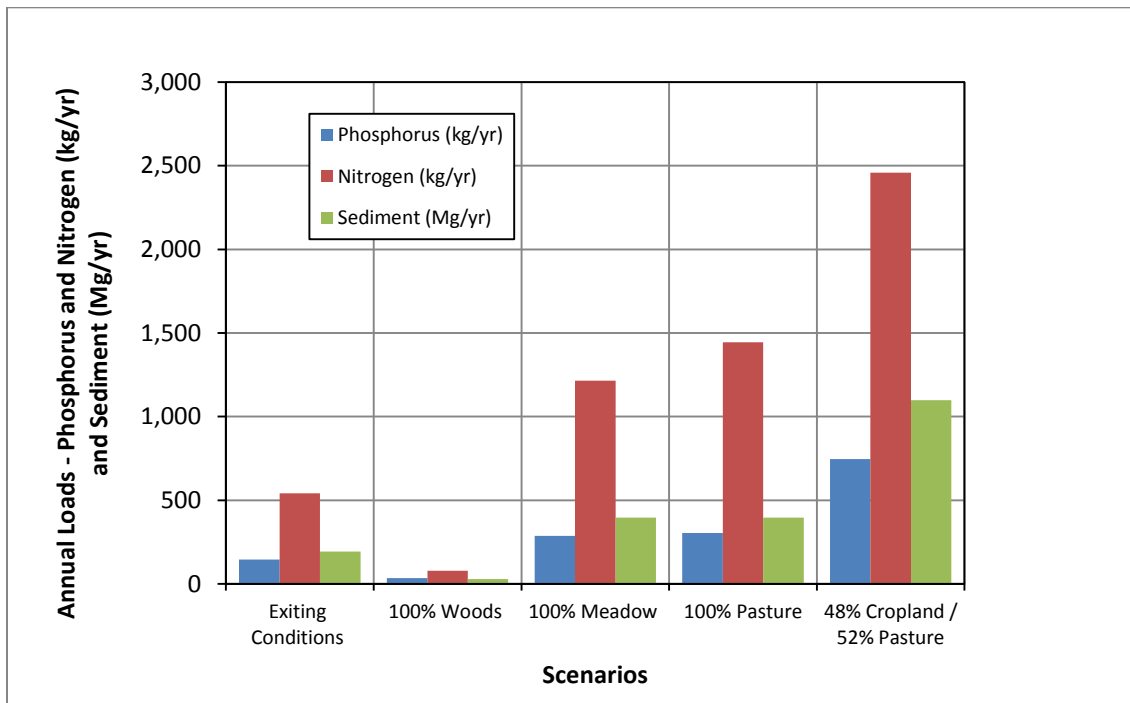
Figure 11. Annual nutrient and sediment loads from easement area from STEPL model.

conditions are described as grasslands protected from grazing and are typically hayed (TR55). Using the existing land use in the model, the nitrogen (N) load is 542 kg/yr, the P load is 145 kg/yr, and the sediment load is 194 Mg/yr (Table 6, Figure 11). Of this 496 kg/yr of N, 125 kg/yr P, and 177 Mg/yr sediment is coming from the grasslands in Group 1. Areas currently in forest have very low loads.
