**Ozarks Environmental and Water Resources Institute
(OEWRI) Missouri State University (MSU)**

**Stream Crossing Inventory and Evaluation,
Upper Big Barren Creek Watershed, Southeast
Missouri**

FINAL REPORT

January 26, 2018

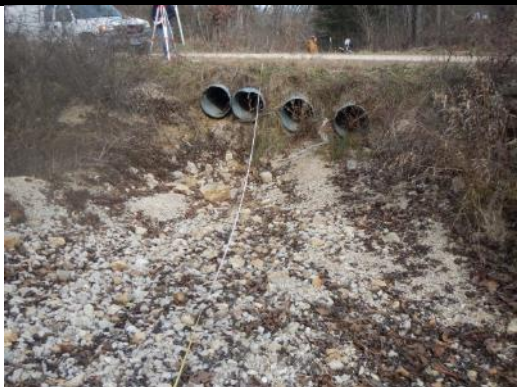
<p>Pipe Culvert (Site 16)</p>

to destabilization as the road fill can be eroded away as head cut moves upstream causing the crossing to fail.

5. Head cuts moving up tributaries from the lowering of base level at the modified main channel causes repeated episodes of crossing failure (Sites 10, 11, and 16). If traffic volume is a concern here, these crossings may be good candidates for box culverts that can pass flow generally as large as the present channel capacity. This could lower maintenance costs over time.

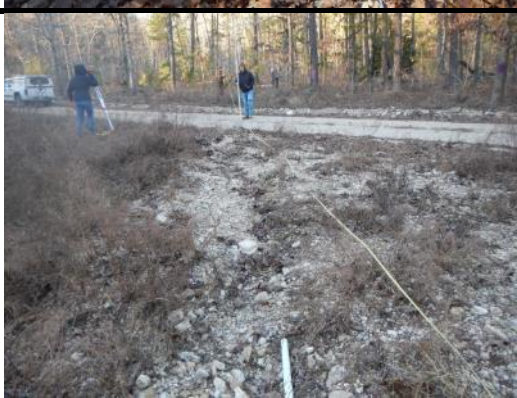
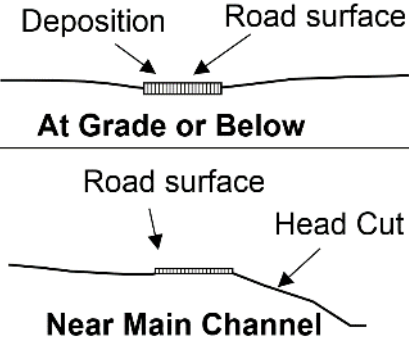
<p>Gravel LWC (Sites 5,8, 9,10,11,12, 13,15,18)</p>

Gravel LWCs are where road surface is built on top of the channel bed, allowing water to flow across the road surface and is made of gravel either found locally in the stream or in some cases quarried limestone or dolomite. These are generally built on roads with low traffic volume. A total of 12 gravel LWCs were identified in this study at Sites 1-3, 5, 8-13, 15, and 18. Generally in dry streams gravel LWC are built at the grade of the stream and create deposition zones due to being over widened. This may be good, since road crews need a place to get aggregate without having to go into the stream and destabilize the channel and banks (Jacobson and Gran 1999). Gravel LWCs along tributaries near the main channel are also being destabilized as head cuts move upstream. In wet areas gravel LWC crossings placed in shallower areas create forced riffles. They may need additional gravel after large floods as smaller gravel is transported away leaving larger cobbles at the crossings that are difficult for vehicles to drive across.

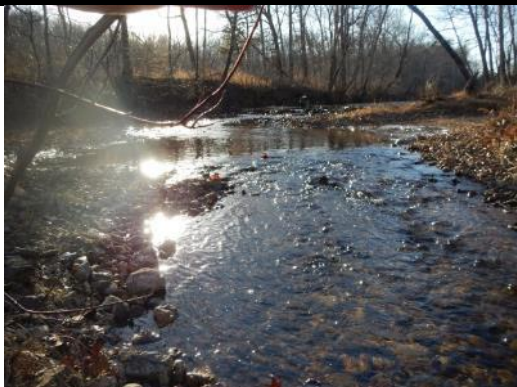
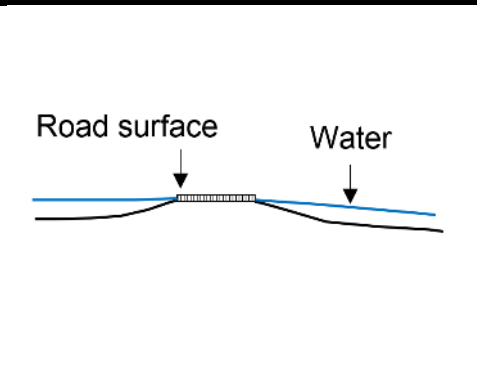
<p>Road surface</p> <p>Water</p> <p>Scour</p>
Gravel LWC (Sites 1,2,3)

4. Wet crossings located above the natural area tend to cross at riffles located between the bluff pools (Sites 1, 3, and 4). For the most part these crossings are stable, but frequently become impassible during even moderate floods. Since this area is hydrologically unique and ecologically sensitive, it may be worth the resources to install box culverts in this area. Here a two-stage design that has a low flow channel for fish passage would be recommended (Ward et al. 2016).

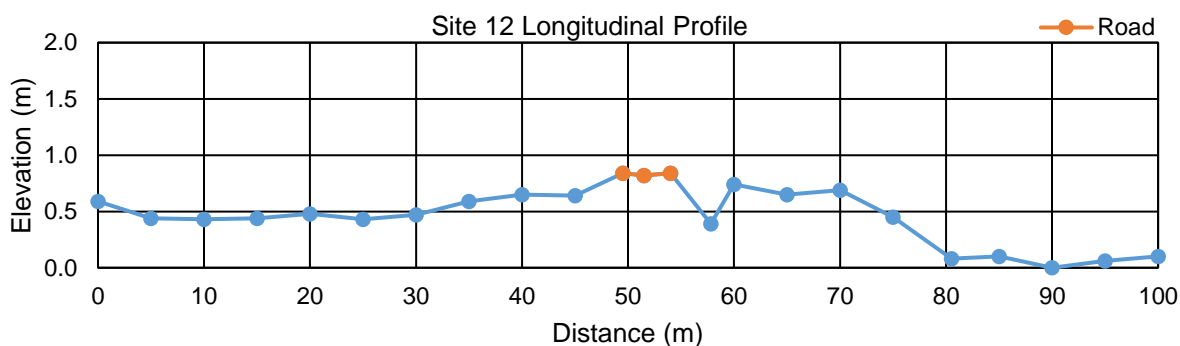
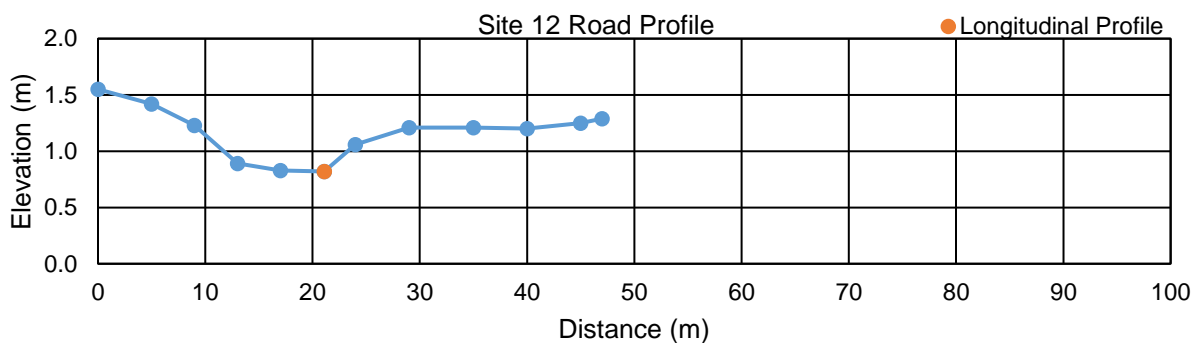
Site 12: Big Barren Creek at J-173 (private road upstream of Polecat Hollow)

Particle Size Distribution (mm)	Upstream	Downstream
d10	16	1
d25	25	16
d50	77	45
d75	119	64
d84	128	64
d90	130	64
dMax	200	128

Channel Geometry	Upstream	Downstream
Active Width (m)	6.5	12.6
Bankfull Width (m)	21	16
Bankfull Depth (m)	2.2	1.6
Bankfull W/D Ratio	9.8	10.6
Slope (%)		1.6

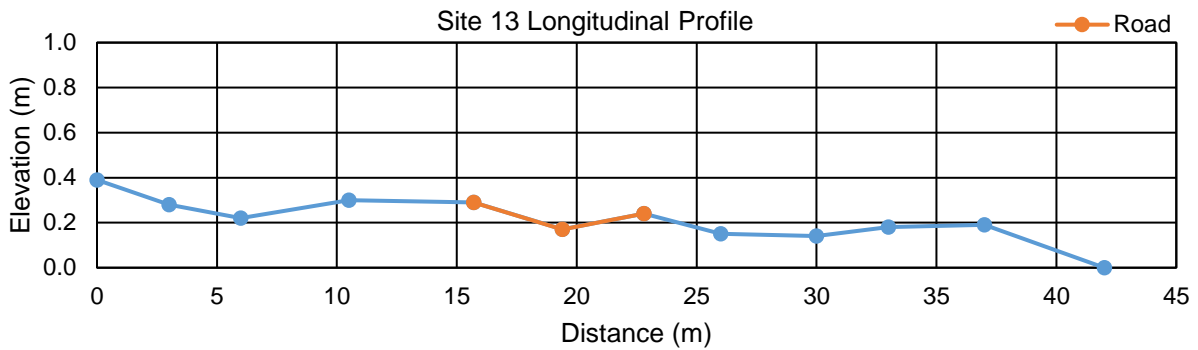
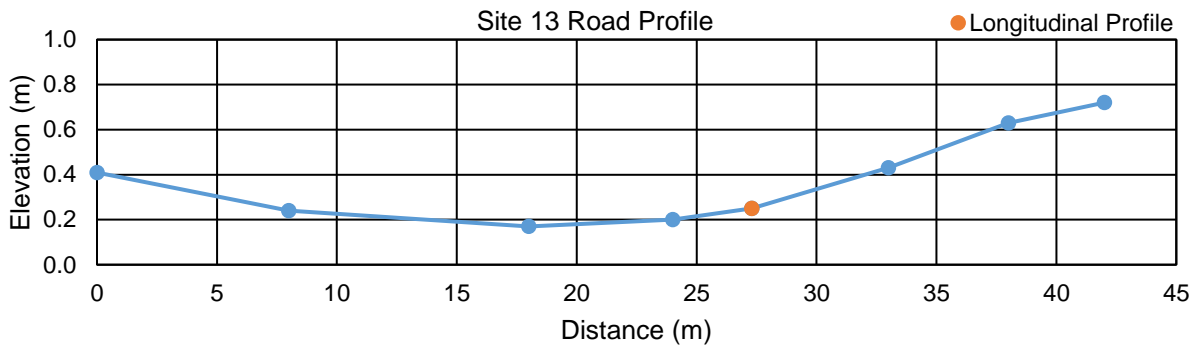
Site 13: Big Barren Creek at J-173 (below North bend)

Particle Size Distribution (mm)	Upstream	Downstream
d10	1	10
d25	9	16
d50	22.6	22.6
d75	64	32
d84	168	41
d90	255	45
dMax	300	90

Channel Geometry	Upstream	Downstream
Active Width (m)	3.4	14.7
Bankfull Width (m)	3.4	33.6
Bankfull Depth (m)	0.2	0.1
Bankfull W/D Ratio	17	336
Slope (%)		1.25

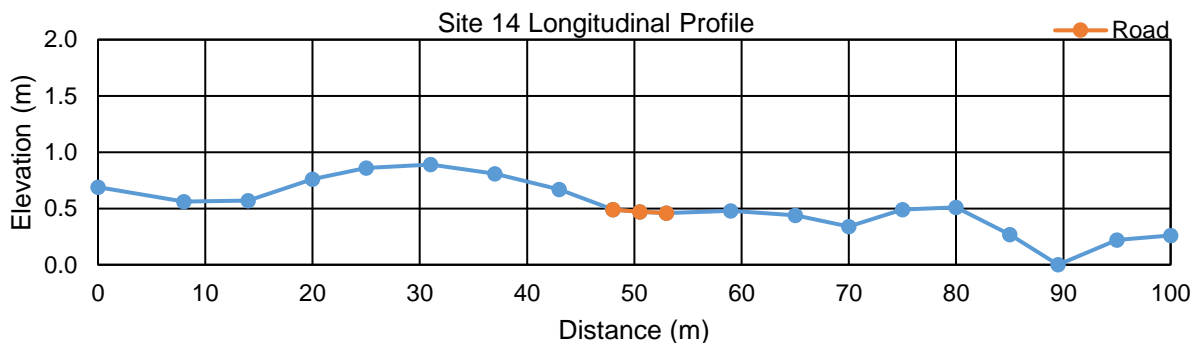
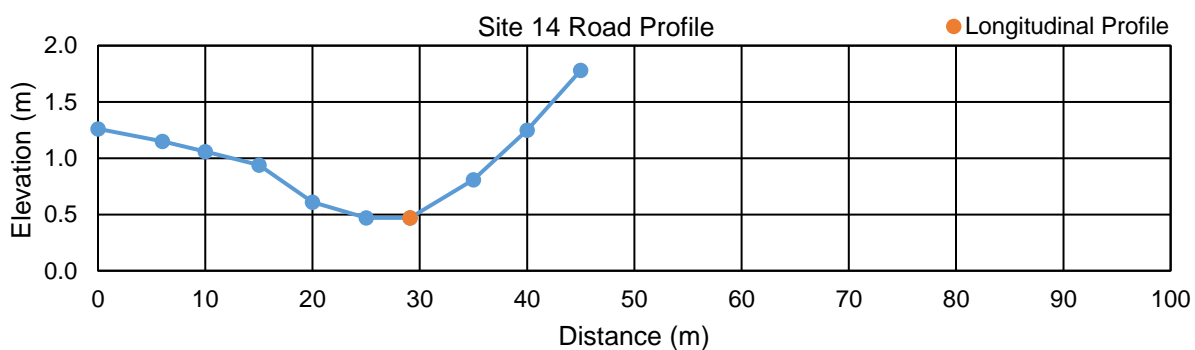
Site 14: Big Barren Creek at J-173 (above North bend)

Particle Size Distribution (mm)	Upstream	Downstream
d10	1	5.6
d25	11	10
d50	16	11
d75	32	16
d84	37	22.6
d90	47	22.6
dMax	100	45

Channel Geometry	Upstream	Downstream
Active Width (m)	9.4	9.9
Bankfull Width (m)	13.6	14.1
Bankfull Depth (m)	0.4	1.1
Bankfull W/D Ratio	52.7	12.8
Slope (%)		0.54

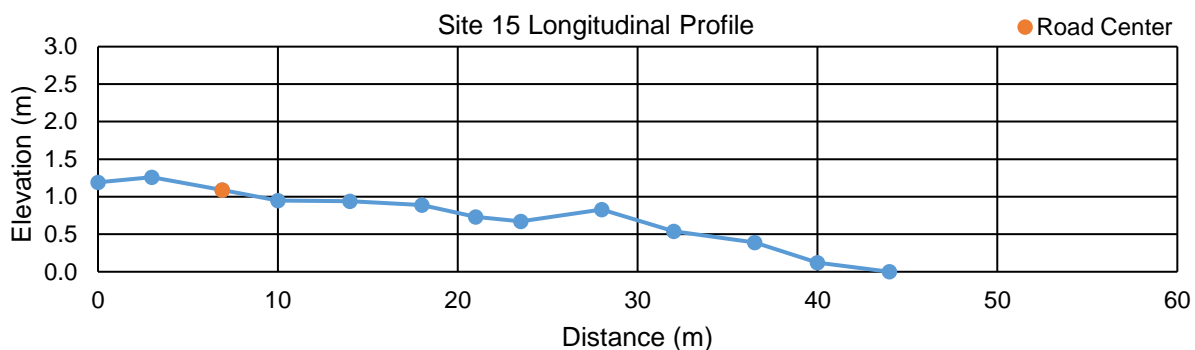
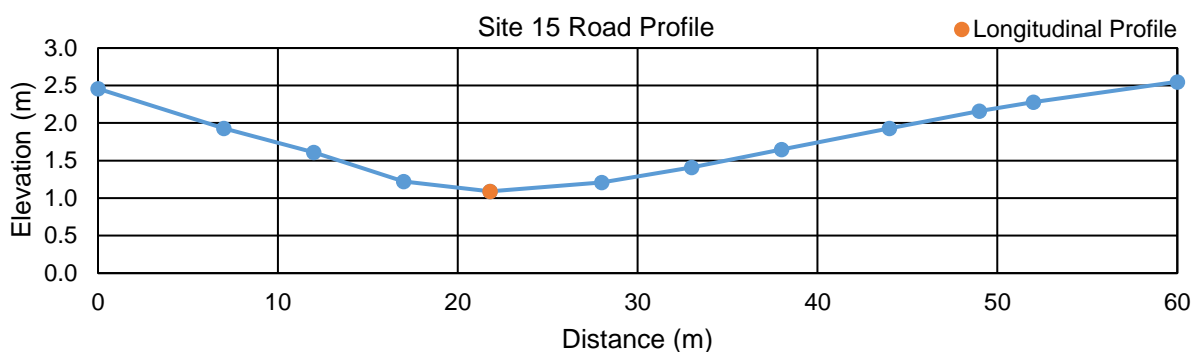
Site 15: Big Barren Creek at J-173 B (by old schoolhouse)

Particle Size Distribution (mm)	Upstream	Downstream
d10	15	1
d25	22.6	5.6
d50	22.6	16
d75	32	64
d84	32	64
d90	32	69
dMax	225	128

Channel Geometry	Upstream	Downstream
Active Width (m)	9	6.2
Bankfull Width (m)	11	10.5
Bankfull Depth (m)	0.7	0.6
Bankfull W/D Ratio	15.7	21.2
Slope (%)		2.11

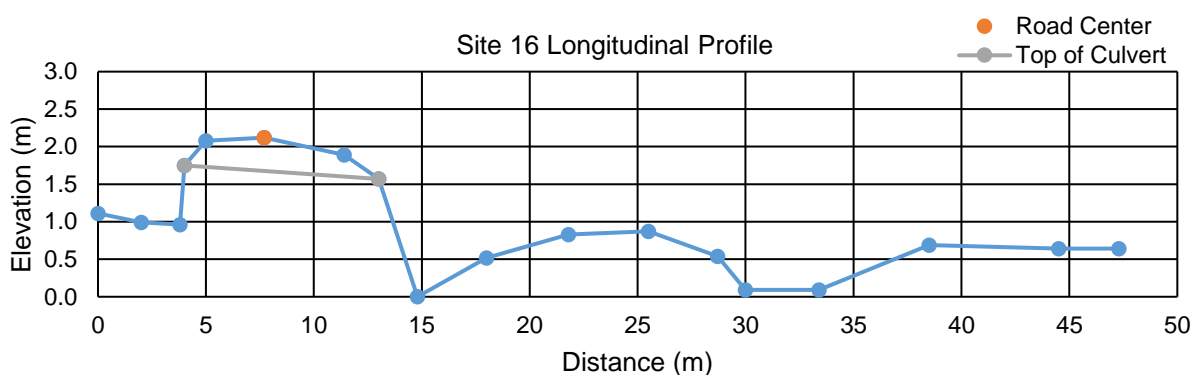
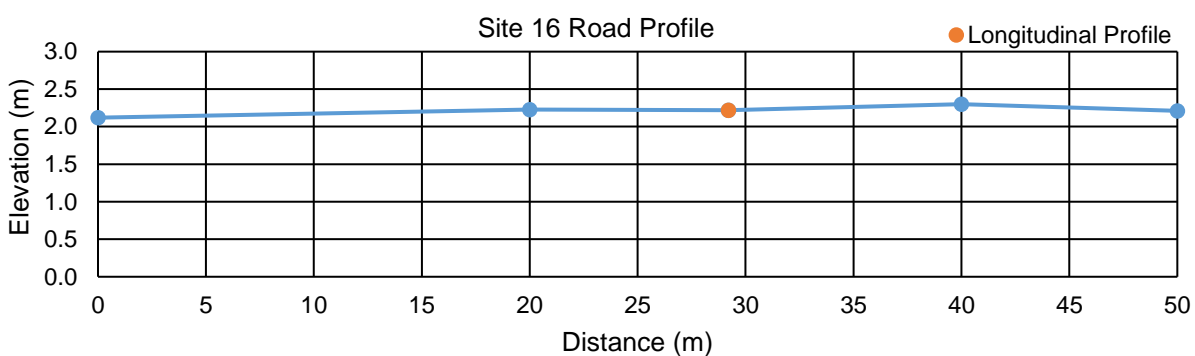
Site 16: Unnamed tributary at J-173

Particle Size Distribution (mm)	Upstream	Downstream
d10	No access	7
d25	No access	11
d50	No access	16
d75	No access	30
d84	No access	32
d90	No access	33
dMax	No access	45

Channel Geometry	Upstream	Downstream
Active Width (m)	4.4	8.9
Bankfull Width (m)	5.7	12.3
Bankfull Depth (m)	1.1	0.8
Bankfull W/D Ratio	5.1	19.9
Slope (%)		0.75

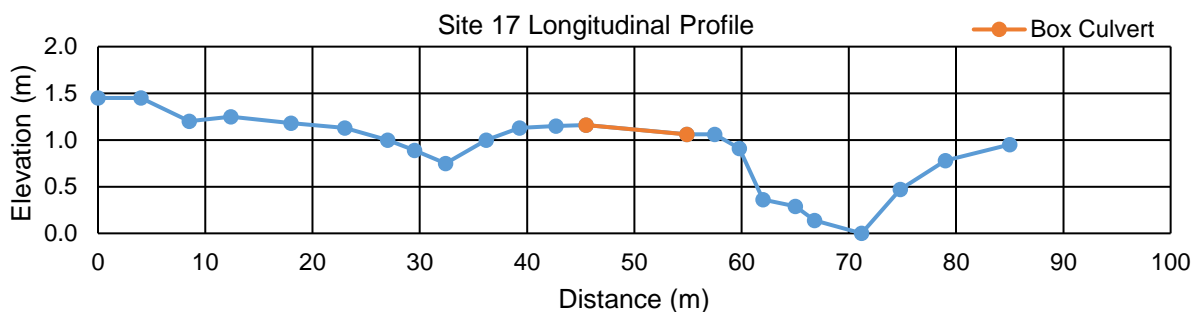
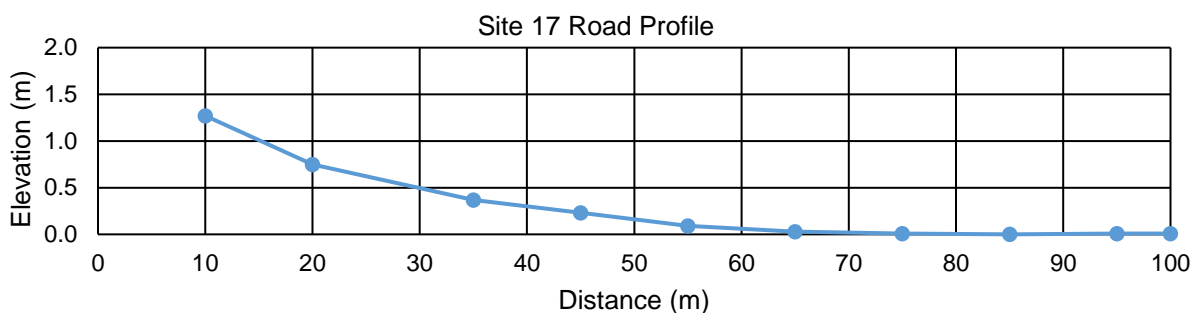
Site 17: Big Barren Creek at State Highway J

Particle Size Distribution (mm)	Upstream	Downstream
d10	1	1
d25	1	1
d50	1	1
d75	8	2.8
d84	11	5.6
d90	22.6	5.6
dMax	32	16

Channel Geometry	Upstream	Downstream
Active Width (m)	5.7	1.8
Bankfull Width (m)	5.7	10.2
Bankfull Depth (m)	0.6	0.5
Bankfull W/D Ratio (m)	12.5	28.2
Slope (%)		0.68

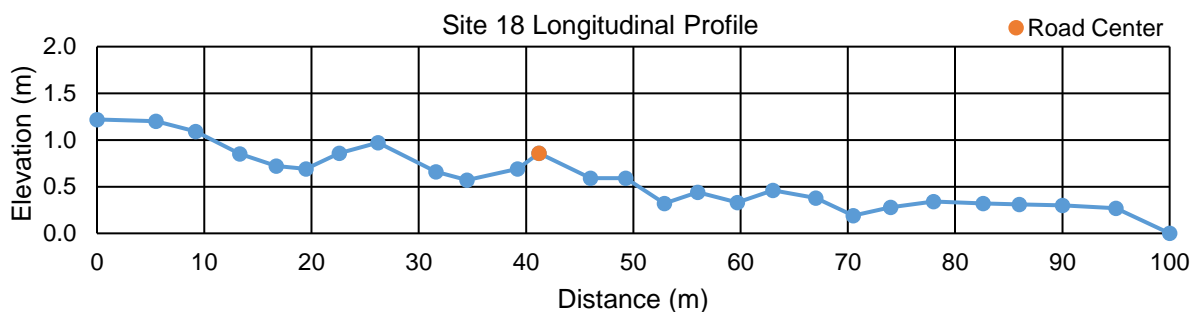
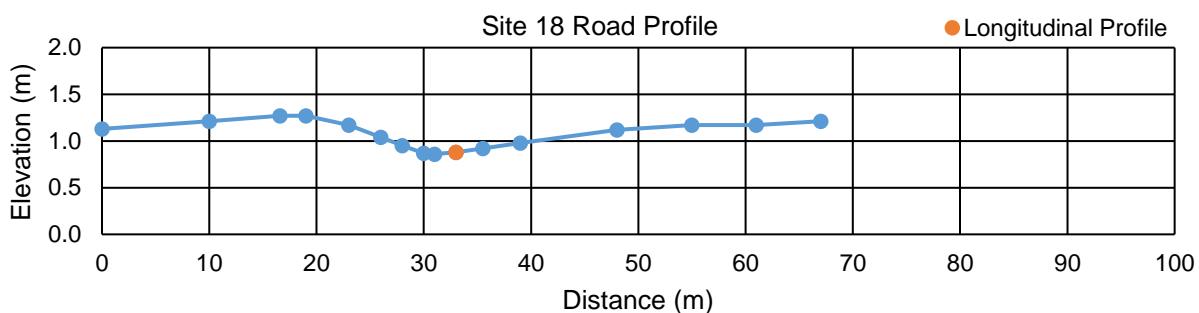
Site 18: Big Barren Creek at J-174 (road to Freeman Cemetery)

Particle Size Distribution (mm)	Upstream	Downstream
d10	11	3.1
d25	22.6	5.6
d50	32	11
d75	45	22.6
d84	45	22.6
d90	64	22.6
dMax	64	32

Channel Geometry	Upstream	Downstream
Active Width (m)	7.2	3.3
Bankfull Width (m)	7.2	8.1
Bankfull Depth (m)	0.5	0.6
Bankfull W/D Ratio	18.1	25.6
Slope (%)		0.65
