**WARD BRANCH STREAM RESTORATION
PROJECT**

POST-CONSTRUCTION ASSESSMENT

FINAL REPORT

August 27, 2008

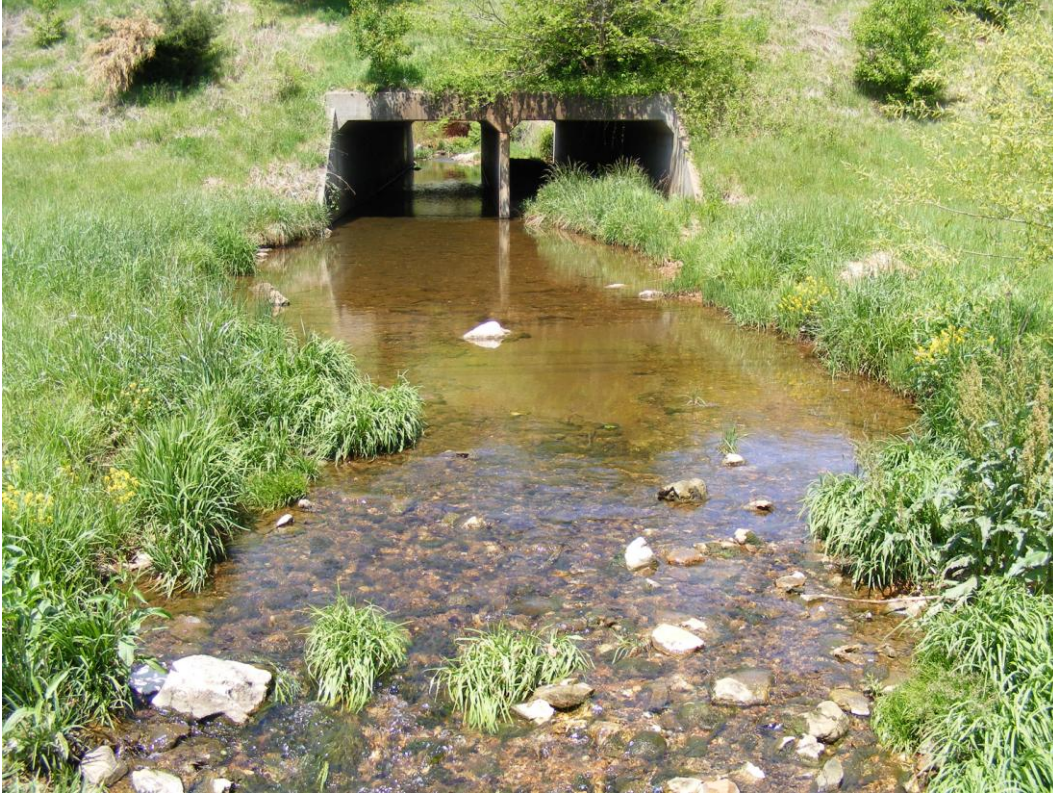
Picture 1. Republic Road bridge upstream of upper cart bridge looking upstream May 2008 (St. 100 feet)

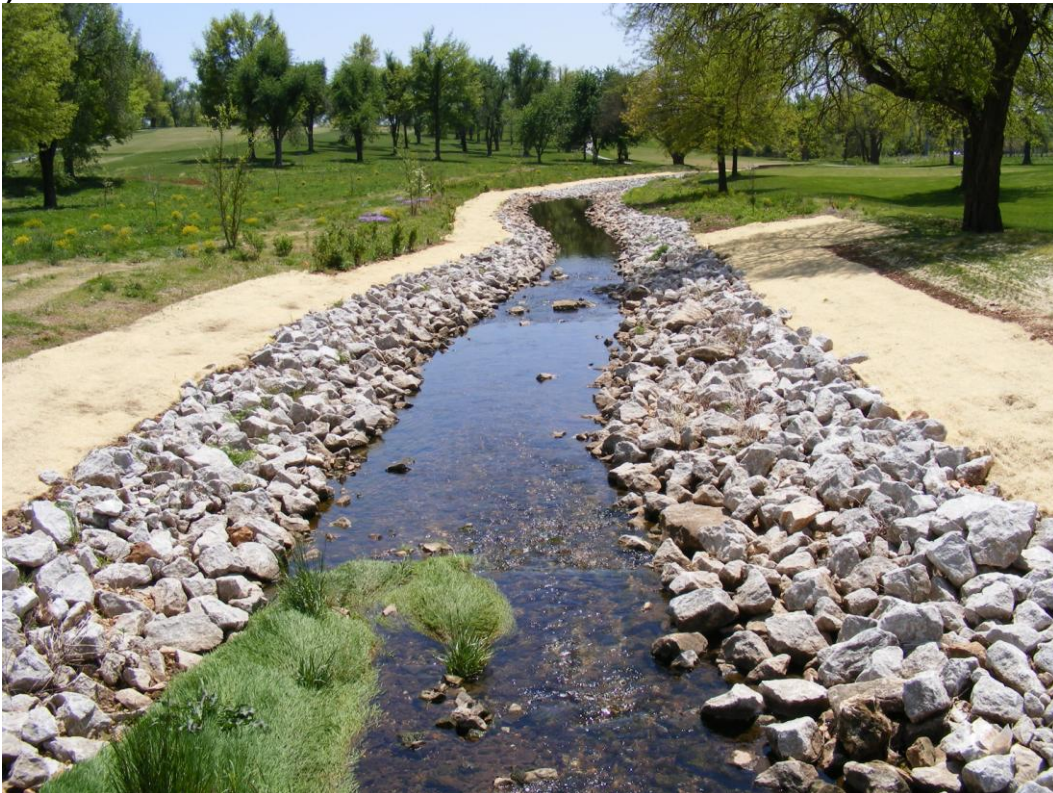
Picture 2. Downstream of upper cart bridge looking downstream May 2008 (St. 120 feet)

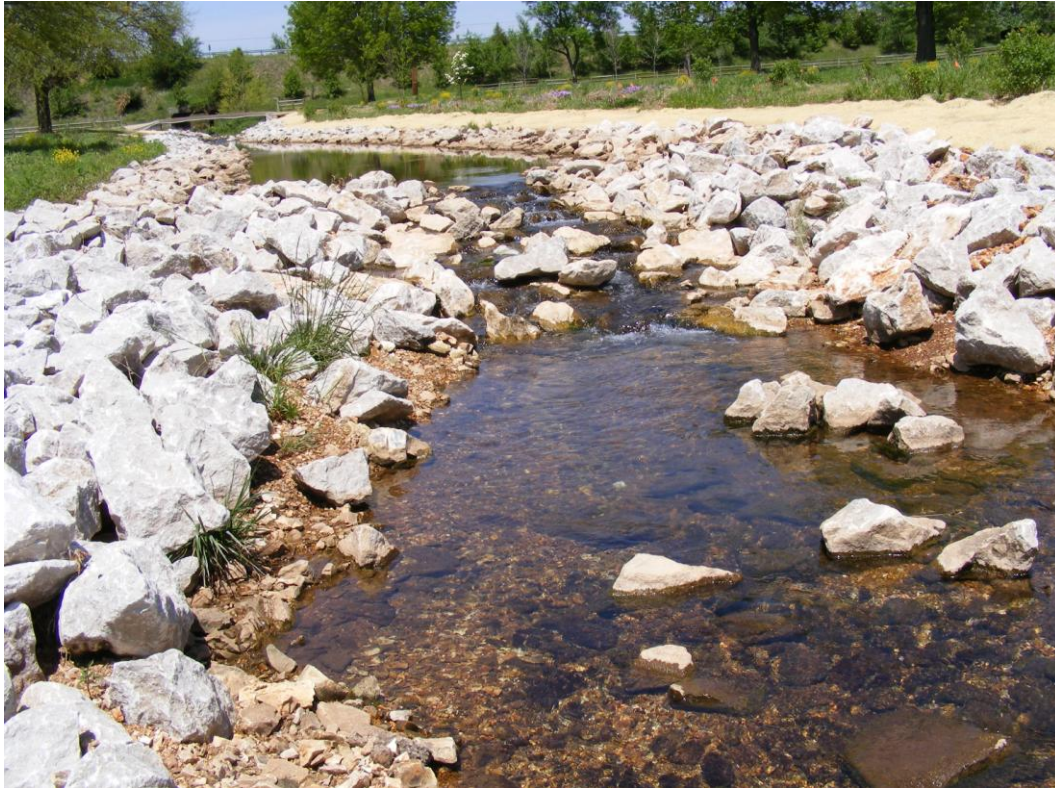
Picture 3. Example of grade control structure downstream of upper cart bridge looking upstream May 2008 (St. 450 feet)

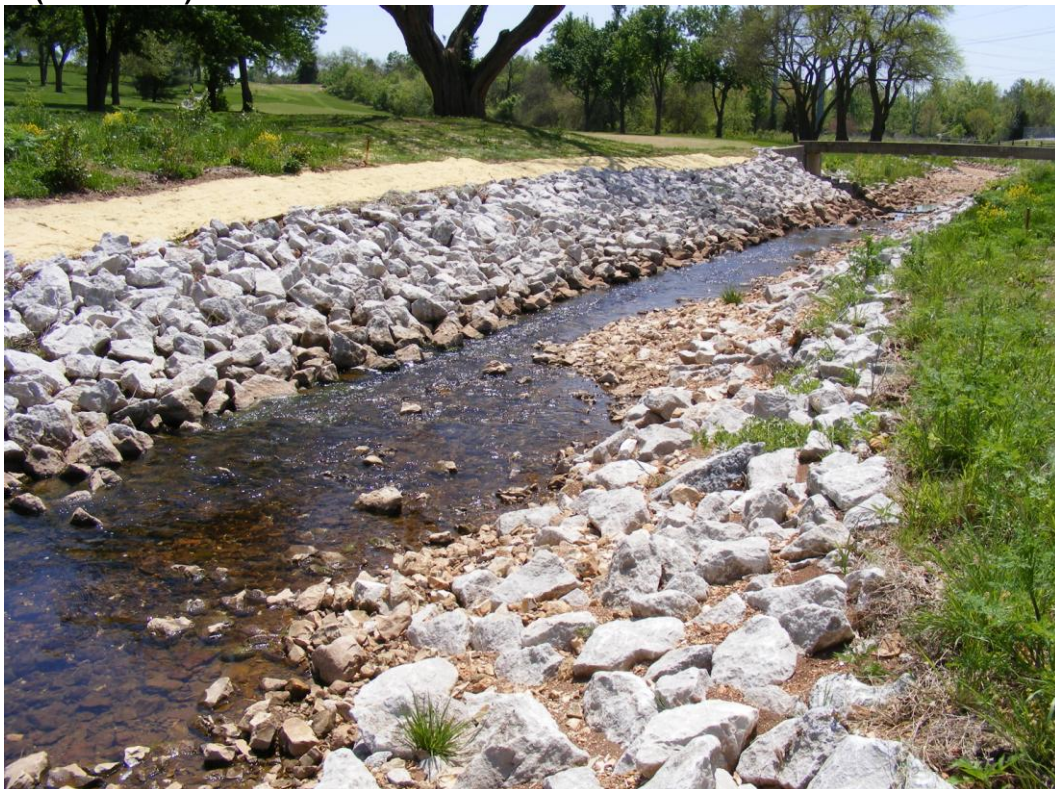
Picture 4. Upstream of lower cart bridge looking downstream May 2008 (St. 600 feet)

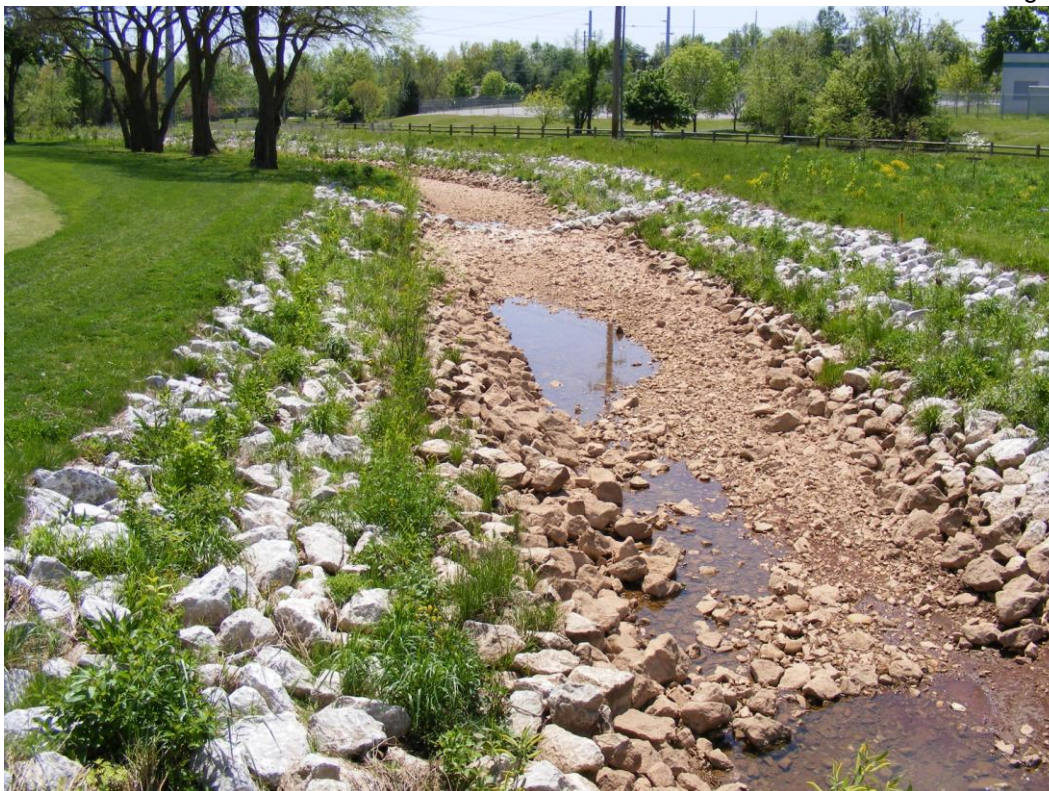
Picture 5. Below lower cart bridge and second grade control looking downstream May 2008 (St. 800 feet)

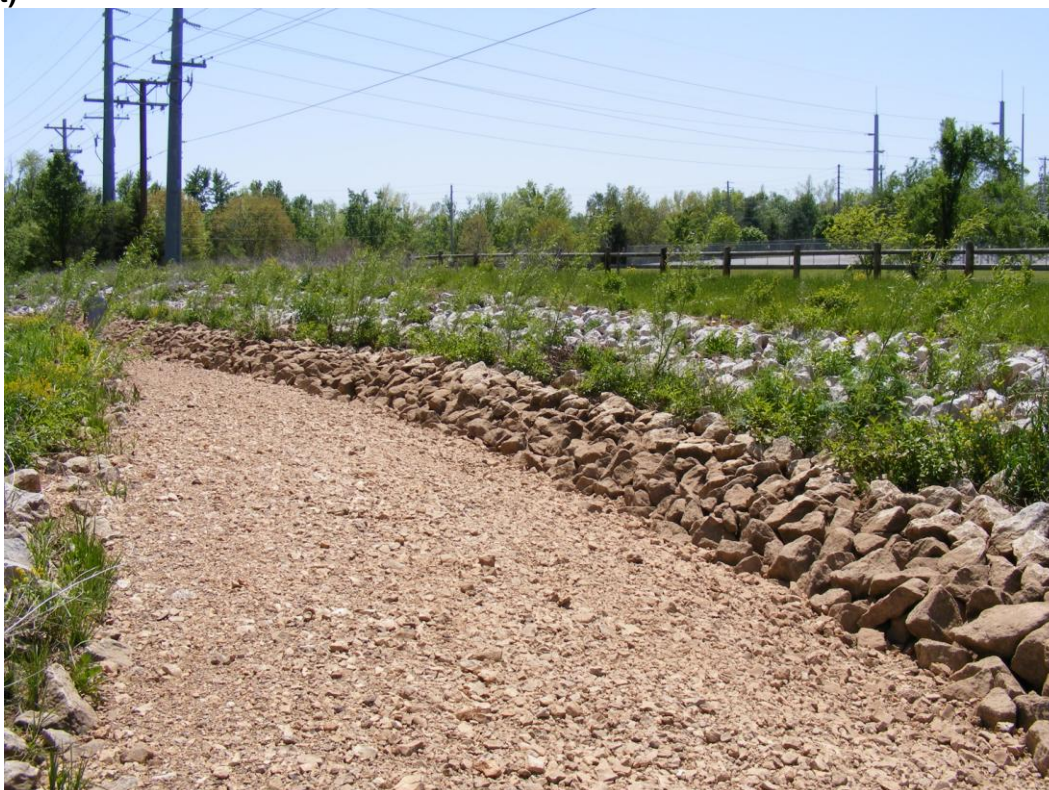
Picture 6. Composite revetment along the once active eroding reach looking downstream May 2008 (St. 1,000 feet)

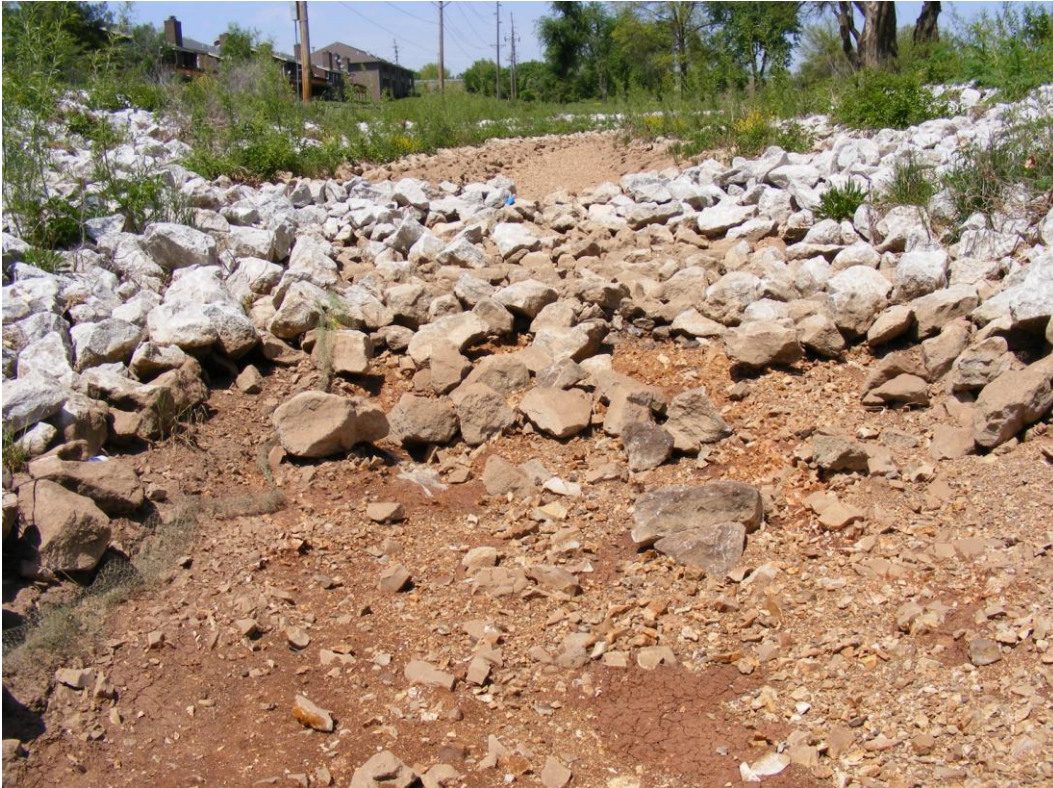
**Picture 7. Lower grade control structures near the end of Golf Course Reach looking upstream
May 2008 (St. 1,150 feet)**

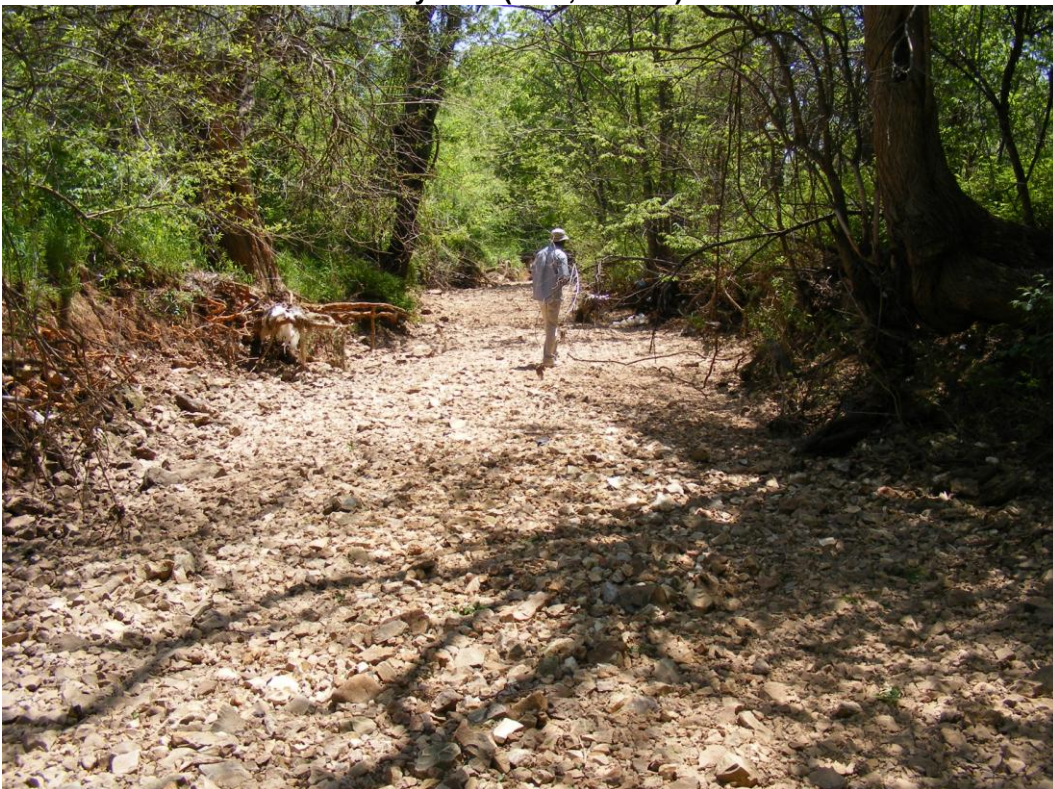
**Picture 8. Plane-bed reach below constructed channel looking downstream May 2008 (St. 1,250
feet)**

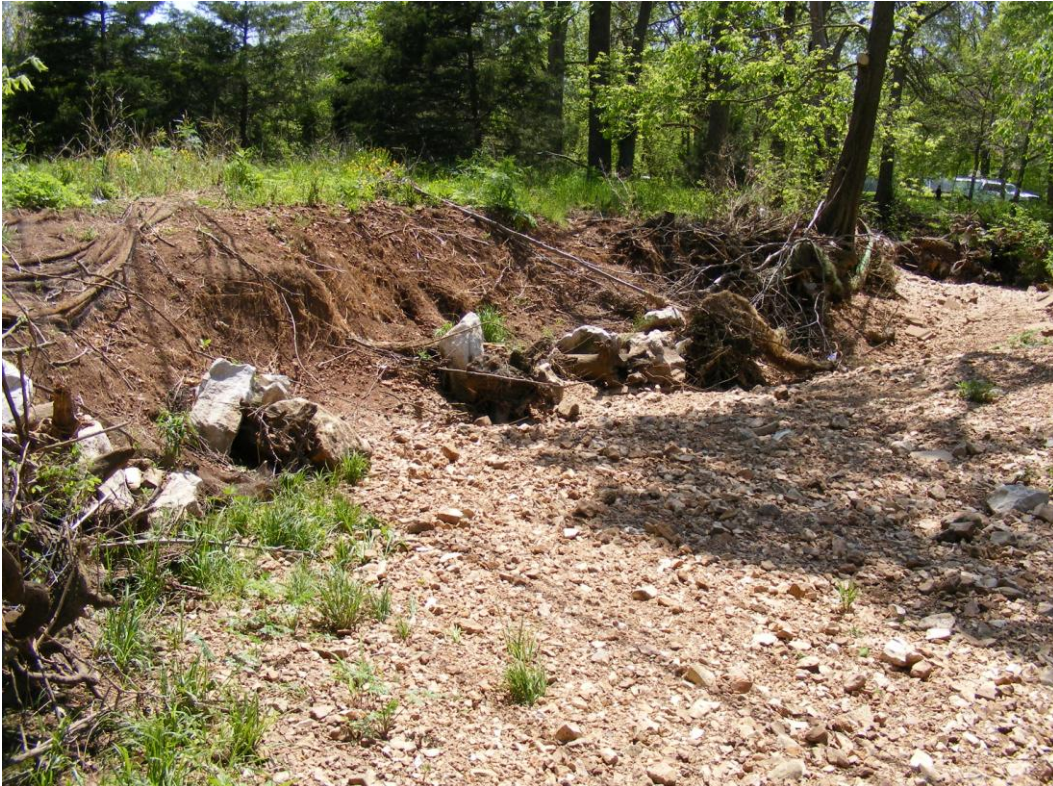
Picture 9. Root wads at meandering sub-reach looking downstream May 2008 (St. 1,650 feet)

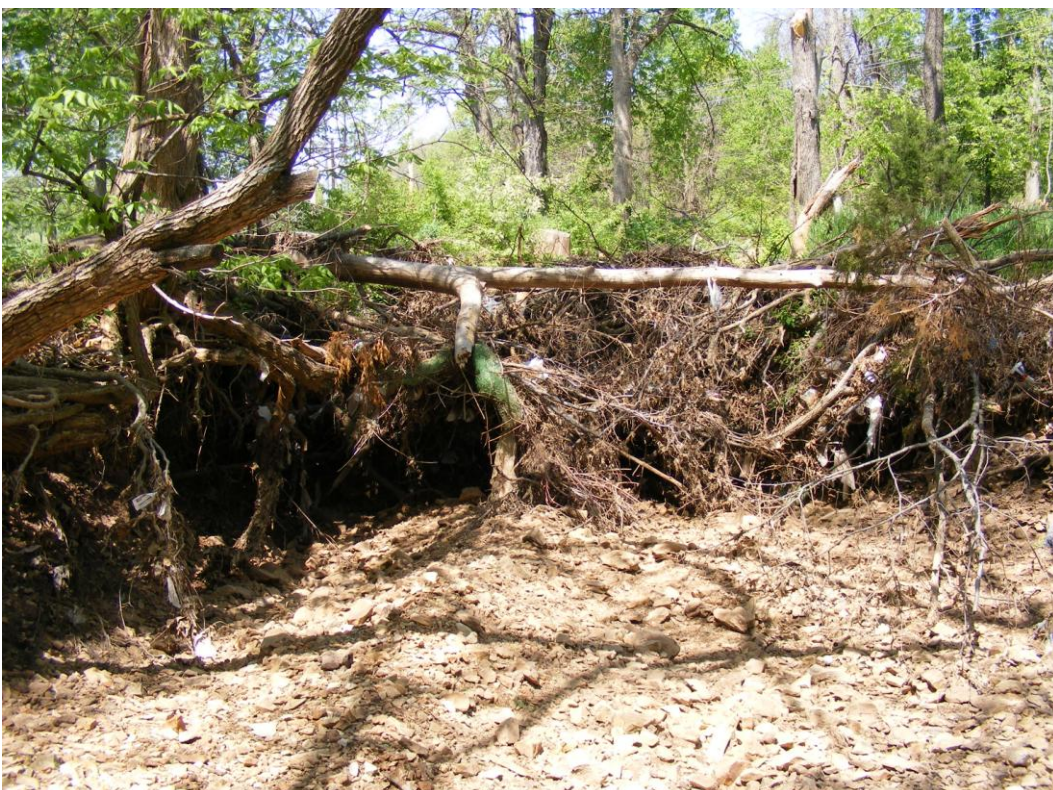
Picture 10. Large woody debris jam at station 1,730 feet looking downstream May 2008 (St. 1,730 feet)

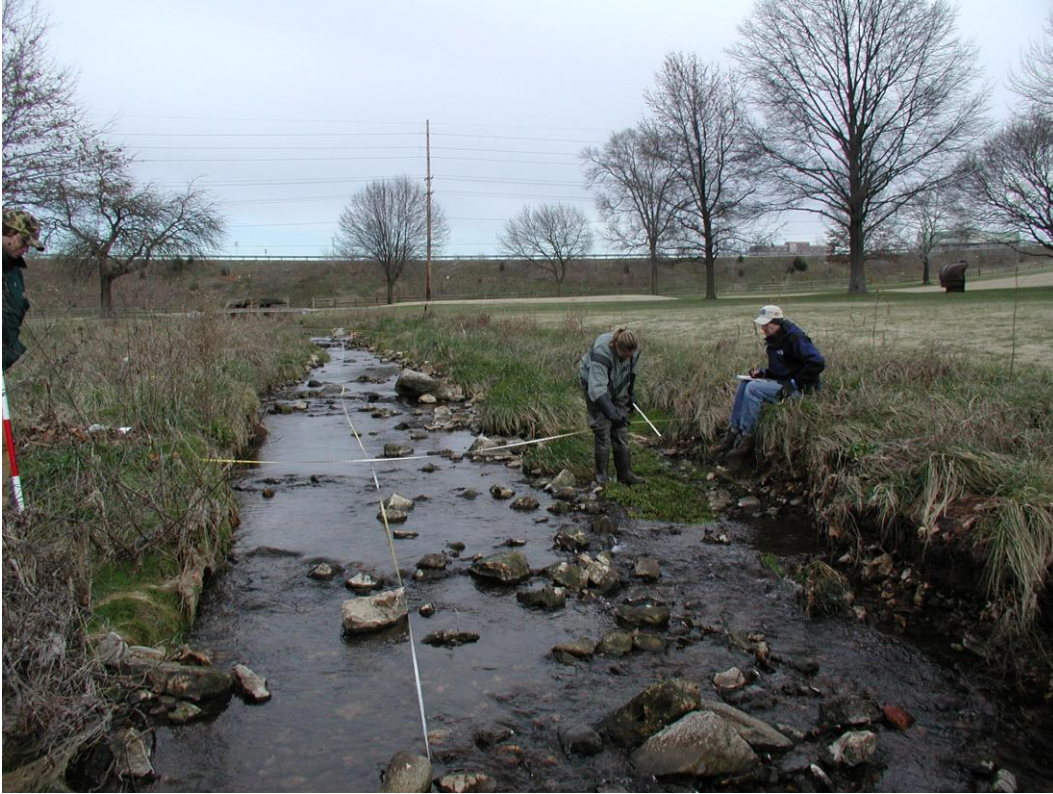
Picture 11. BEFORE - Riffle below first cart bridge looking upstream December 2004 (St. 400 feet)

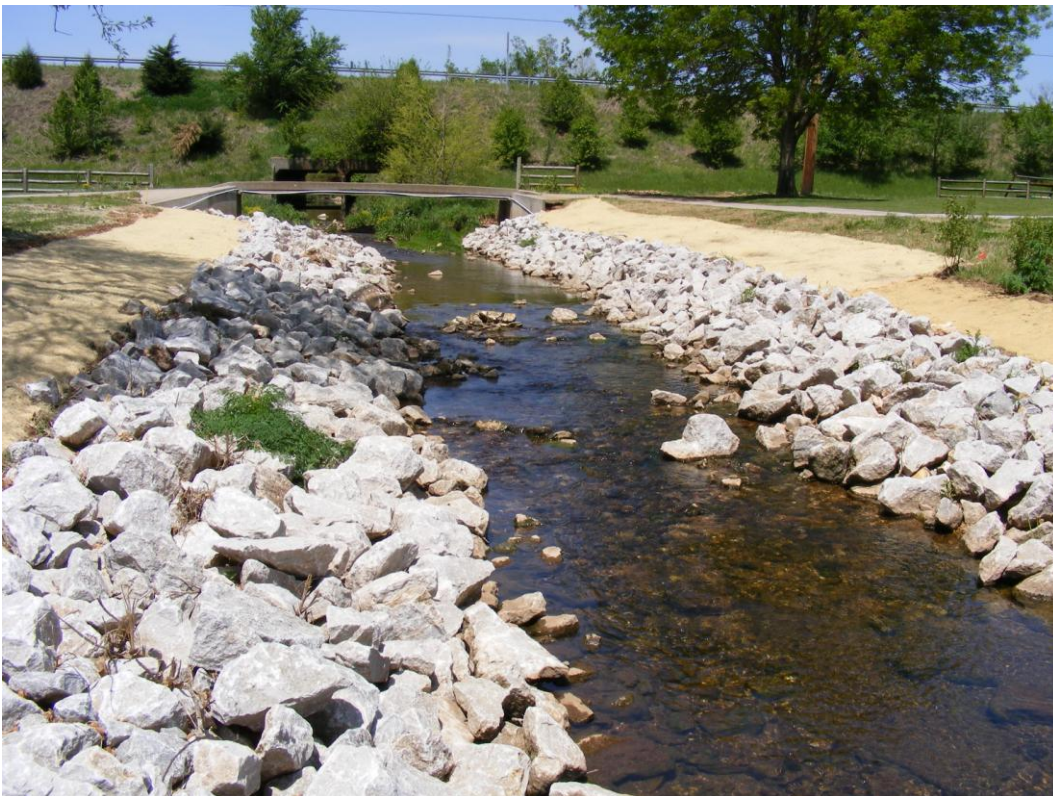
Picture 12. AFTER - Riffle below first cart bridge looking upstream May 2008 (St. 200 feet)

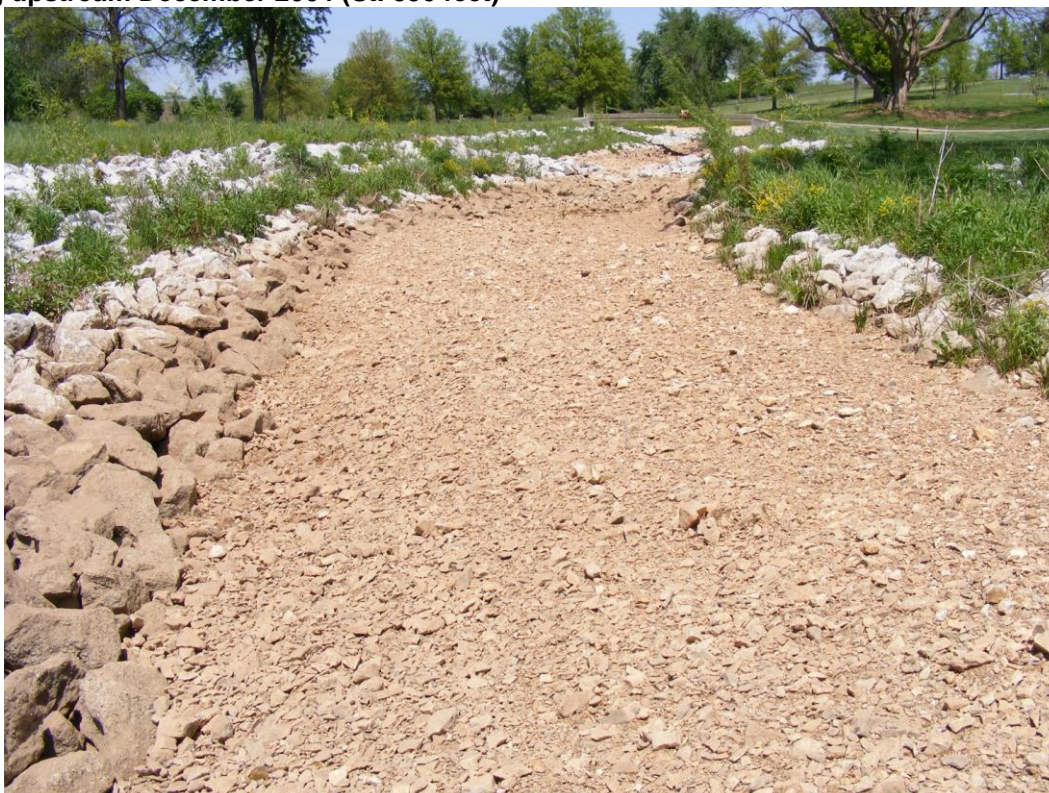
Picture 14. AFTER - Maintained riffle crest position, bank protection and enhanced riparian corridor May 2008 (St. 900 feet)

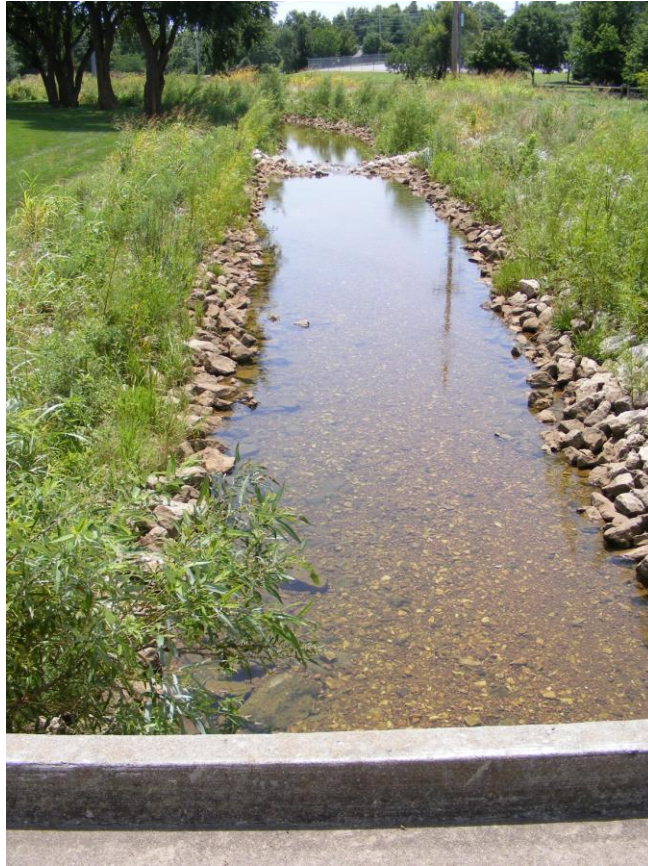
Picture 23. Vegetation growth in composite revetment, July 2008 (St. 750 ft)

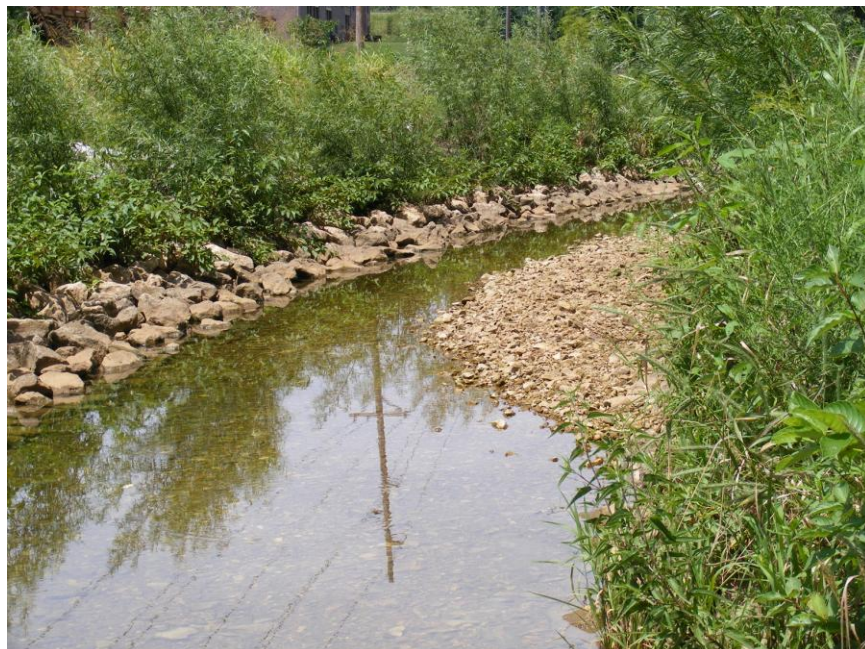
Picture 24. Gravel bar formation at bankfull bench, July 2008 (St. 950 ft)
