**The Ozarks Environmental and Water Resources Institute (OEWRI)
Missouri State University (MSU)**

FINAL REPORT

**Nonpoint Source Bank Erosion and Water Quality
Impairment Assessment, James River at Rivercut Golf
Course, Greene County, Missouri**

September 17, 2013

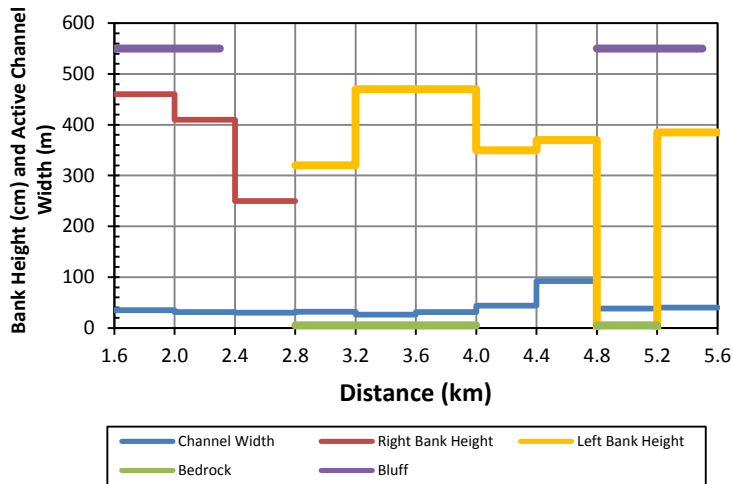
Figure 4. Bank and channel conditions in study reach.

Bedrock bluffs and natural obstructions have a major influence on the channel along the 4 km long study reach. Bluffs and bedrock along the bank toe were observed along the bank of the river along the easement for the majority of the reach length and bedrock can be found along the bed of the river frequently (Figure 4). When it occurs, bedrock in the bed and along bluffs limits the ability of the river to meander and scour the bed and is typical of streams in the Ozarks (Pavlovsky, 2004). Field measurements taken in July 2013 show the active channel width varies from about 26 m from 3.2-3.6 km up to 93 m from 4.4-4.8 km. The active channel refers to both the wetted part of the channel at low flow, but also the gravel bars located adjacent to the water, but set below the bank. The high active channel widths indicate areas where large bars are present in the channel. Bank heights vary from around 2.5-4.7 m through the study reach. Bank heights vary due to the age of the deposit from terraces that could be >10,000 years old to recently formed benches only formed over the last 100 years (Brakenridge 1981; Hajic et al. 2007; Owen et al. 2011). Colluvium/alluvium banks exist at the base of the bluffs along most of the reach with the exception of the bluff adjacent to the river from 4.8-5.2 km. Bank heights measured in the field were used to calculate total sediment volume lost to erosion from the historical aerial photography analysis.

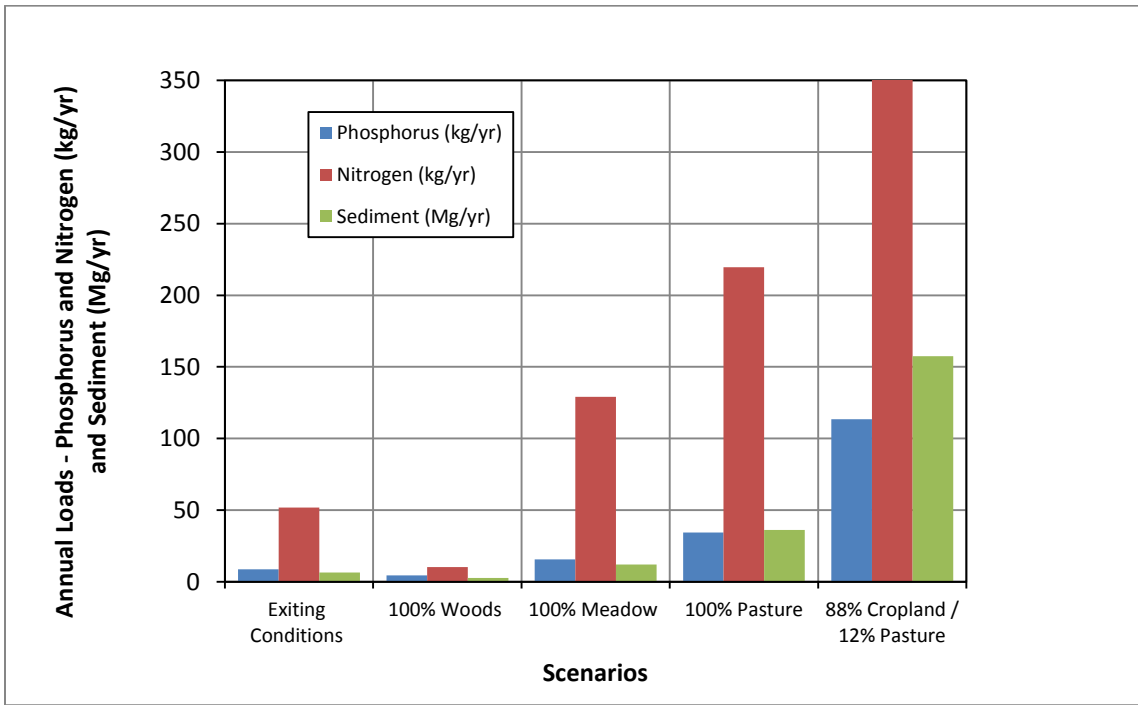
Figure 7. Annual nutrient and sediment loads from easement area from STEPL model.

STEPL results show that most of the nutrients and sediment leaving the existing easement area are coming from the grasslands that are currently being managed for hay. The majority (66%) of the existing land use within the area is in forest, with the remainder in “meadow”. The meadow conditions are described as grasslands protected from grazing and are typically hayed (TR55). Using the existing land use in the model, the nitrogen (N) load is 51.8 kg/yr, the P load is 8.7 kg/yr, and the sediment load is 6.5 Mg/yr (Table 6, Figure 7). Of this 44.9 kg/yr of N, 5.6 kg/yr P, and 4.6 Mg/yr sediment is coming from the grasslands. Areas currently in forest have very low loads.
