# **Channel Stability and Riparian Corridor Assessment to Identify Nonpoint Source Pollution, Wilson Creek, Springfield, Missouri**

*Field work completed July 20, 2012*

August 3, 2012

OEWRI EDR-12-003

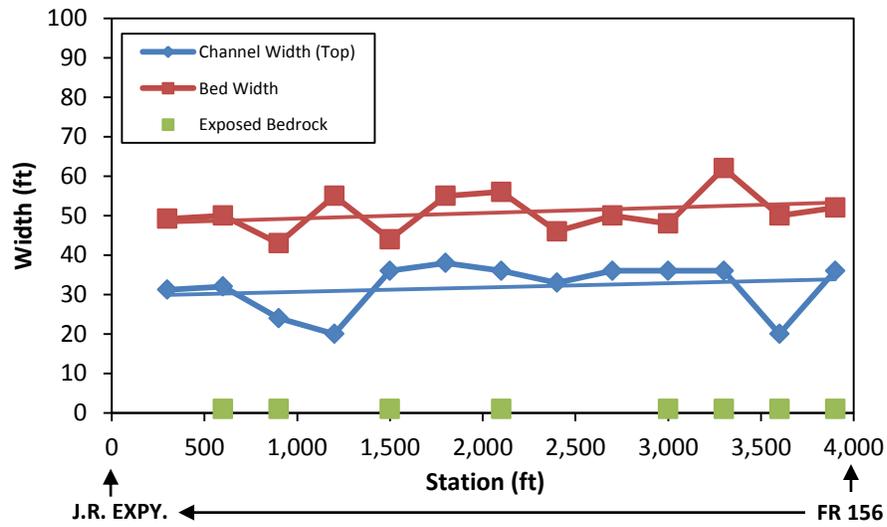
Figure 4. North Segment – Channel Width and Bedrock

Channel and bed width decreased downstream and bedrock was exposed along the bed throughout the majority of the reach (Figure 4). Bed width ranged from 20-38 ft and channel width ranged from 43-62 ft wide. While channel width should be expected to increase downstream, bedrock can control bed elevation and slope locally to disrupt that downstream pattern. The banks through this segment ranged from 4.6-16.4 ft high. The majority of the banks through this reach would be considered moderate to moderately high (4-8 ft) (Figure 5). Bank in the upper 500 ft and near station 1,200 ft would be considered high and susceptible to erosion (> 8ft). Bank heights were highest in the upper 500 ft of the site, with banks exceeding 12 ft near the knickpoint at 3,600 ft where the bed drops 8 ft. Bank angles that exceed 70° are common all along the north segment reach. High banks with steep angles should be considered an erosion risk.

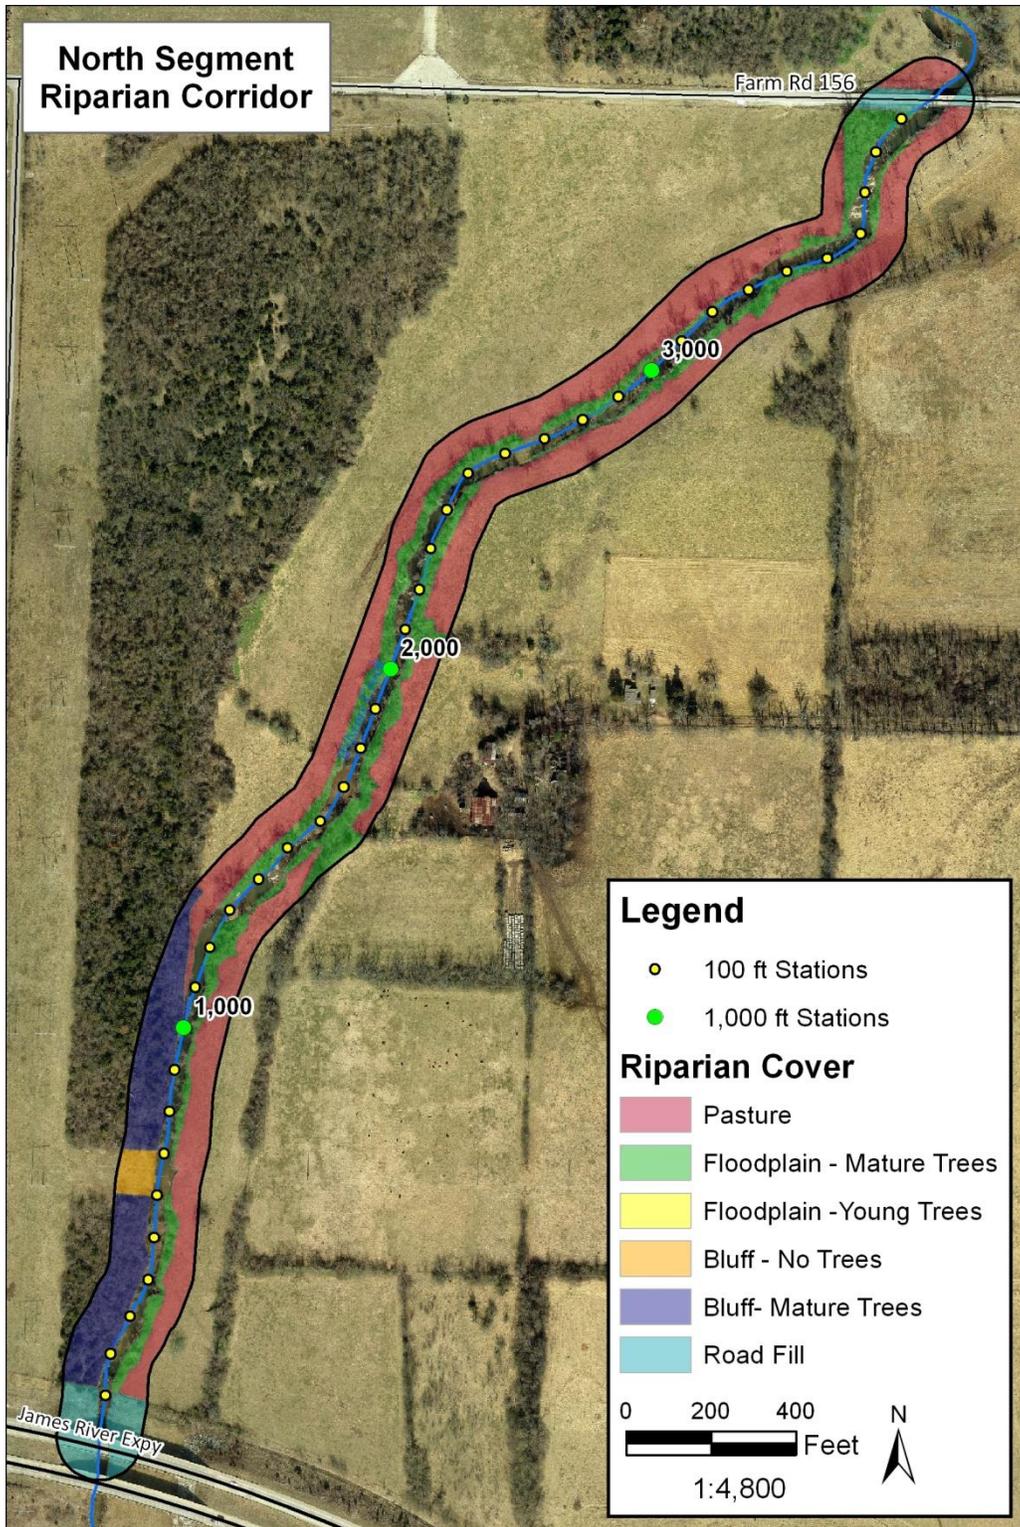
Figure 6. North Segment Riparian Corridor

The riparian corridor was assessed 100 ft on both sides of the centerline of the stream. The buffer through the north segment is mostly pasture with a thin line of mature trees along both banks (Figure 6). The entire buffer area is approximately 15.6 acres with around 8.7 acres of pasture (≈56%). Mature floodplain trees that make up the current thin corridor make up about 3.6 acres (23%) of the entire 100 buffer (Table 2). The vegetation along the bluffs is also mature, with the exception of the powerline easement between 700-600 ft. Also, the road fill along James River Expressway is grass and appears to be periodically maintained.

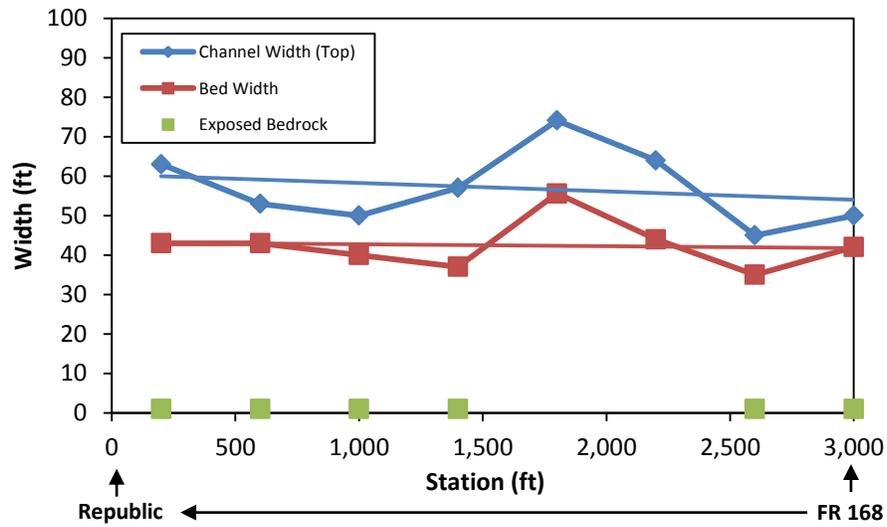
Figure 7. South Segment – Channel Width and Exposed Bedrock

Channel width and bed width increase slightly downstream and bedrock is exposed at the surface along most of the reach (Figure 7). Bed width ranged from 35-55.6 ft and channel width ranged from 45-74.1 ft. Bed and channel widths were higher in the areas of the channel where no bedrock was present in the channel (Stations 1,900-2,300 ft). Banks along the south segment range from 3.3-6.9 ft and appear to be relatively less susceptible to erosion than the north segment with lower bank heights and angles. Bank heights through the south segment would be classified moderate (<6 ft) with the exception of the moderately high bank at station 600 ft (Figure 8). High bank angles were mostly along the right bank though this reach. The highest erosion risk is along the right bank near 600 ft where the height is >6 ft with a steep angle.

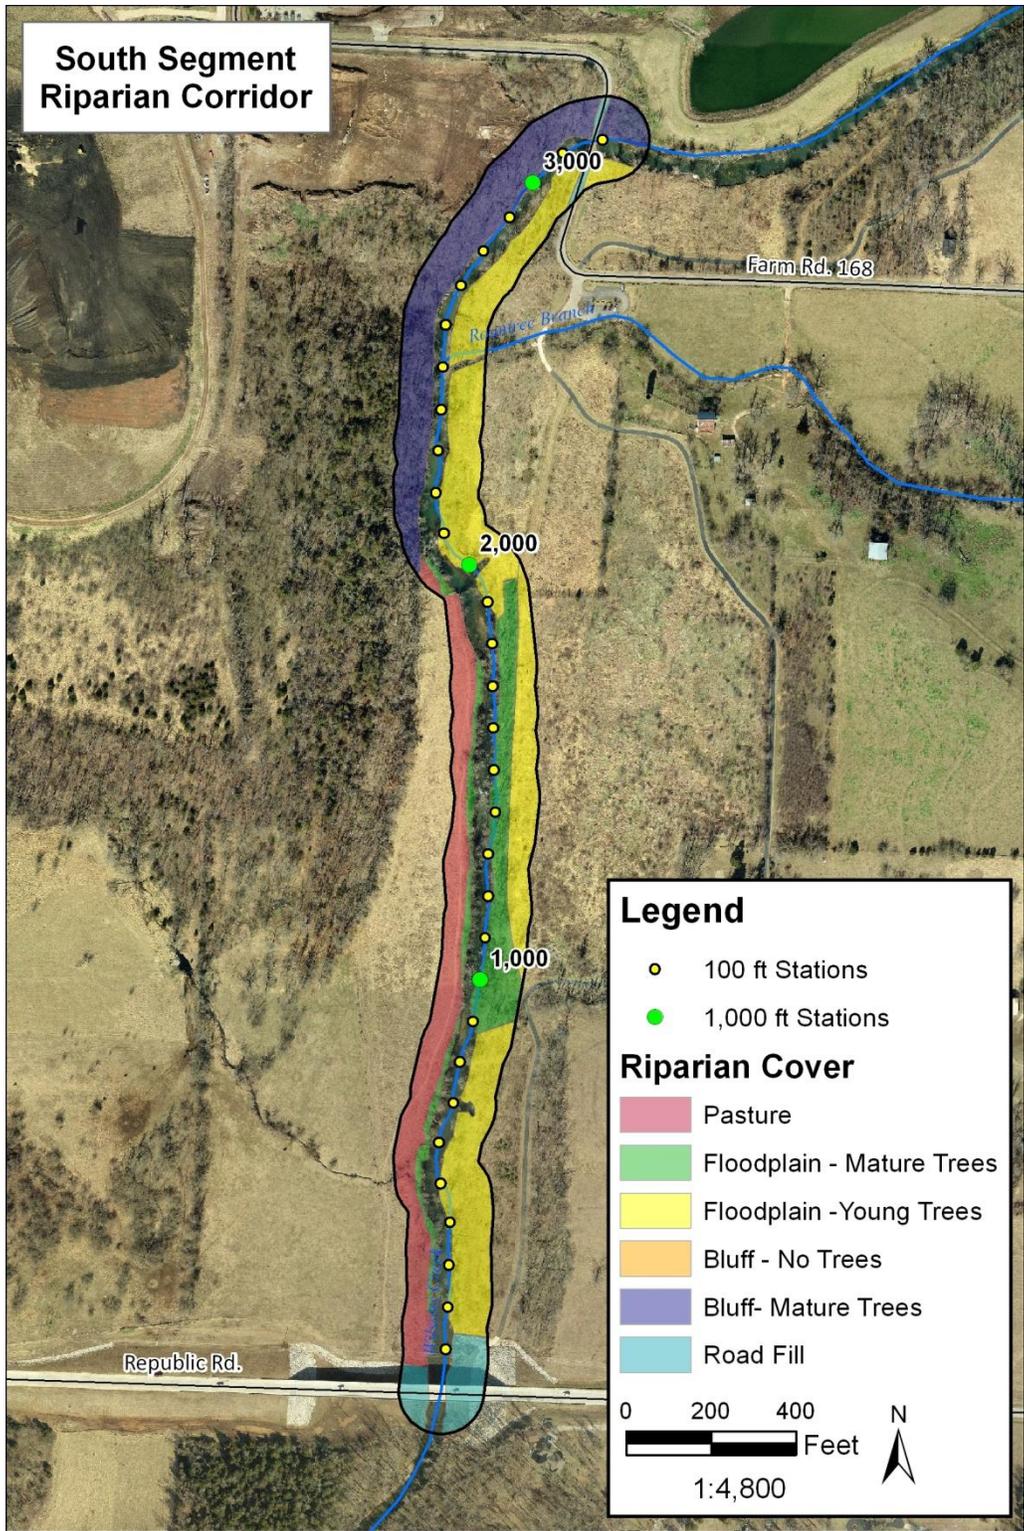
Figure 9. South Segment Riparian Corridor

The riparian corridor through the south segment is much healthier and more mature than the north segment. The east bank in particular is in good shape with a thin line of mature trees flanked by younger trees along the floodplain, likely allowed to grow when the Greenway was established (Figure 9). The upper 1,000 ft of the west side of the stream is bluff covered by mature trees. The remaining 2,000 ft has a thin line of mature trees and grass pasture beyond. The entire buffer area is 12 acres, with 4.8 acres (40.3%) covered by young trees on the floodplain (Table 3). The bluff is 2.5 acres (20.8%) of the buffer and the grass pasture makes up about 2.3 acres (19%) of the buffer. The remaining 0.7 acres (5.9%) is the road fill near Republic Road.
