Long-Term Impact of Exploitative Logging on Forest Watershed Hydrology in the Missouri Ozarks

Marc R. Owen, Shoukat Ahmed, Sierra N. Casagrand, and Robert T. Pavlowsky
Ozarks Environmental and Water Resources Institute (OEWRi)
Department of Geography, Geology, and Planning
Missouri State University

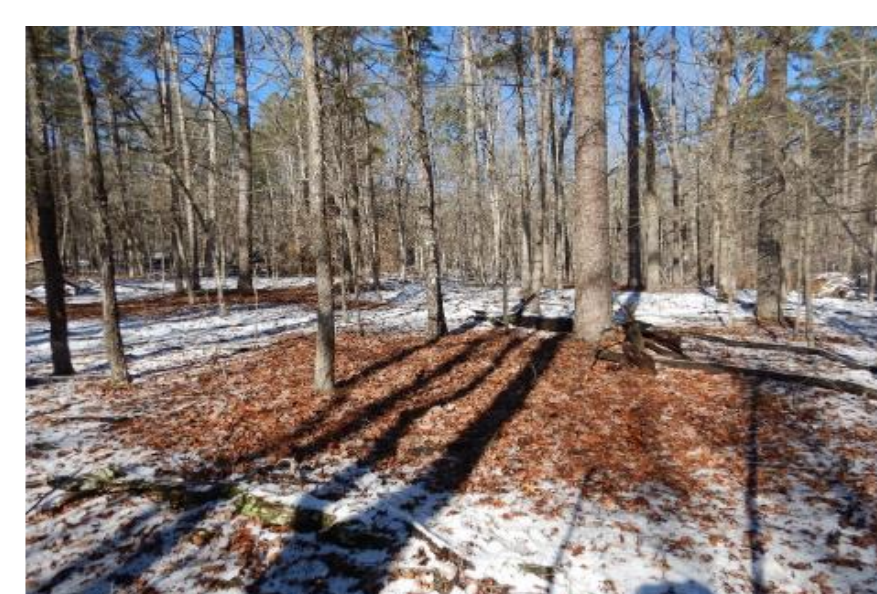
Photo 1. Example of pines intercepting light snowfall in winter.

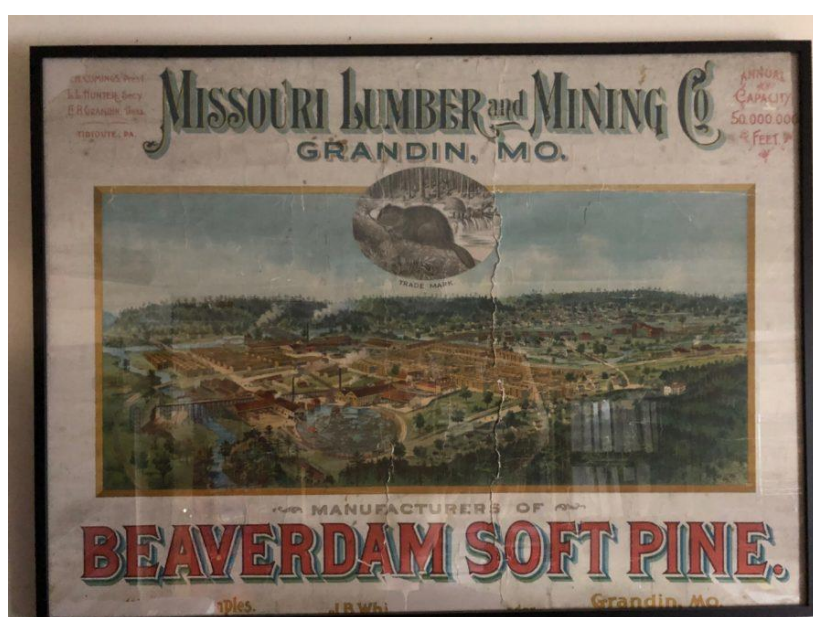
Photo 6. (above) Tram railways were used to move saw logs across the Current River to the mill at Grandin. (from Western Historical Manuscripts Collection—University of Missouri)

- During peak production, roughly 70 acres of trees were cut daily to feed the operation and logs were transported to the mill on tram railways (Photo 6).

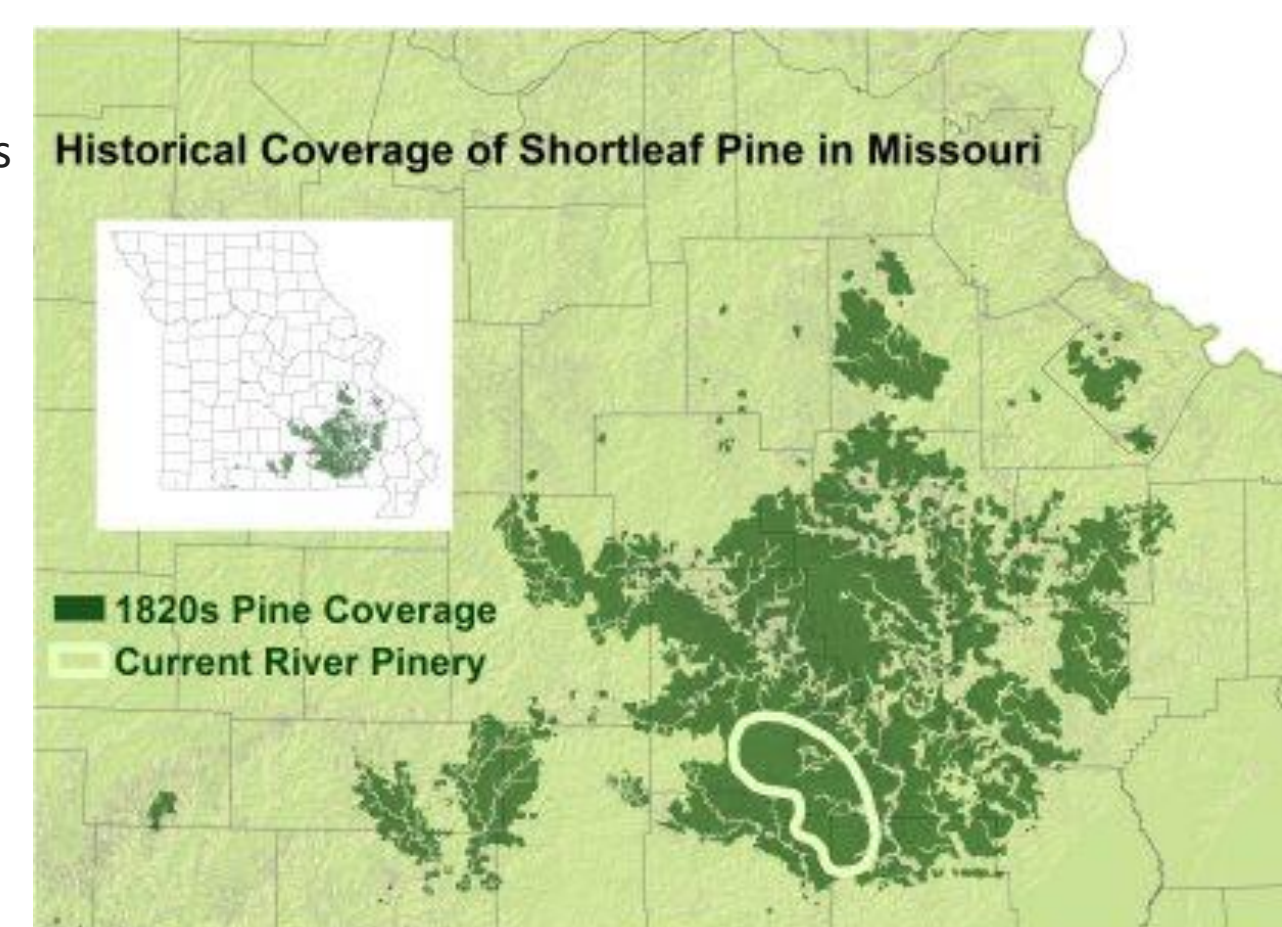
Figure 4. Map showing the native distribution of shortleaf pine in southeast Missouri in the 1820s. (from <https://oakfrescience.com>)

- Shortleaf pine was once the dominant tree species in local forests that was targeted by commercial logging and today only 10% of the pre-settlement pine forest remains (Photo 7 and Figure 4).

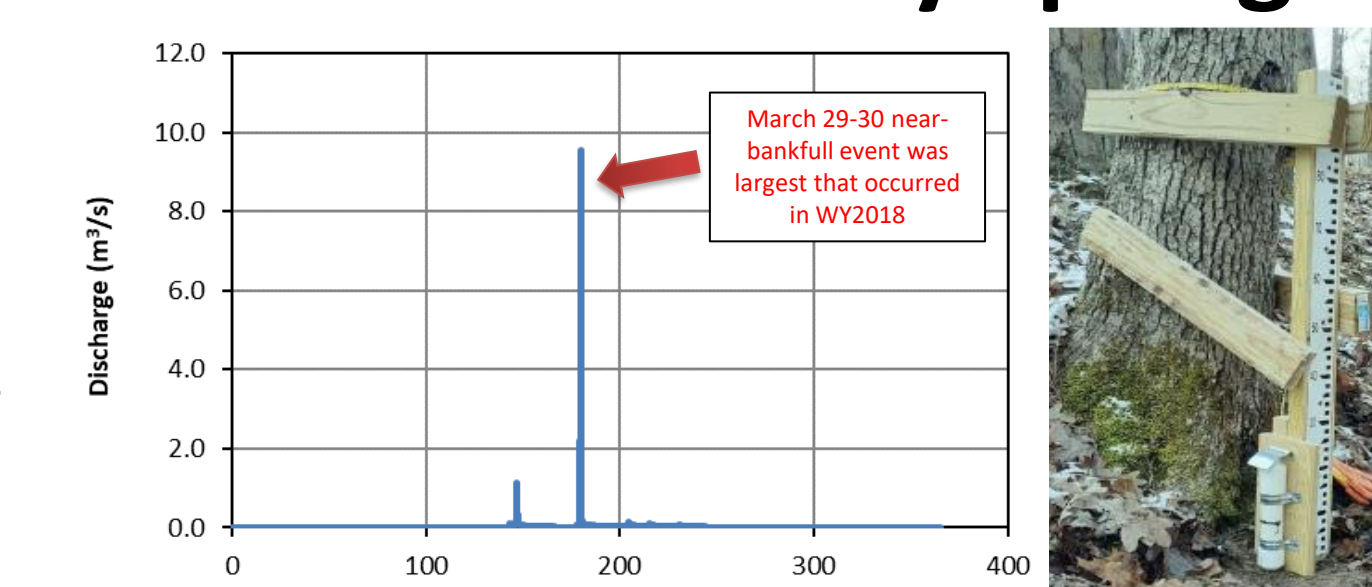
Figure 8. Annual hydrograph for WY2018 showing only two significant flood events over the year. Photo shows an example of gaging station installed in sub-basins within the watershed.

- A model were developed to test how the increase in pines within the watershed could influence runoff during a bankfull event during leaf-off conditions (Figure 8).
- A series of storms from March 27th-30th, 2018 produced 12.5 cm of rainfall and a near-bankfull flood used in the simulation.
- Model was calibrated to field data with runoff and peak discharge within 10% of observed (Figure 9).
- Two pre-settlement scenarios were tested: 1) with 3x greater pine cover than today by sub-watershed; and 2) 100% pine cover.
- Scenario 1 – Modern runoff depth, peak discharge, and cross-sectional stream power increased 7-17% compared to pre-settlement #1 (Figure 9 and Table 1).
- Scenario 2 – Modern runoff depth, peak discharge, and cross-sectional stream power increased 25-37% compared to pre-settlement #2.

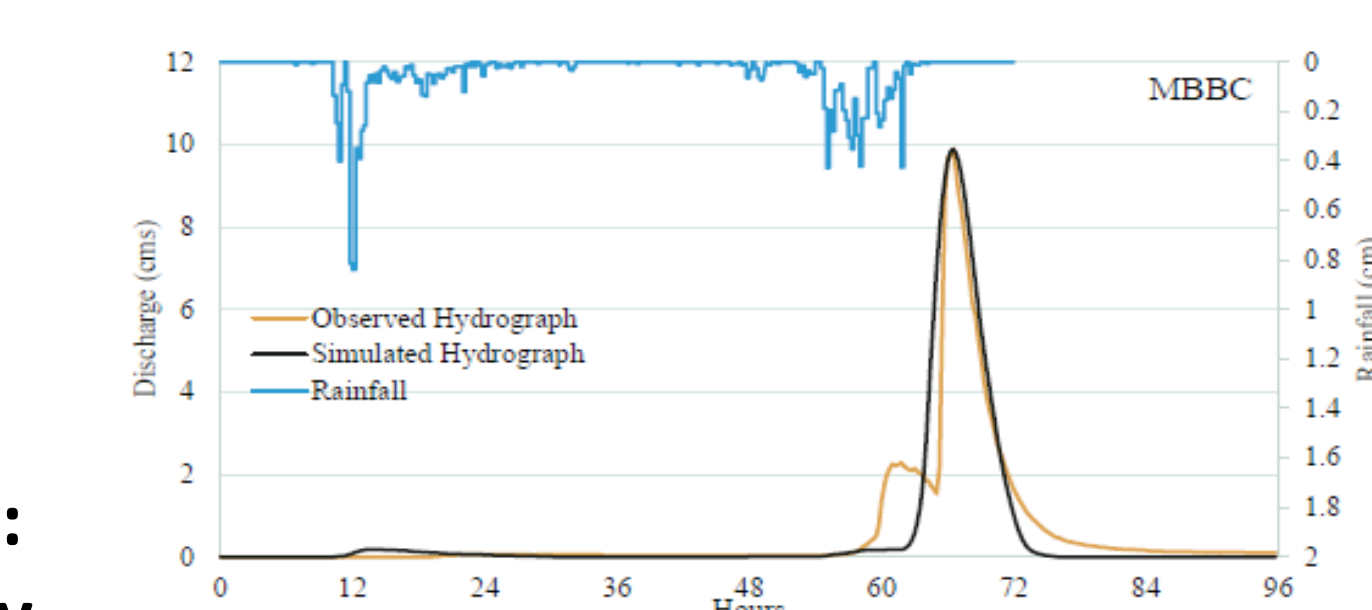
Figure 9. Simulated and observed hydrograph and rainfall.

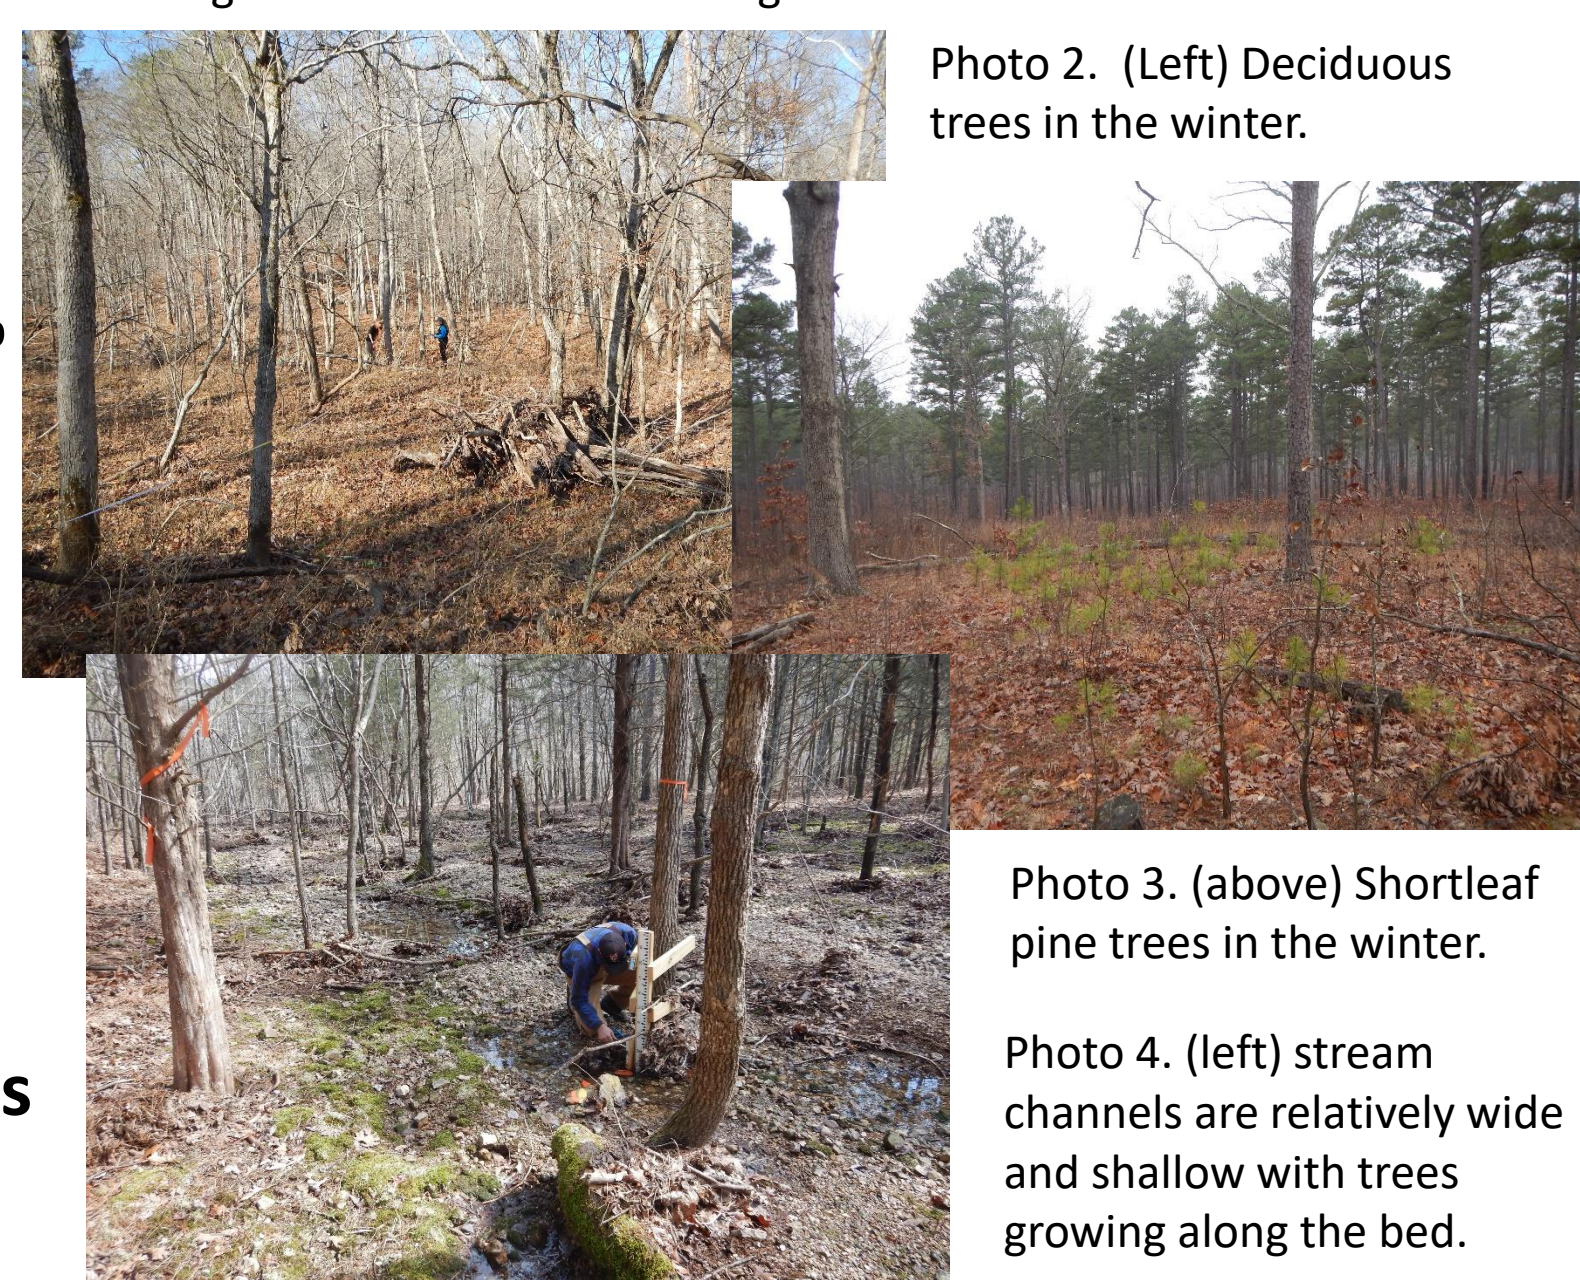
Photo 2. (Left) Deciduous trees in the winter.

Photo 3. (above) Shortleaf pine trees in the winter.

Photo 4. (left) stream channels are relatively wide and shallow with trees growing along the bed.

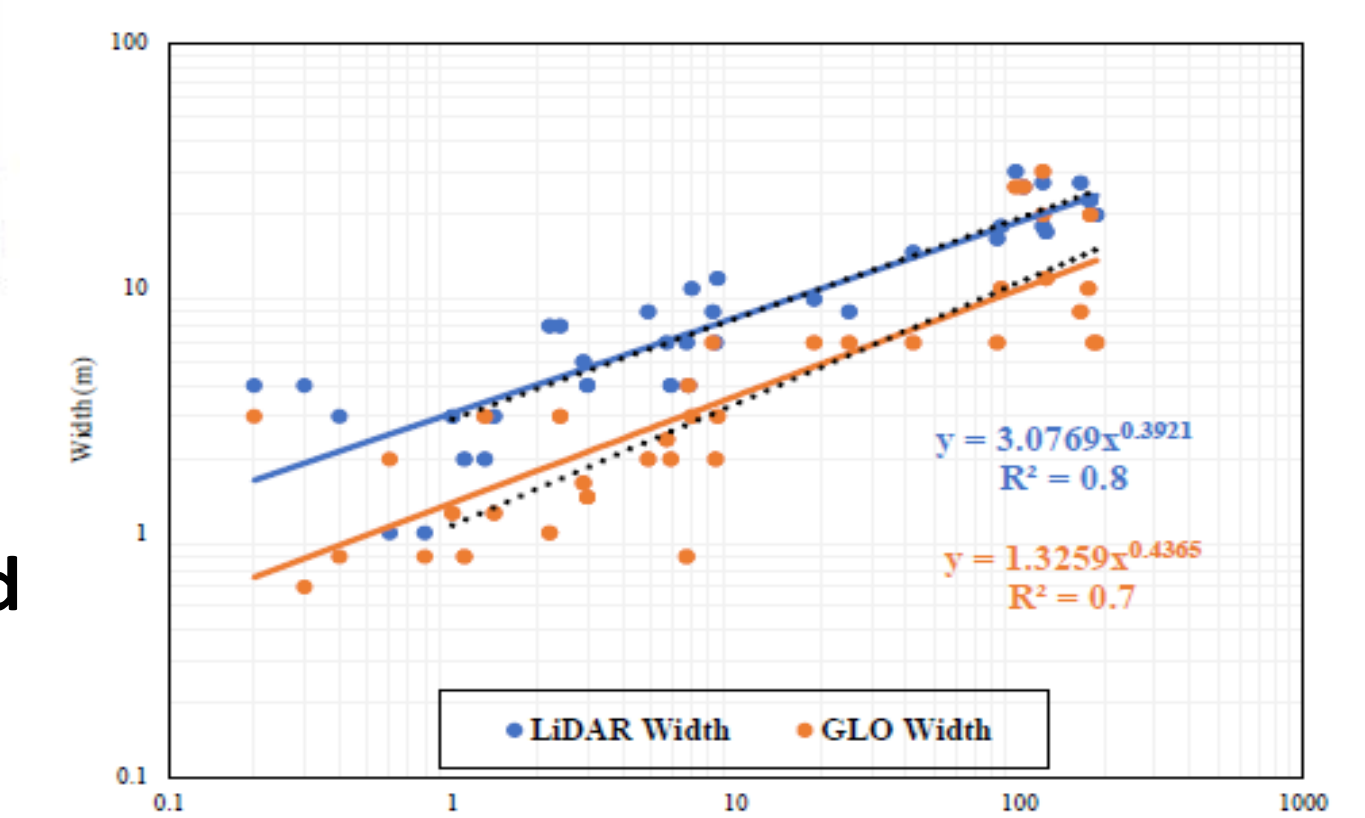
Figure 7. GLO recorded width from 1821 compared to modern LiDAR derived width.

- Overall, modern widths were on average 2.6 times larger than in 1821 (Figure 7).
- The largest increase was in 2nd order streams averaging 3.4-fold increase.
