**The Ozarks Environmental and Water Resources Institute (OEWRI)
Missouri State University (MSU)**

Big River Mining Sediment Assessment Project

Big River Borrow Pit Monitoring Project

FINAL REPORT

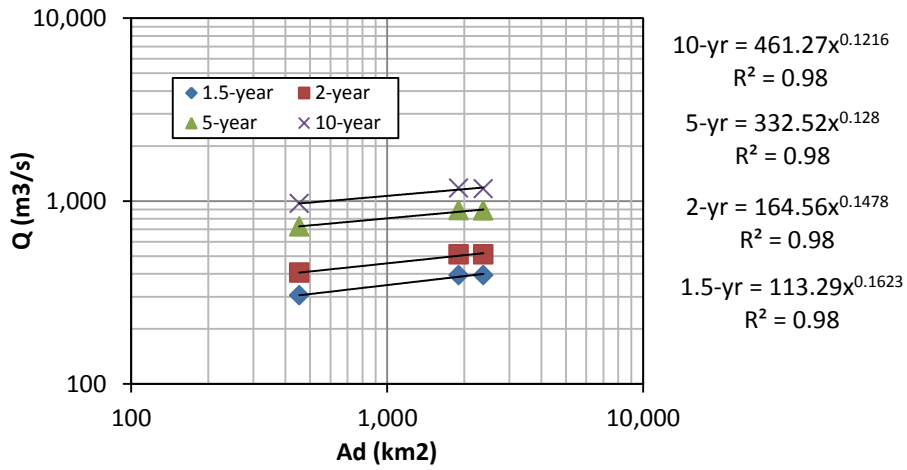
Figure 6. Downstream Flood Frequency Analysis for Big River Gages.

Flood frequency was estimated for the Bar Site using regression equations based on interval discharges and drainage area relationships at the three USGS gages for the 1.5-yr, 2-yr, 5-yr, and 10-yr floods (Figure 6).

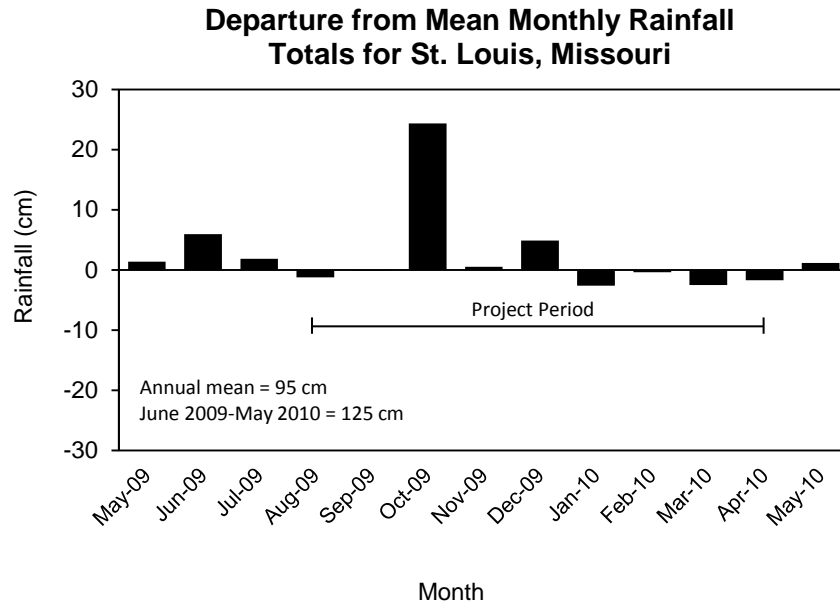
Figure 8. Project Period Rainfall Compared to Historical Rainfall Records From St. Louis, Missouri.

October 2009 was extraordinarily wet for eastern Missouri with >4 times (24 cm) more rainfall than the mean monthly total expected for St. Louis (Figure 8). Over the 9 month long monitoring period the area experienced approximately 30% more rainfall than the average annual total resulting in 16 high water events that exceeded the mean annual discharge ($5.5 \text{ m}^3/\text{s}$) at the Irondale gage (Figure 9). Four high water events reached or exceeded the 1-yr flood discharge ($\approx 180 \text{ m}^3/\text{s}$). However, only one of these was an overbank flood event which occurred on October 30th, producing a peak discharge of $980 \text{ m}^3/\text{s}$ at the Irondale gage, which is about the 10-yr flood event. This event inundated the floodplain at the Bar Site to a depth of about 4 m. The pre-excavation surveys and excavation occurred prior to these high water events, during a seasonal dry period. However, two weeks after the excavation (before the post-excavation survey was conducted), two small high water events resulted in a river stage near the critical flow depth.

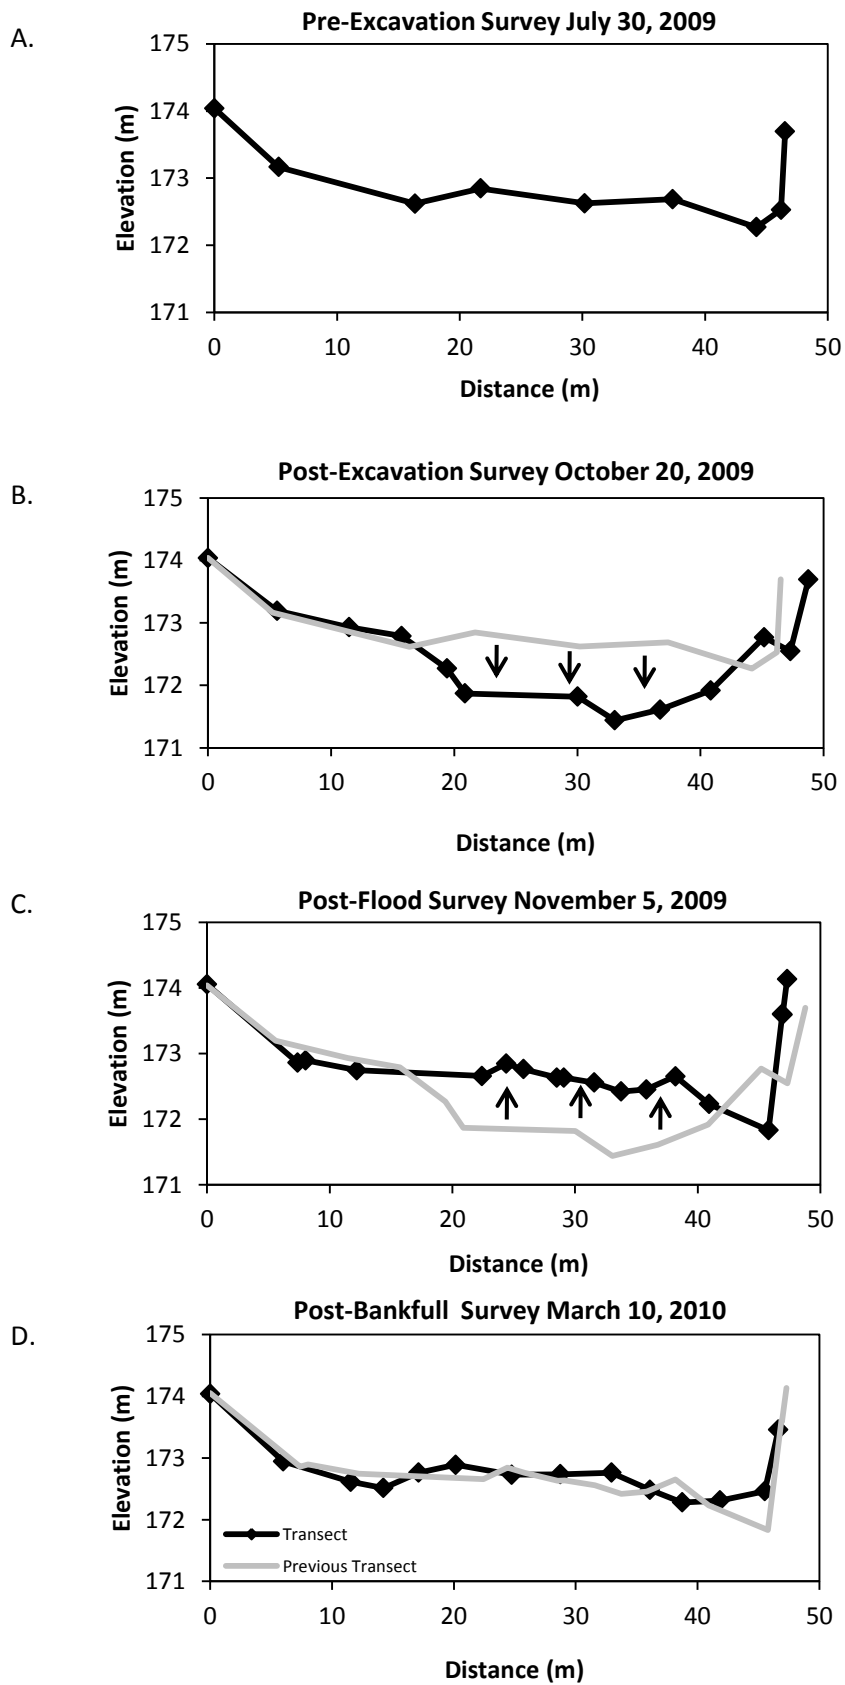
Figure 10. Changes in Bone Hole Cross-Section at Station R-km 165.4 in the A.) Pre-Excavation Survey, B.) Post-Excavation Survey, C.) Post-Flood Survey and D.) Post-Bankfull Survey.

Pre-Excavation Survey. On July 30, 2009 the pre-excavation survey was performed at the Bone Hole. Without prior knowledge of the specific location and extent of the excavation, the survey extended from just above Owl Creek confluence to the low-water bridge, assuming that excavation activities would not occur upstream of the tributary. Channel deposits tend to accumulate as aggraded channel fill upstream of low-water bridge dams where the channel is relatively wide with low slope. As the flow shallows and spreads over the bridge, turbulence appears to cause scour along the sides of the channel in the bank toe area resulting in deposition of a center bar (Figures 4 and 10a). This split thalweg pattern is typically formed where diverging flows occur in over-widened channel sections, particularly where slope breaks and transport capacity decreases behind the dam (Rosgen, 1996; Knighton, 1998). In addition, a small scour pool has formed immediately below the confluence of Owl Creek near the southwest edge of the survey area and may also contribute to the divergent flow pattern indicated at this site. The bed conditions along the western portion of the survey area are transitional and grade from a relatively deep pool located upstream of the survey area into a pool tail and depositional zones within the project area (Figure 10a).

Post-Flood Survey. On October 30th a large flood with a 10-yr recurrence interval occurred in the Big River. A post-flood survey performed on November 5 shows the sediment volume in the excavation pit increased by $+326 \text{ m}^3$ ($+426 \text{ yd}^3$), almost completely filling in the pit to within 62 m^3 or 16% of the pre-excavation condition (Figures 10c and 11). At the reach-scale, -206 m^3 (-269 yds^3) of additional sediment was removed by the flood over the same period, bringing the total amount of sediment lost over the monitoring period to nearly -400 m^3 . This suggests that, despite the in-filling of the excavation pit, there was a net decrease in stored channel material in the monitoring reach caused by the large flood. As described above, this result is likely due to the extensive scour that took place at the upstream end of the survey reach, out of the excavation area. This bed form pattern from the post-flood survey is similar to that observed prior to excavation suggesting that the channel is recovering to the pre-excavation scour/deposition pattern (Figure 10c). Nevertheless, the large flood caused further bed erosion by deepening and extending the upstream pool tail into the survey reach. Large floods have the capacity to erode, transport, and deposit a volume of sediment greater than the amount of material removed for the borrow pity in a single event.

larger scale changes in sediment supply and transport in the Big River. However, it appears the channel in the vicinity of the excavation pit has returned to its pre-excavation condition indicating that borrow pit recovery by sedimentation occurred in less than 9 months at this site, albeit most of the re-deposition was associated with one 10-yr flood event, which would not be expected in an “average” year (Figure 10d).

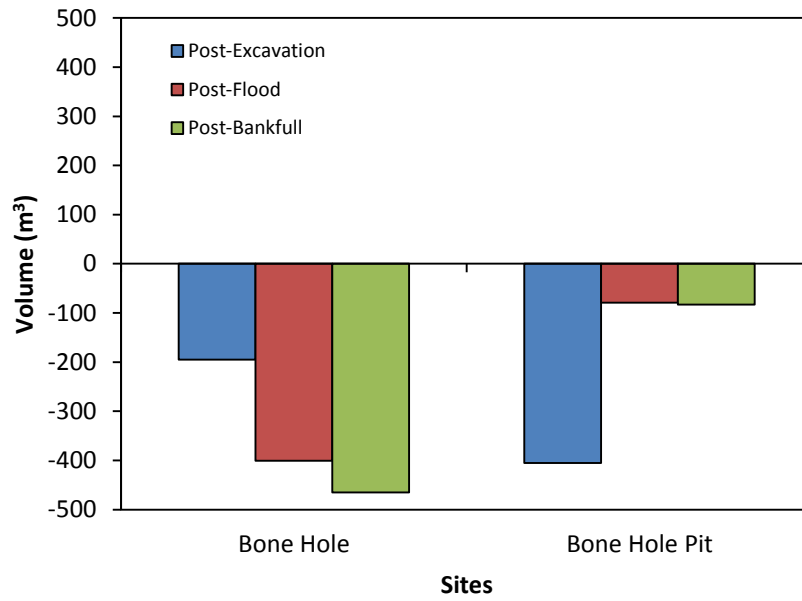
Figure 11. Absolute Volume Changes Measured at the Bone Hole Relative to Pre-Excavation Condition.

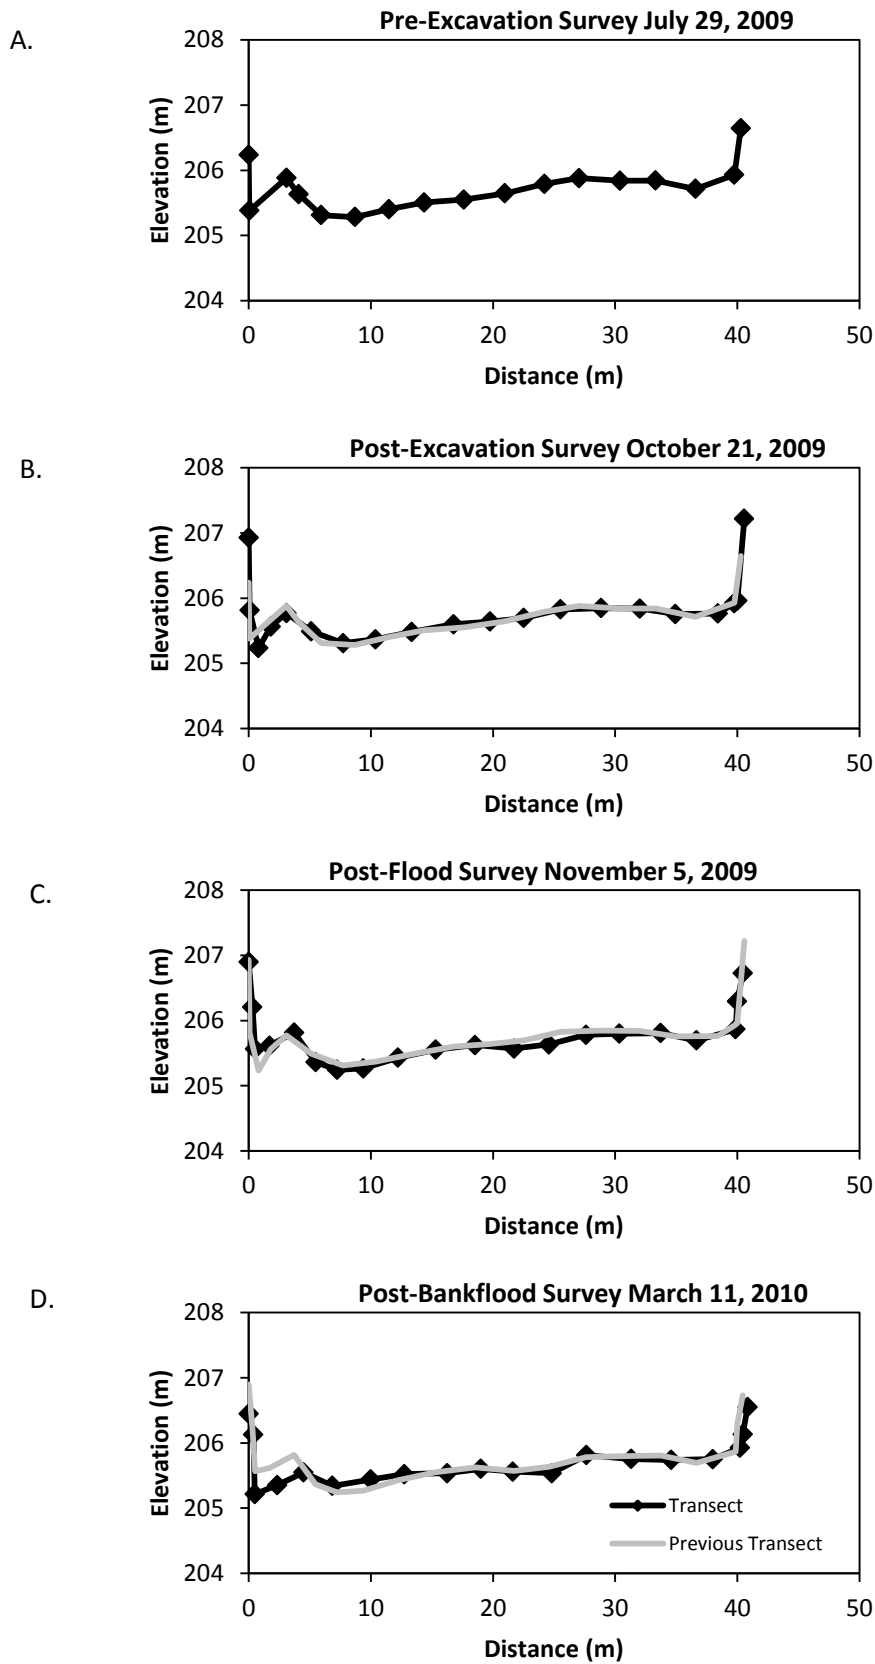
Figure 12. Changes at the Bar Head, Cross-Section at Station R-km 163.4 in the A.) Pre-Excavation Survey, B.) Post-Excavation Survey, C.) Post-Flood Survey and D.) Post-Bankfull Survey.

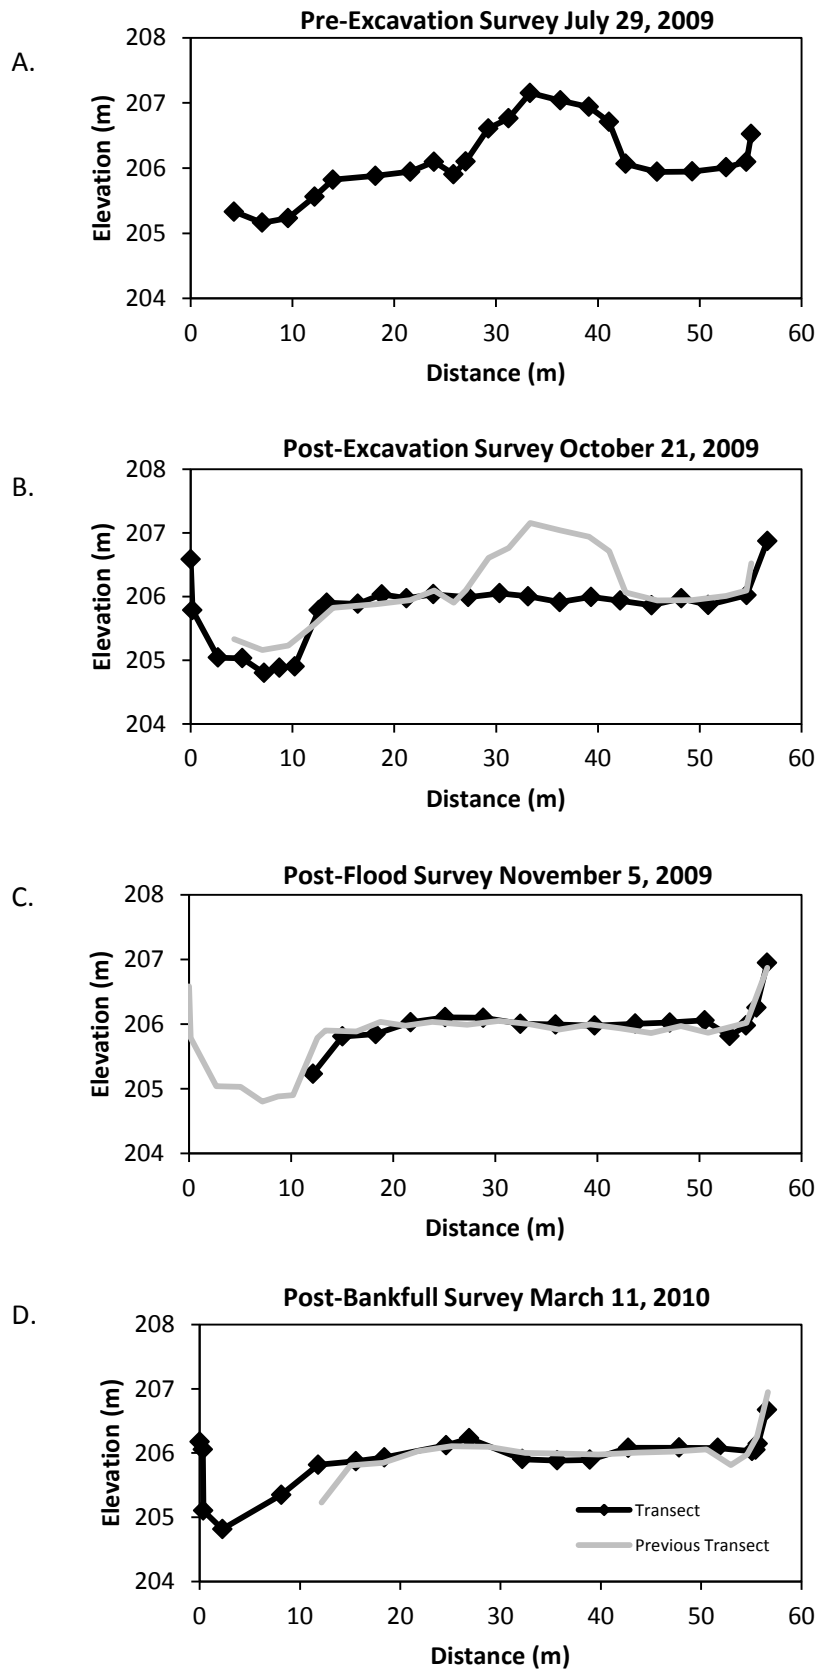
Figure 13. Changes at the Bar Middle, Cross-Section at Station R-km 163.4 in the A.) Pre-Excavation Survey, B.) Post-Excavation Survey, C.) Post-Flood Survey and D.) Post-Bankfull Survey.

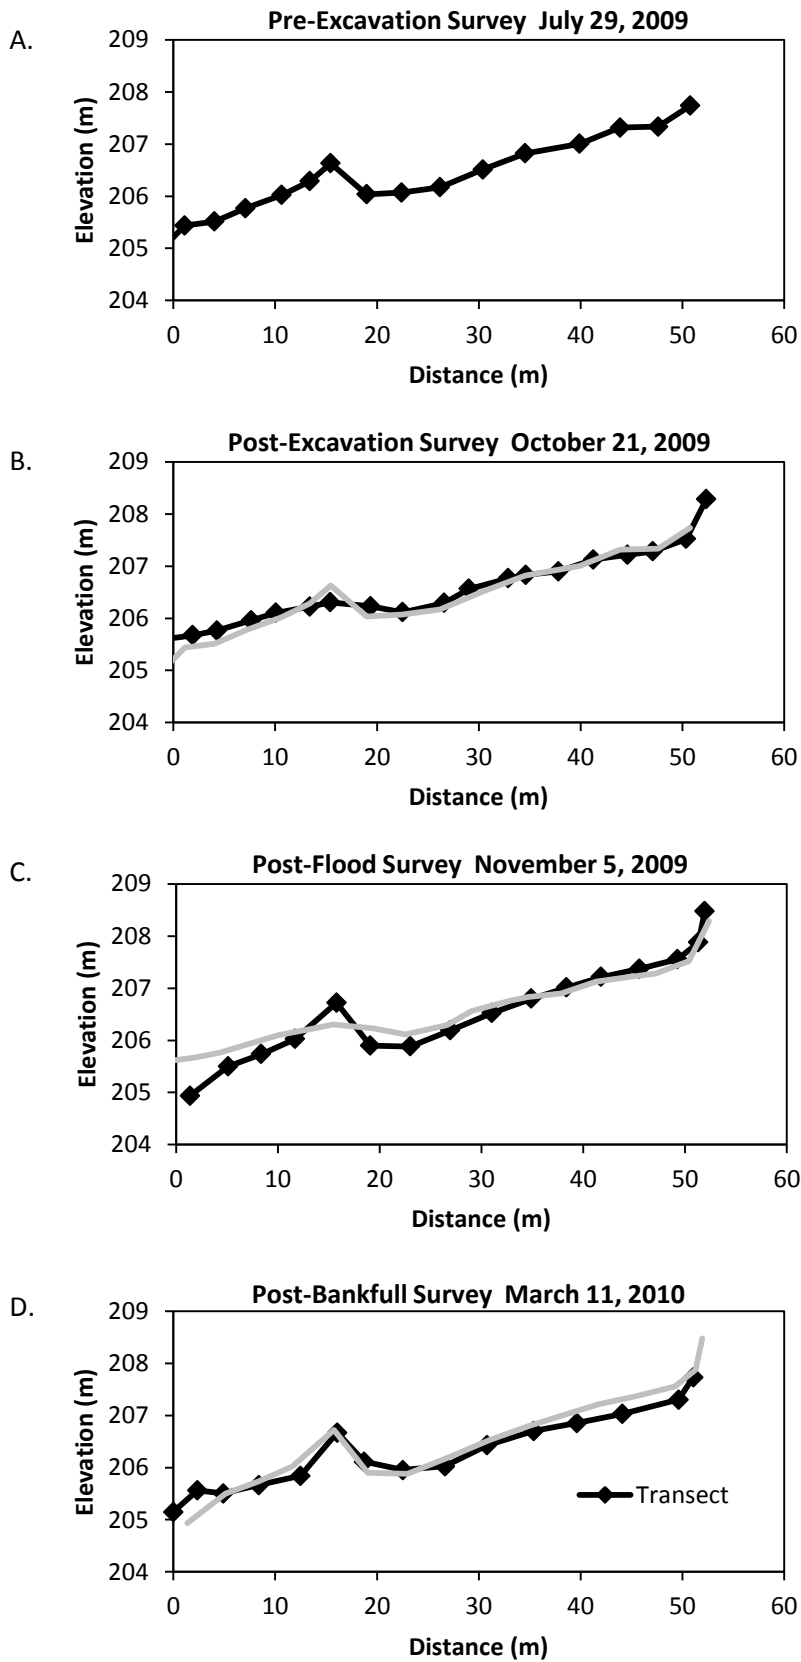
Figure 14. Changes at the Bar Tail, Cross-Section at Station R-km 163.4 in the A.) Pre-Excavation Survey, B.) Post-Excavation Survey, C.) Post-Flood Survey and D.) Post-Bankfull Survey.

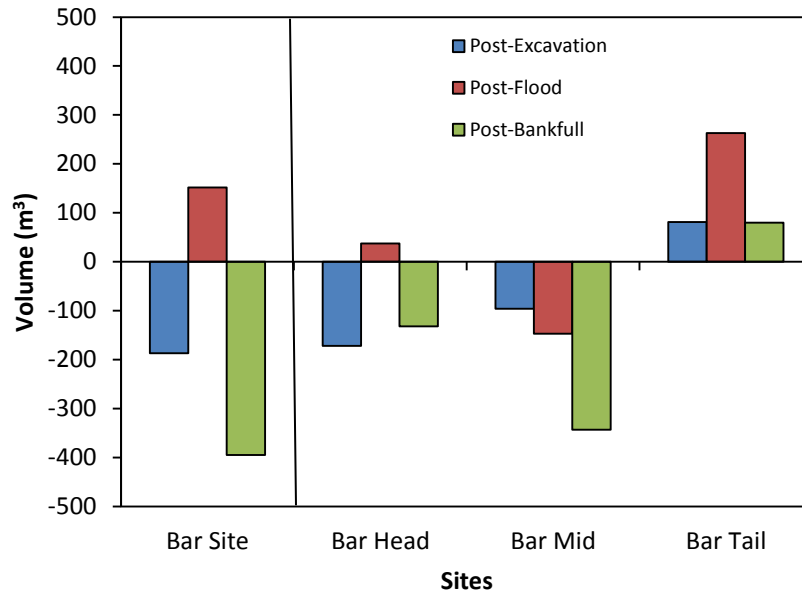
Figure 15. Absolute Changes in Measured Volume at the Bar Site Relative to Pre-Excavation Condition.

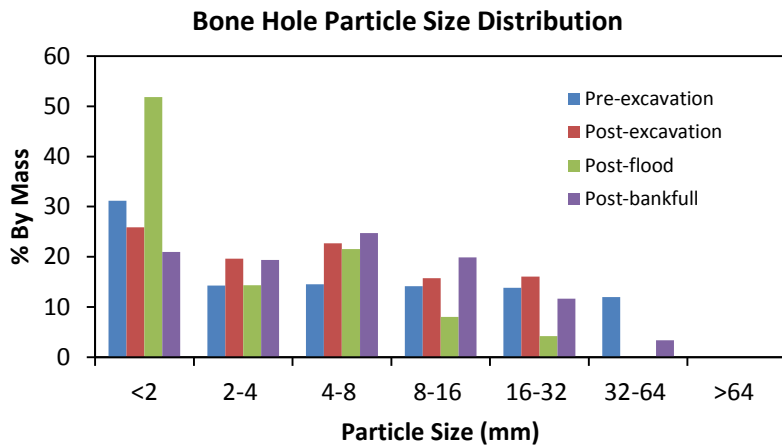
Figure 16. Average Particle Size Distribution from Samples Collected From the Bone Hole.

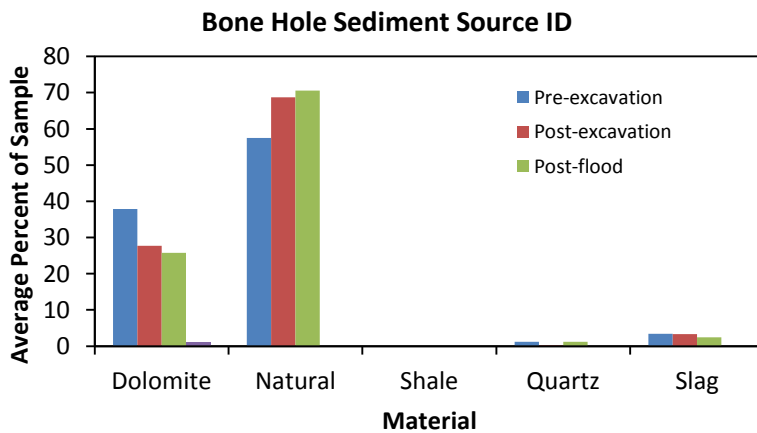
Figure 17. Sediment Composition of Samples Collected From the Bone Hole.

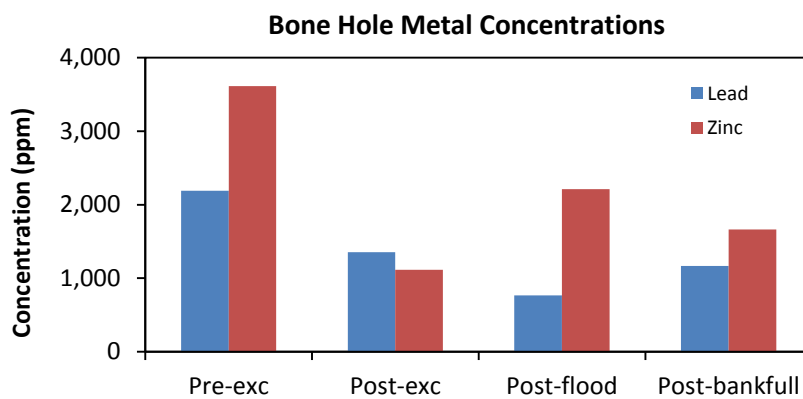
Figure 18. Average Concentration of Metals in Samples Collected From the Bone Hole.

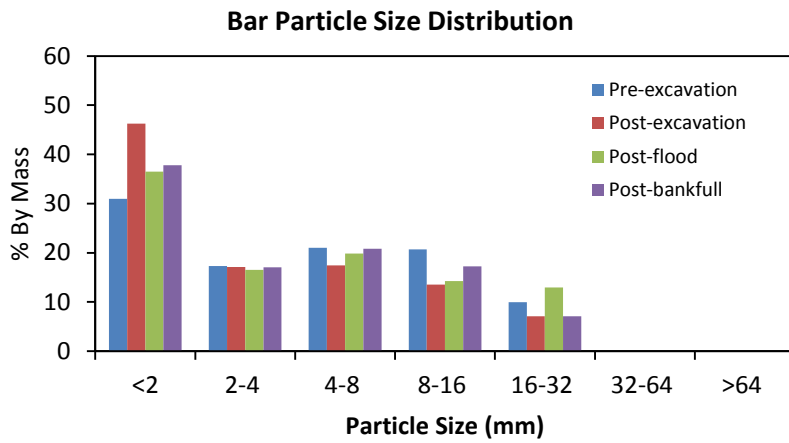
Figure 19. Average Particle-Size Distribution From Samples Collected at the Bar Site.

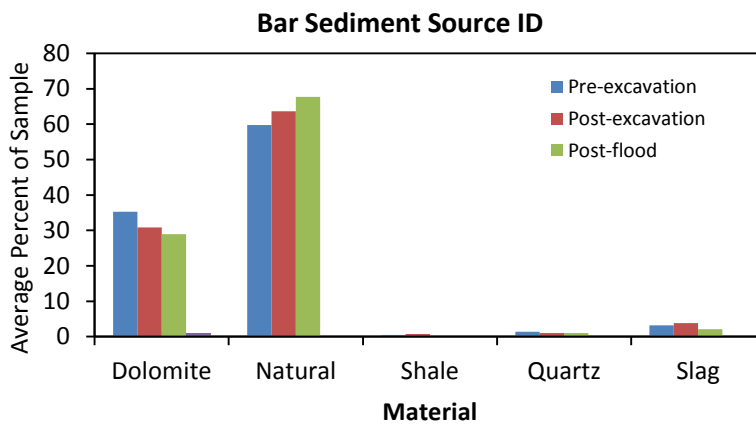
Figure 20. Sediment Composition of Samples Collected at the Bar Site.

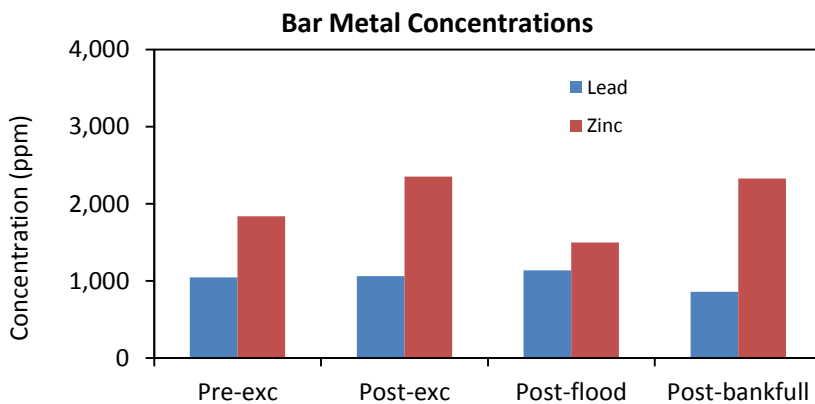
Figure 21. Average Concentration of Metals in Samples Collected From the Bar Site.

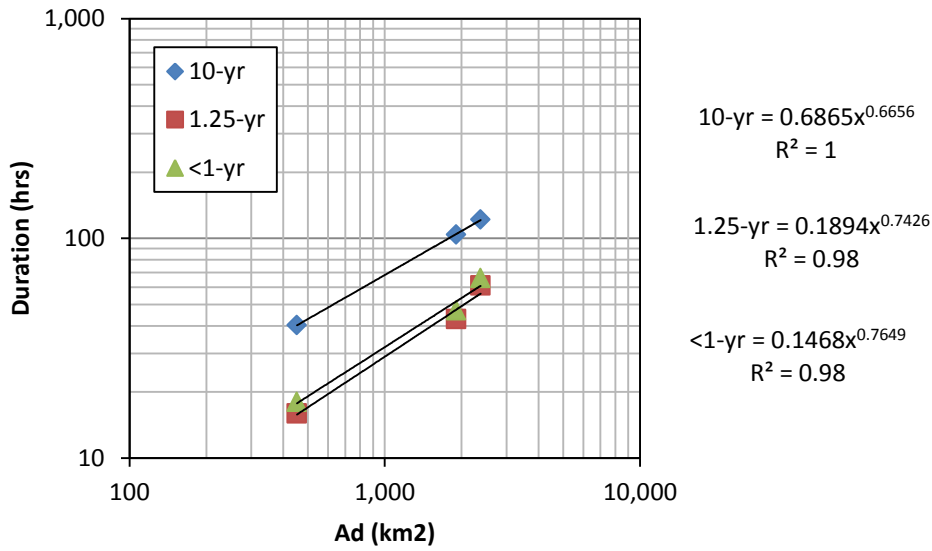
Figure 22. Drainage Area-Duration Relationships the A.) Base and B.) 95% Peak from Hydrographs for Selected Floods at Big River Gages.

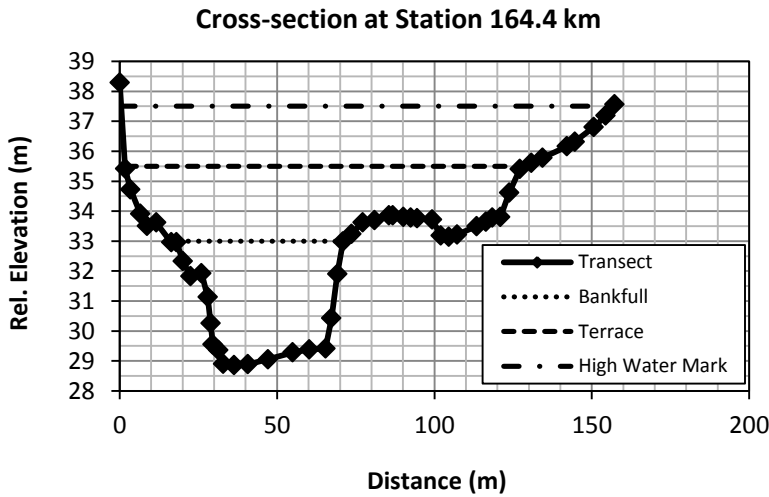
Figure 23. Channel Hydrologic Characteristics at Station R-km 163.4 Near the Bar Site Cross-Section.

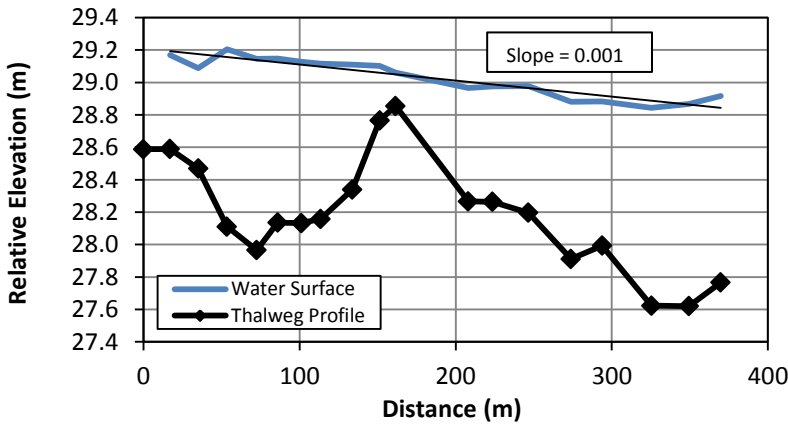
Figure 24. Longitudinal Profile at the Bar Site.

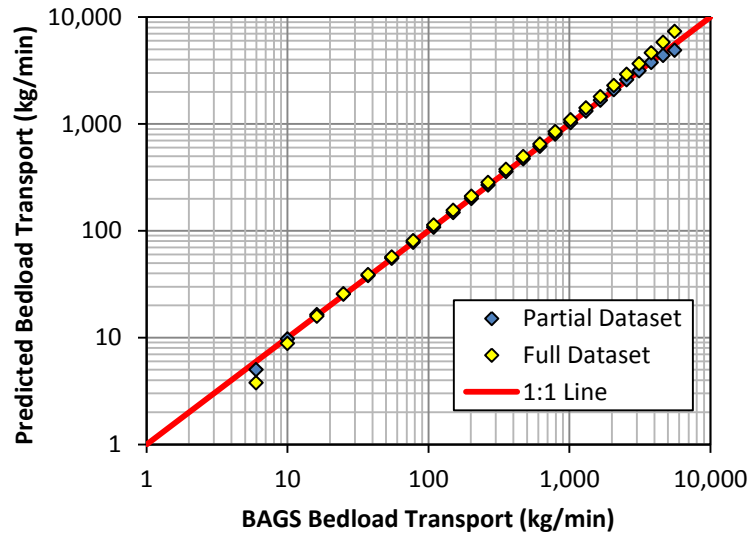
Figure 26. Bedload Transport Rating Curve Evaluation A.) Rating Curve and B.) Analysis of Model Fit Comparing Both Full and Partial Datasets.

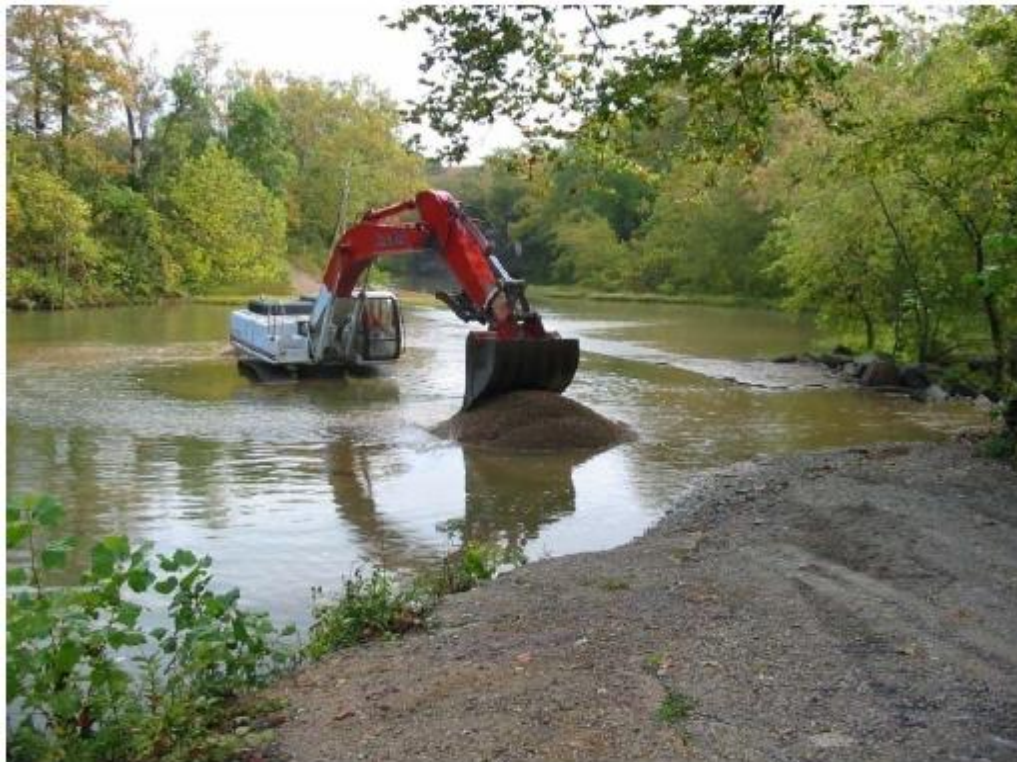
Excavation activities at the Bone Hole site are consistent with post-excavation survey results. (Photos from HGL Field Oversight Report).

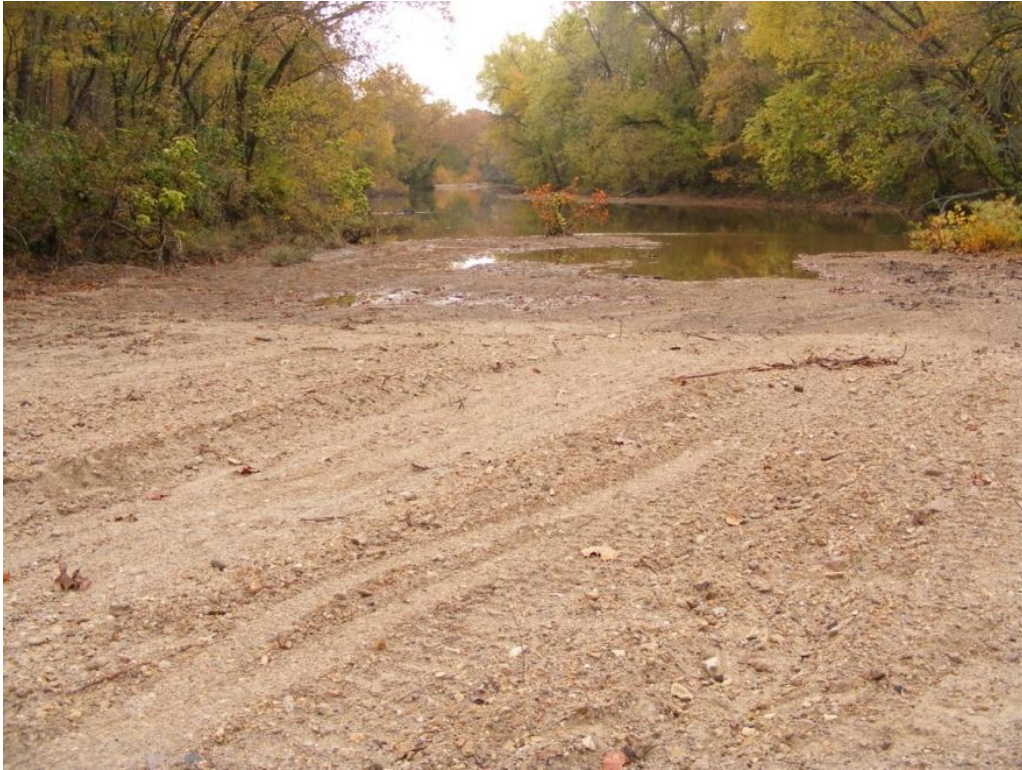
Looking upstream across excavated bar head. Notice excavator tracks and flat topography.

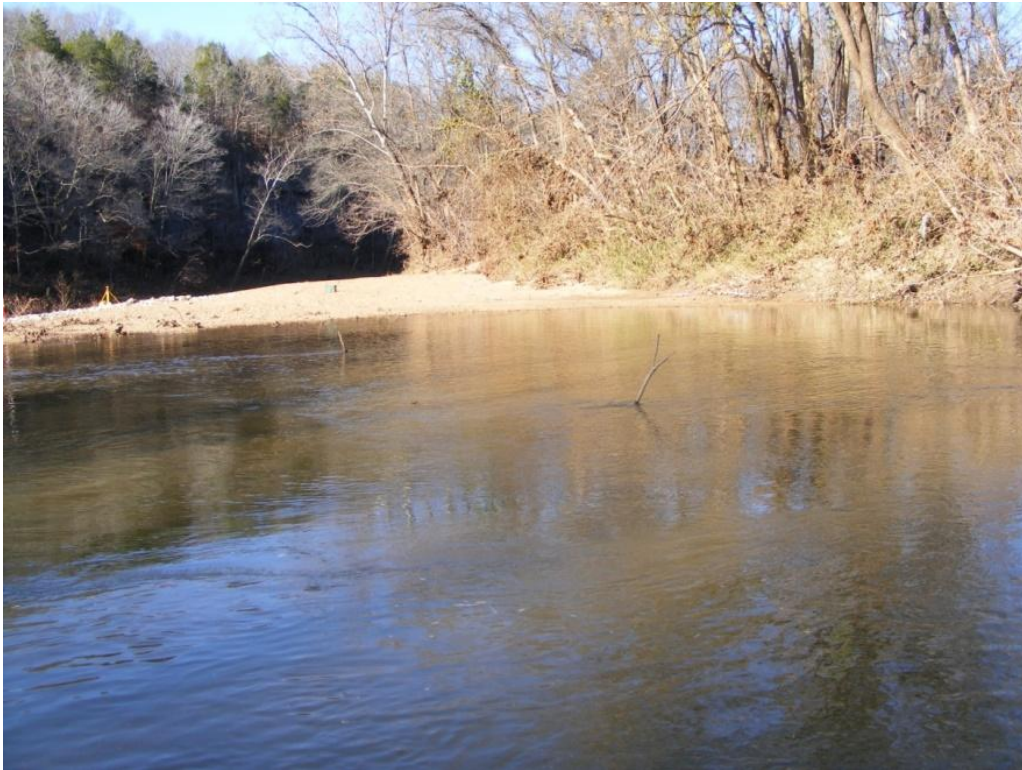
Looking downstream at bar head, post-flood.
