**LONG-TERM HYDROLOGICAL IMPACTS OF HISTORICAL LOGGING ON
RECENT HYDRO-GEOMORPHIC CONDITIONS, BIG BARREN CREEK
WATERSHED, MARK TWAIN NATIONAL FOREST**

A Master's Thesis

Shoukat Ahmed

July 2021

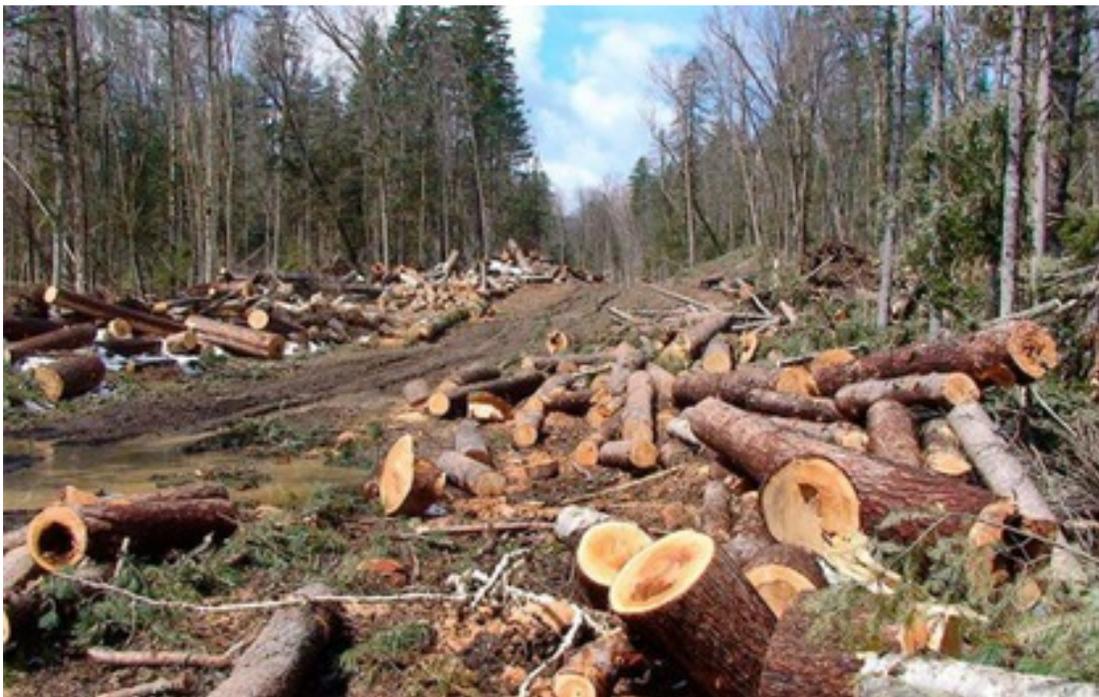
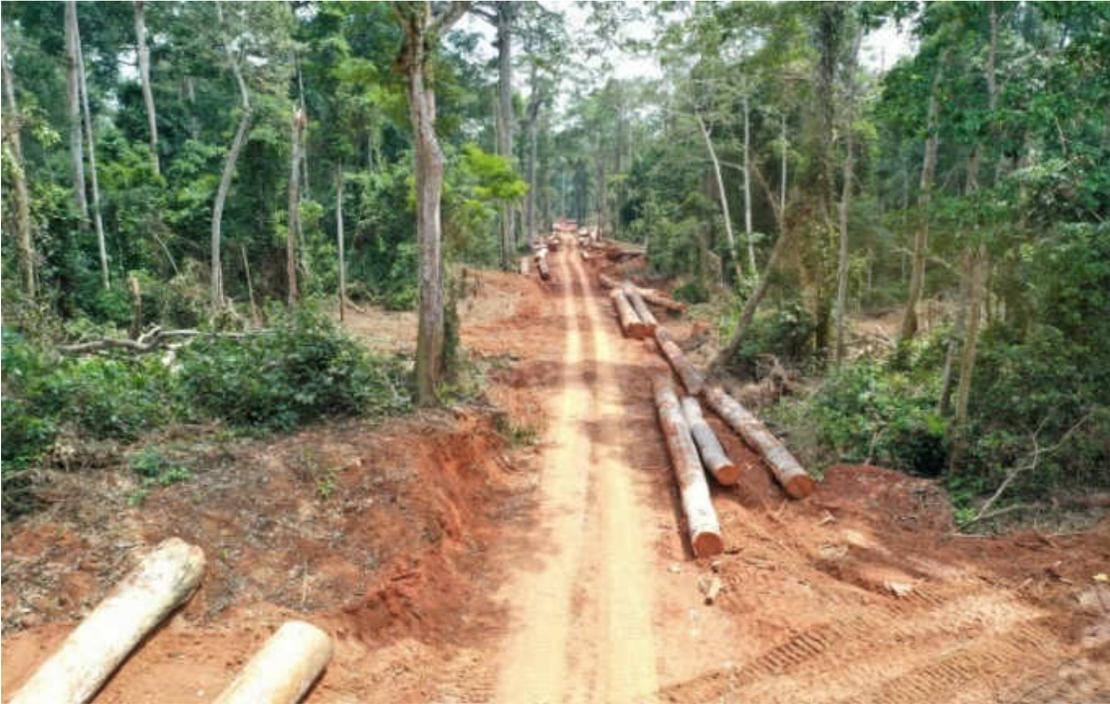
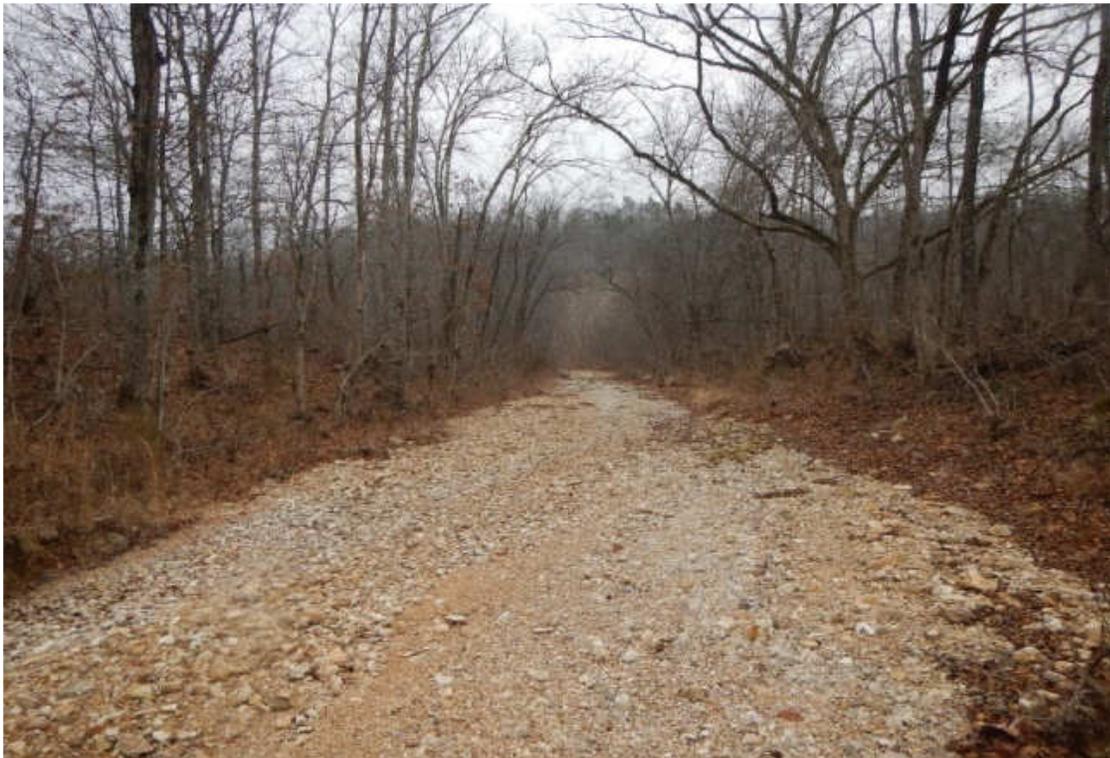
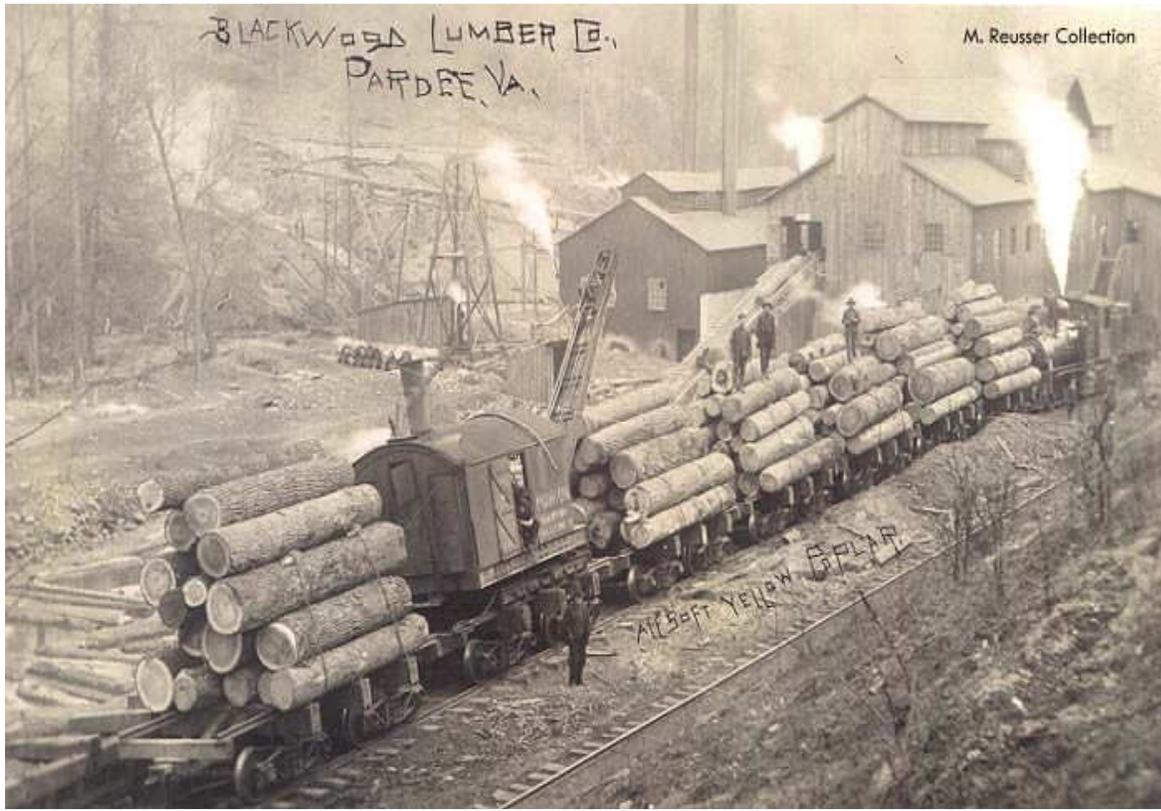
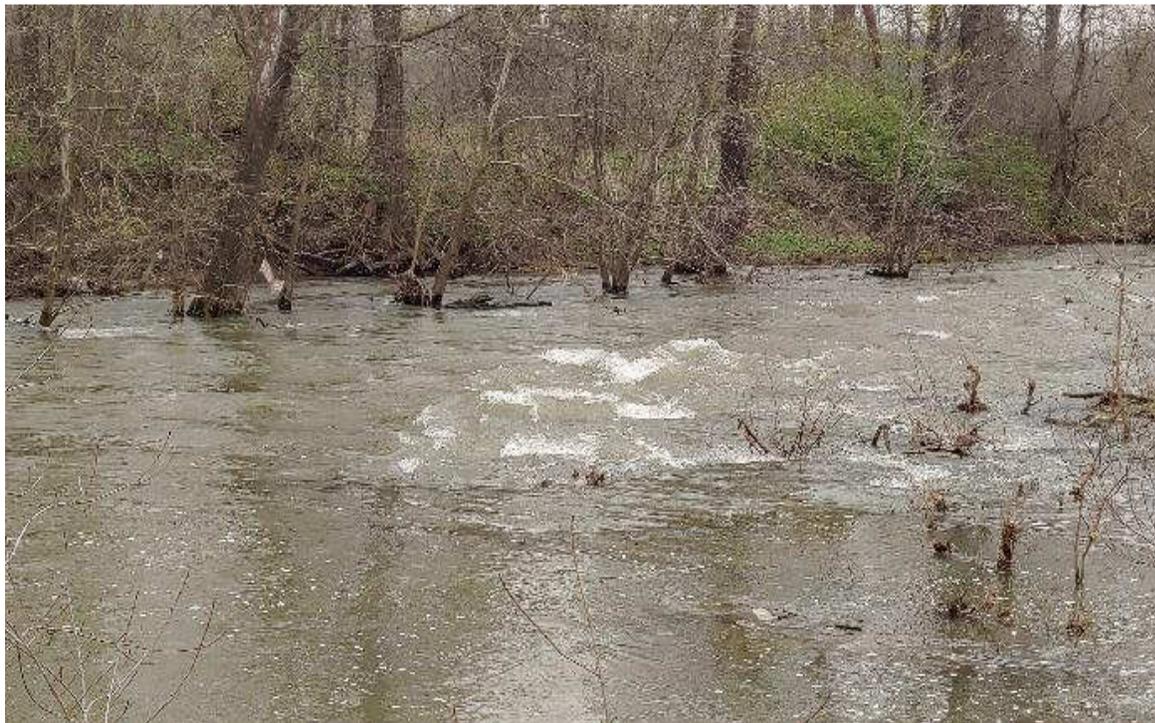
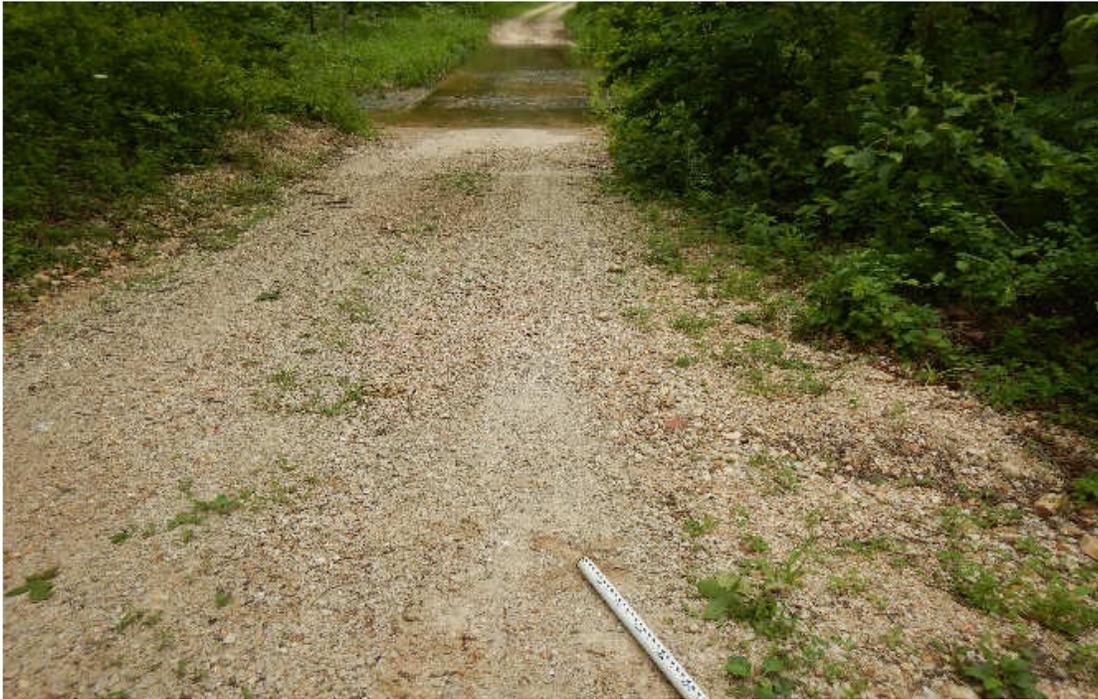
Figure 1: Forest disturbances. (A) timber harvesting; (B) logging road; (C) stream channelization; (D) logging railbeds; (E) flooding; (F) road crossing.

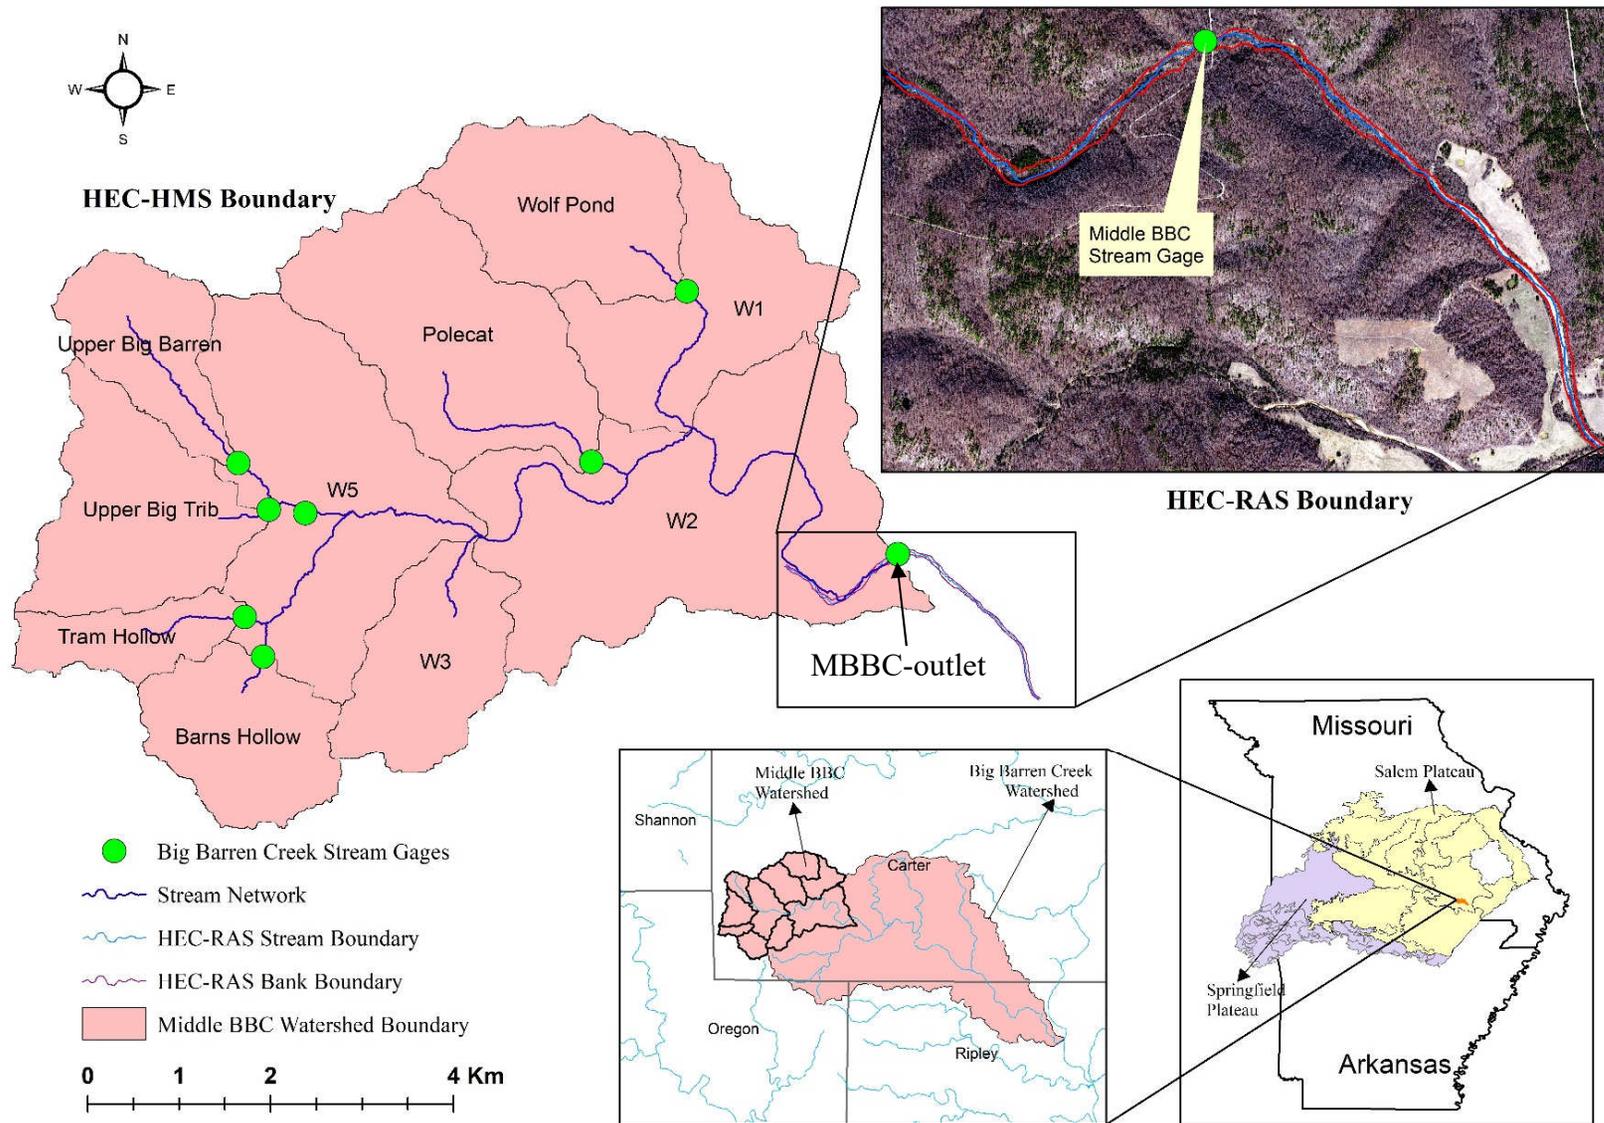
Figure 5. HEC-HMS and HEC-RAS model boundary of the study area

In this study, using the MBBC gage as an outlet, around 48 km² watershed was generated using the HEC-HMS 4.4 tool, and this watershed boundary was then used for hydrologic simulation to reflect different land-use scenarios (Figure 5). In addition, a 4.5 km channel segment was selected for steady-state hydraulic simulation in the 1D HEC-RAS model (Figure 5). This segment was selected because it contained different types of channel forms, including multi-threaded, single-channel, stream crossing, incision, headcut, and channelized. Thus, this segment will be useful to evaluate the hydraulic channel responses for different channel types.

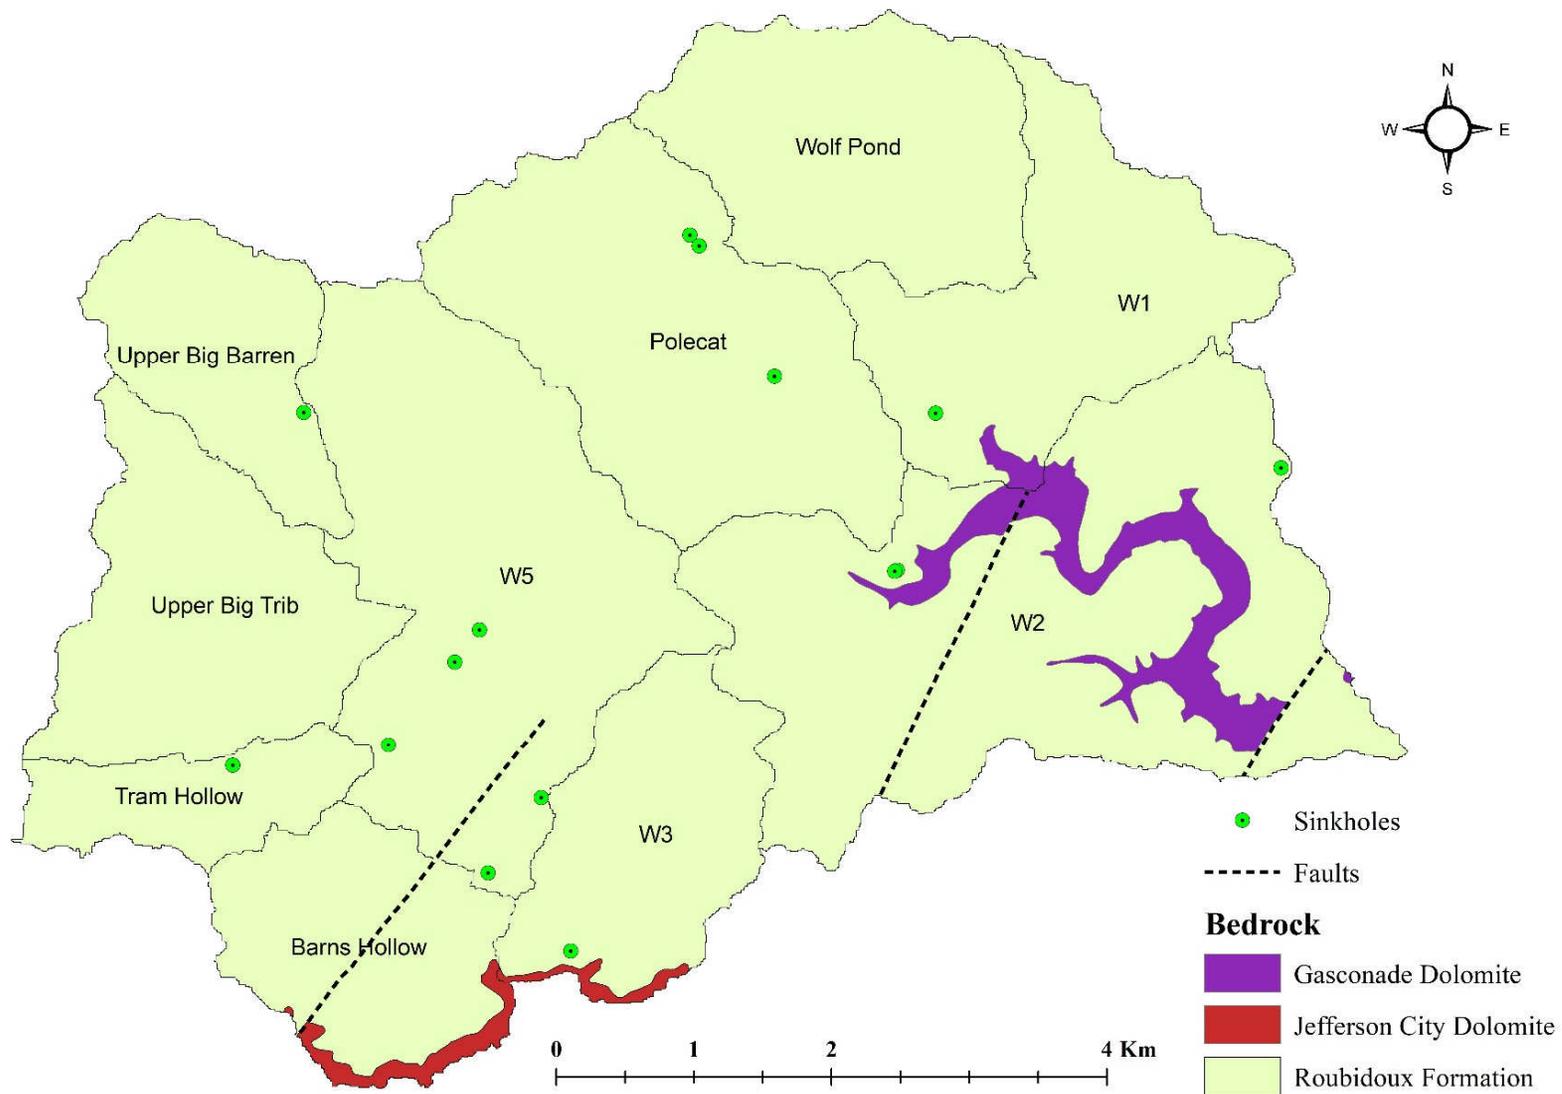
Figure 6. Bedrock geology map of the Middle Big Barren Creek watershed.

The MBBC watershed is underlain by Lower Ordovician-age strata that includes Gasconade Dolomite, Roubidoux Formation, and Jefferson City Dolomite (Weary et al., 2014) (Figure 6). The Gasconade Dolomite has a maximum exposed thickness of around 85 m and consists of dolomite, chert, sandstone, and orthoquartzite (Weary et al., 2014). The Jefferson City Dolomite is composed of dolomite, quartz, sandstone, and chert (Weary et al., 2014). The average thickness of Jefferson City Dolomite is 122 m (Weary et al., 2014). The Roubidoux Formation has a maximum thickness of 76 m and is composed of sandstone, orthoquartzite, cherty dolomite, and sandy dolomite (Weary et al., 2014; Weary and Schindler, 2004). This formation is considered the most extensive surface rock in the central Ozarks (Fletcher and McDermott, 1957). The Wilderness-Handy fault zone that passes through MBBC has a significant influence on the groundwater flow of this area (Weary et al., 2014) (Figure 6). There are 15 mapped sinkholes in this watershed, mainly in the Roubidoux Formation and Jefferson City Dolomite (Weary et al., 2014). The formation of these sinkholes is due to the dissolution of dolostone (Weary et al., 2014).

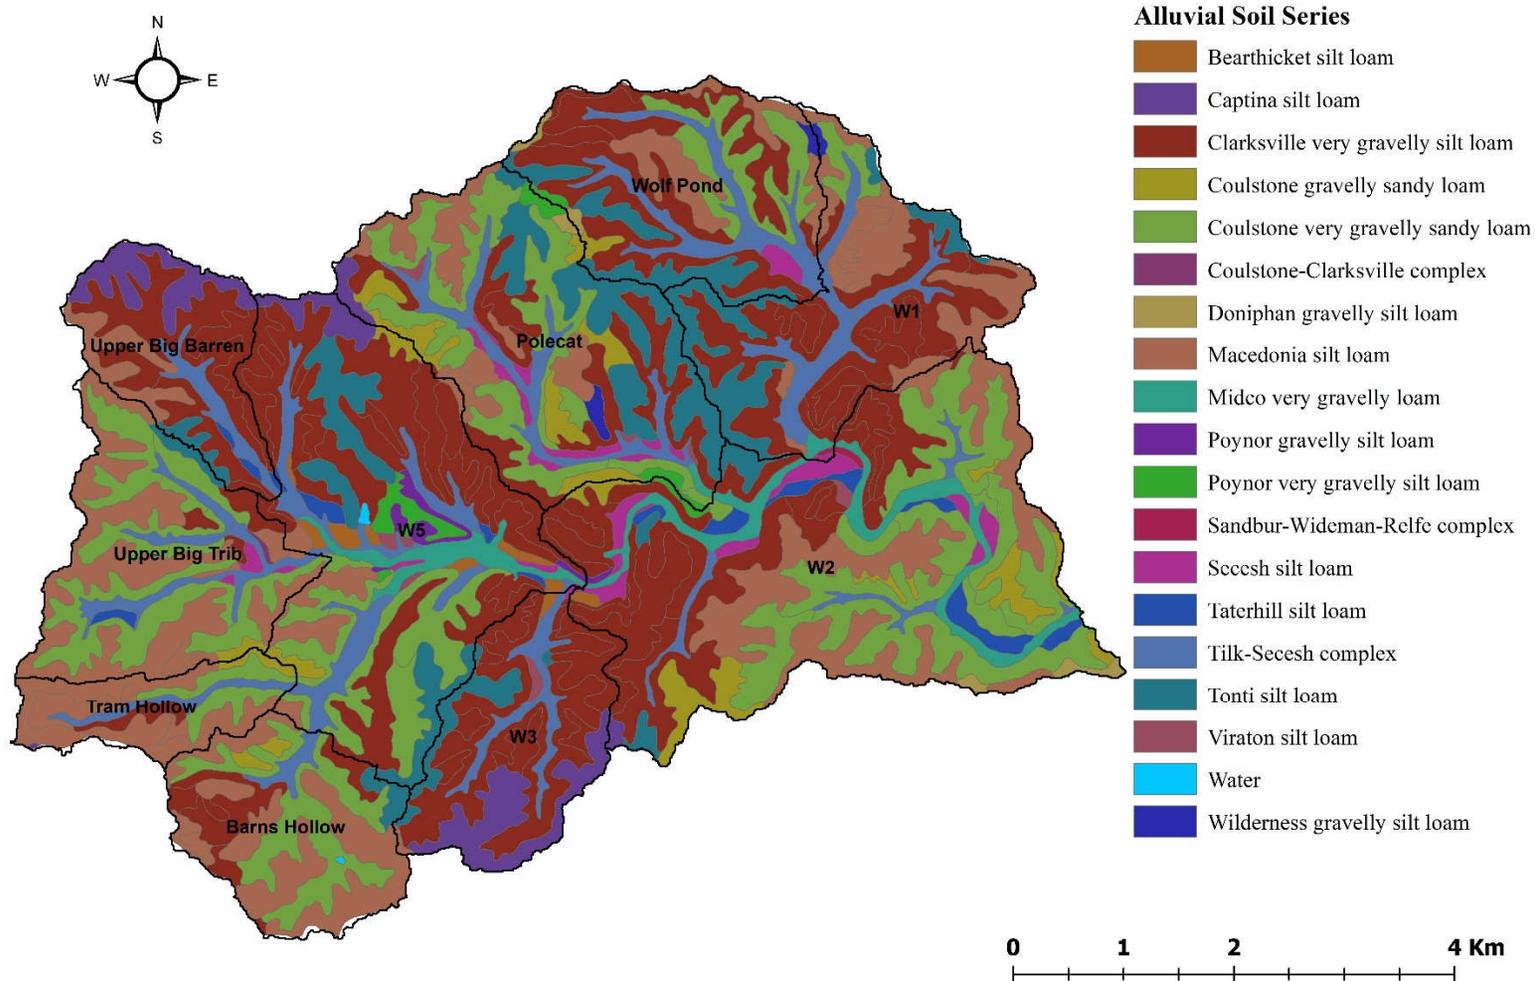
Figure 7. Alluvial soil map of the Middle Big Barren Creek watershed.

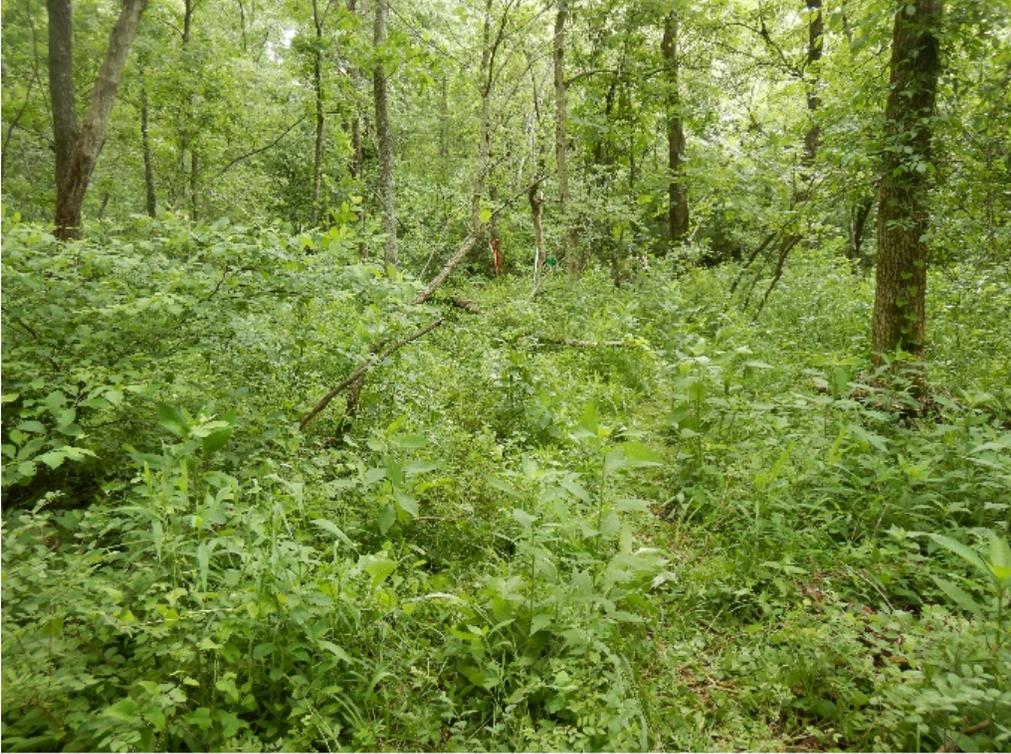
A) Site-1

Figure 8A. Site-1 covered by dense vegetation creating an impediment to flow.

Among the eight survey sites, the single-channel was found in site 4 (MBBC gage location). The multi-threaded channel was found at site-1, 2, 3, 5, and 6 (Figure 8). Sites 7 and 8 were characterized by a channelized stream, and a headcut was observed upstream of site 7 (Figure 8)

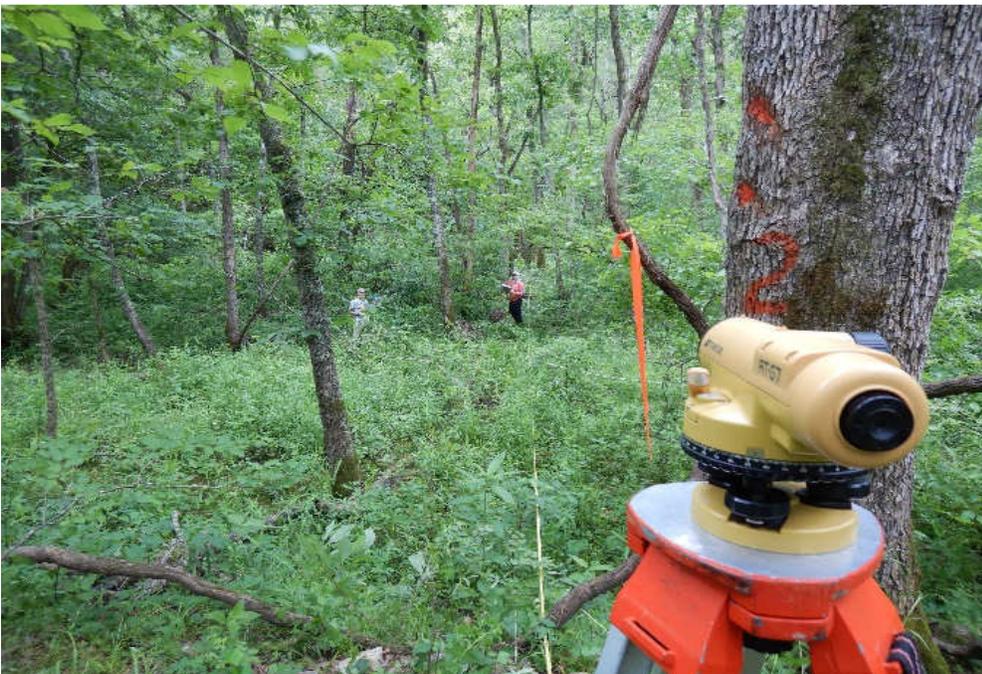
B) Site-2

Figure 8B. Channel cross-section survey at site-2 using an auto-level.

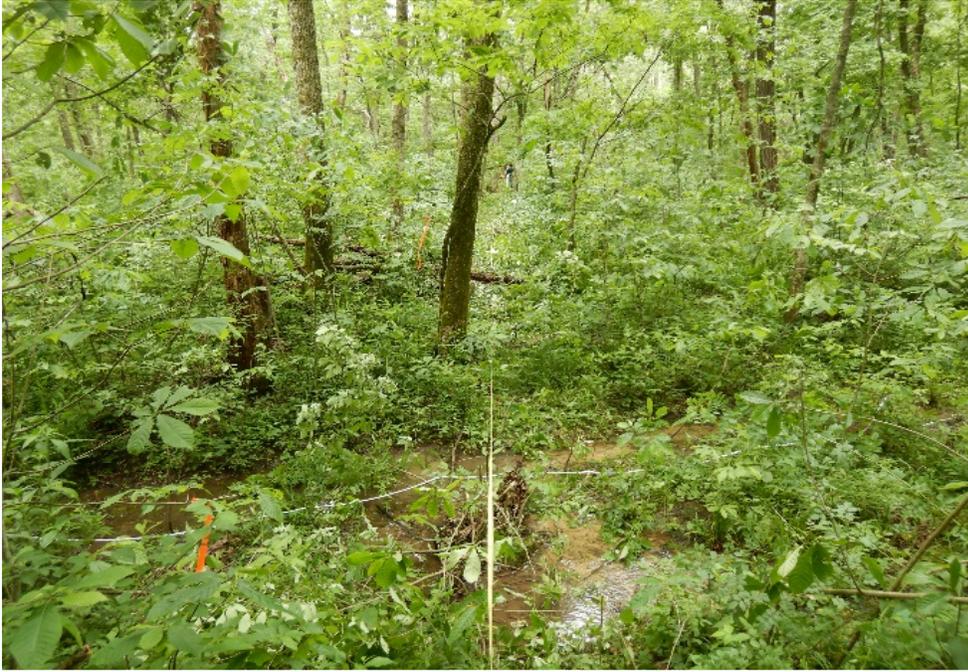
C) Site-3

Figure 8C. Water flowing through the multiple channels at site-3.

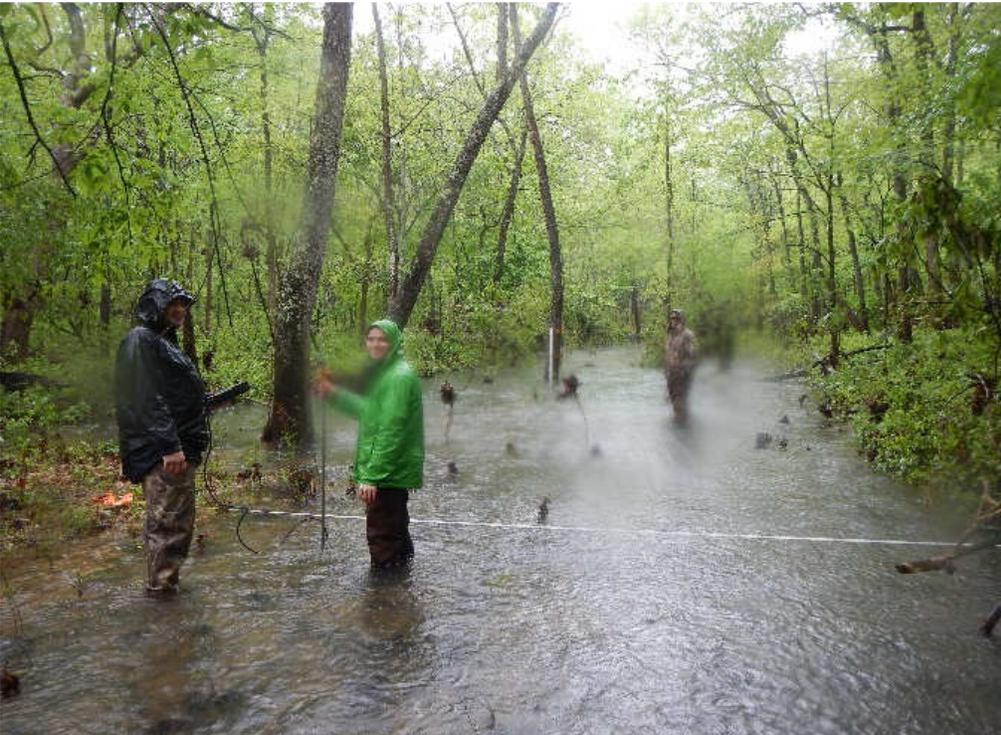
D) Site-4

Figure 8D. Collecting discharge measurement with SonTek FlowTracker at the MBBC gage location (site-4).

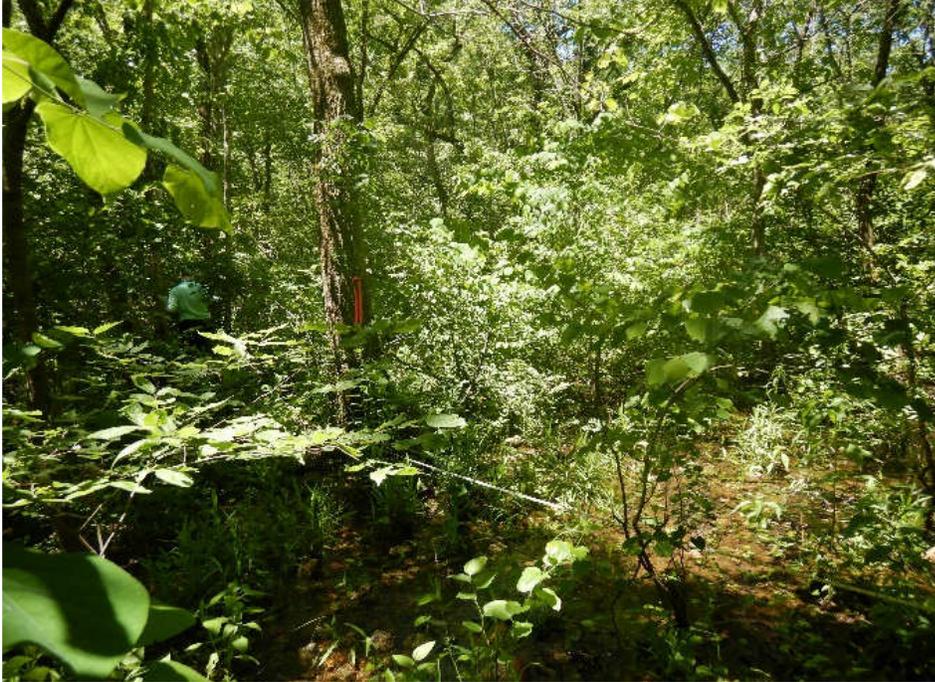
E) Site-5

Figure 8E. Looking downstream at site-5 during a flow condition.

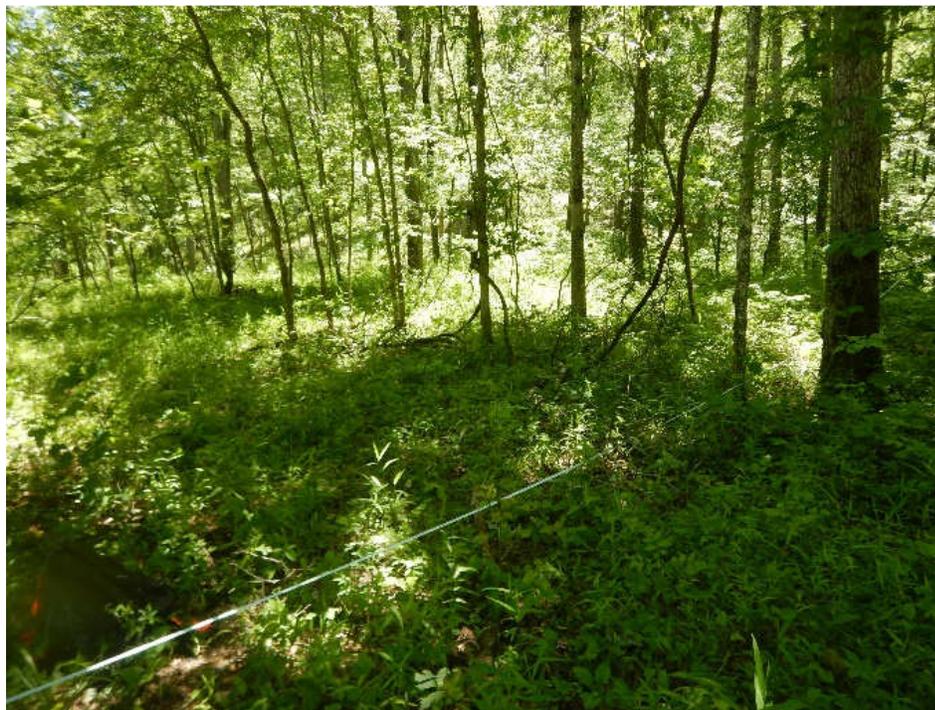
F) Site-6

Figure 8F. Channel bed of site-6 was covered by dense vegetation located upstream to the headcut.

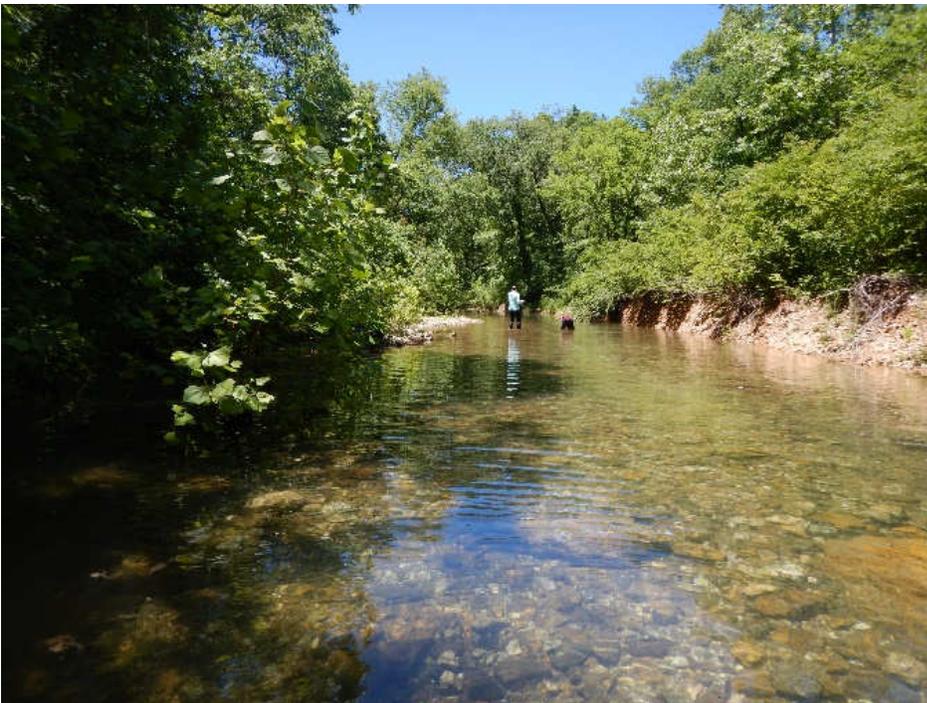
H) Site-8

Figure 8H. Looking downstream at site-8. Channel bed characterized by gravel-cobble.

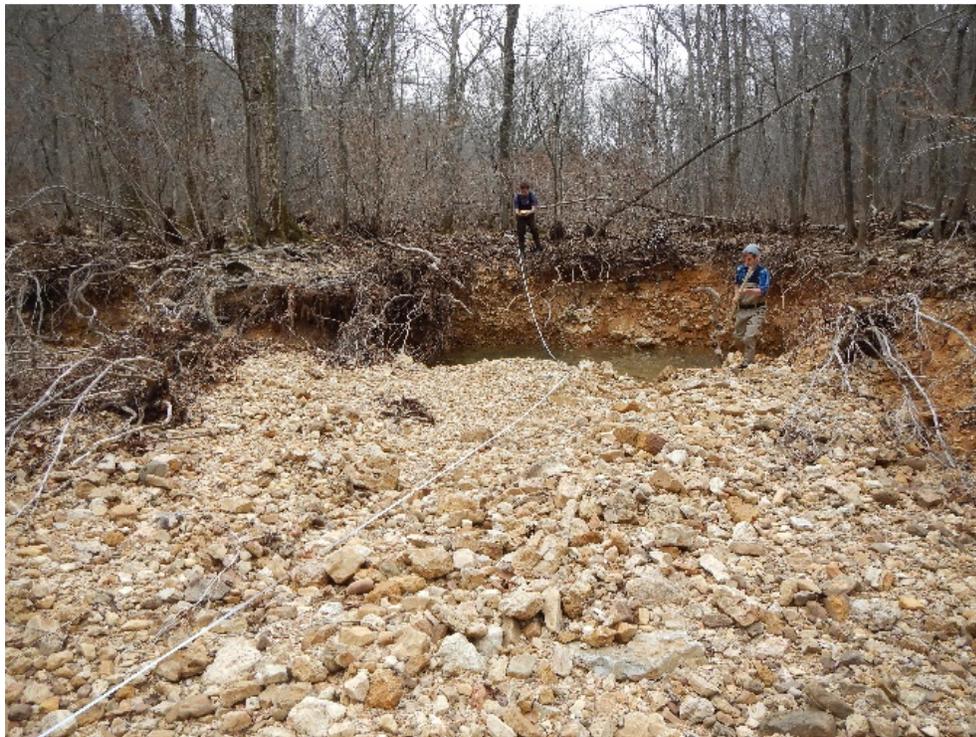
J) Incised Channel

Figure 8J. The incised channel looking downstream to the headcut.

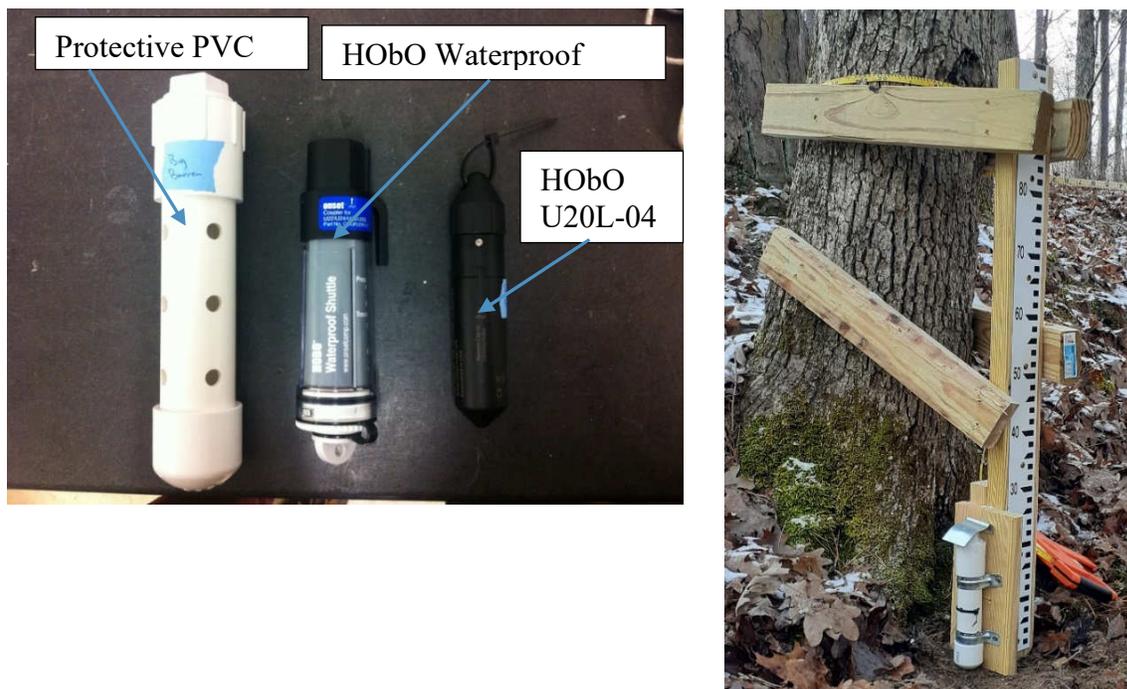
Figure 10. (a) HObo U20L-04 data logger, (b) gage installation.

A total of eight gaging stations were installed in the MBBC watershed. However, six of them (UBT, UBB, TH, WP, PC, and MBBC) were used in the model simulation validation procedure. The stage and discharge of each gage were recorded every 5-minutes intervals using Hobo U20L-04 Water Level Loggers (Figure 10a) (OEWRI, 2016). The data logger was installed inside a PVC pipe and attached firmly to a 1-2 m staff gage that was installed at each site (Figure 10b). The level logger uses the change in pressure caused by increasing the water level in the pipe to measure the water surface level (Owen et al., 2021). The raw data is downloaded every ten weeks interval using the HObo Waterproof Shuttle (Figure 10a).

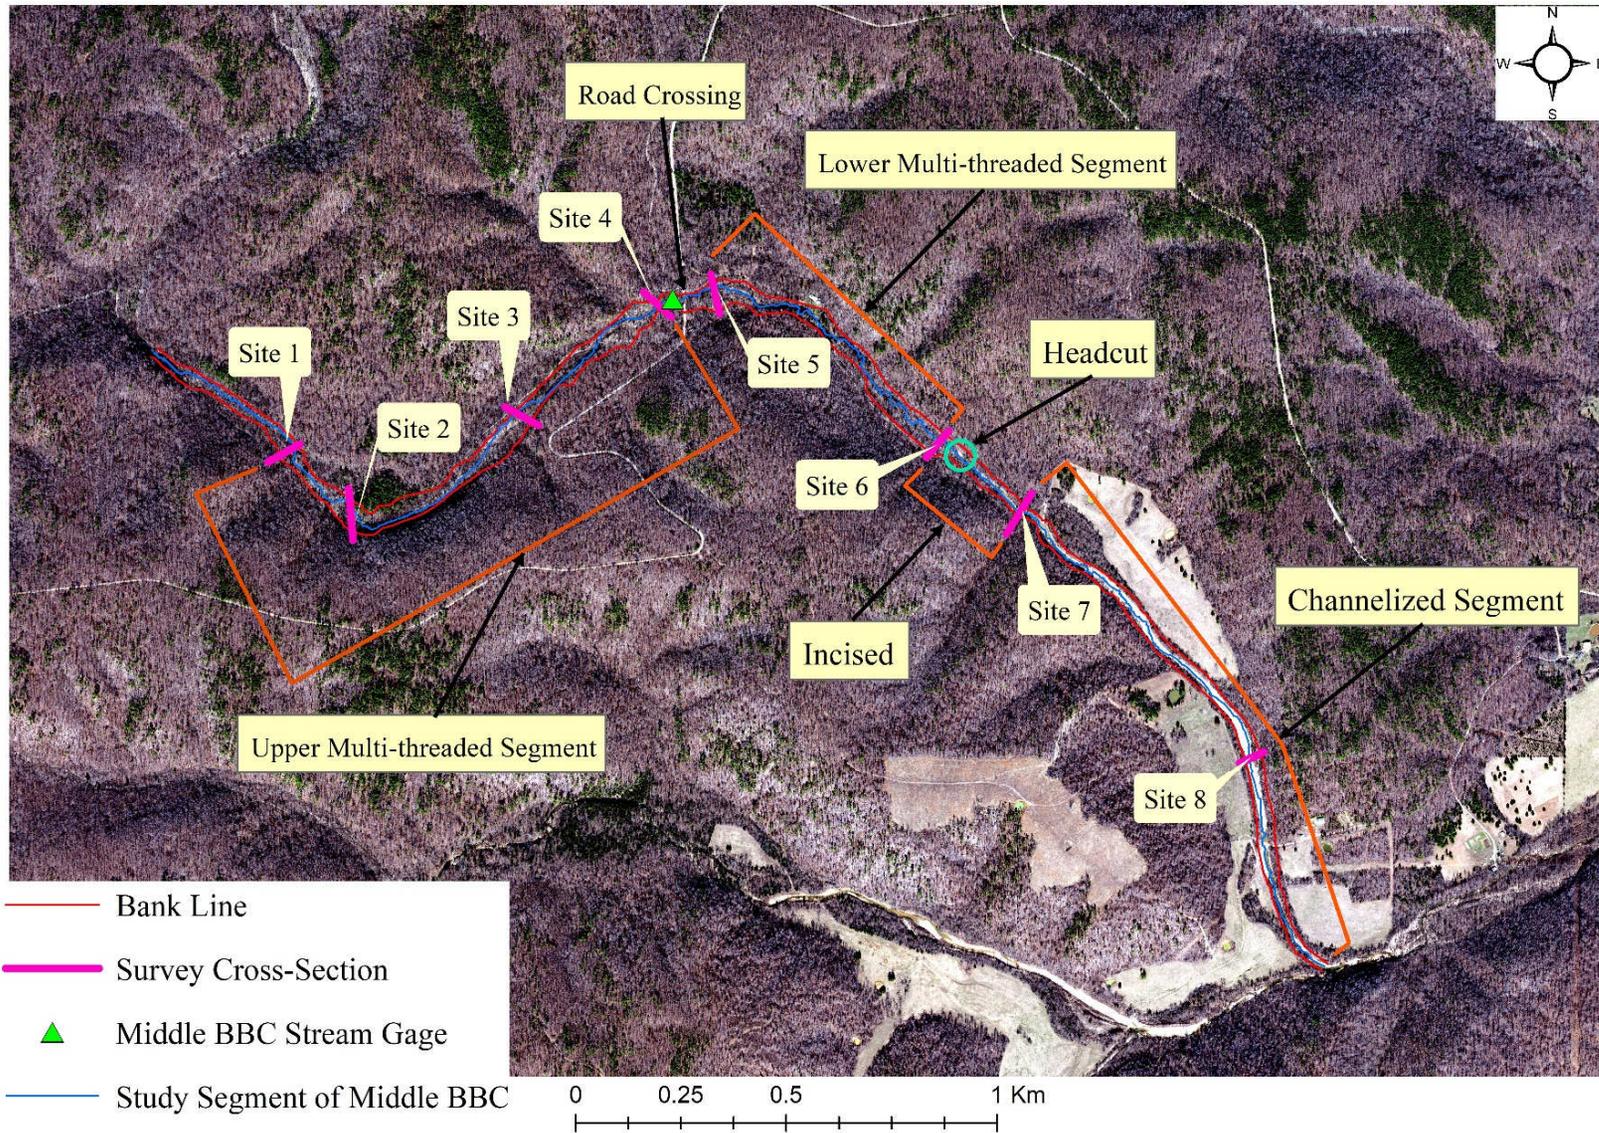
Figure 11. Field survey sites location and channel types.

Arcement and Schneider (1993) found that the flow depth of a sample area is equal to the hydraulic radius, R . In this study, the hydraulic radius of the eight surveyed sites (Figure 11) were calculated using xsecAnalyzer version 17 developed by the NRCS, an excel based software for determining the hydraulic parameters by using a single cross-section and relative roughness

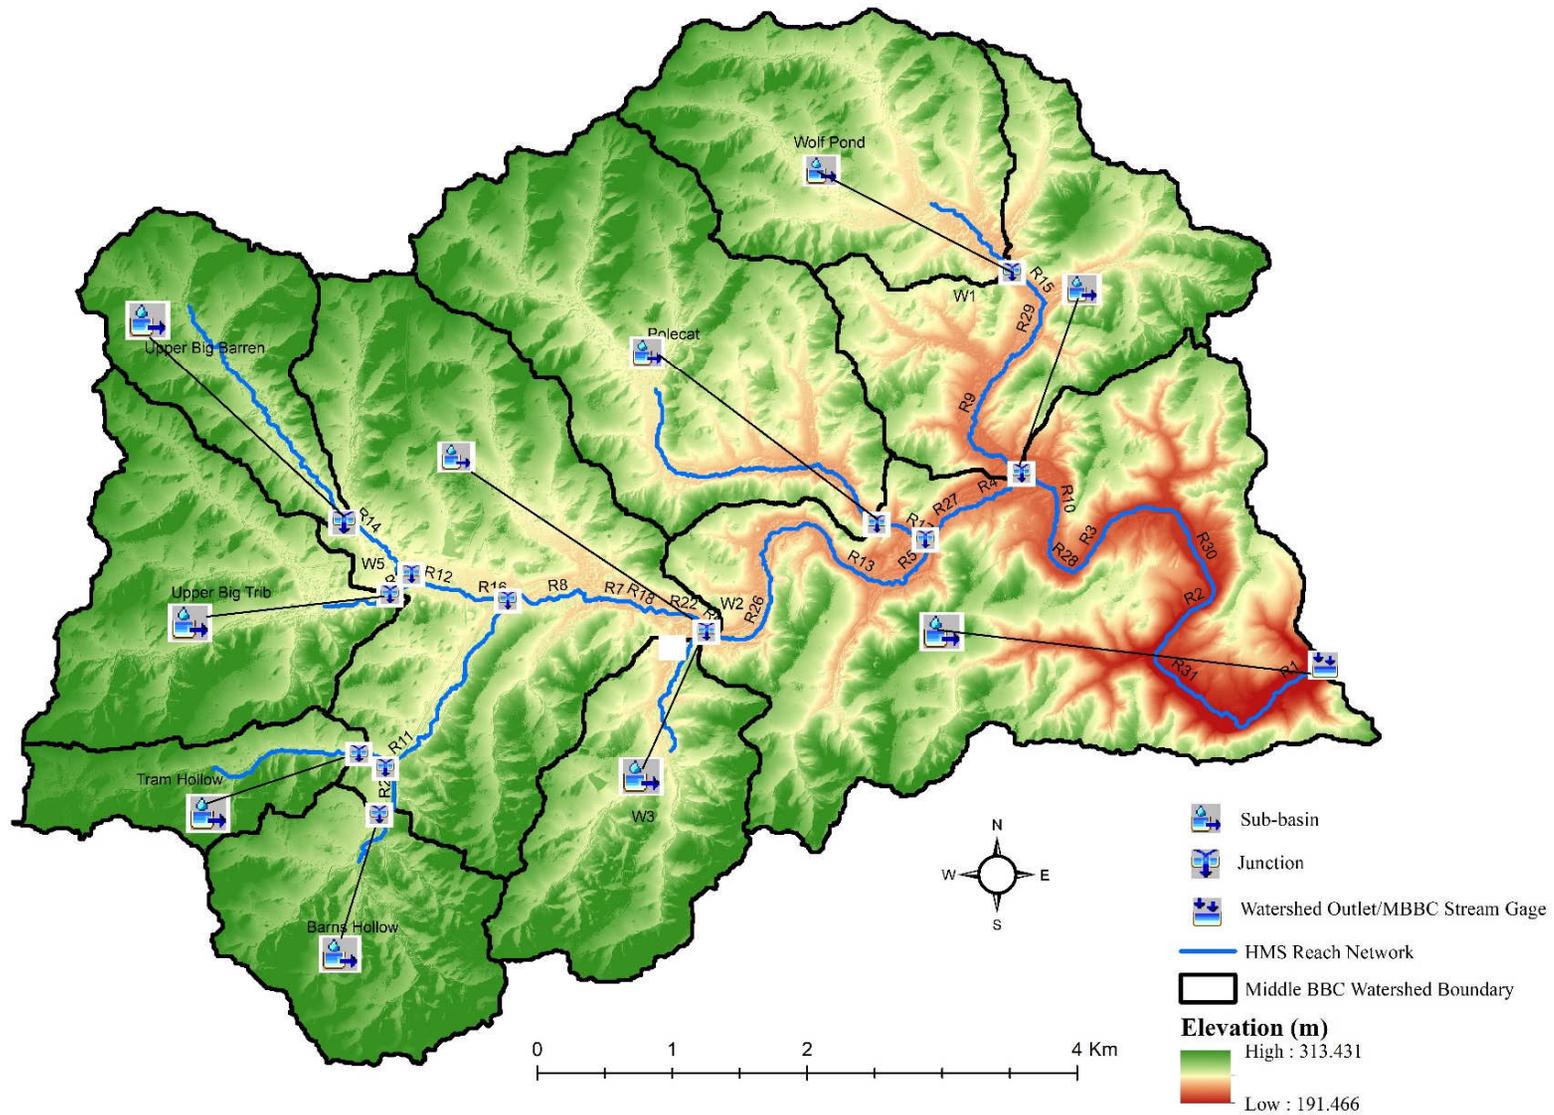
Figure 12. HEC-HMS model setup.

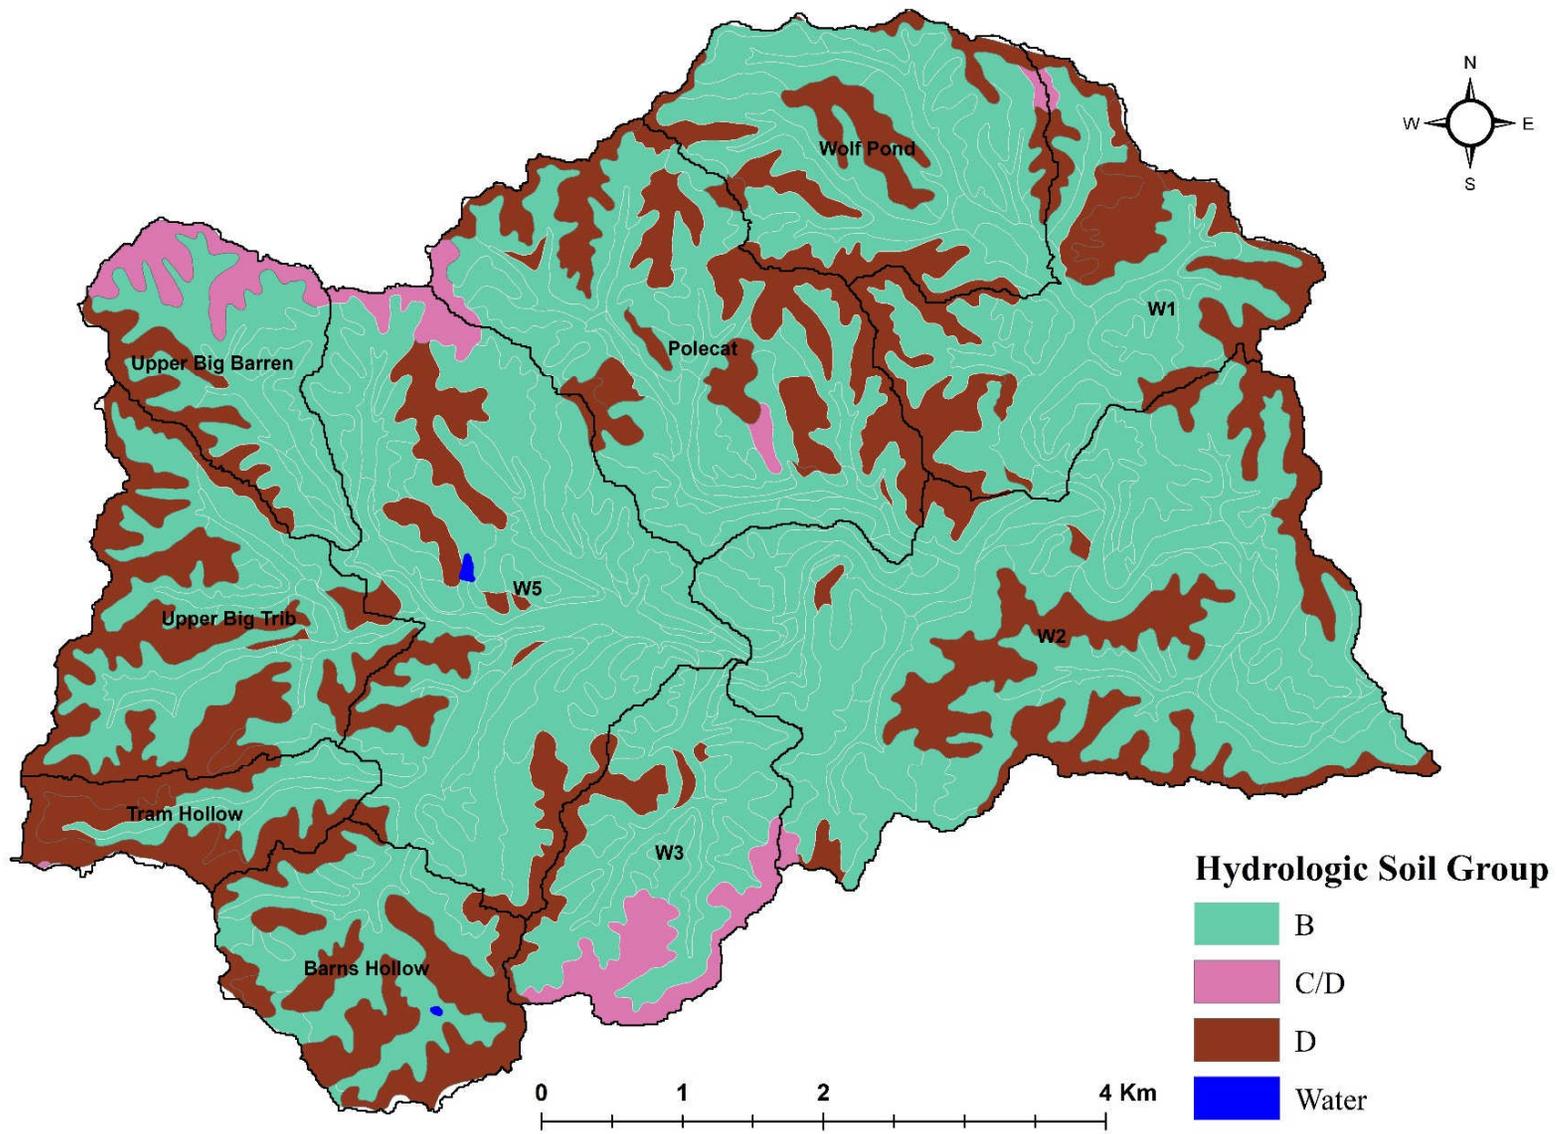
Figure 13. Hydrologic Soil Group (HSG) of the MBBC watershed .
