**LONG-TERM HYDROLOGICAL IMPACTS OF HISTORICAL LOGGING ON
RECENT HYDRO-GEOMORPHIC CONDITIONS, BIG BARREN CREEK
WATERSHED, MARK TWAIN NATIONAL FOREST**

A Master's Thesis

Shoukat Ahmed

July 2021

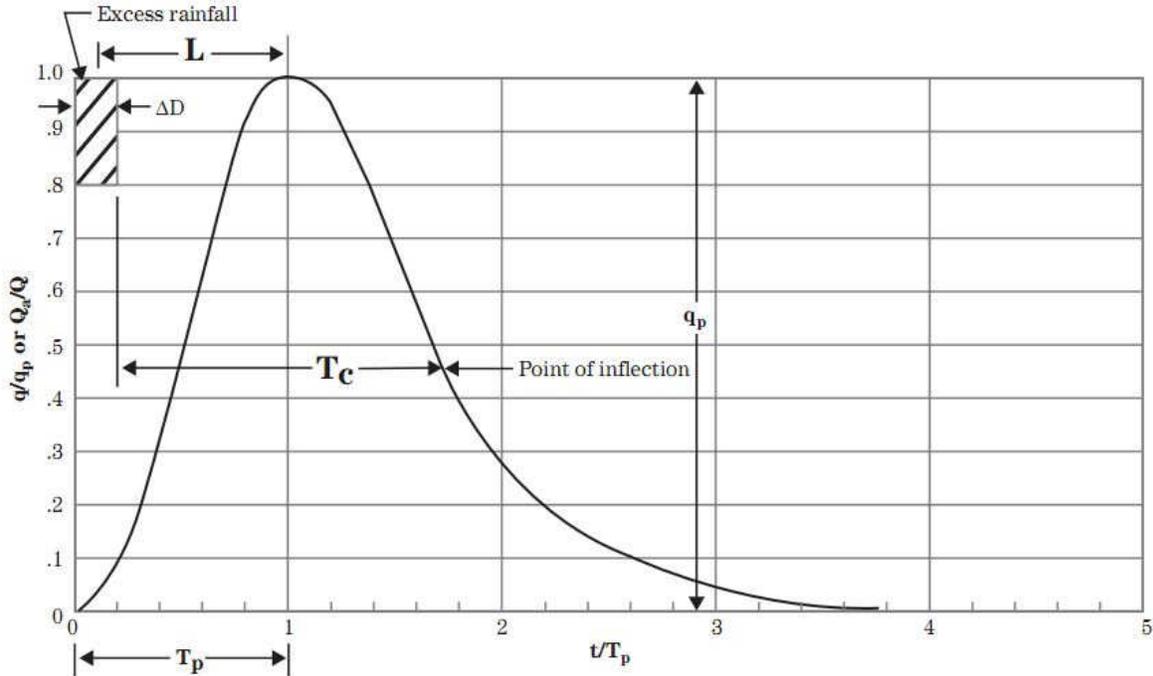
Figure 14. Watershed lag time (L) and time of concentration (T_c) to a dimensionless unit hydrograph.

Transform Method. In a watershed, the transform method calculates the direct runoff from the excess precipitation (Hu and Shrestha, 2020). The SCS unit hydrograph option in the transform method requires a watershed lag time (minute) and a peak rate factor that defines the percentage of unit runoff before the peak discharge. The watershed lag time covers a broad range of conditions ranging from heavily forested watersheds with a steep channel to meadows (NRCS, 2010). The watershed lag time usually defines the time duration (hour/minute) between the centroid of excess rainfall and peak discharge (Figure 14) (NRCS, 2010).

Where L is the lag time, T_c is the time of concentration, T_p is the time to peak, ΔD is the duration of excess rainfall, t/T_p is the dimensionless ratio of any time to time to peak, q is the discharge rate at time t (m^3/s), q_p is the peak discharge rate at time T_p , Q_a is the runoff volume (cm) up to t , and Q is the total runoff volume (cm).

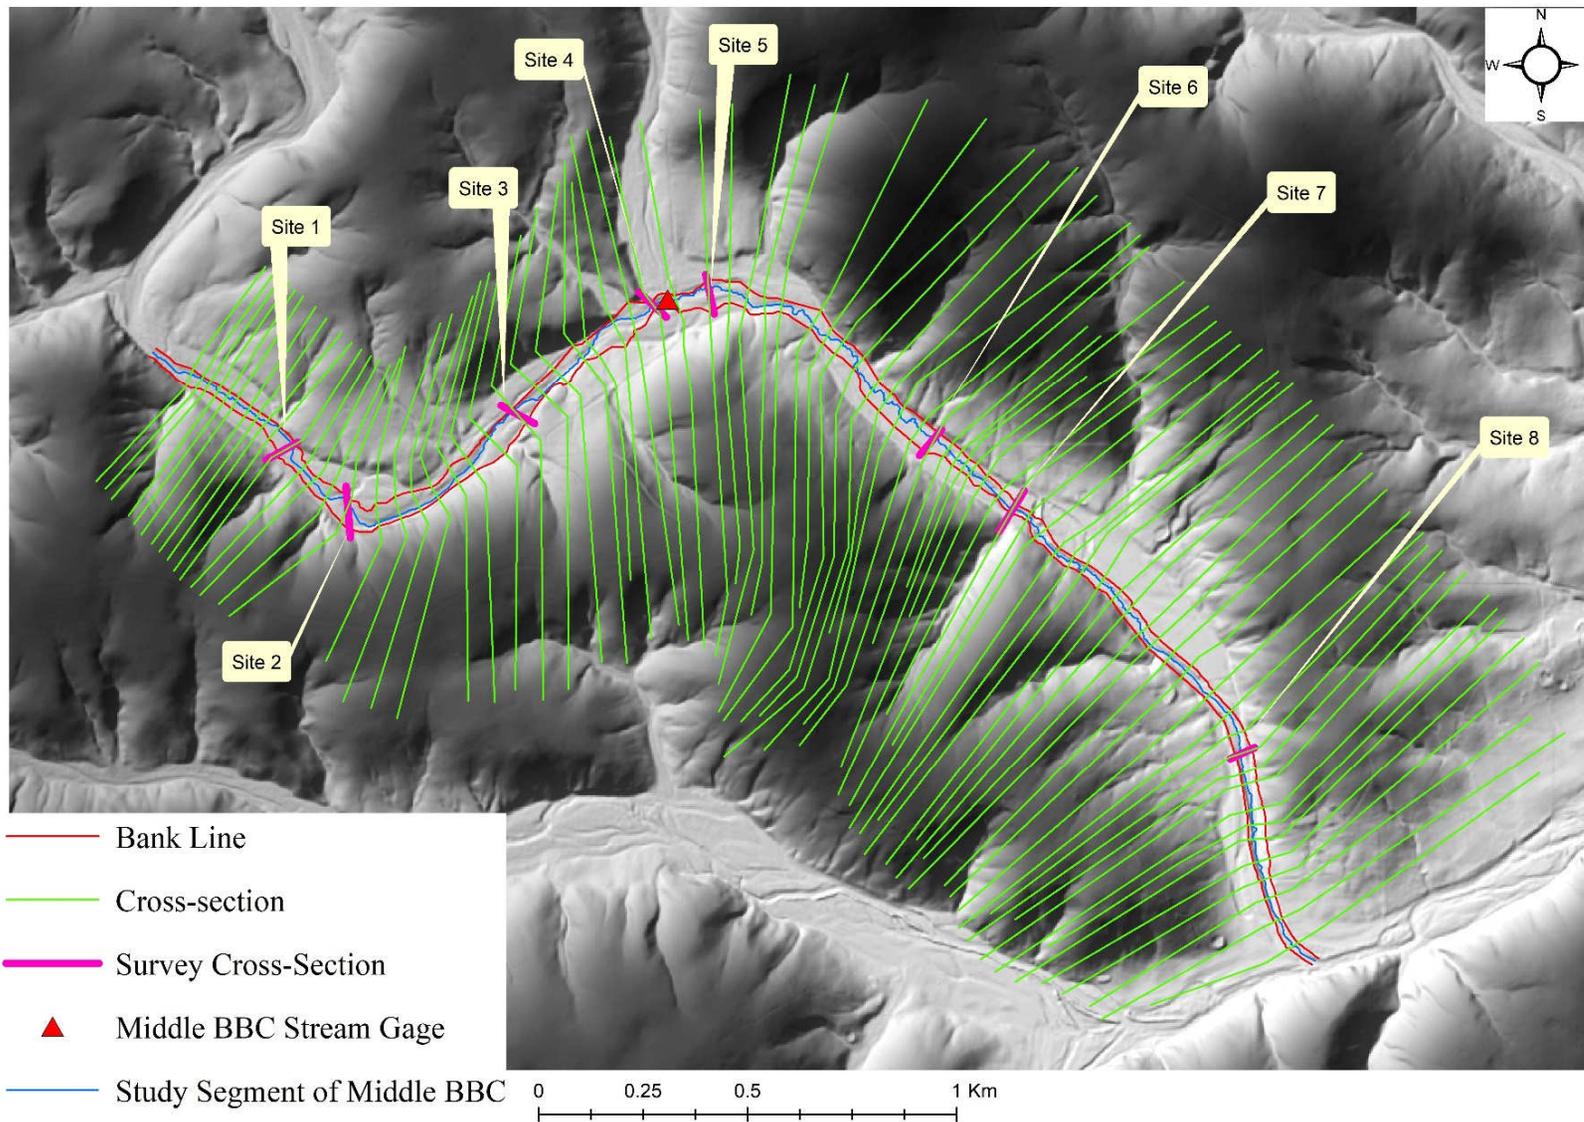
Figure 15. HEC-RAS model boundary parameters.

Where τ_0 is shear stress (N/m²), γ is the specific weight of water (N), R is the hydraulic radius (m) of the cross-section, S_e is the energy gradient or channel slope (m/m).

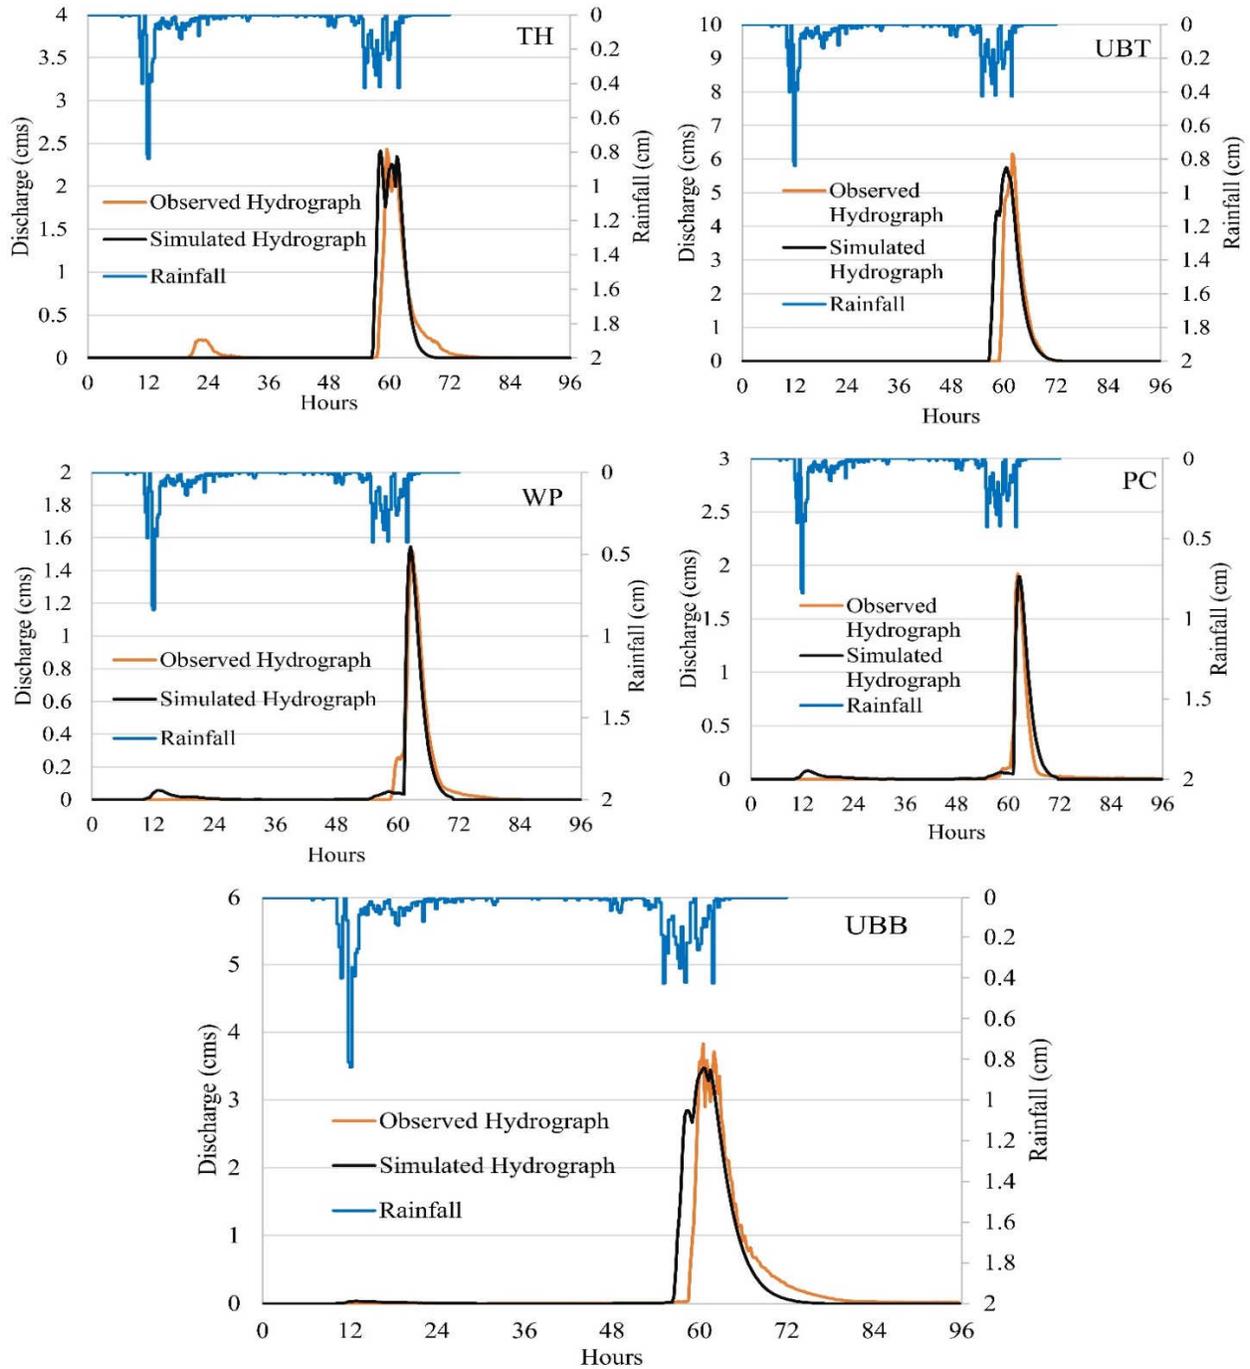
Figure 16. Calibrated hydrographs of the five sub-basins gage locations.

watershed for model calibration and validation. The simulated peak discharge, lag time, and flow duration were matched significantly with the observed data that yielded an excellent NSE value of 0.85 and 0.642 for model validation (Table 17, Figure 17, 18).

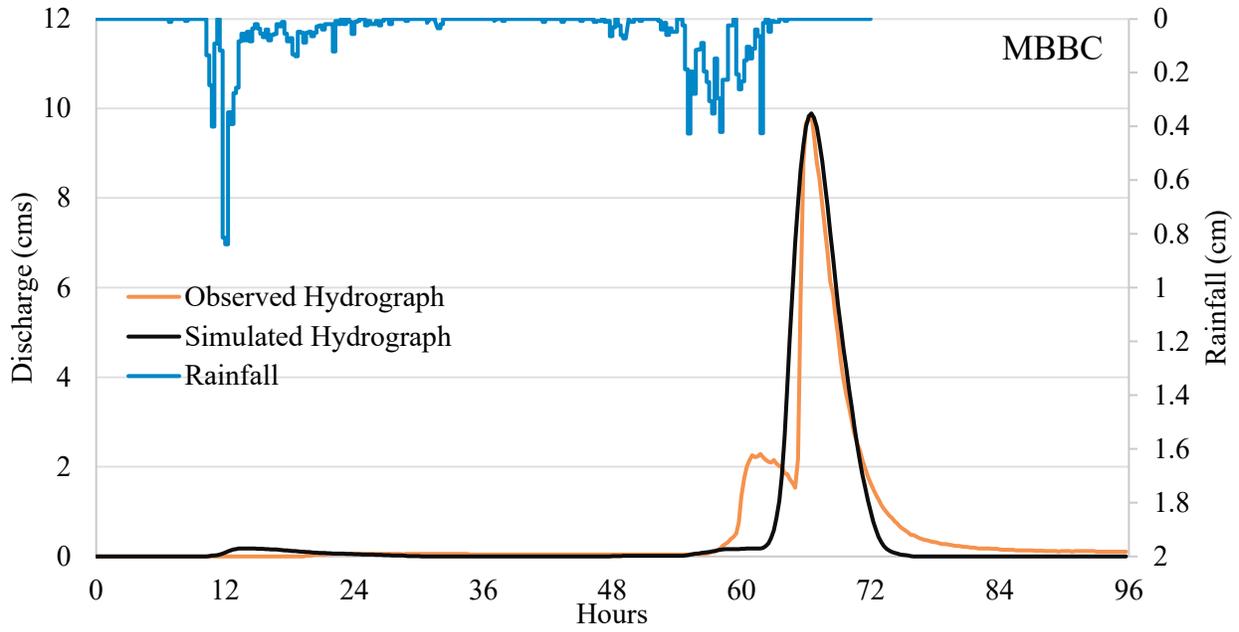
Figure 17. Calibrated hydrograph at MBBC gage location.

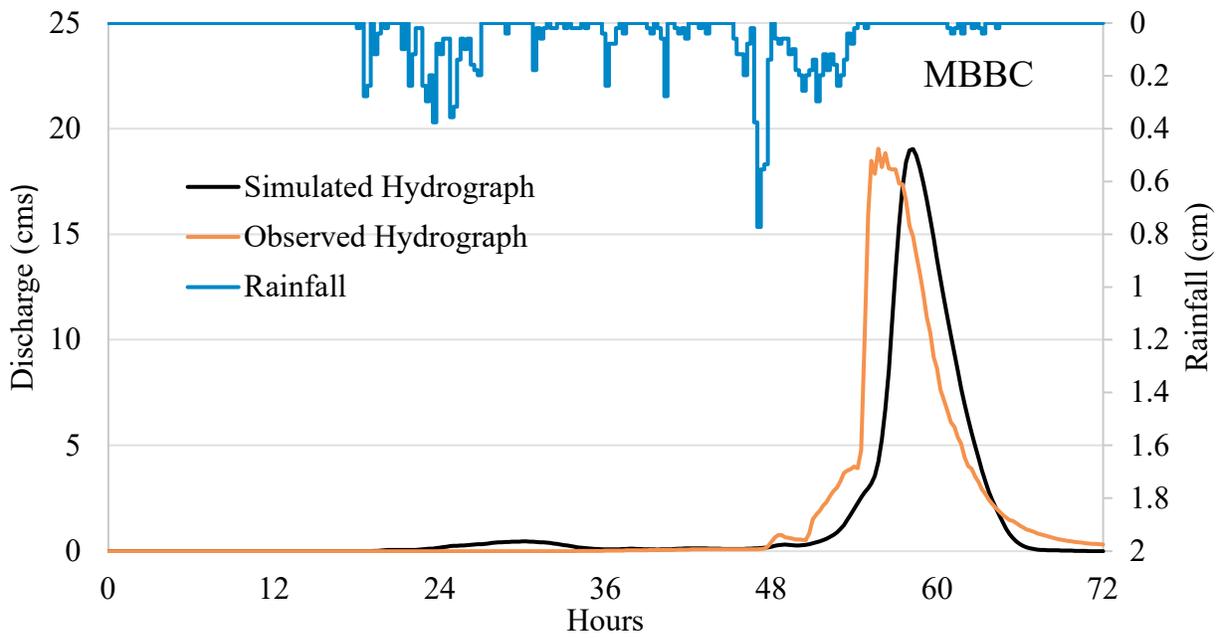
Figure 18. Validated hydrograph at MBBC gage location.

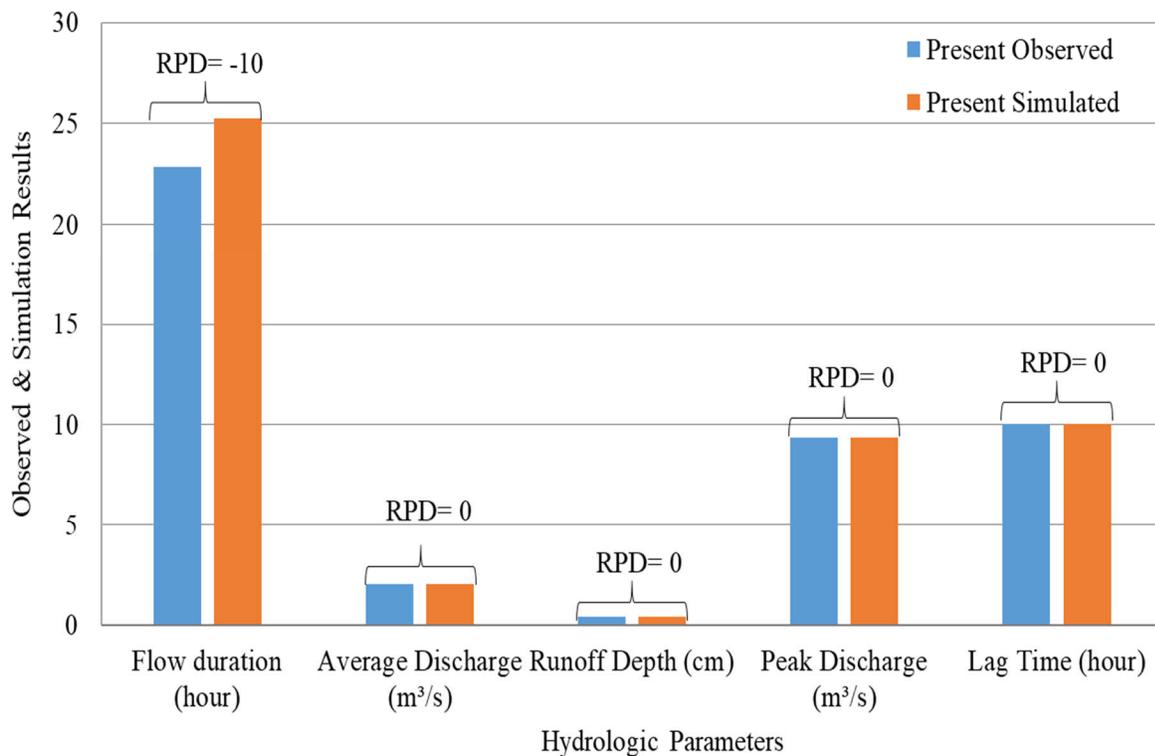
Figure 19. Present-day (2016) HEC-HMS simulation results at MBBC watershed outlet.

with the observed data (Appendix C). The Middle Big Barren Creek watershed outlet showed excellent results despite having greater variability in the five sub-basins (Figure 19). The RPD of average discharge, runoff depth, and lag time were zero (Figure 19, Appendix C). In contrast, the simulated flow duration was 2.42 hours higher than the observed data (22.83 hours). However, the RPD was around only 10%. The NSE coefficient value of this outlet was 0.85. Thus, it can be concluded that the HEC-HMS simulation accurately represented the present-day overall hydrology and rainfall-runoff scenarios of the MBBC watershed (Figure 19).

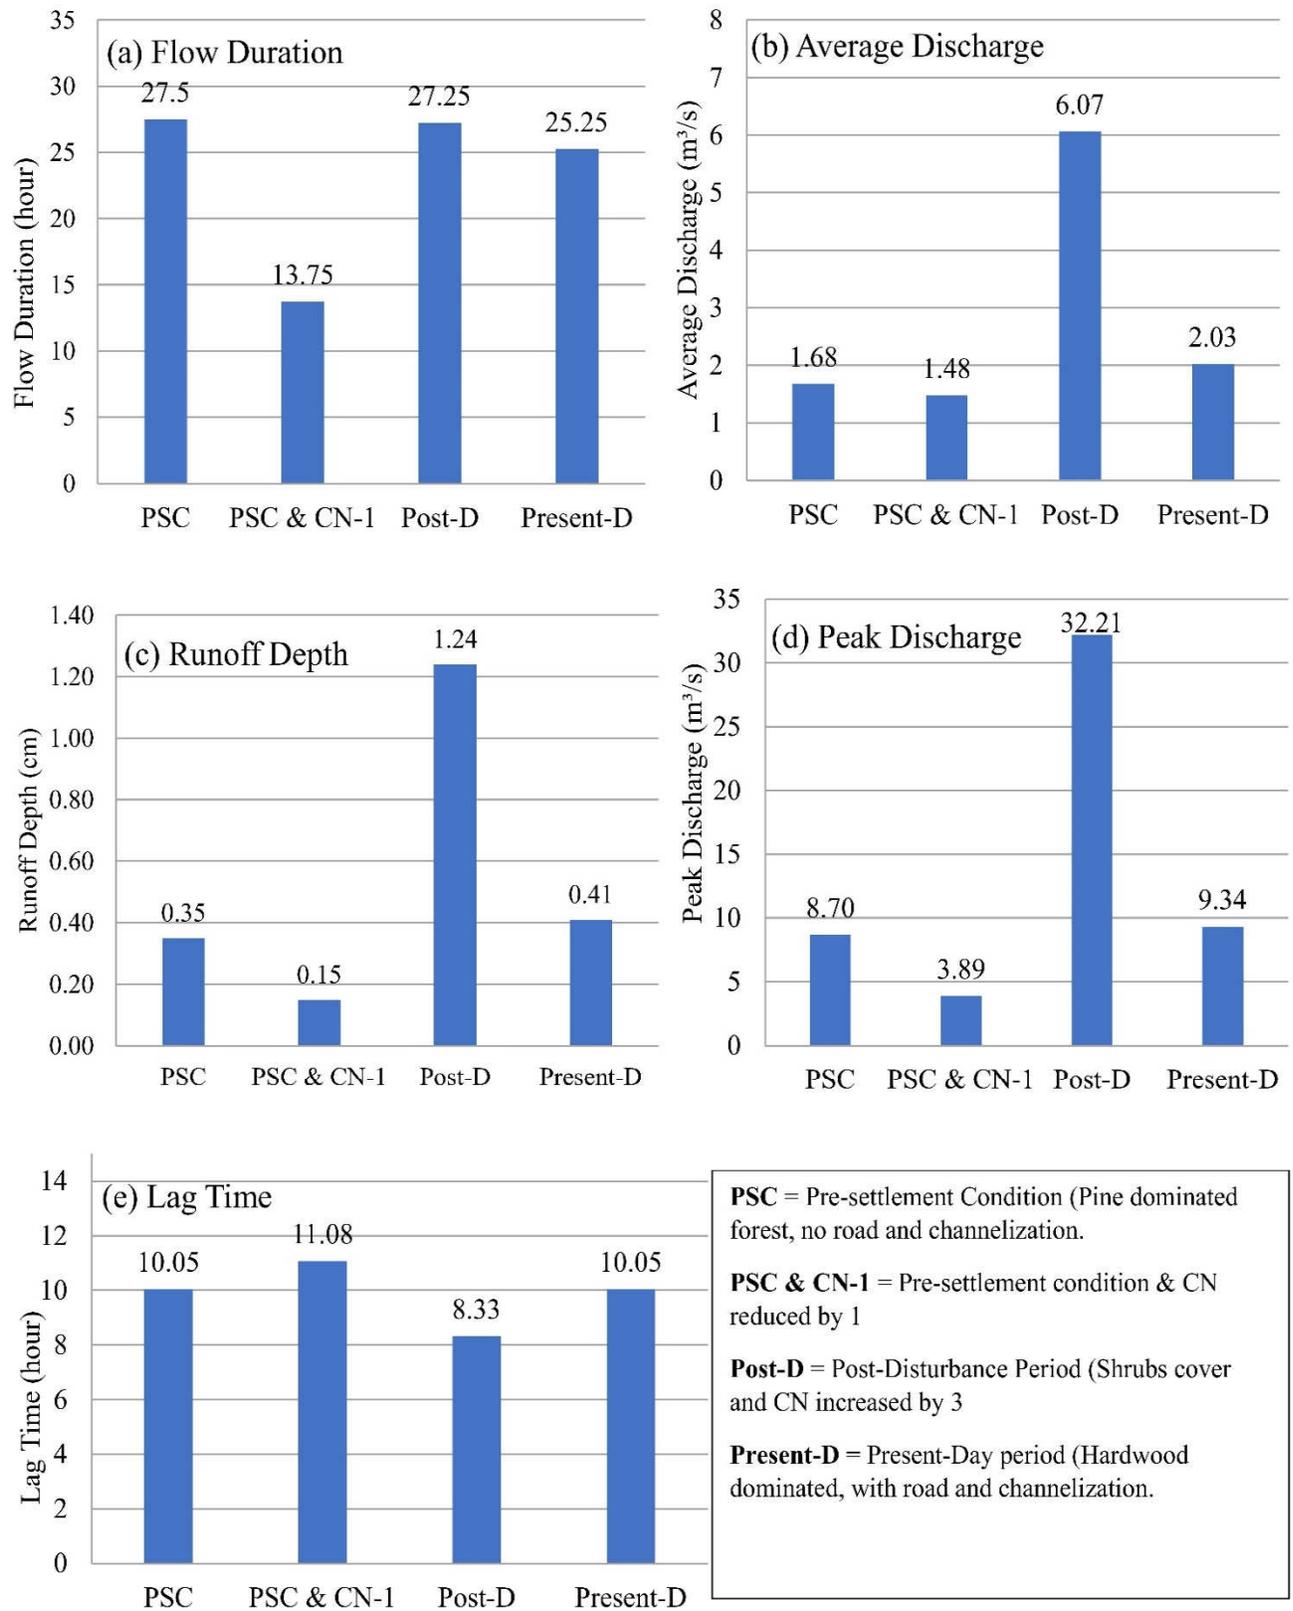
Figure 20. Hydrologic parameters at MBBC gage location for different scenarios.

The simulated hydrographs showed variability of the hydrologic parameters in different scenarios (Figure 21). In the first trial of the pre-settlement scenario, the flow duration was 8% lower in the present-day hardwood-dominated forest cover compared to the shortleaf pine-dominated forest condition for a 12.48 cm rainfall event (Table 19; Appendix D). The present-day flow duration was 25.25 hours, which was simulated at 27.50 hours during the shortleaf pine-dominated forest condition (Figure 20a, 21). The present-day average discharge was 21% higher than the shortleaf pine-dominated forest condition (Table 19). In the pre-settlement forest cover, the average discharge was 1.68 m³/s, which increased to 2.03 m³/s in the present-day condition (Figure 20b, 21). The runoff depth under the current hardwood-dominated forest condition (0.41 cm) was 17% higher than the pre-settlement runoff depth (0.35 cm) (Table 19; Figure 20c, 21). The minimum change was found in the watershed's peak discharge (Table 19; Figure 20d, 21). It was found that in the present-day hardwood forest-dominated watershed, the peak discharge (9.34 m³/s) was only 7% higher than the shortleaf pine-dominated forest (8.7 m³/s) (Table 19, Figure 20d, 21). No change was observed in the watershed lag time (Figure 20e,

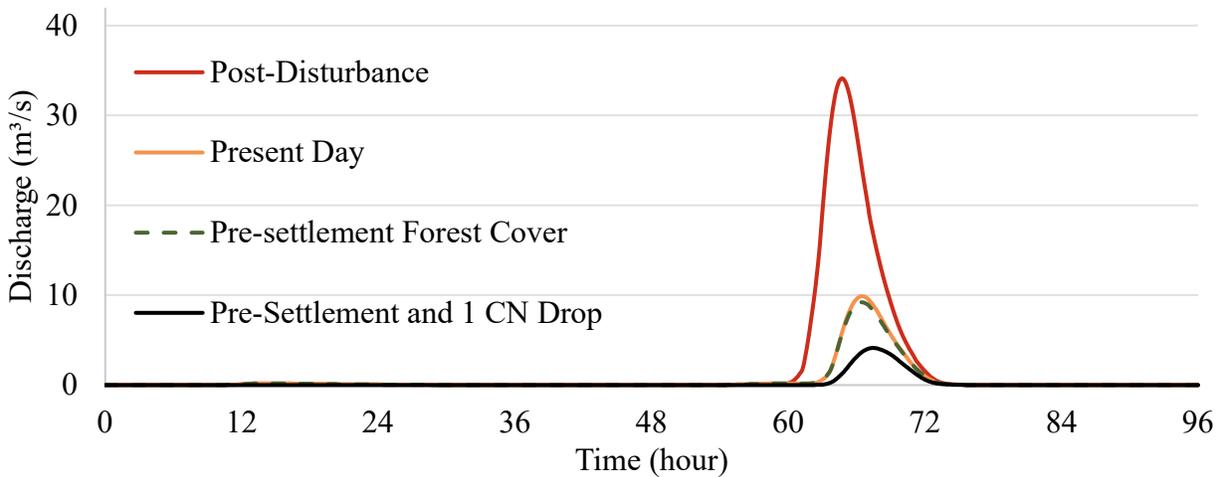
Figure 21. Hydrograph of the four different scenarios.

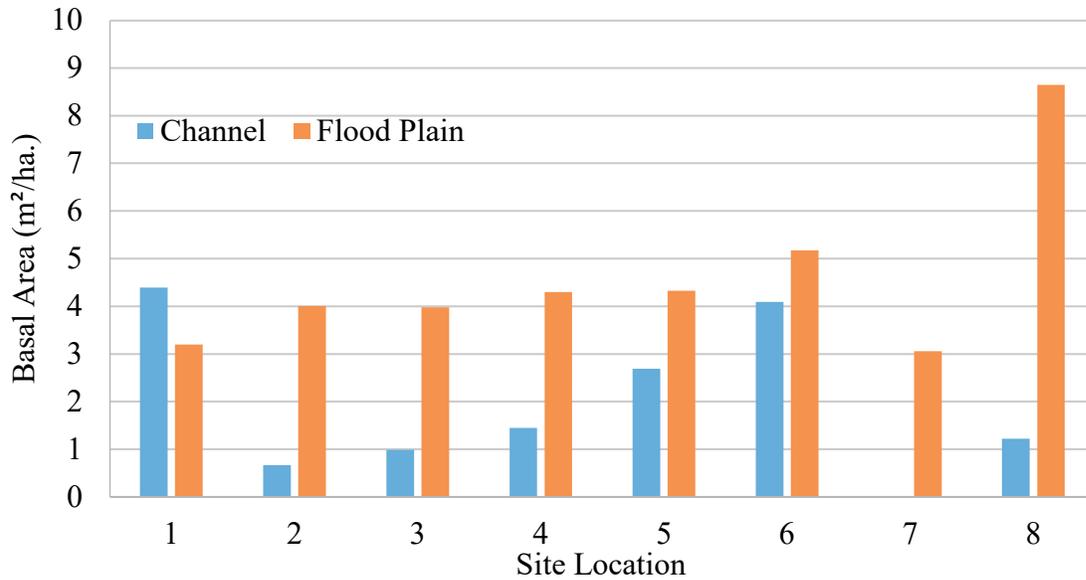
Figure 22. Estimated basal area of the study sites.

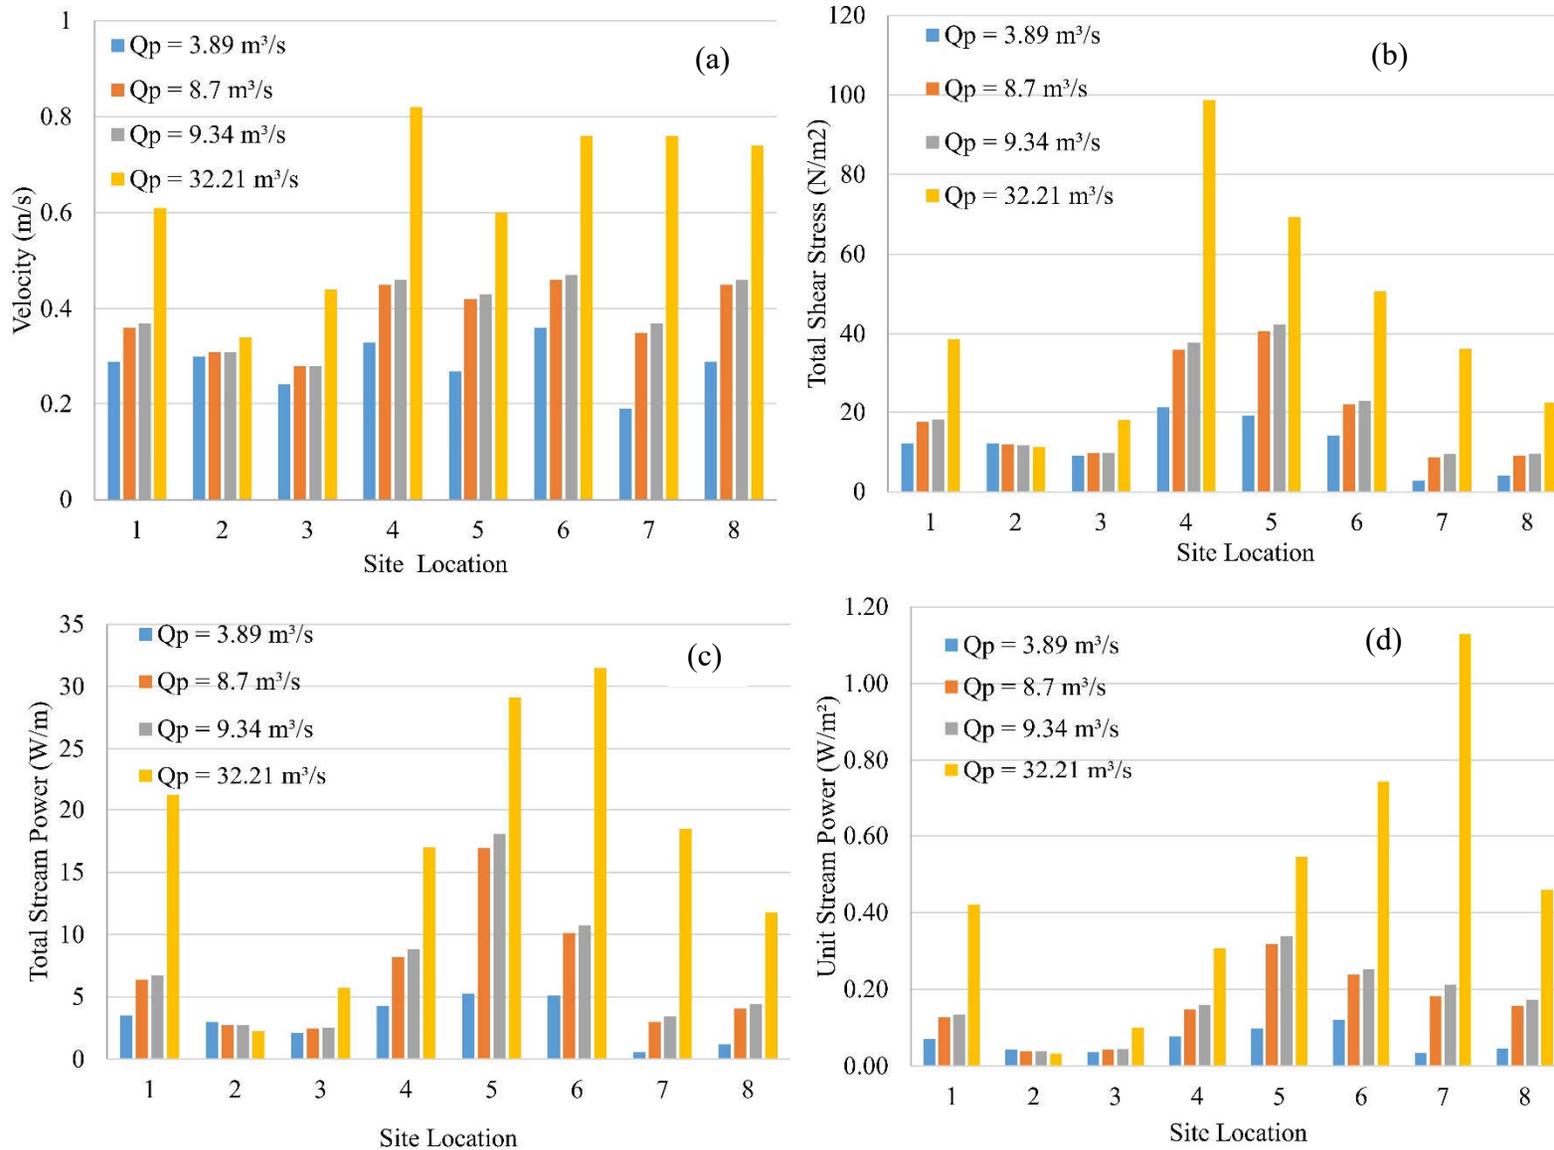
Figure 23. HEC-RAS simulation results of the study sites.

Channel Velocity. Channel velocity is an important hydraulic parameter that is essential for controlling the bedload transport rate (Wilcock et al., 2009). In addition, flow velocity and hydraulic depth are important factors for estimating the stream power or the erosion potential of a stream. (Naiman et al., 2005; Yang and Stall, 1974). The changes in channel velocity-depth relation can significantly alter the channel form by making it broader and deeper (Mosley, 1982). For a constant discharge, channel cross-sectional area (m^2) and mean flow velocity (m/s) are highly correlated with each other (Naiman et al., 2005). A narrow shape channel causes a deeper and faster flow, whereas an increase in width causes shallow depth and slow flow (Naiman et al., 2005). Channel velocity for the pre-settlement forest cover and good soil condition (SCS CN – 1) discharge ($3.89 m^3/s$) varied between 0.19 to 0.36 m/s. In this scenario, a maximum velocity of 0.36 m/s was found at site-6 (just above the headcut), and the minimum velocity was found at site-7 (Figure 23a). The conversion of shortleaf pine-dominated forest cover to hardwood-dominated forest cover did not change the channel velocity of the study sites. In this scenario, the channel velocity ranged from 0.28 to 0.46 m/s (Figure 23a). However, in the post-disturbance period, channel velocity was increased to a range from 0.34 to 0.82 m/s (Figure 23a). The relation among the channel velocity, hydraulic depth, and top width showed that in the post-disturbance discharge ($32.21 m^3/s$), the channelized segments (site-7 & 8) were undergone an increase in the hydraulic depth and decrease in top width that caused higher channel velocity in these segments (Figure 23a, 24, 25). However, despite having low hydraulic depth and high top width, the maximum channel velocity (0.82 m/s) was observed at site-4 (Figure 23a, 24, 25).

Channel Shear Stress. Channel shear stress is another crucial factor that controls the sediment transport and erosion process (Krause, 2010). It is vital to determine the channel's sediment transport at a bankfull discharge as it is considered the channel-forming discharge (Krause, 2010). Channel shear stress is proportionately related to the hydraulic radius and energy gradient slope of a channel (Brunner, 2016). In this study, the site-specific distribution of channel shear stress showed a gradual downward transition from the multi-threaded site-4 to the channelized site-8 for the post-disturbance scenario discharge ($32.21 \text{ m}^3/\text{s}$); as a result of decreasing energy gradient slope (Figure 23b, 28). In addition, the hydraulic radius was almost the same as the hydraulic depth of the channel (Figure 24). In the post-disturbance scenario, the maximum shear stress (around 98.71 N/m^2) was found in site 4 (Figure 23b). However, the energy gradient slope and hydraulic radius of site-5 were higher than site-4 (Figure 28). A pool effect was responsible for the higher shear stress of site-4. The water surface elevation of site-4 was 1.55 m for the post-disturbance period, which was estimated at 1.28 m at site-5 (Appendix H-4, H-5). Due to this higher depth, the shear stress of site-4 was higher than site-5. No significant change was observed in the total shear stress due to the conversion of hardwood forest dominated to shortleaf pine-dominated forest condition (Figure 23b). However, in the post-disturbance scenario, a significant change in shear stress was found in the single-channel compared to the multi-threaded channels of the study stream. In the post-disturbance scenario, the shear stress site-7 was around 13 times higher compared to the pre-settlement forest cover and good soil condition (Figure 23b).

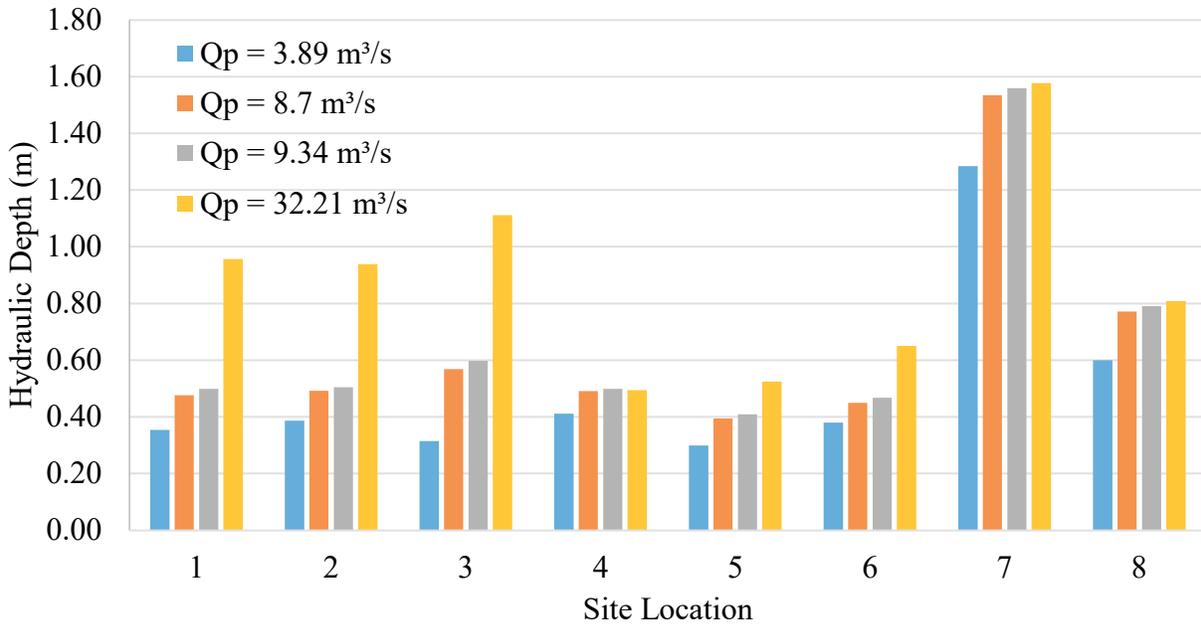
Figure 24. Hydraulic depth of the study sites.

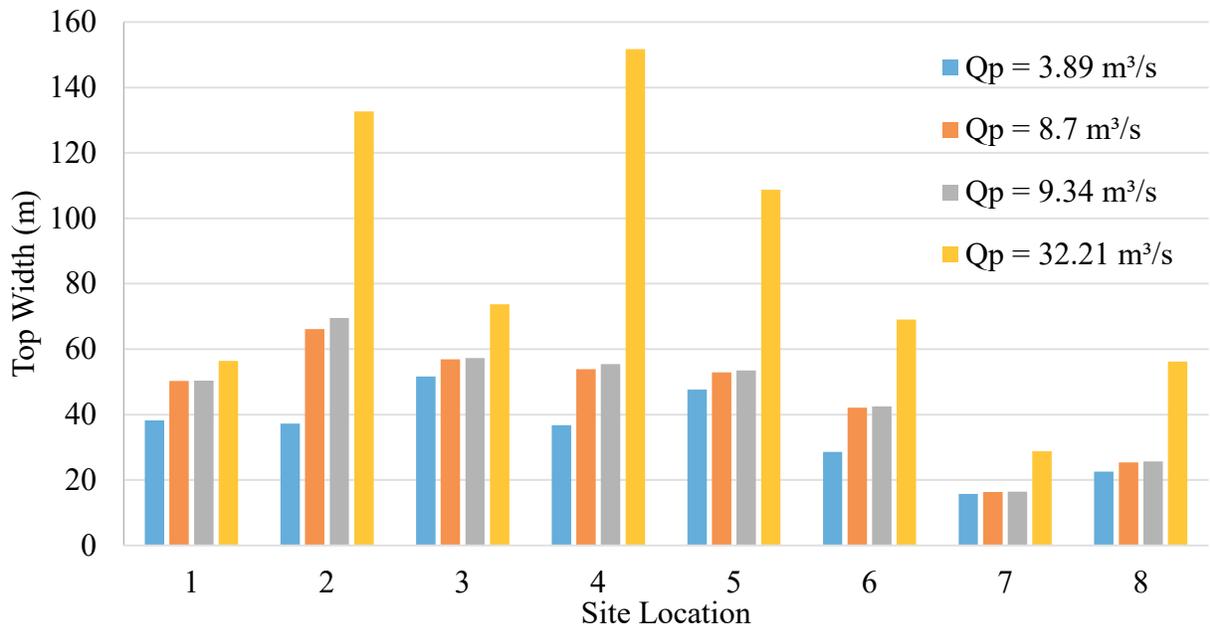
Figure 25. Top width of the study sites.

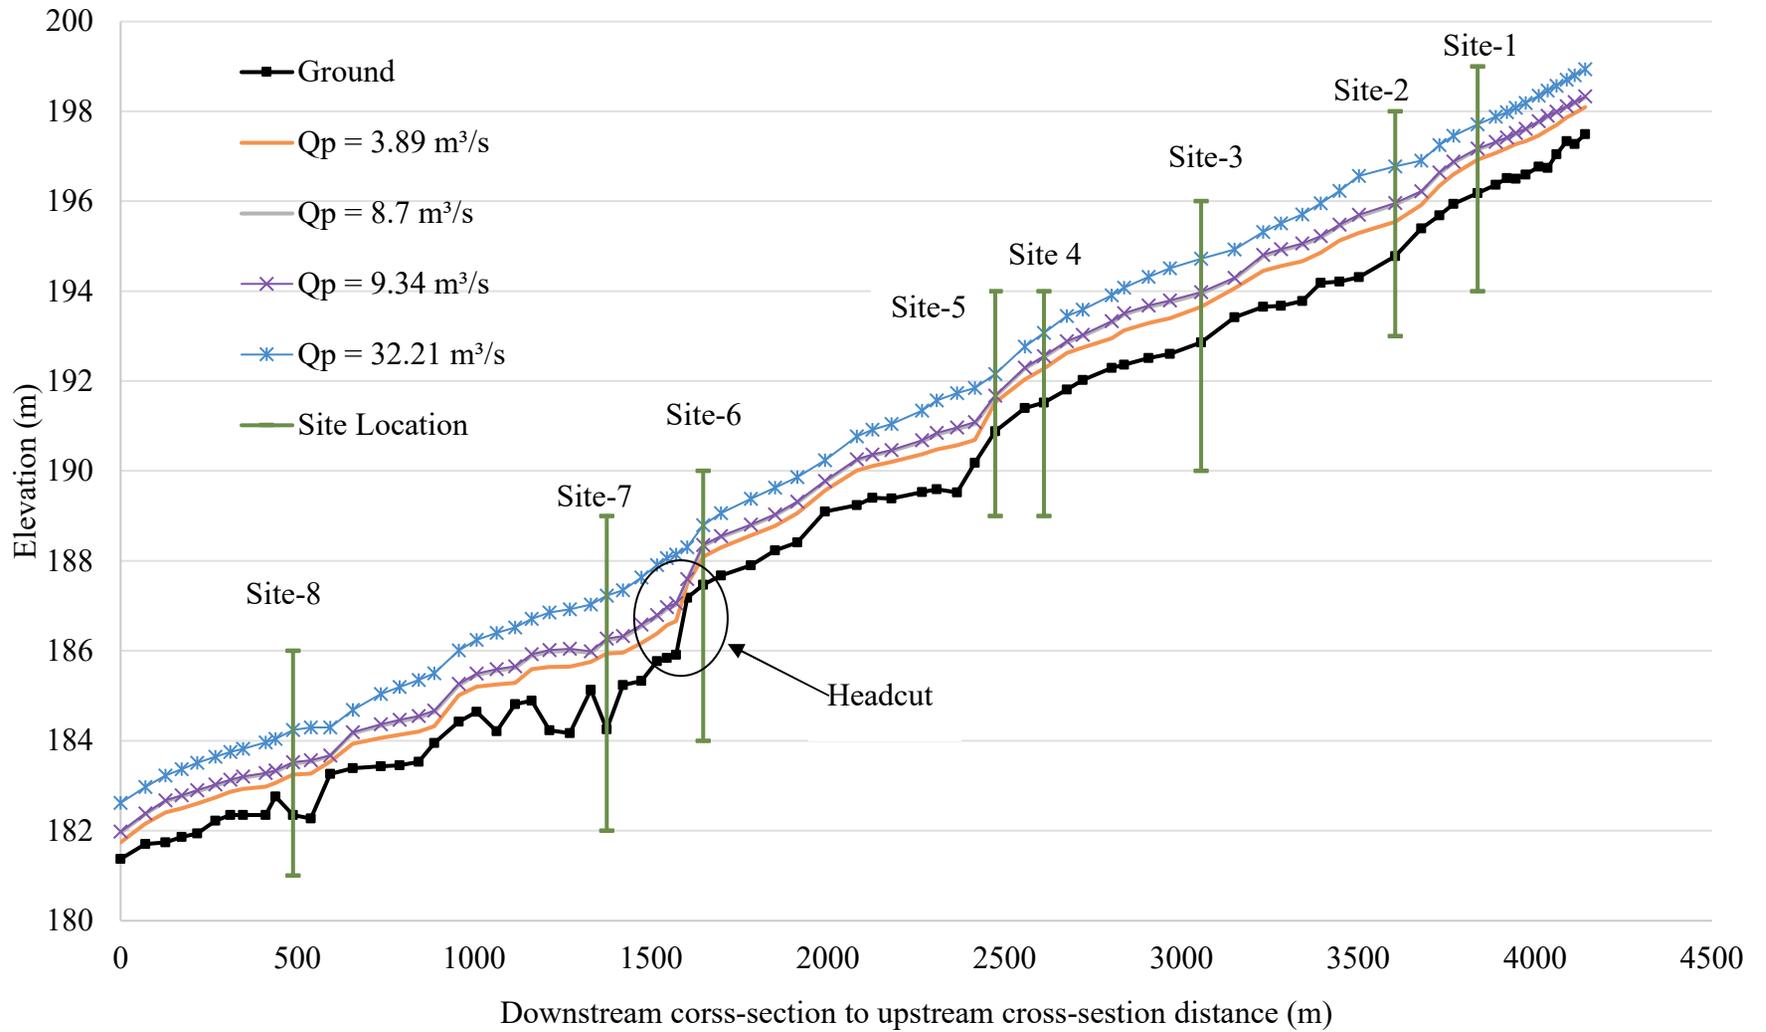
Figure 26. Longitudinal profile of the study stream and water surface elevations.

The Froude numbers in all simulations were relatively low throughout the entire channel segment except the headcut location (Figure 26, 27). The Froude number is a function of channel velocity, hydraulic depth, and gravitational acceleration that can be expressed as $F = V/\sqrt{gd}$ where V is velocity, g is the acceleration due to gravity, and d is hydraulic depth (Krause, 2010). For the pre-settlement forest cover to present-day scenario discharges, the multi-threaded segments (site-1 to 6) experiences a lower Froude number (< 0.4) since the channel slope of this segment was gentle (0.004) (Figure 26, 27). In contrast, this scenario changed to the single-channel and channelized segments (Figure 26). In the headcut location, the Froude number was estimated above one that caused a super-critical flow in this segment (Figure 26, 27).

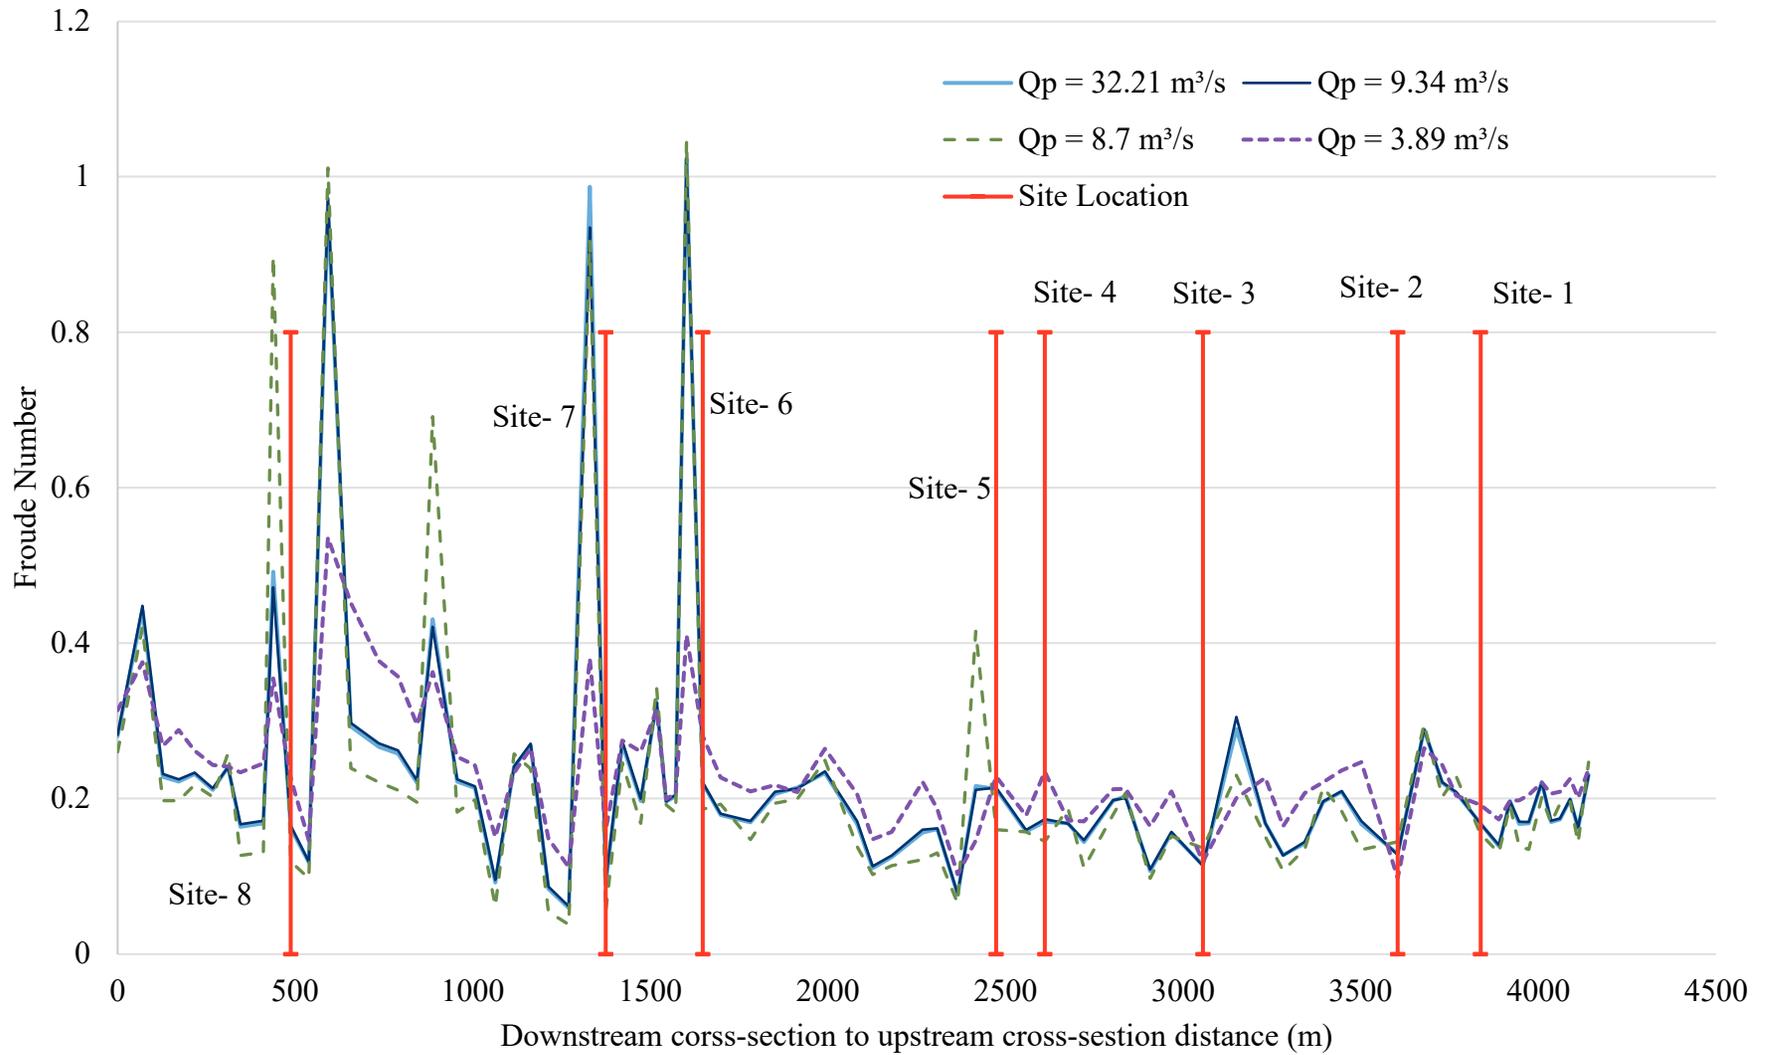
Figure 27. Channel Froude number along with the longitudinal profile.

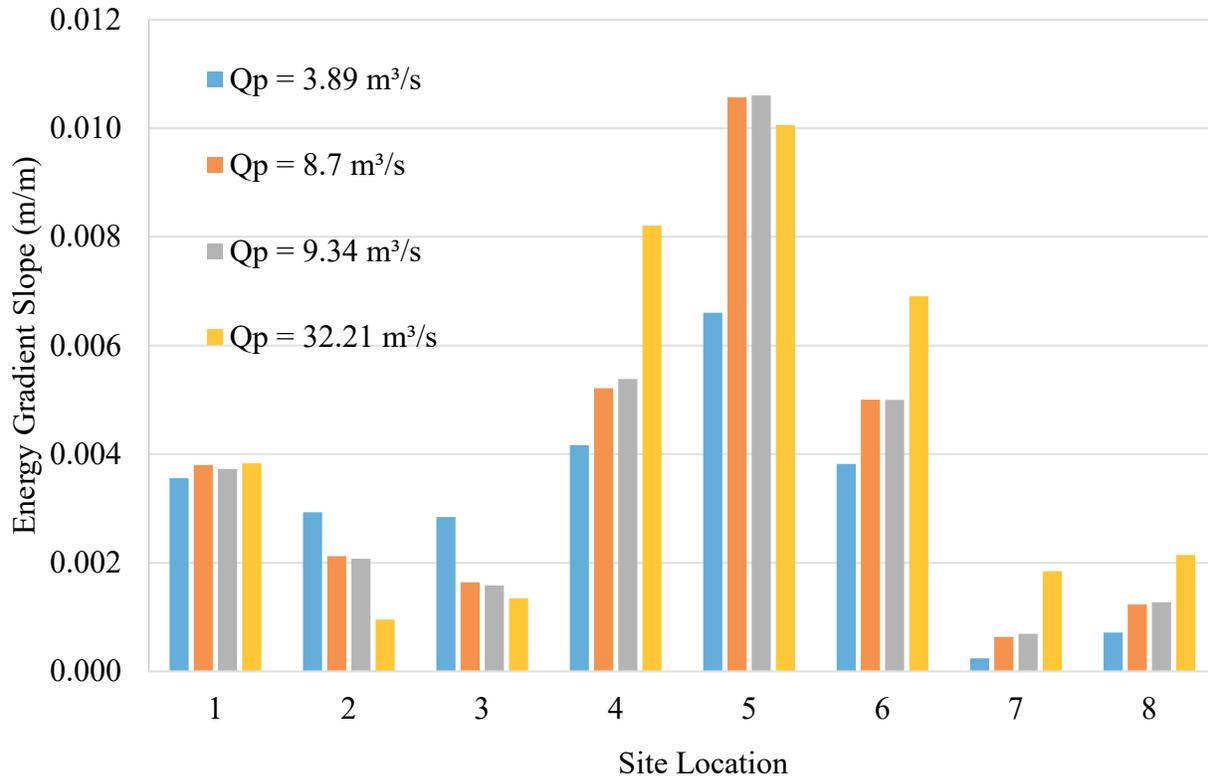
Figure 28. Energy gradient slopes for different discharges.
