**LONG-TERM HYDROLOGICAL IMPACTS OF HISTORICAL LOGGING ON
RECENT HYDRO-GEOMORPHIC CONDITIONS, BIG BARREN CREEK
WATERSHED, MARK TWAIN NATIONAL FOREST**

A Master's Thesis

Shoukat Ahmed

July 2021

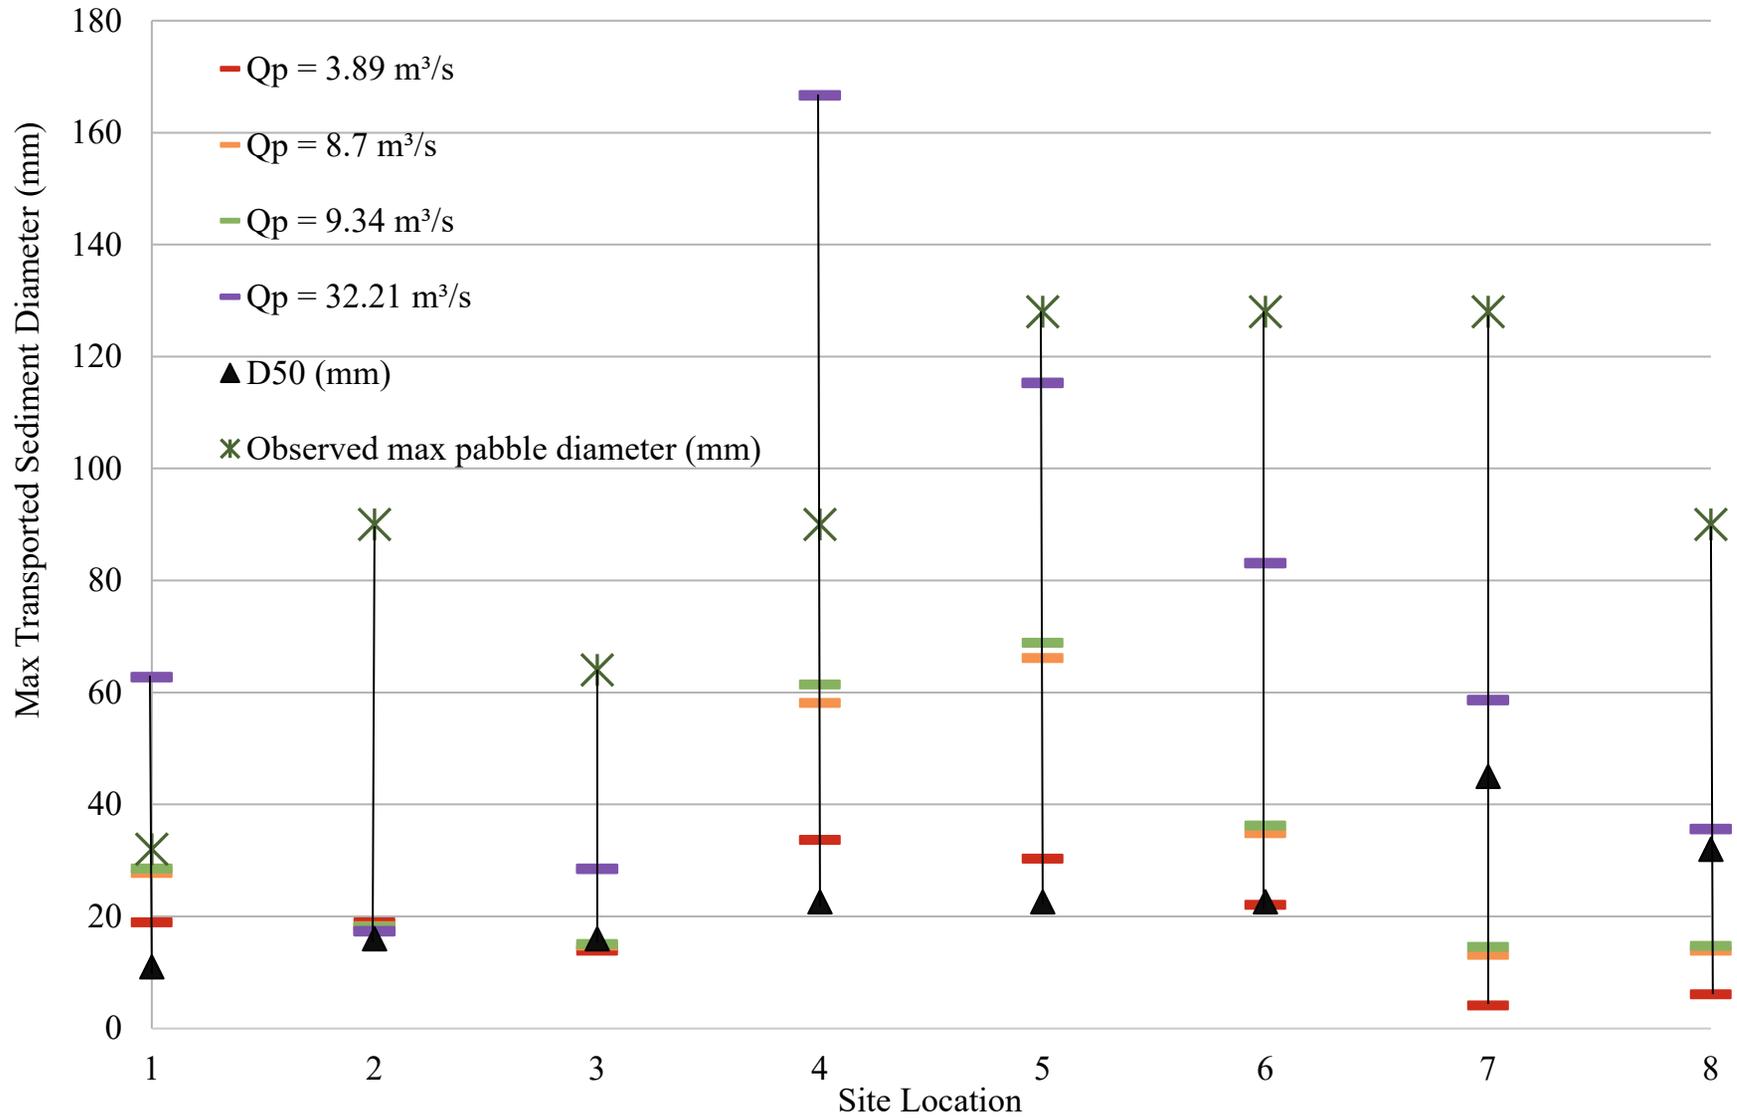
Figure 29. Maximum moveable sediment diameter for different peak discharges.

In this study, the HEC-RAS simulated shear stress and their associated moveable maximum sediment diameter were compared with the channel types and field measured grain size distribution. The simulated shear stress (around 99 N/m^2) of site-4 for the post-disturbance discharge was enough to move sediment with a maximum diameter of 167 mm (large cobble) (Figure 29). The pebble count survey result showed that this site's maximum observed pebble diameter was 90 mm, and D50 was 22.6 (Figure 29). Thus, the post-disturbance discharge could significantly alter the bed form and sediment transport of site-4. A similar finding was also found at site-1, where the post-disturbance discharge generated shear stress could transport a 63 mm sediment that was higher than the observed maximum pebble diameter (32 mm) (Figure 29). However, a different scenario was observed for the remaining four sites. On these sites, the post-

The overall shear stress distribution of the entire study stream showed that during the pre-settlement forest cover and good soil condition ($Q = 3.89 \text{ m}^3/\text{s}$), the average shear stress of the multi-threaded segment was 19 N/m^2 , which was calculated 33 N/m^2 in the channelized segment (Appendix I-1). The average shear stress of the incised and single-channel was estimated at 58 N/m^2 for the discharge of $3.89 \text{ m}^3/\text{s}$ (Appendix I-1). In the present-day scenario, the average shear stress of the incised single channel was considerably higher compared to other scenarios. In the present day, the average shear stress of this segment was estimated at 105 N/m^2 and a maximum of 307 N/m^2 was calculated at the headcut location that causing more channel incisions by increasing erosion and sediment supply. Channel incision occurs when a stream is affected by huge imbalances between upstream sediment supply and respective transporting power due to anthropogenic and natural disturbances (Simon and Rinaldi, 2006). It happens more where degradation starts without widening the channel with maximum boundary shear stress and unit stream power (Simon and Thorne, 1996). The lower w/d ratio (< 10) upstream to site-7 is crucial for increasing the incised channel and headcut migration. From this headcut location to site-7, the total shear stress dropped 307 to 10 N/m^2 (Appendix I-3). This condition had made this site-7 a depositional zone that obtained sediment from the headcut erosion.

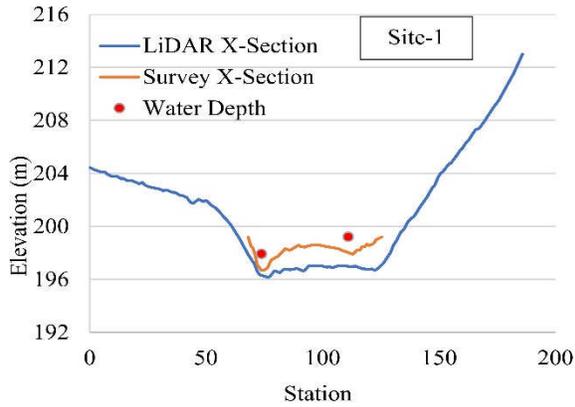
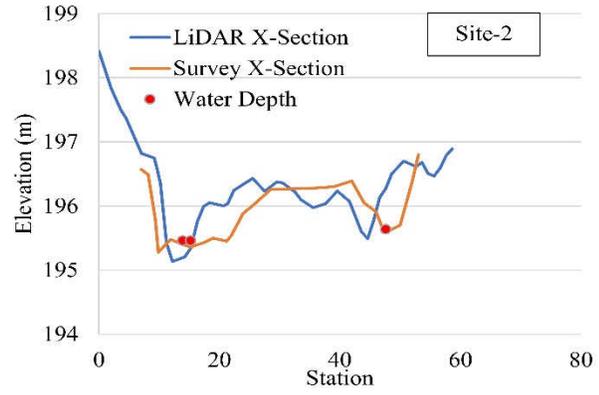
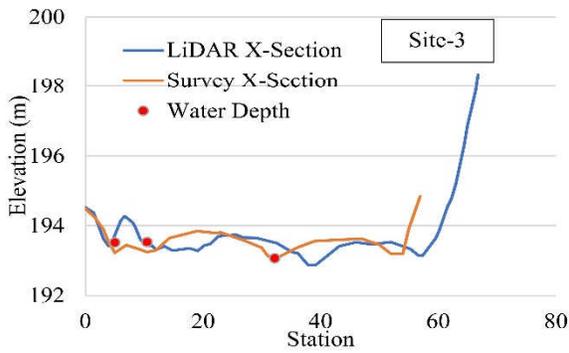
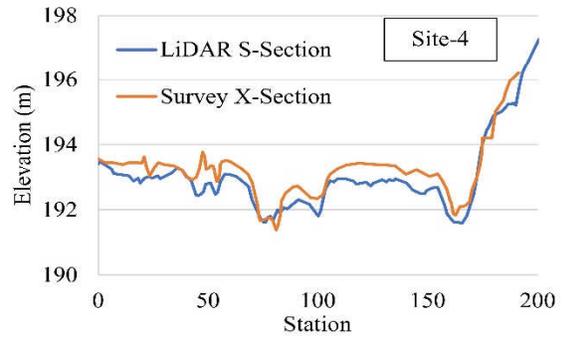
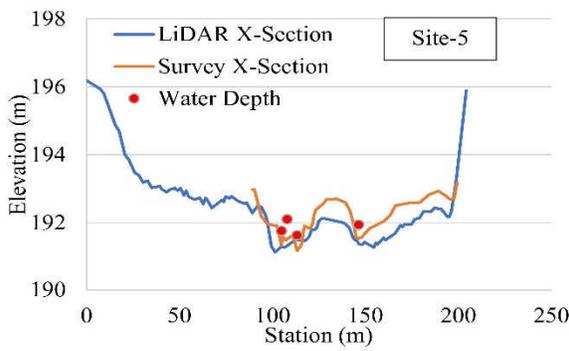
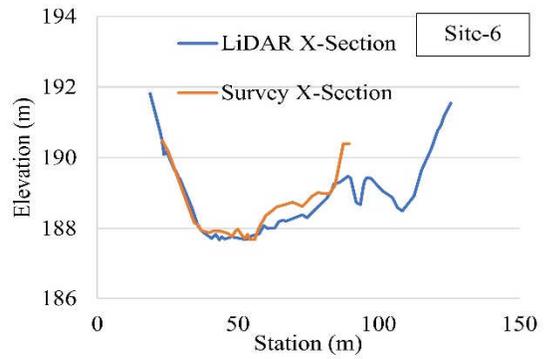
Appendix B. Comparison between field survey and LiDAR extracted cross-sections.

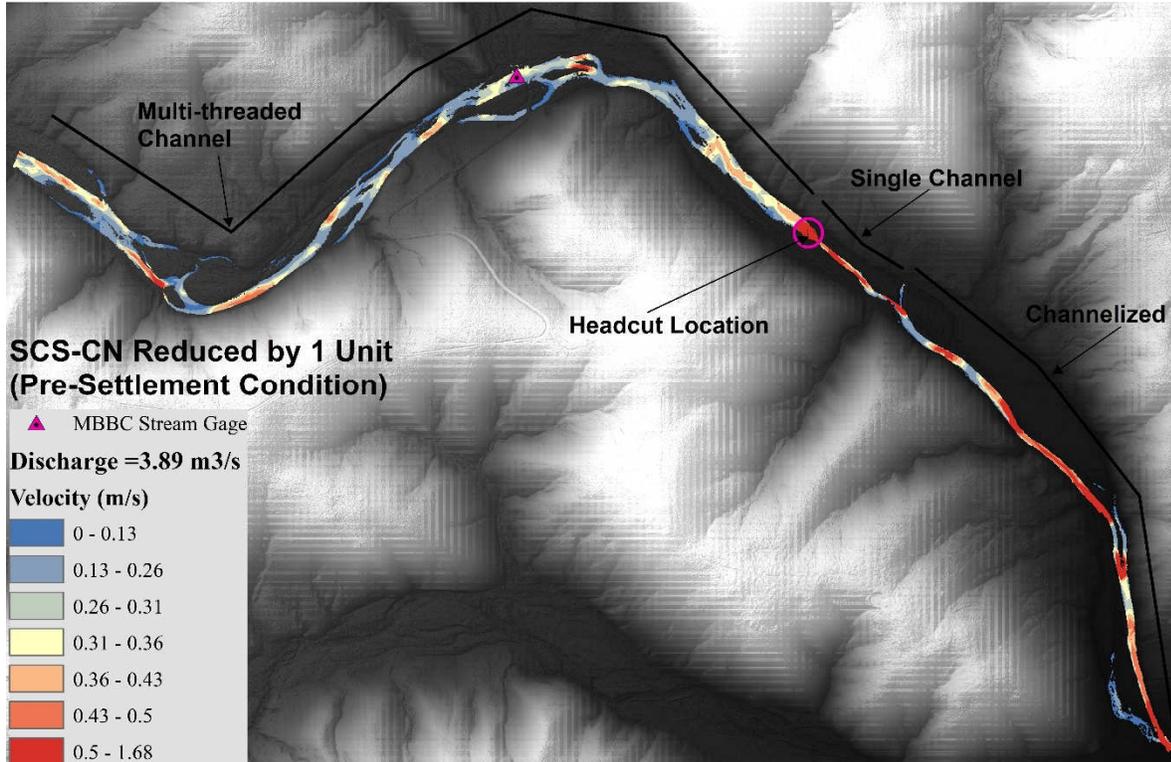
Appendix G-1: Channel's velocity distribution for $Q_p = 3.89 \text{ m}^3/\text{s}$ discharge

Overall stream velocity showed higher velocity in the segment from the headcut to the channelized segment (Appendix G). Changing flow patterns from sub-critical to supercritical due to headcut and low stream bed resistance was responsible for the increased velocity of this segment. On average, during the post-disturbance period, the average velocity of the multi-threaded segment was increased by two times compared to the pre-settlement forest cover and good soil condition (Appendix G-1, G-4). A higher velocity was found near the bank of the multi-threaded segment that caused stream bank erosion during the post-disturbance period (Appendix G-4). In the post-disturbance scenario (32.21 m³/s), the average velocity of the single-channel was ranged from 0.71 to 1.11 m/s that was found from 0.49 to 1.55 m/s in the channelized segment (Appendix G-4). No significant change was observed in the average velocity due to converting presettlement shortleaf pine-dominated forest cover to the present-day hardwood-dominated forest.

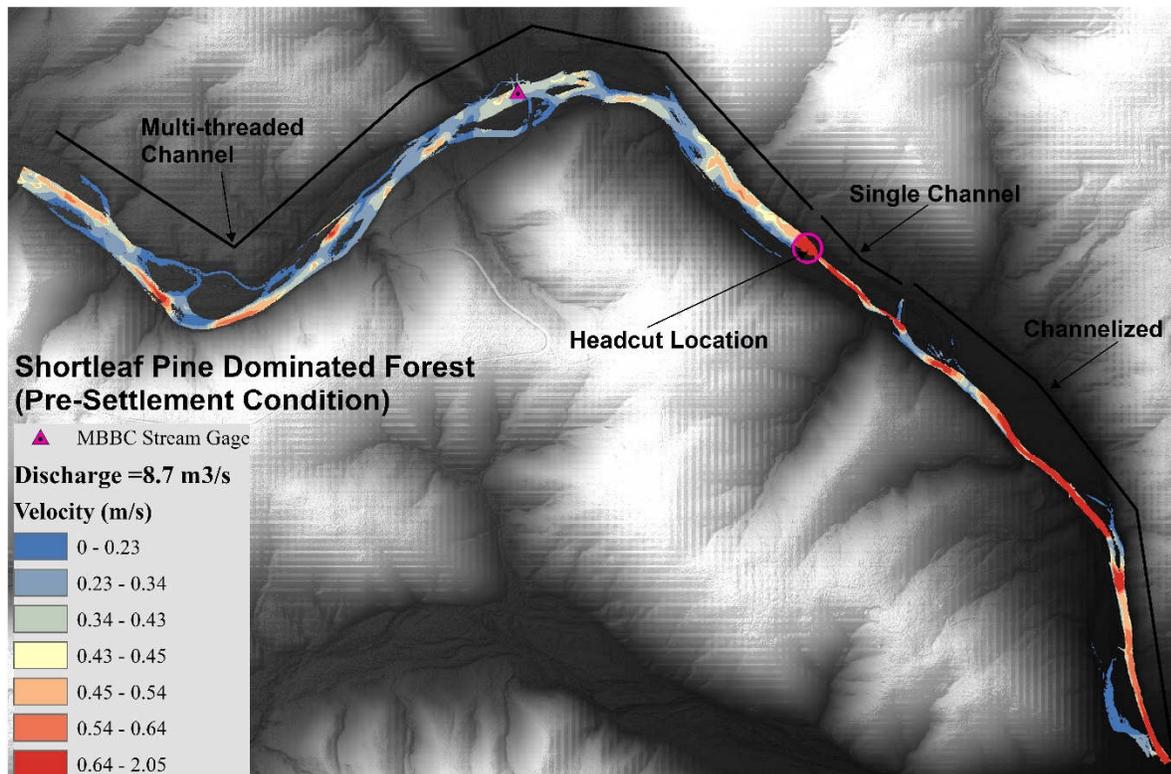
Appendix G-2: Channel's velocity distribution for $Q_p = 8.7 \text{ m}^3/\text{s}$ discharge

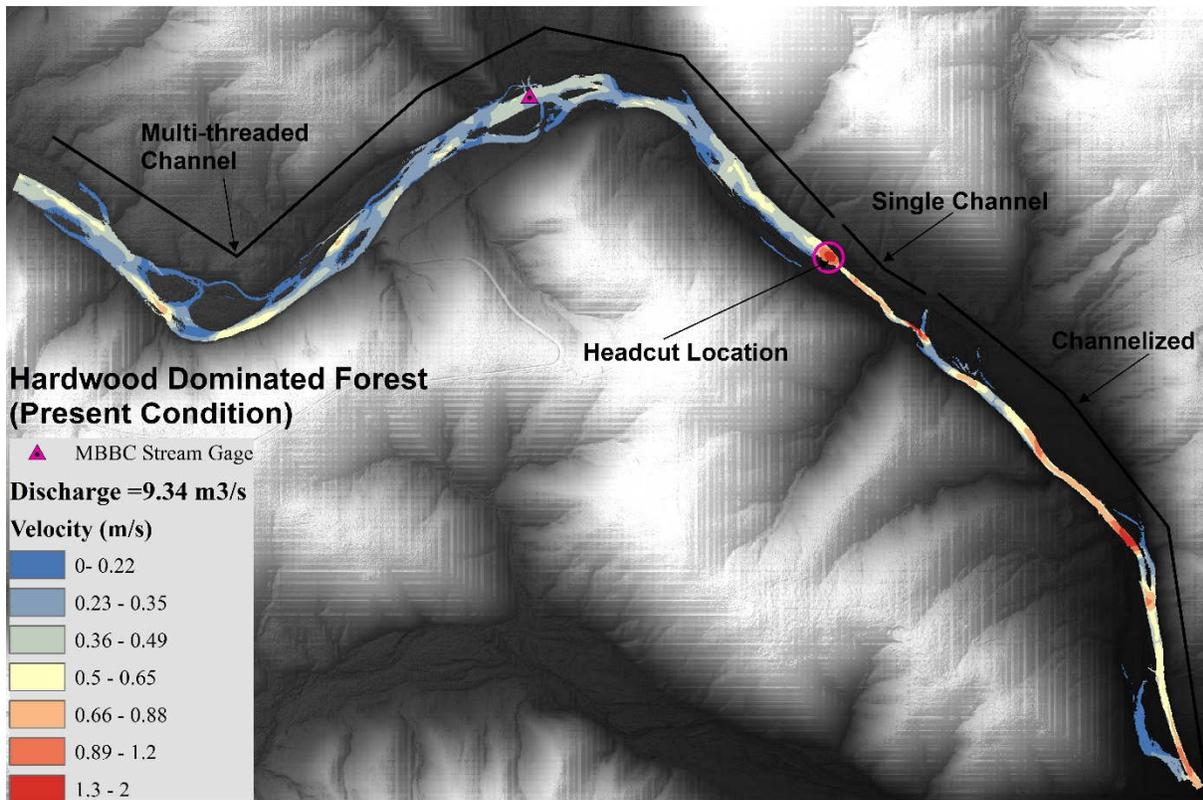
Appendix G-3: Channel's velocity distribution for $Q_p = 9.34 \text{ m}^3/\text{s}$ discharge

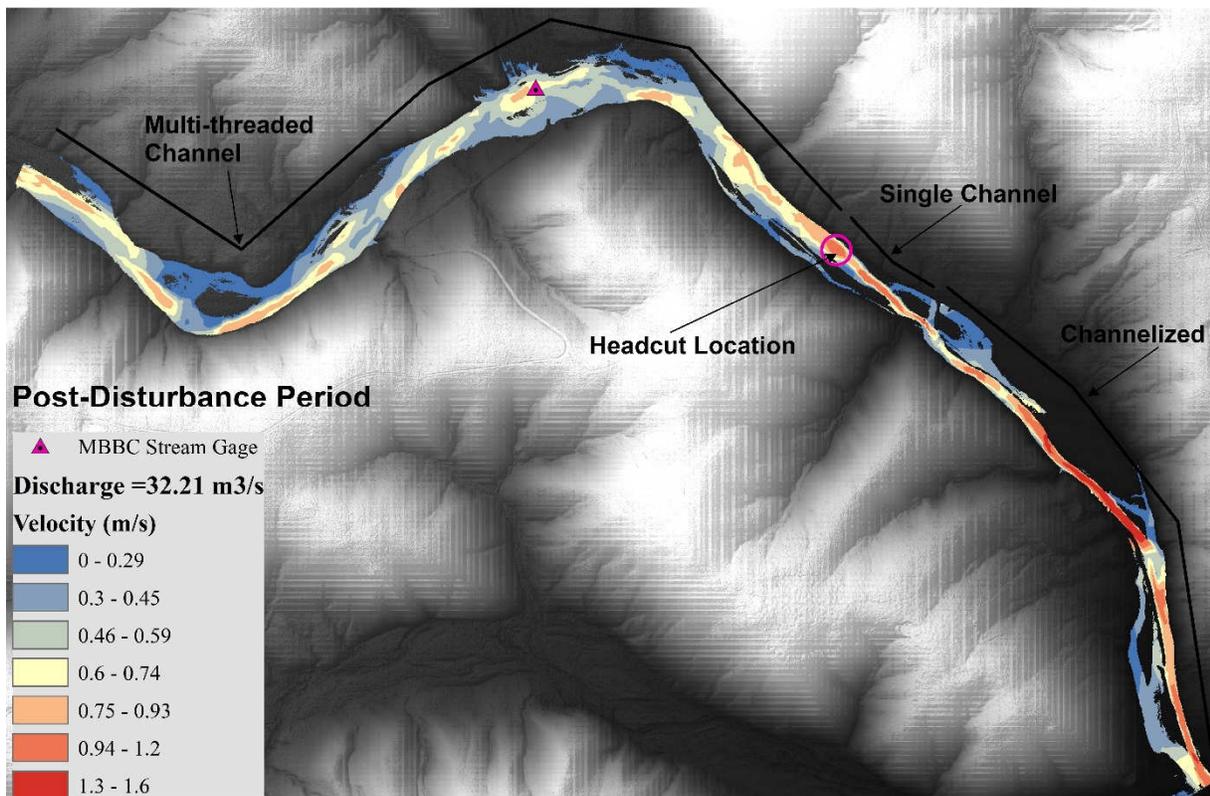
Appendix G-4: Channel's velocity distribution for $Q_p = 32.21 \text{ m}^3/\text{s}$ discharge

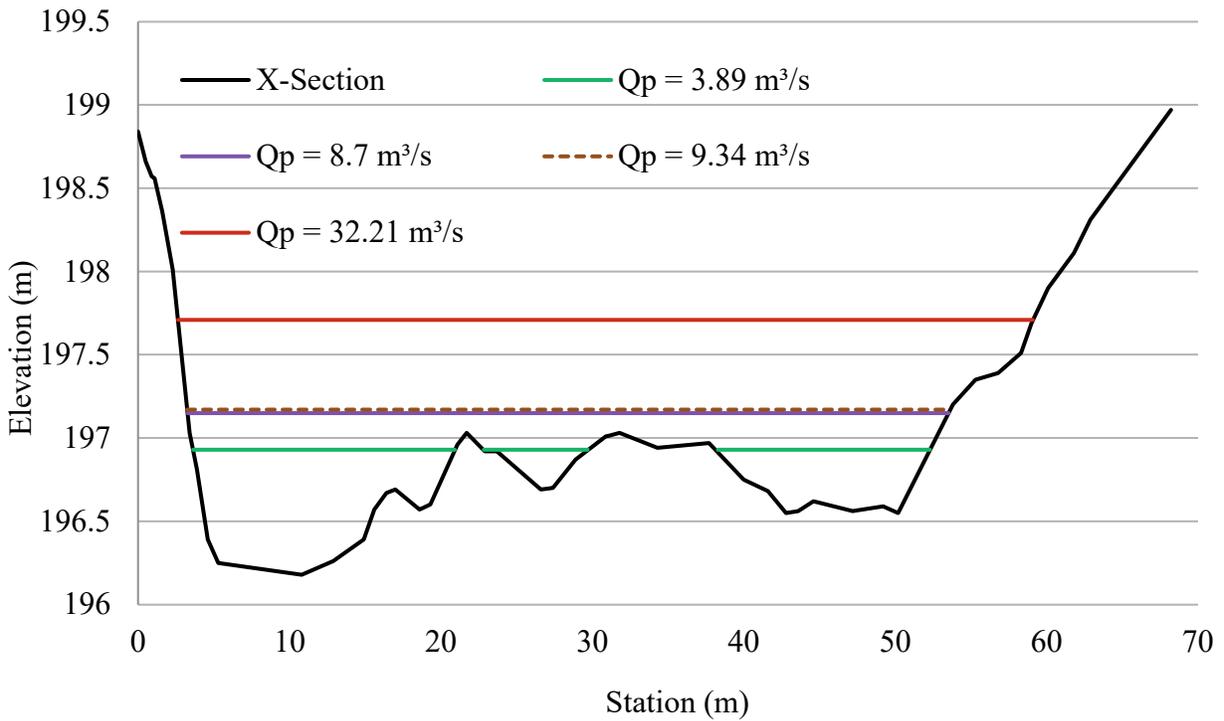
Appendix H-1. Water surface elevations at site-1 at different peak discharge.

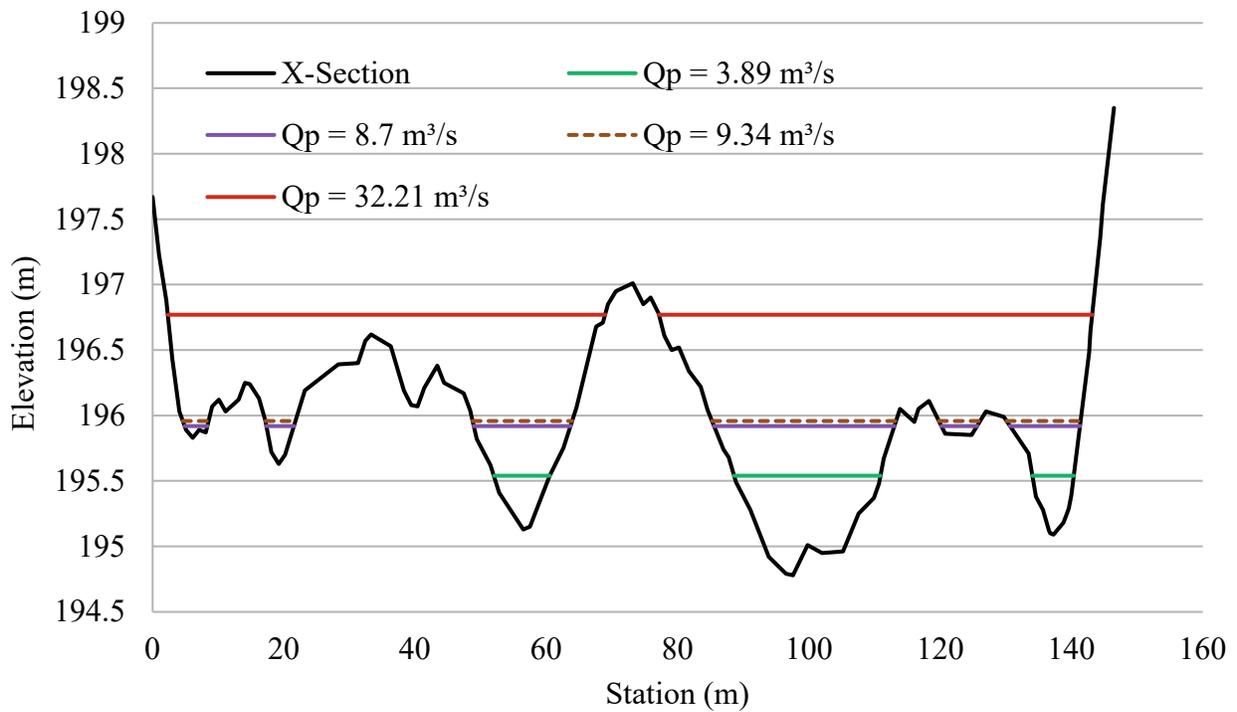
Appendix H-2. Water surface elevations at site-2 at different peak discharge.

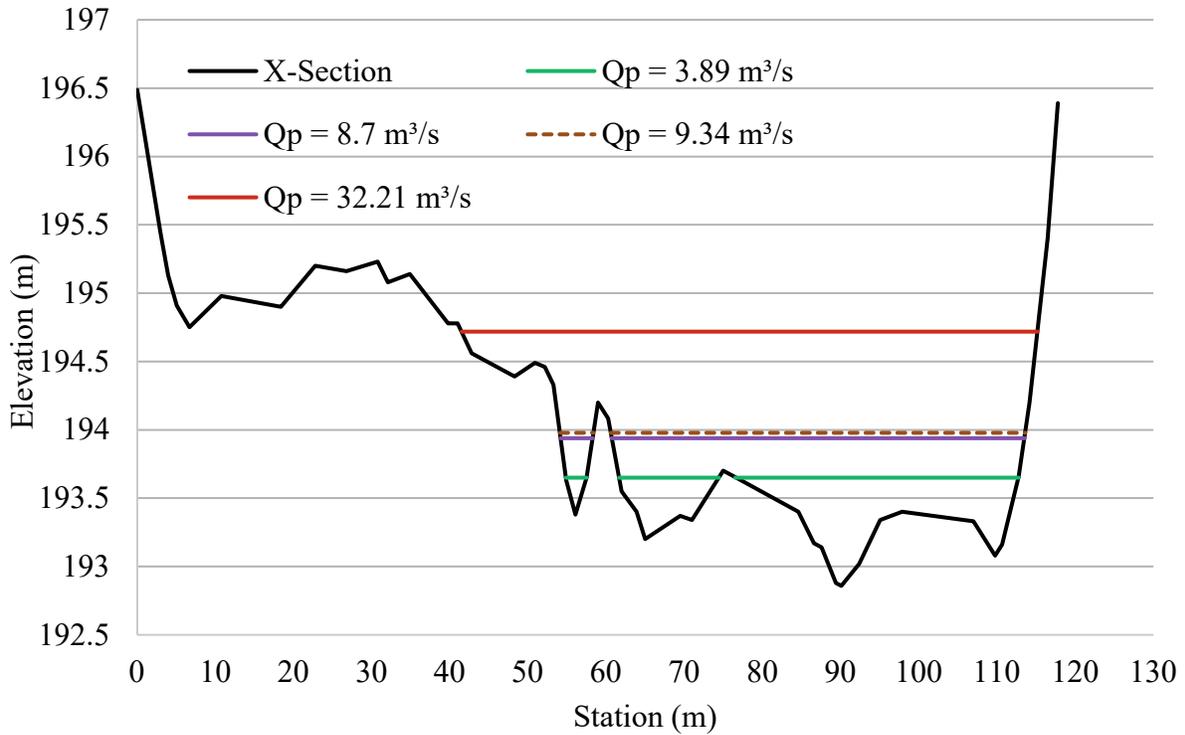
Appendix H-3. Water surface elevations at site-3 at different peak discharge.

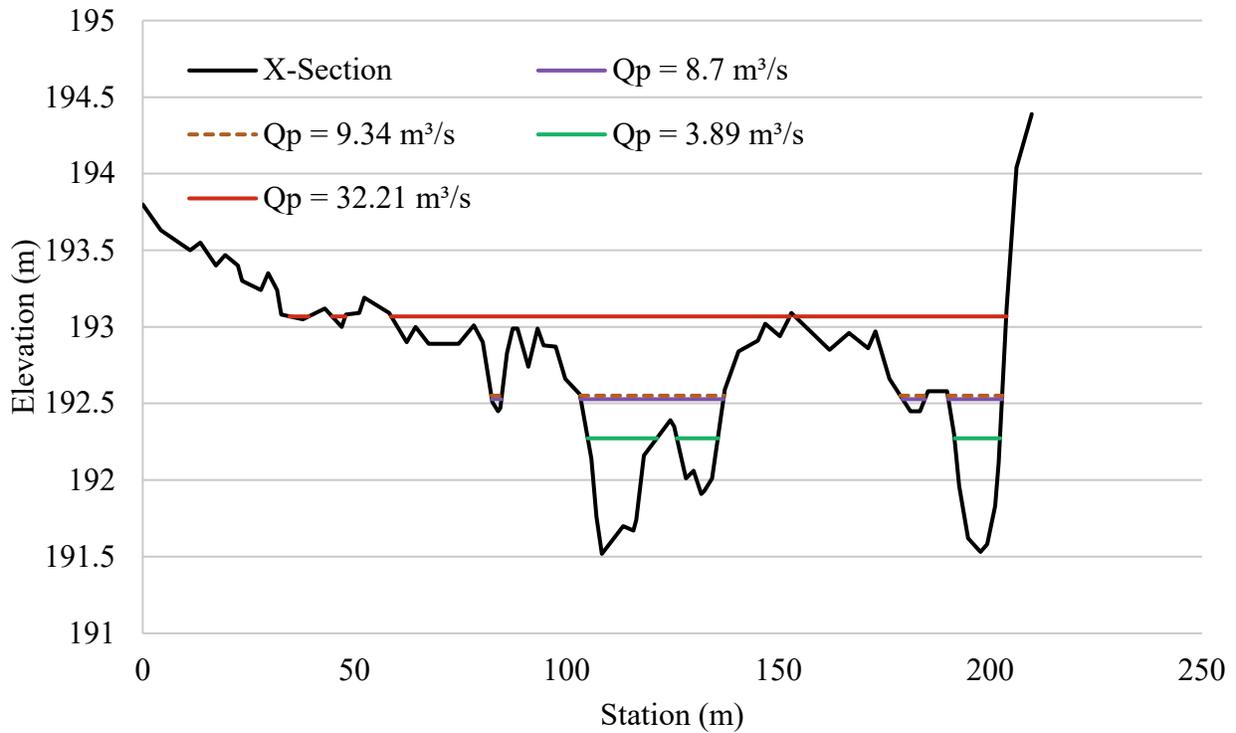
Appendix H-4. Water surface elevations at site-4 at different peak discharge.

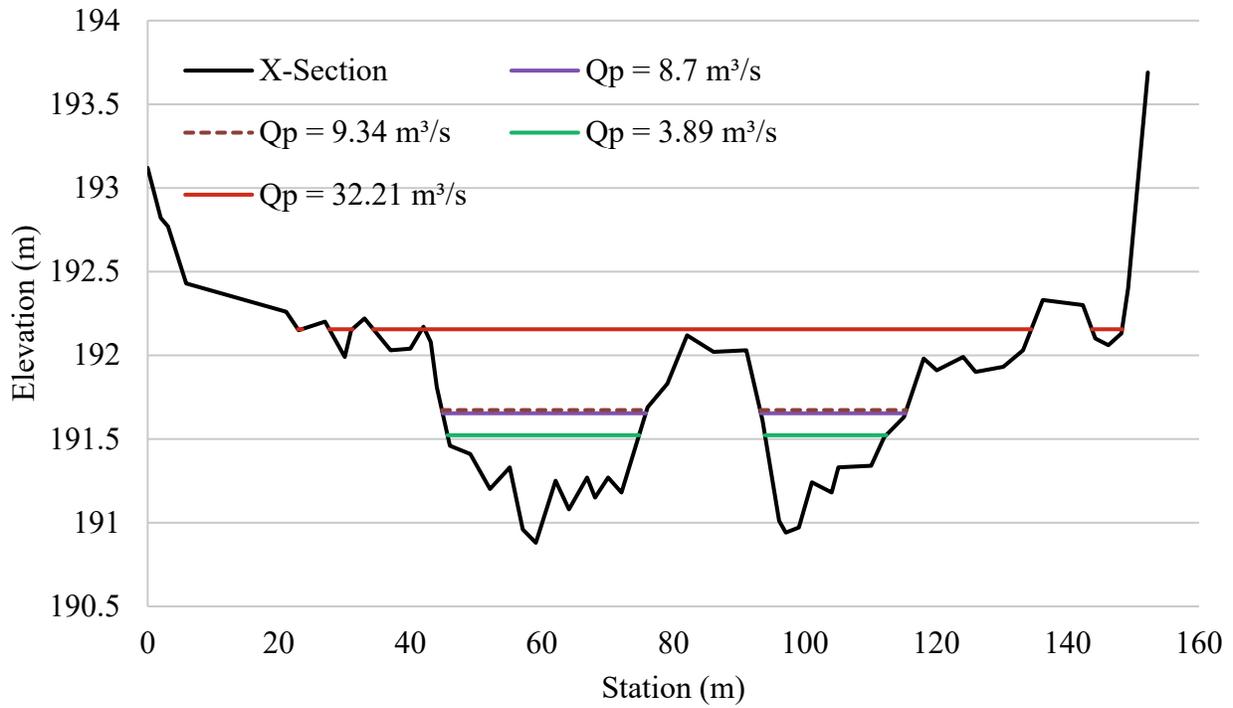
Appendix H-5. Water surface elevations at site-5 at different peak discharge.

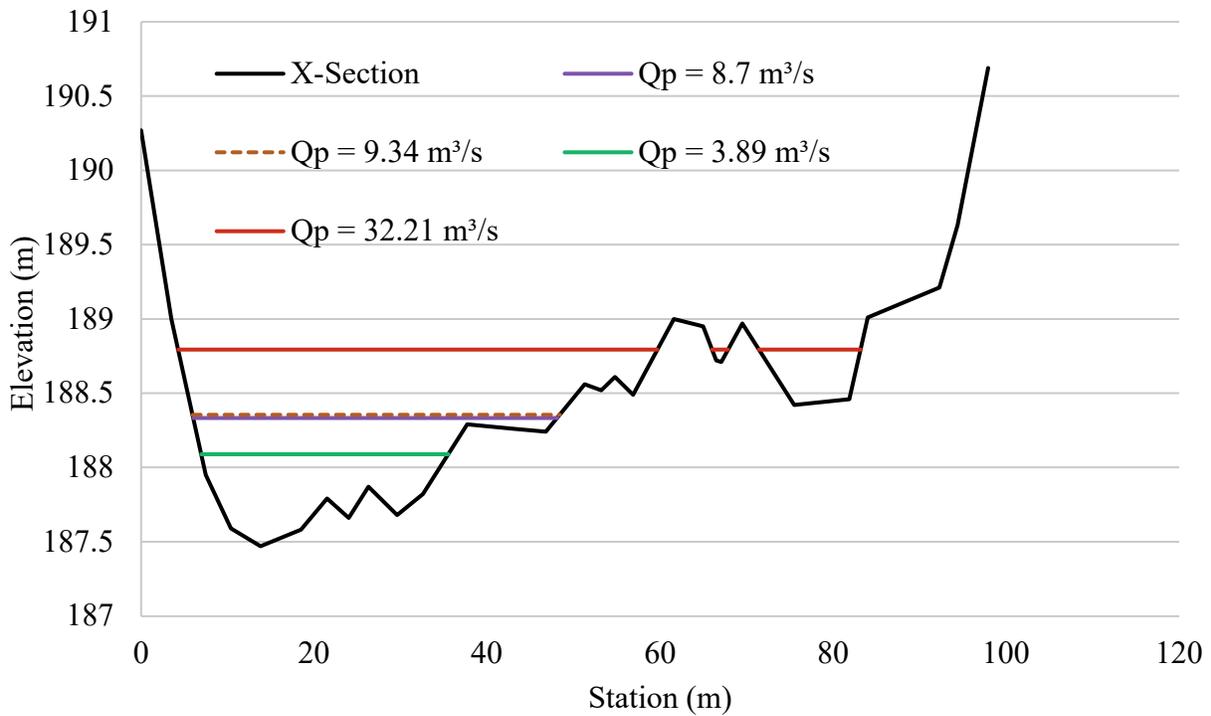
Appendix H-6. Water surface elevations at site-6 at different peak discharge.

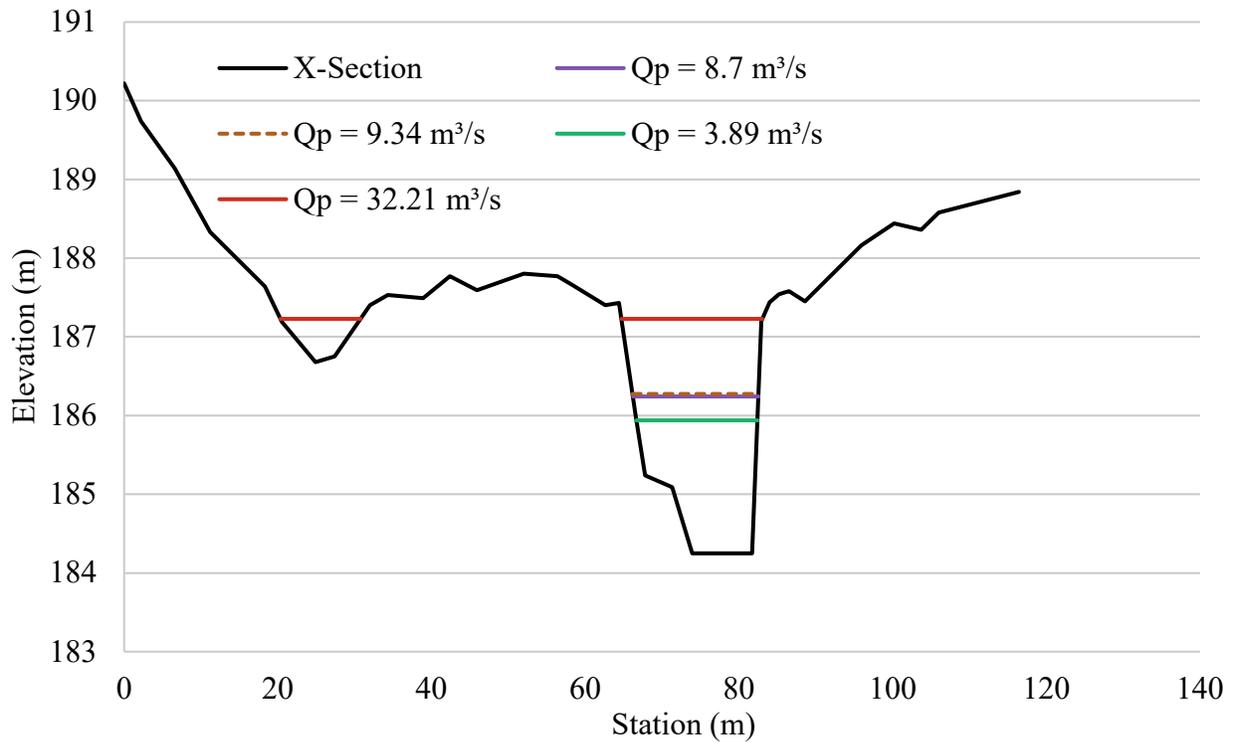
Appendix H-7. Water surface elevations at site-7 at different peak discharge.

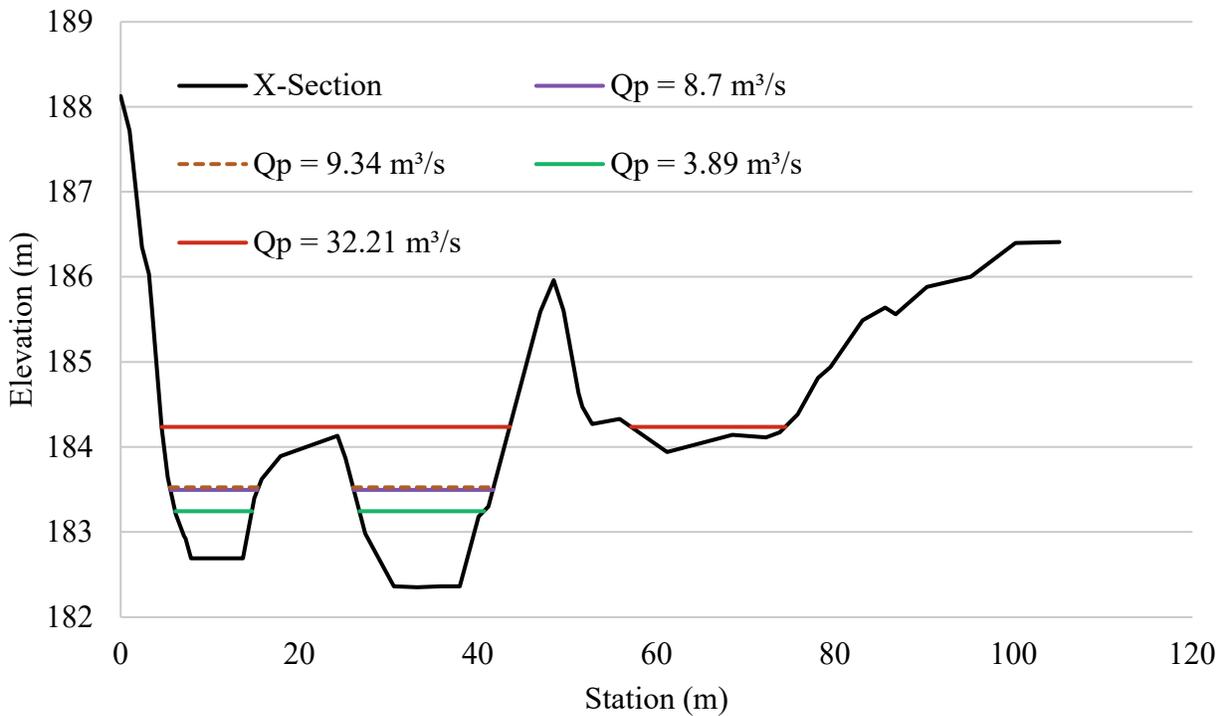
Appendix H-8. Water surface elevations at site-8 at different peak discharge.

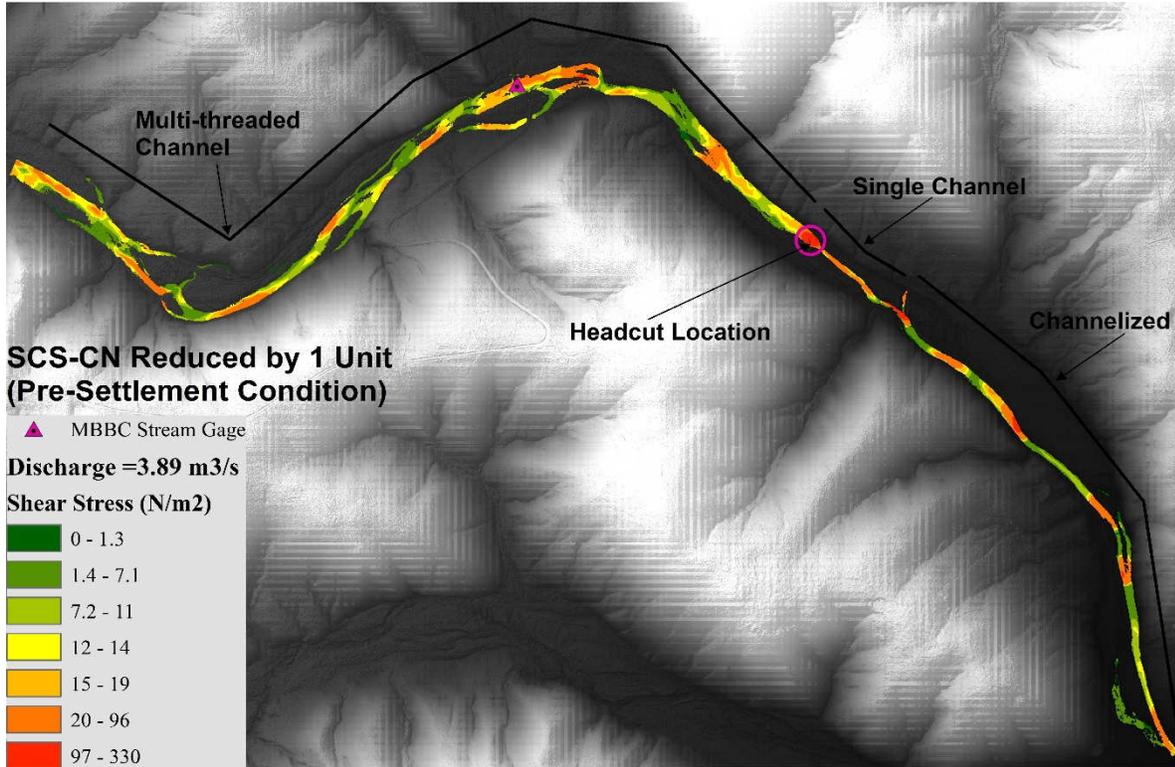
Appendix I-1. Channel's total shear stress distribution for $Q_p = 3.89 \text{ m}^3/\text{s}$ discharge.

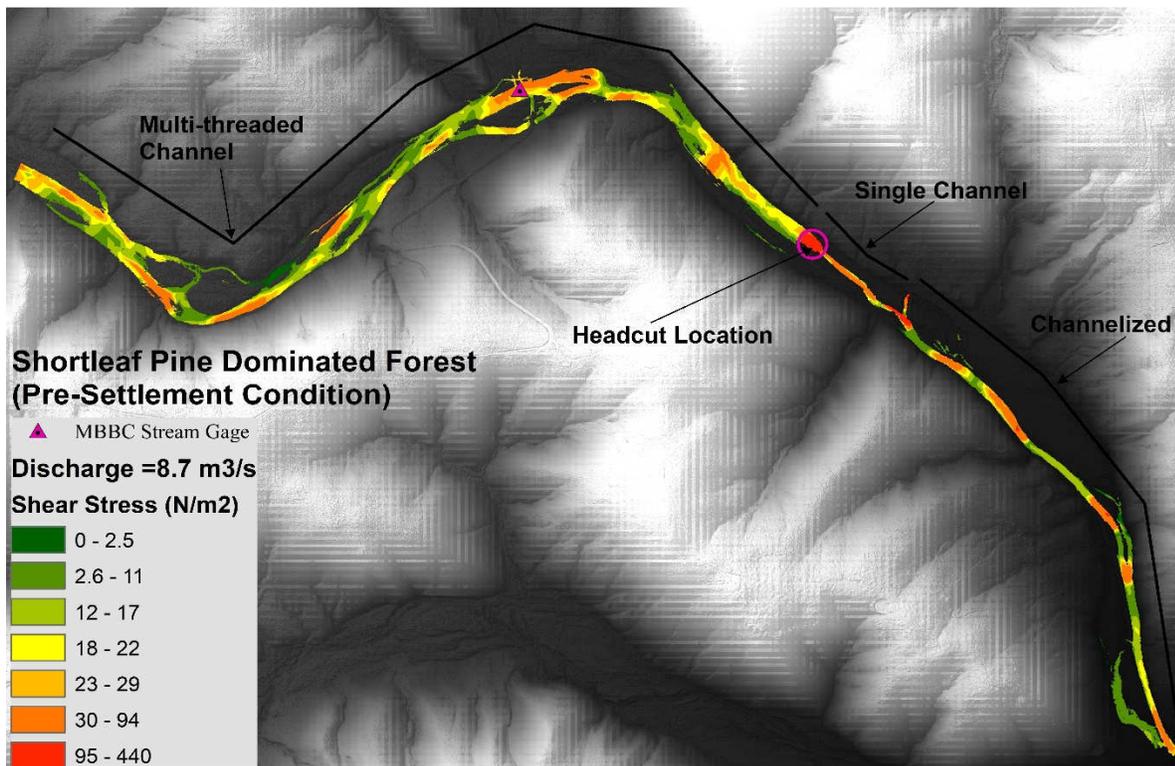
Appendix I-2. Channel's total shear stress distribution for $Q_p = 8.7 \text{ m}^3/\text{s}$ discharge.

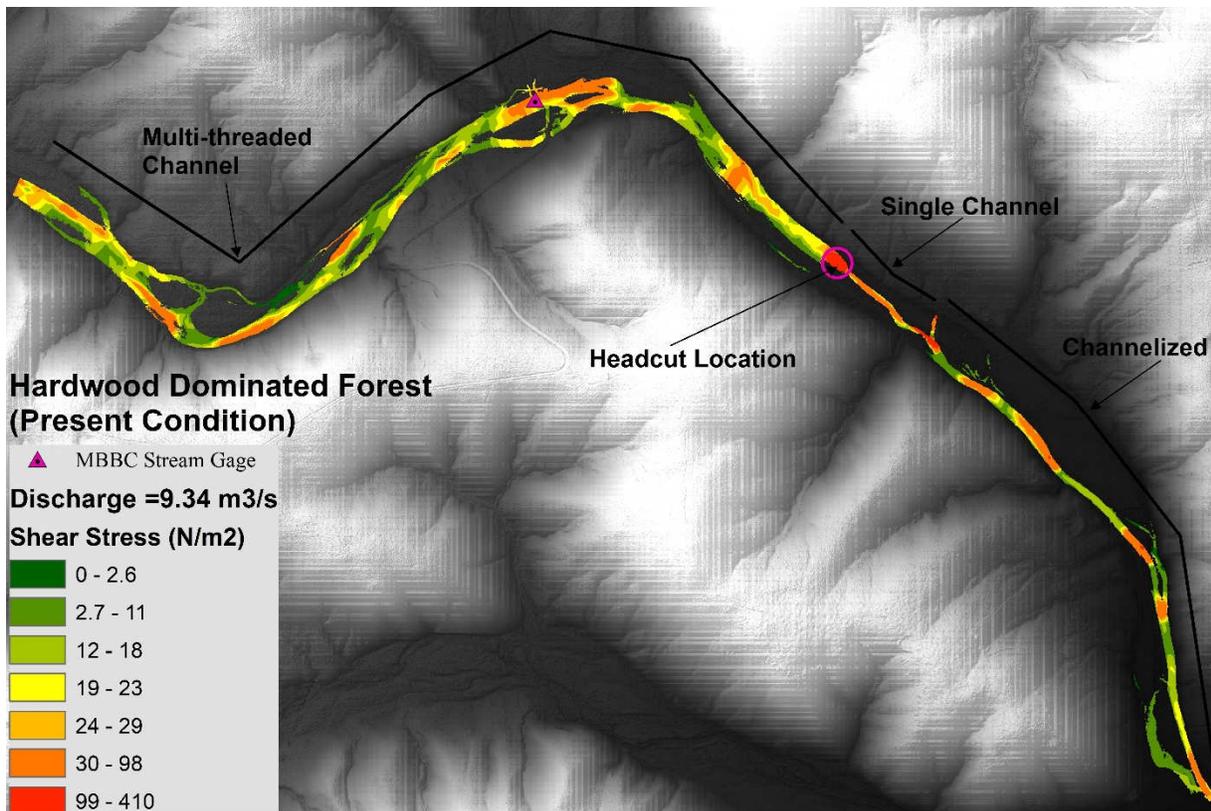
Appendix I-3. Channel's total shear stress distribution for $Q_p = 9.34 \text{ m}^3/\text{s}$ discharge.

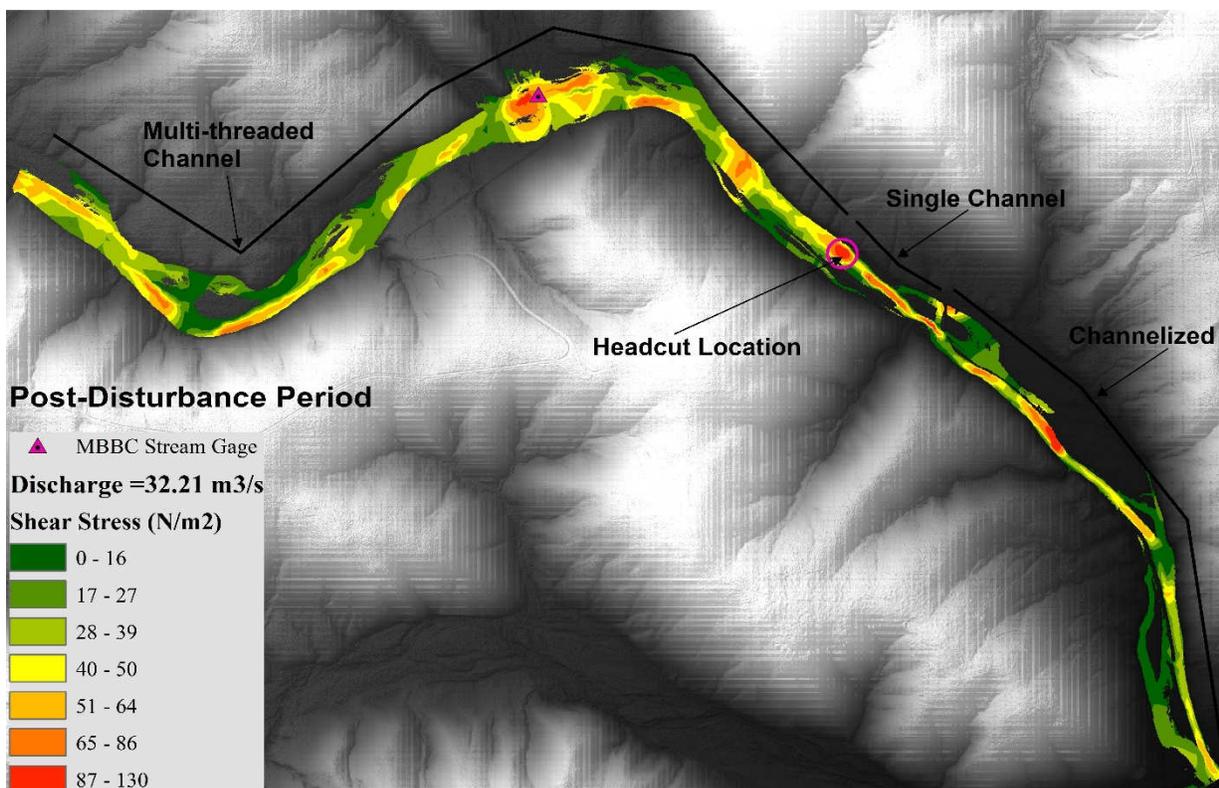
Appendix I-4. Channel's total shear stress distribution for $Q_p = 32.21 \text{ m}^3/\text{s}$ discharge.

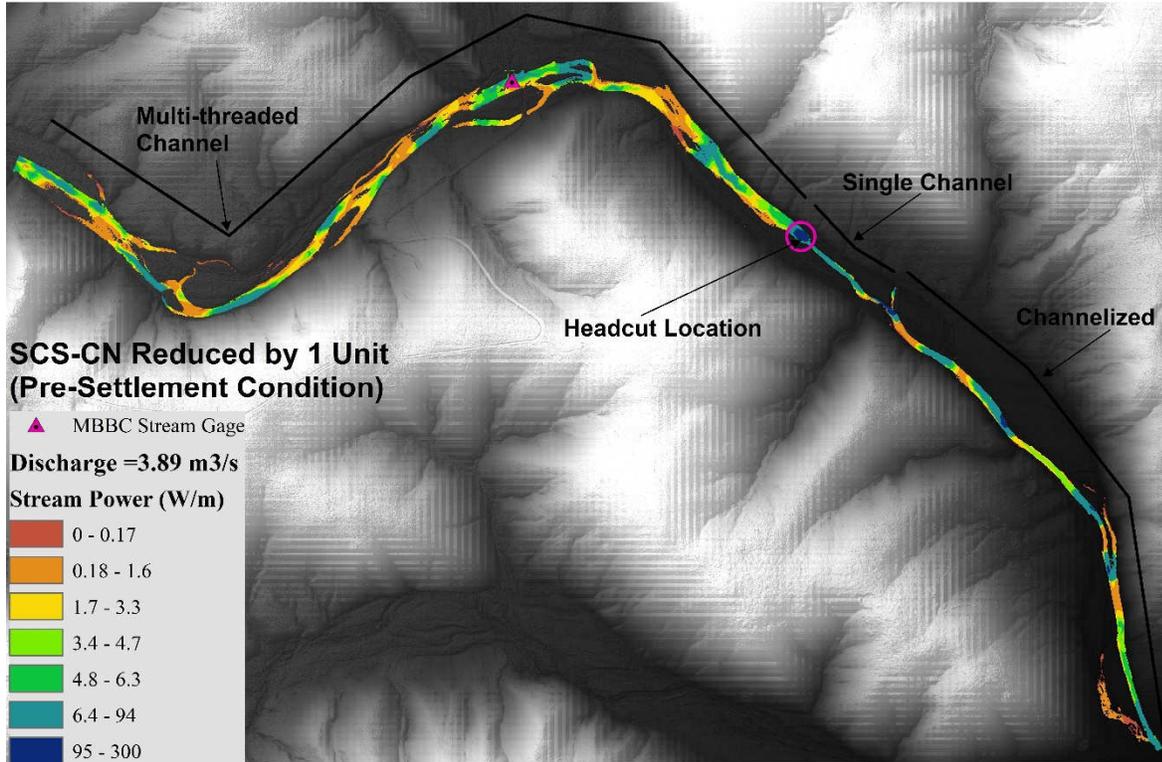
Appendix J-1. Channel's total stream power distribution for $Q_p = 3.89 \text{ m}^3/\text{s}$ discharge.

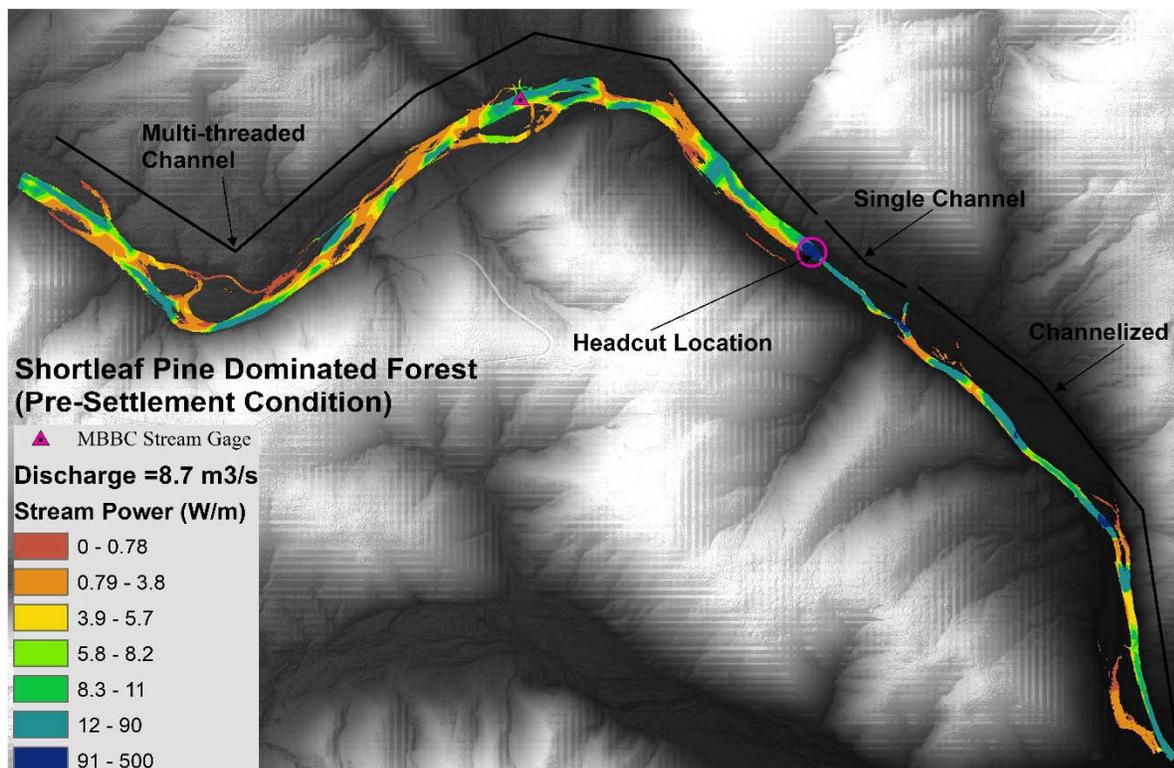
Appendix J-2. Channel's total stream power distribution for $Q_p = 8.7 \text{ m}^3/\text{s}$ discharge.

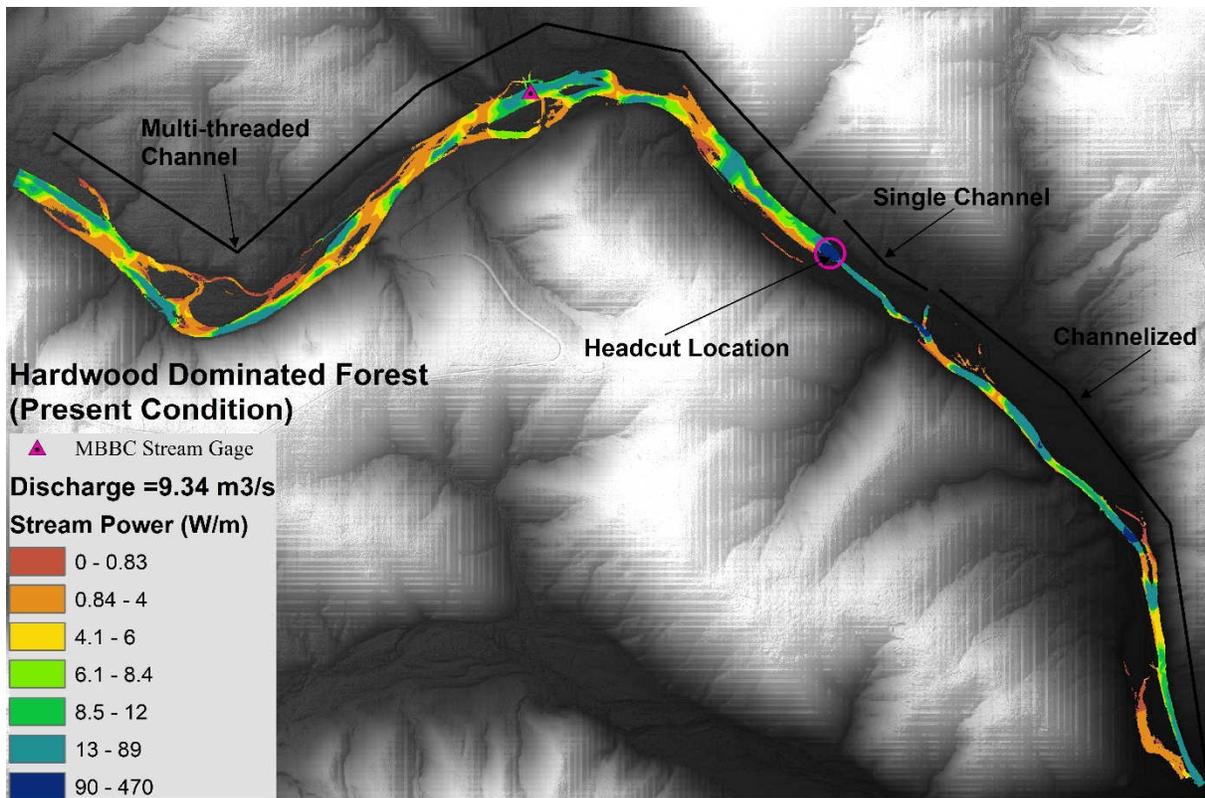
Appendix J-3. Channel's total stream power distribution for $Q_p = 9.34 \text{ m}^3/\text{s}$ discharge.

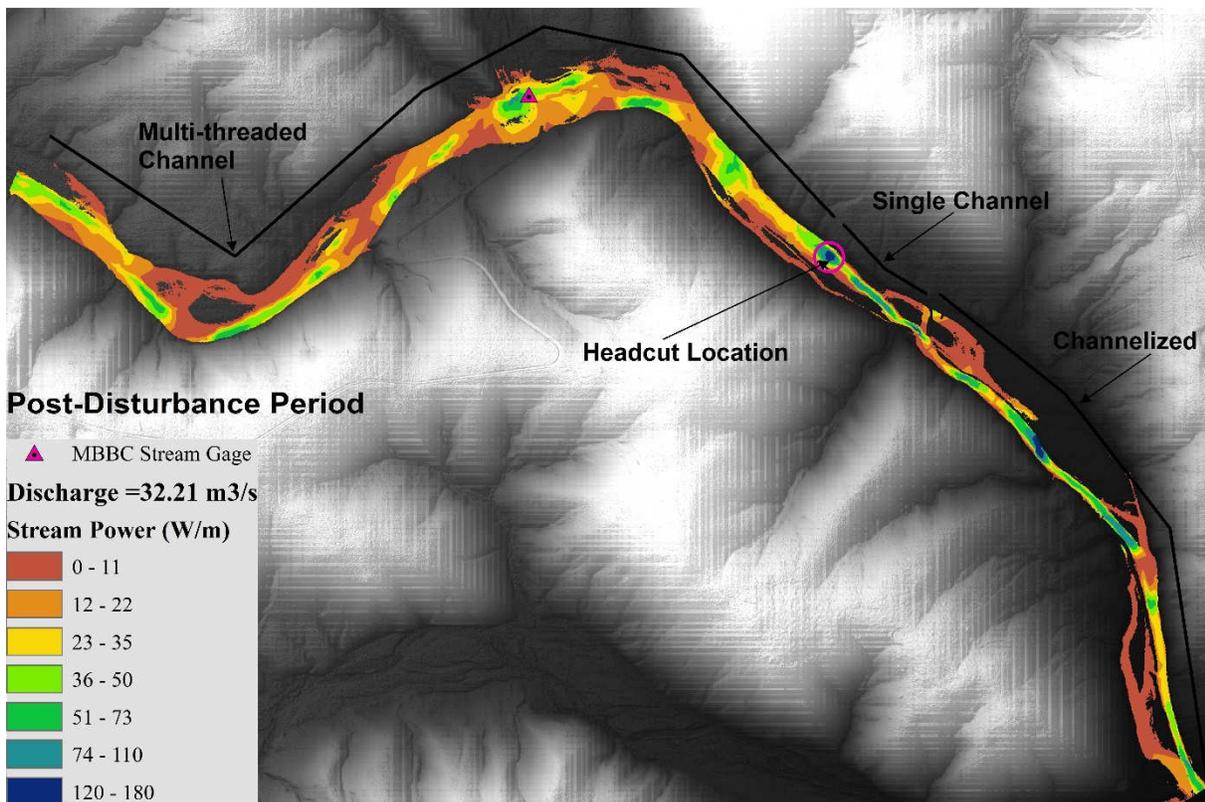
Appendix J-4. Channel's total stream power distribution for $Q_p = 32.21 \text{ m}^3/\text{s}$ discharge.
