Geomorphic Analysis of Lackman Tributary, Lenexa, KS.

Final report to Olsson Associates for the City of Lenexa, Kansas

December 17, 2009

OEWRI TR-09-004

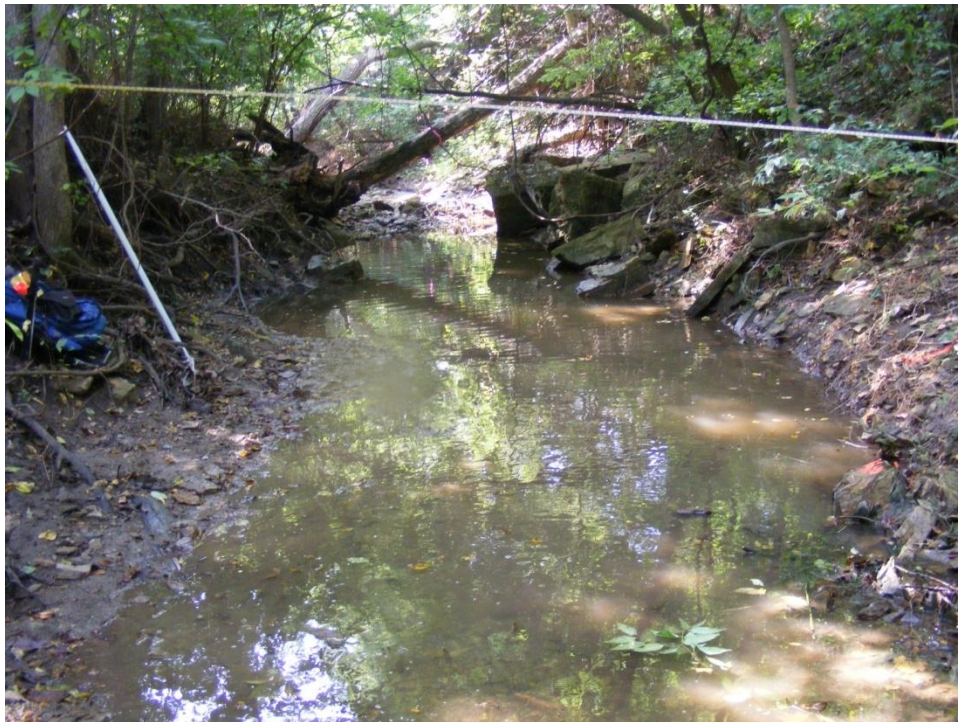
Photo 42. R14 – xs 15 St. 1,530 looking upstream (Sept. 2009)

SR-14-C: Riffle-Pool Reach with bedrock control (Station 1,750-1,100 ft)- This sub-reach begins below obvious influence of the knick-point where the valley begins to widen slightly. There are relatively well formed floodplains found in several places along this reach.
